**Inspection Photos
Spill # 484557
Inspection
Date:5/31/2023**

**All Photos taken
by Kris Neidel**

COLORADO
Oil & Gas Conservation
Commission
Department of Natural Resources

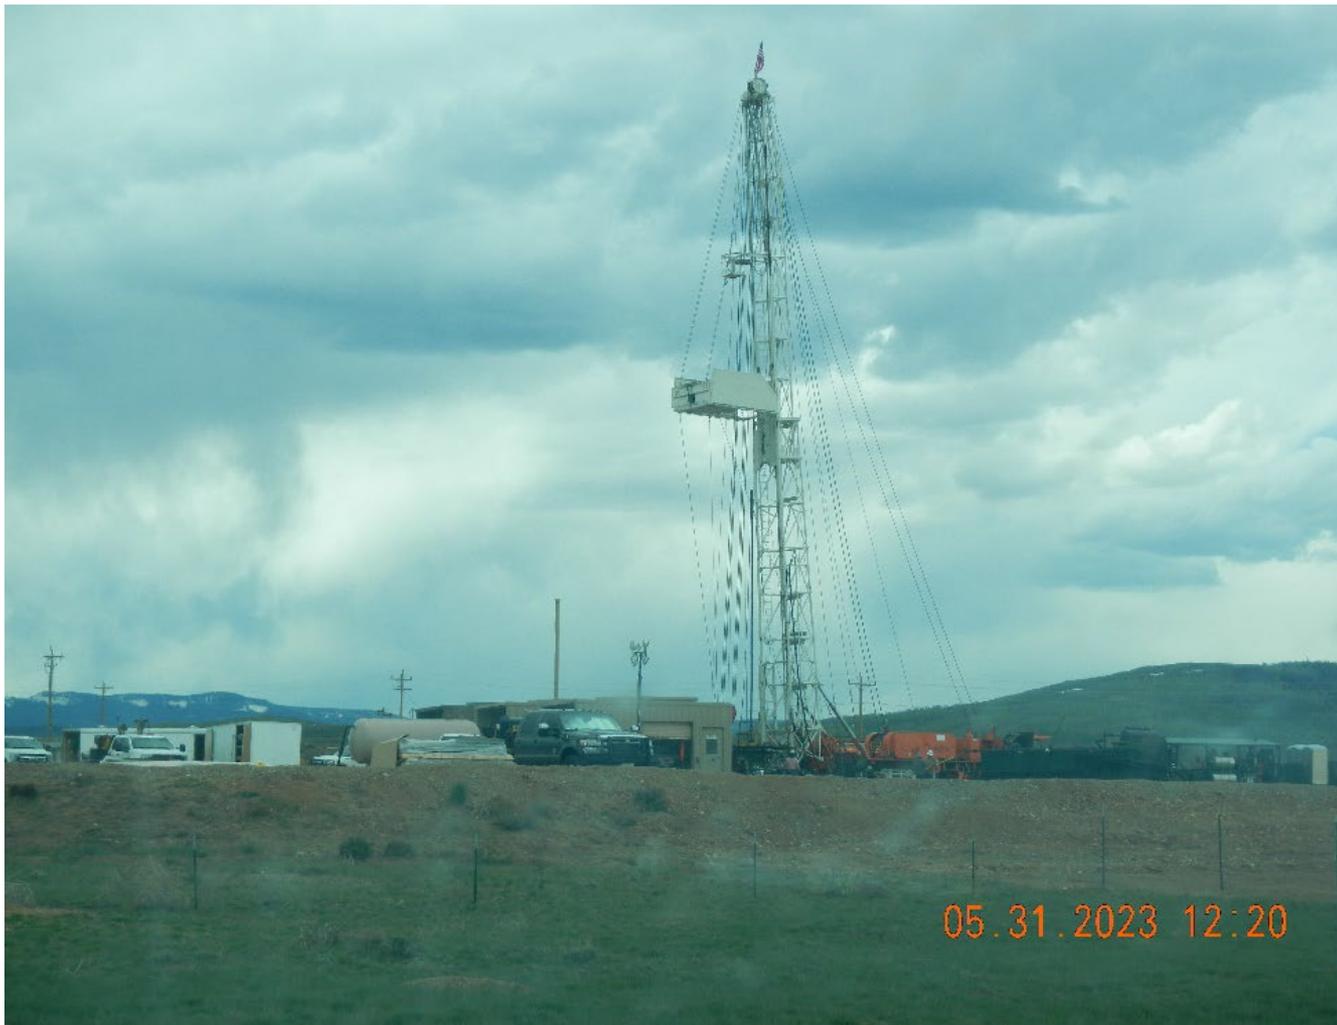
Photo #1 Work over rig on Spicer Annex.

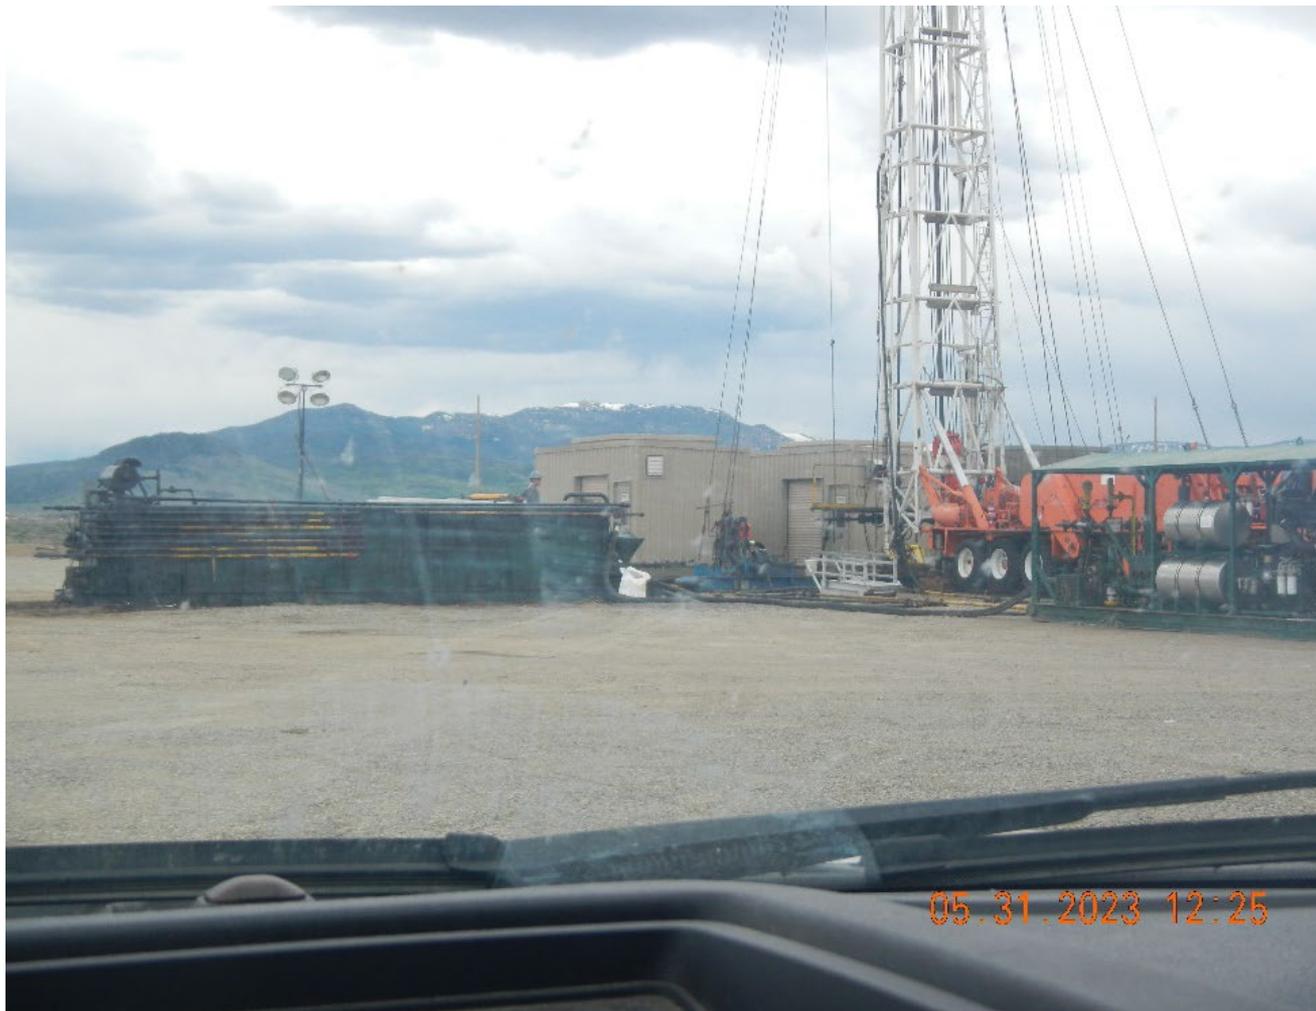
Photo #2 Open top tank part of rig crew. This tank was the source of this spill. Free fluid was removed from pad surface. NO soil has been removed. At the time of inspection, the well was flowing back to open top tank, staff did not approach the rig crew with the well flowing to the tank.

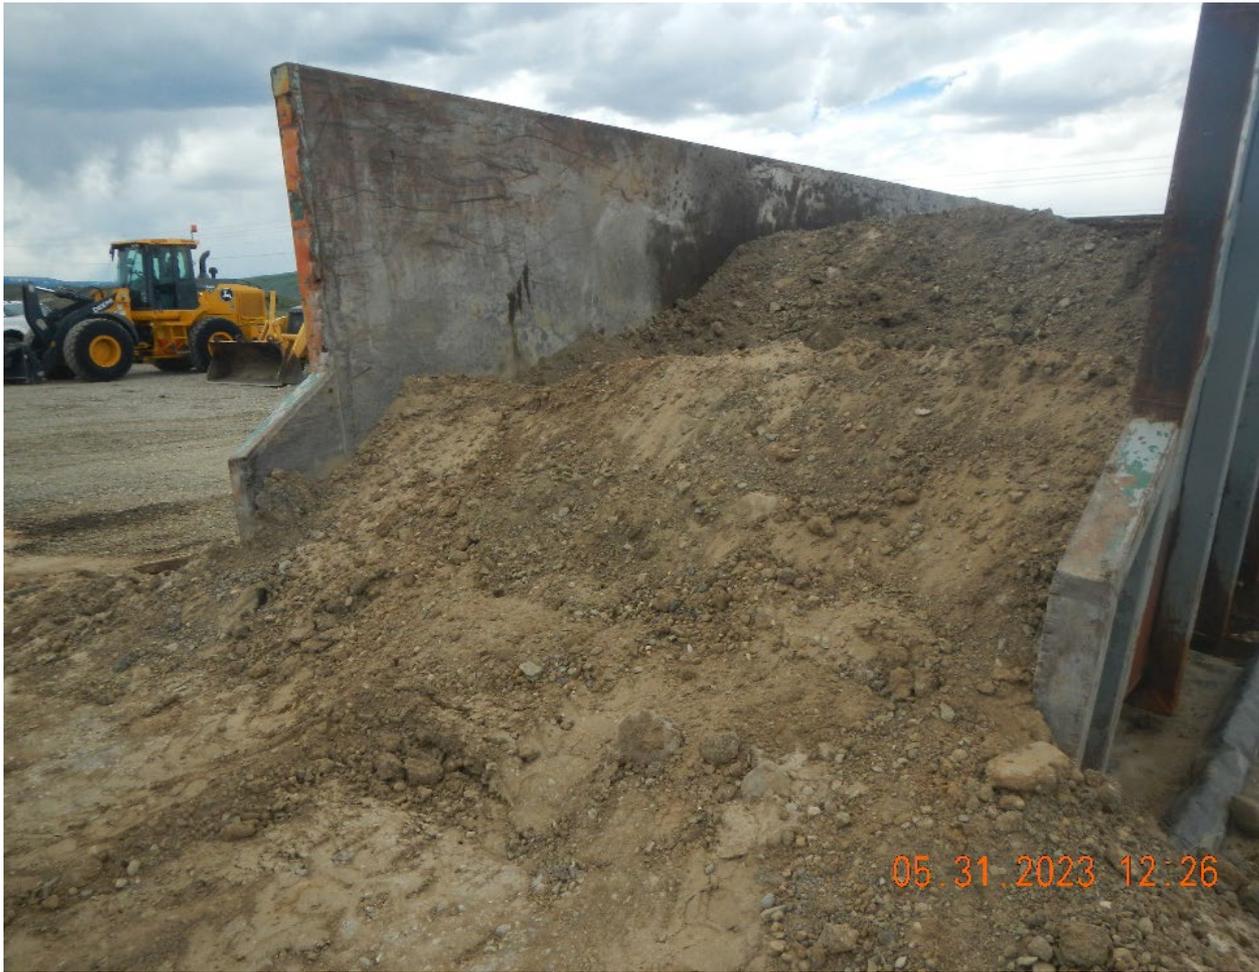
Photo #3 Shale bin on location on west side of location. What is this? Soil appeared dry, no pooled fluid.

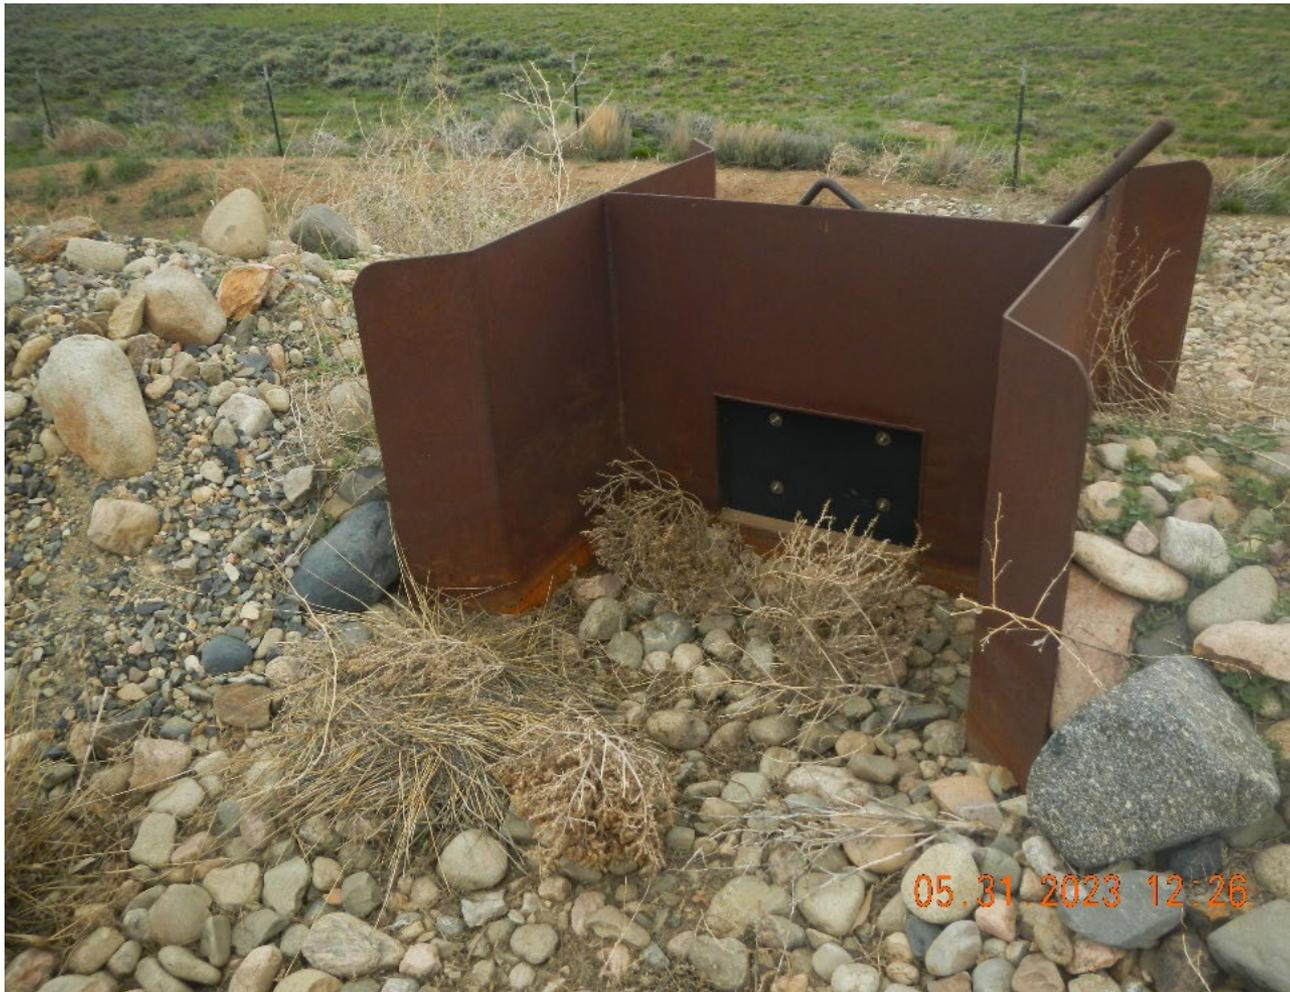
Photo #4 Stormwater gate, in closed position.

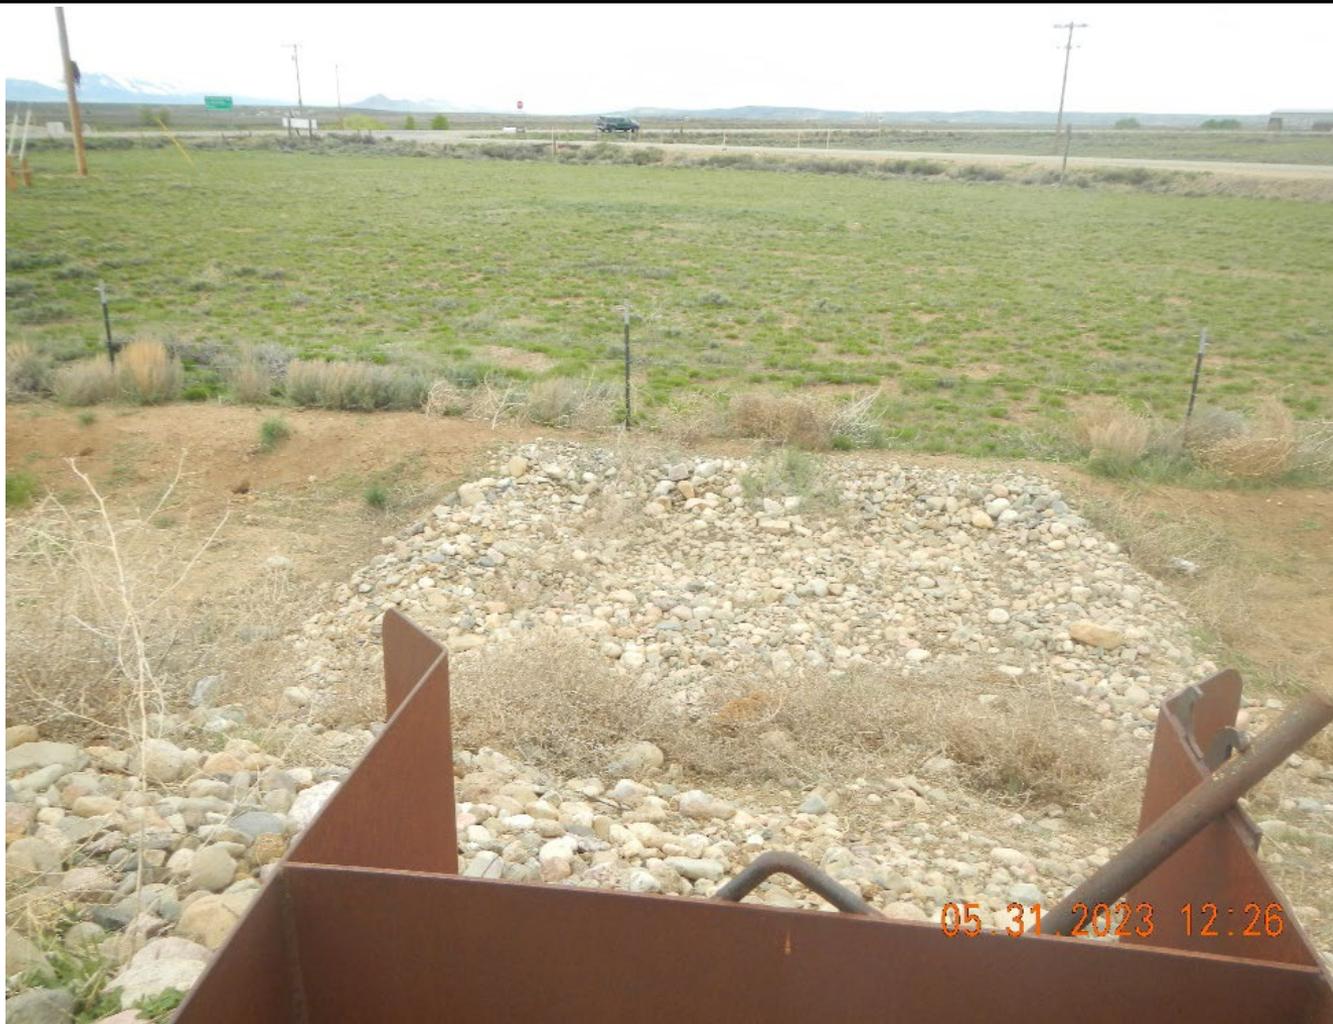
Photo #5 stormwater discharge.

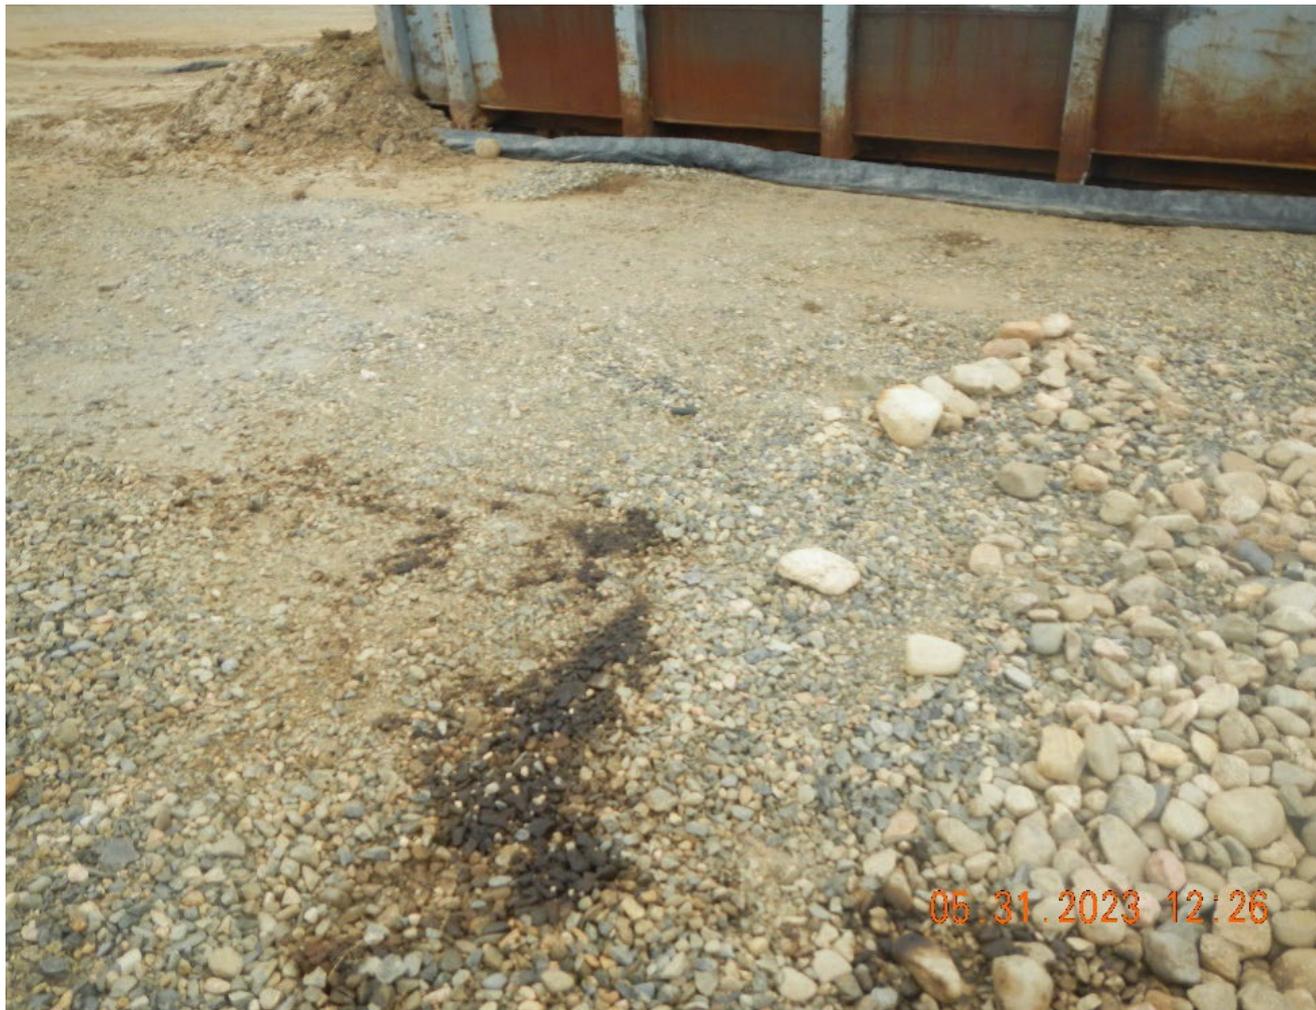
Photo #6 Staining on pad near shale bin, in background.

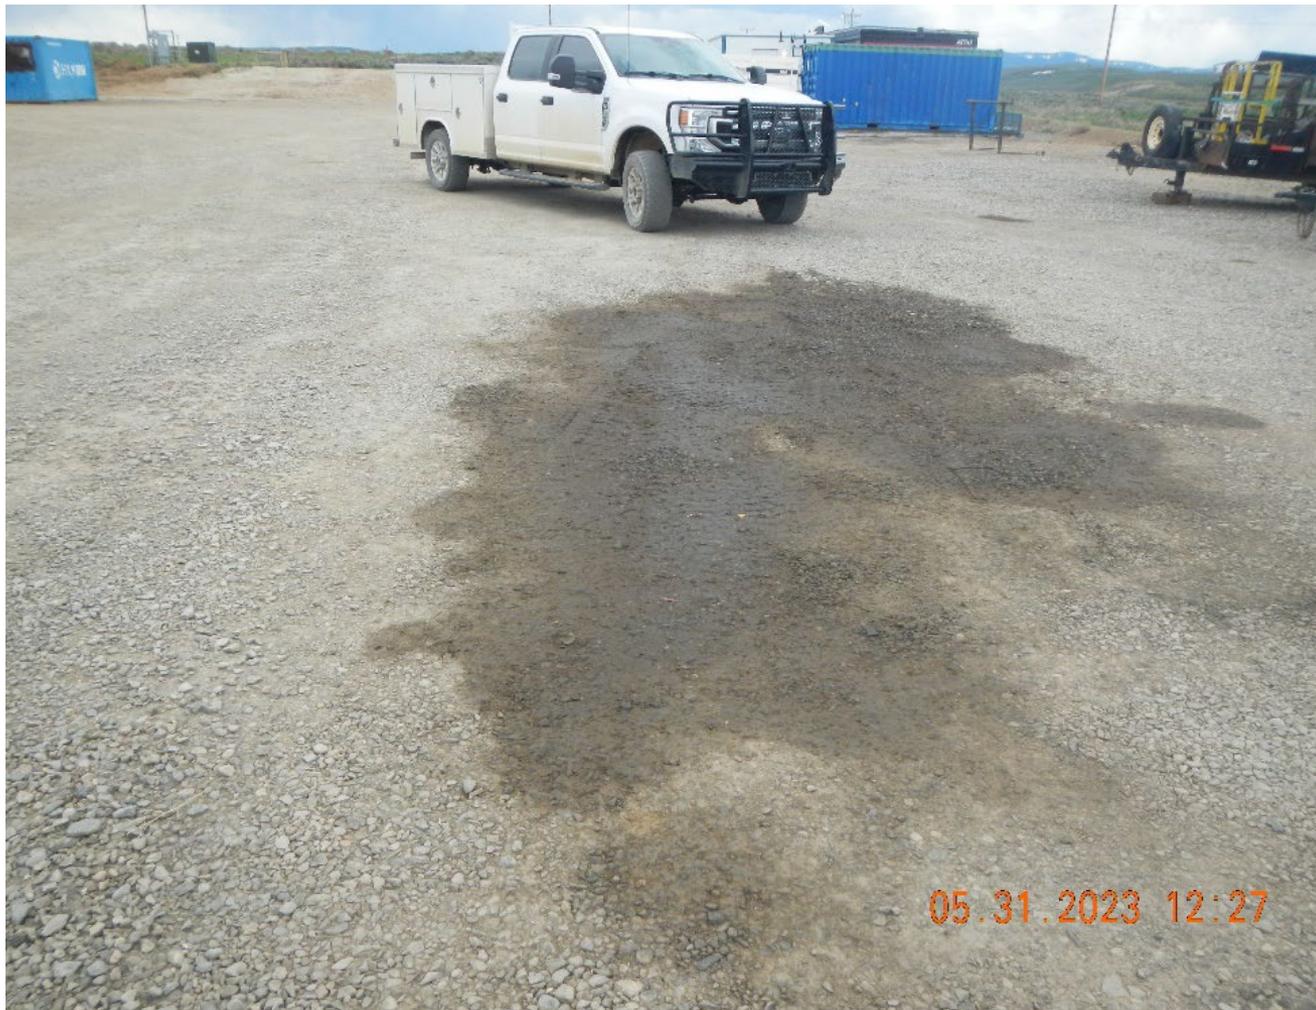
Photo #7 staining on pad. This area was observed on previous inspections, this area was used for the road around the drill pad, lon south side of pad

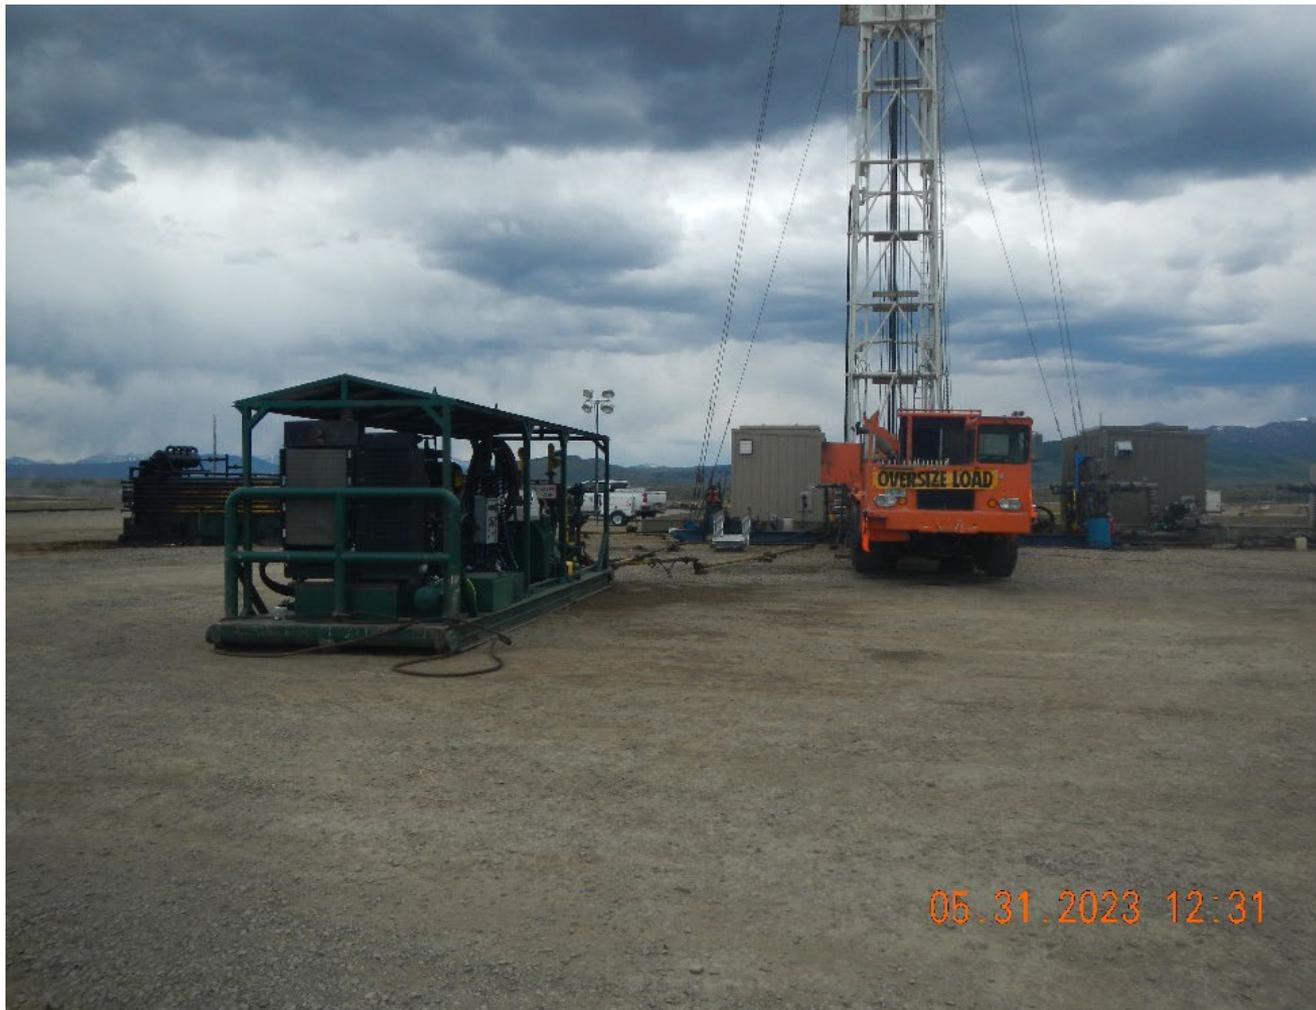
Photo #8 open top tank to left of photo. Rig pump in foreground.

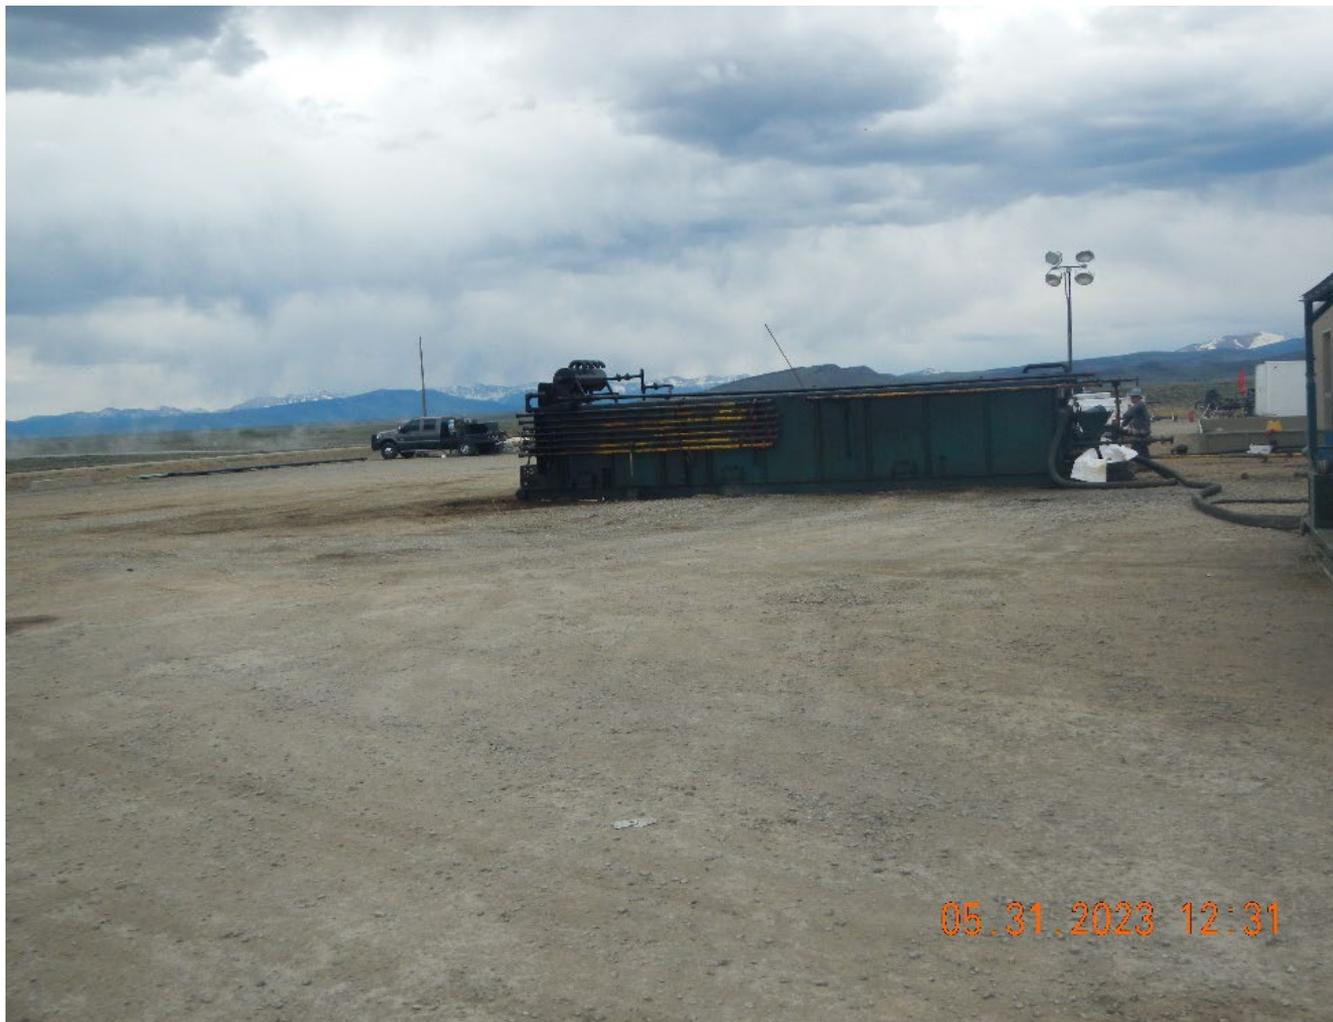
Photo #9 looking at open-top tank looking northwest

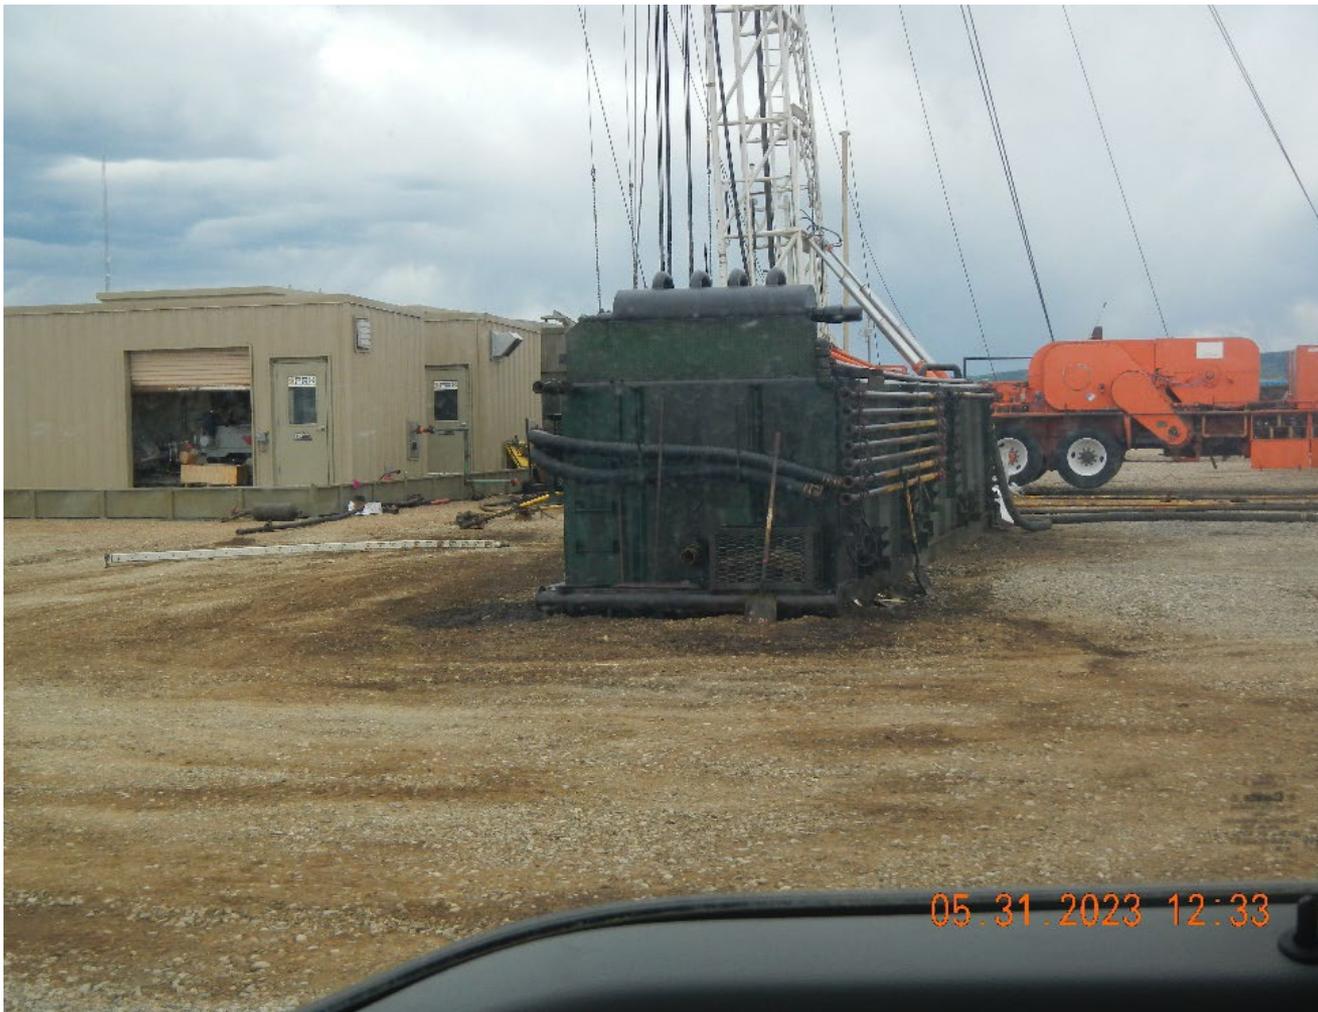
Photo #10 stained soil around tank is remnant of spill.
