Tank Battery Closure Checklist

Additional Attachments (Optional)	Partially Buried Vault Closure
Site Name & COGCC Facility Number	Ditlev-Simonsen GU 2 O SA
Remediation Project #	25682
Site Information	
General Condition of Site	Good condition
USCS Soil Type	<i>Sandy Clay / Sandy Clay</i>
Estimated Depth to Groundwater	<20'
Hydrocarbon Impacted Soils / Spills	HC impacted soils encountered
Salt Crusted Soils or Impacted Vegetation	None observed

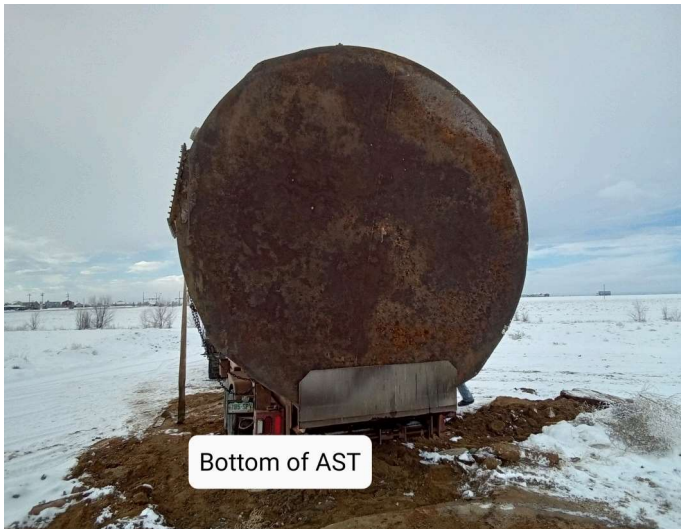
R1 - P1

Looking west

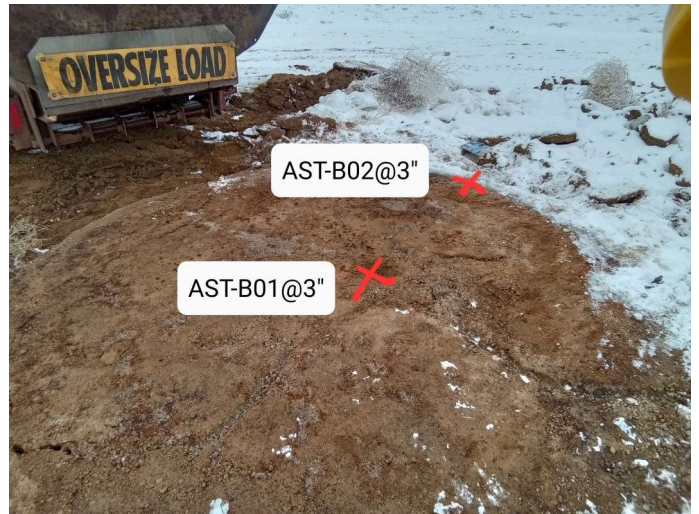
R1 - P2

Looking west

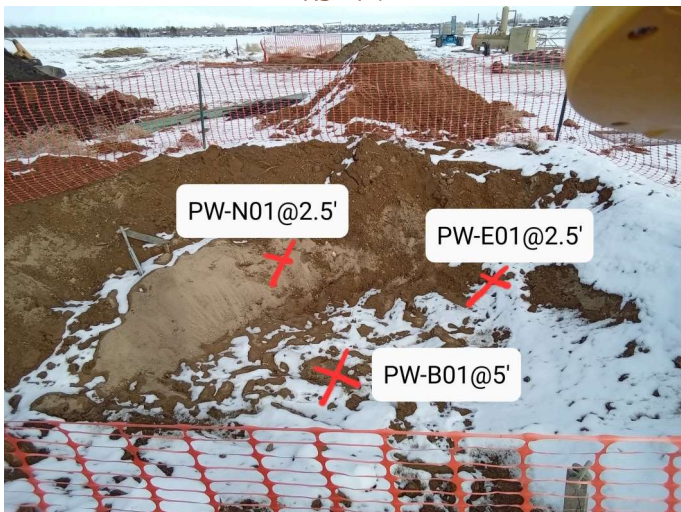
R3 - P1

Looking west

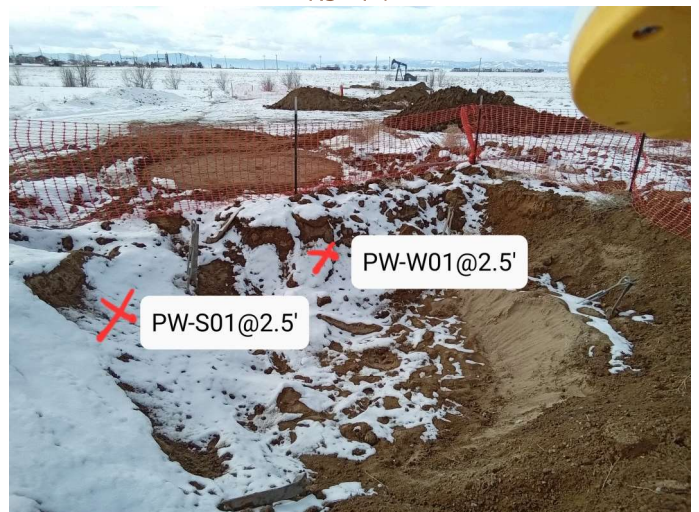
R5 - P1

Looking west

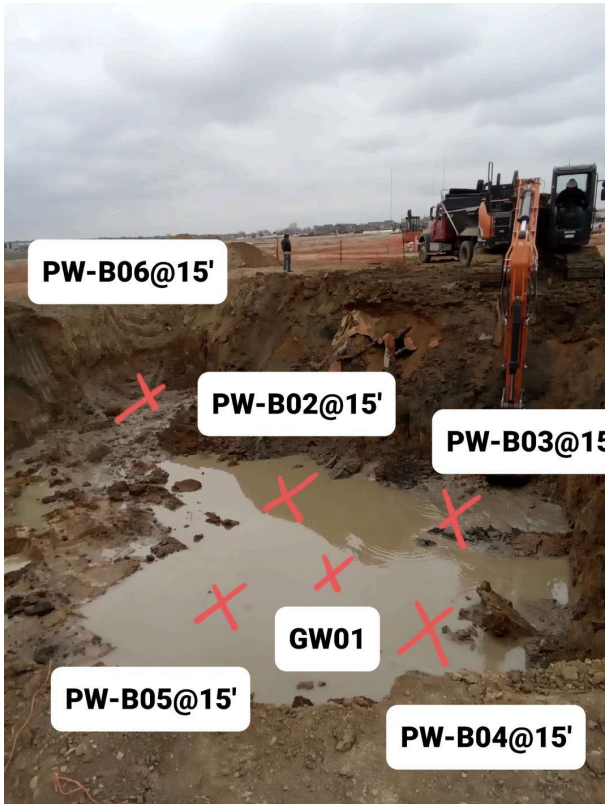
R12 - P1

Looking west

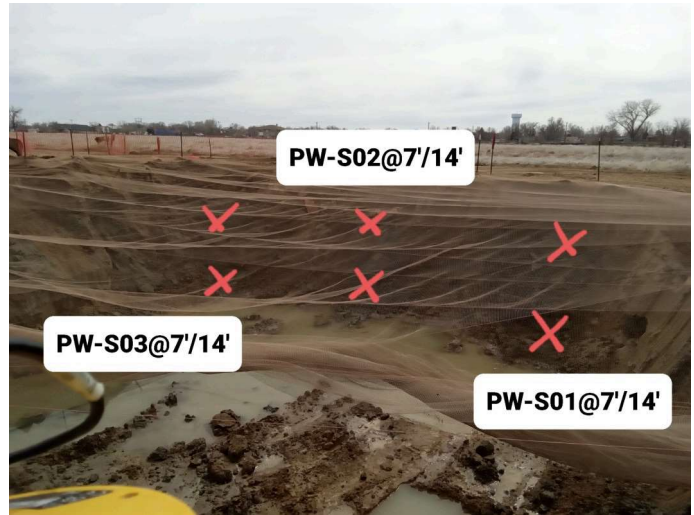
R18 - P1

Looking south

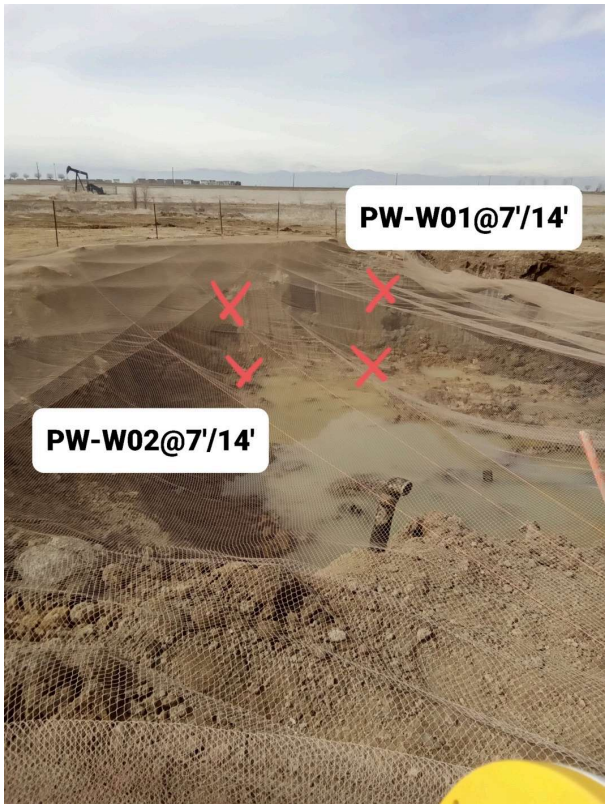
R22 - P1

Looking west

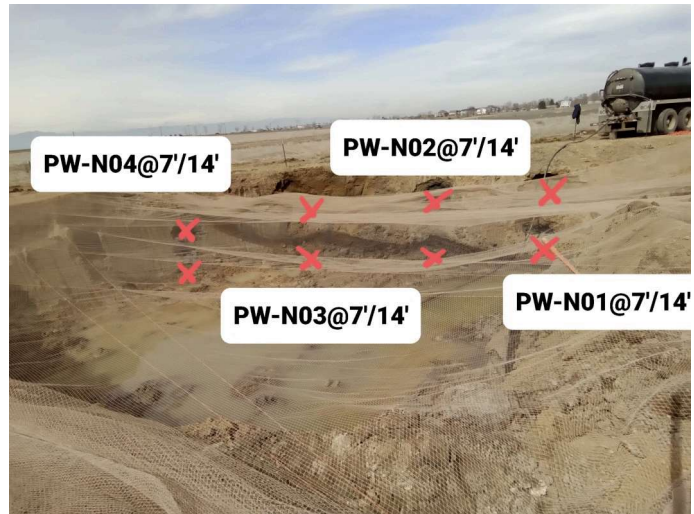
R30 - P1

Looking north

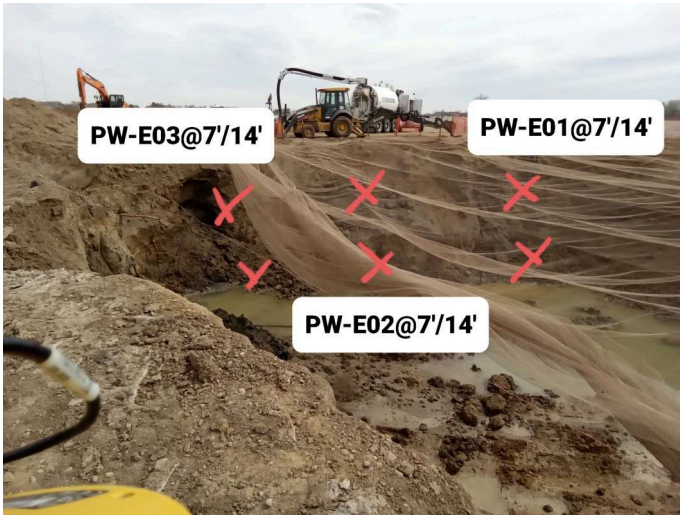
R35 - P1

Looking east

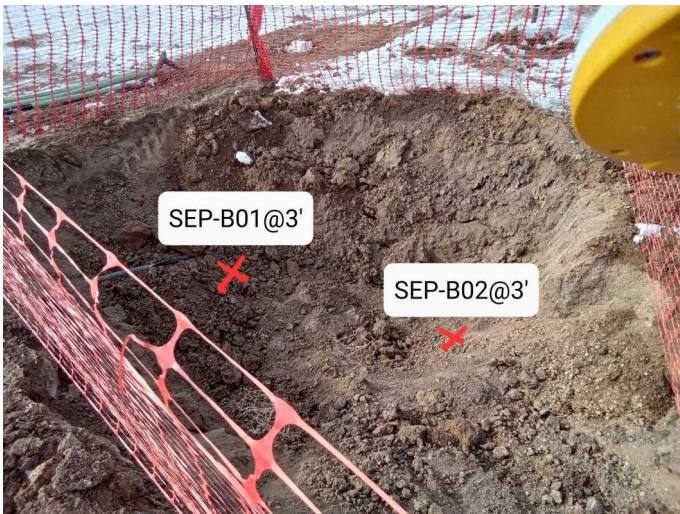
R1 - P1

Looking west

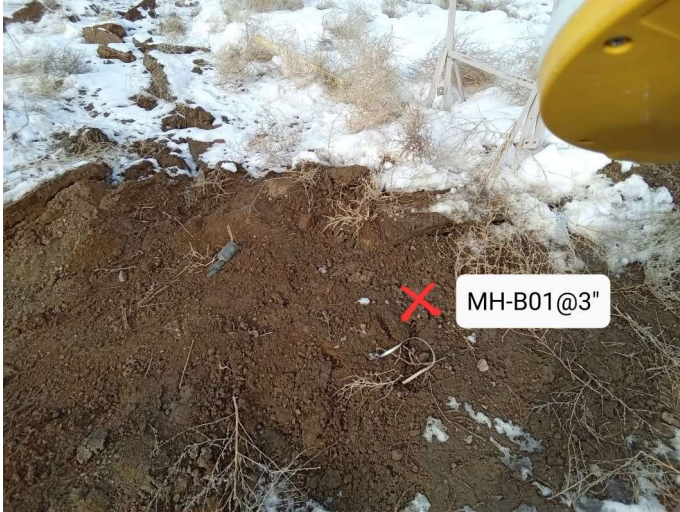
R1 - P1

Looking west

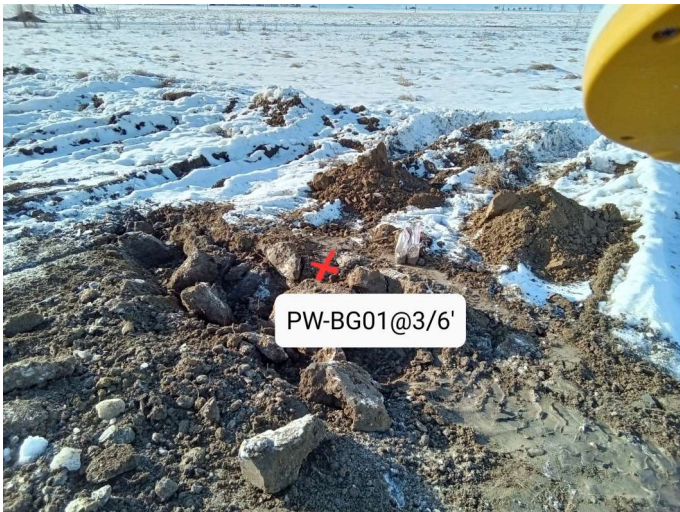
R1 - P1

Looking west

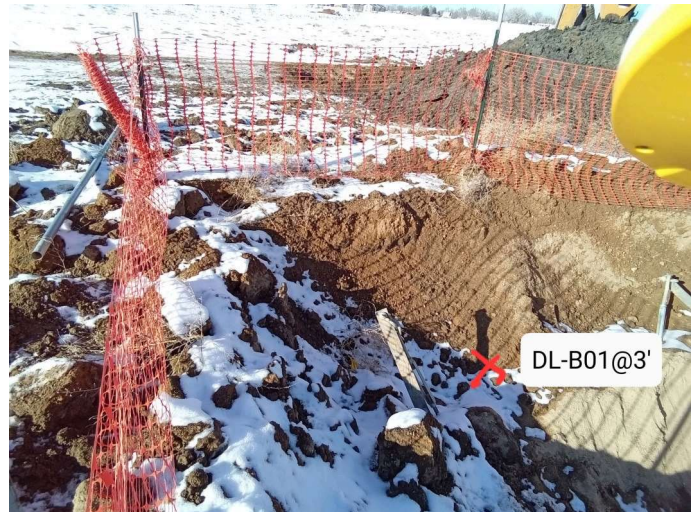
R3 - P1

Looking west

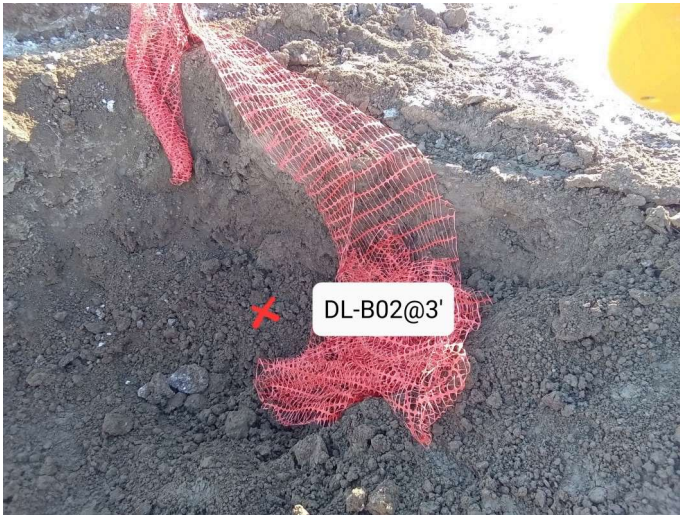
Looking west
