**Inspection Photos**  
**Location Name: CAERUS PICEANCE LLC D13 Pad**  
**Location #: 334565**

**COLORADO**  
Oil & Gas Conservation  
Commission  
Department of Natural Resources

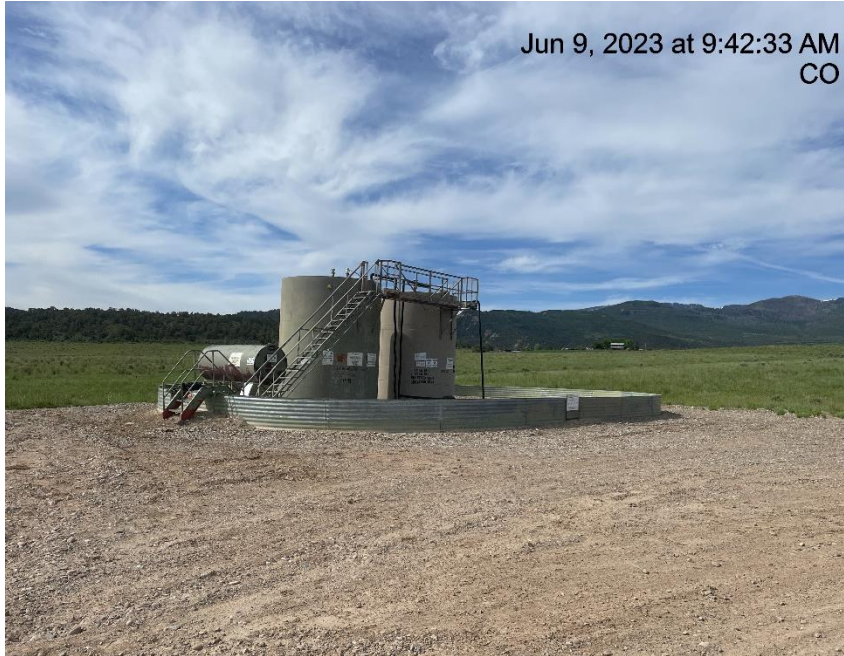
**Photo # 9945 From entrance to location**

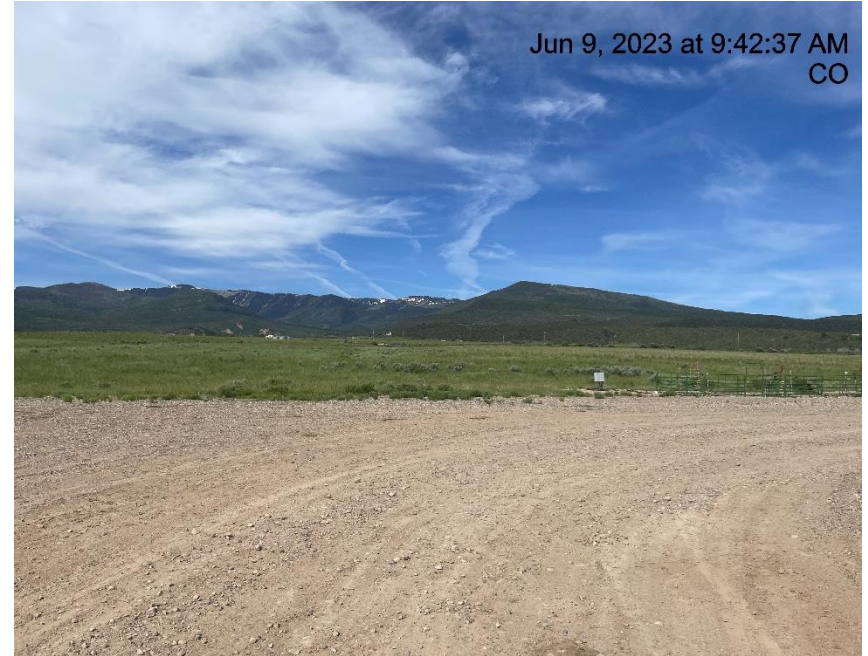
**Photo # 9946 From entrance to location**

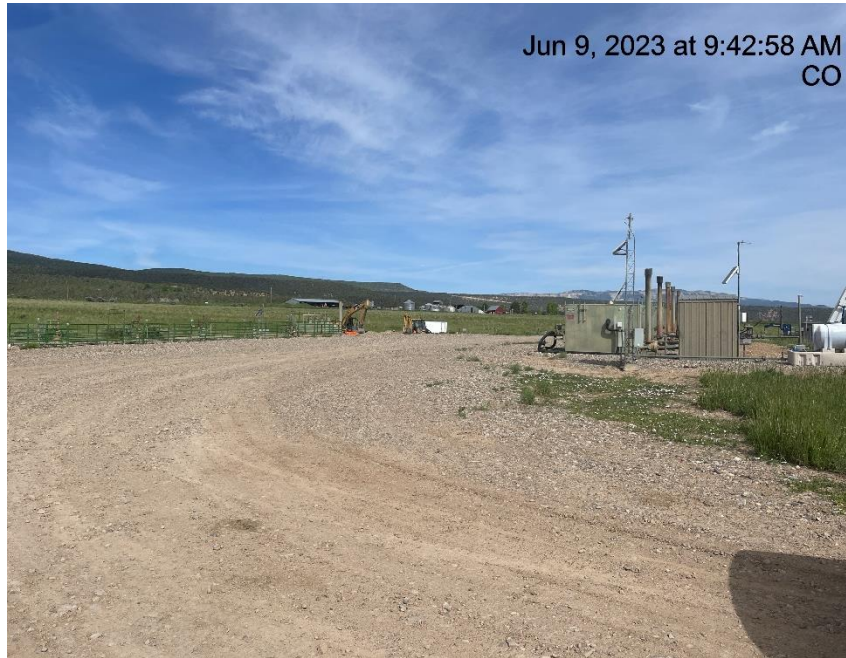
**Photo # 9947 From entrance to location**

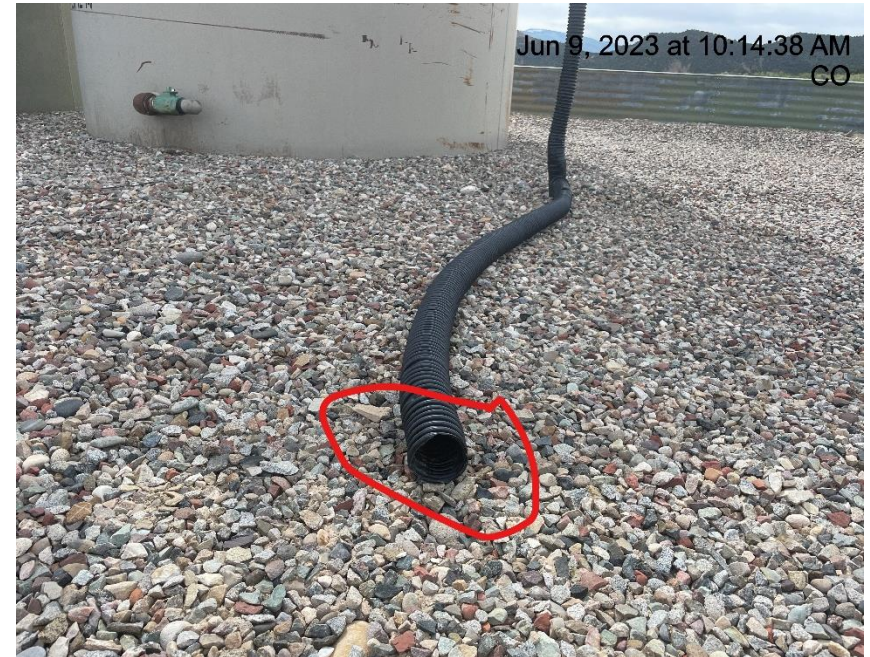
**Photo # 9957 Flowline heating insulation open ended**

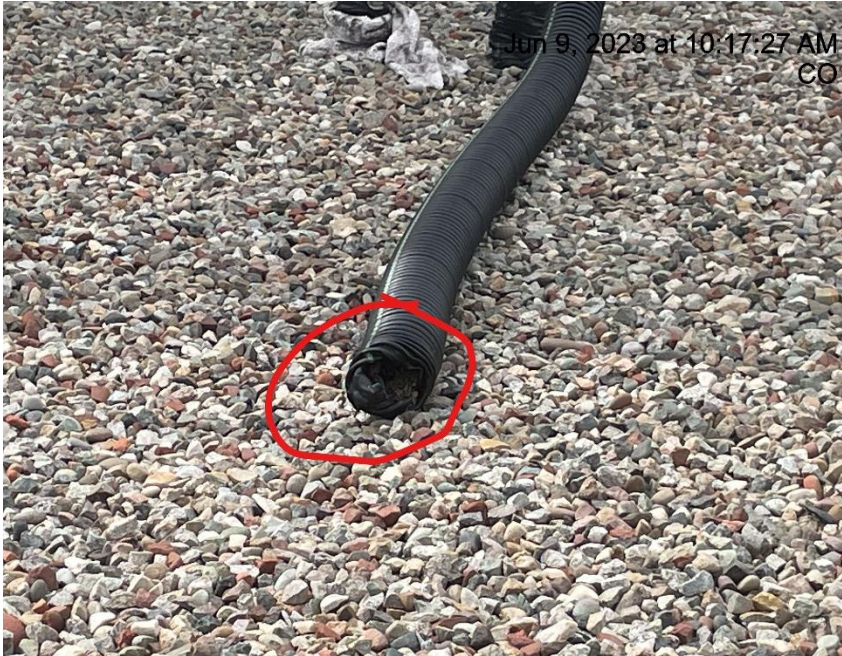
Photo # 9963 Flowline heating insulation open ended

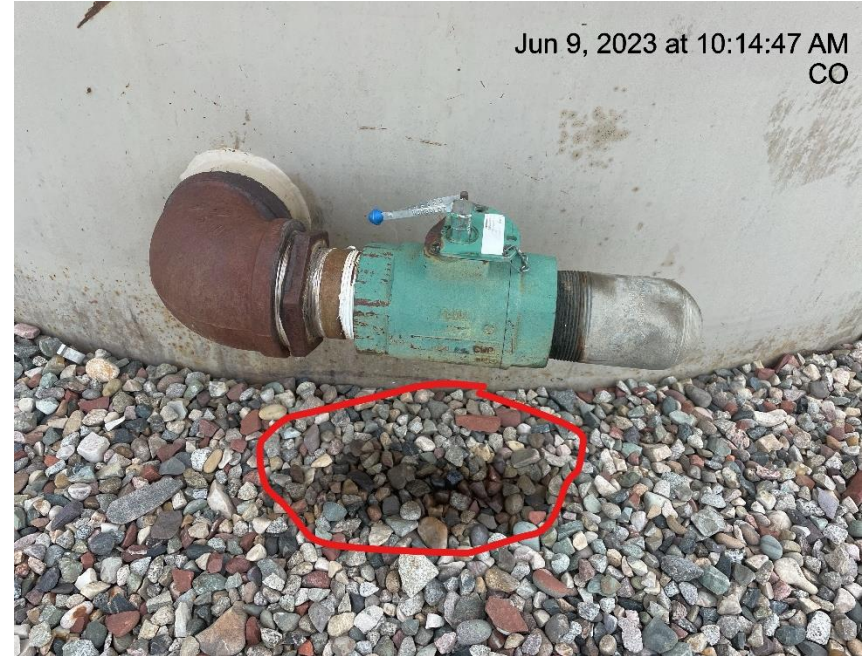
Photo # 9958 Stained gravel

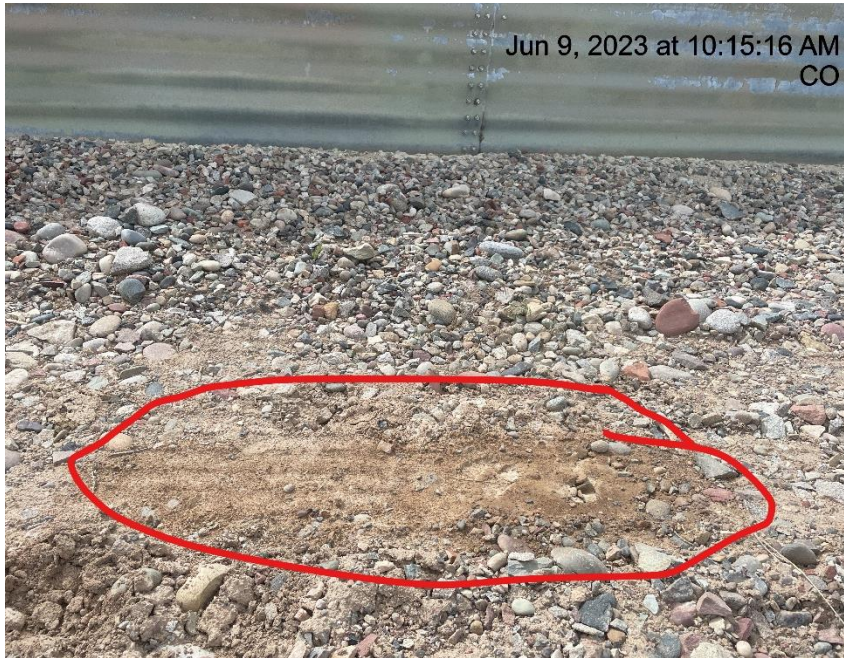
**Photo # 9959 Stained soils**

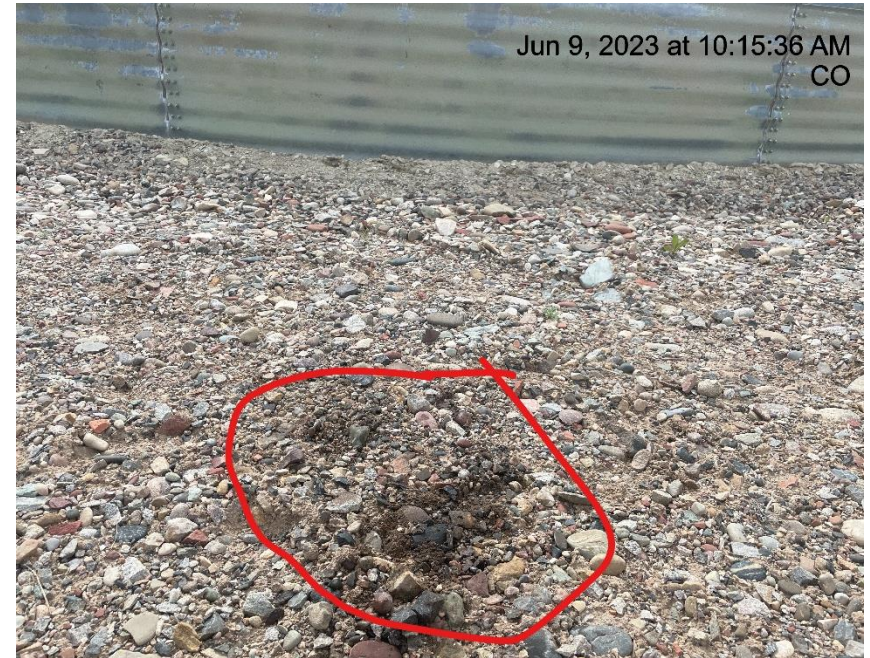
**Photo # 9960 Stained soils & gravel**
