Inspection Photos

API: 055-06301

Operator: CAPTUREPOINT LLC

Inspection Date: 6/8/2023

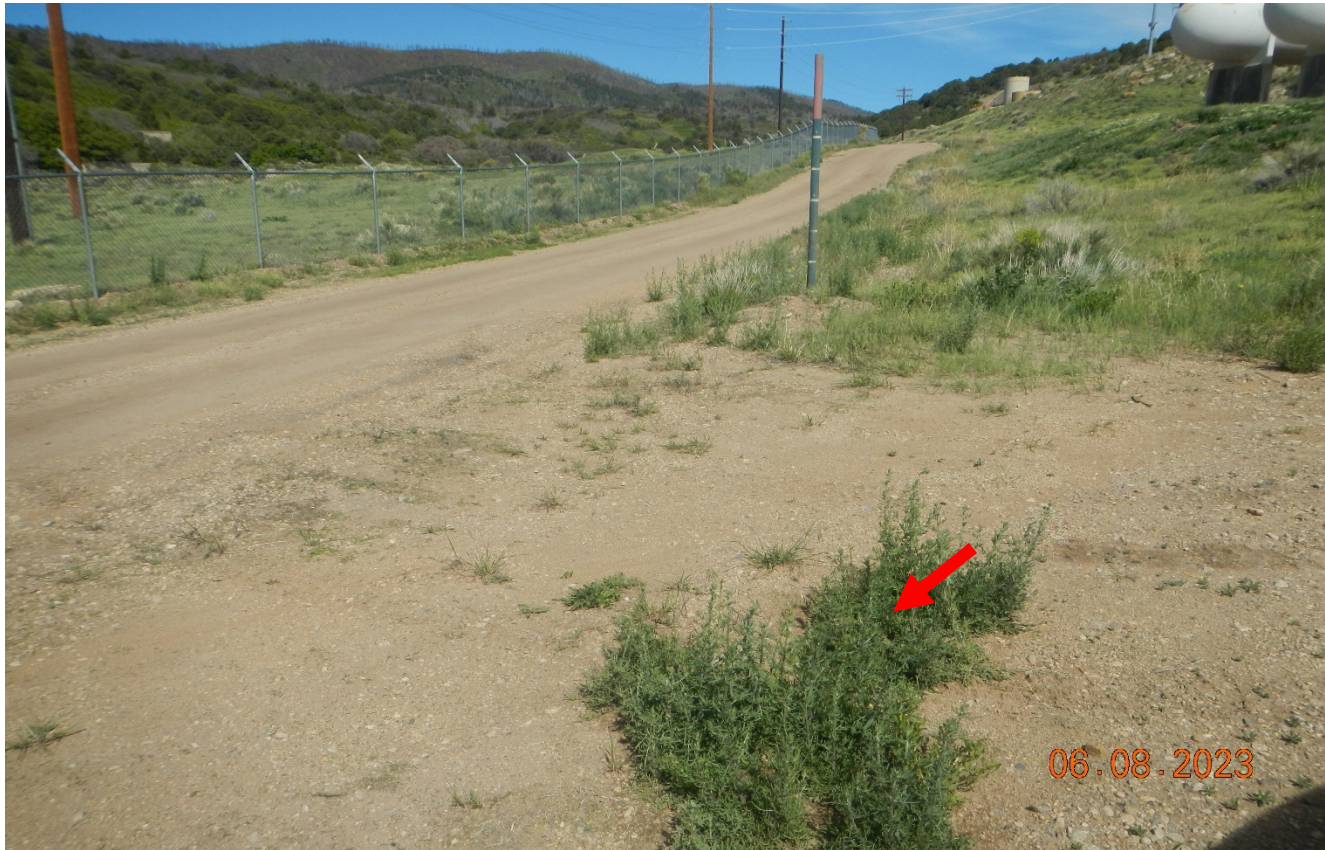
Photo 2. Facing northeast at the Gas Plant. There are noxious weeds along the road that needs to be controlled. Red arrow → Diffuse knapweed.

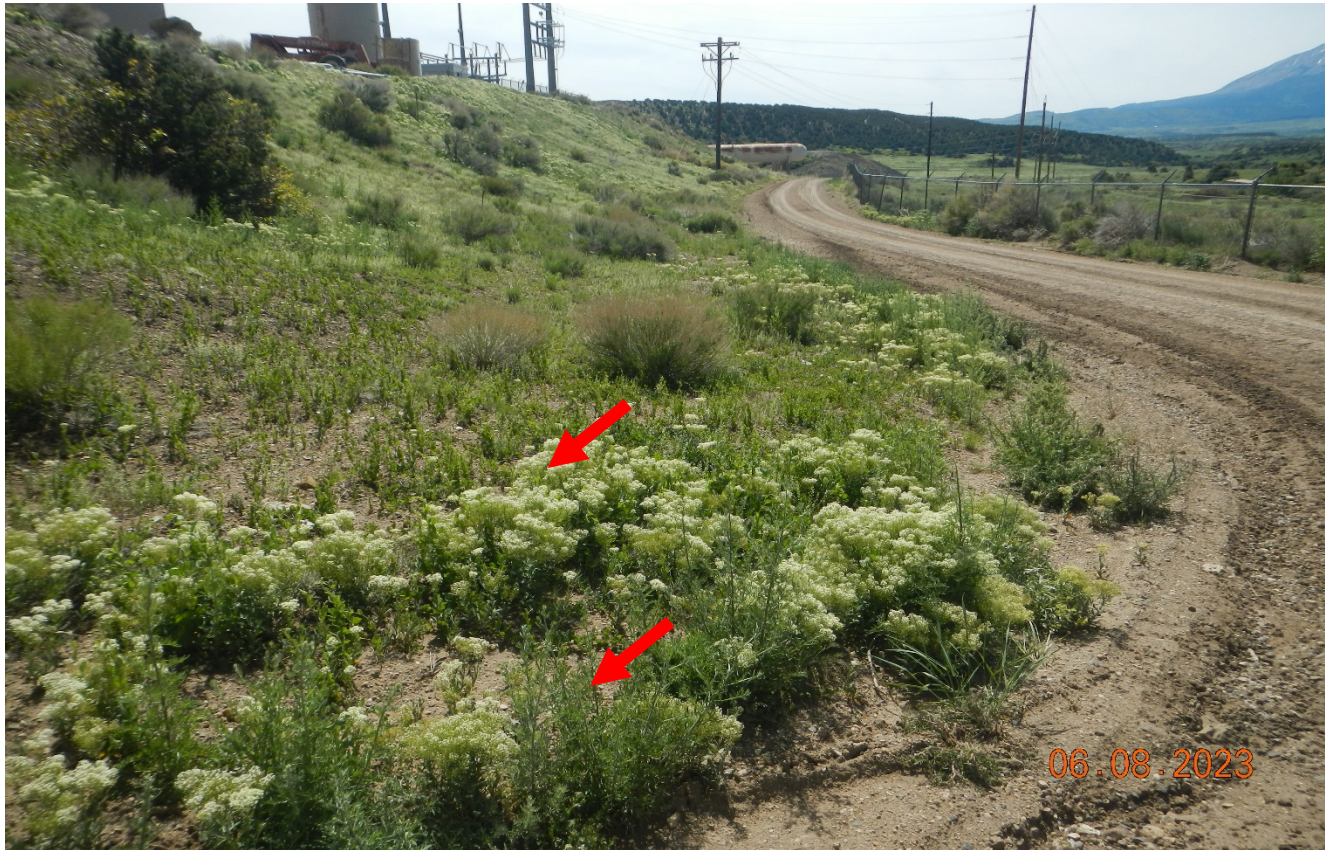
Photo 1. Facing west at the entrance of the Gas Plant. There are noxious weeds along the road that need to be controlled. Red arrow → Diffuse knapweed, Hoary crest.

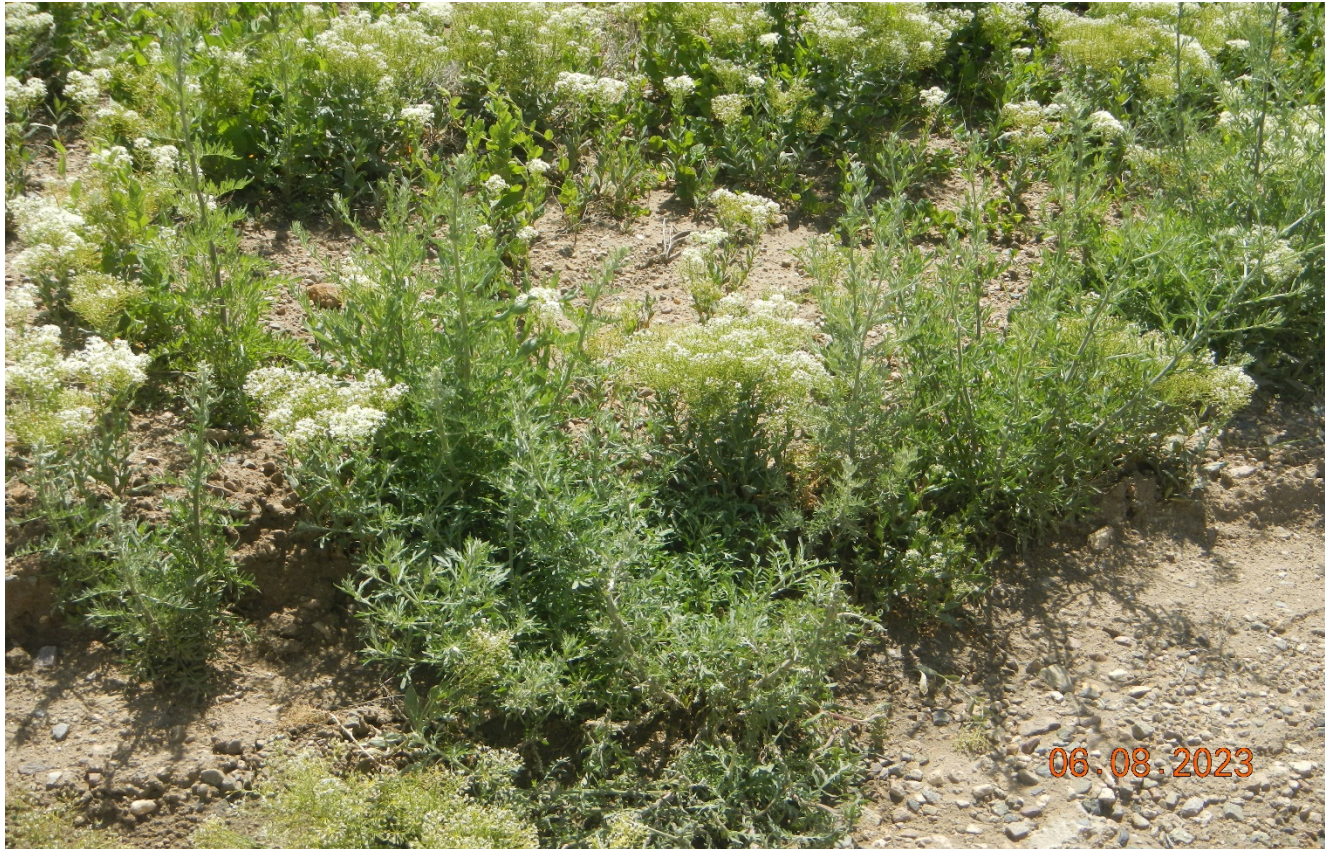
Photo 3. Close up view of Hoary crest and Diffuse knapweed found at the gas facility and wellsite.

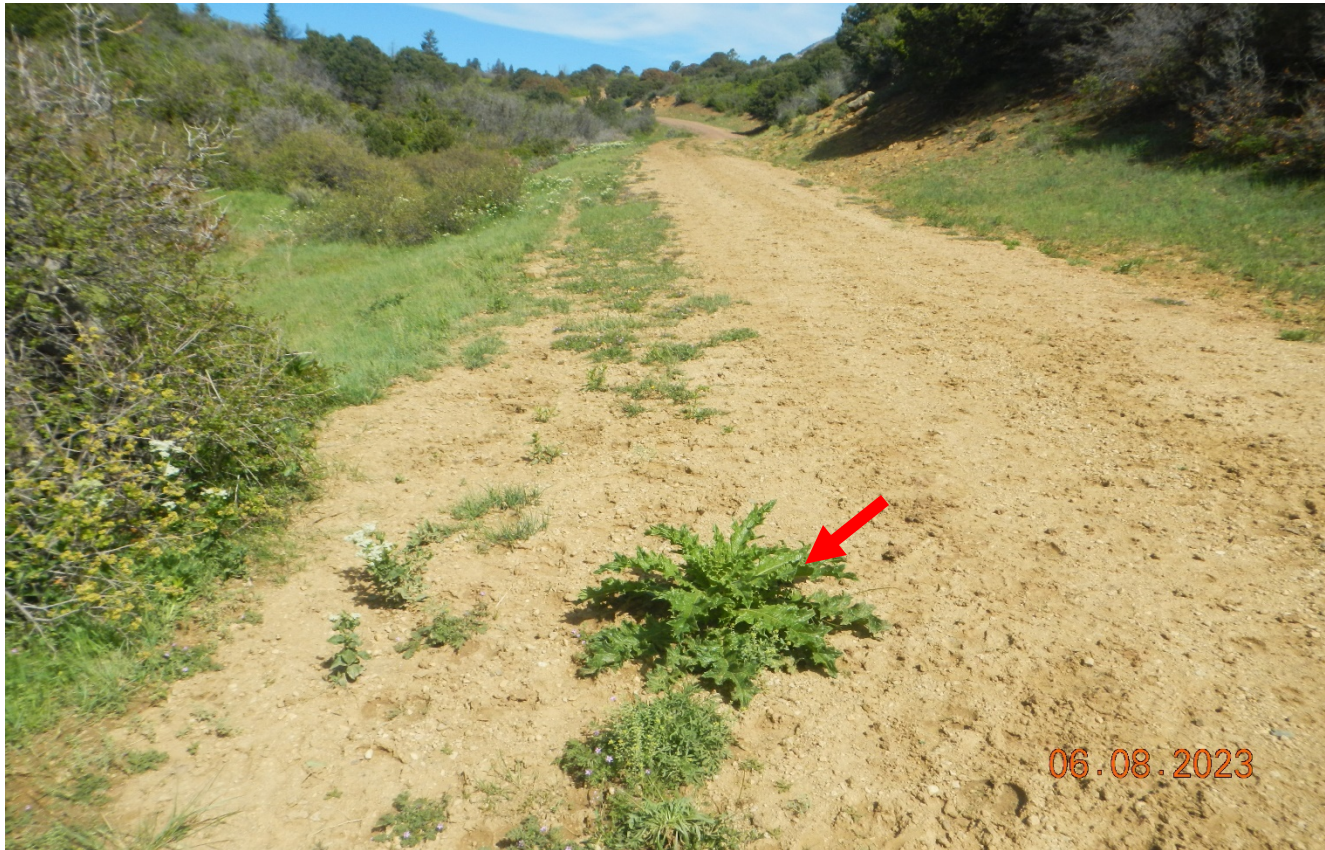
Photo 4. Facing northwest along the road. There are noxious weeds along the road that need to be controlled. Red arrow → Musk thistle.

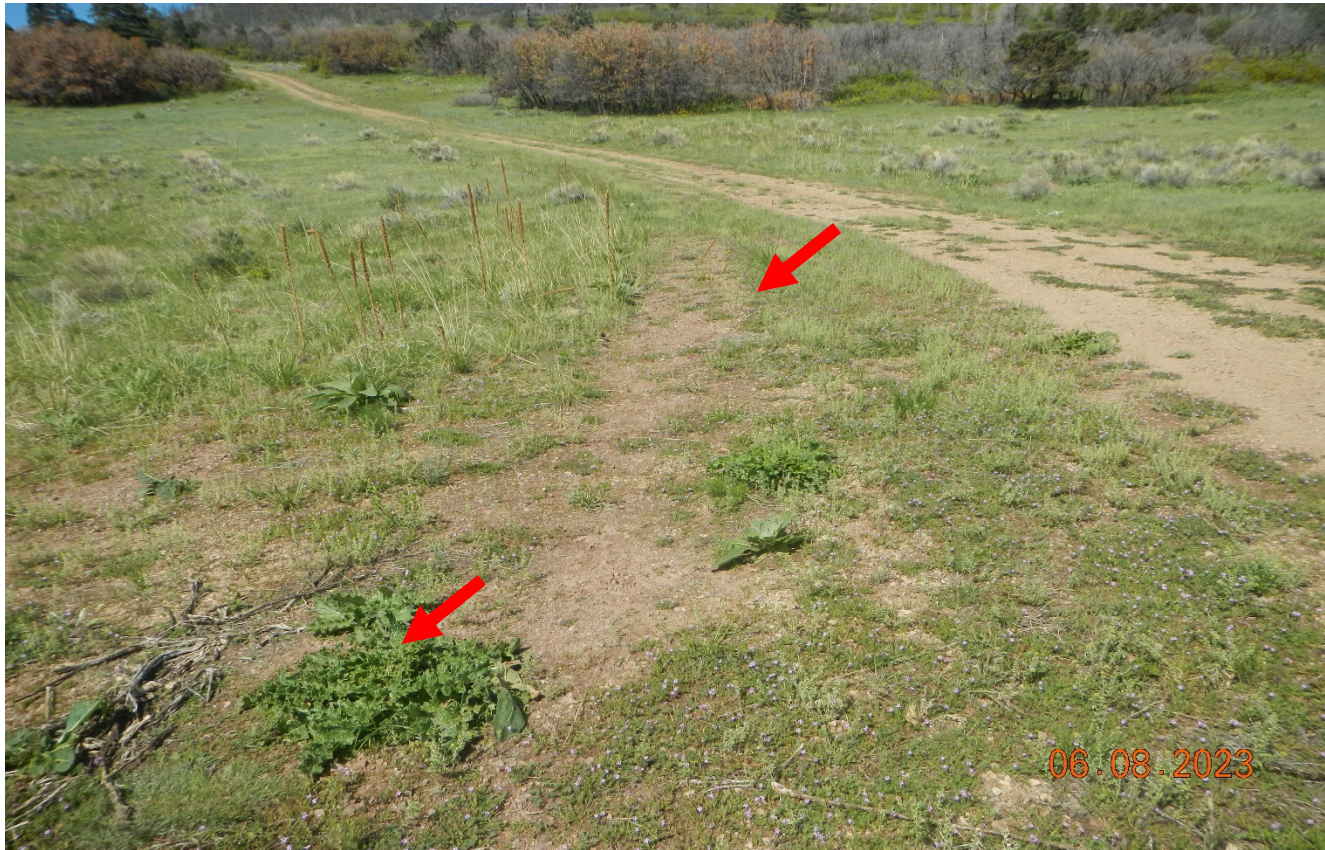
Photo 5. Facing southwest along the access road. There are noxious weeds that need to be controlled. Red arrow → Mullein and Musk thistle.

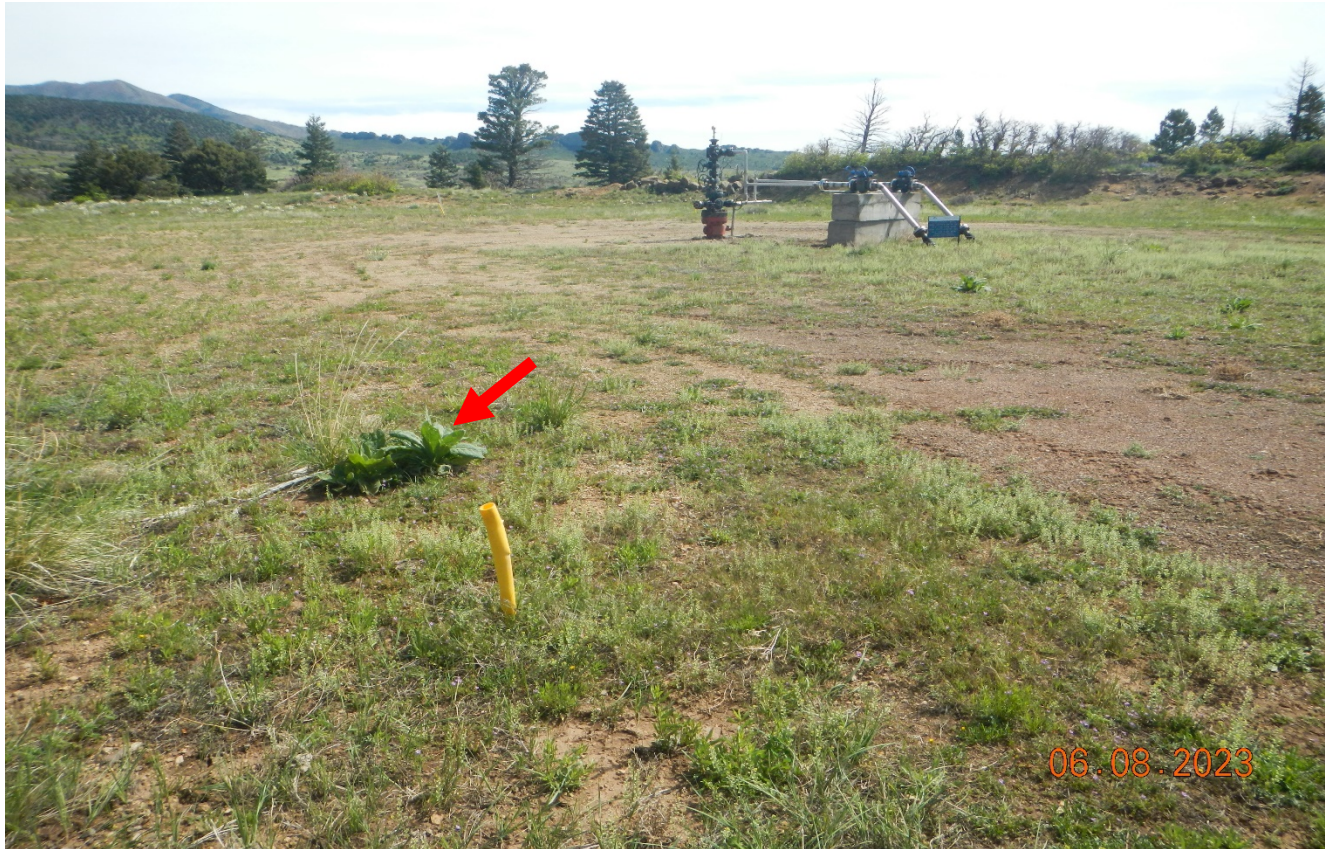
Photo 6. Facing north toward the location. Red arrow → Mullein Noxious weed.
