Inspection Photos

API: 055-06285

Operator: CAPTUREPOINT LLC

Inspection Date: 6/8/2023

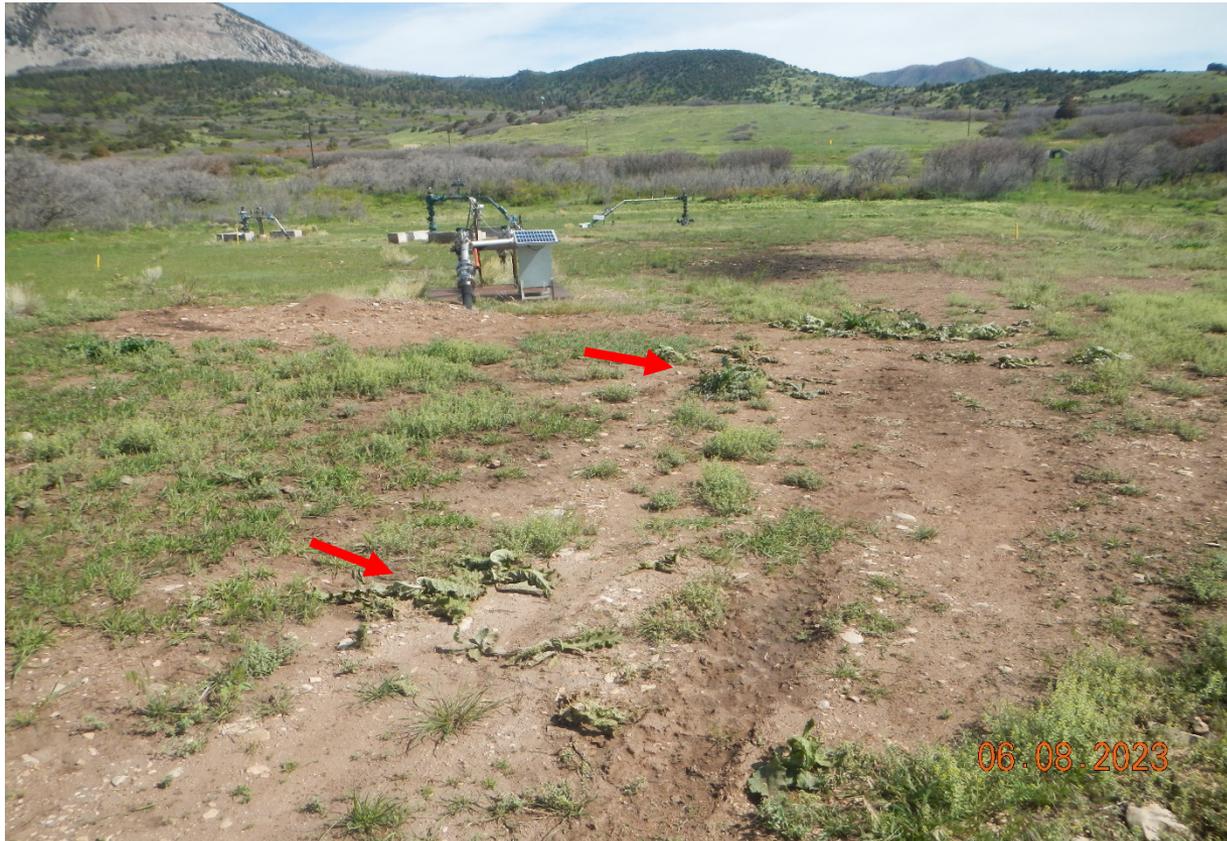
Photo 1. Facing northwest toward the location. There are numerous noxious weeds at the location and some are wilted from recent weed control effort. Red arrow → Scotch thistle

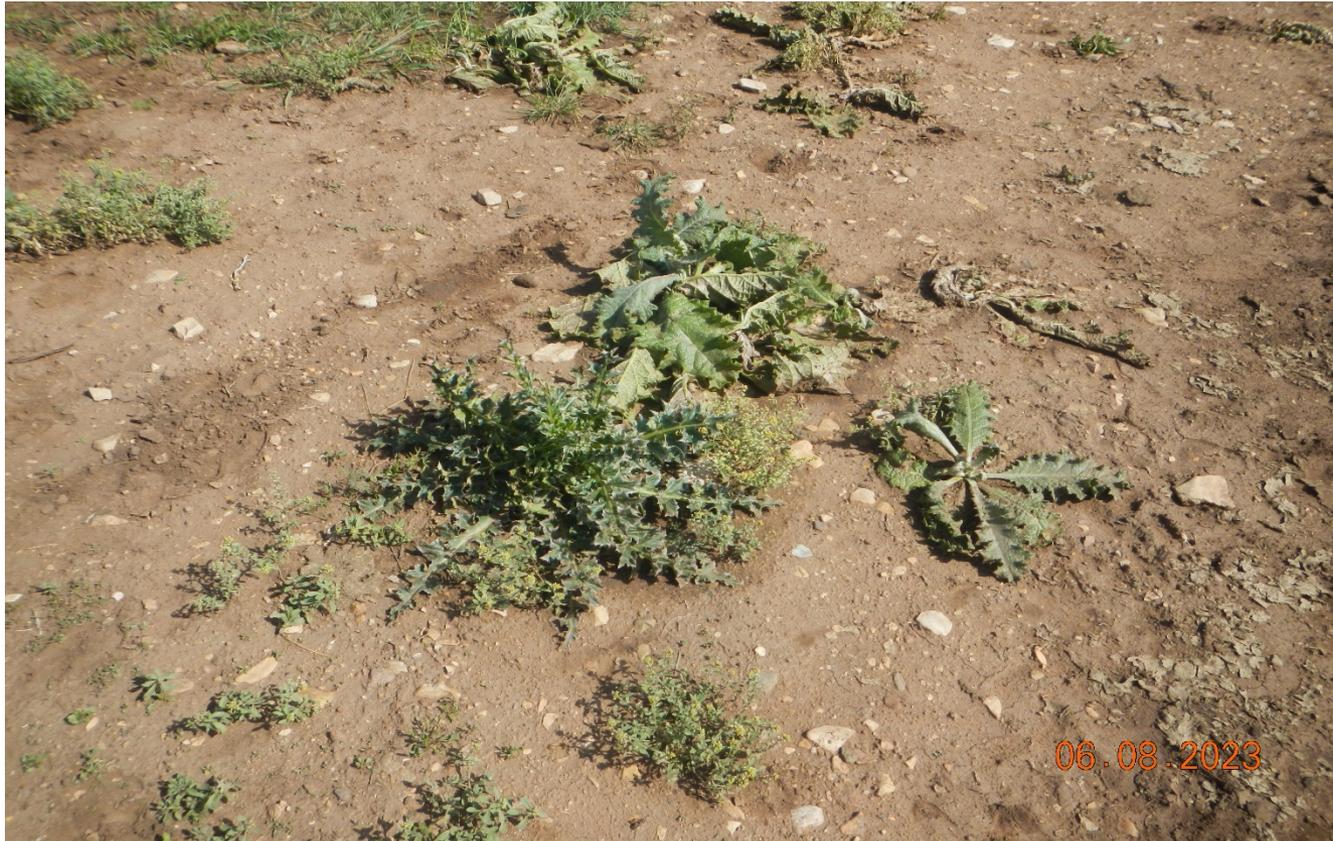
Photo 2. There appears to have been control of some noxious weeds on location but there are some that were missed and a follow up treatment needs to be performed.

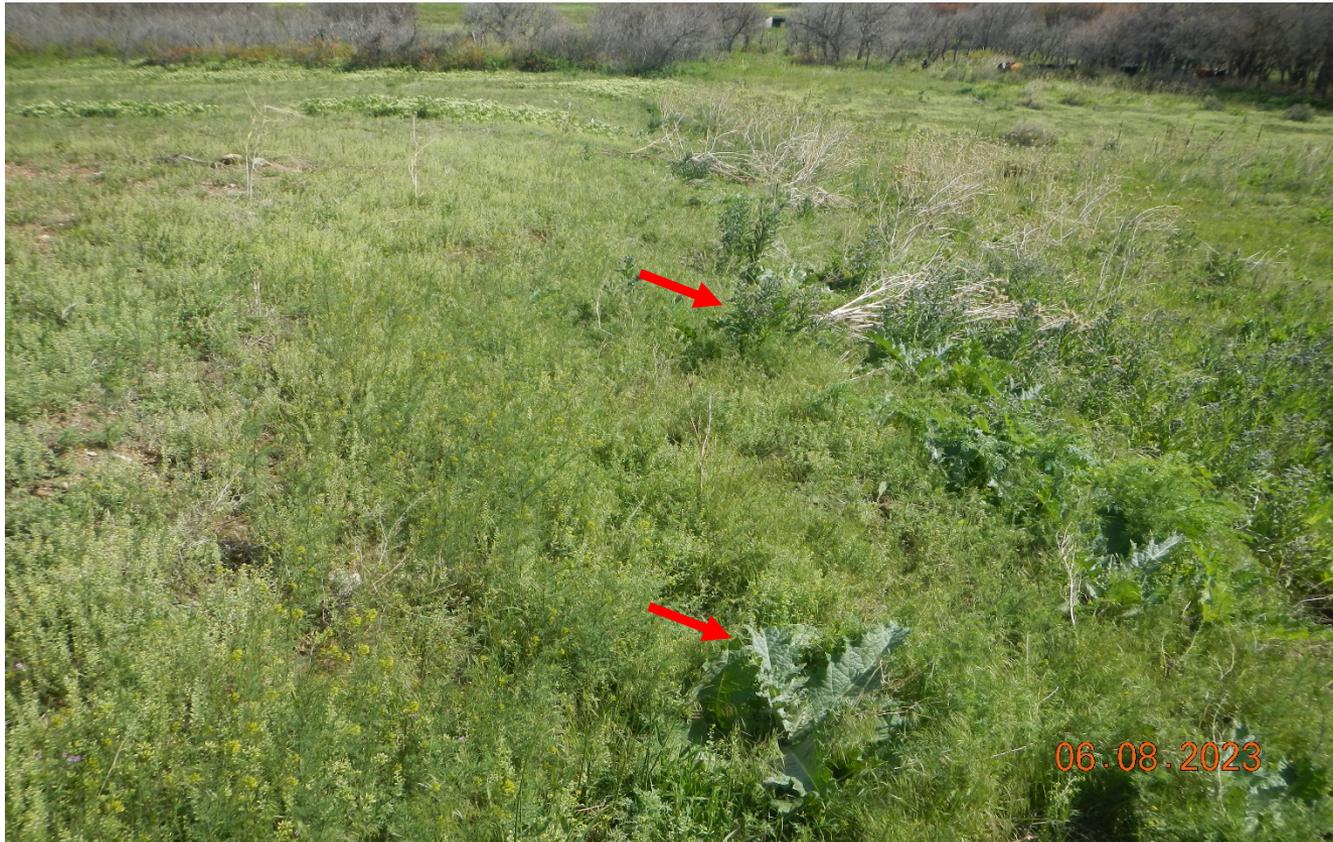
Photo 4. Facing north at east side of the location.. There are numerous noxious weeds that have not been controlled with no sign of wilting.

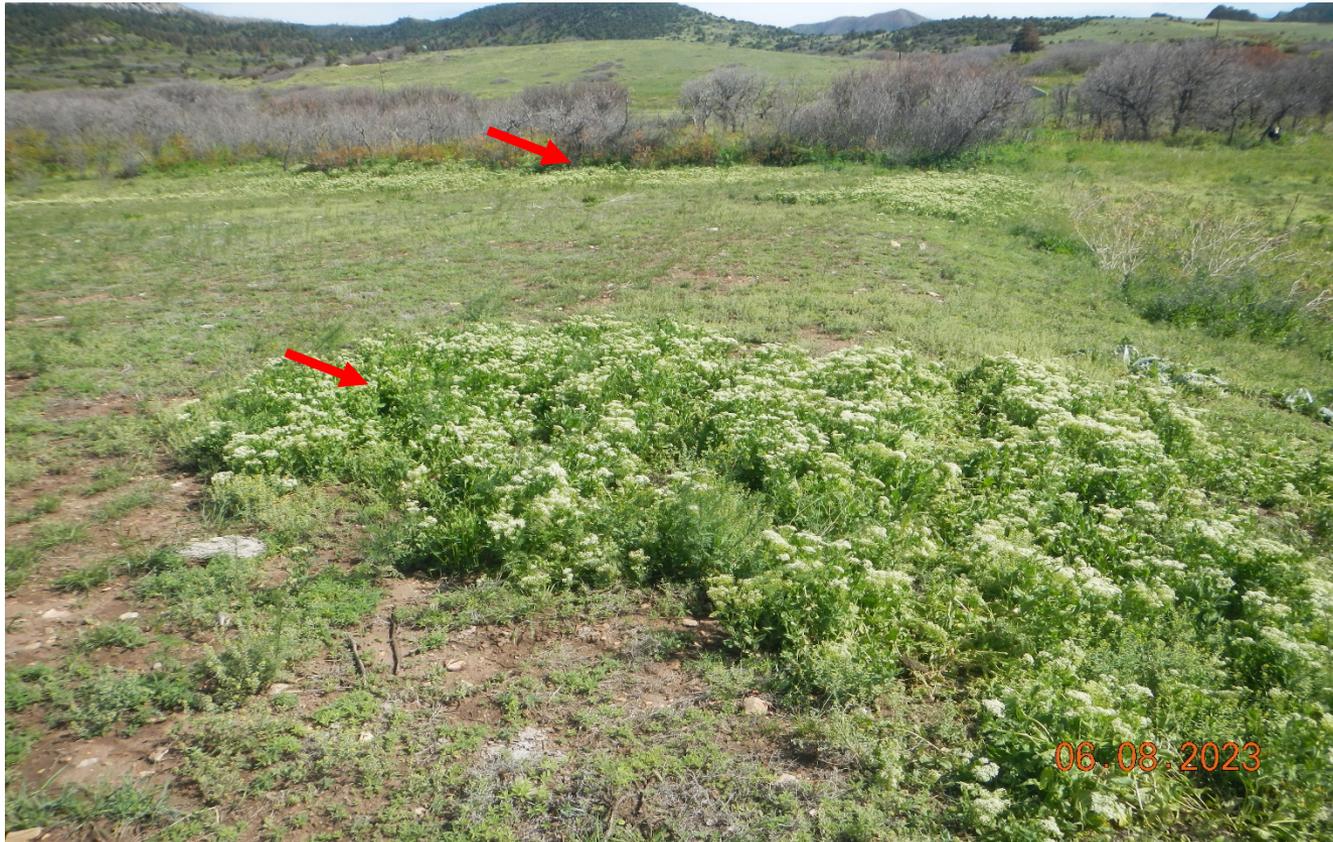
Photo 5. Facing north at the northeast side of the location. There is patches of Hoary crest which is a List B noxious weed that needs to be controlled.
