Inspection Photos

API: 055-06283

Operator: EDWARDS ENERGY CORPORATION

Inspection Date: 6/8/2023

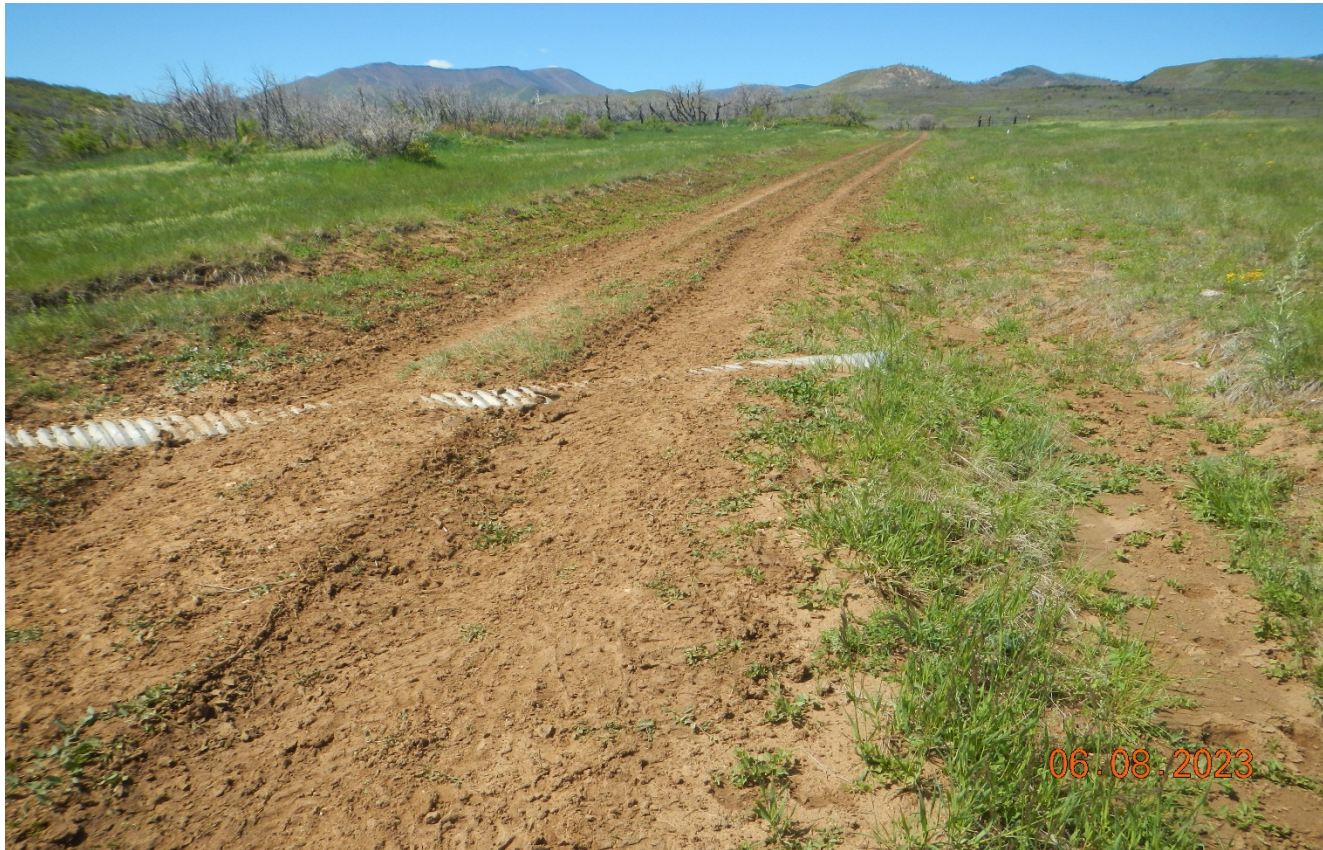
Photo 1. The culvert installed along the access road is not maintained and stormwater is bypassing the culvert. Lat/Long:37.50521,-105.07444. Previous corrective action has not been completed.

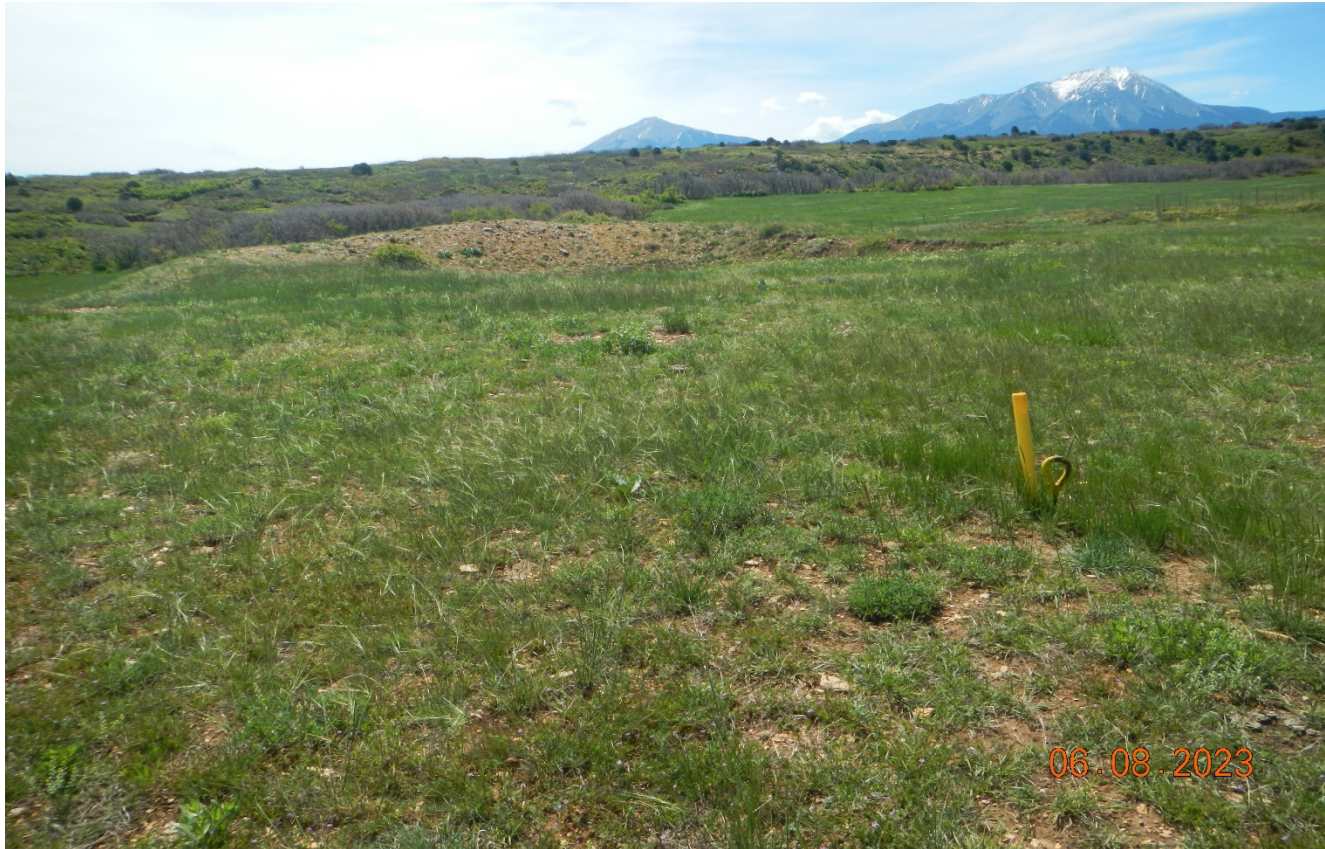
Photo 2. Facing southeast toward the location which was never recontoured and reclaimed per 1004 Rules. There are four guyline anchors that remain and the pit was not backfilled and reclaimed. Previous corrective action has not been completed.

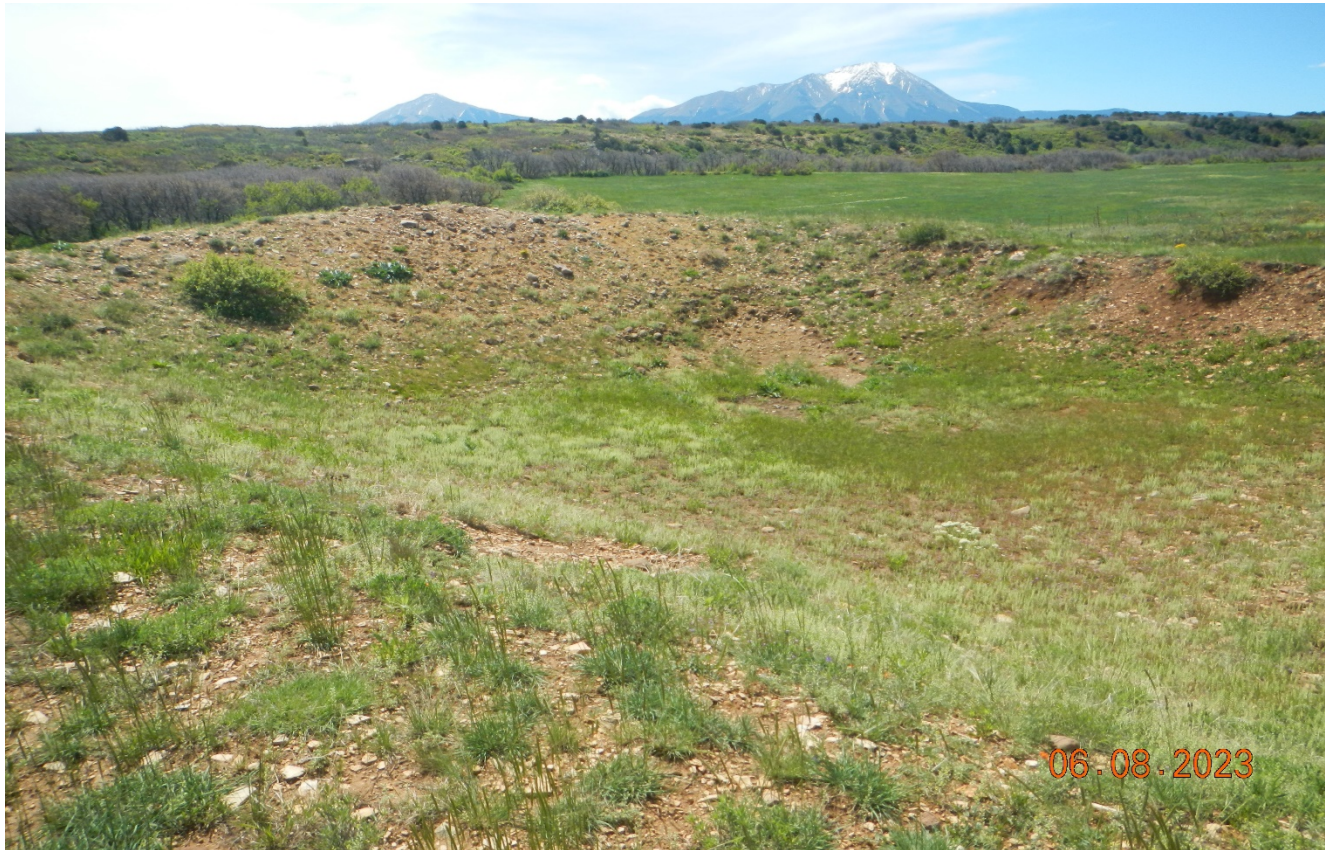
Photo 3. Facing southeast toward the pit which is approximately 100'x100' in size.

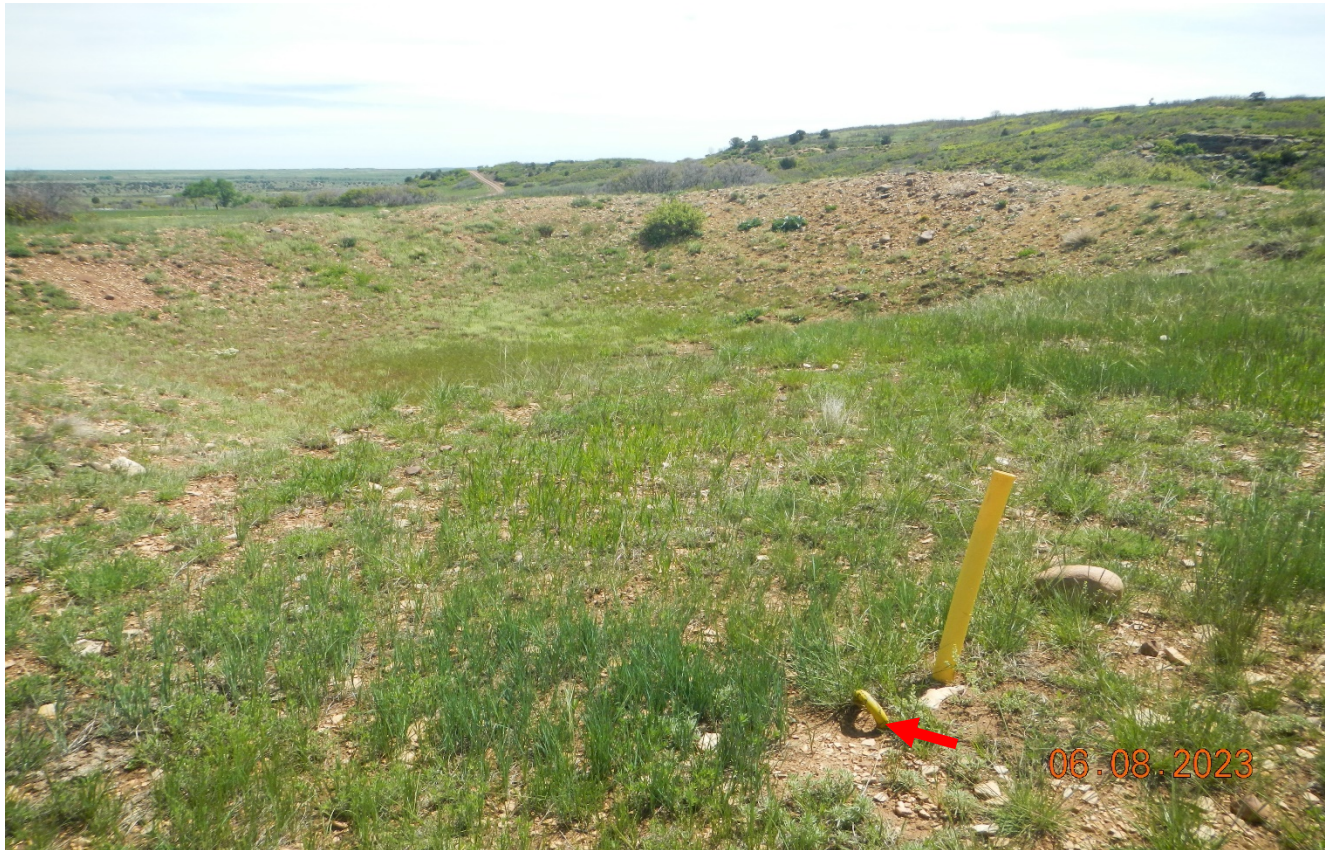
Photo 4. Facing northeast toward the pit which is approximately 100'x100' in size. Guyline anchor remains at red arrow.

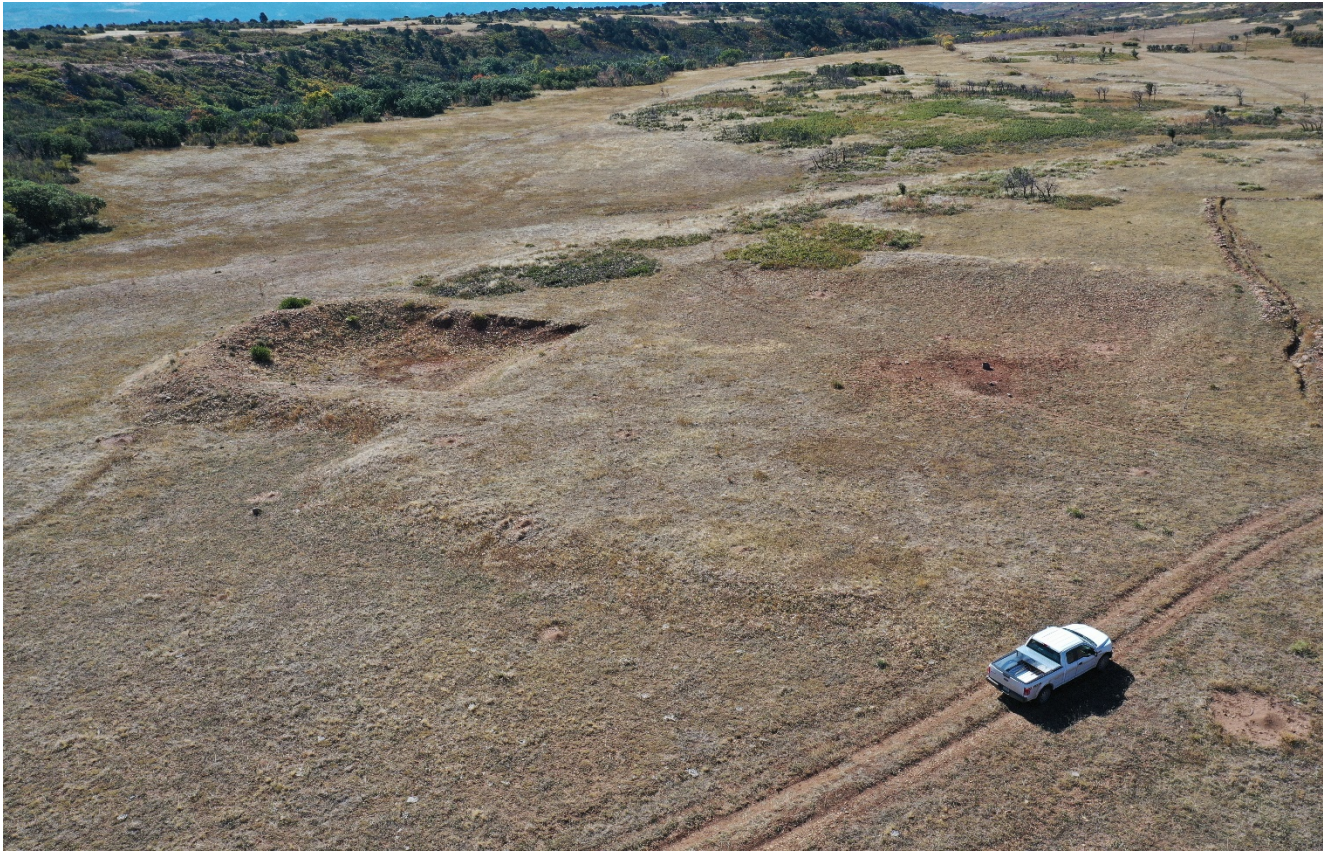
Photo 5. 2021 Drone aerial photo facing southeast toward the location disturbance which is approximately 1.3 acres.

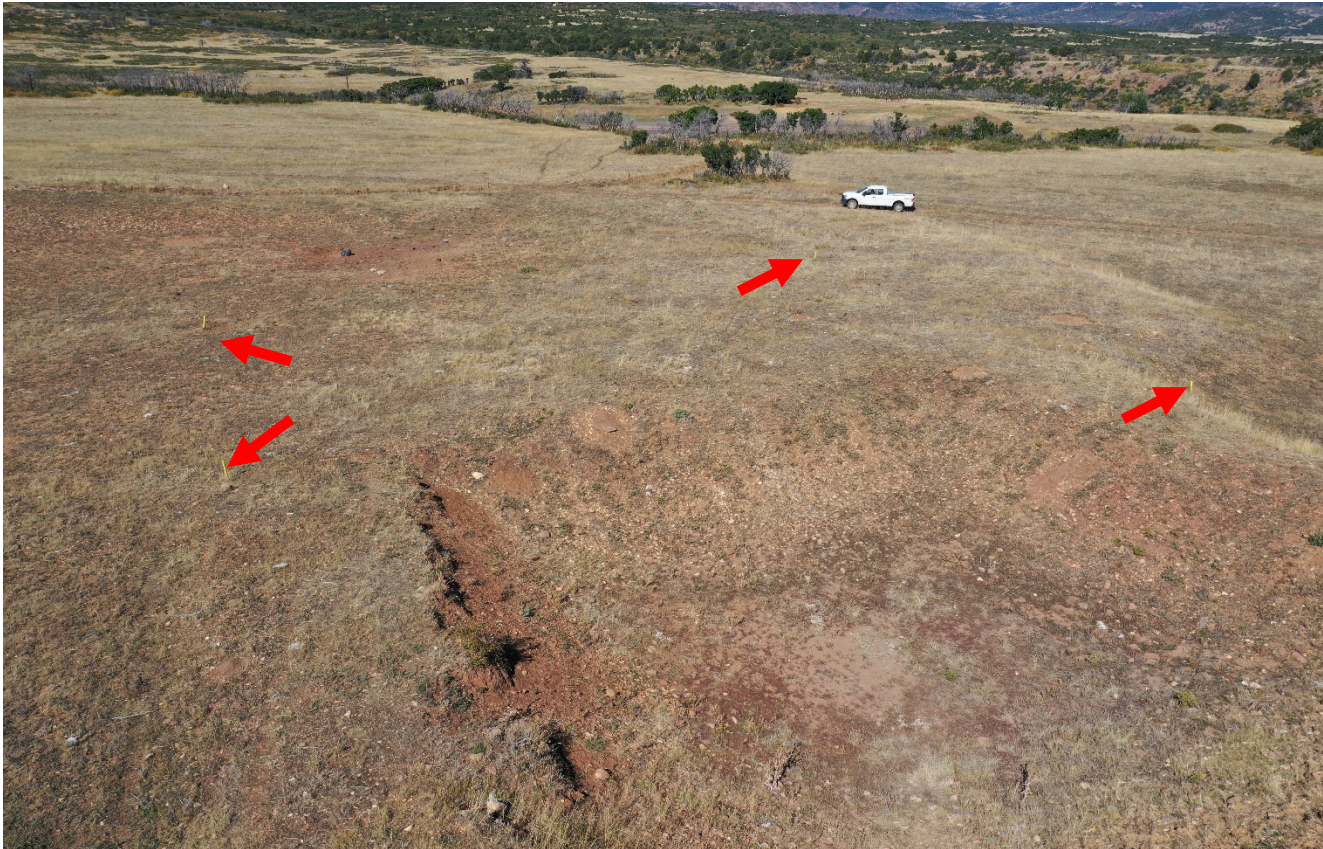
Photo 6. 2021 Drone aerial photo facing northwest. The red arrow points to the four guyline anchors that were never removed.
