Inspection Photos

API: 055-06209

Operator: CAPTUREPOINT LLC

Inspection Date: 6/8/2023

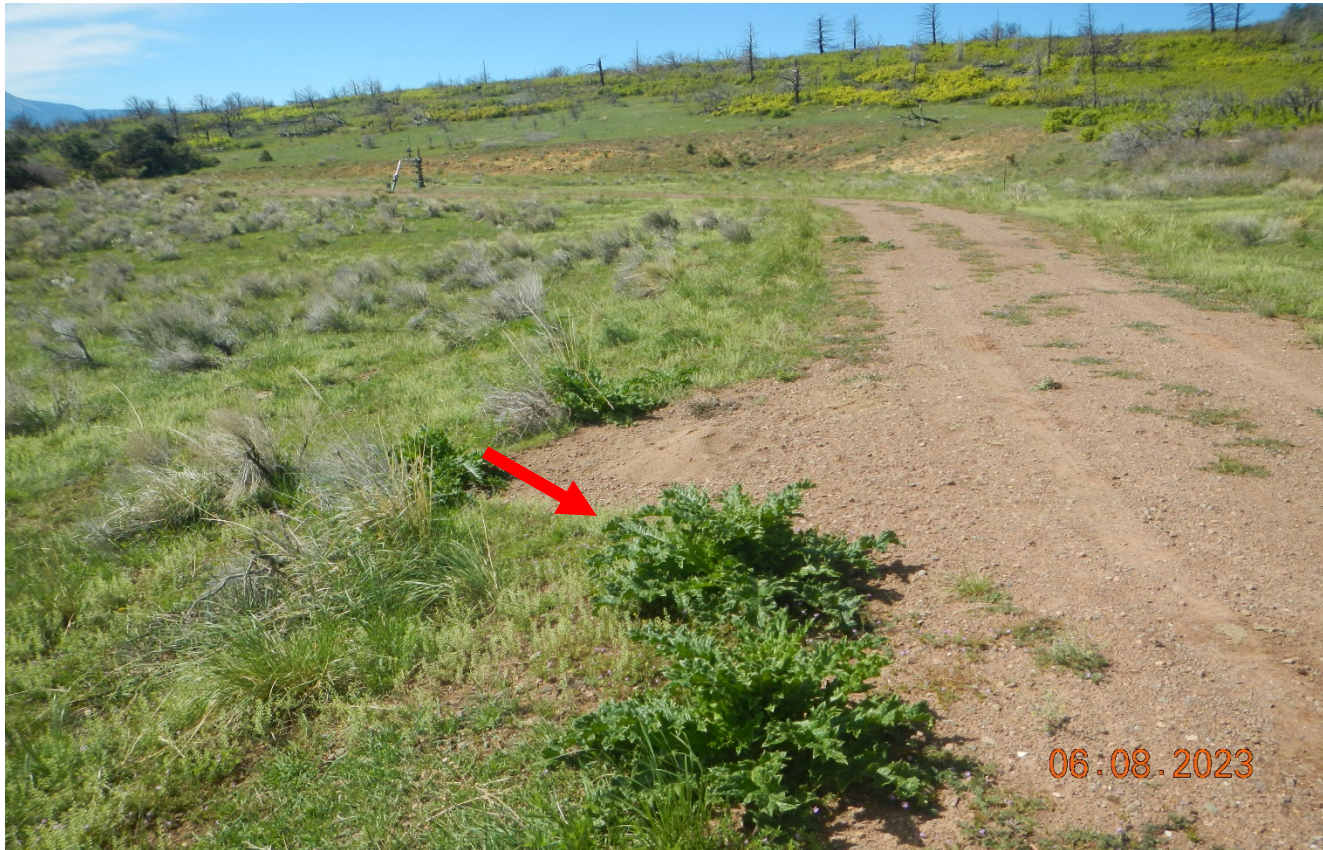
Photo 1. Facing south along the access road. There are noxious weeds along the road that need to be controlled. Red arrow → Scotch thistle.

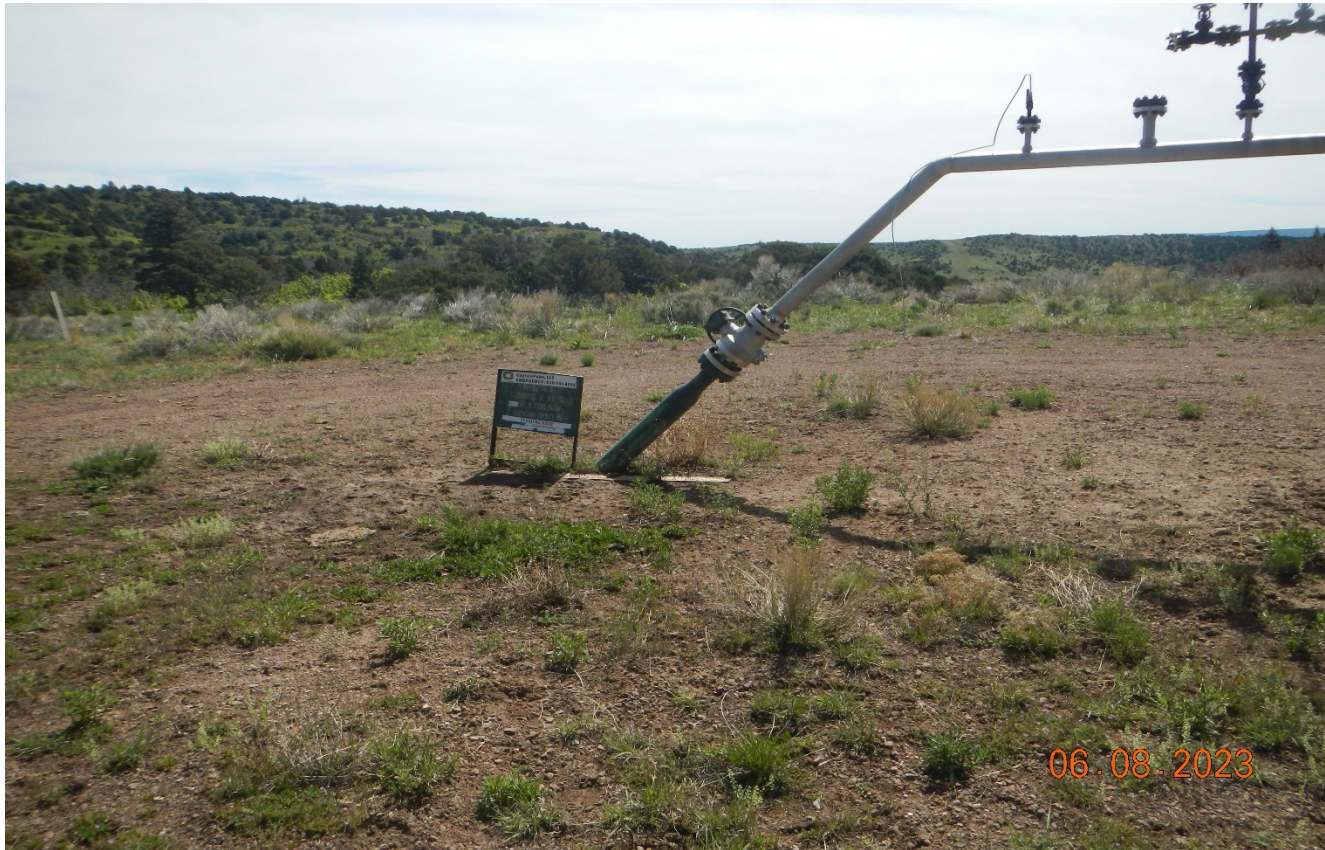
Photo 2. Well sign does not reflect current Operator and needs to be updated.

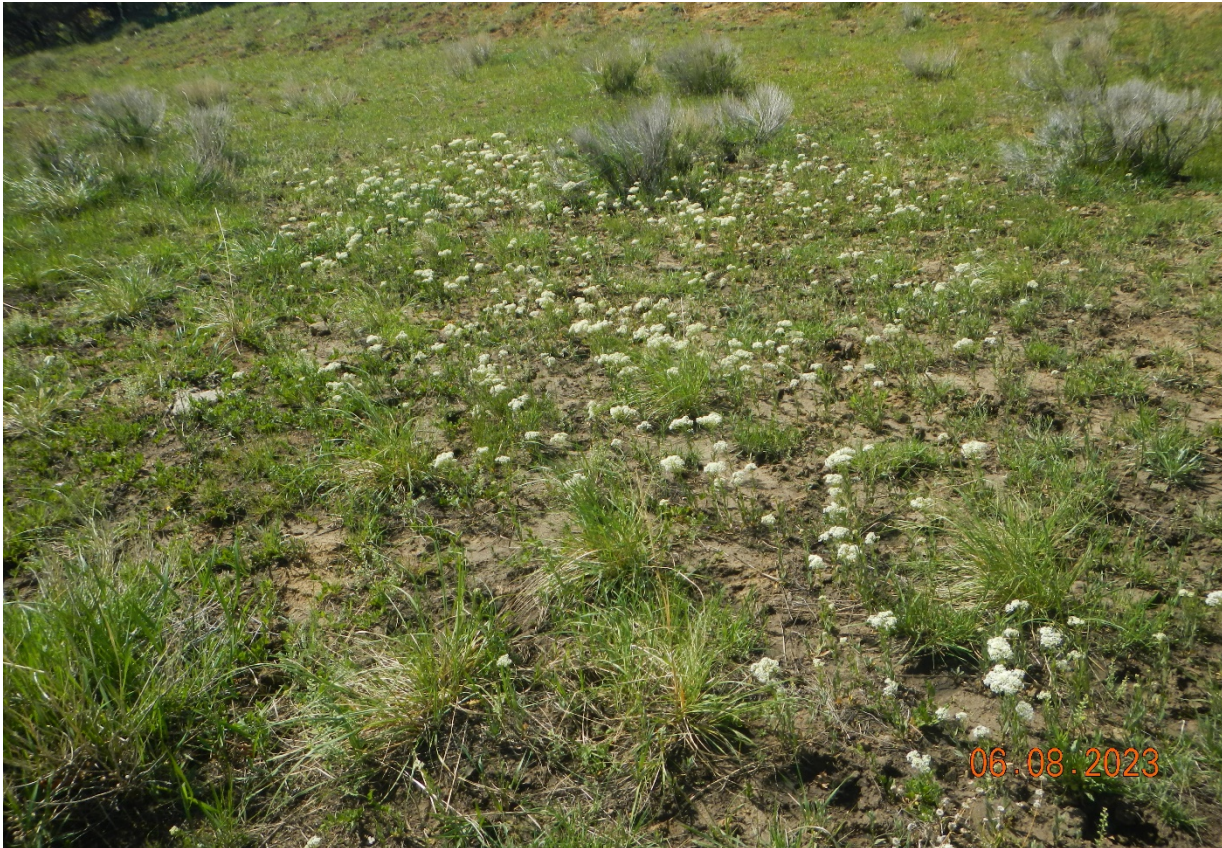
Photo 2. There are noxious weeds Hoary crest (Whit top) along the southeast side of the location that needs to be controlled.

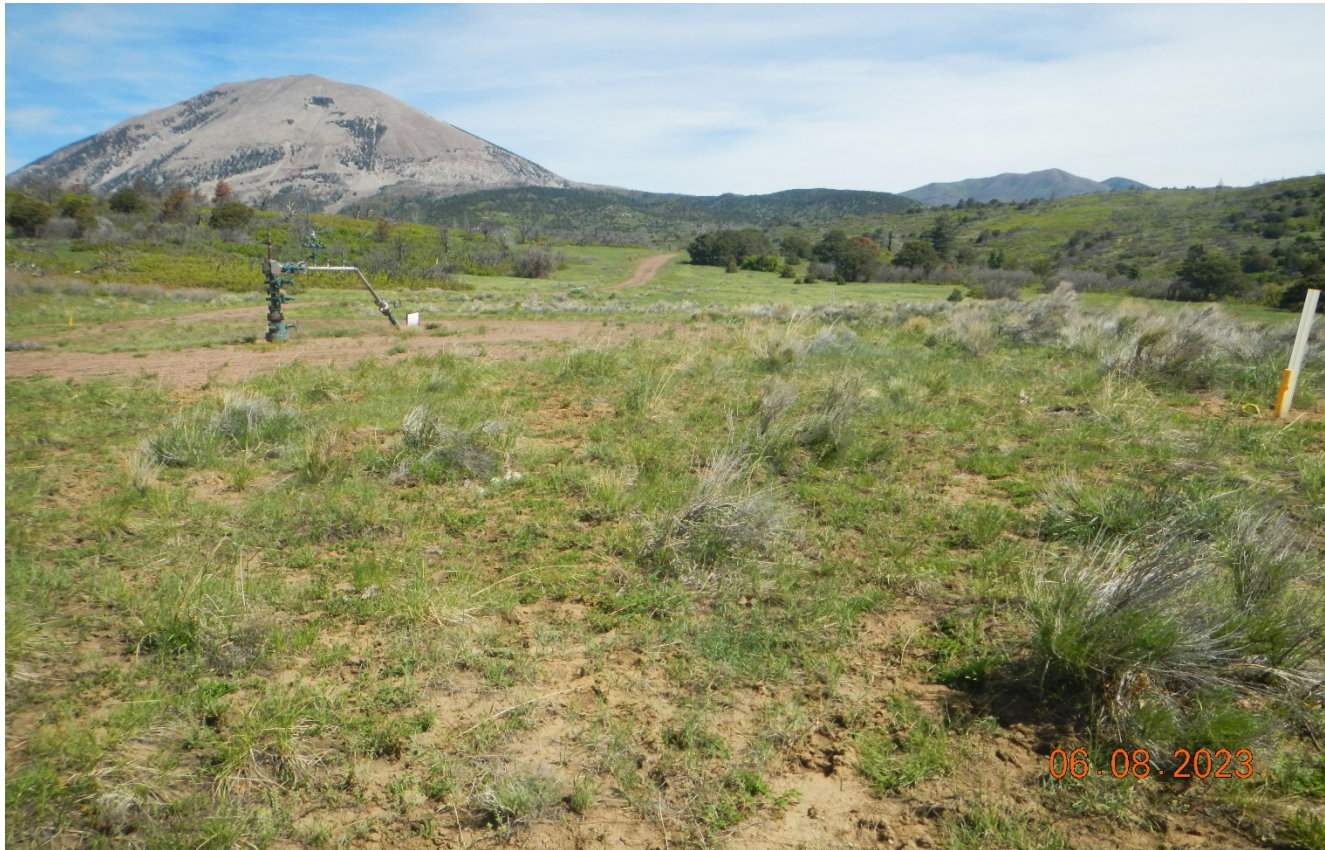
Photo 4. Facing northwest at the location.
