Inspection Photos

Location Name: Anschutz State 5-62-26-25 SWNW

Location ID: 438941

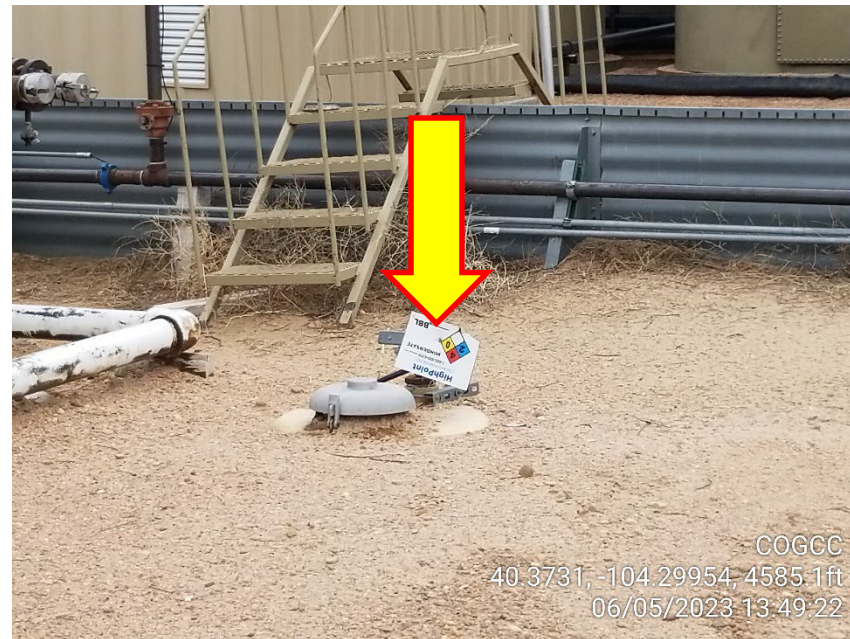
Photo 12 – Missing Capacity Label

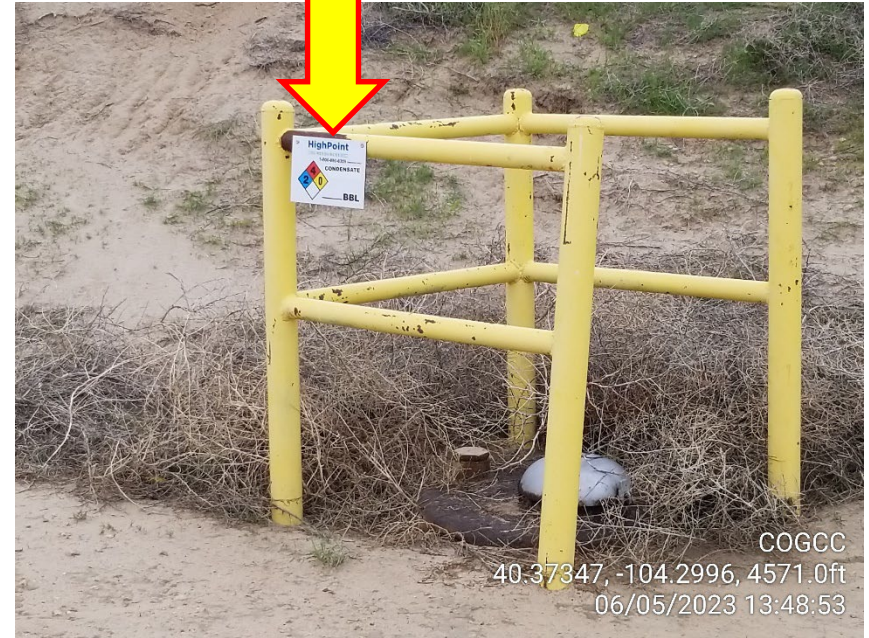
Photo 14 – Missing Capacity Label
