Storm Water Management and Erosion control
Location Name: VISION ENERGY LLC BALDY CREEK UNIT 1-17
Location #: 322404

**Location Overview: Location is approximately
30 yards from Baldy Creek
Section/Township/Range: 17 7S90W**

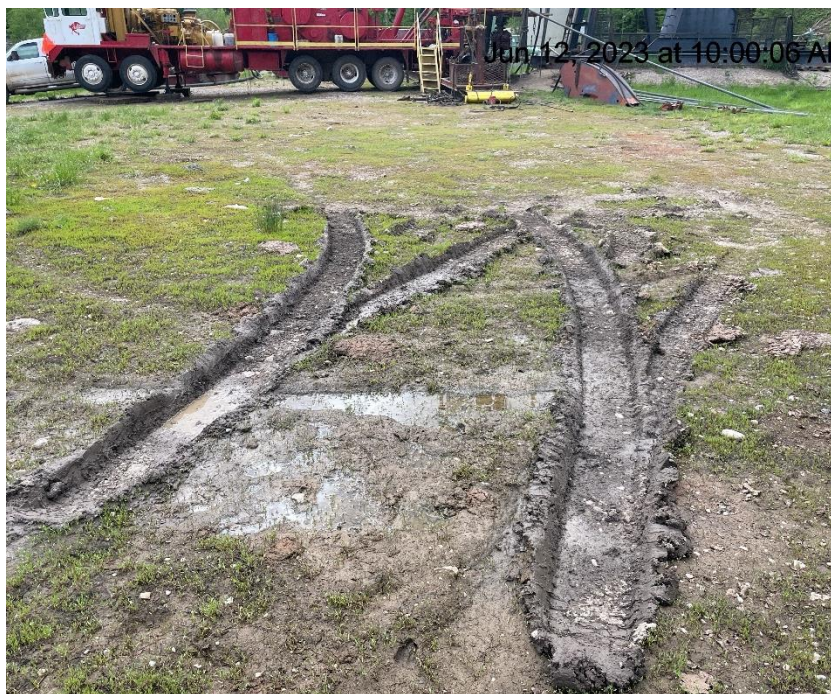
Photo # 102 Lack of stabilization/compaction

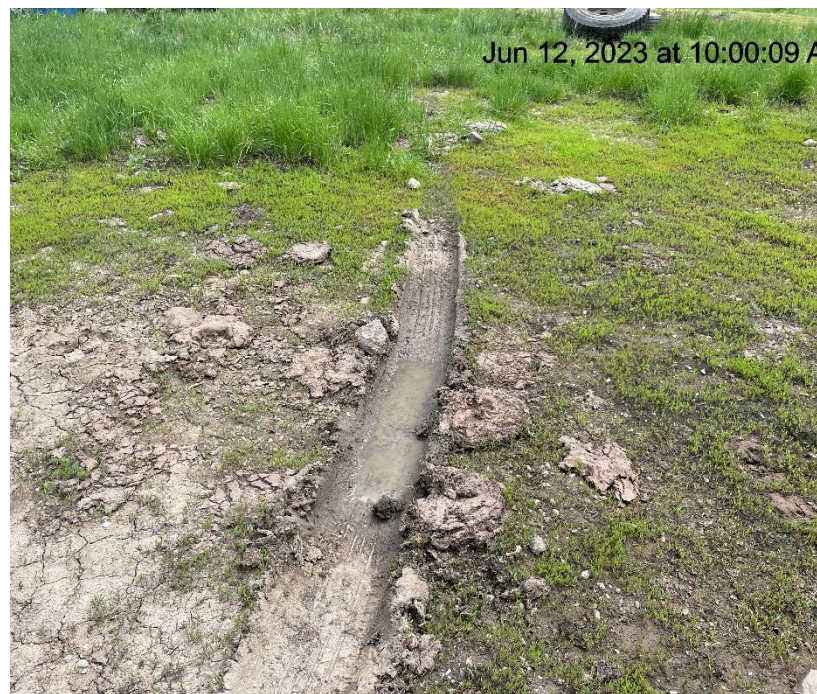
Photo # 103 Lack of stabilization/compaction

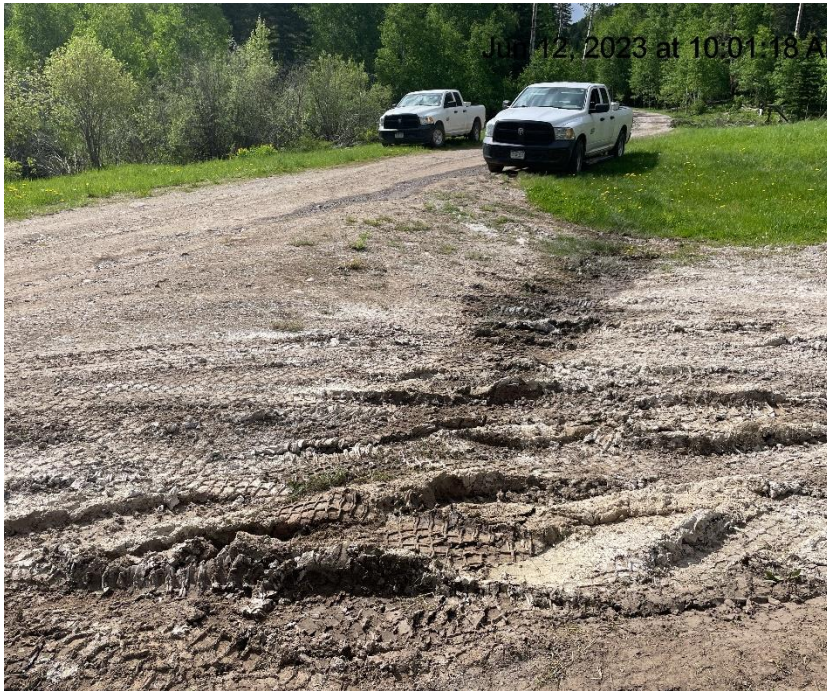
**Photo # 106 Lack of stabilization/compaction/
Insufficient tracking BMP's**

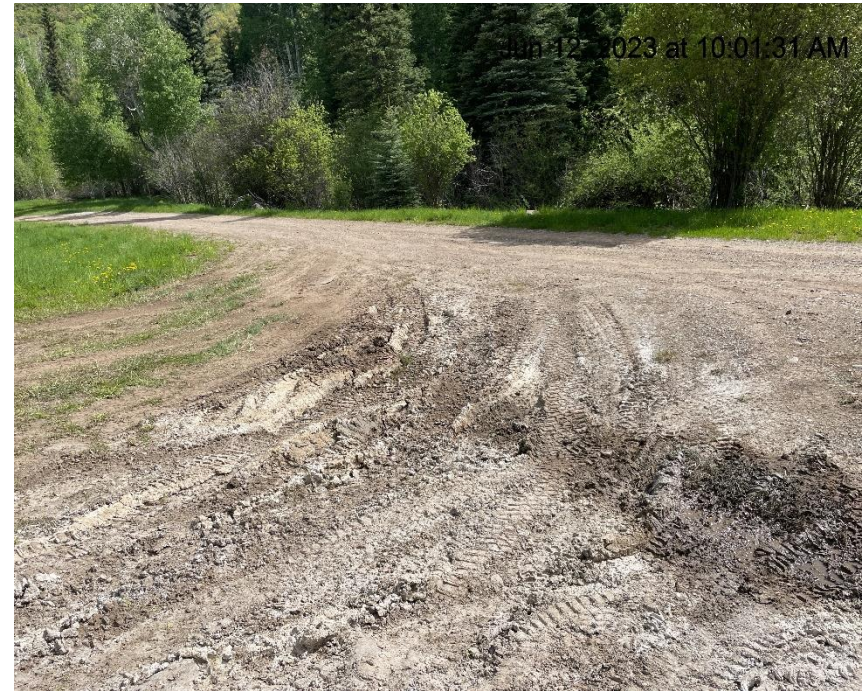
**Photo # 107 Lack of stabilization/compaction/
Insufficient tracking BMP's**

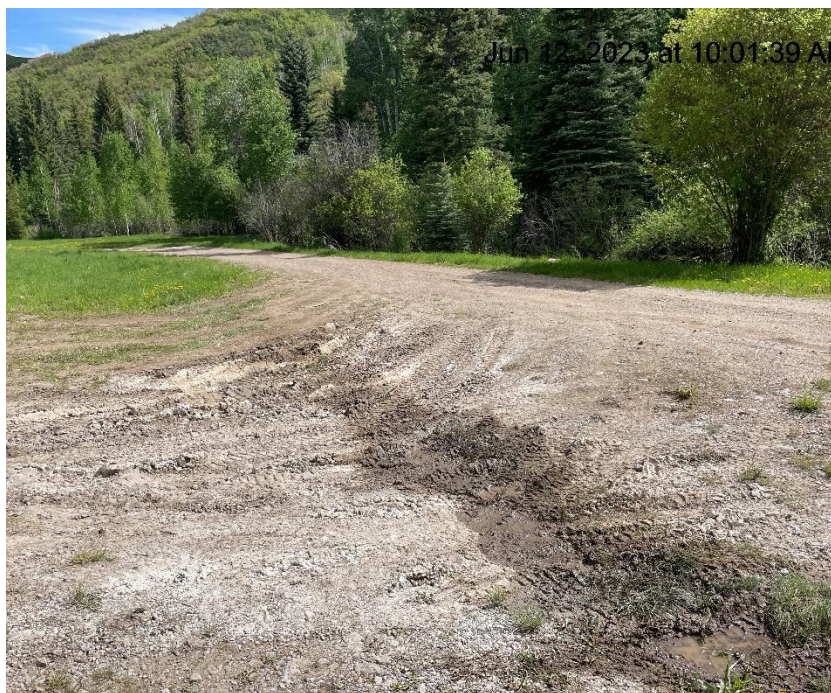
**Photo # 108 Lack of stabilization/compaction/
Insufficient tracking BMP's**

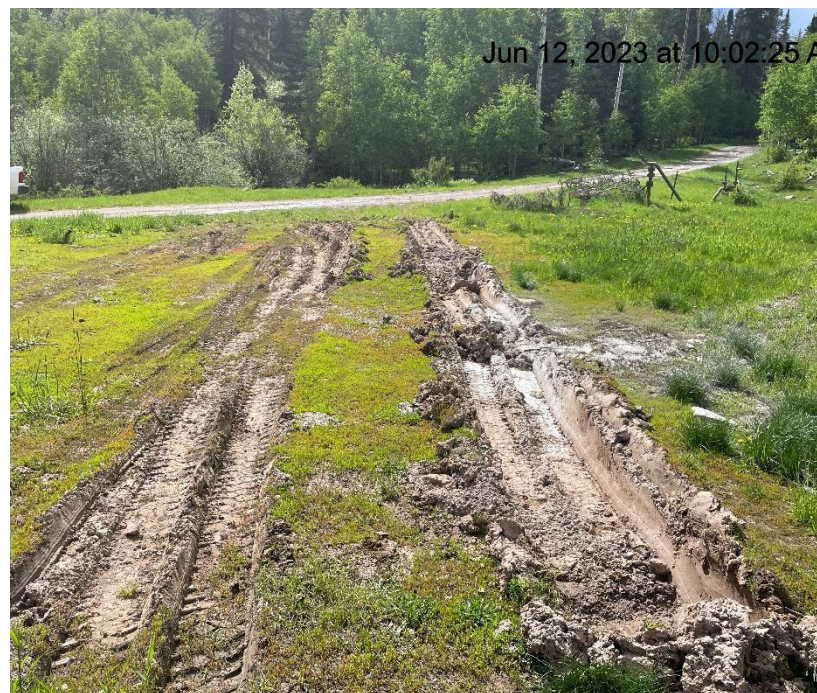
Photo # 110 Lack of stabilization/compaction

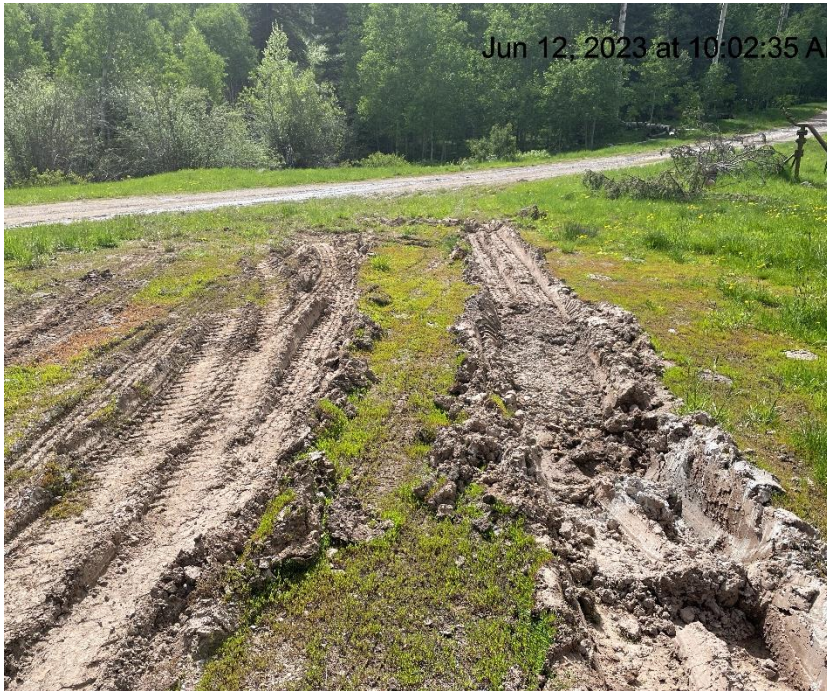
Photo # 111 Lack of stabilization/compaction

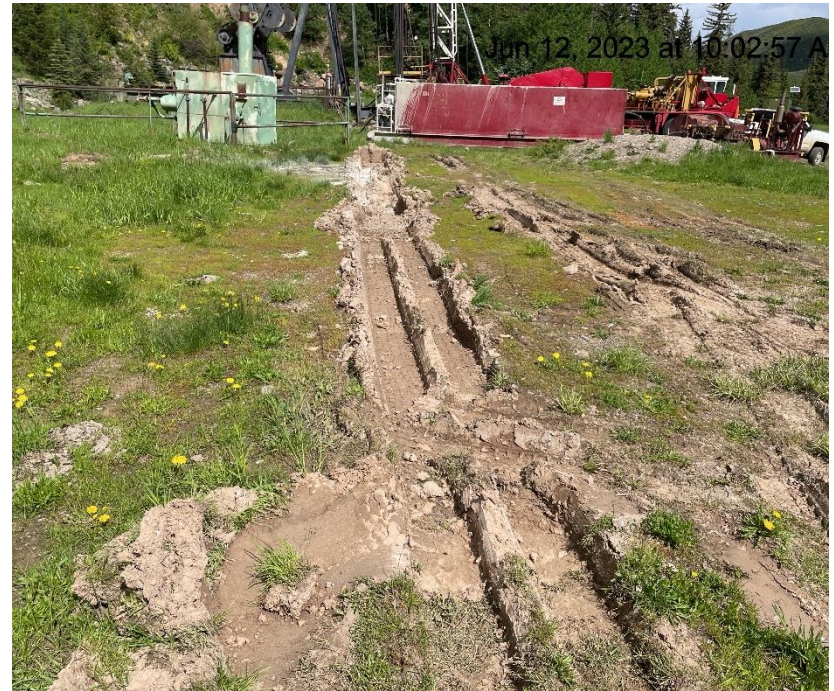
Photo # 112 Lack of stabilization/compaction

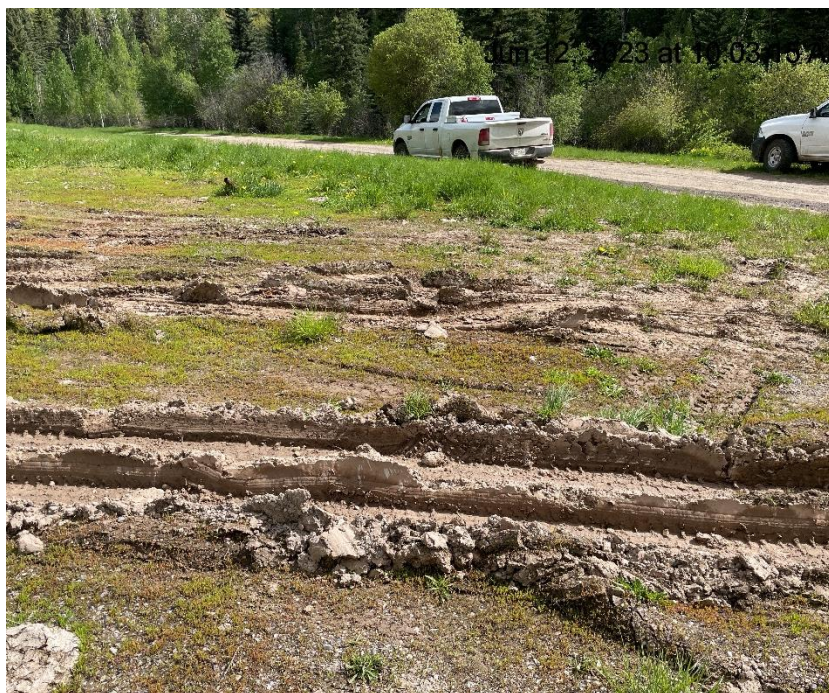
Photo # 114 Lack of stabilization/compaction

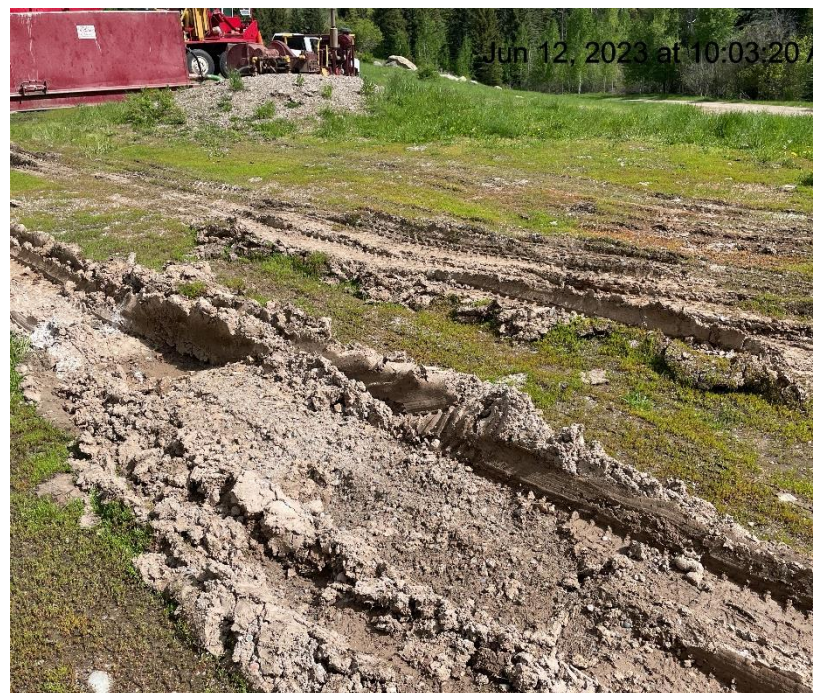
Photo # 115 Lack of stabilization/compaction

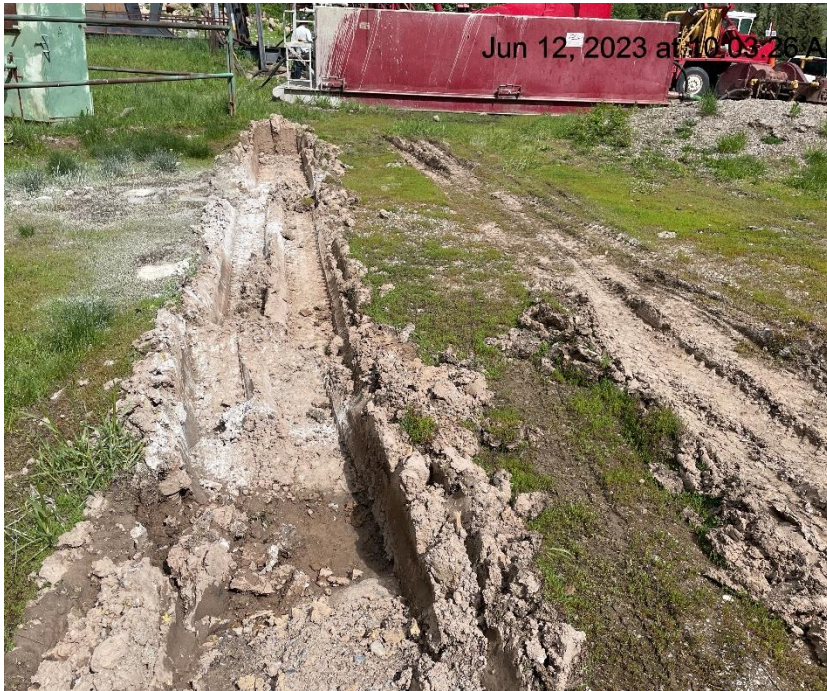
Photo # 116 Lack of stabilization/compaction

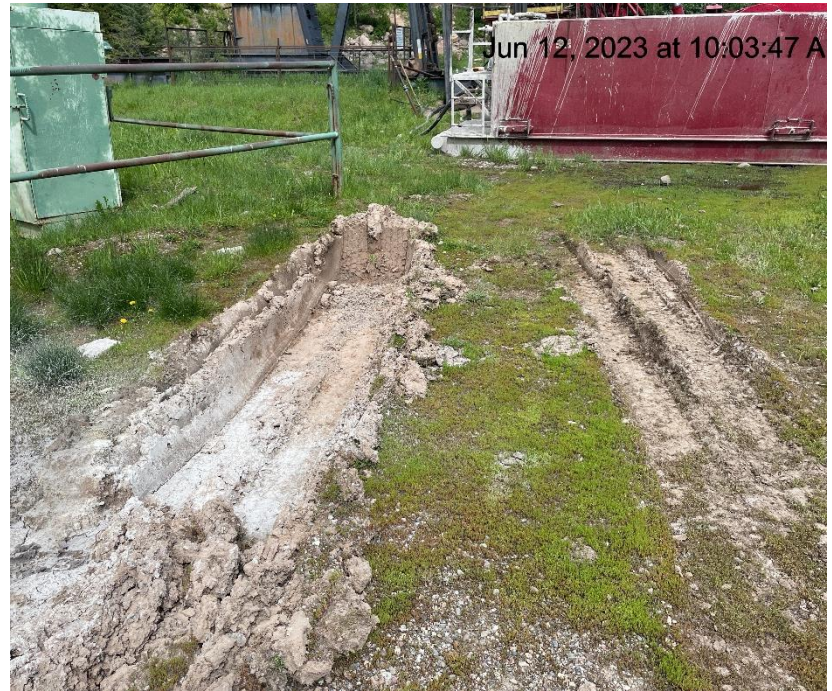
Photo # 118 Lack of stabilization/compaction
