Inspection Photos

Location Name: VISION ENERGY LLC BALDY CREEK UNIT 1-17

Location #: 322404

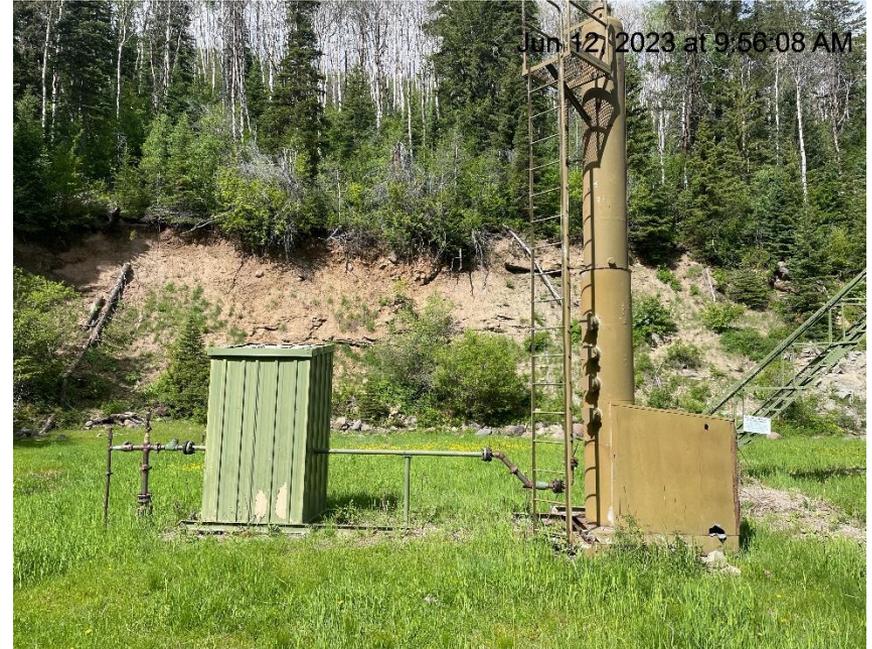
Photo # 95 Weeds/undesirable plant species encroaching on equipment

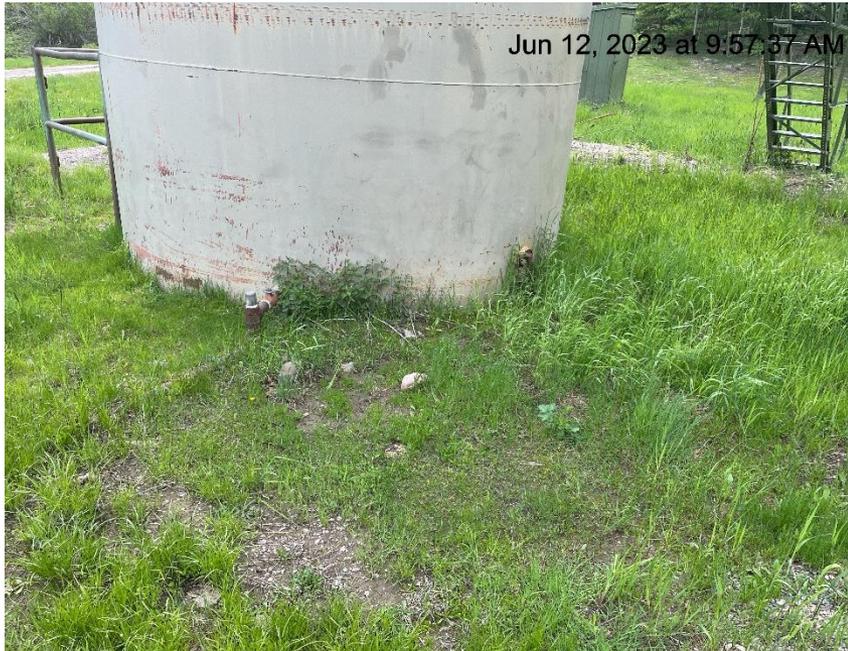
Photo # 98 Weeds/undesirable plant species encroaching on equipment

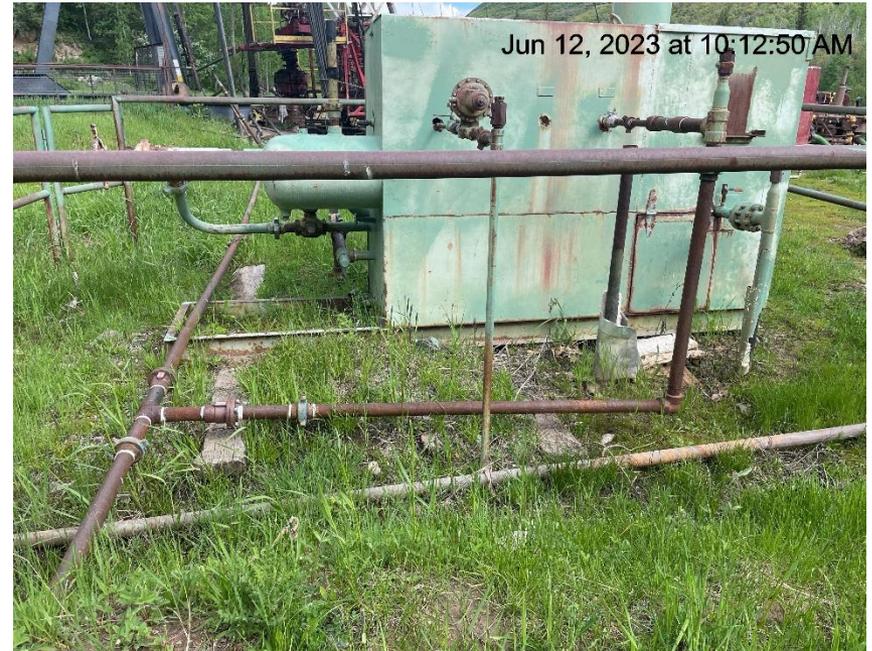
Photo # 122 Weeds/undesirable plant species encroaching on equipment

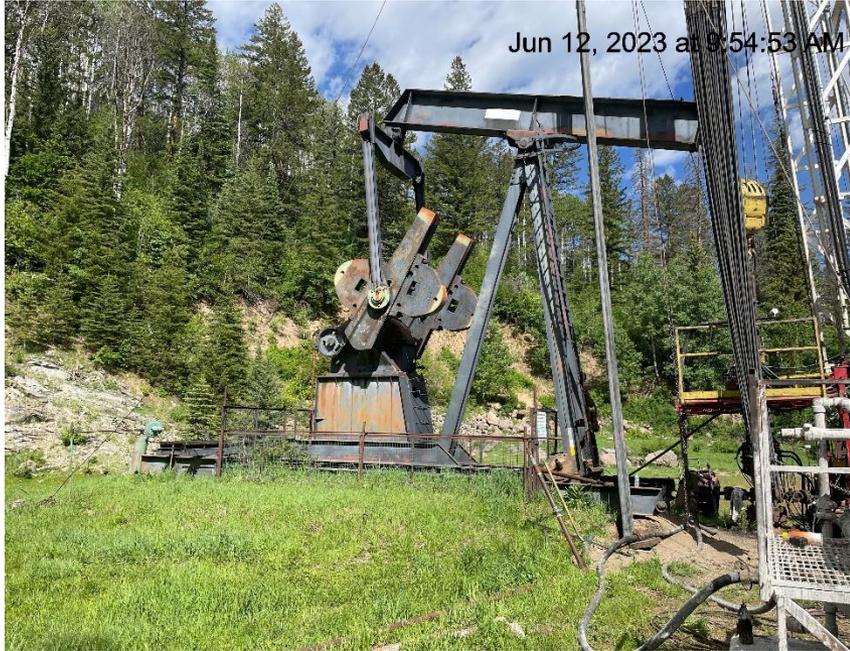
Photo # 93 Weeds/undesirable plant species encroaching on equipment

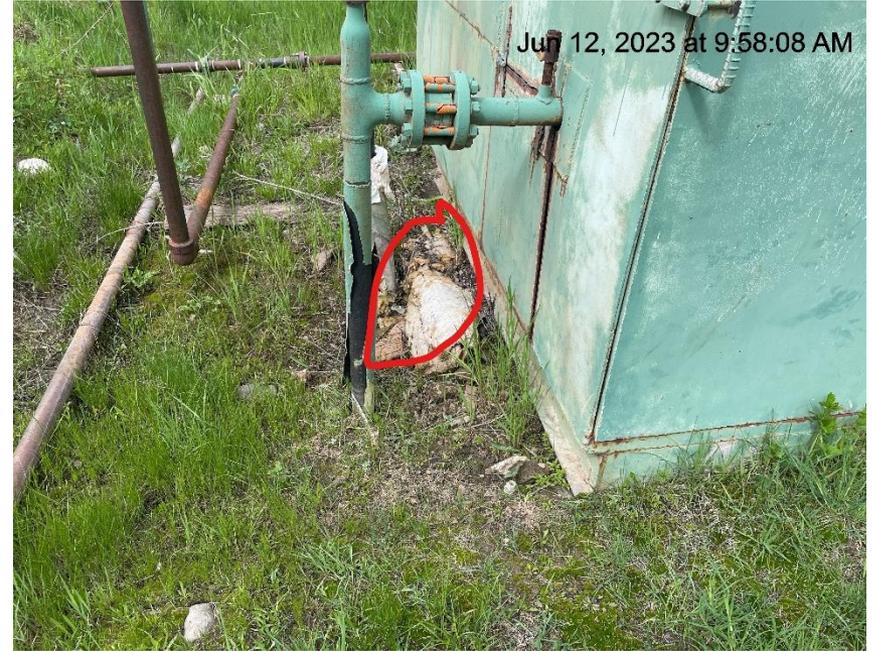
Photo # 99 Debris

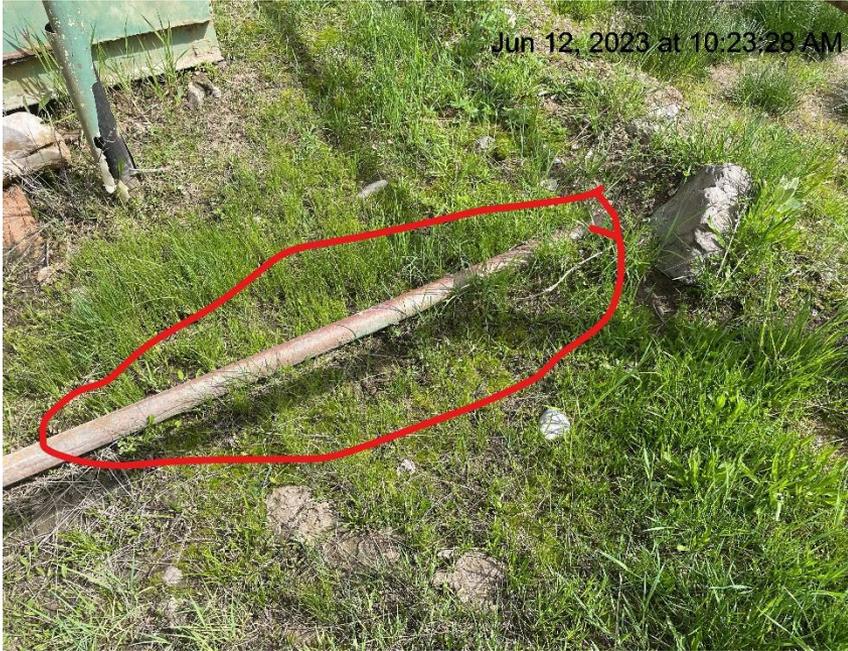
Photo # 131 Debris

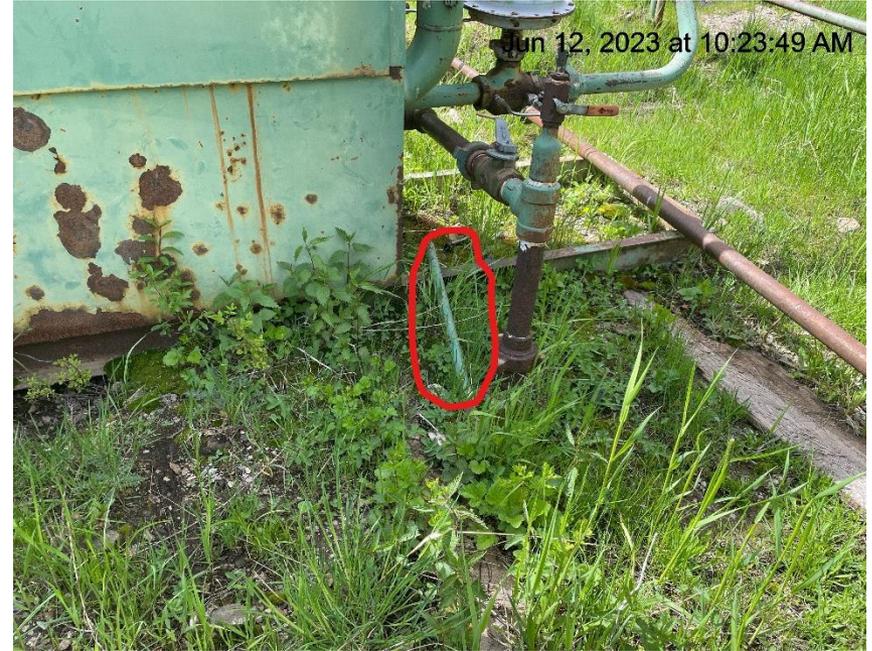
Photo # 132 Debris

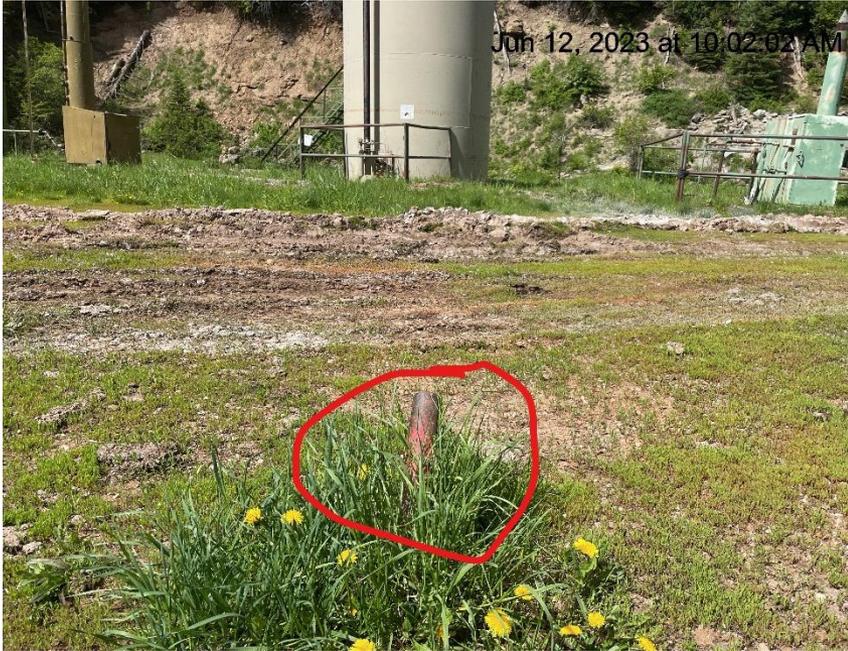
Photo # 109 Improperly marked deadman/anchor

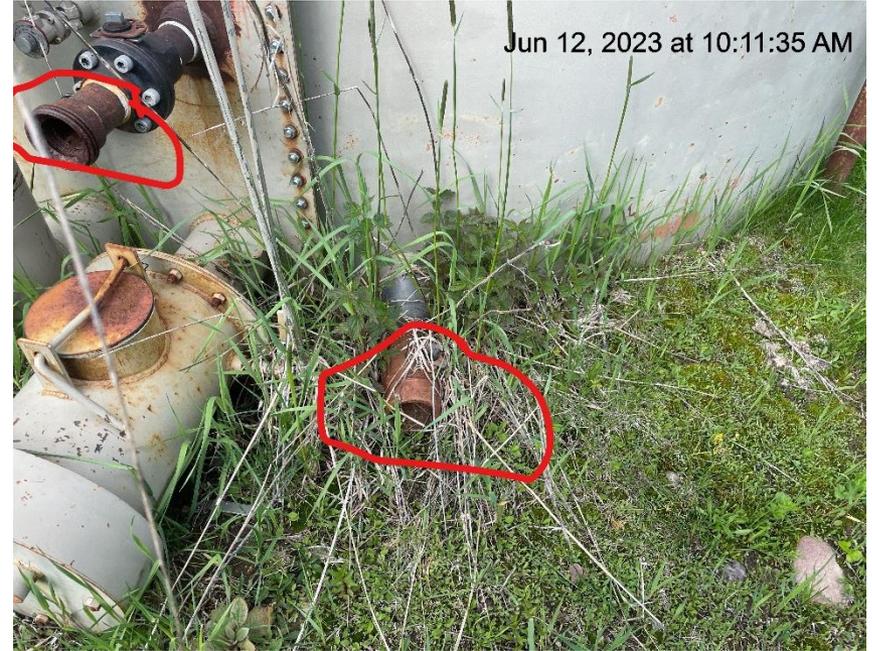
Photo # 121 Open ended load lines

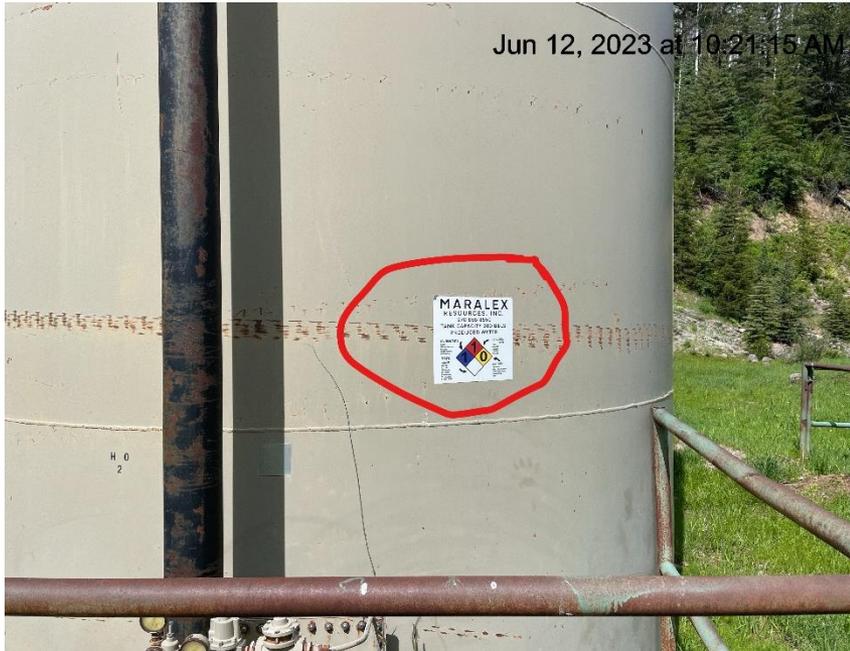
Photo # 130 Tank label has incorrect information

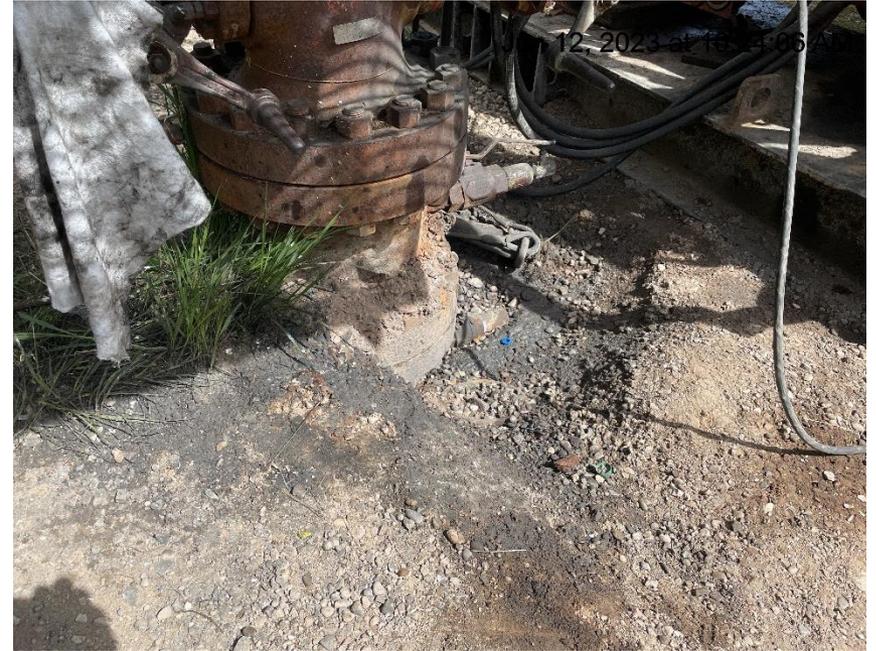
Photo # 133 Stained soils & gravel

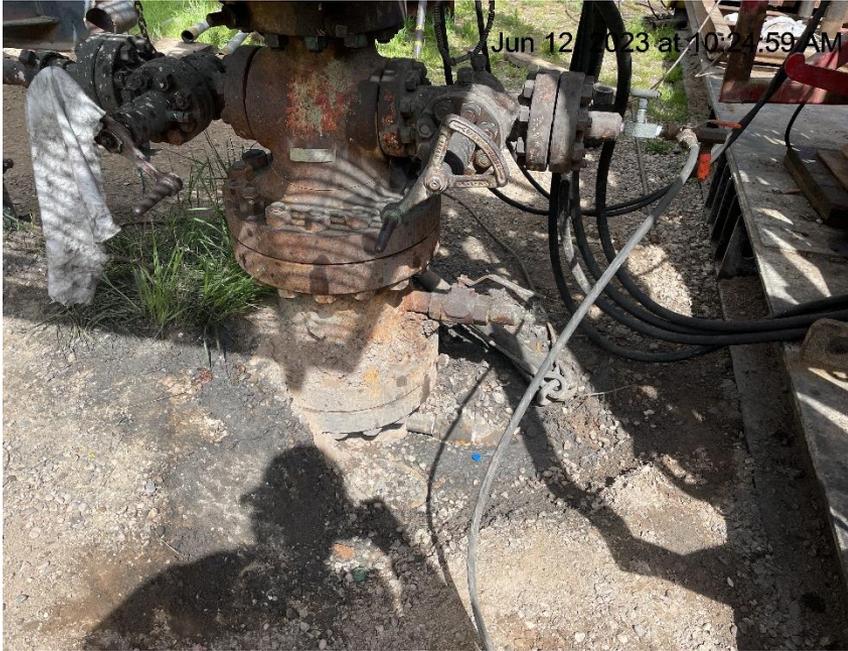
Photo # 134 Stained soils & gravel

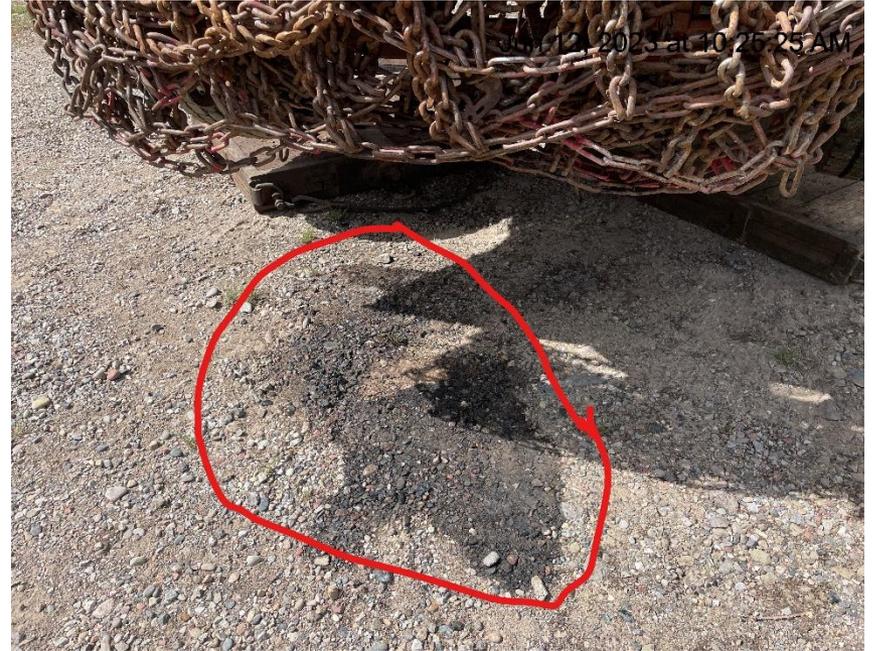
Photo # 136 Stained soils & gravel

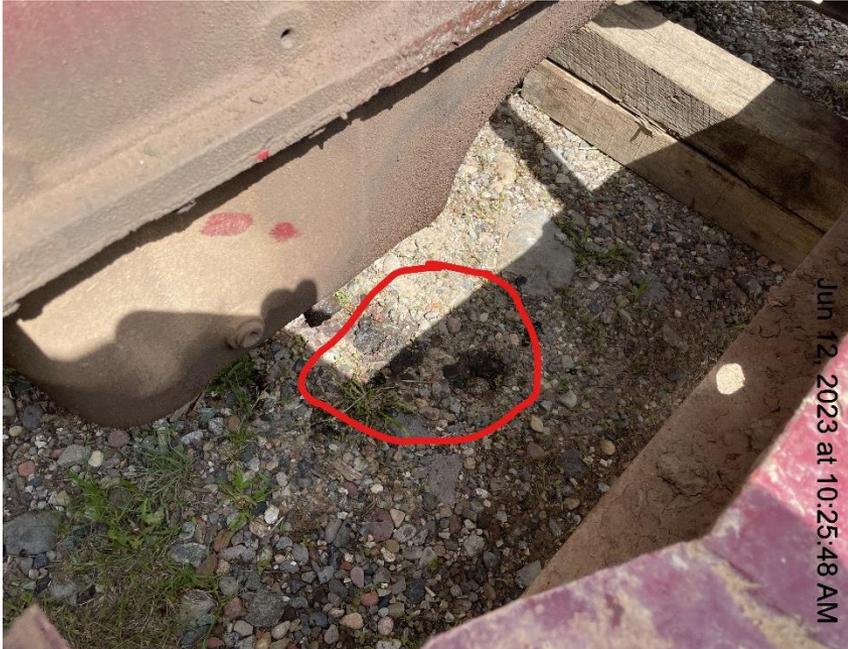
Photo # 137 Stained soils & gravel

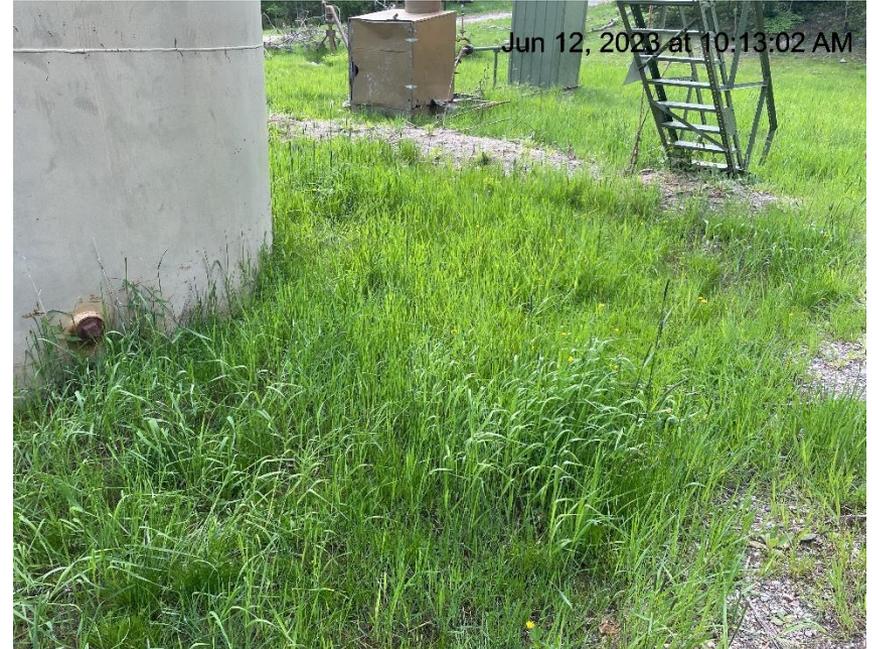
Photo # 123 Secondary containment not sufficient to contain 110% of tank capacity spilled or released materials/containment needs maintenance.

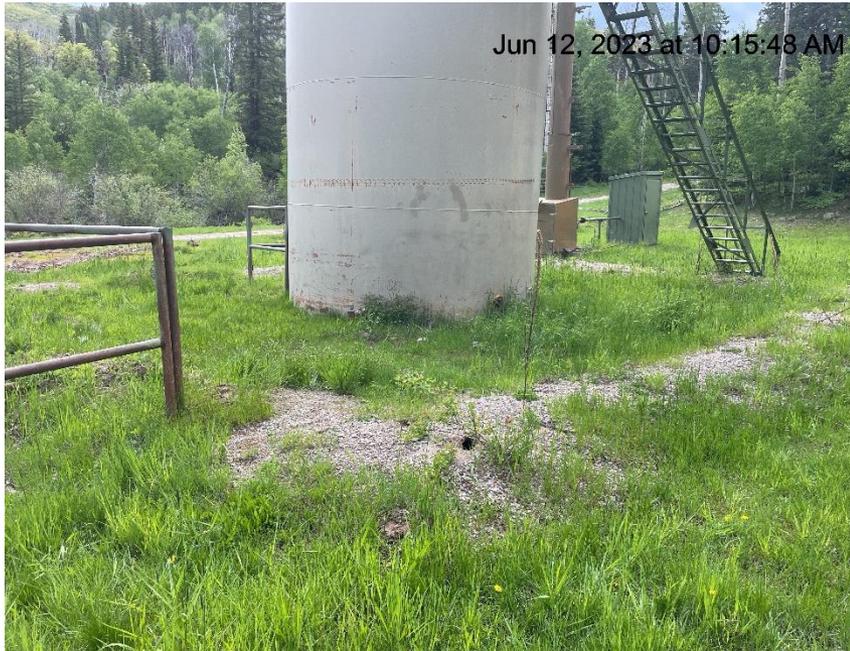
Photo # 126 Secondary containment not sufficient to contain 110% of tank capacity spilled or released materials/containment needs maintenance.

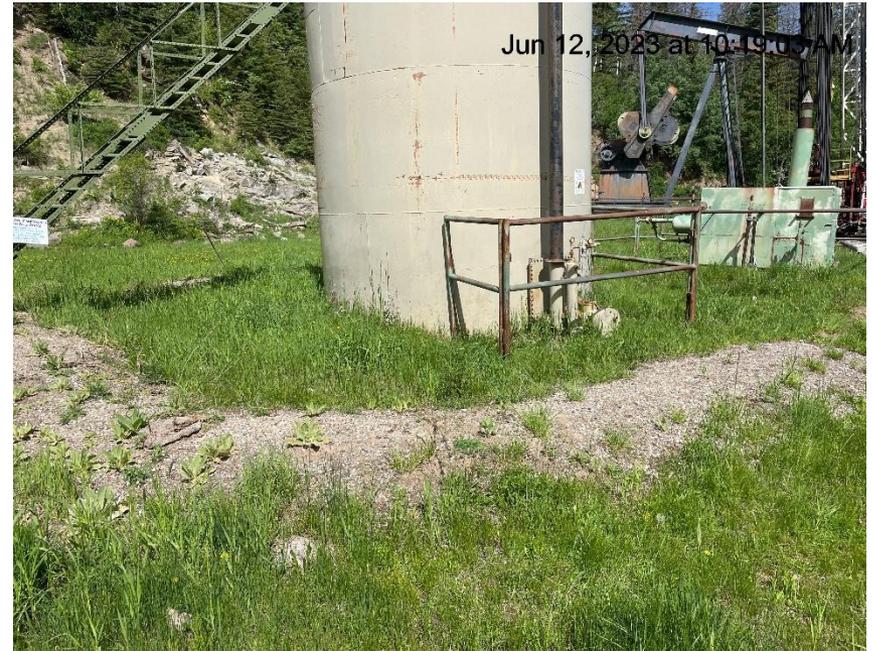
Photo # 128 Secondary containment not sufficient to contain 110% of tank capacity spilled or released materials/containment needs maintenance.
