**KT Resources LLC
Ant Hill Unit 30-42
Location #316154**

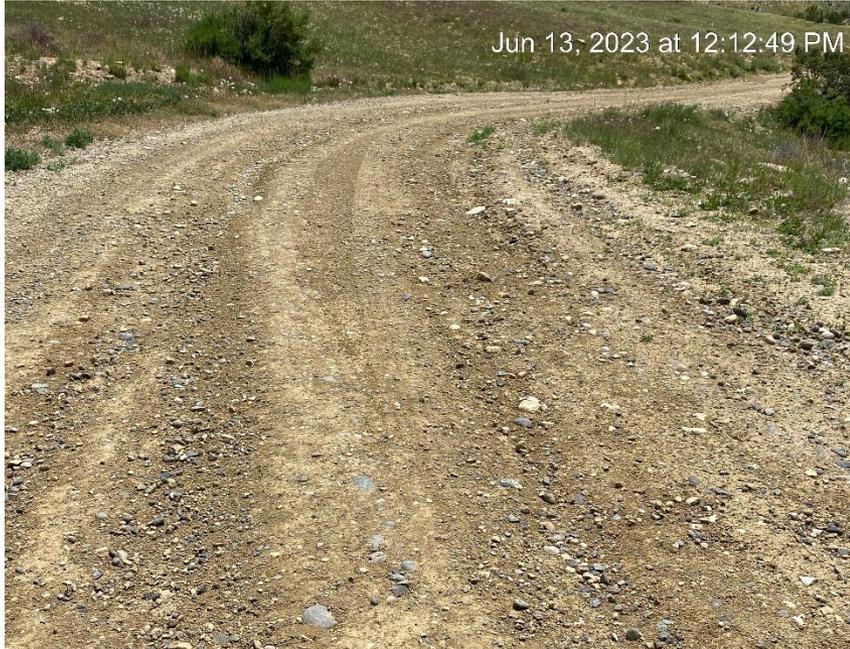
East side access road to location

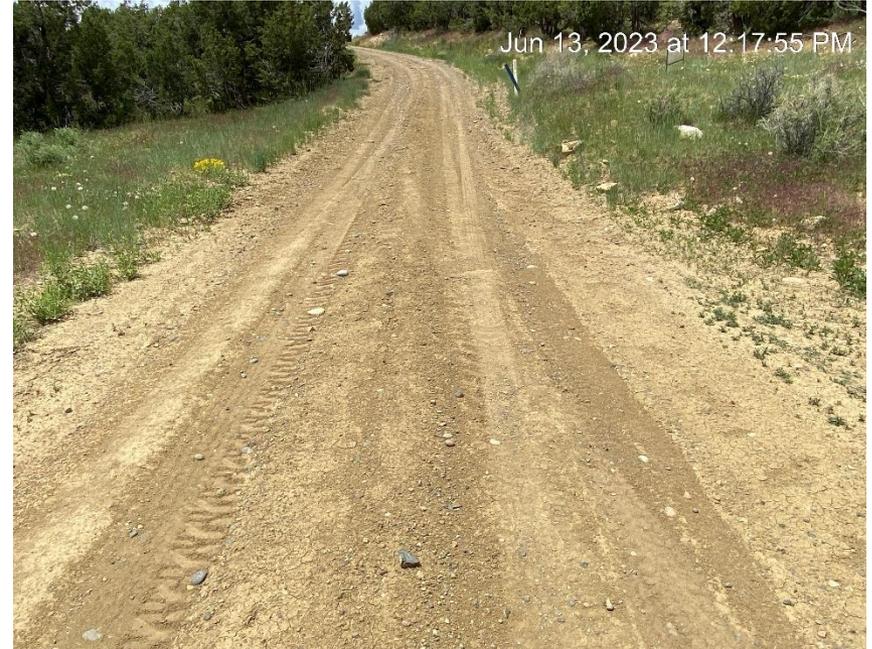
West side access road to location

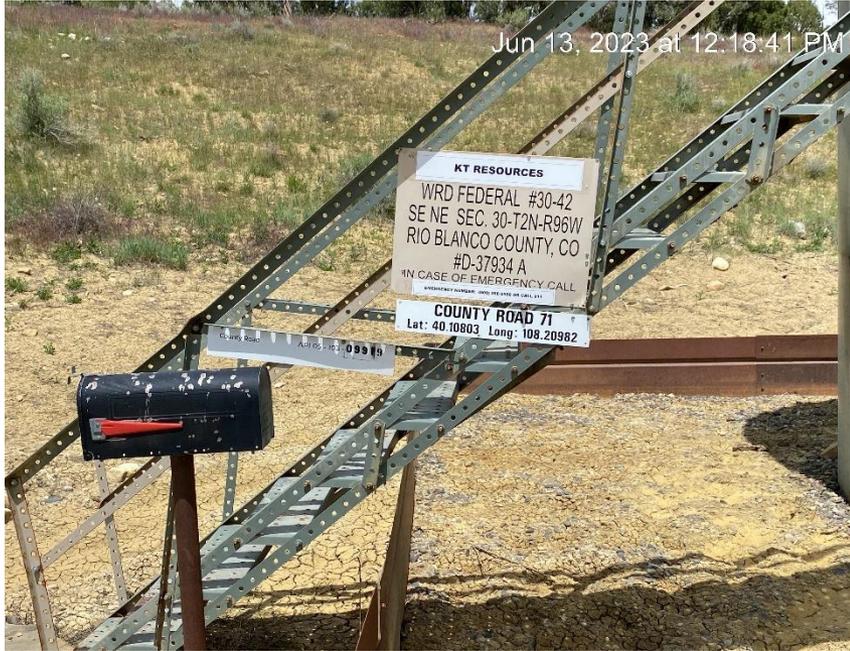
Tank battery signs

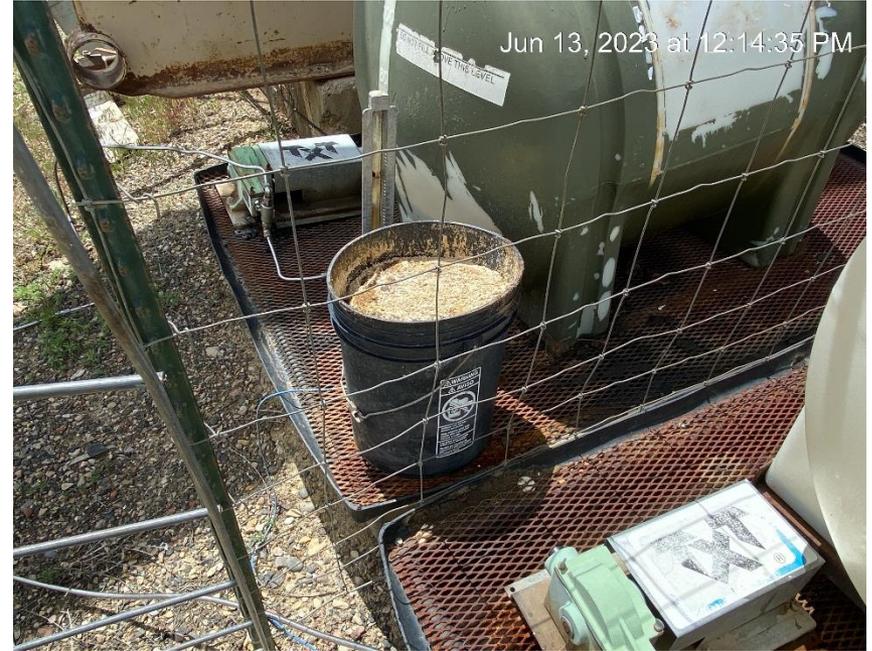
Debris

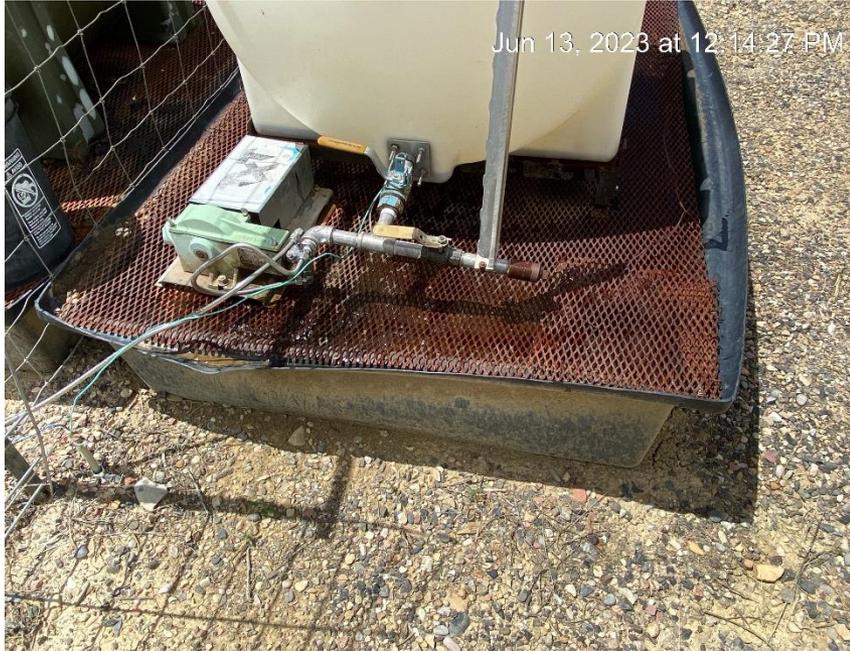
Containment full

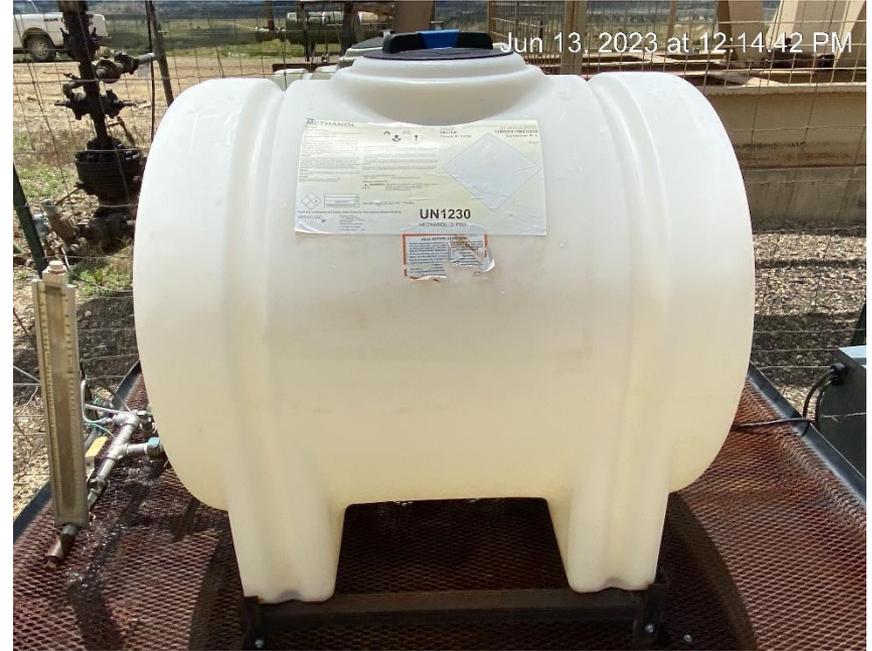
Faded and illegible label

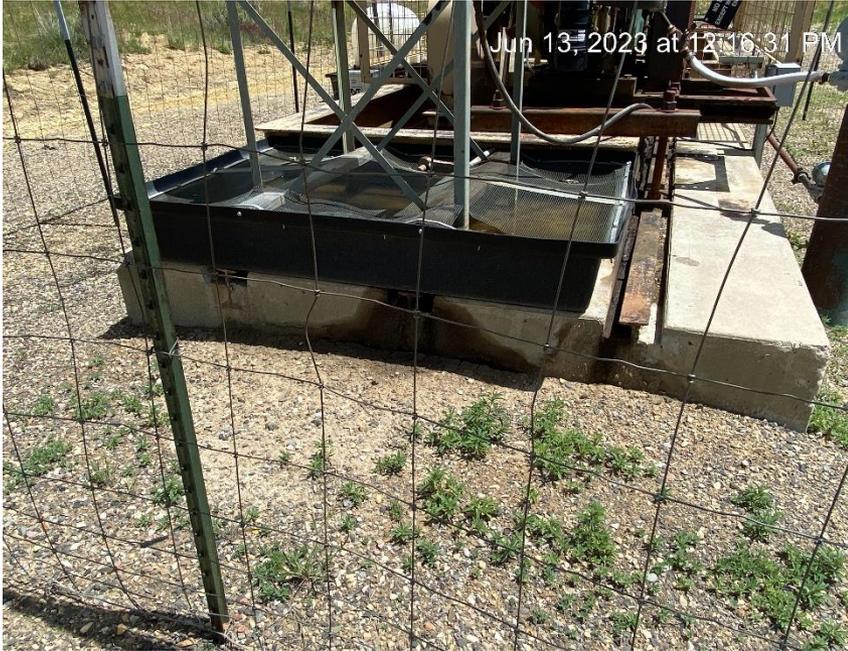
Leaking equipment and stained soil

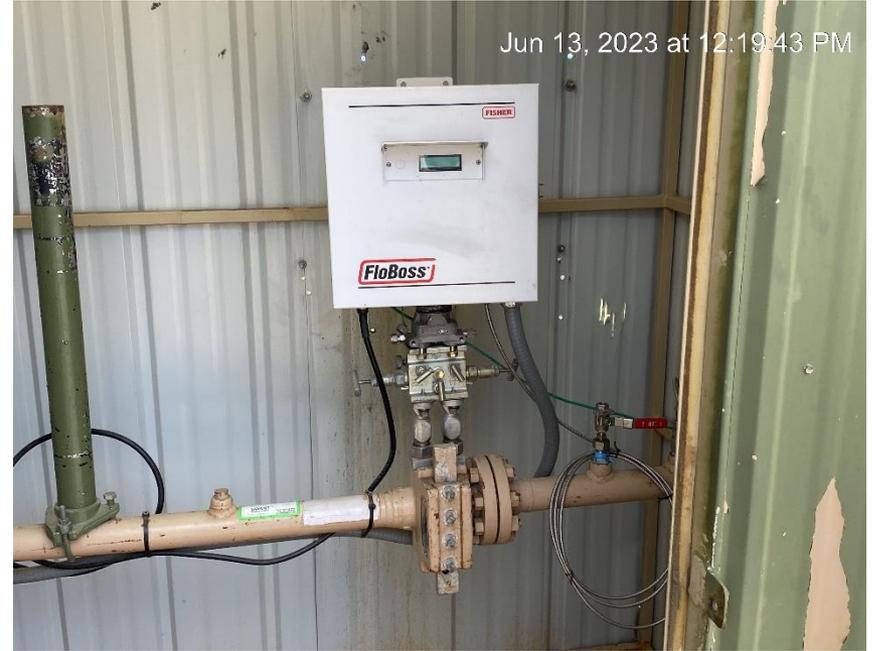
No gas meter calibration visibly displayed

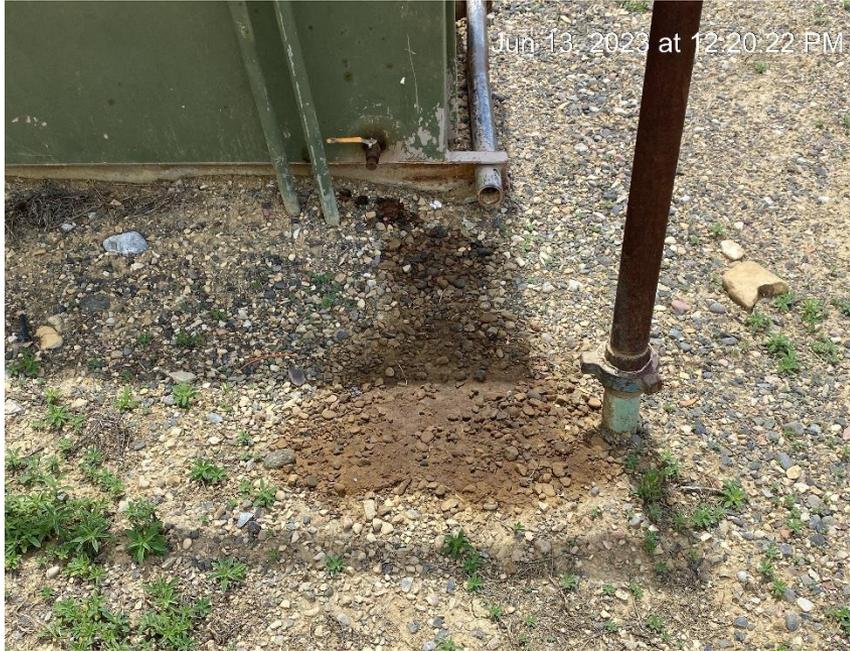
Stained soil

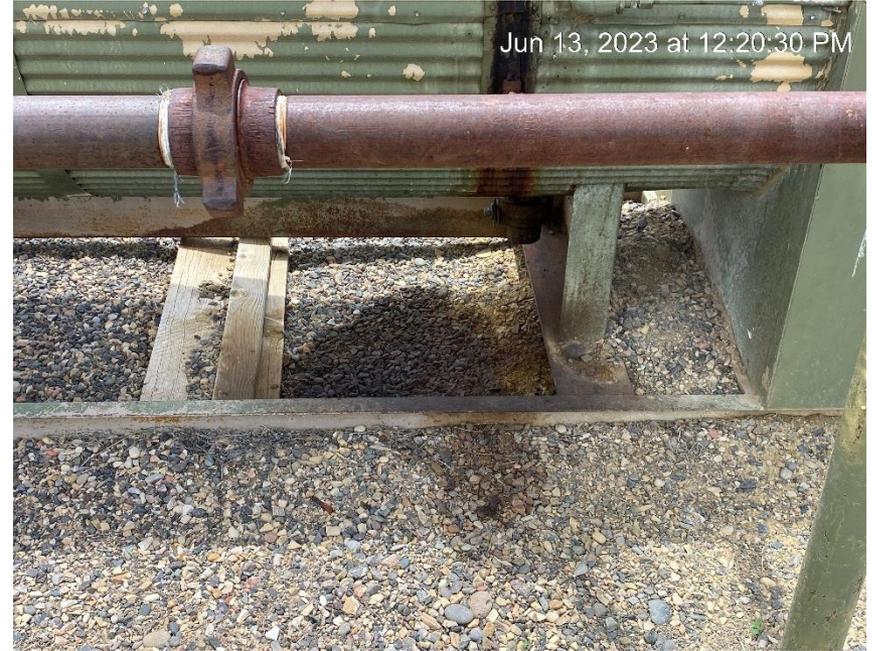
Stained soil

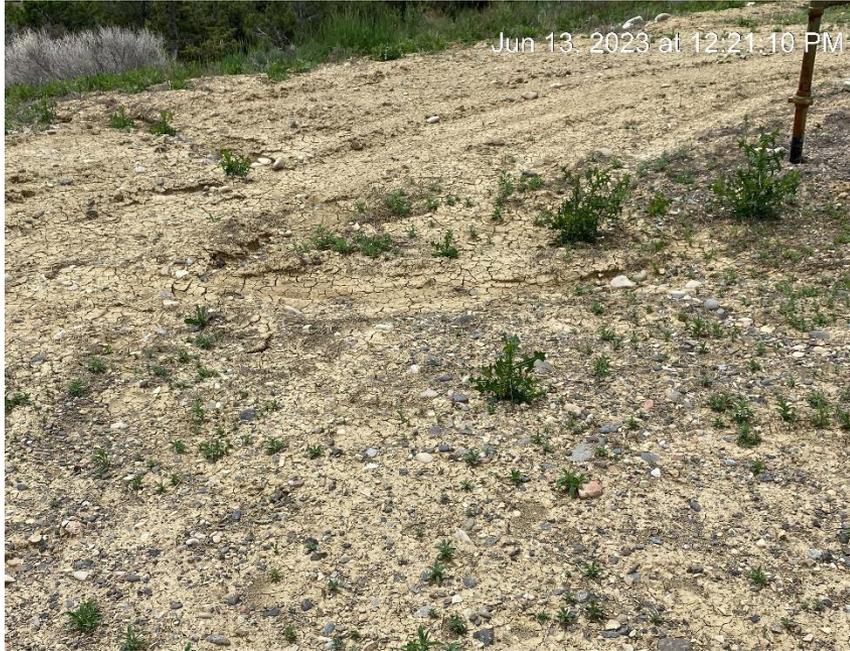
Erosion and soil migration leaving location

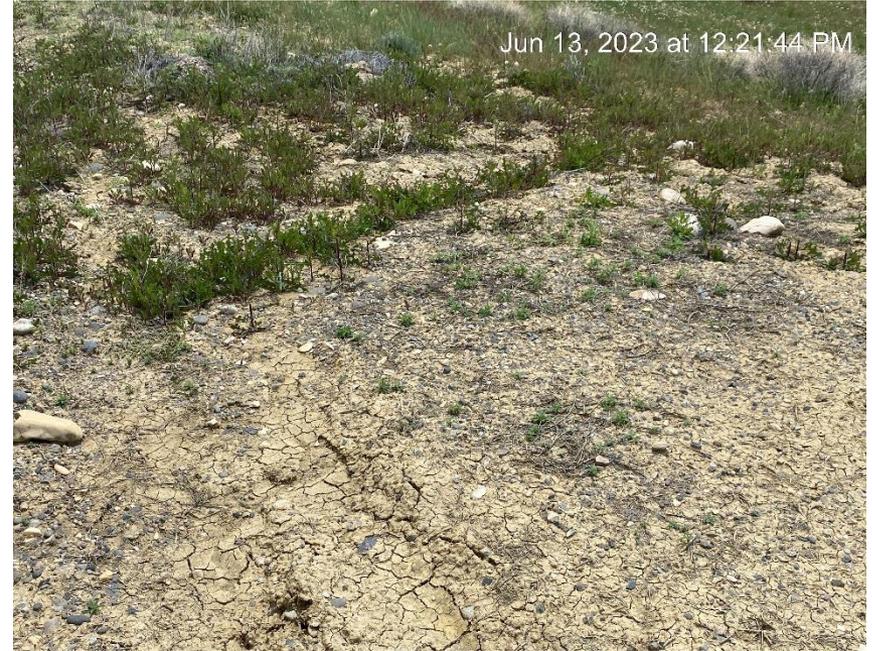
Erosion and soil migration leaving location

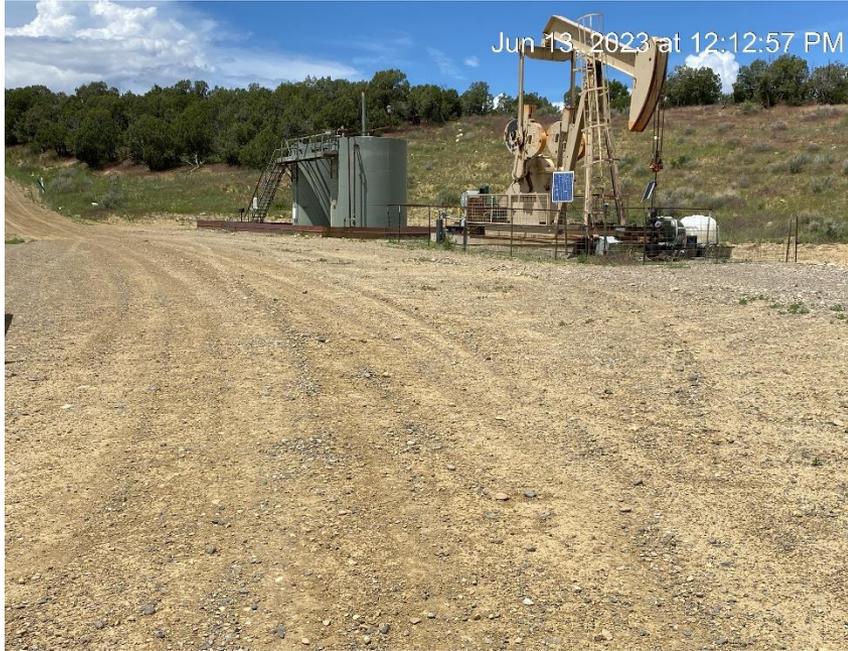
Location entrance and view from Southeast corner

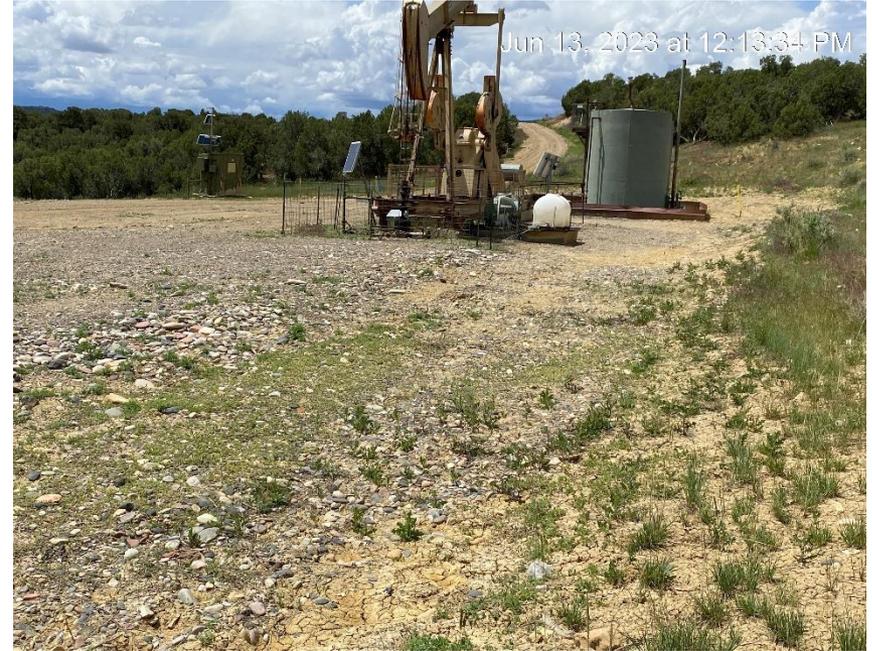
Location view from Northeast corner

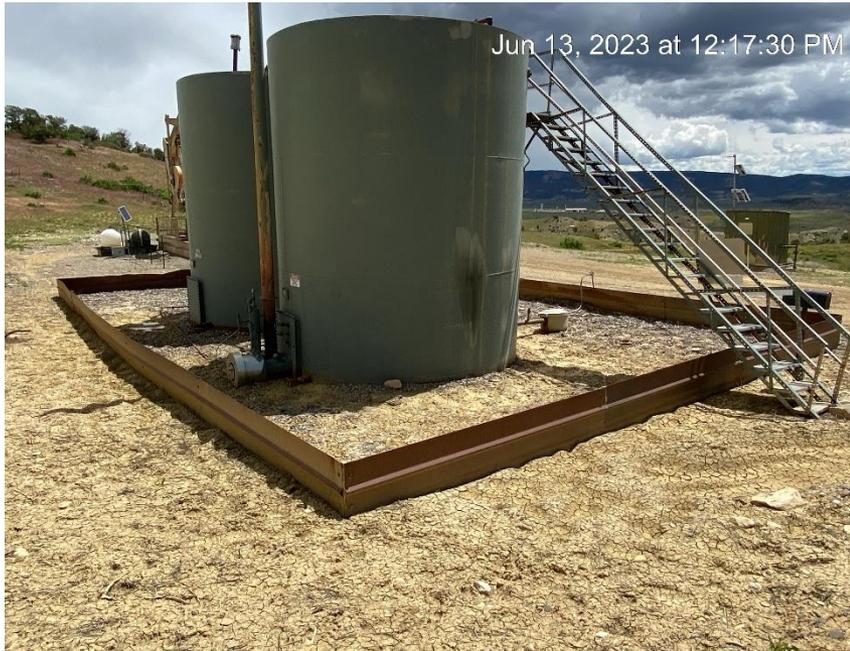
Location view from Northwest corner

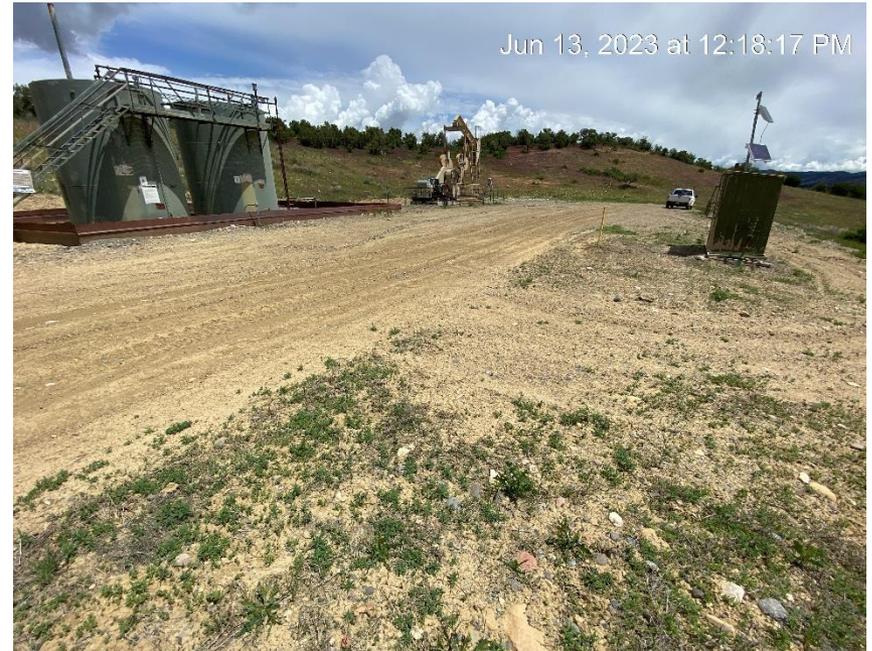
Location entrance and view from Southwest corner
