**KT Resources LLC  
Ant Hill Unit Wyatt 31-12  
Location #445610**

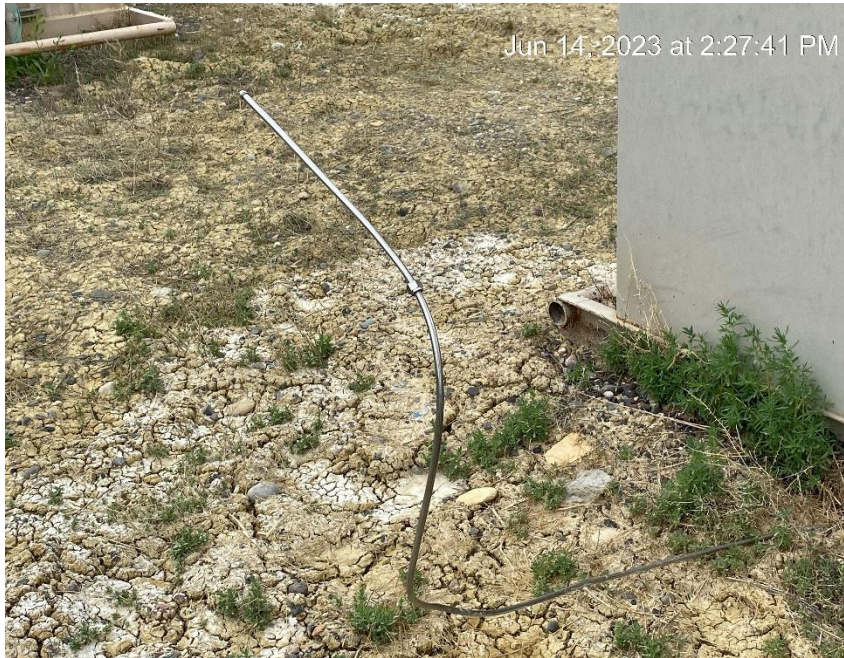
**Debris**

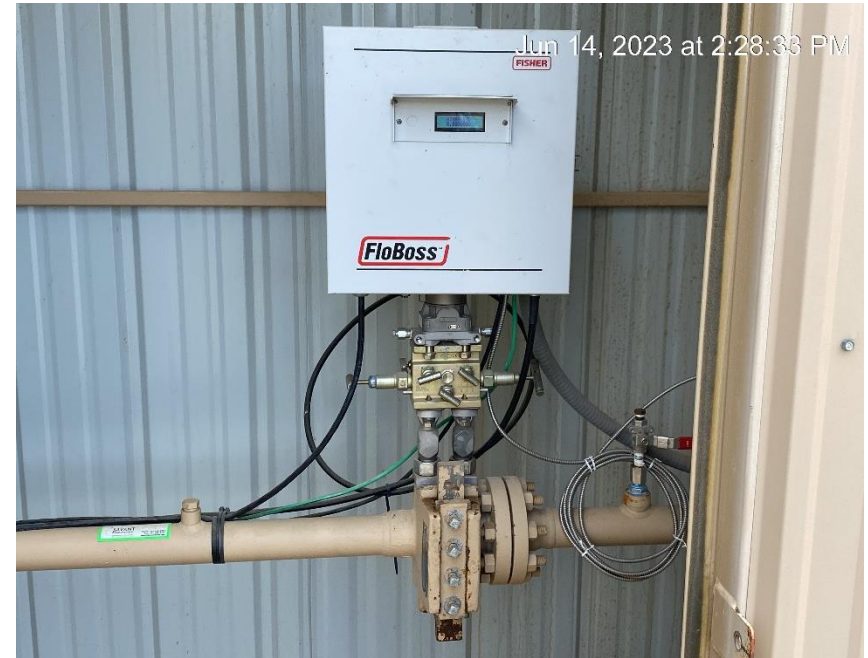
**Gas meter calibration not visibly displayed**

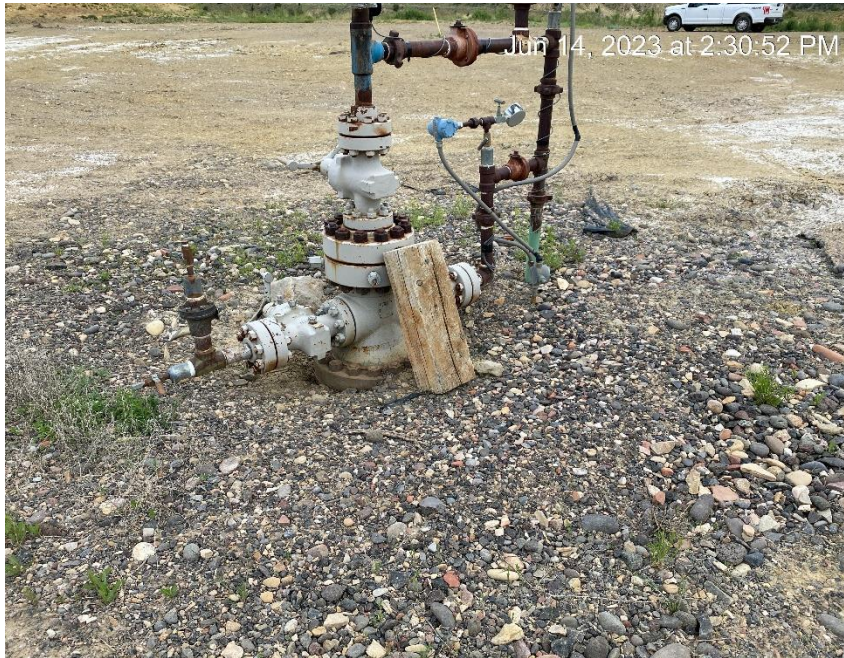
Debris

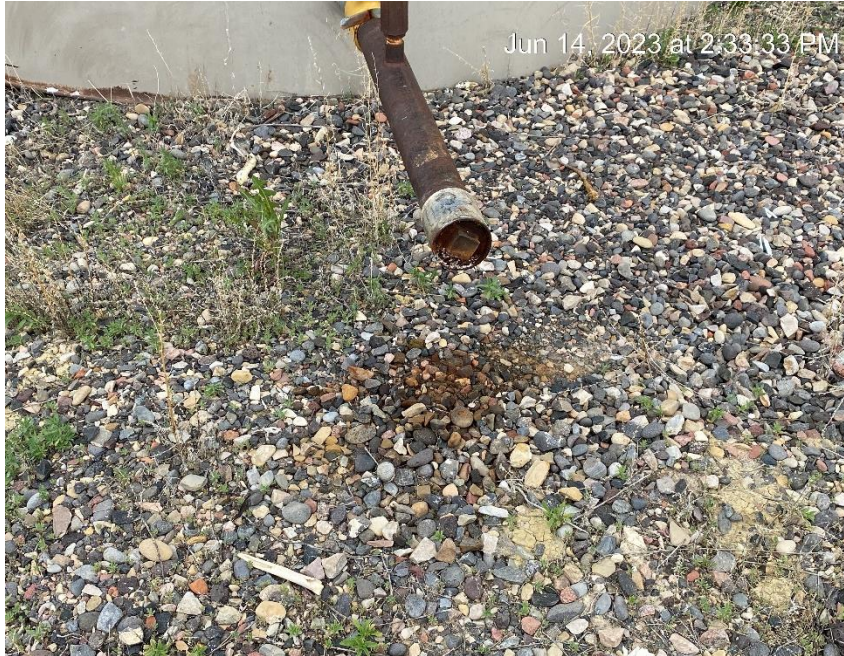
**Stained soil**

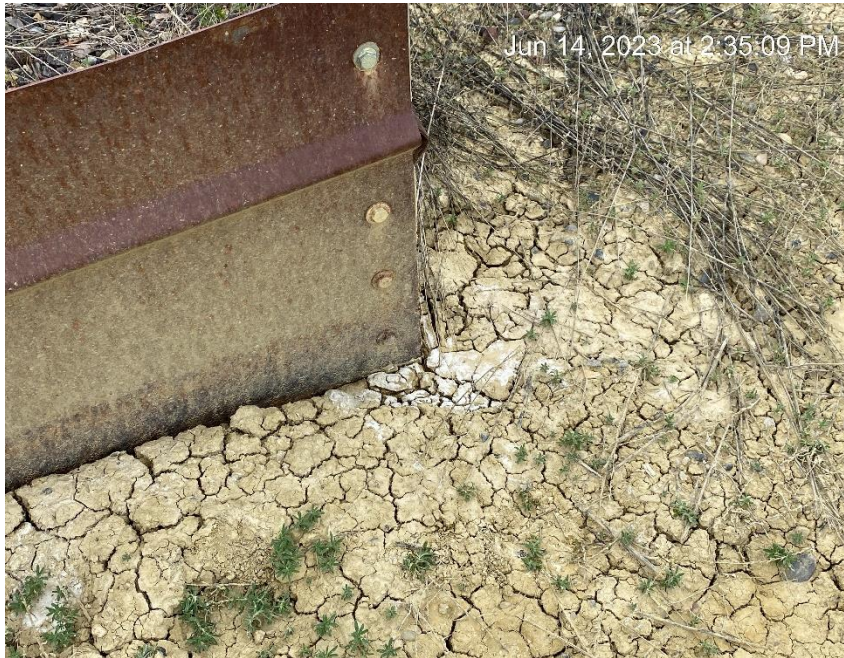
**Leaking containment**

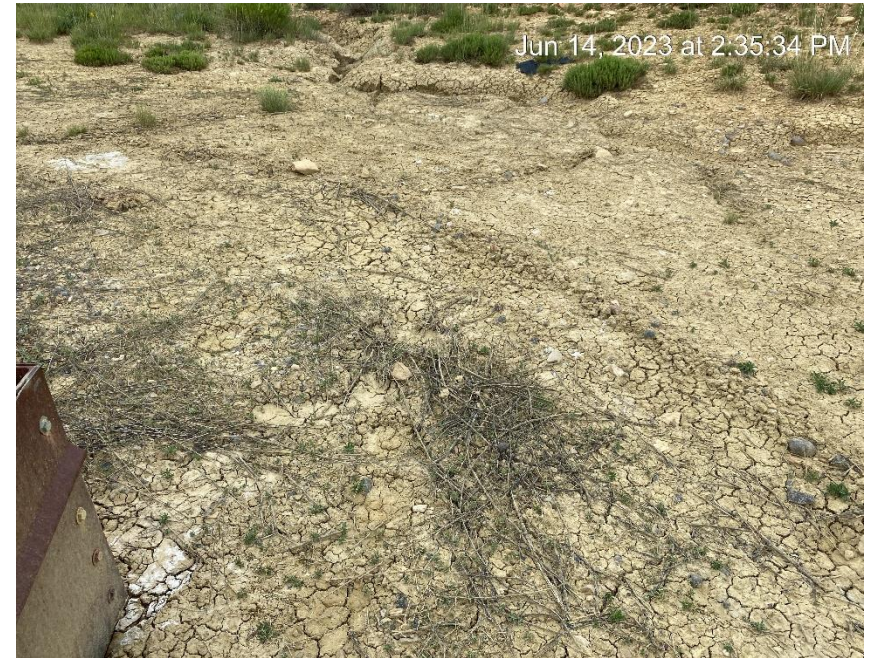
**Erosion away from corner of containment**

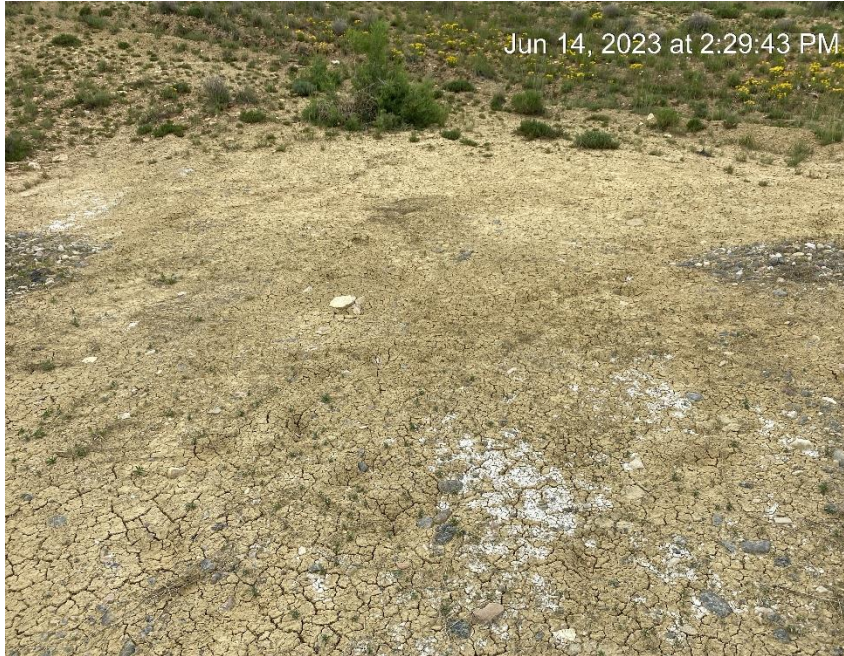
**Soil migration on to location**

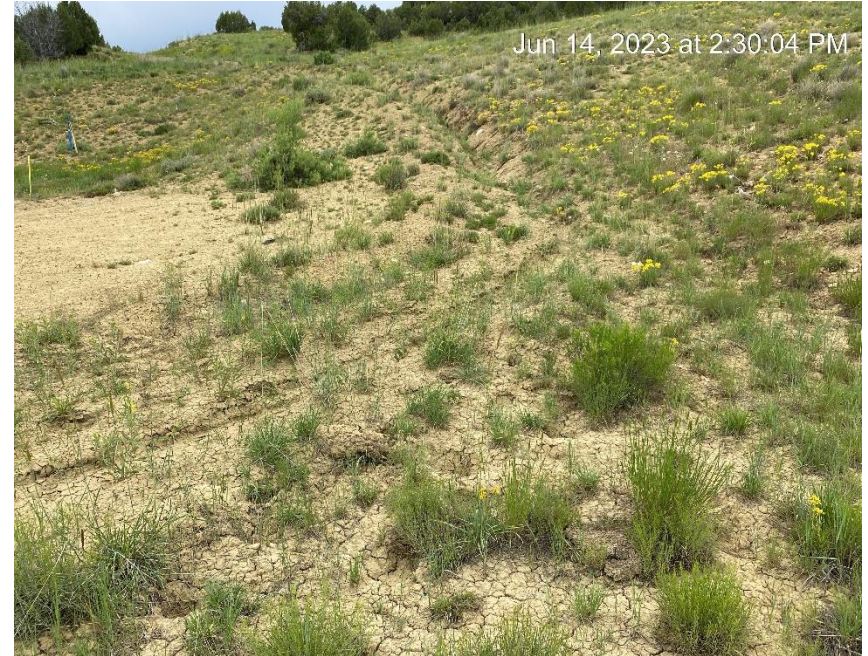
**Erosion and soil migration entering location**

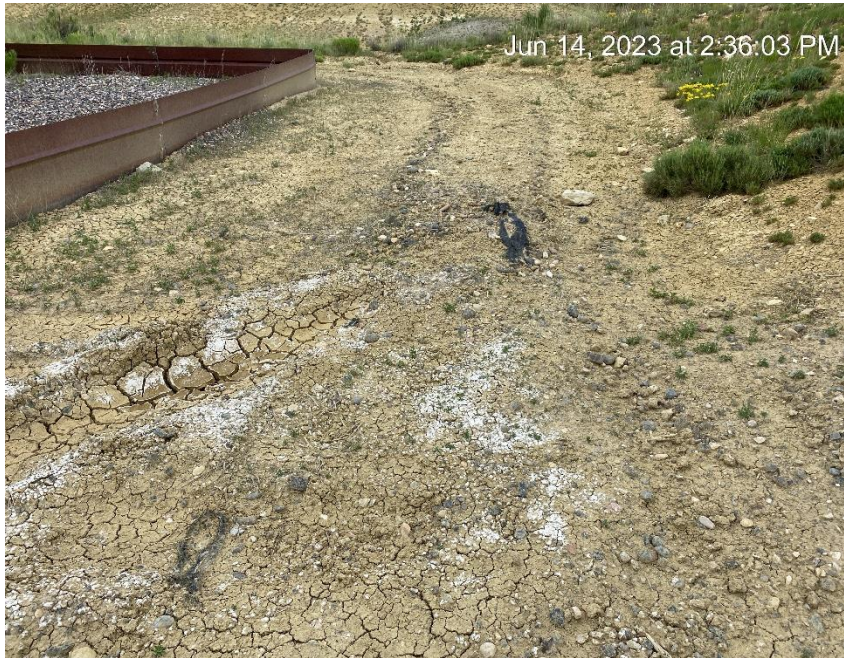
**Vehicle tracking**

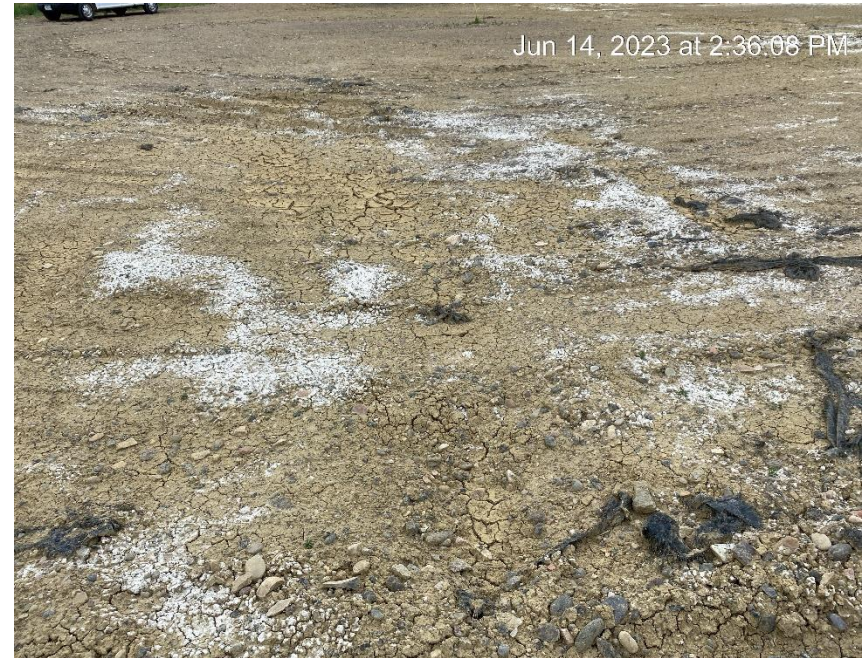
**Lack of staibilization**
