Inspection Photos

Location Name: TEP ROCKY MOUNTAIN LLC HILTON /25-26D

Location ID: 413865

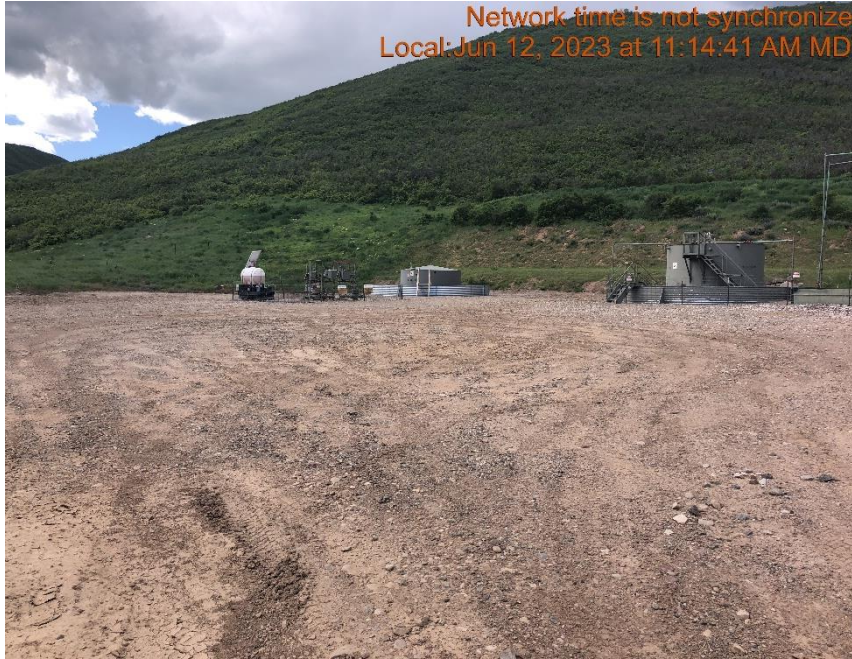
Photo #306 From entrance to location.

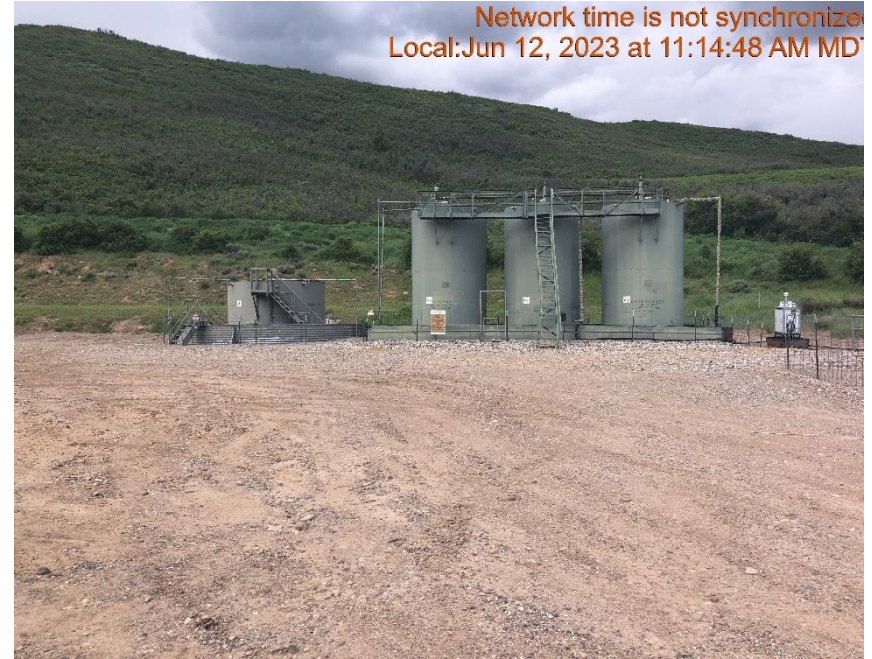
Photo #307 From entrance to location

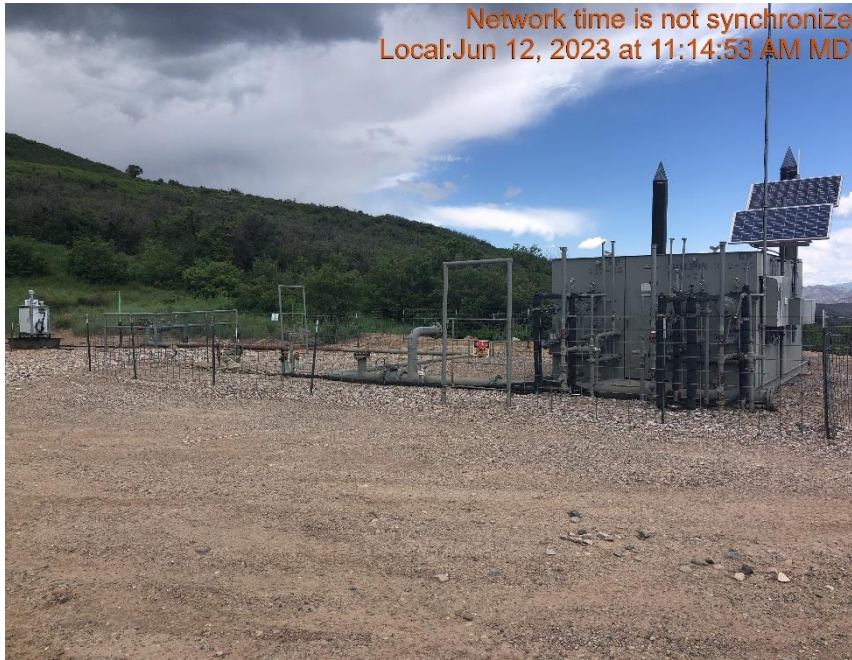
Photo #308 From entrance to location.

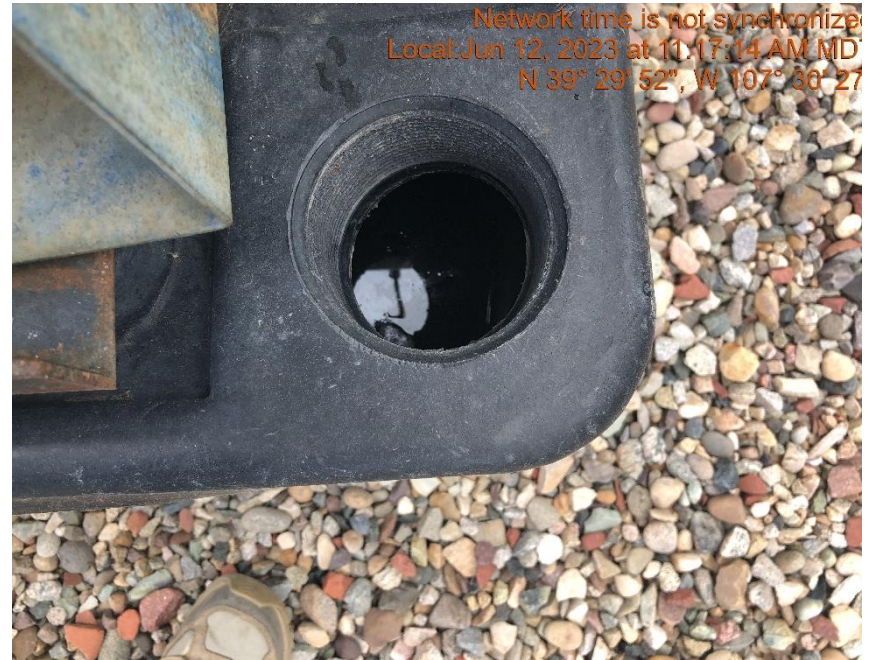
Photo #310 Chemical tank containment full of stormwater.

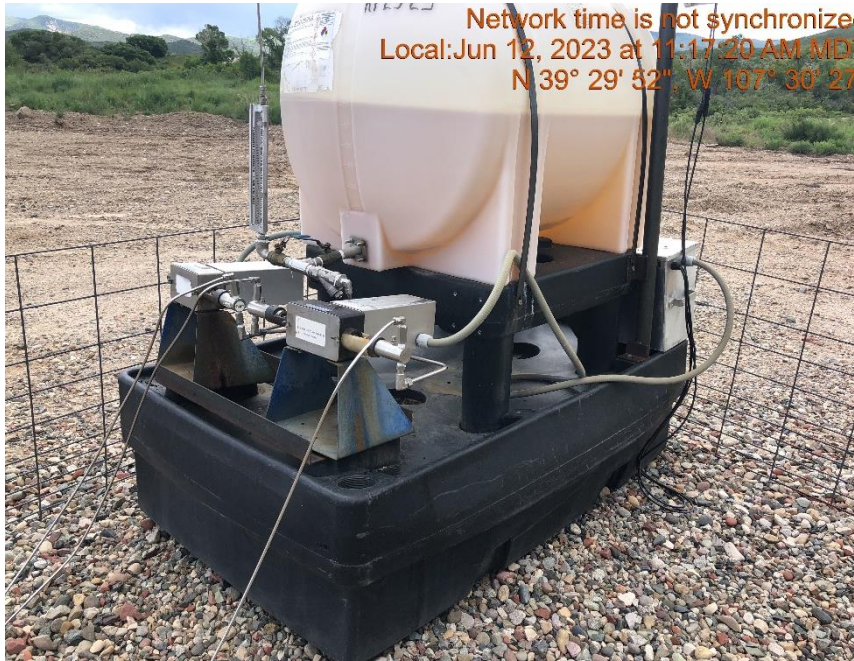
Photo #311 Chemical tank containment full of stormwater.

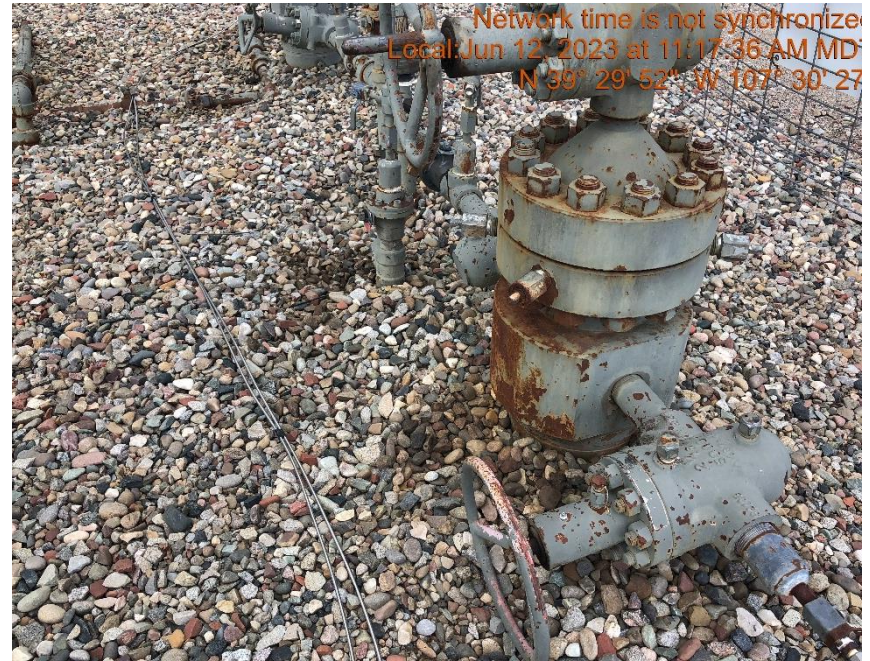
Photo #312 Stained soils and gravel by wellhead.

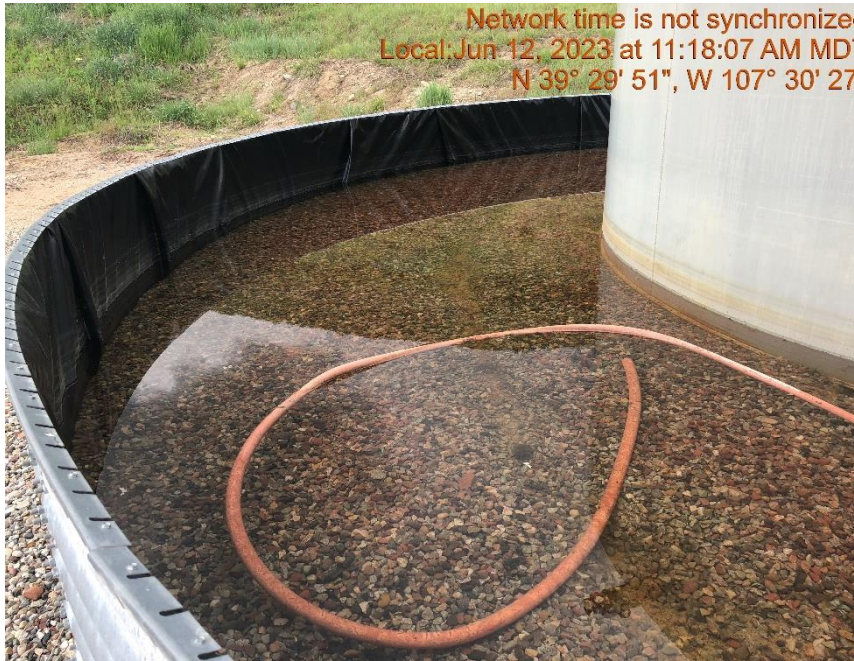
Photo #313 Secondary capacity reduced due to Stormwater.

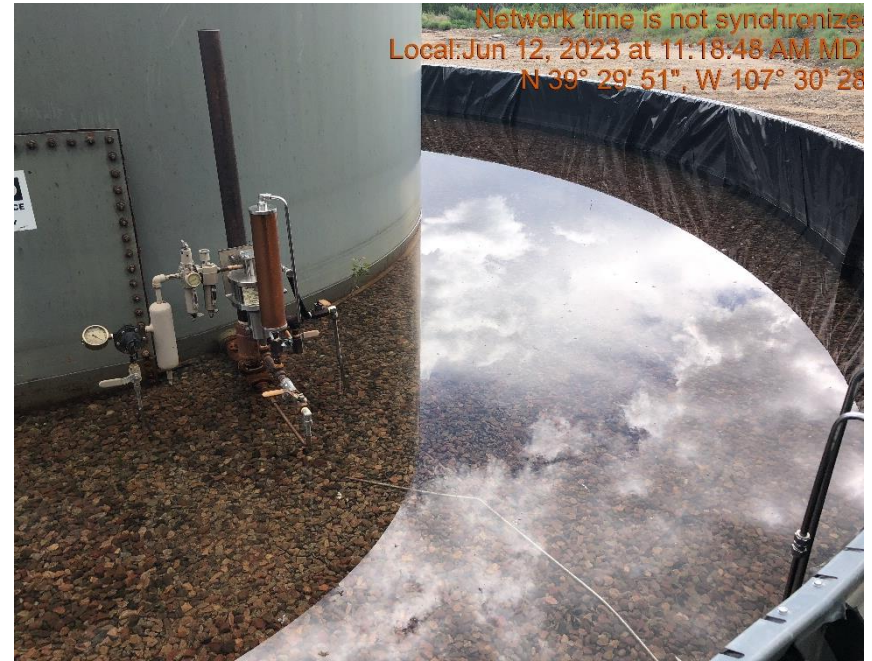
Photo #315 Secondary capacity reduced due to Stormwater.

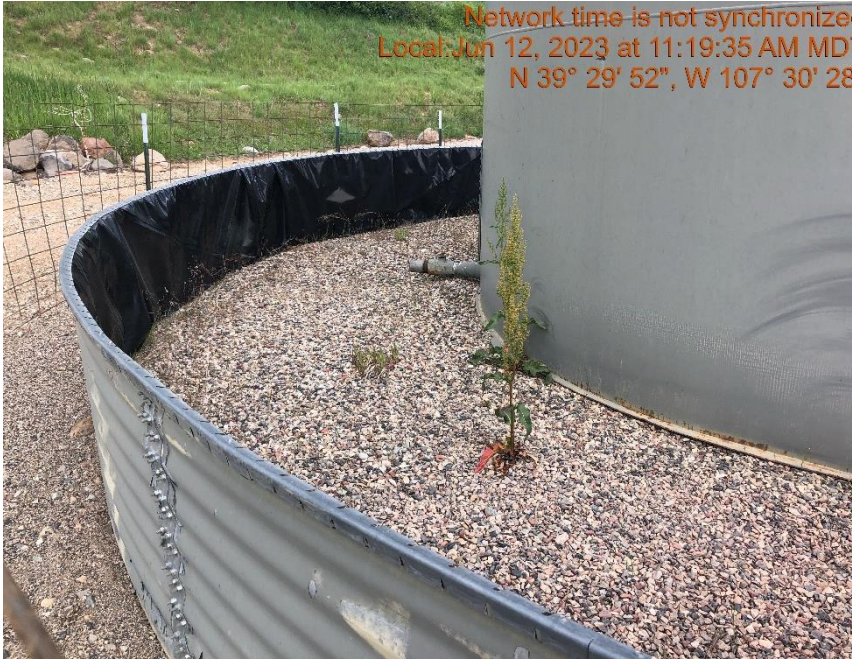
Photo #317 Undesirable plant species in tank containment.

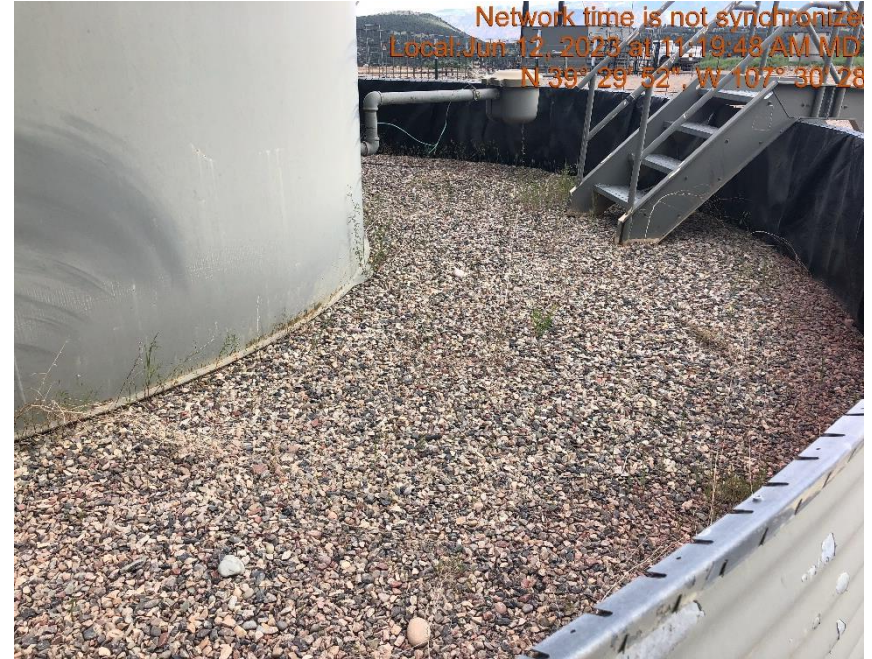
Photo #318 Undesirable plant species in tank containment.

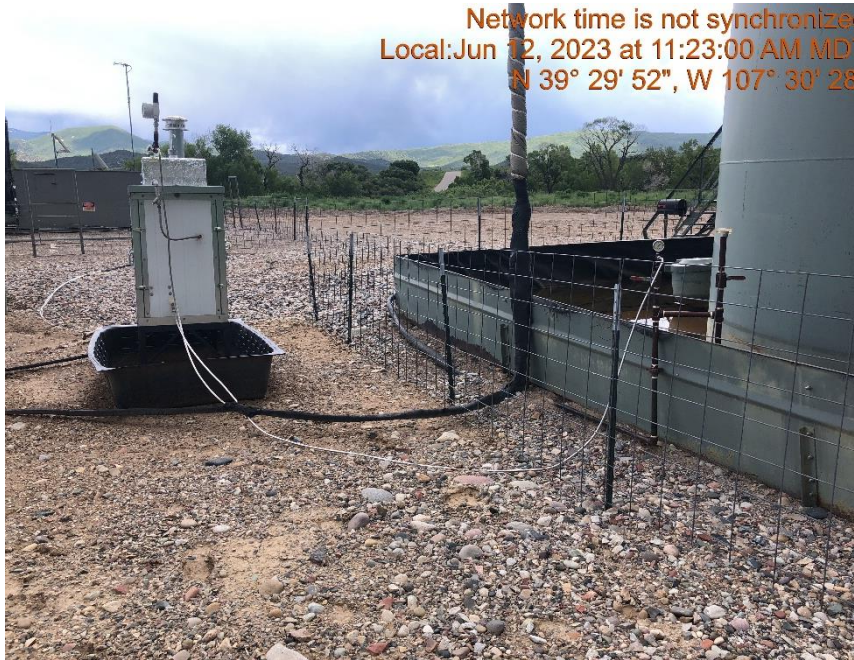
Photo #324 Cata flow heater within 75 feet of tanks.

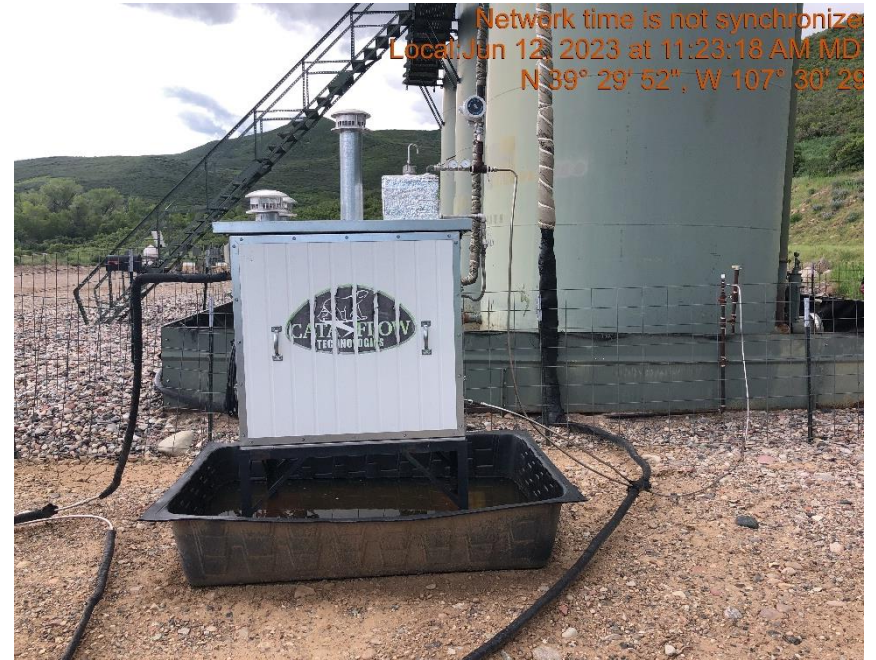
Photo #325 Cata flow heater within 75 feet of tanks.

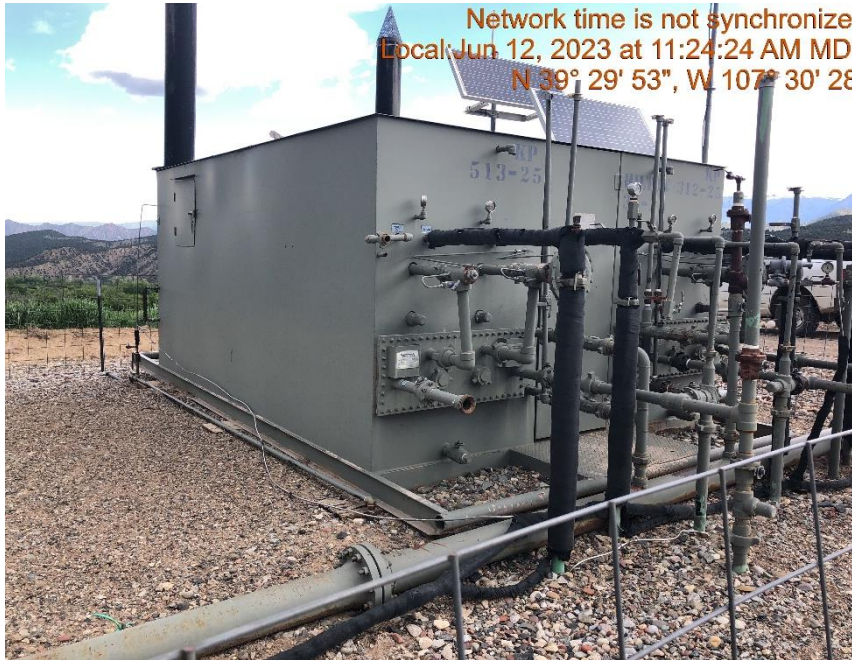
Photo #328 Calibration cards not conspicuously posted.

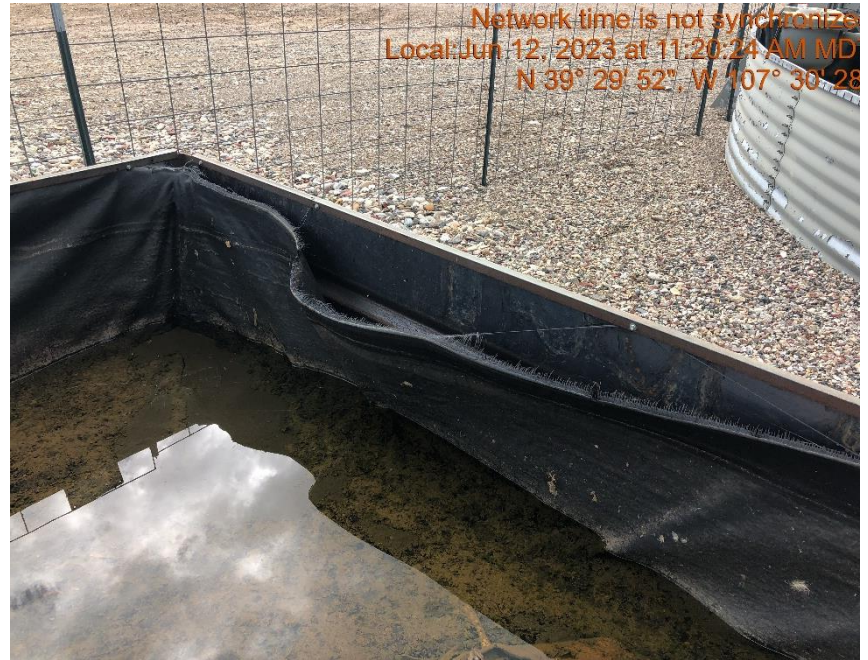
Photo #320 Multiple holes in secondary containment liner.

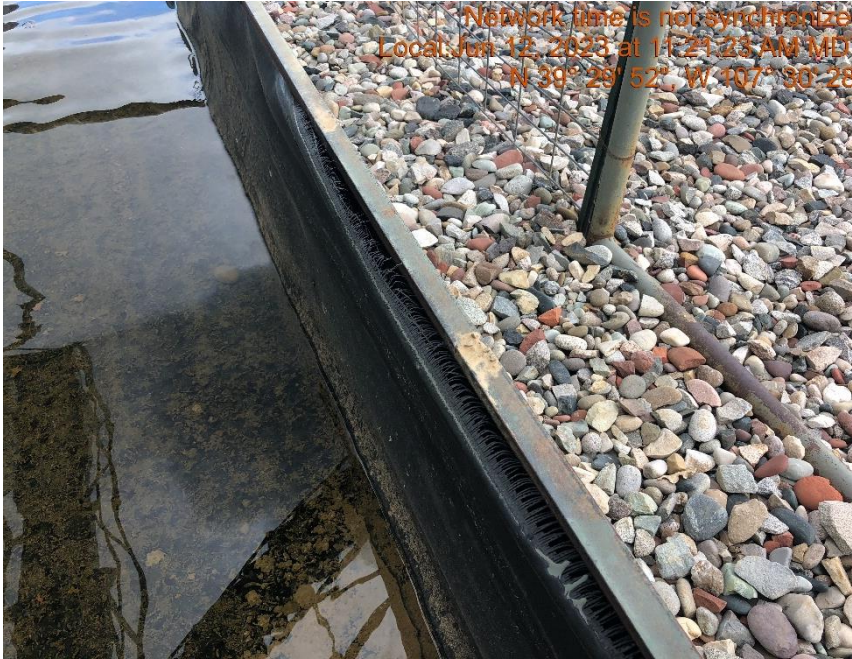
Photo #321 Multiple holes in secondary containment liner.

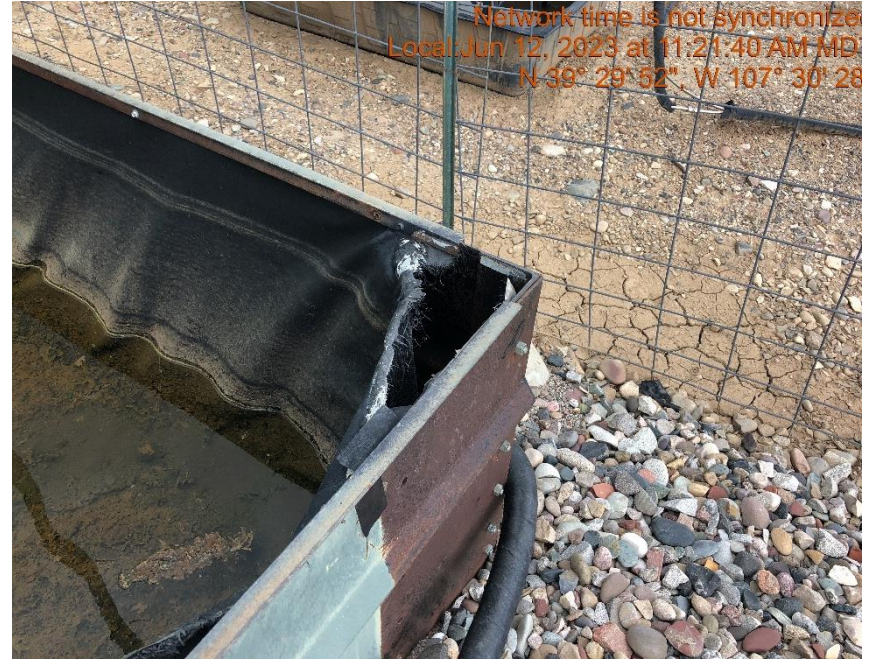
Photo #322 Multiple holes in secondary containment liner.

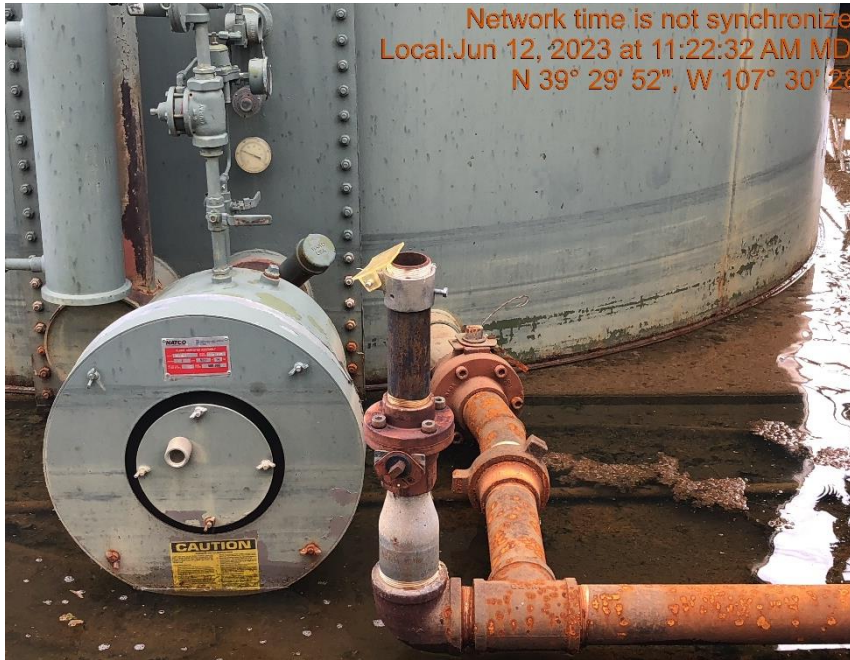
Photo #323 Loadline open ended and not capped.
