**Storm Water Management and Erosion control**  
**Location Name: TEP ROCKY MOUNTAIN LLC DIXON A Pad**  
**Location #: 335550**

**Location Overview: Location is approximately 500 yards from  
Mamm Creek  
Section/Township/Range: 18 6S92W**

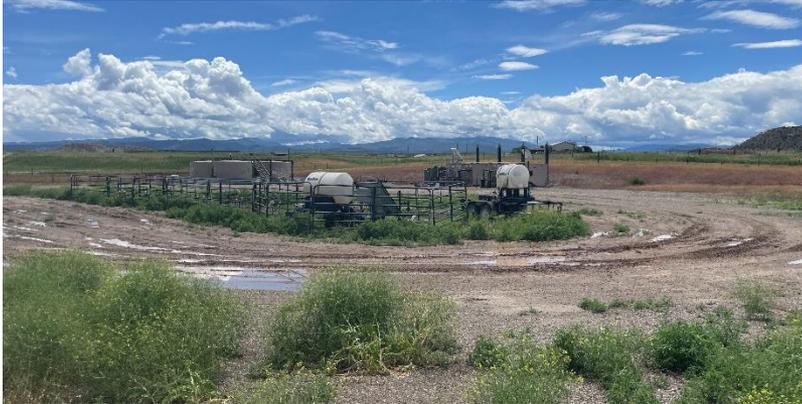
**North West corner of location.**

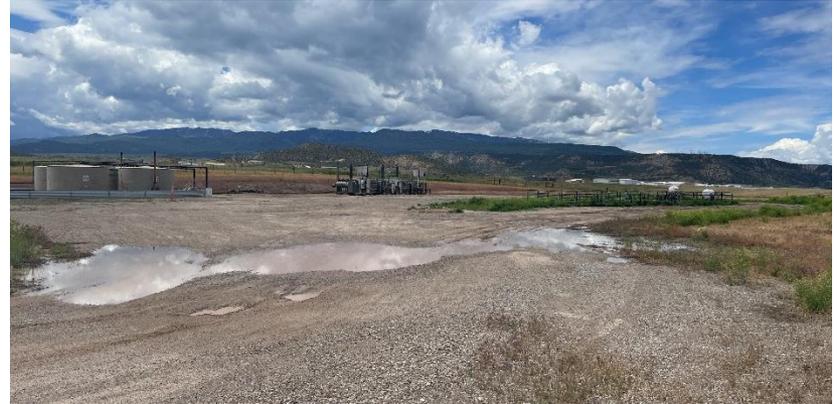
**North East corner of location.**

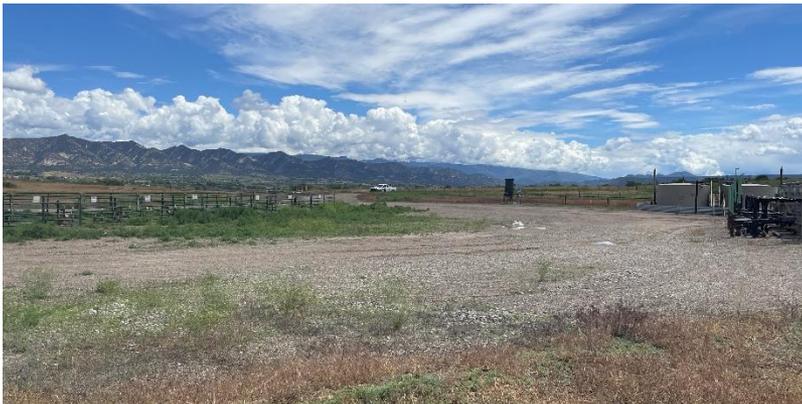
**South West corner of location.**

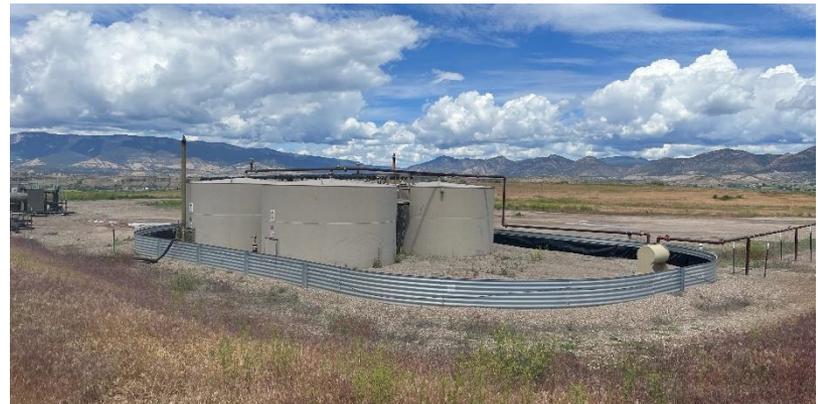
**South East corner of location.**

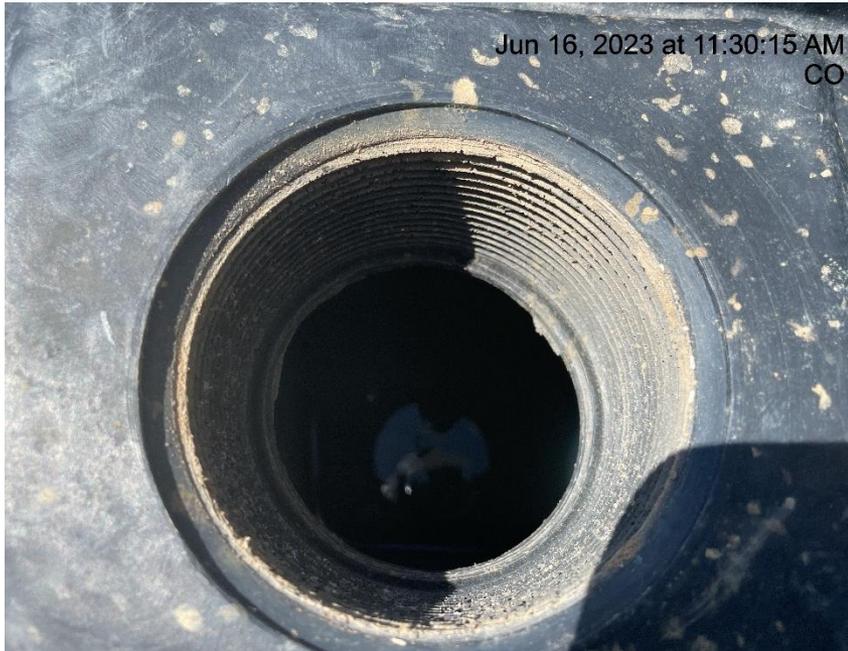
**Photo # 888 Chemical containment approximately 1/2 full  
Failure to maintain chemical BMP's**

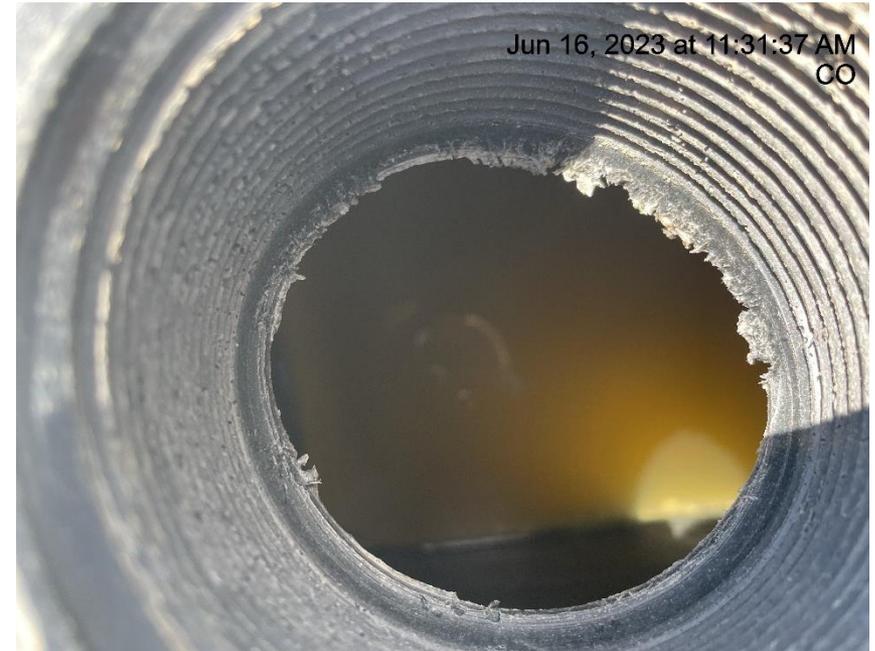
**Photo # 900 Chemical containment approximately 1/2 full  
Failure to maintain chemical BMP's**

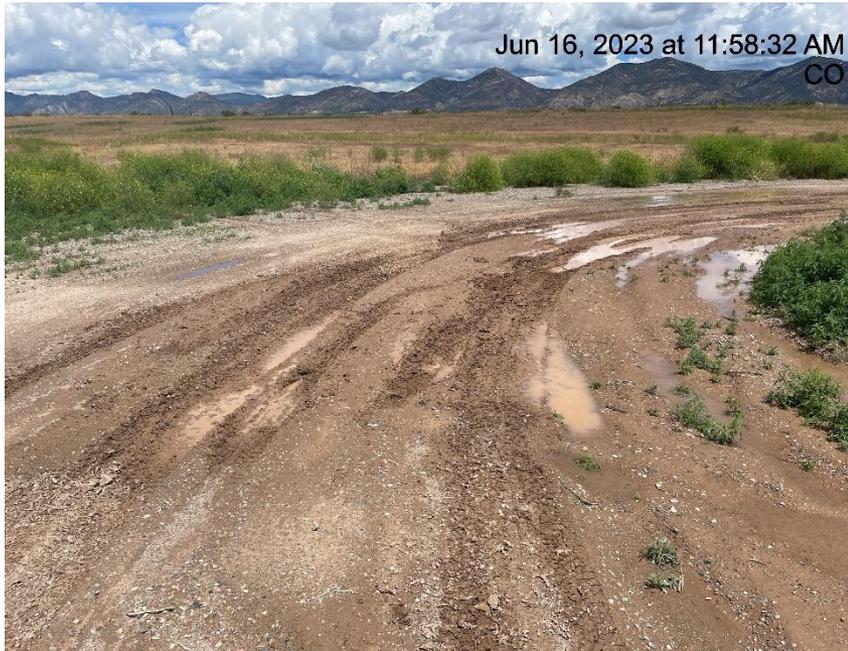
**Photo # 949 Lack of stabilization/compaction**

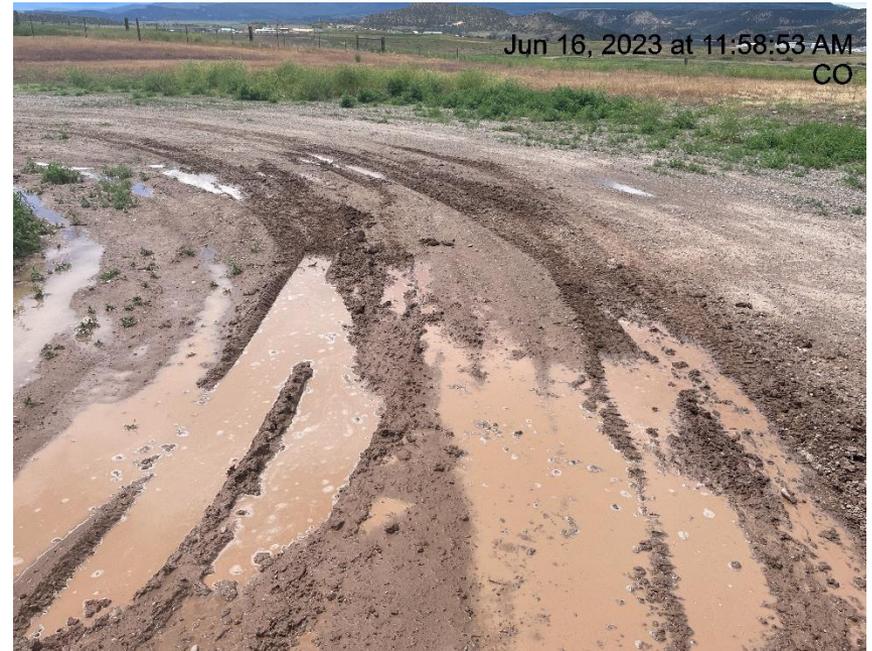
**Photo # 950 Lack of stabilization/compaction**

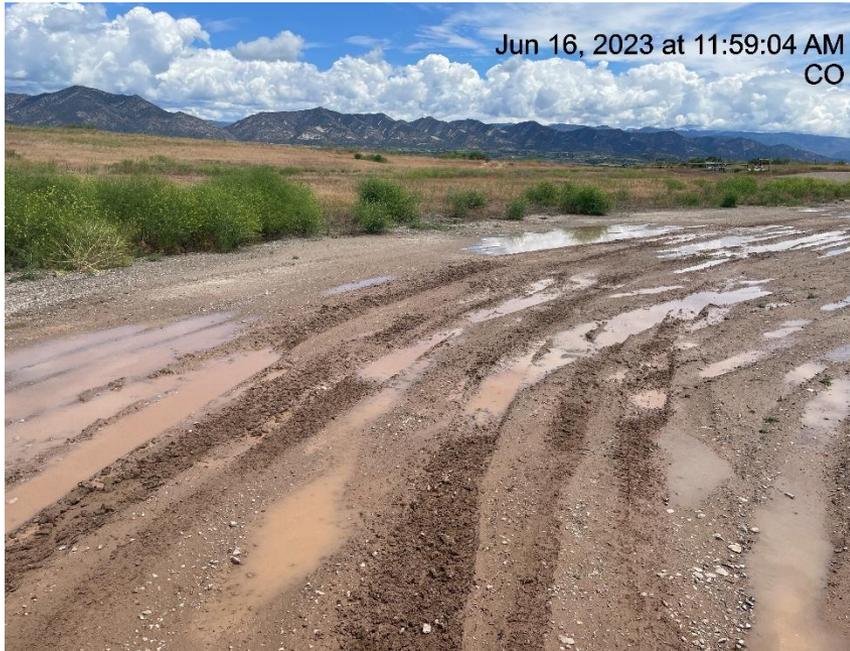
**Photo # 951 Lack of stabilization/compaction**

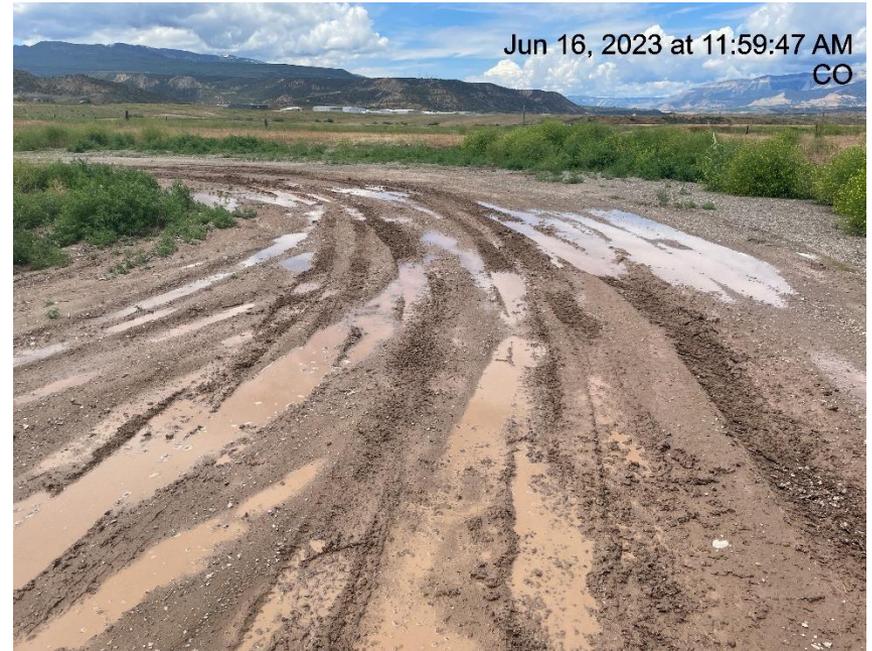
**Photo # 953 Lack of stabilization/compaction**

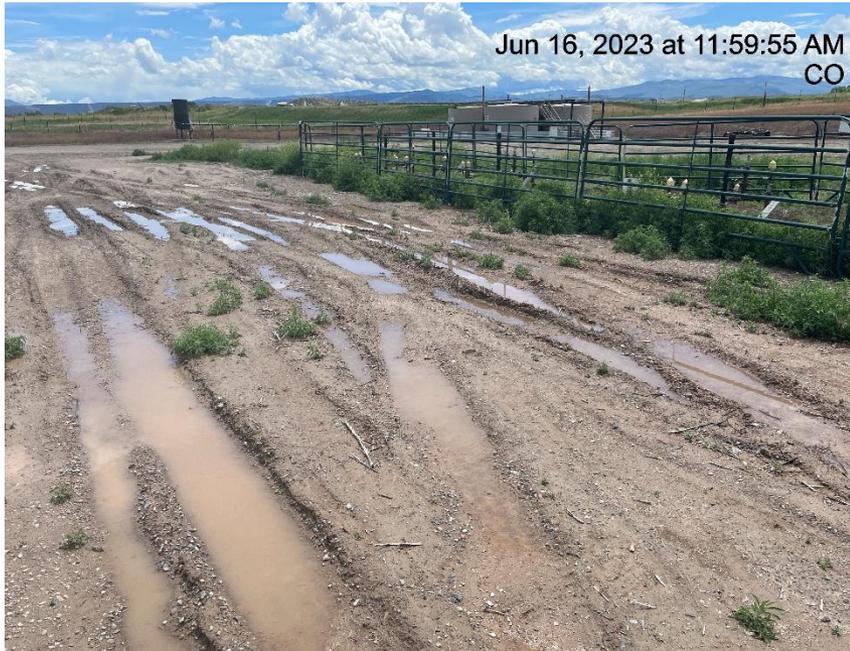
**Photo # 954 Lack of stabilization/compaction**

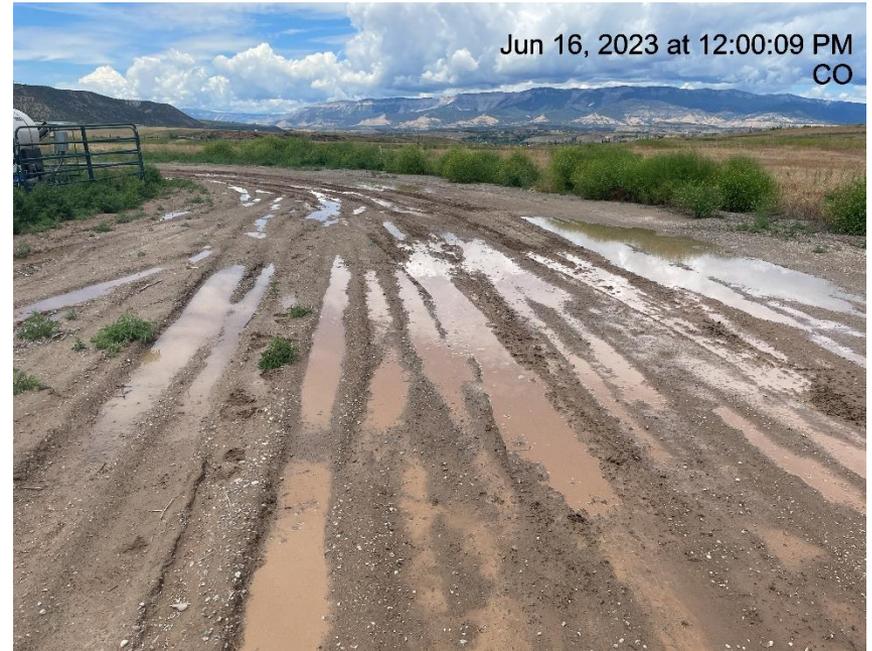
**Photo # 955 Lack of stabilization/compaction**

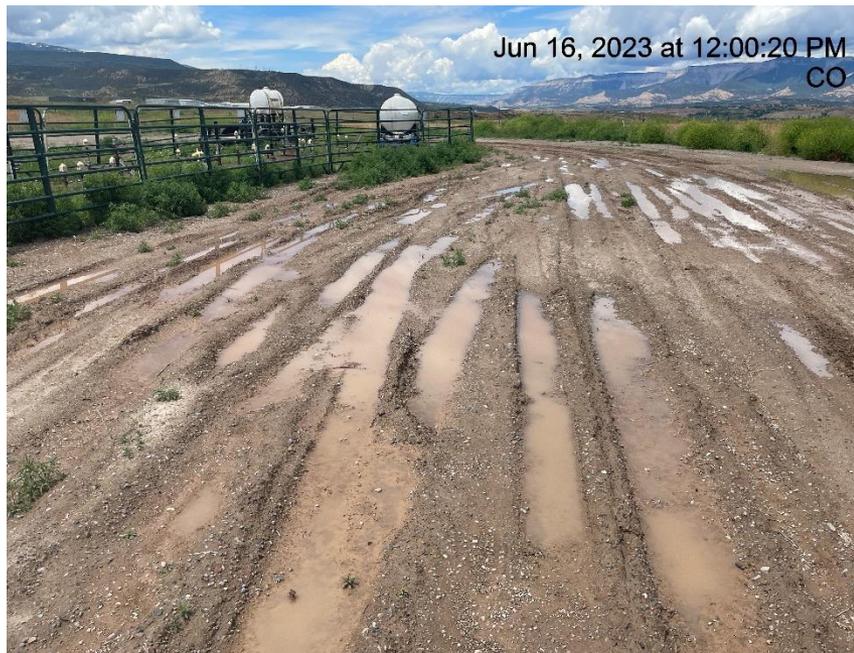
Photo # 956 Lack of stabilization/compaction

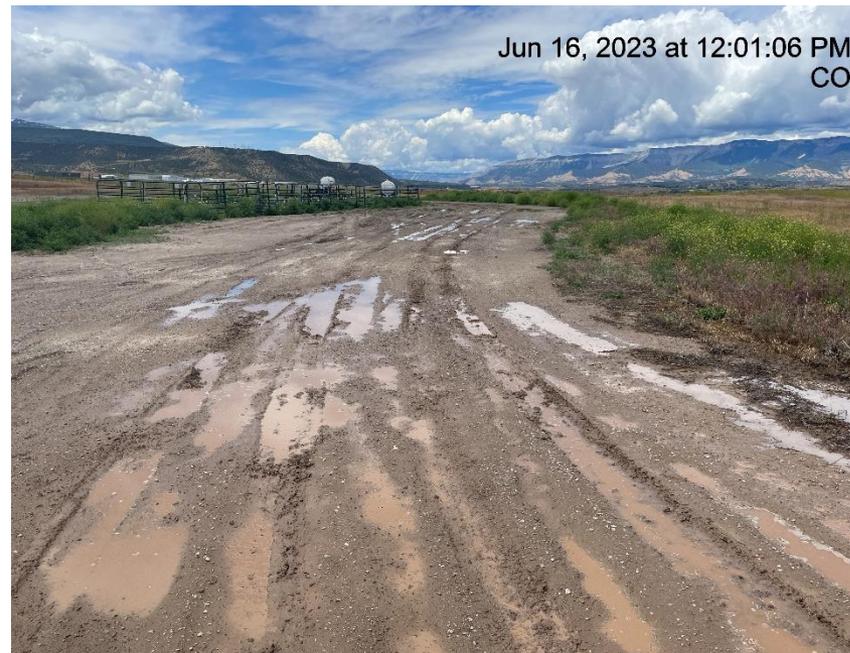
Photo # 959 Lack of stabilization/compaction

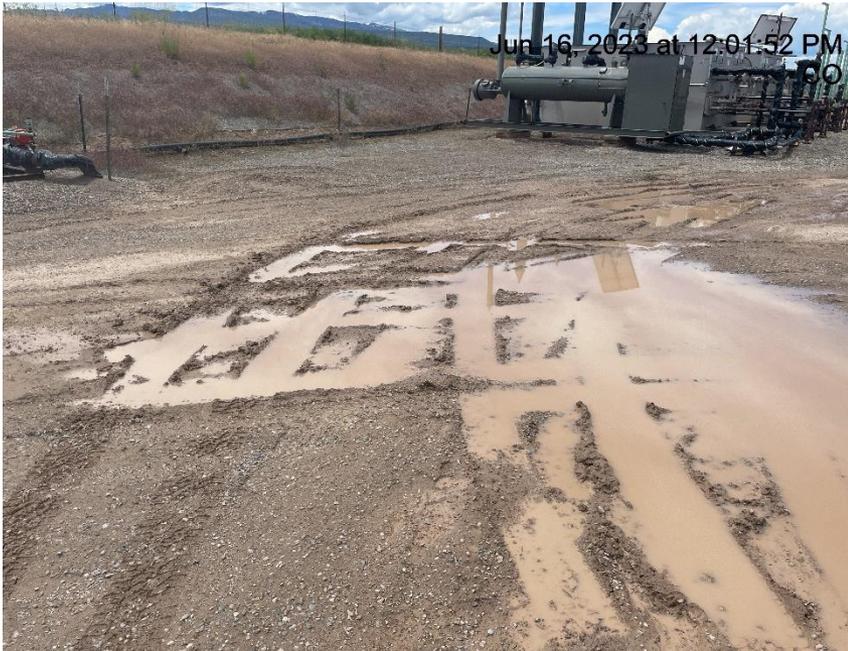
Photo # 961 Lack of stabilization/compaction

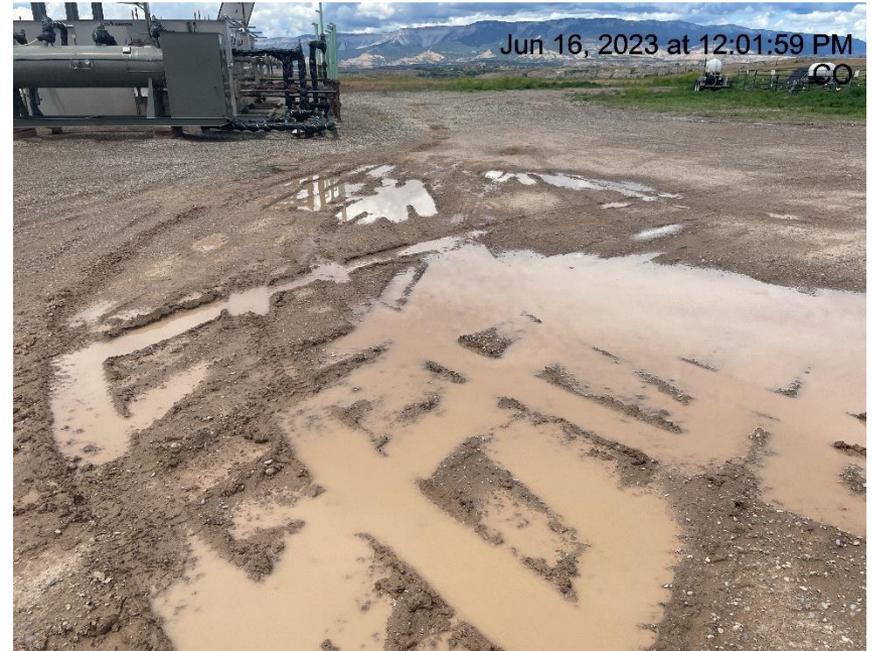
Photo # 962 Lack of stabilization/compaction
