Final Reclamation and Stormwater Inspection

Operator: KLABZUBA OIL & GAS INC - 10148

Location ID: 393818

Inspection Document #: 708200322

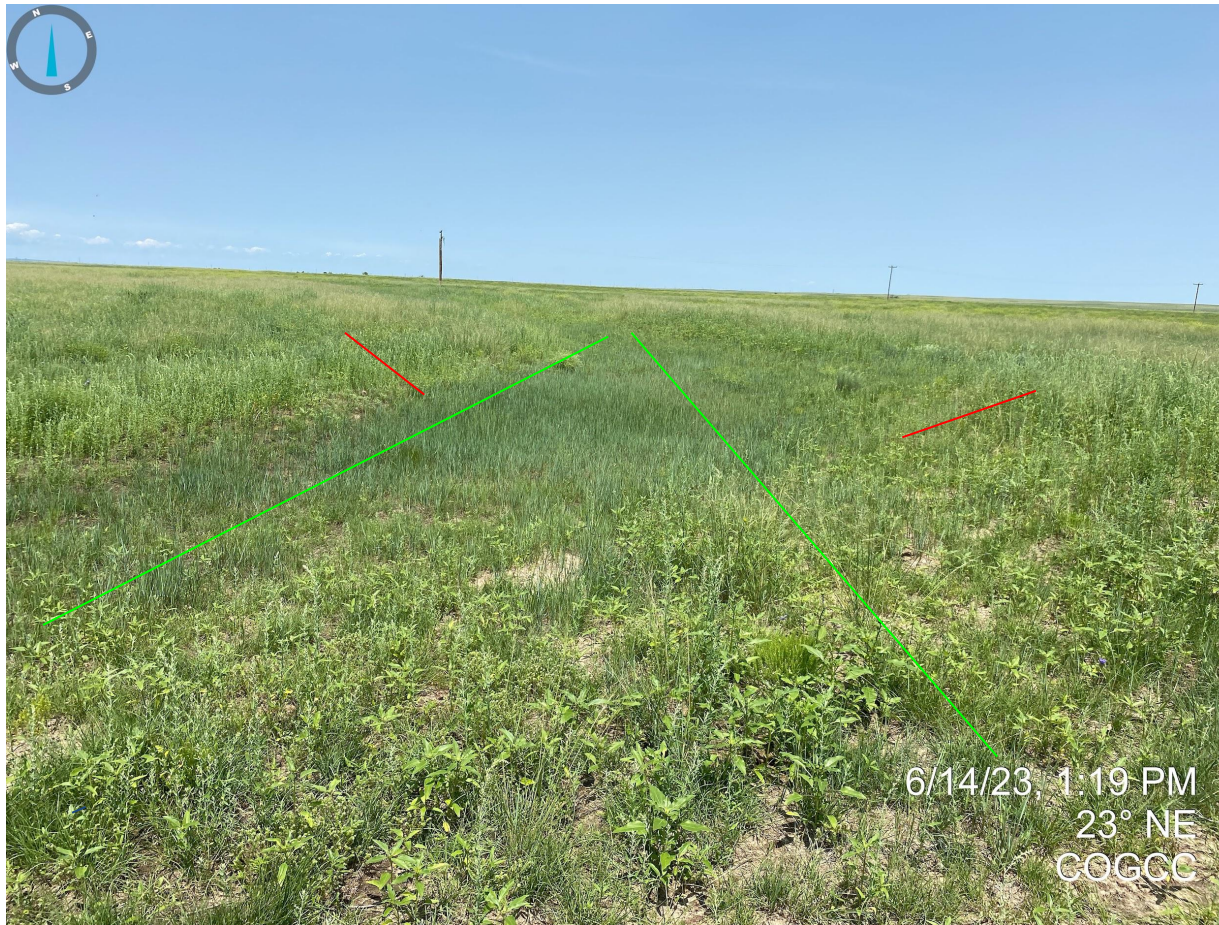
Photo 1. The access road (indicated by green lines) does not appear to have been re-contoured to reflect adjacent topography, indicated by red lines. Additional reclamation activities are required to come into compliance with Rule 1004.

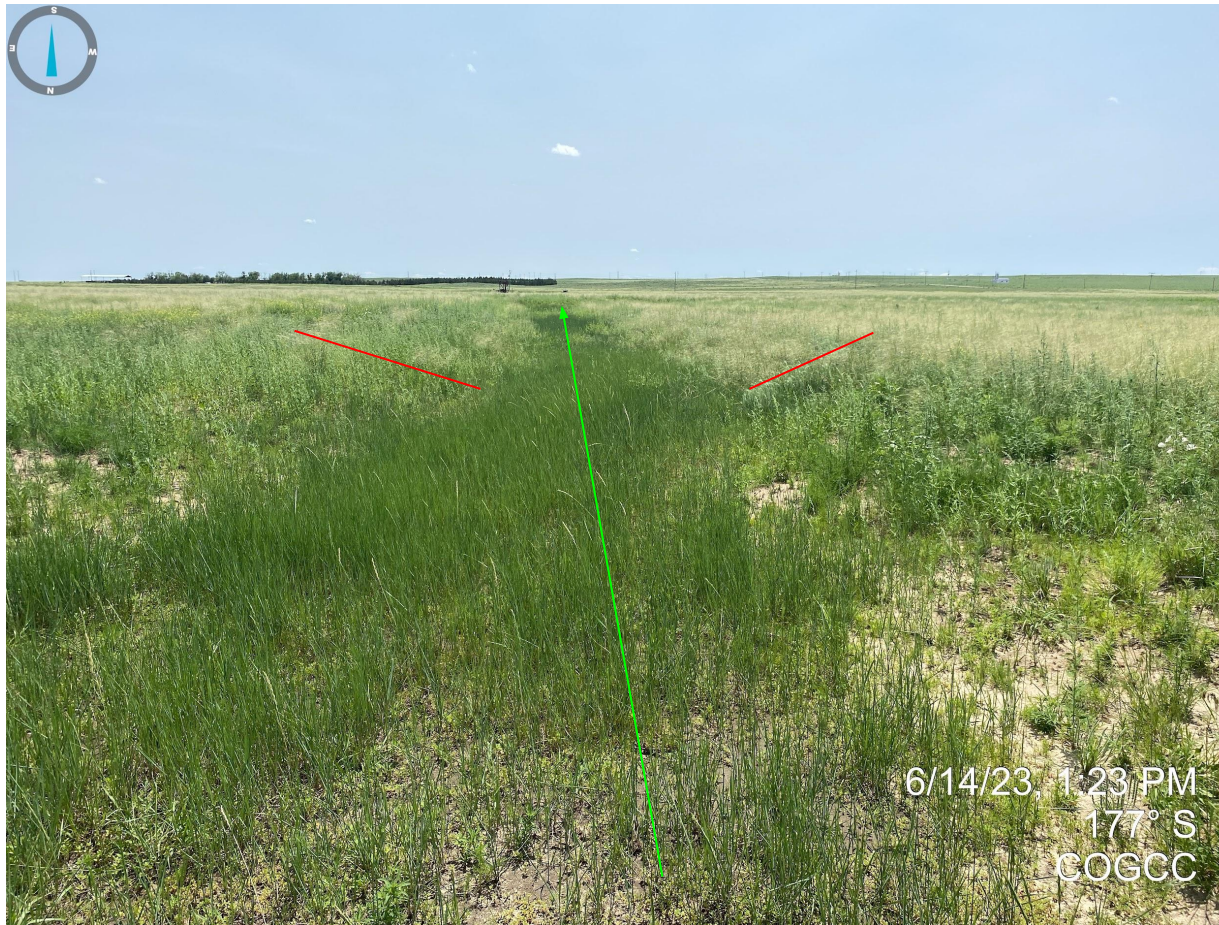
Photo 2. See comments in Photo 1.

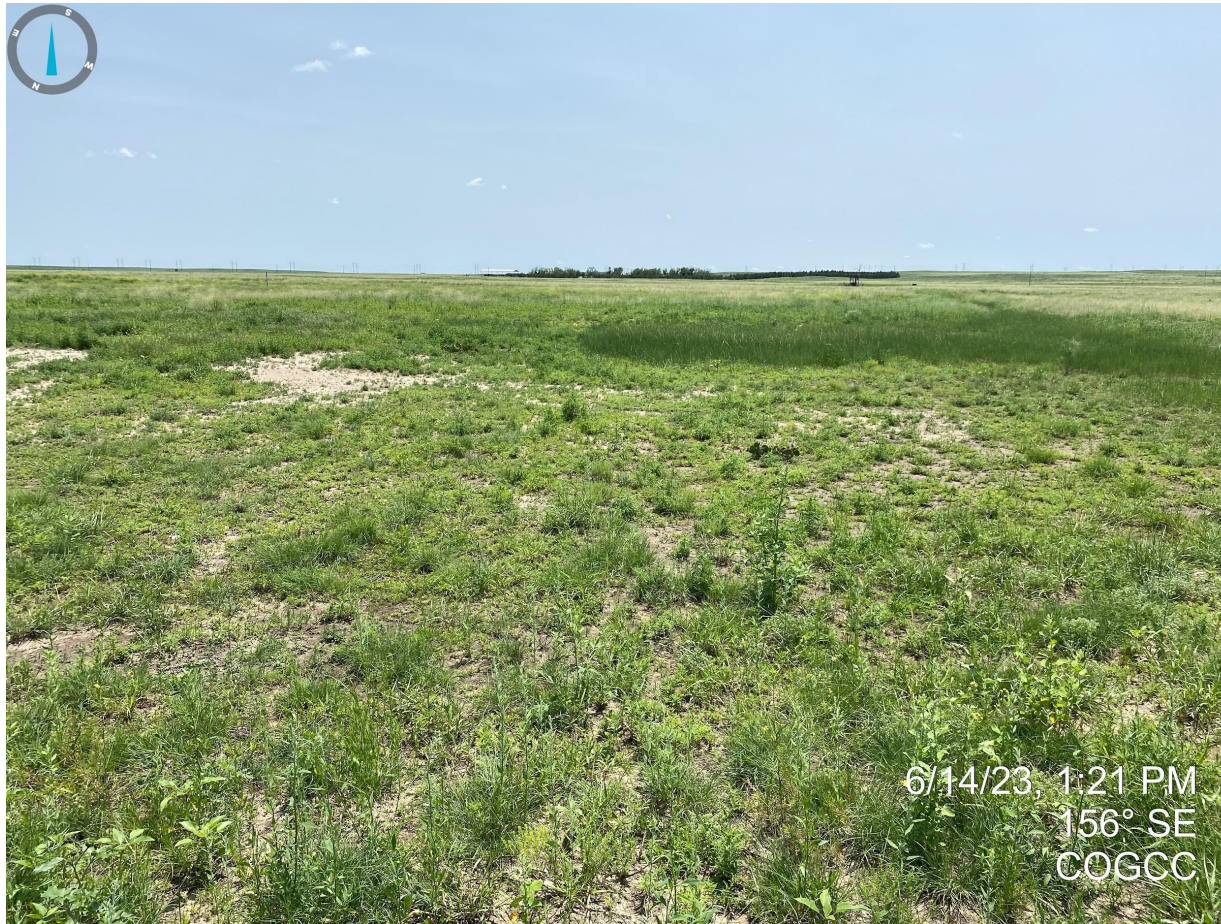
Photo 2. The location does not appear to be progressing towards Rule 1004 standards. Staff observed that debris remains on location, the presence of undesirable vegetation (e.g. kochia and CO List C Noxious Weed-cheatgrass), and areas of exposed soil were observed throughout.

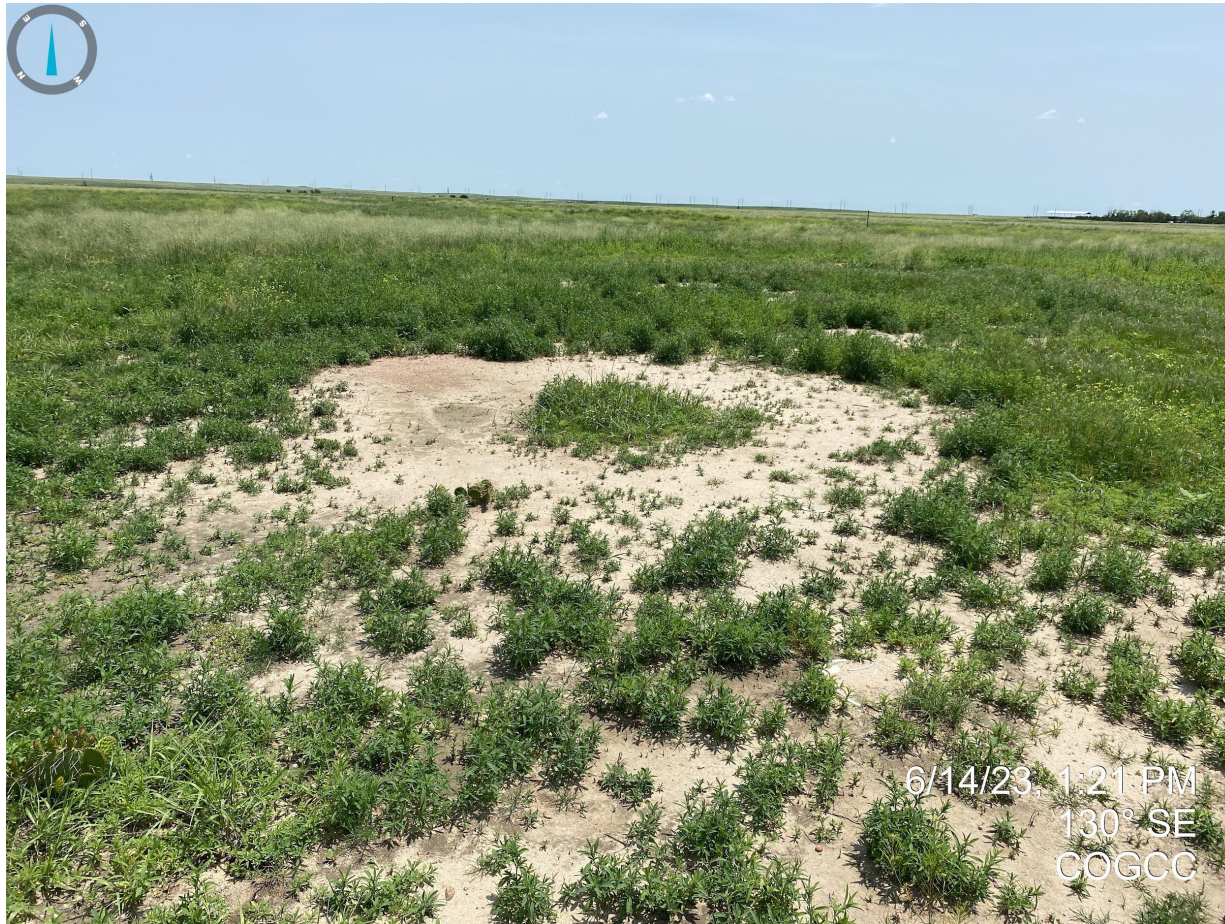
Photo 4. See comments in Photo 3.

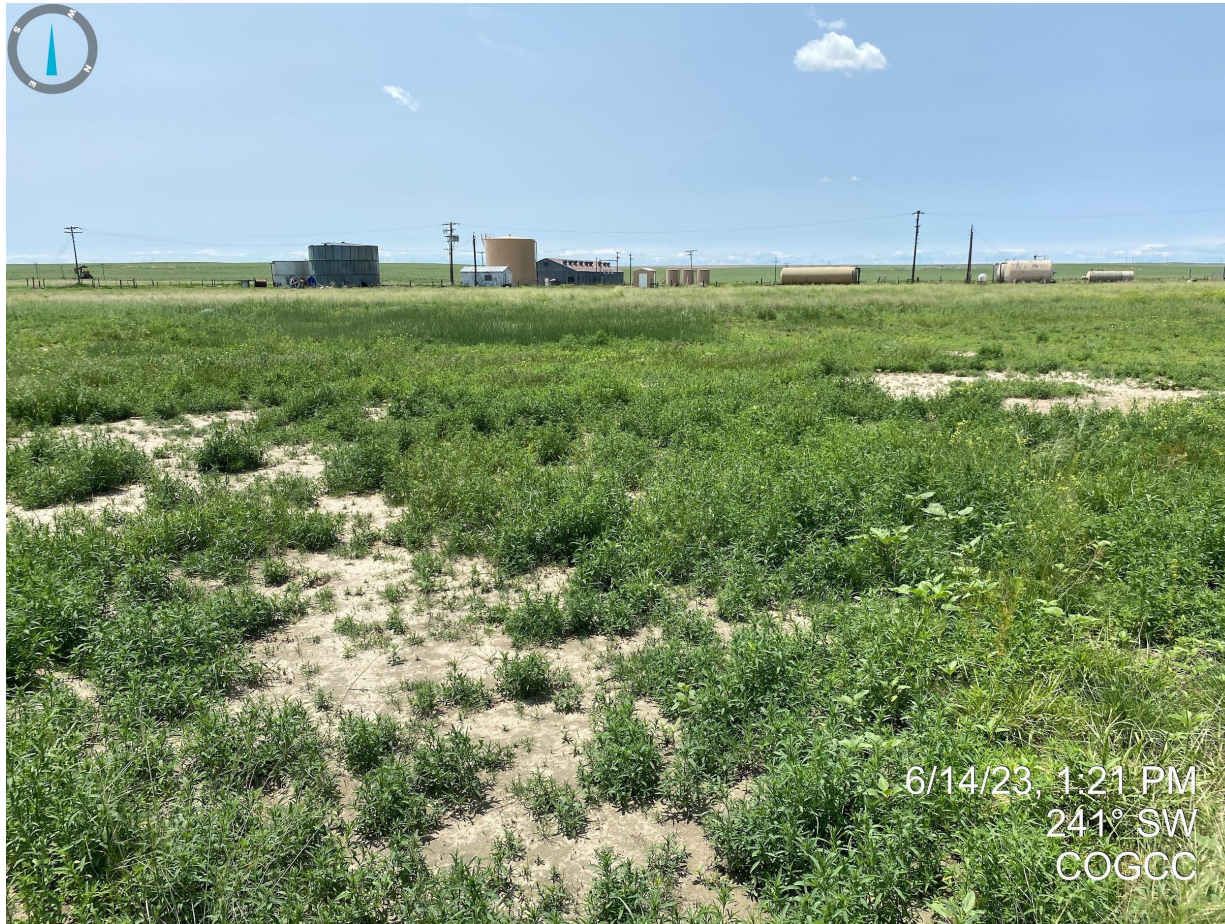
Photo 5. See comments in Photo 3.

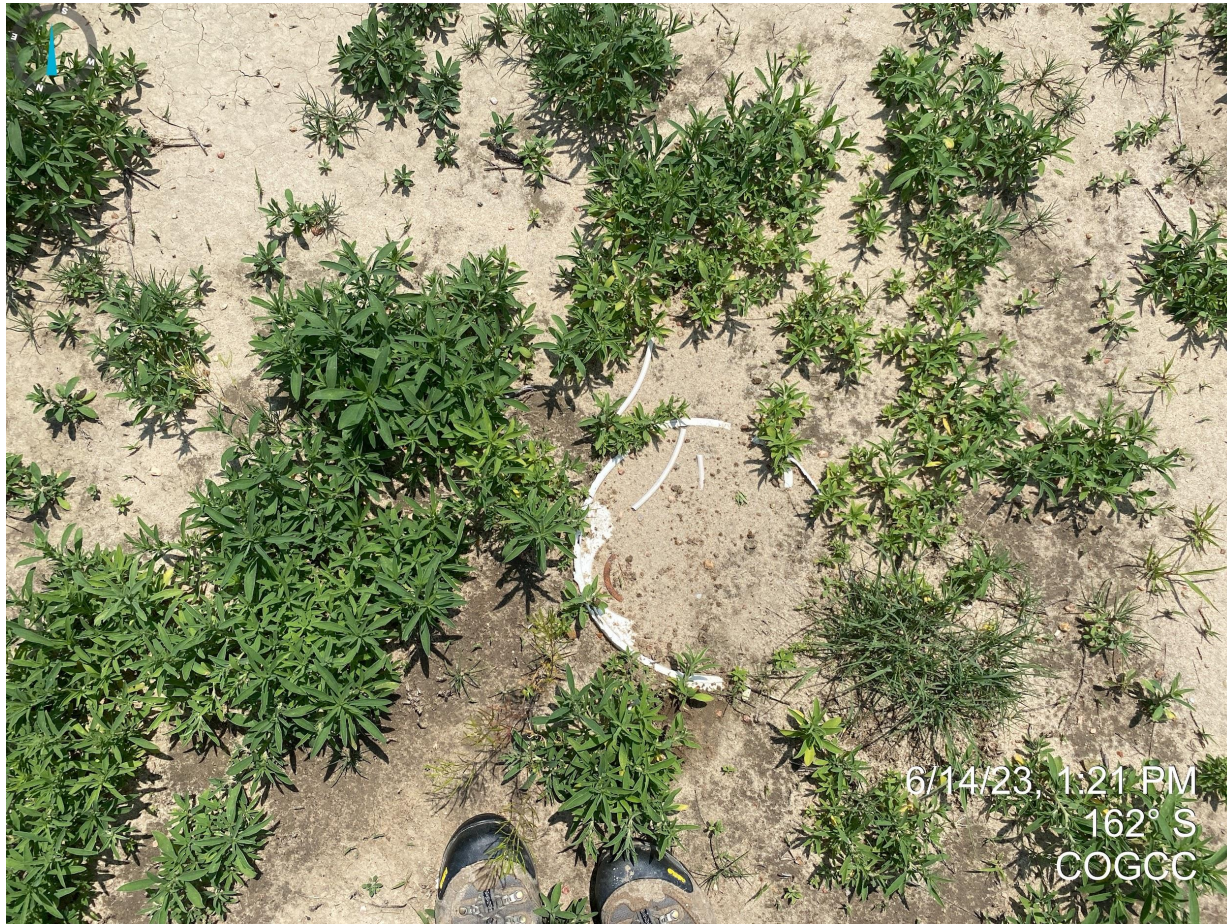
Photo 6. Close up of debris and undesirable vegetation (e.g. kochia).
