## Inspection Photos

Location Name: TEP ROCKY MOUNTAIN LLC GENTRY E Pad

Location #: 335547

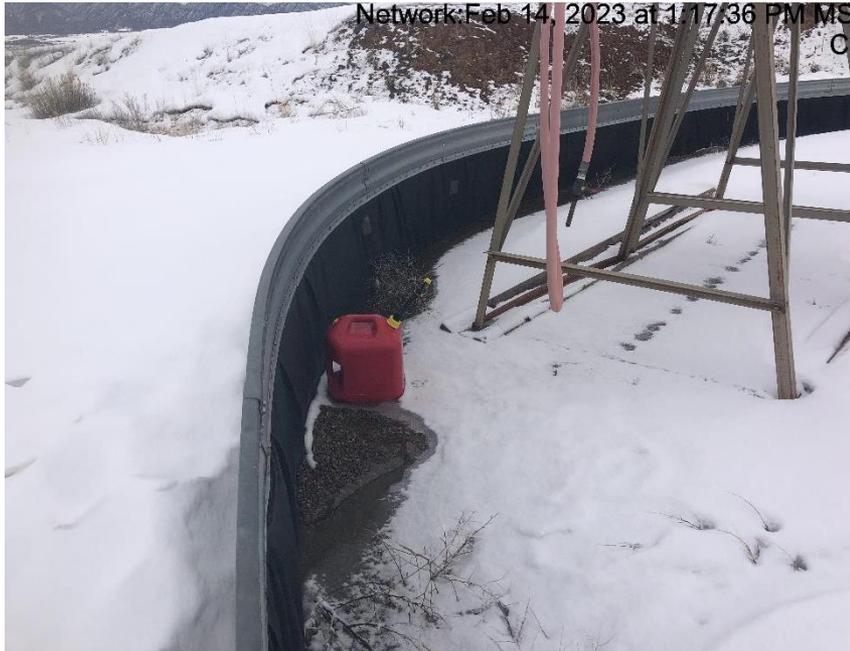
**Photo # 9007 From Inspection 699805442 conducted on 02/14/2023 Unused supplies**

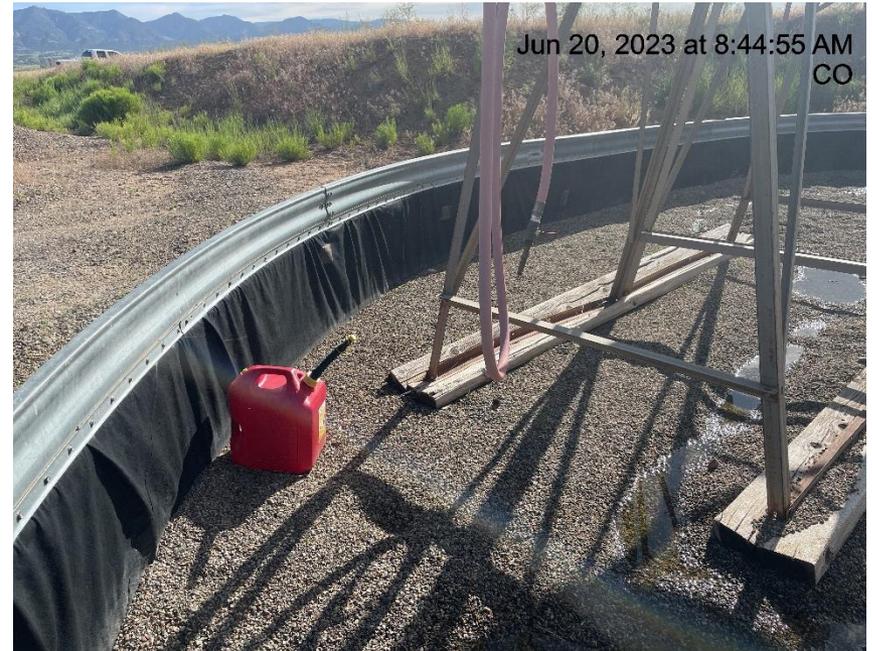
**Photo # 984 Unused supplies**

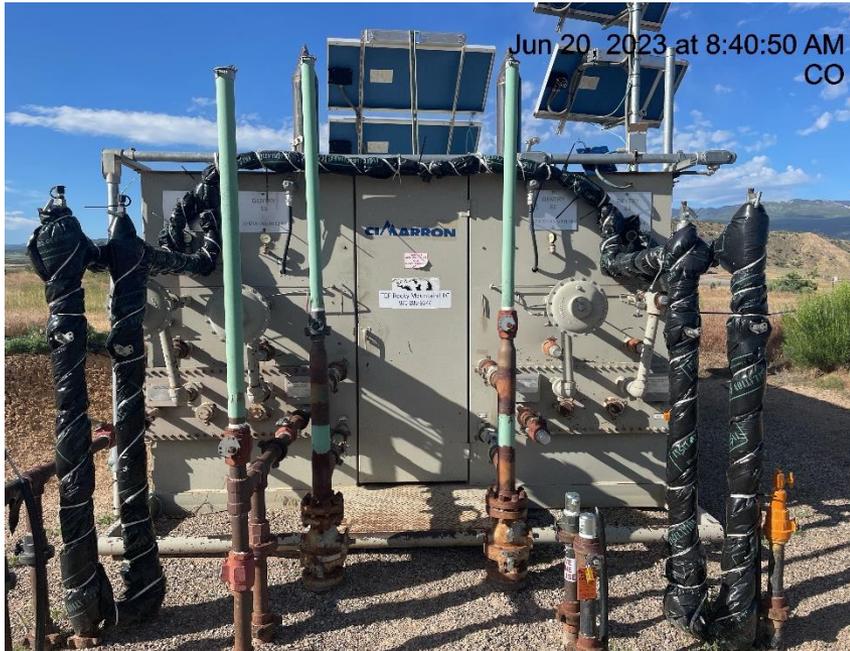
Photo # 978 Meter calibration info not conspicuously posted

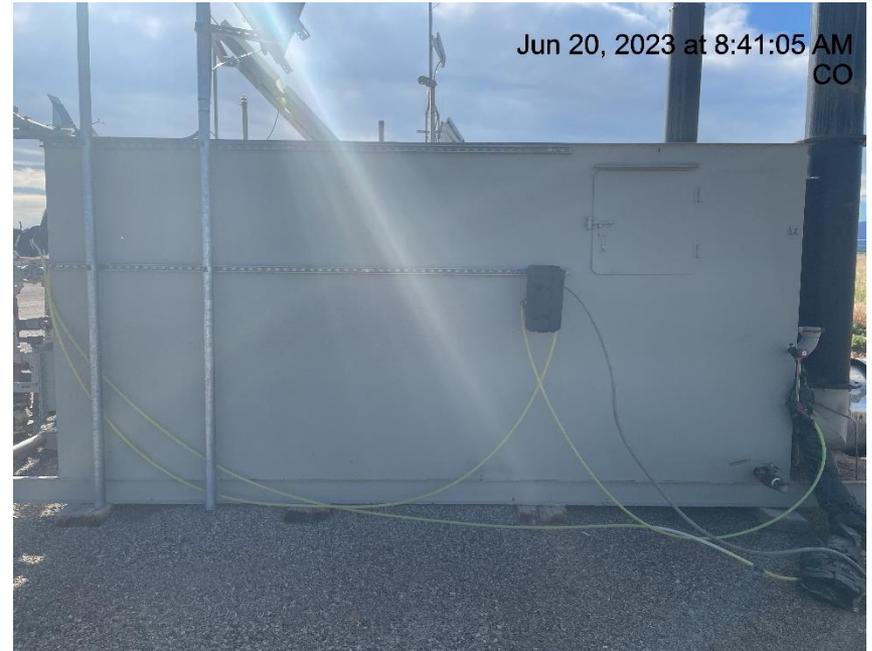
Photo # 979 Meter calibration info not conspicuously posted

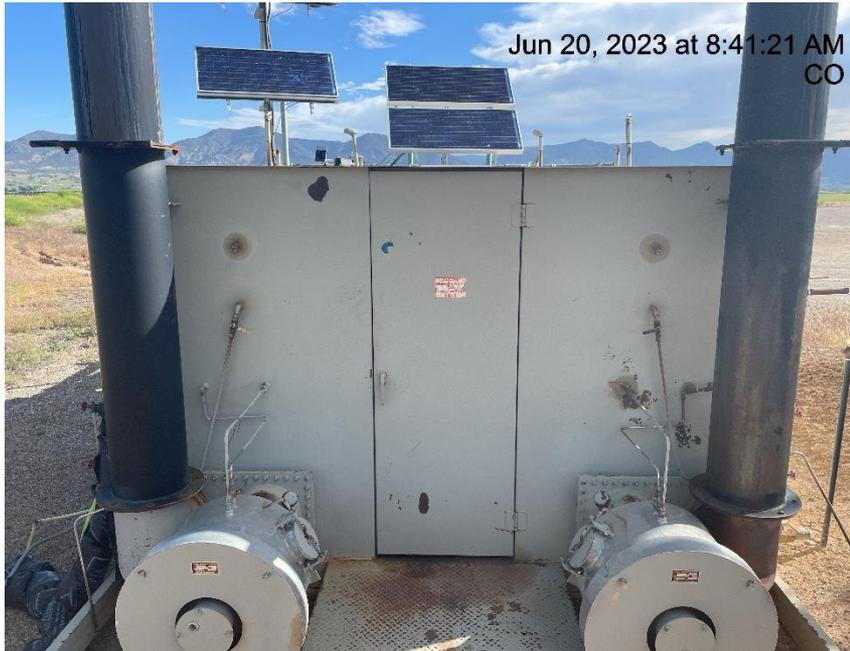
Photo # 980 Meter calibration info not conspicuously posted

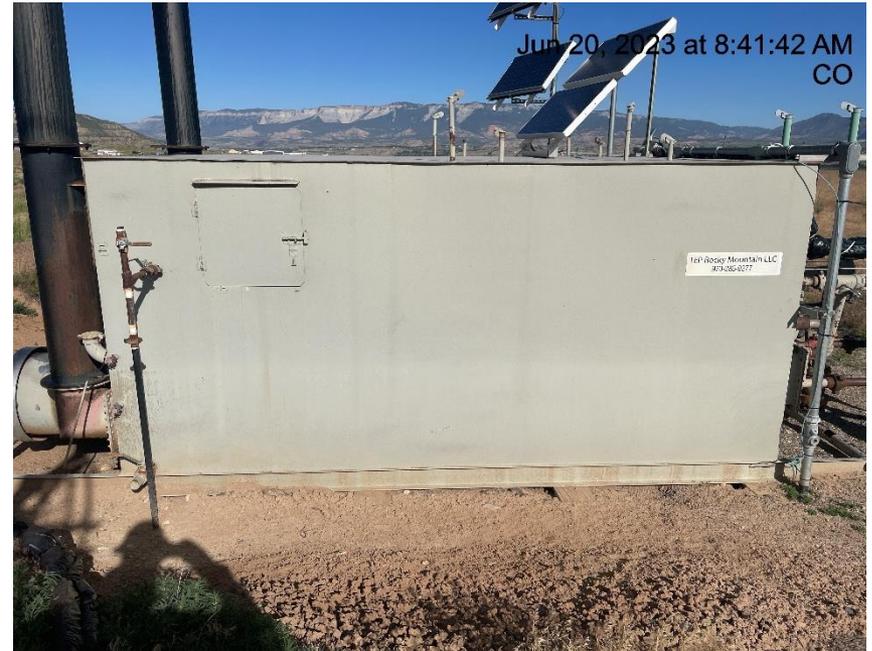
Photo # 981 Meter calibration info not conspicuously posted

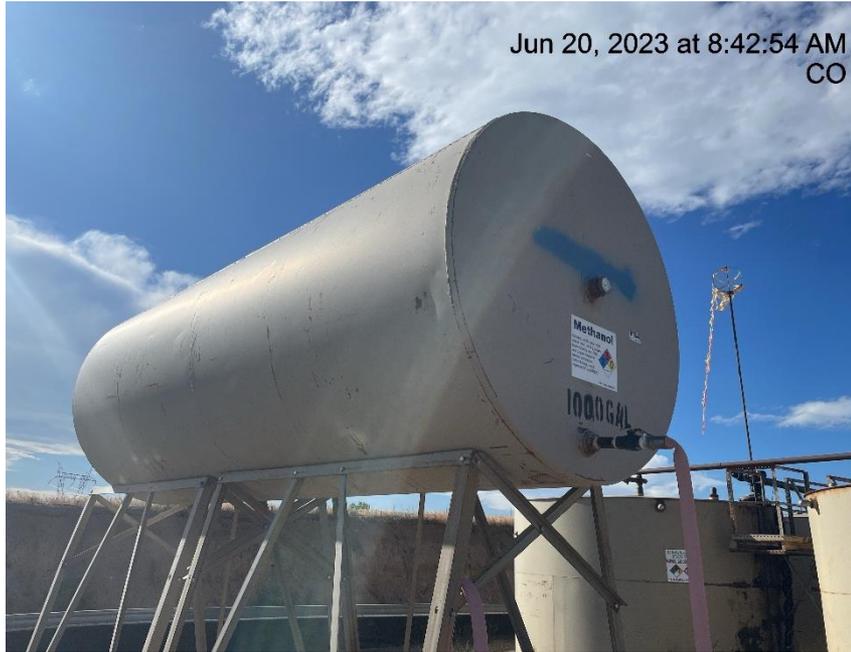
**Photo # 982 Tank missing required information**

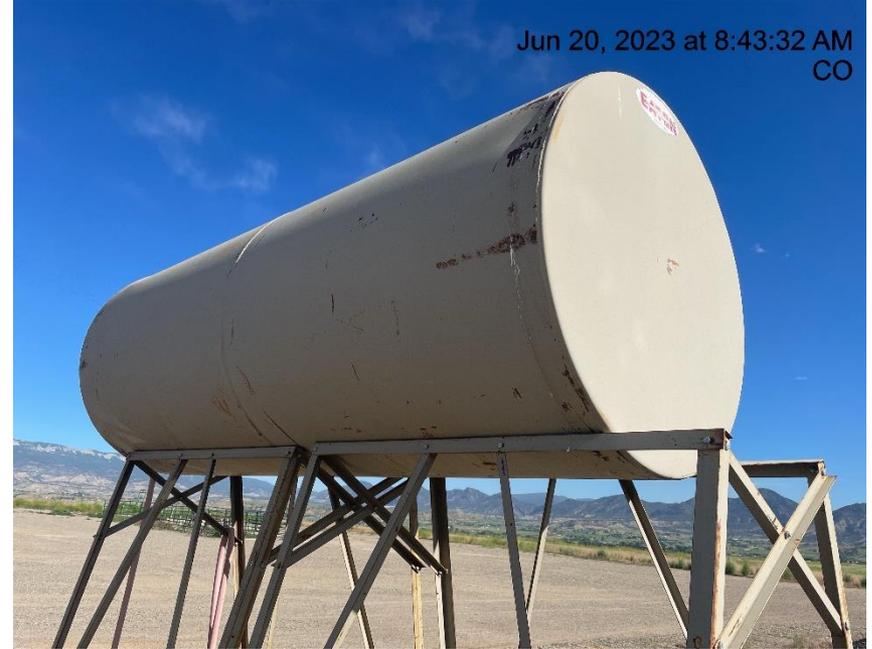
**Photo # 983 Tank missing required information**

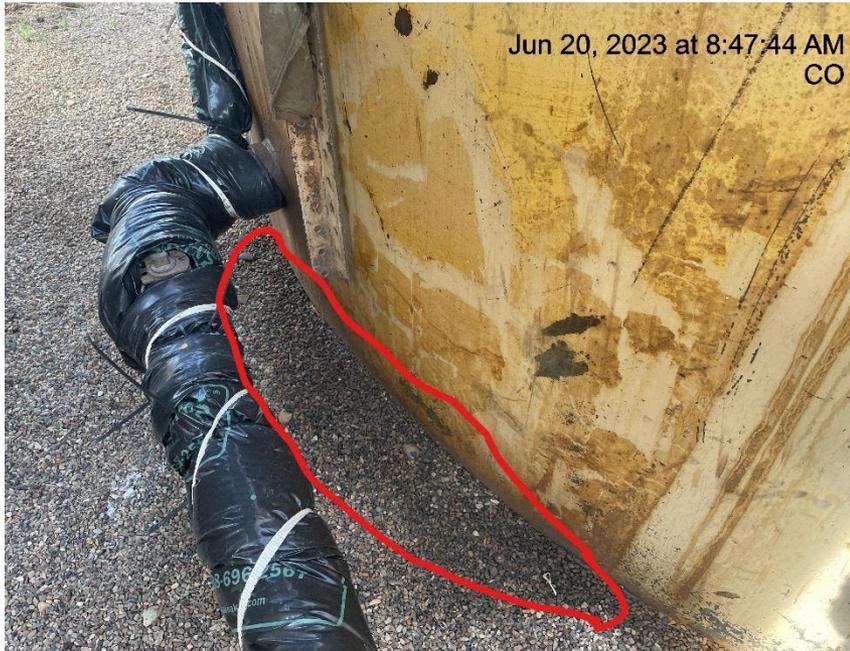
Photo # 986 Stained gravel in secondary containment

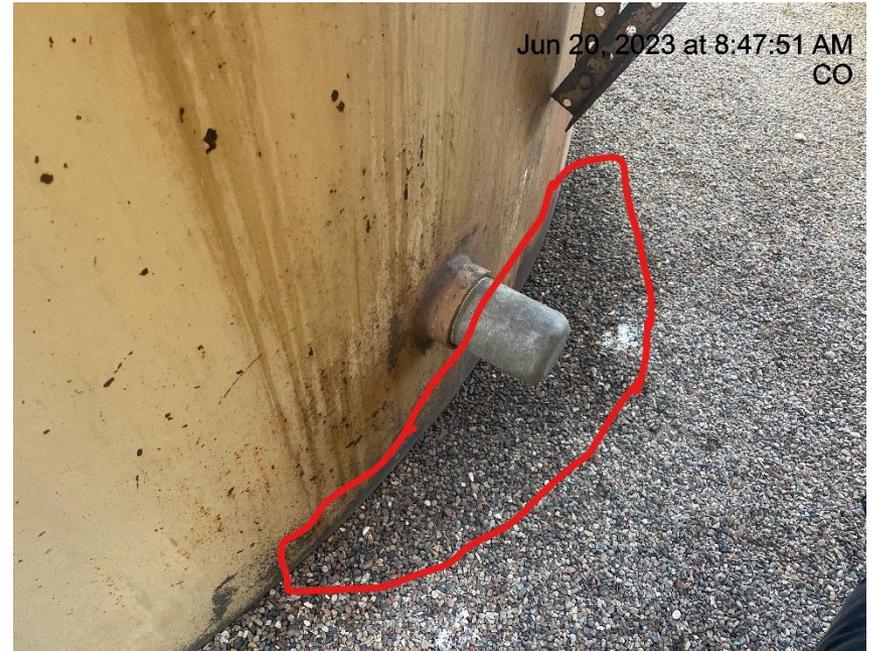
Photo # 987 Stained gravel in secondary containment

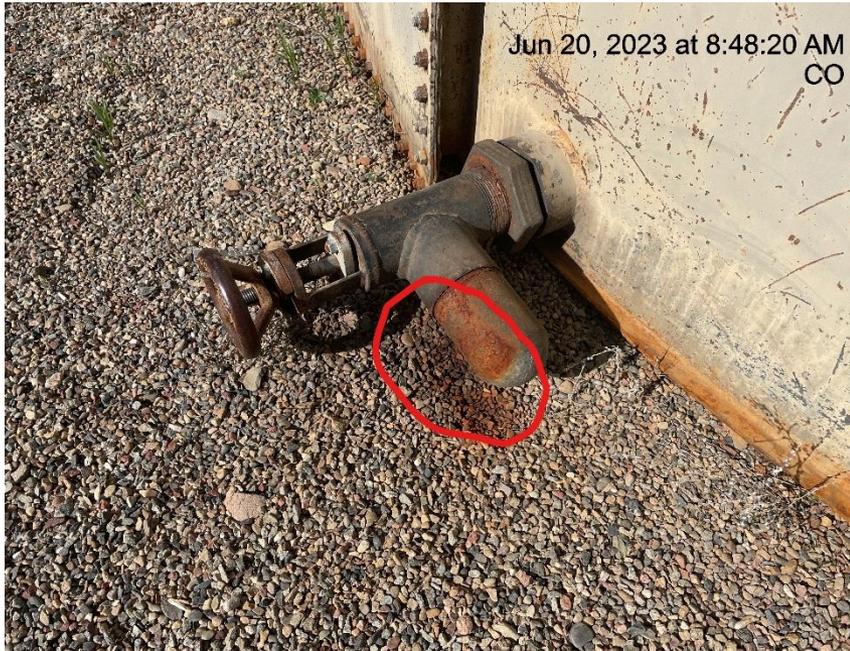
Photo # 990 Stained gravel in secondary containment

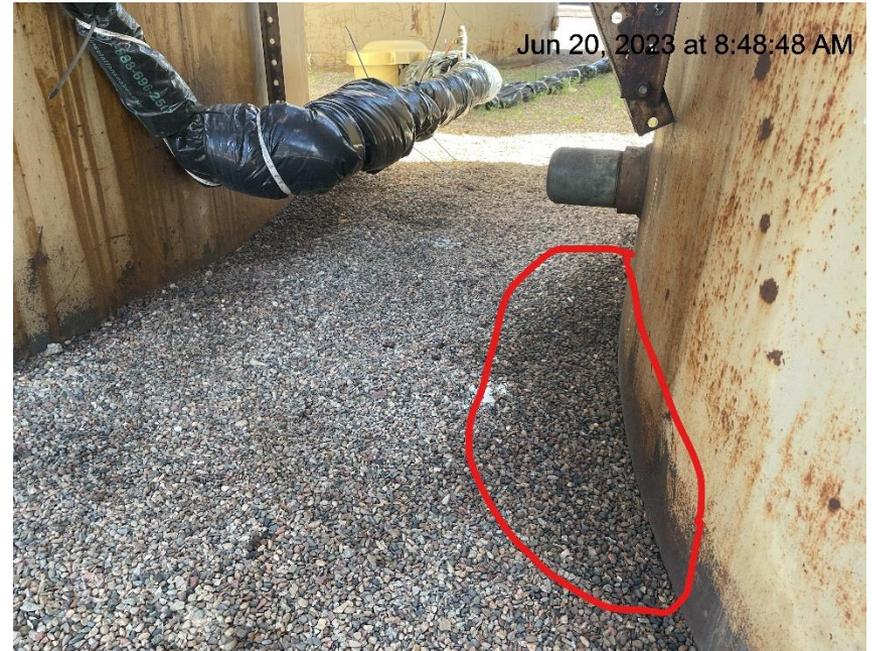
Photo # 991 Stained gravel in secondary containment

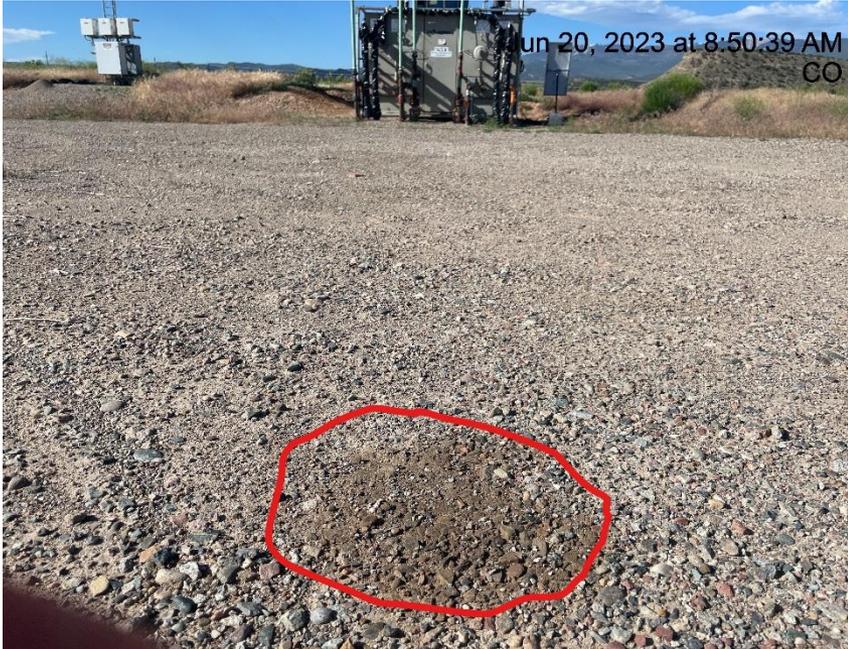
Photo # 992 Stained soils & gravel on location

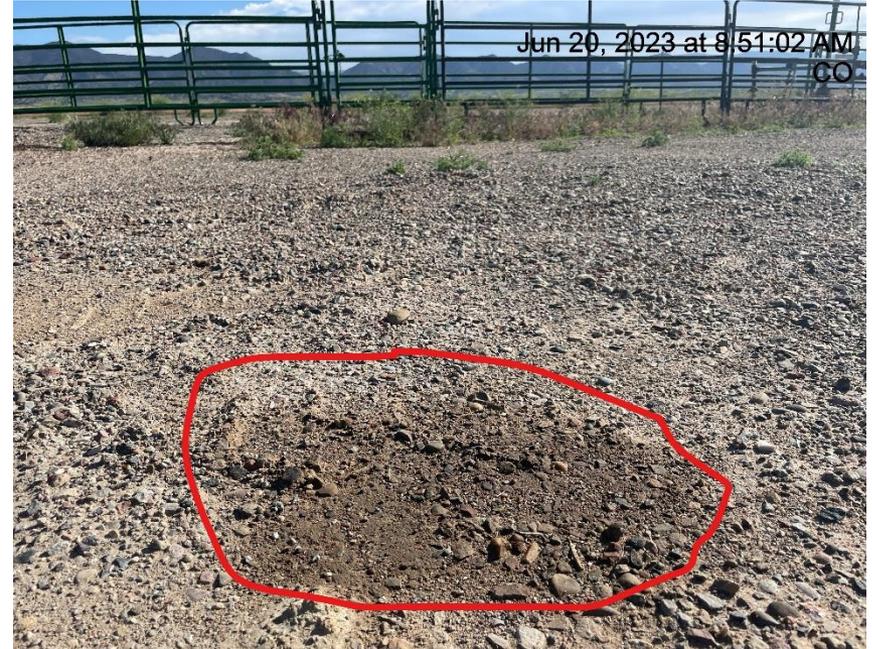
Photo # 993 Stained soils & gravel on location

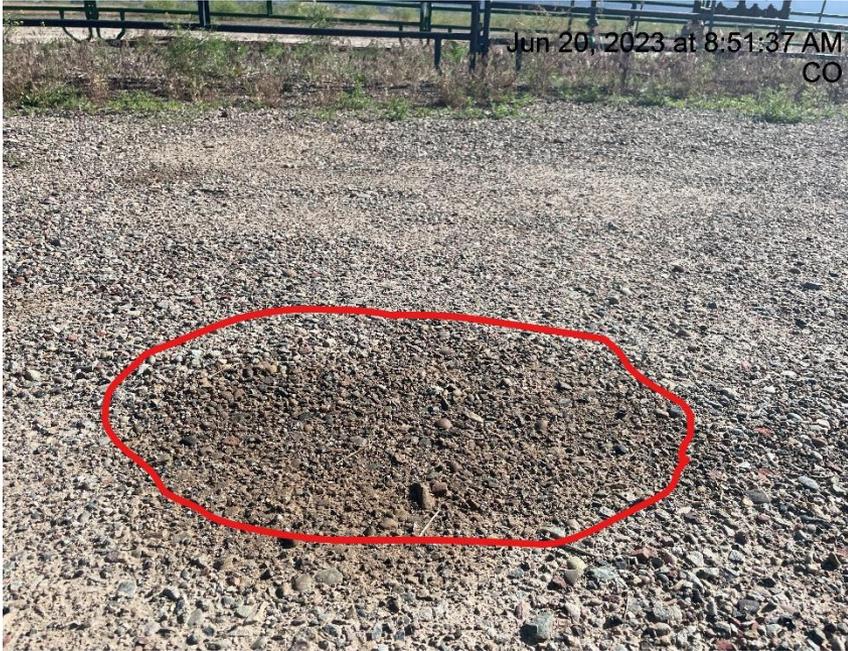
Photo # 995 Stained soils & gravel on location

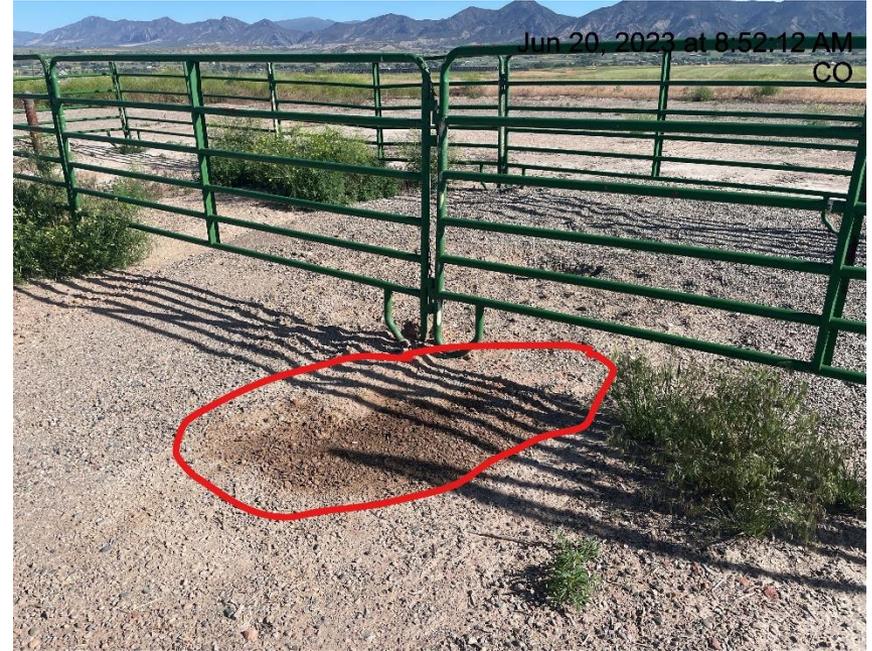
Photo # 997 Stained soils & gravel on location

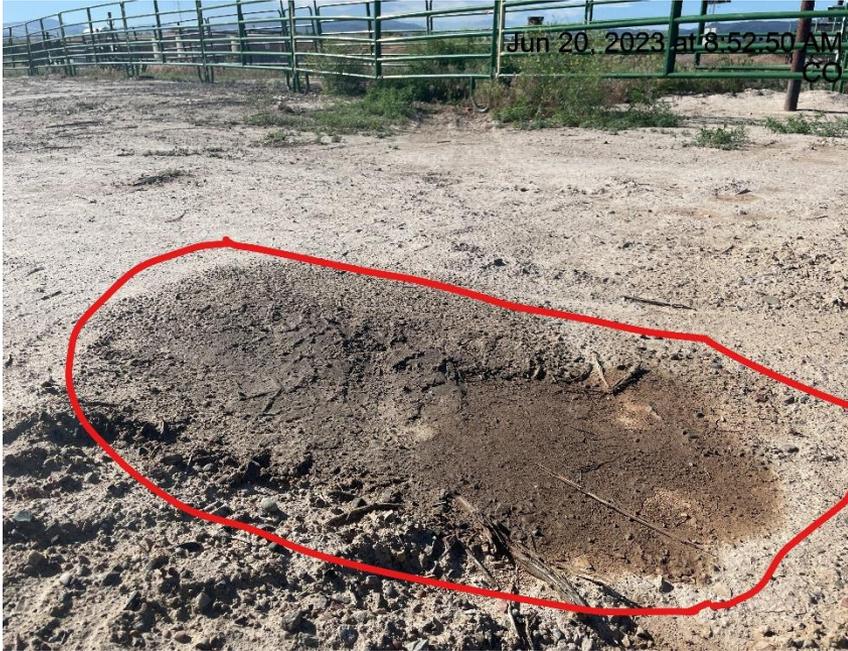
Photo # 998 Stained soils & gravel on location

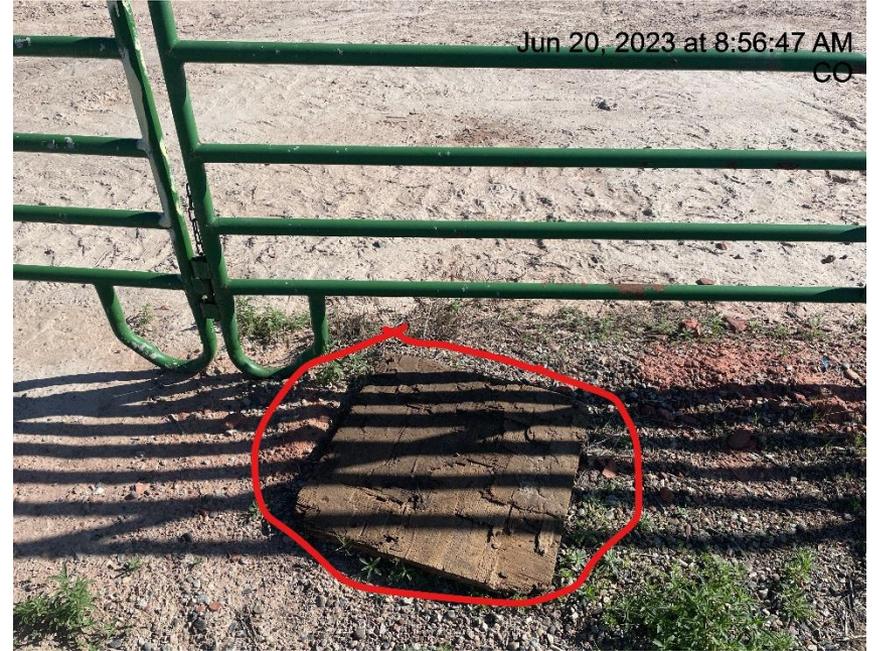
Photo # 1004 Debris

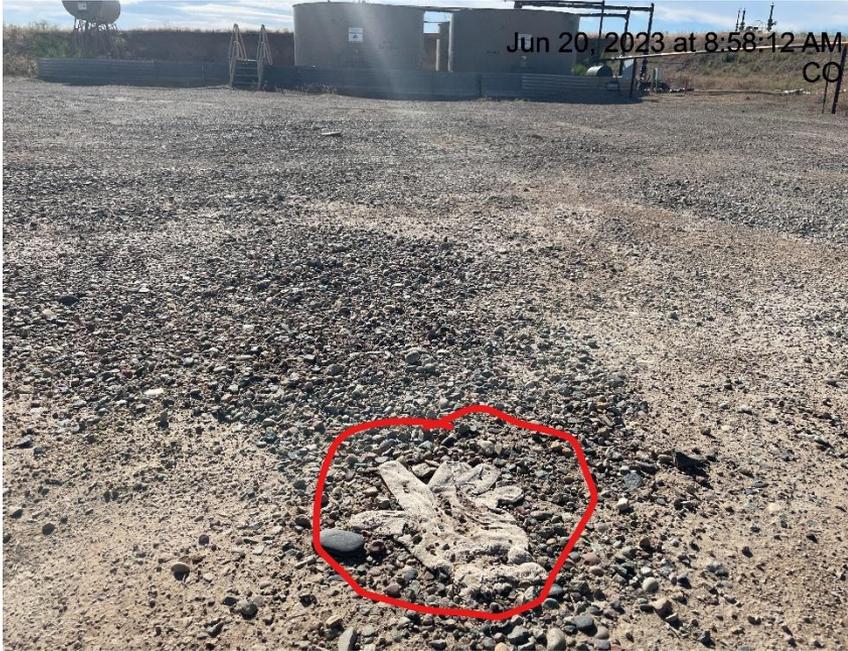
Photo # 1006 Debris

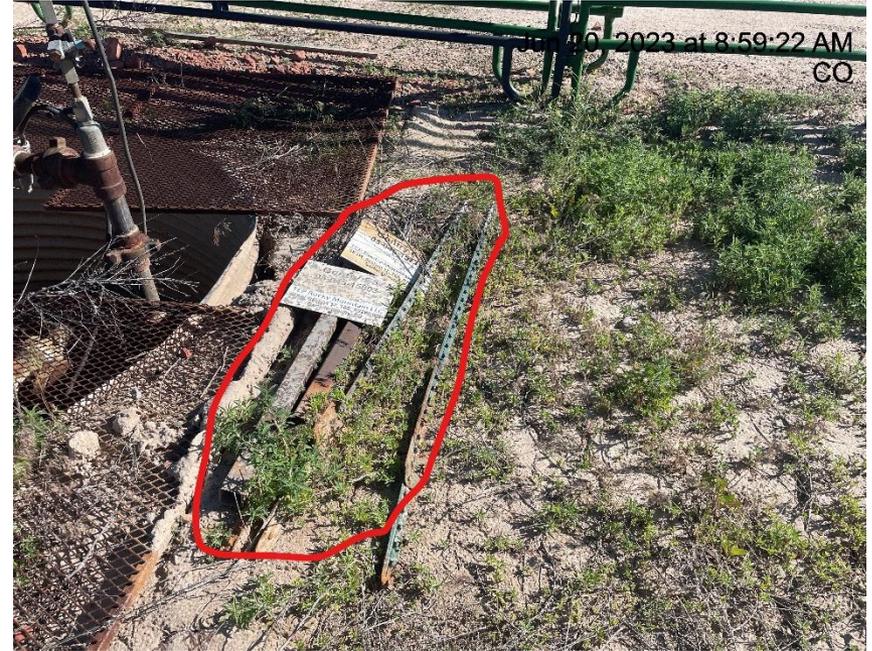
Photo # 1008 Debris

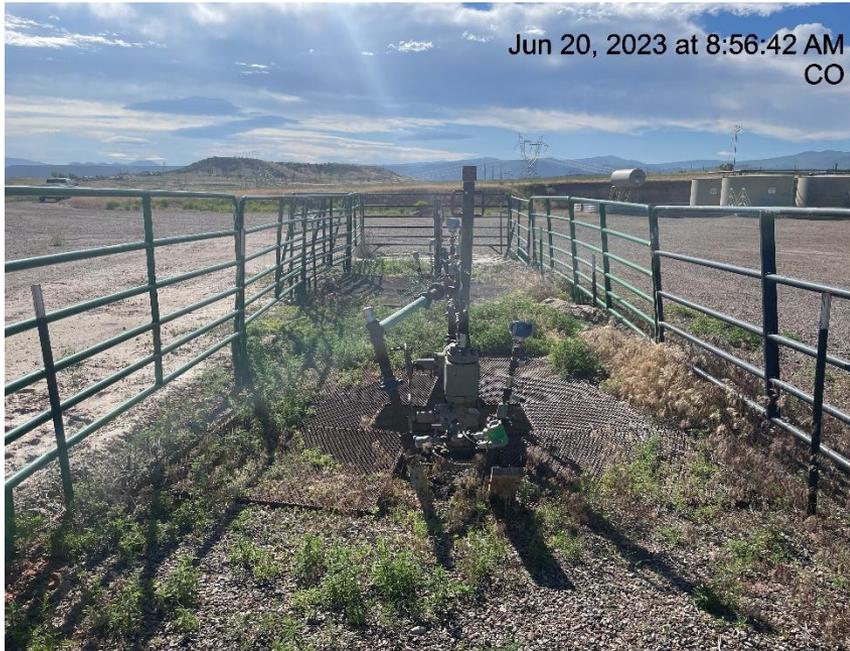
**Photo # 1003 Weeds/Undesirable plant species around wellheads**

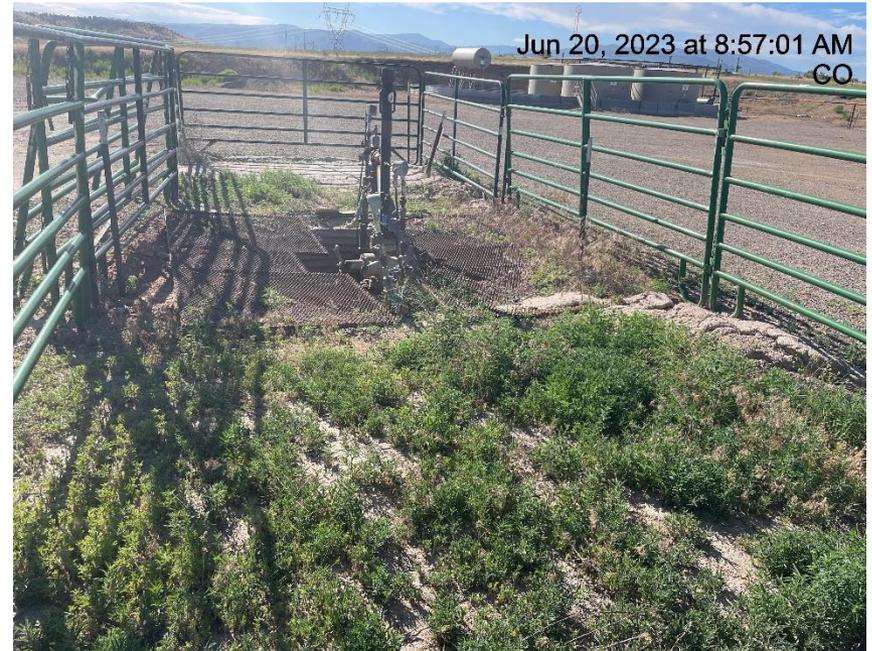
**Photo # 1005 Weeds/Undesirable plant species around wellheads**

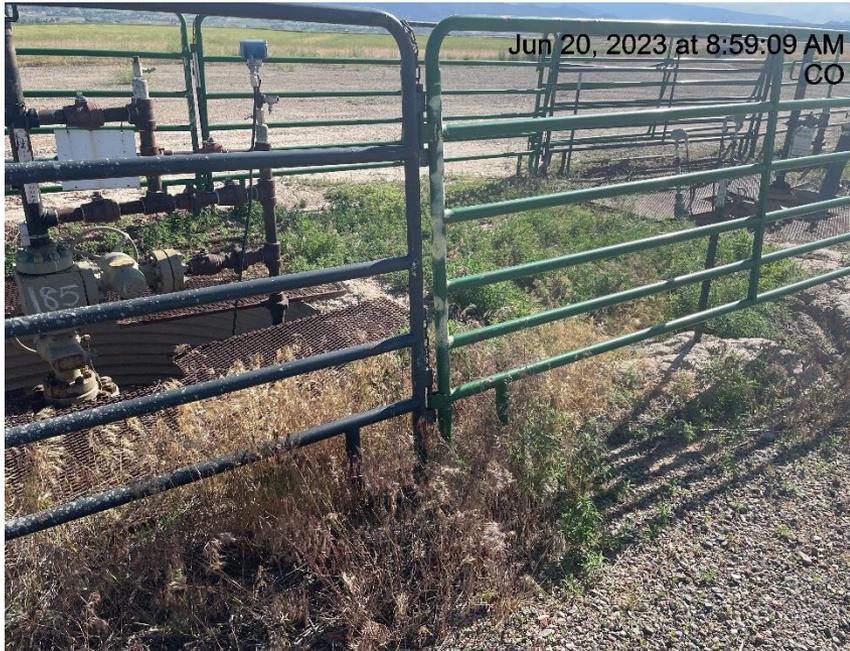
Photo # 1007 Weeds/Undesirable plant species around wellheads

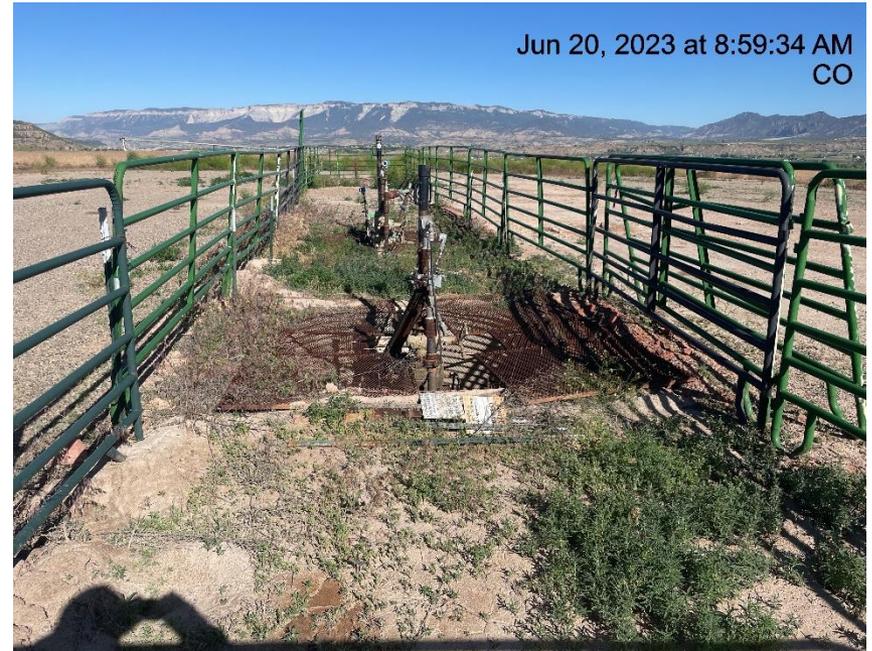
Photo # 1009 Weeds/Undesirable plant species around wellheads

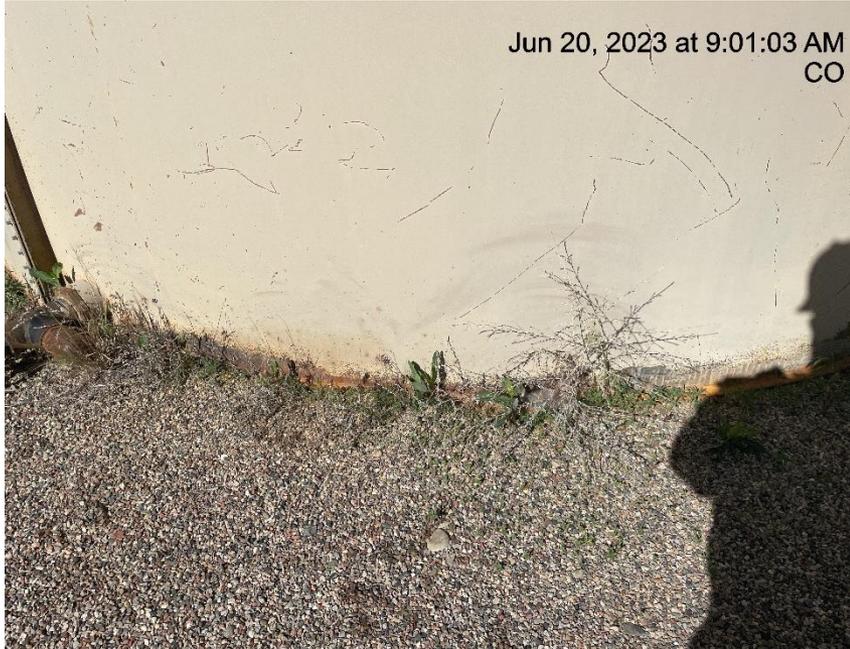
**Photo # 1011 Weeds/Undesirable plant species in secondary containment**

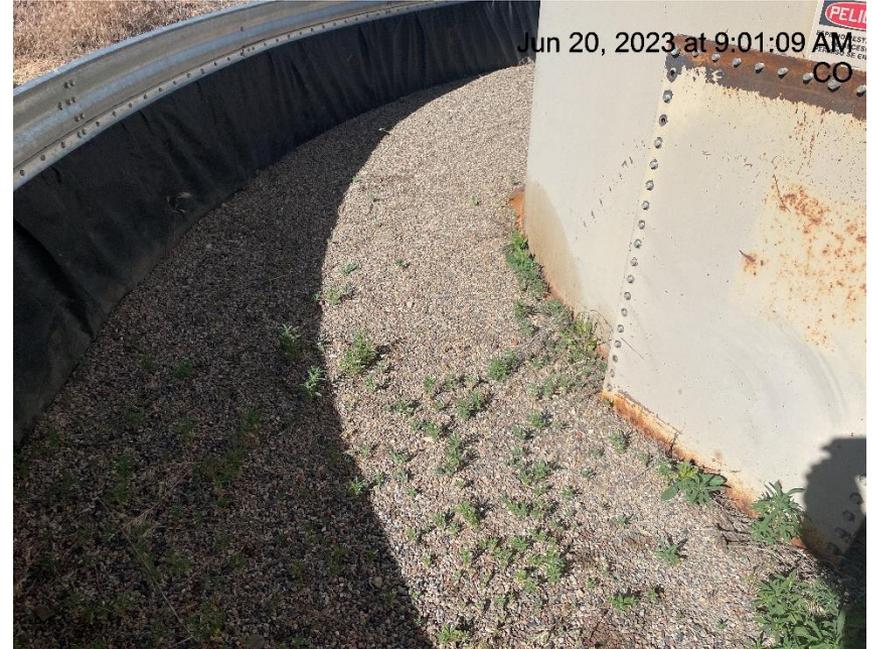
**Photo # 1012 Weeds/Undesirable plant species in secondary containment**

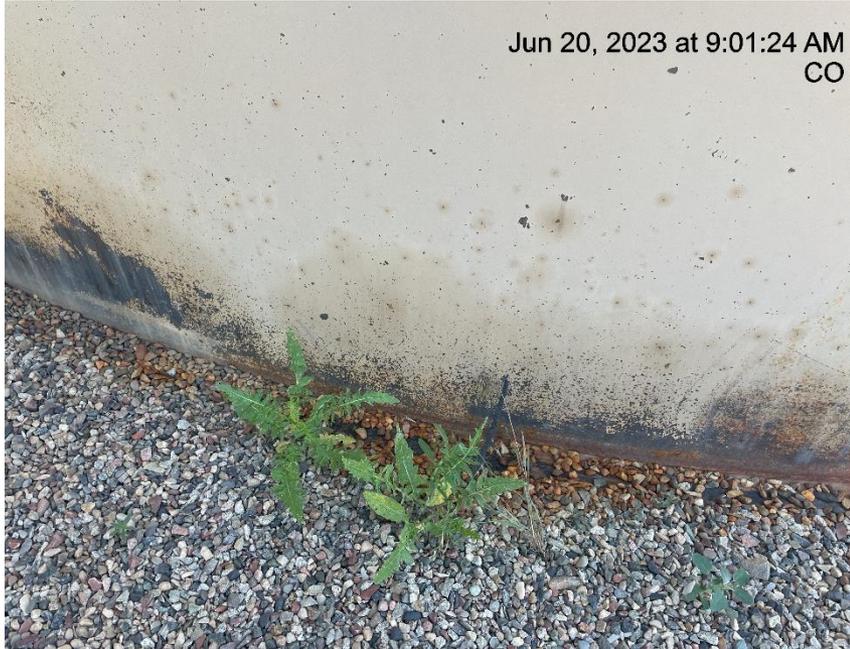
**Photo # 1013 Weeds/Undesirable plant species in secondary containment**

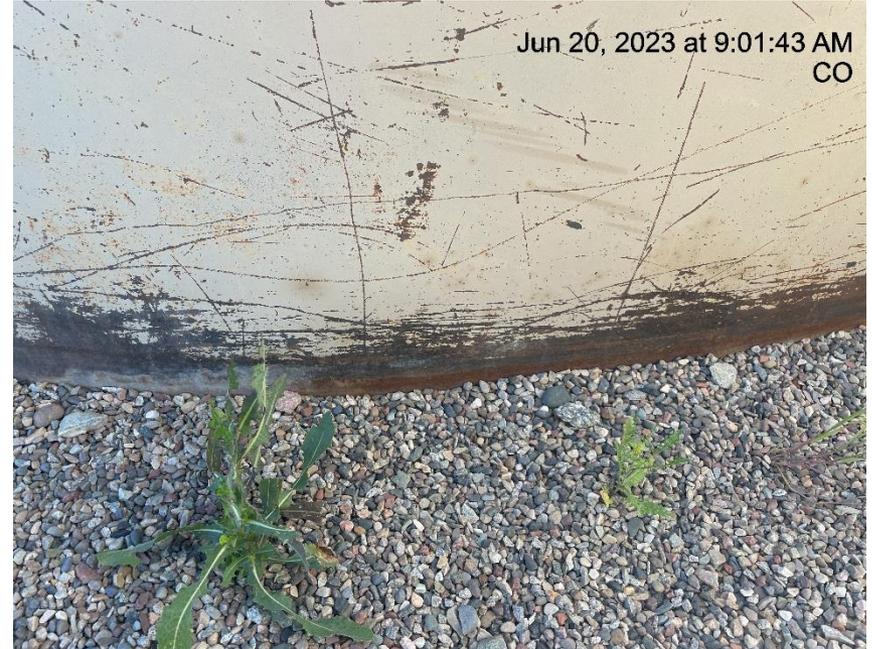
**Photo # 1014 Weeds/Undesirable plant species in secondary containment**

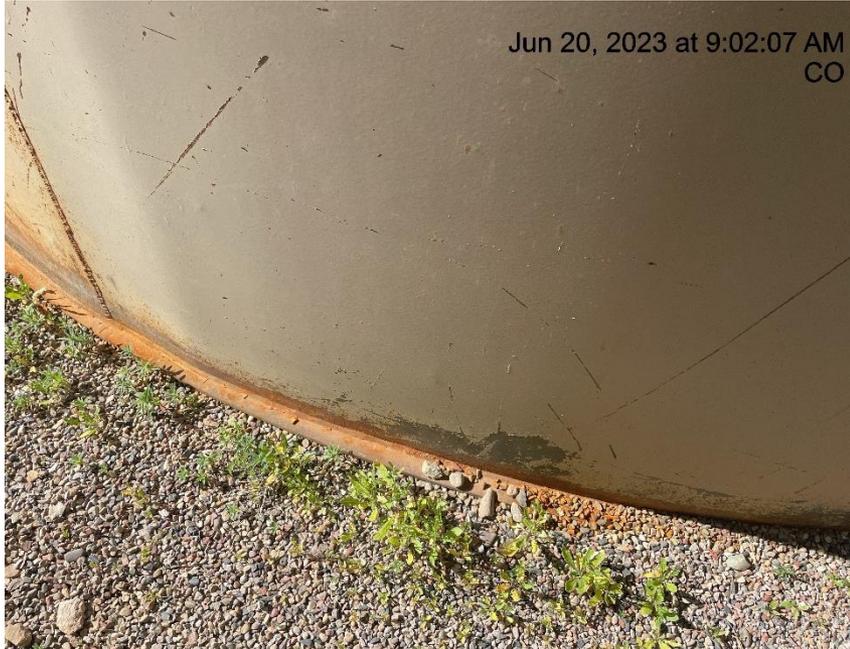
**Photo # 1112 Weeds/Undesirable plant species in secondary containment**

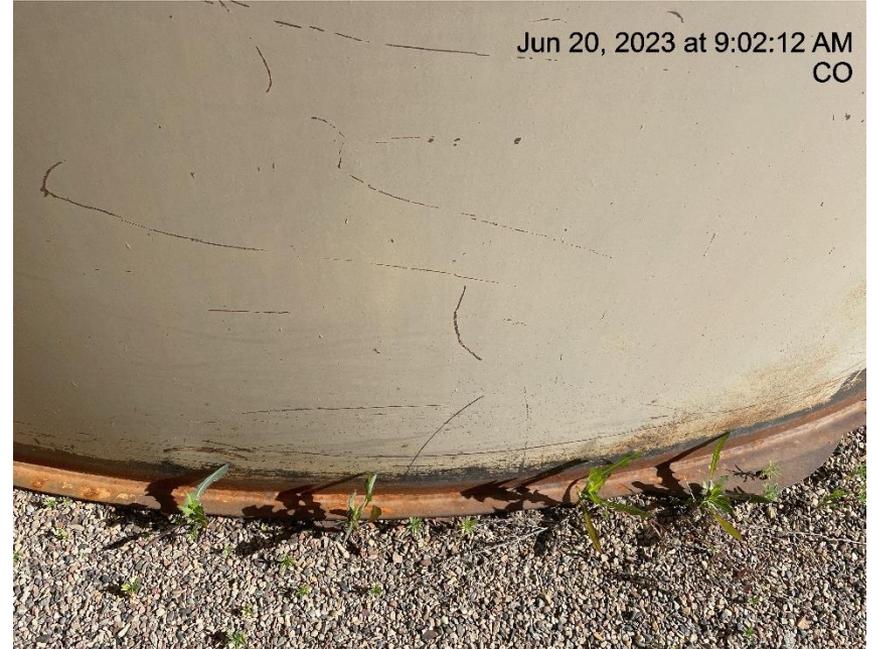
**Photo # 1113 Weeds/Undesirable plant species in secondary containment**
