**Storm Water Management and Erosion control**  
**Location Name: TEP ROCKY MOUNTAIN LLC GENTRY E Pad**  
**Location #: 335547**

**Location Overview: Location is within a 411a Surface Water  
Intermediate Buffer & is approximately 327 yards from  
Mamm Creek  
Section/Township/Range: 17 6S92W**

**COLORADO**  
Oil & Gas Conservation  
Commission  
Department of Natural Resources

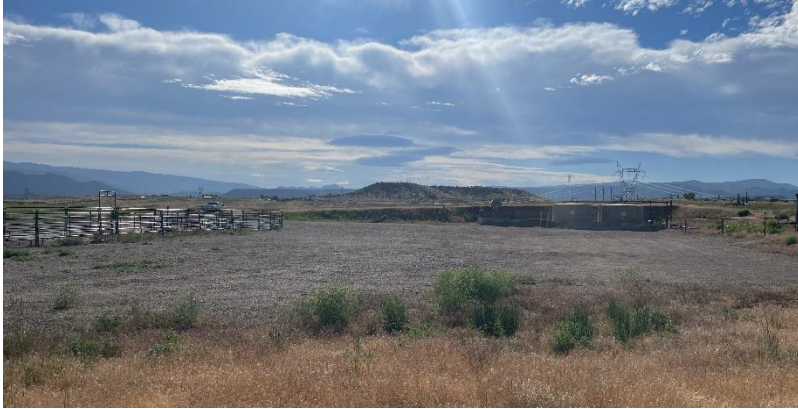
**North West corner of location.**

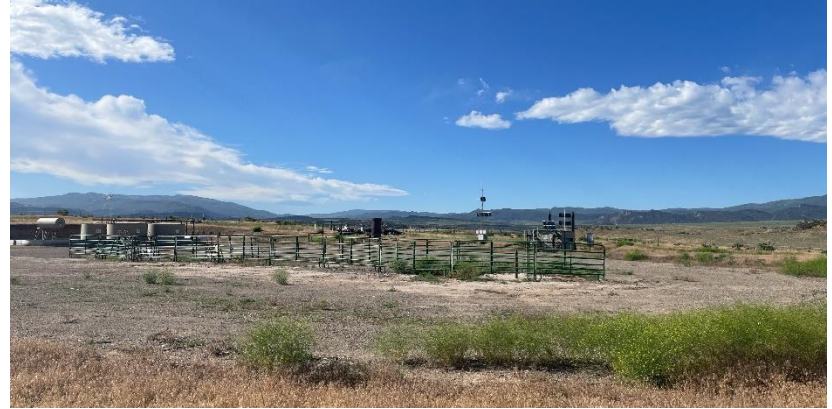
**North East corner of location.**

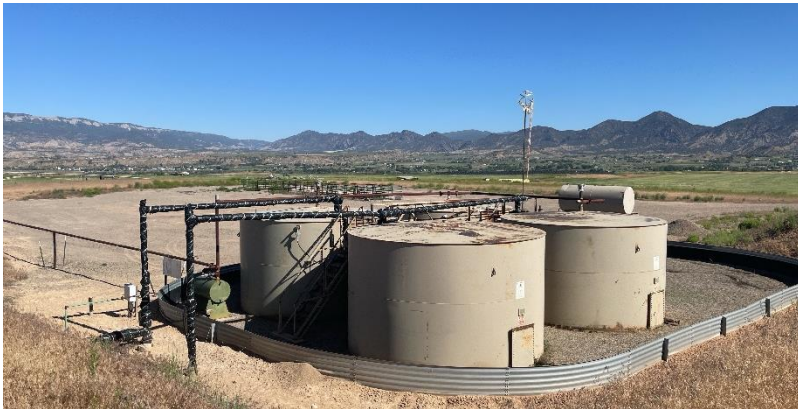
**South West corner of location.**

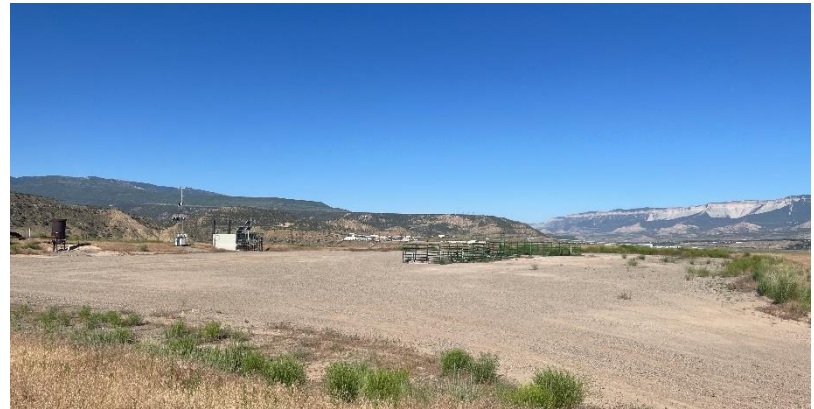
**South East corner of location.**

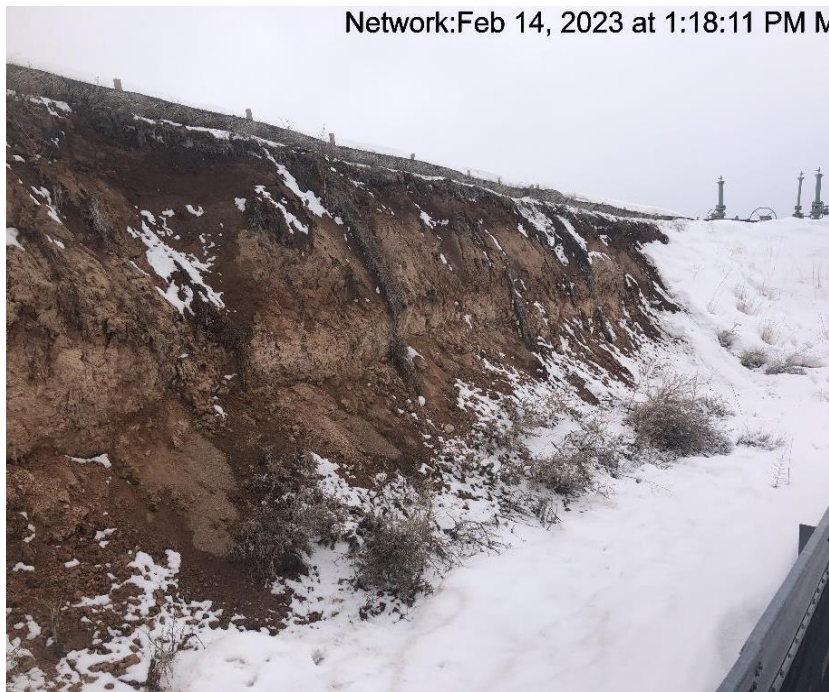
**Photo # 9008 From Inspection 699805442  
conducted on 02/14/2023 Slope stabilization  
BMP's insufficient**

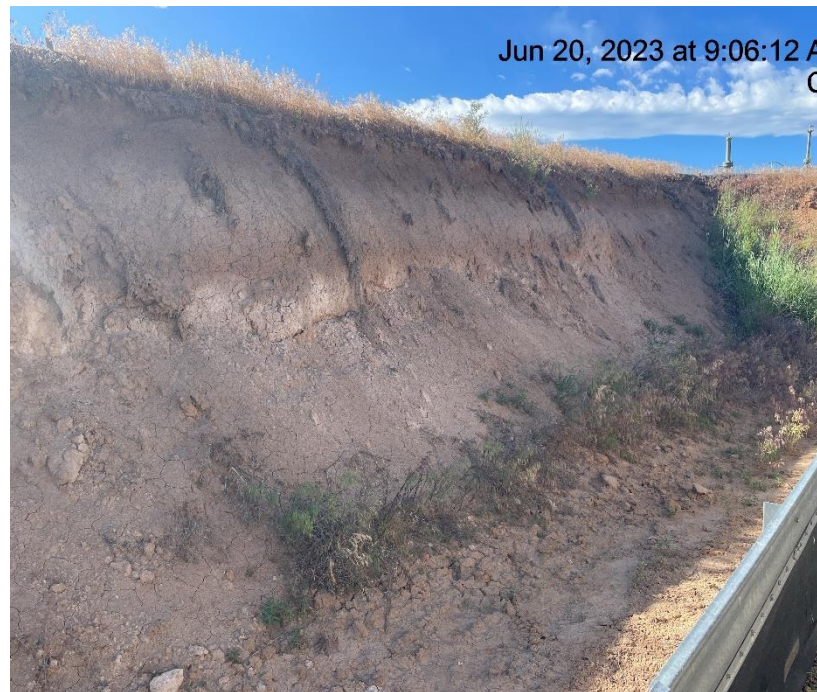
**Photo # 1020 Slope stabilization BMP's insufficient**

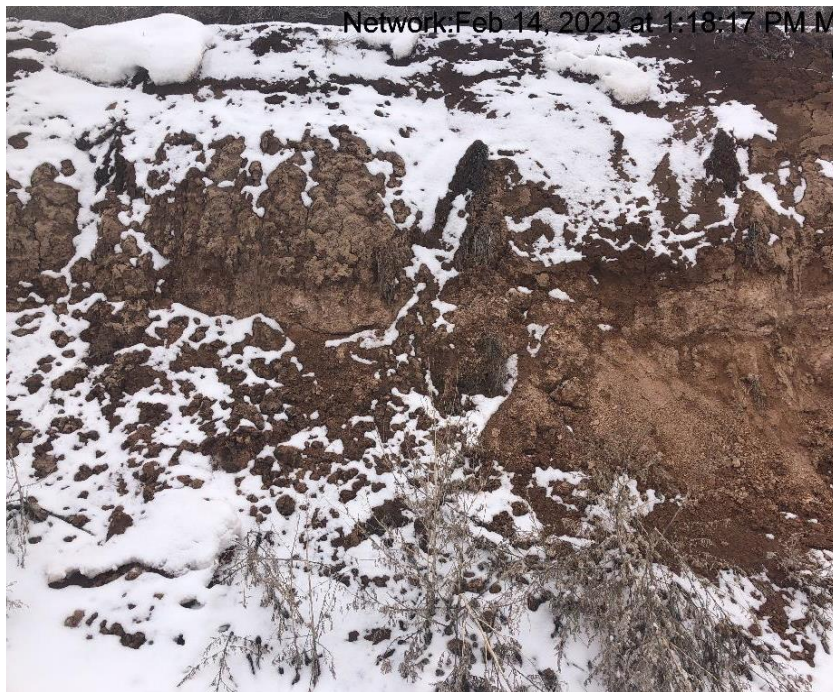
**Photo # 9009 From Inspection 699805442  
conducted on 02/14/2023 Slope stabilization  
BMP's insufficient**

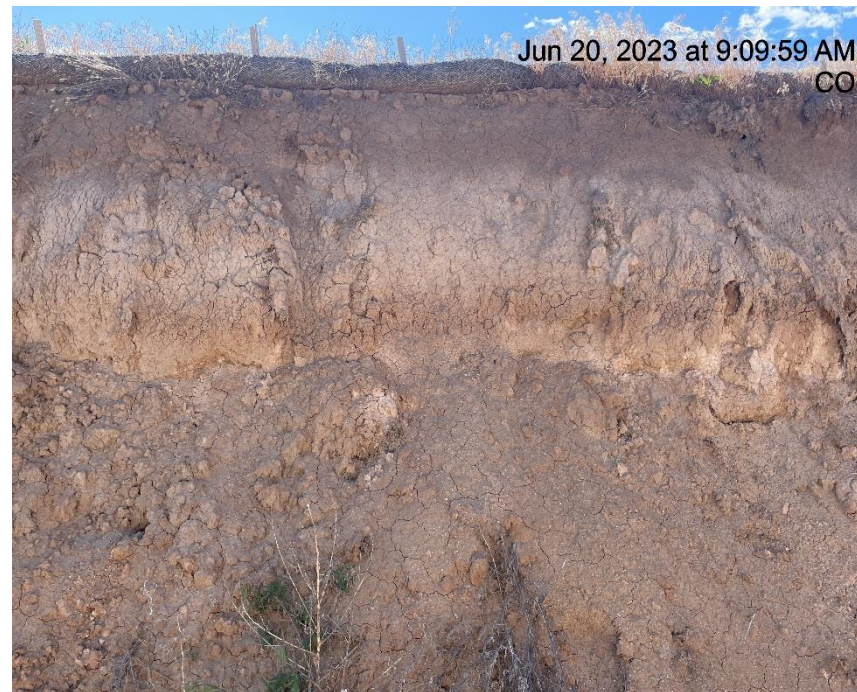
**Photo # 1028 Slope stabilization BMP's insufficient**

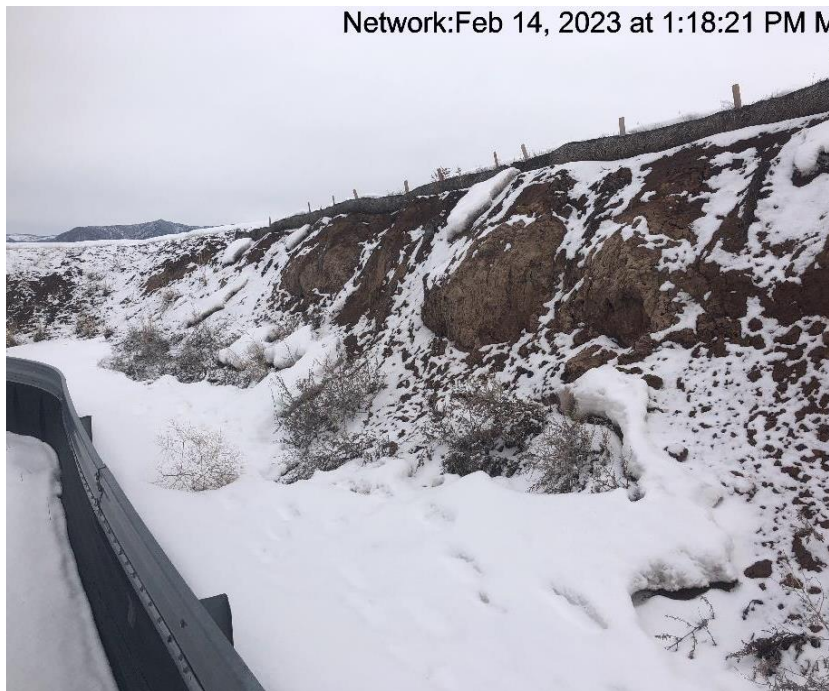
**Photo # 9010 From Inspection 699805442**  
**conducted on 02/14/2023 Run on to location not**  
**being controlled**

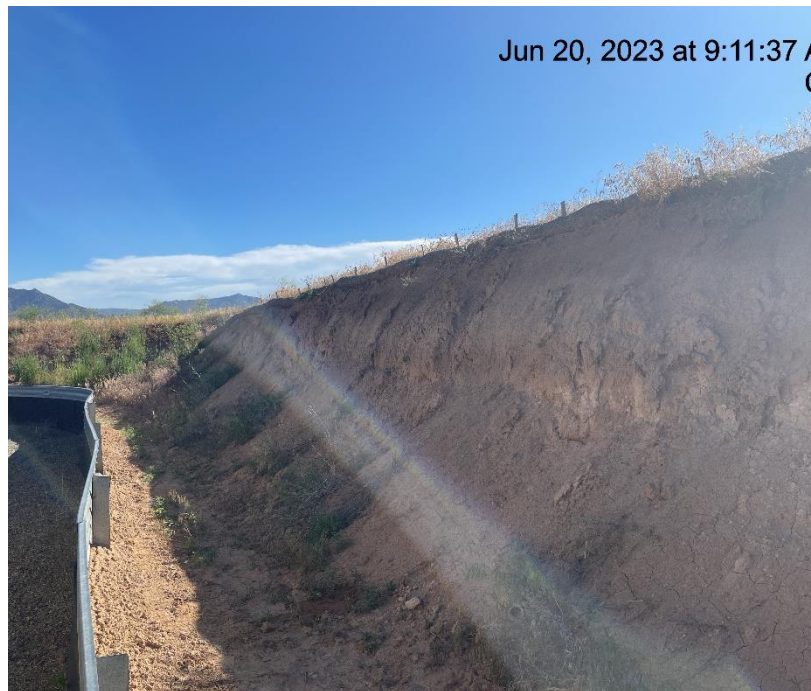
**Photo # 1031 Run on to location not being**  
**controlled**

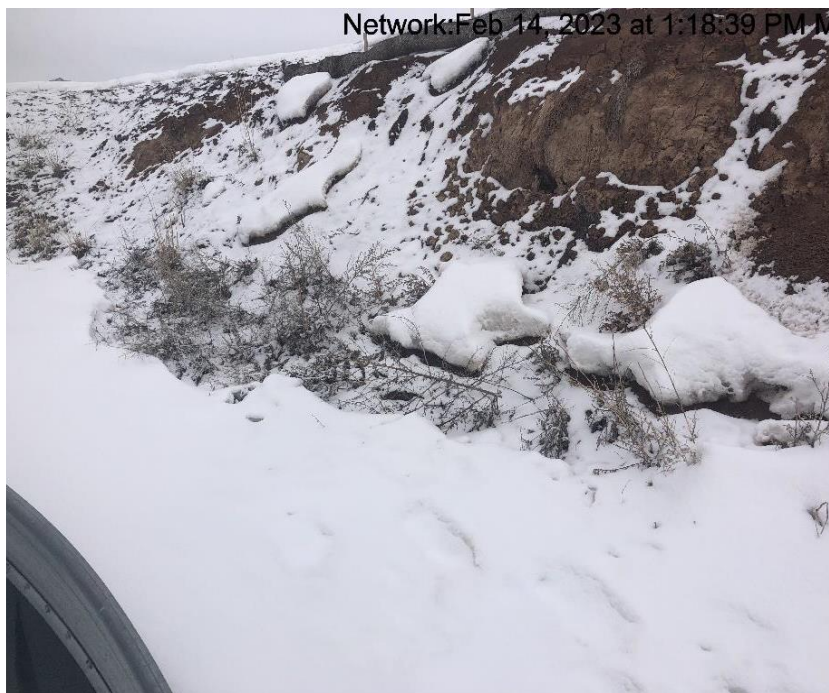
**Photo # From Inspection 699805442 conducted on 02/14/2023 Slope stabilization BMP's insufficient**

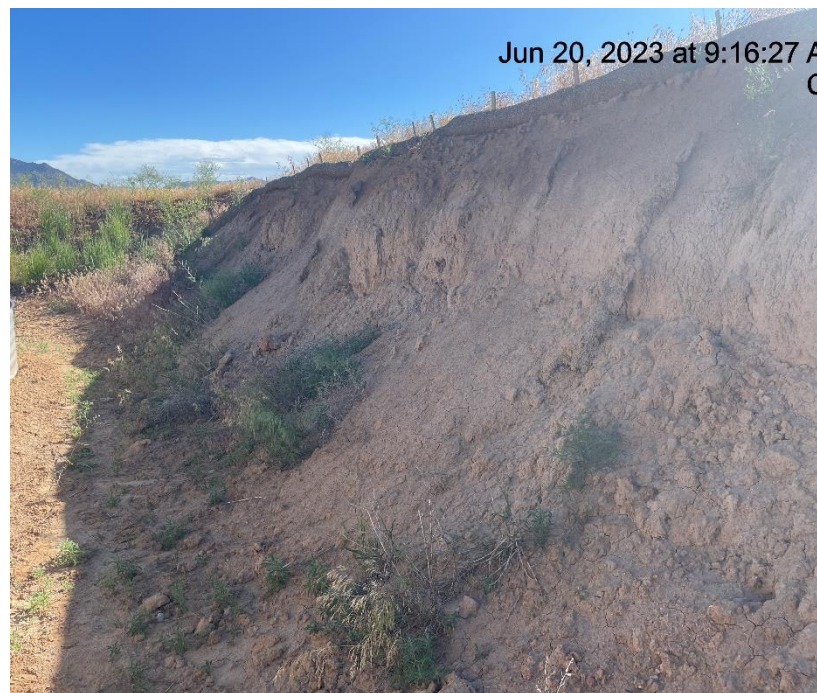
**Photo # 1053 Slope stabilization BMP's insufficient**

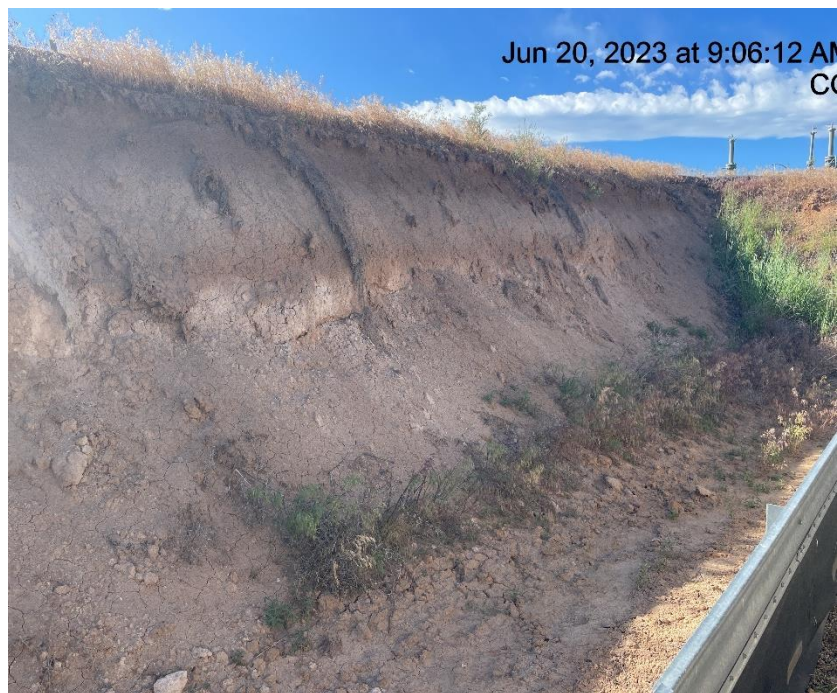
**Photo # 1020 Slope stabilization BMP's insufficient/Run on to location not being controlled**

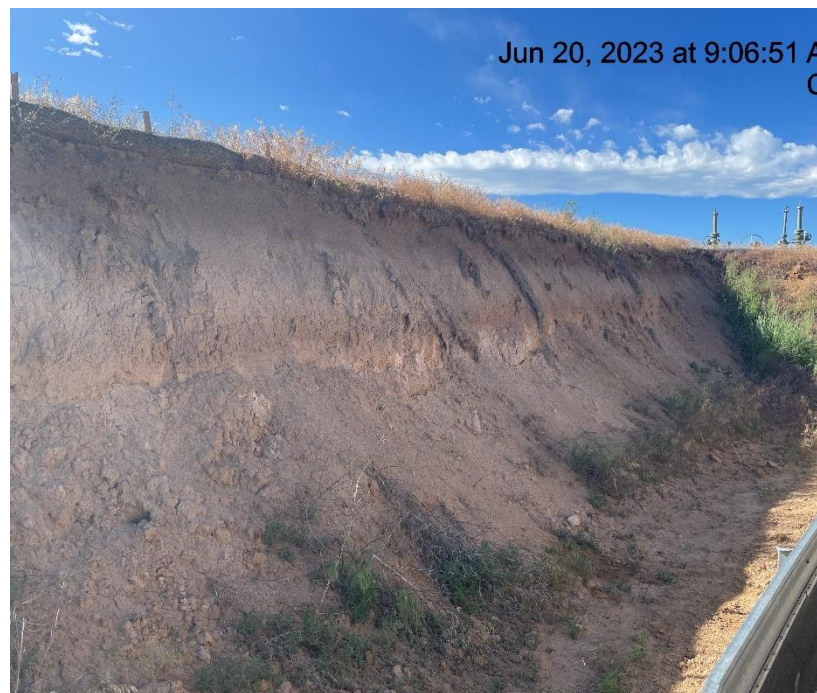
**Photo # 1024 Slope stabilization BMP's insufficient  
Run on to location not being controlled**

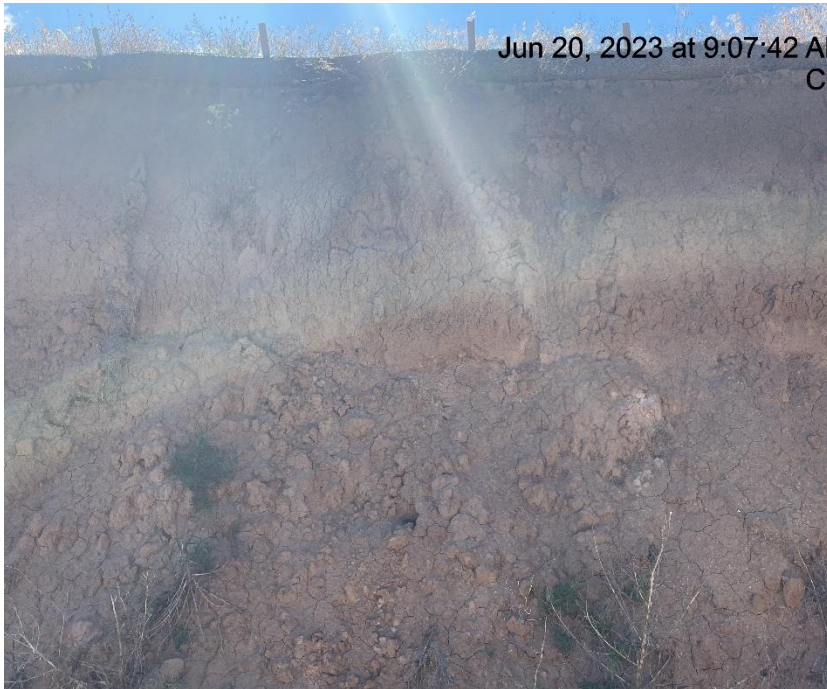
**Photo # 1026 Slope stabilization BMP's insufficient**

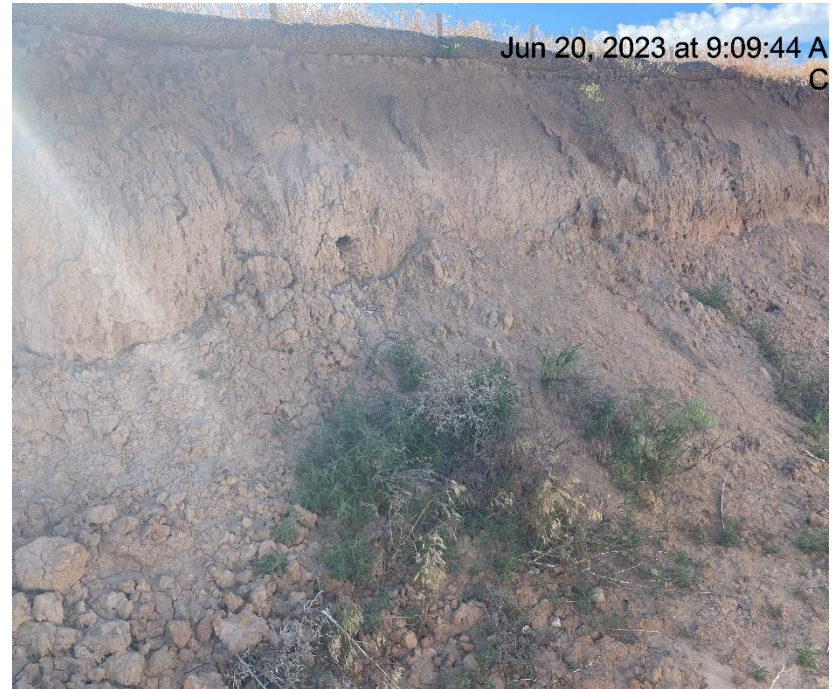
**Photo # 1027 Slope stabilization BMP's insufficient**

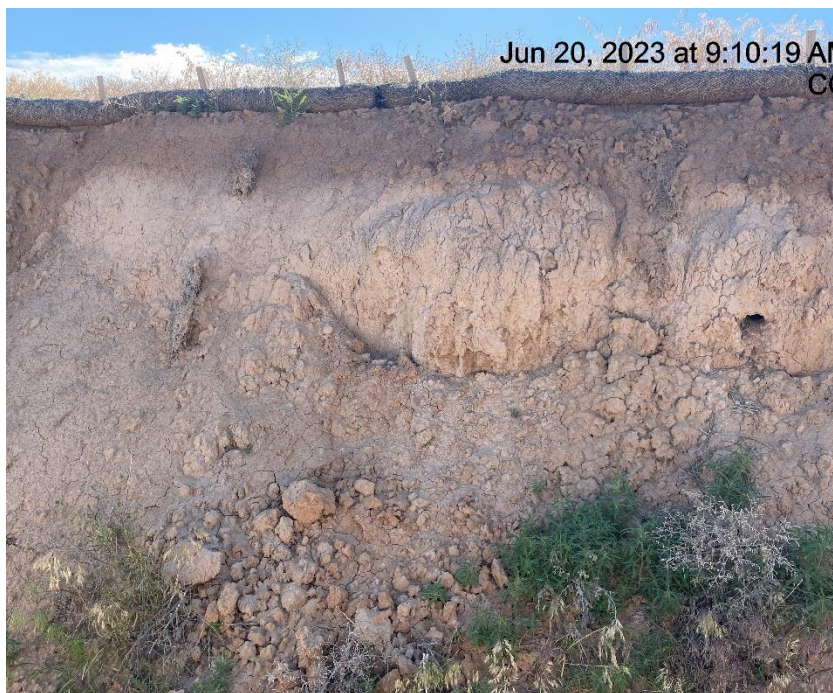
**Photo # 1029 Slope stabilization BMP's insufficient**

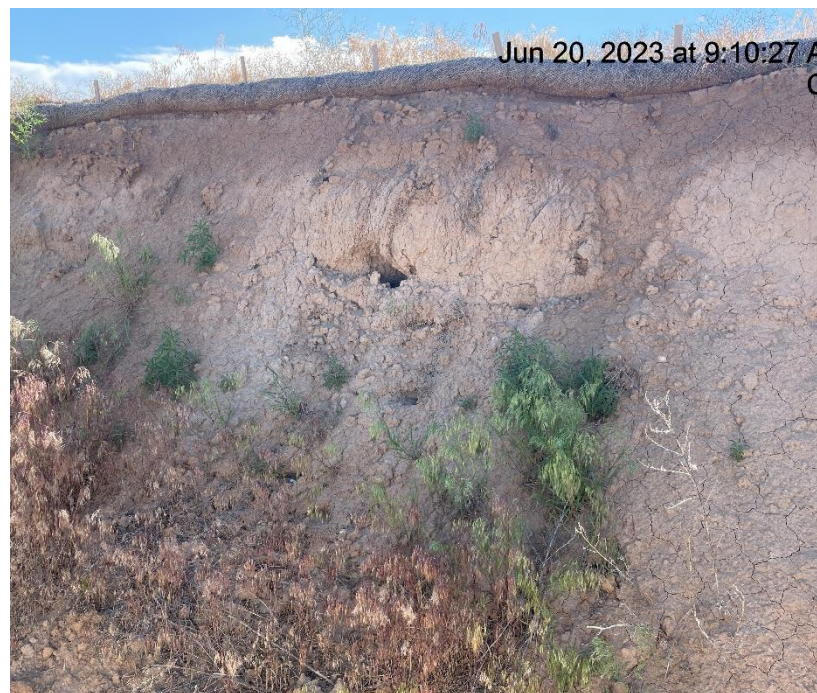
**Photo # 1030 Slope stabilization BMP's insufficient**

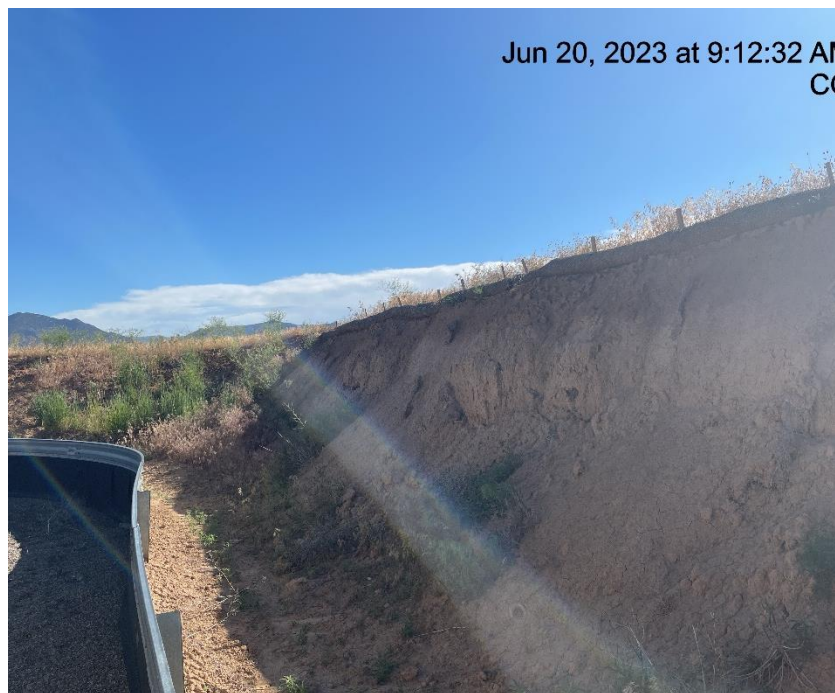
**Photo # 1033 Slope stabilization BMP's insufficient/Run on to location not being controlled**

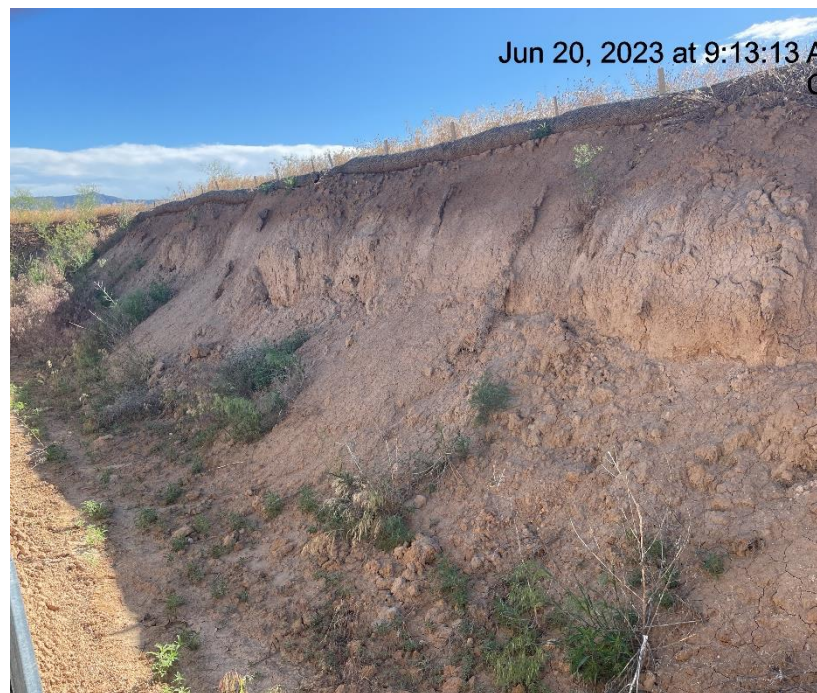
**Photo # 1037 Slope stabilization BMP's insufficient/Run on to location not being controlled**

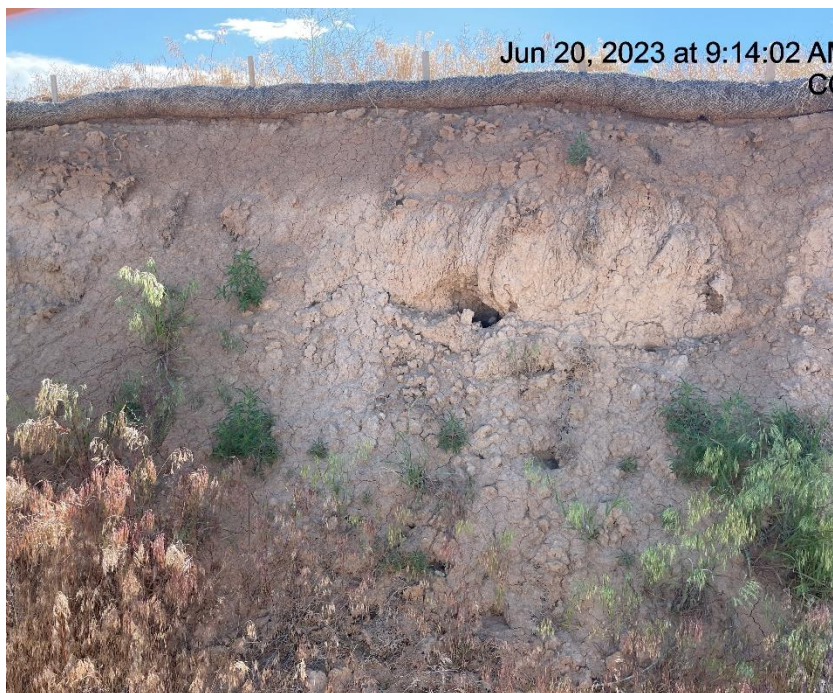
**Photo # 1041 Slope stabilization BMP's insufficient**

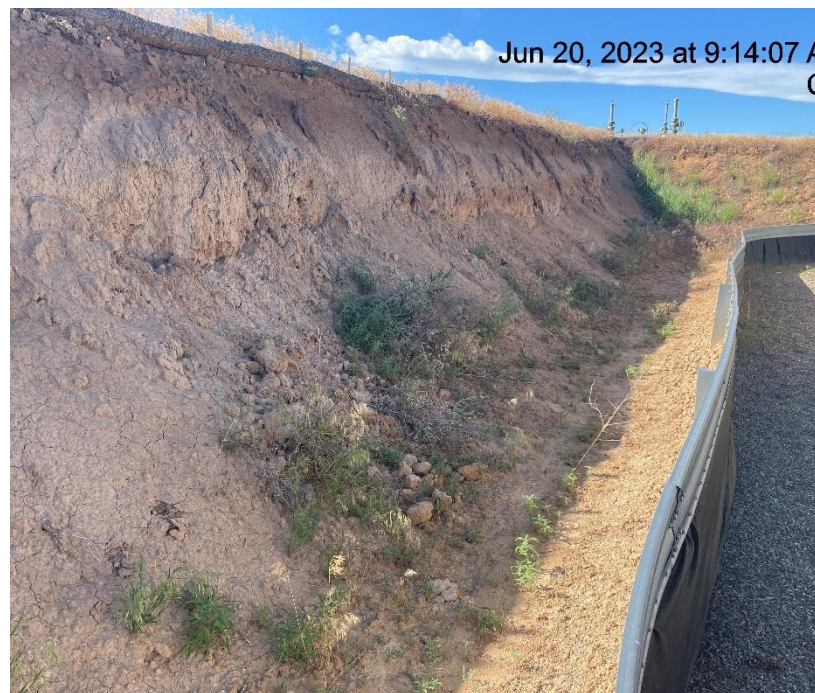
**Photo # 1042 Slope stabilization BMP's insufficient/Run on to location not being controlled**

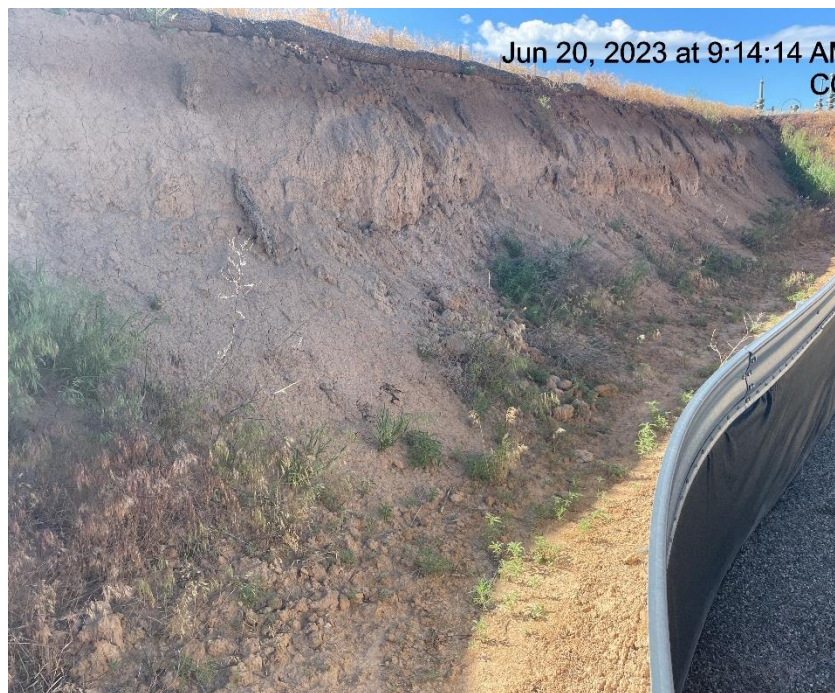
**Photo # 1043 Slope stabilization BMP's insufficient/Run  
on to location not being controlled**

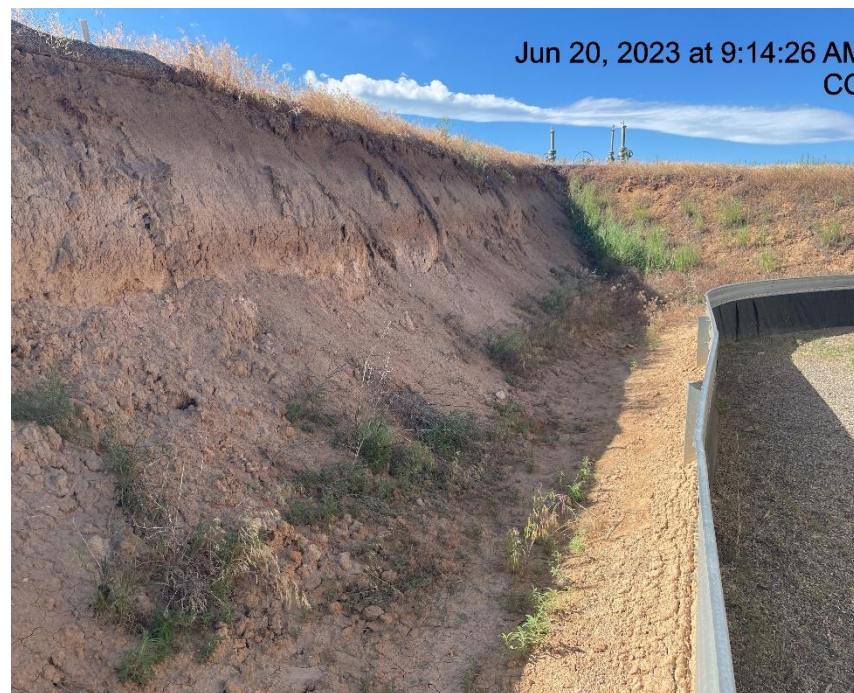
**Photo # 1044 Slope stabilization BMP's insufficient/Run  
on to location not being controlled**

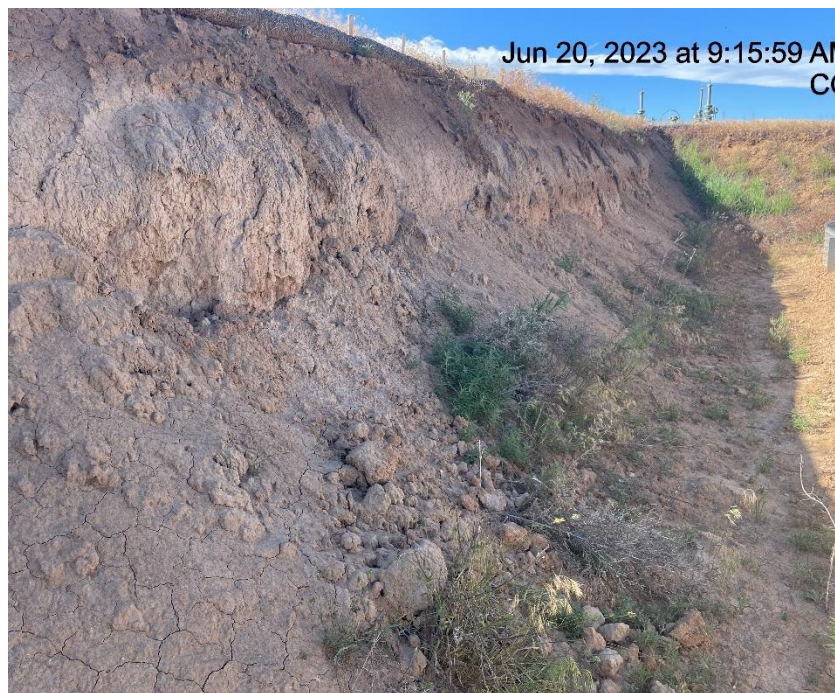
**Photo # 1050 Slope stabilization BMP's insufficient**

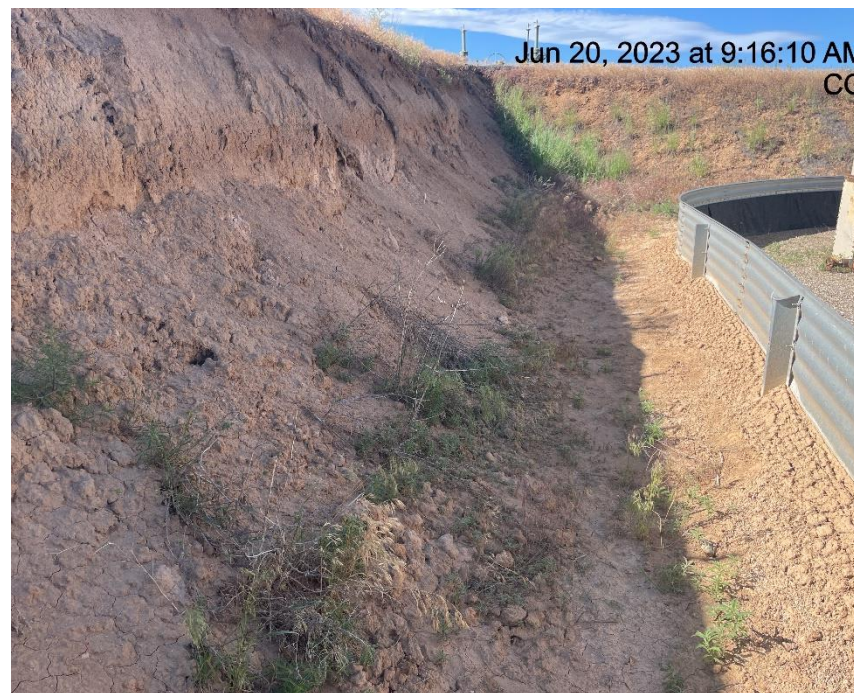
**Photo # 1051 Slope stabilization BMP's insufficient/Run on to location not being controlled**

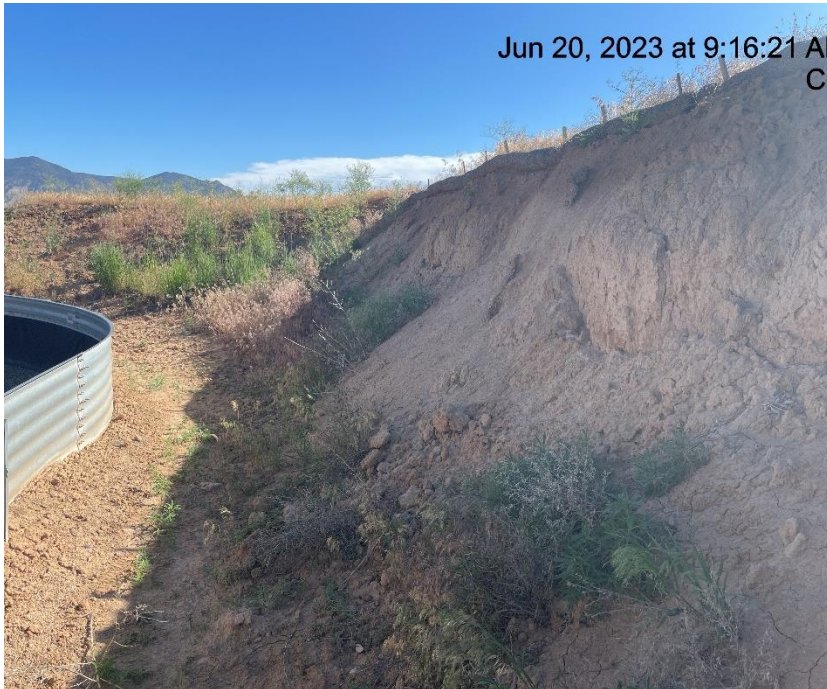
**Photo # 1052 Slope stabilization BMP's insufficient/Run  
on to location not being controlled**
