Inspection Photos

Location Name: CAERUS PICEANCE LLC A29NE Pad

Location #: 335178

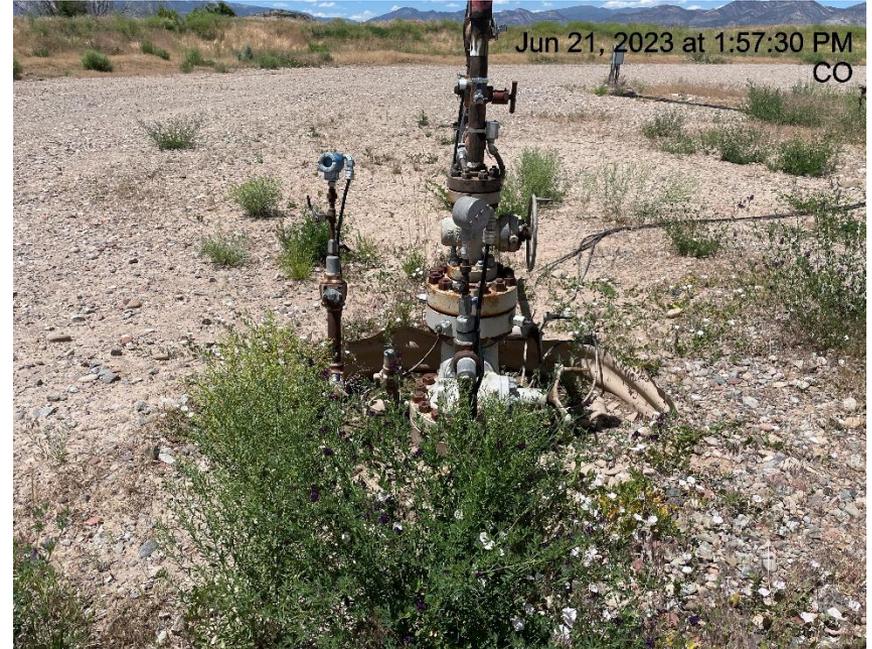
Photo # 1344 Weeds/undesirable plant species around wellheads

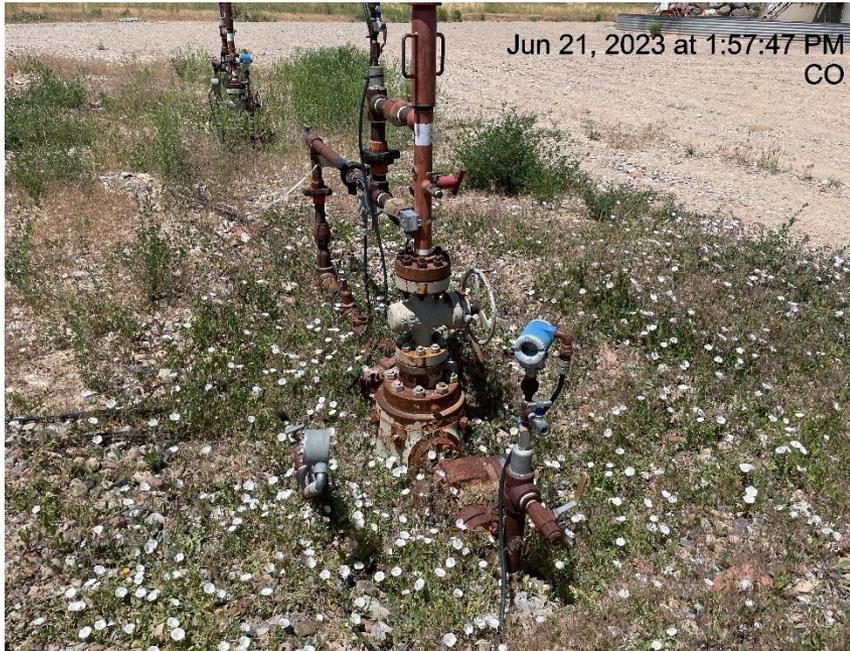
Photo # 1345 Weeds/undesirable plant species around wellheads

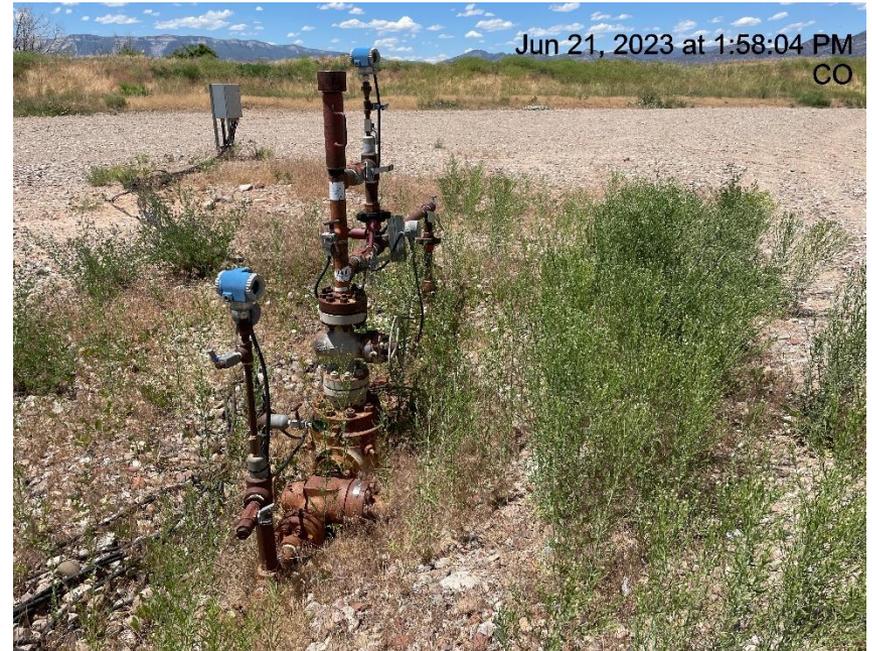
Photo # 1346 Weeds/undesirable plant species around wellheads

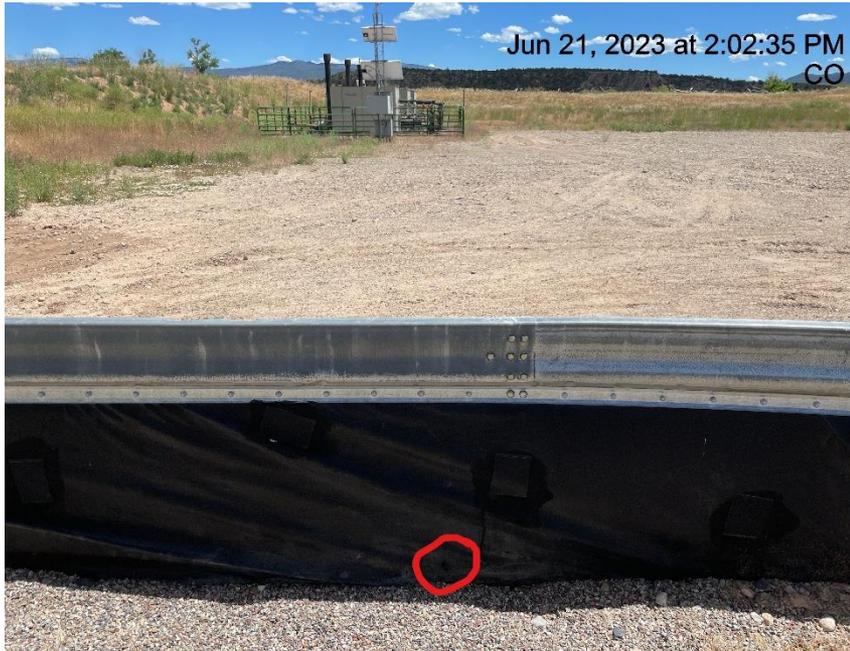
Photo # 1357 Hole in secondary containment liner/liner needs maintenance

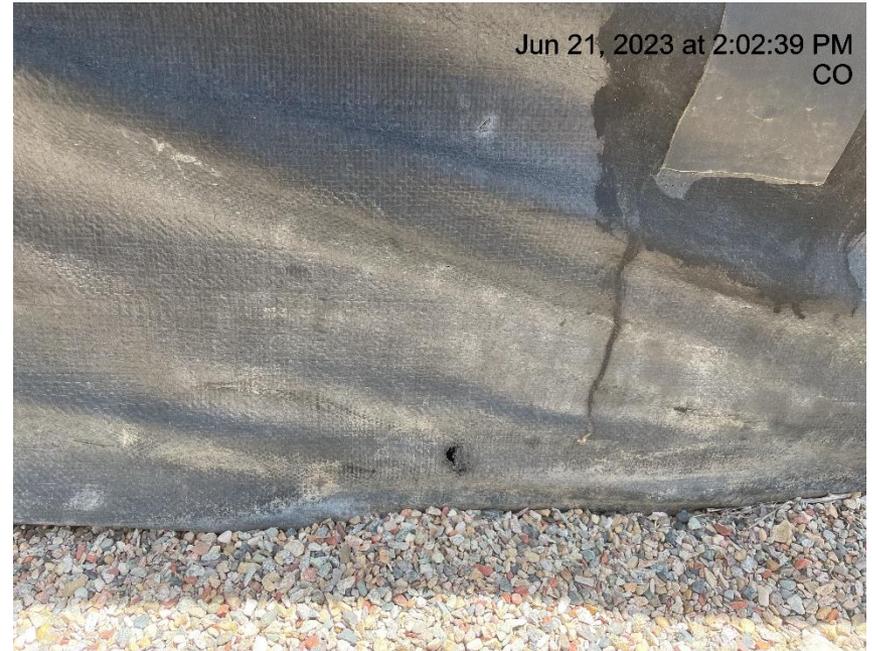
Photo # 1358 Hole in secondary containment liner/liner needs maintenance

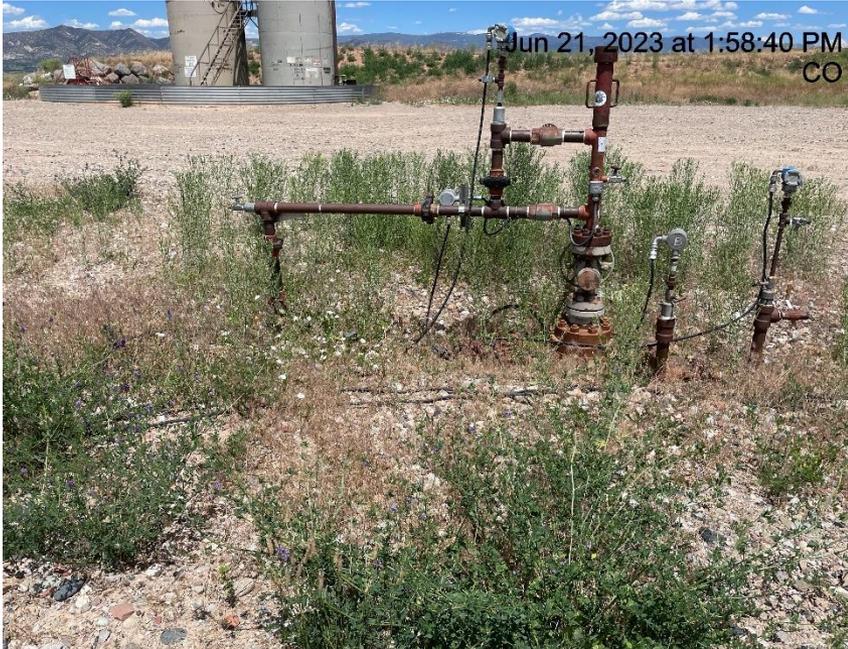
Photo # 1348 Weeds/undesirable plant species around wellheads
