Final Reclamation Inspection

Operator: PDC ENERGY INC - 69175

Location ID: 323096

Inspection Document #: 701900895

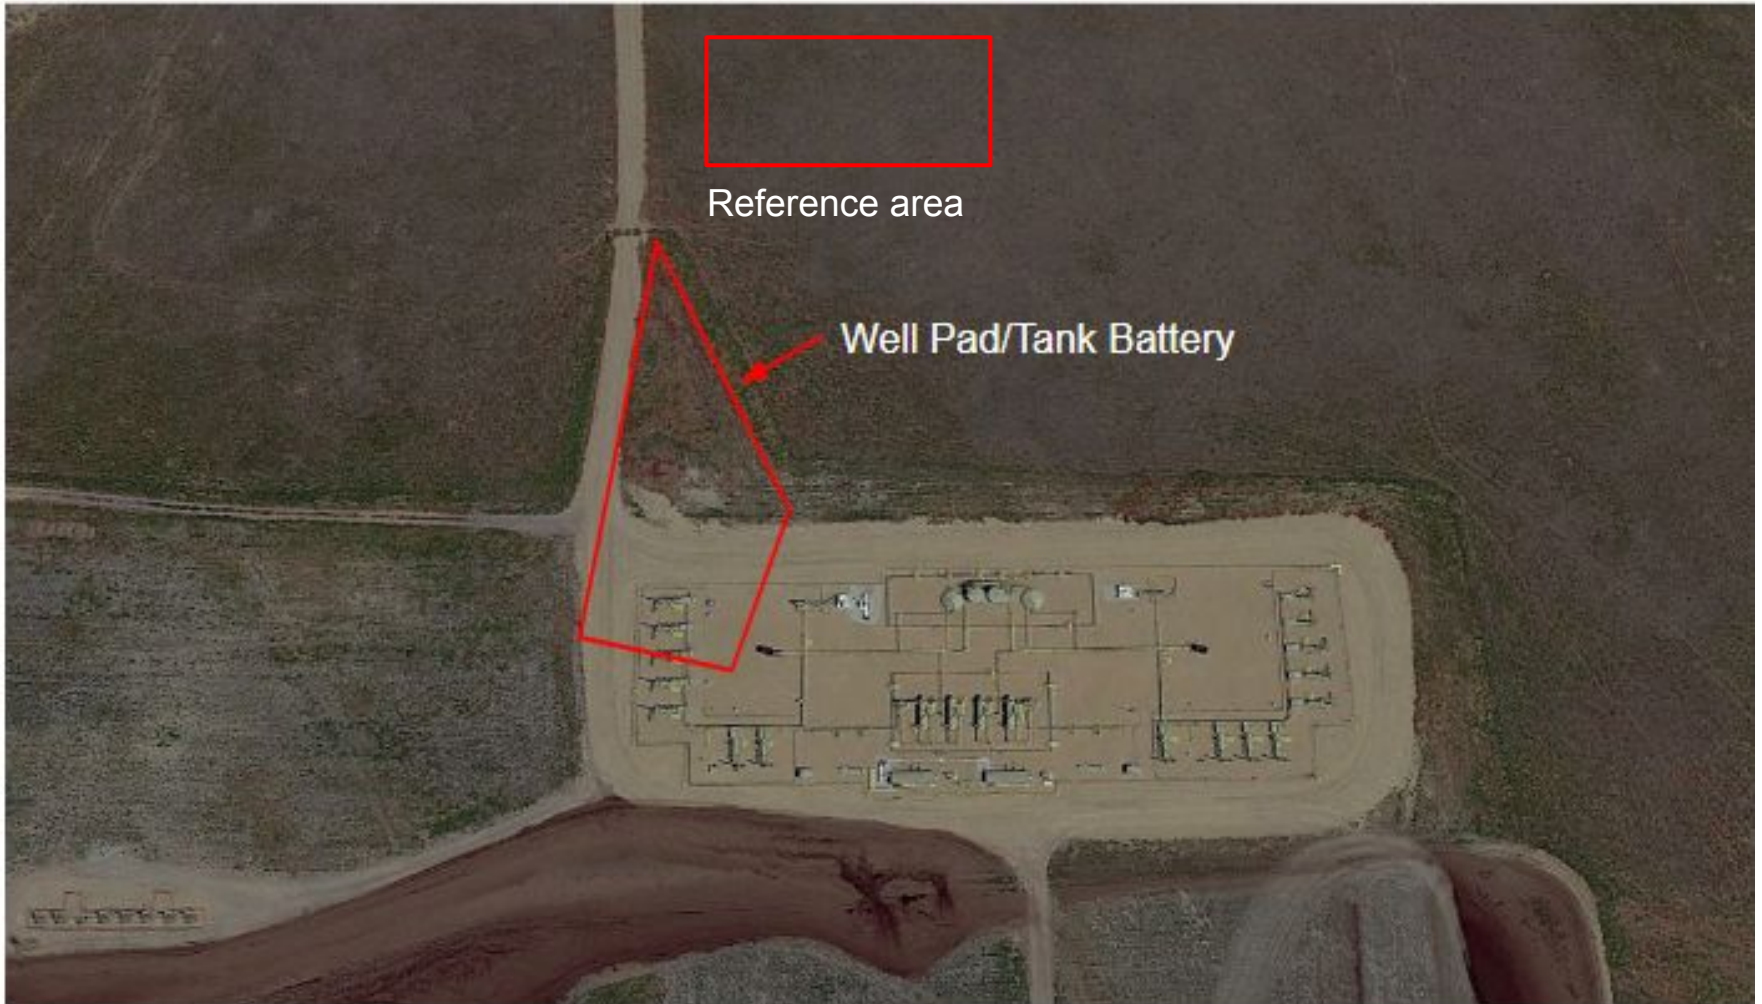
Photo 1. 2021 aerial imagery of the well pad, tank battery and reference area. Note: well pad and tank battery shared a disturbance pad. Historical imagery confirms that the tank battery was on the southern end of the disturbance and has been completely absorbed by the new Kerr McGee production facility, location ID 464149.

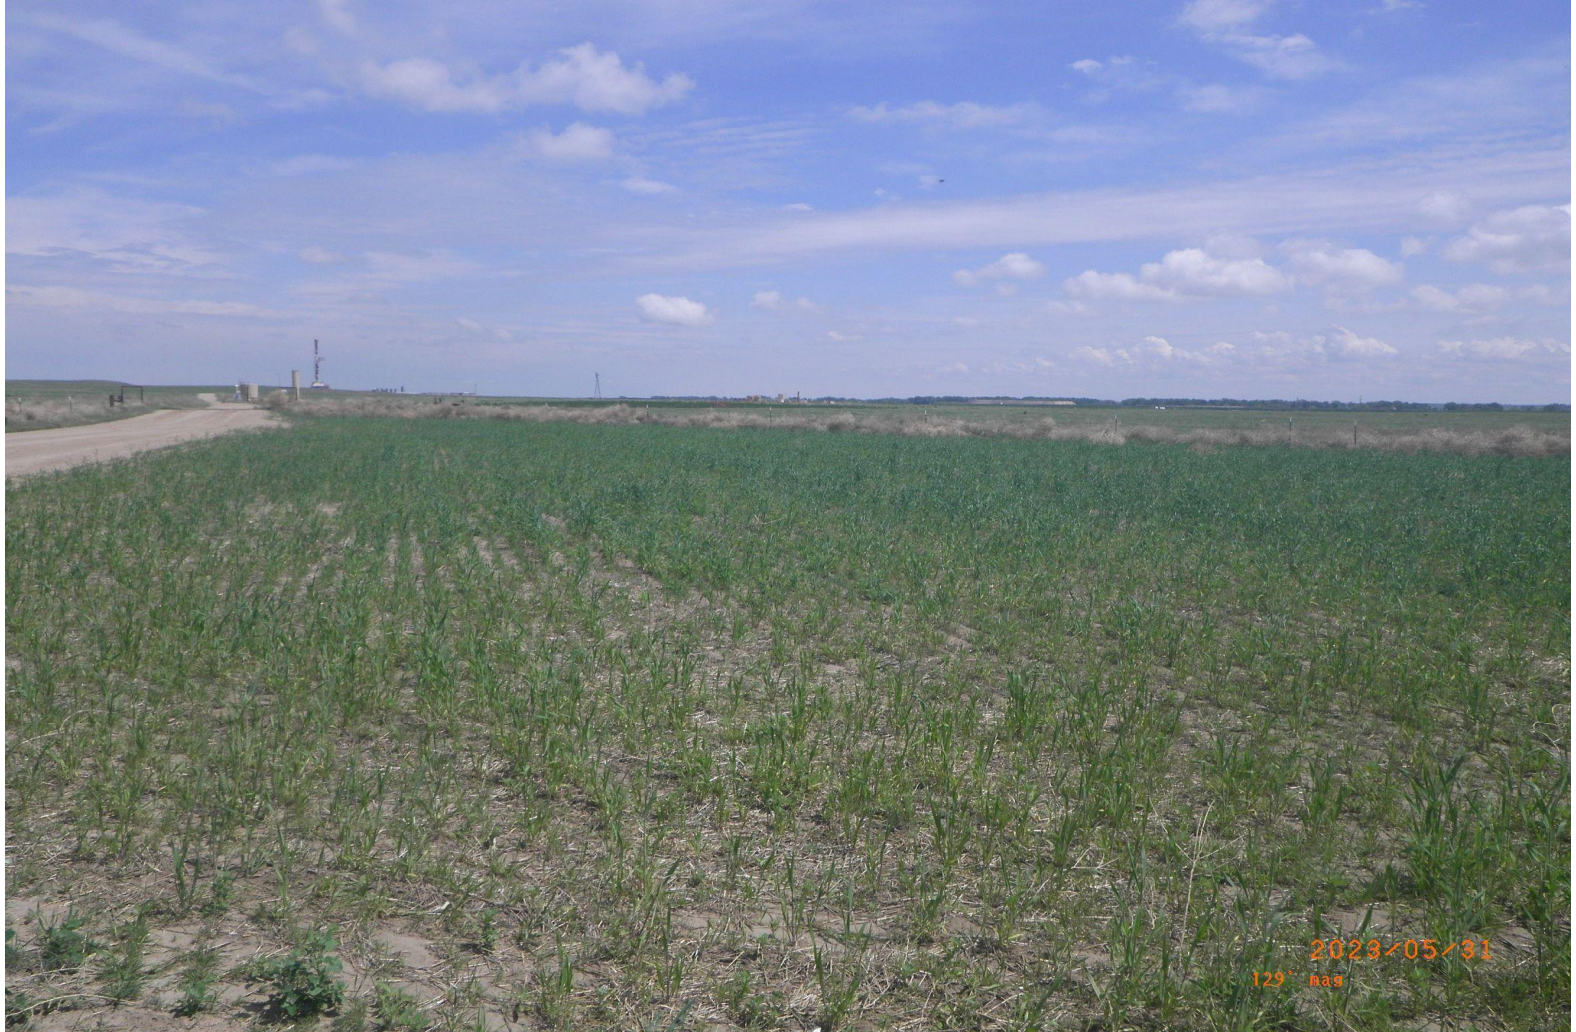
Photo 2. Overview photo of the well pad taken at ground level from the southern edge facing north.

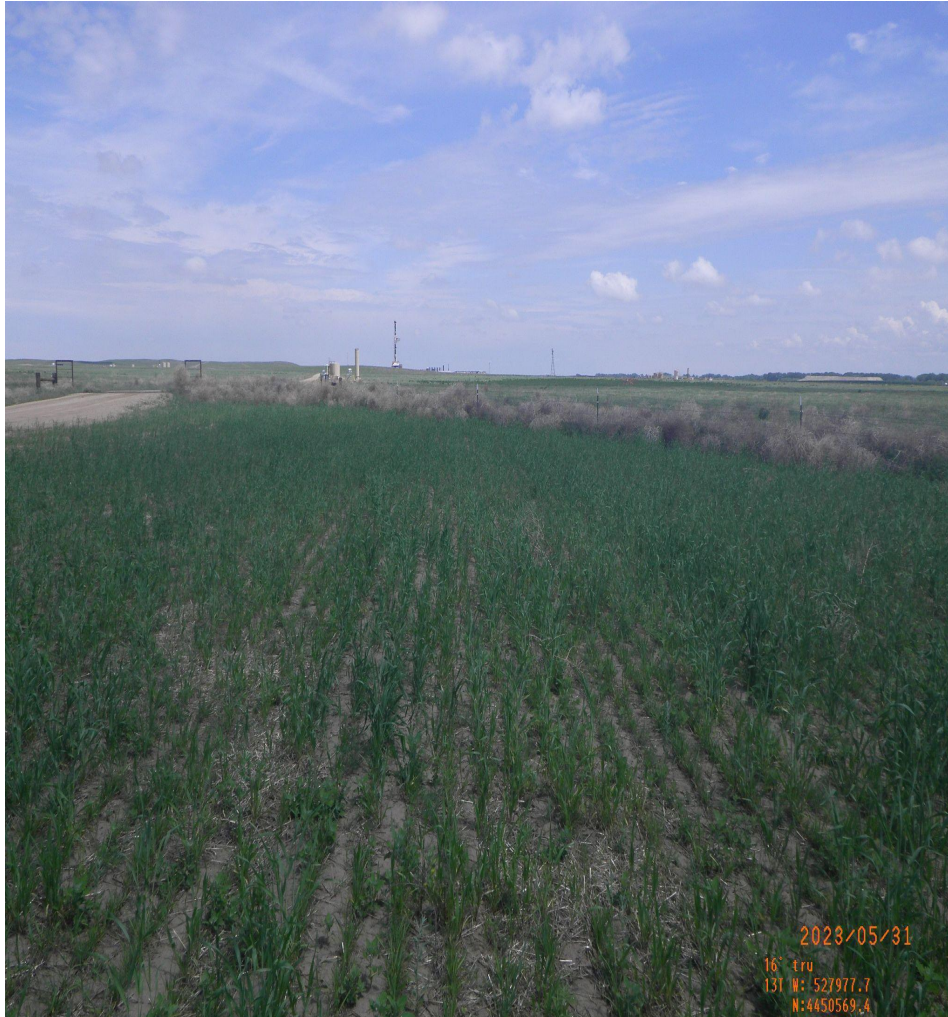
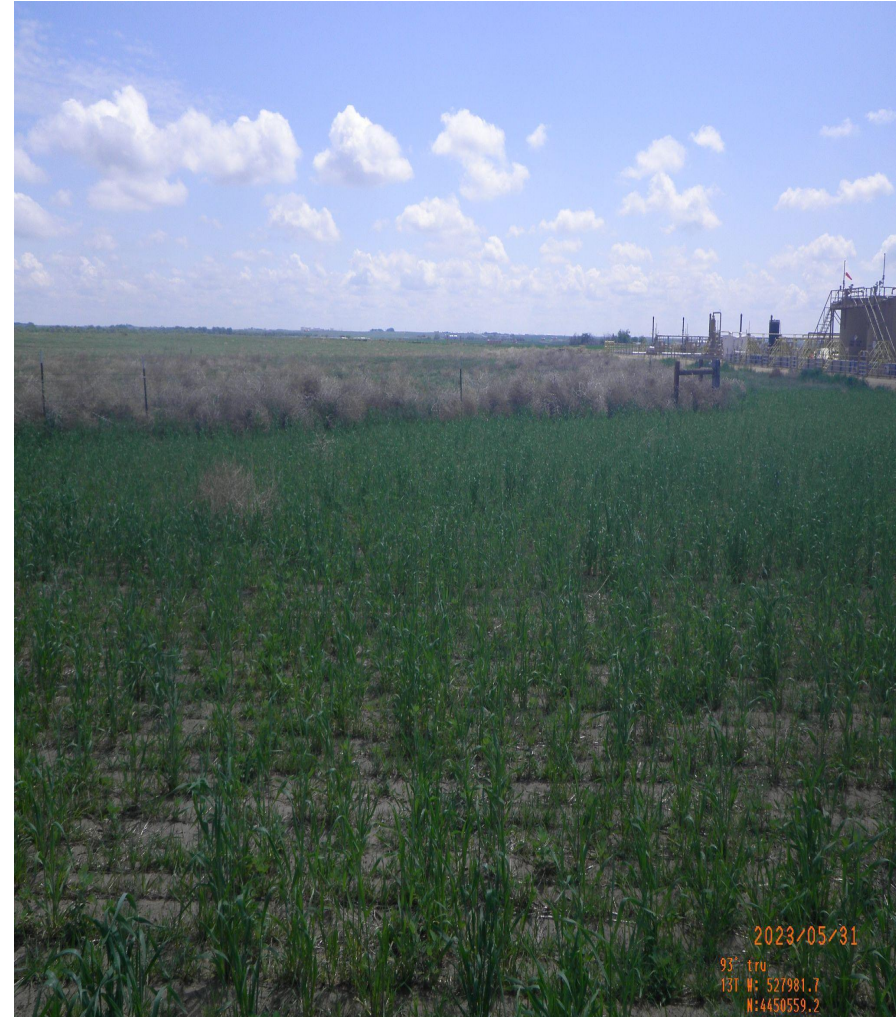
Photo 3. Cardinal photos taken from the middle of the well pad. Left photo facing north, right photo facing east.

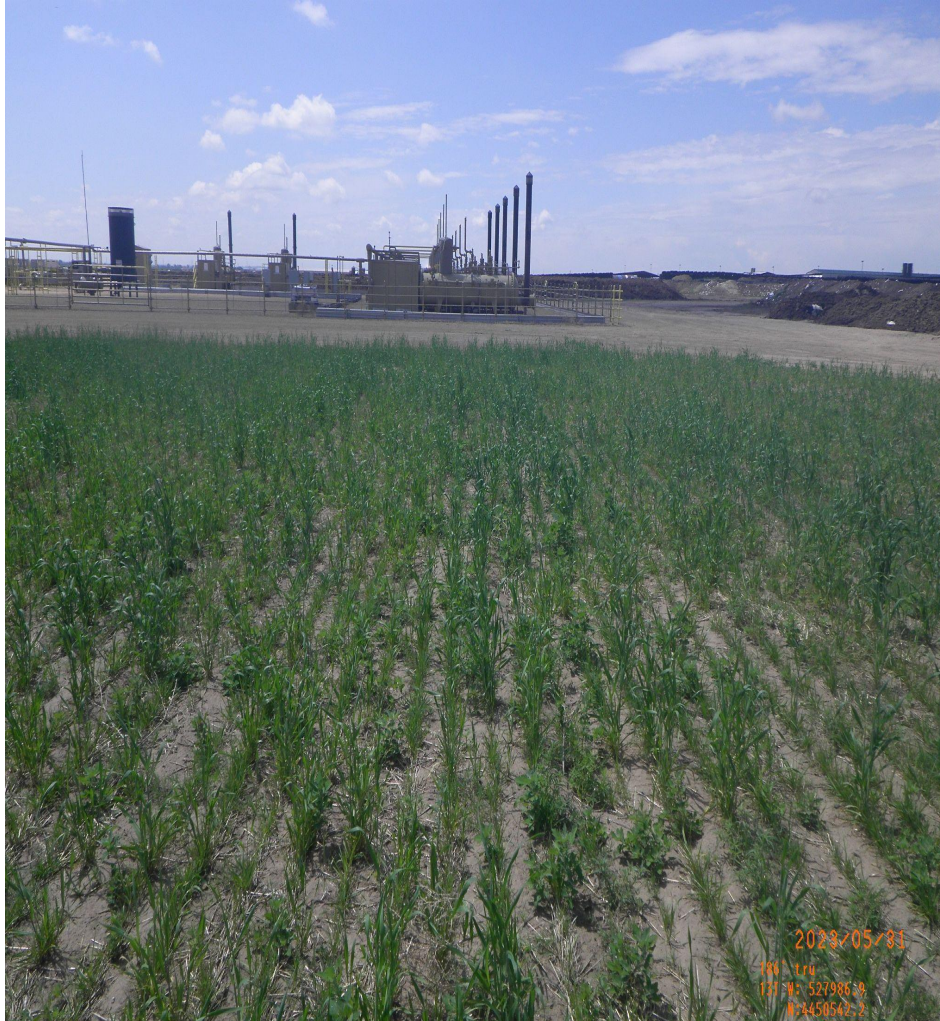
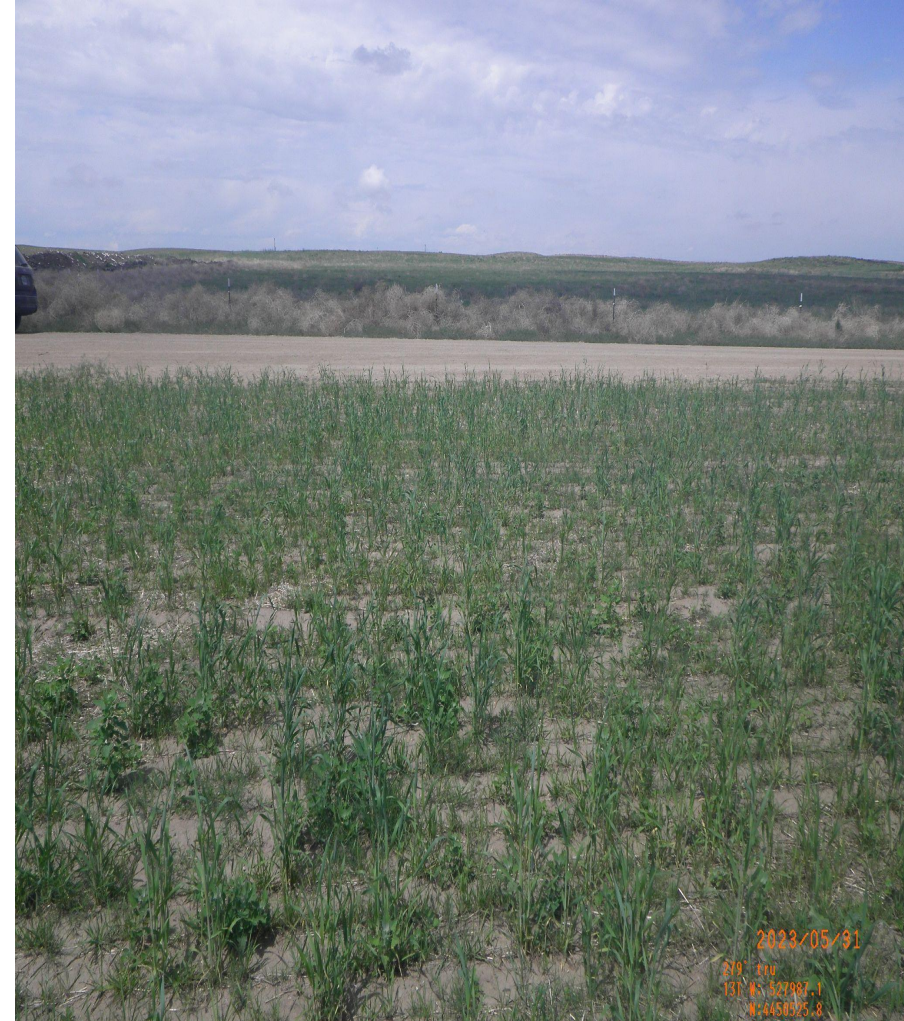
Photo 4. Cardinal photos taken from the middle of the well pad. Left photo facing south, right photo facing east. Note: well pad has a higher density of perennial grass cover compared to reference area which is dominated by cheatgrass (see photo #6).

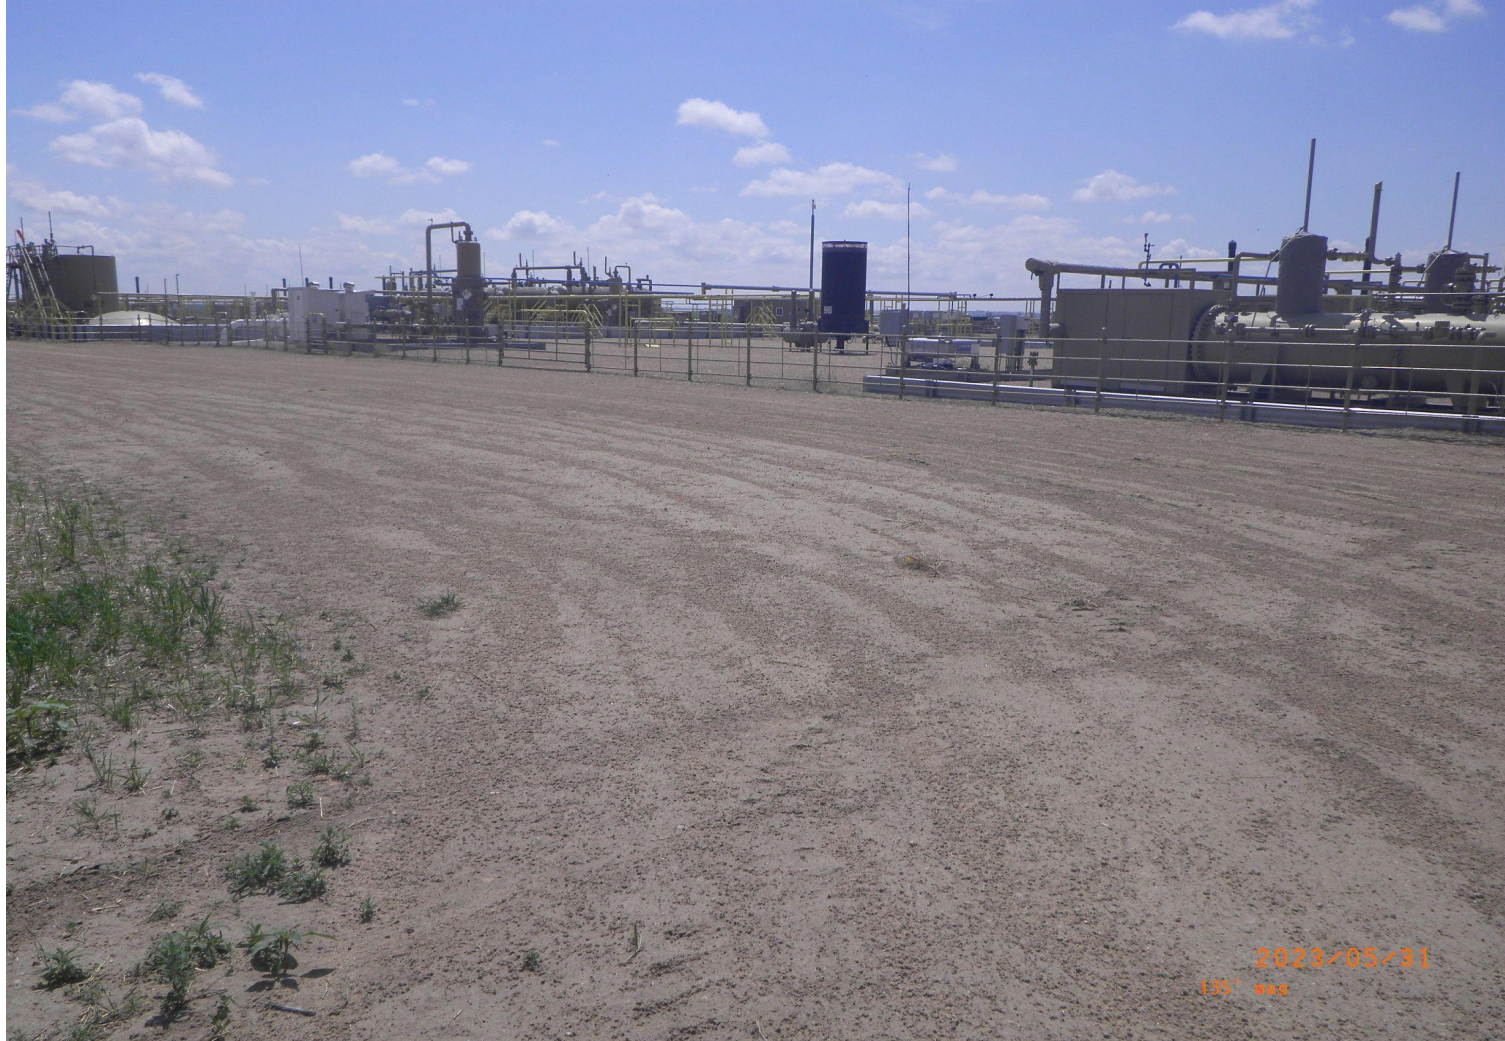
Photo 5. Overview photo of the tank battery taken at ground level from the northern edge facing south. Note: tank battery disturbance has been absorbed my new active facility to the south.

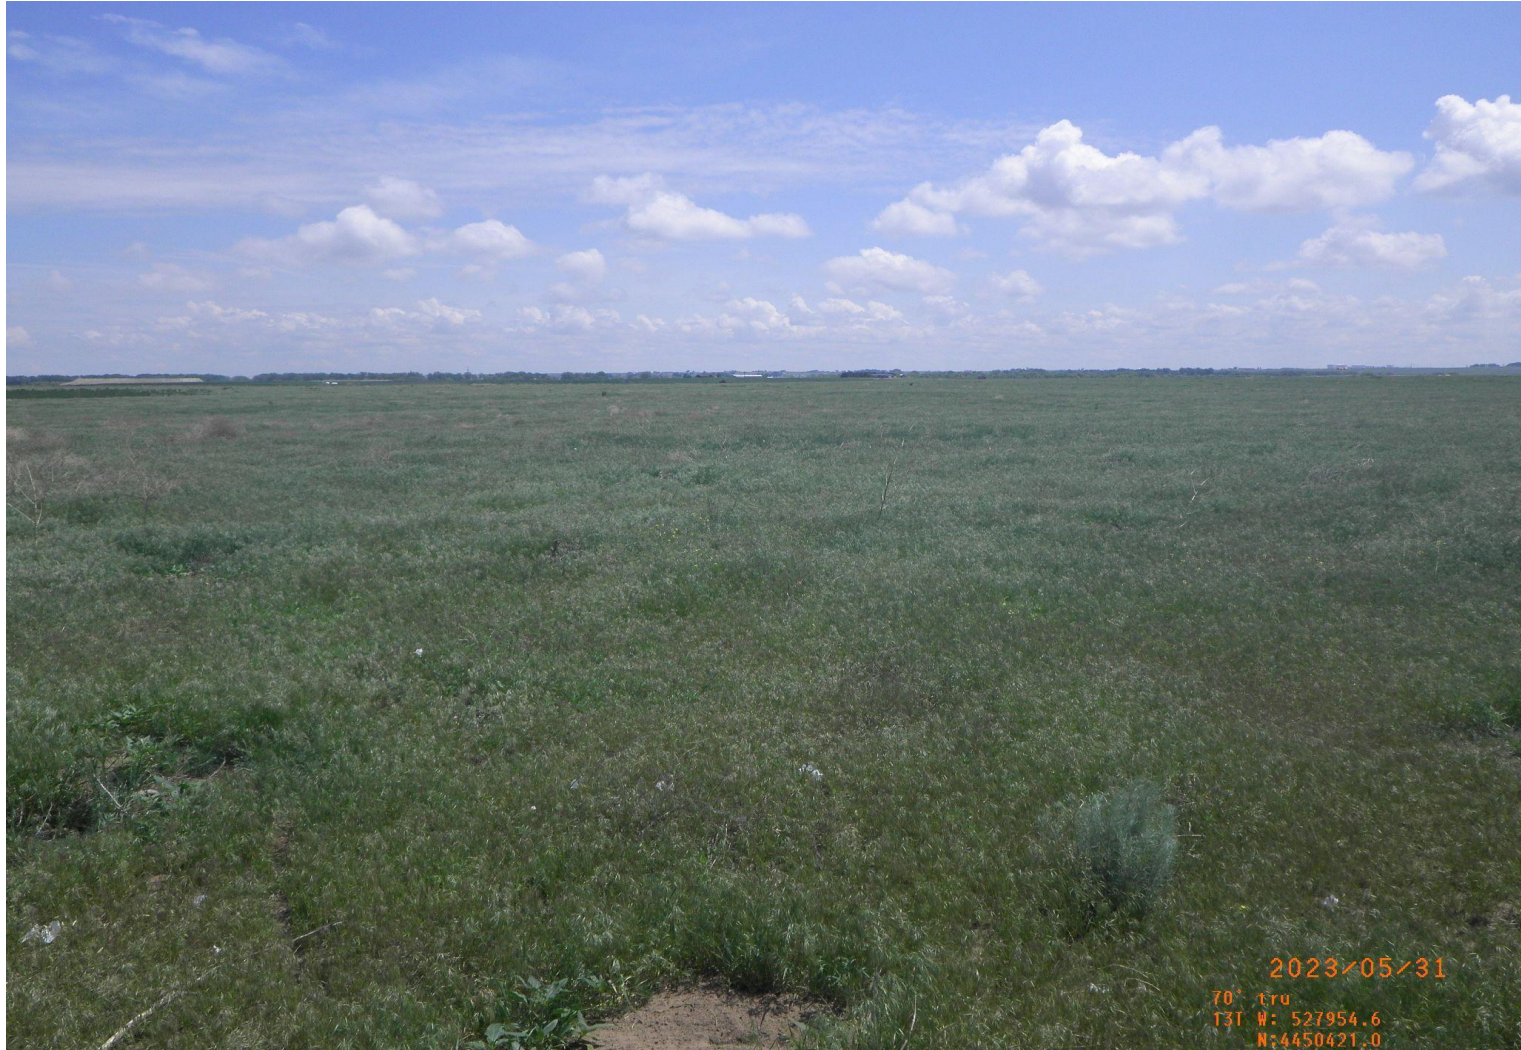
Photo 6. Well pad reference area to the north of the shared disturbance.
