Inspection Photos
Location Name: CAERUS PICEANCE LLC A13W Pad
Location ID: 334564

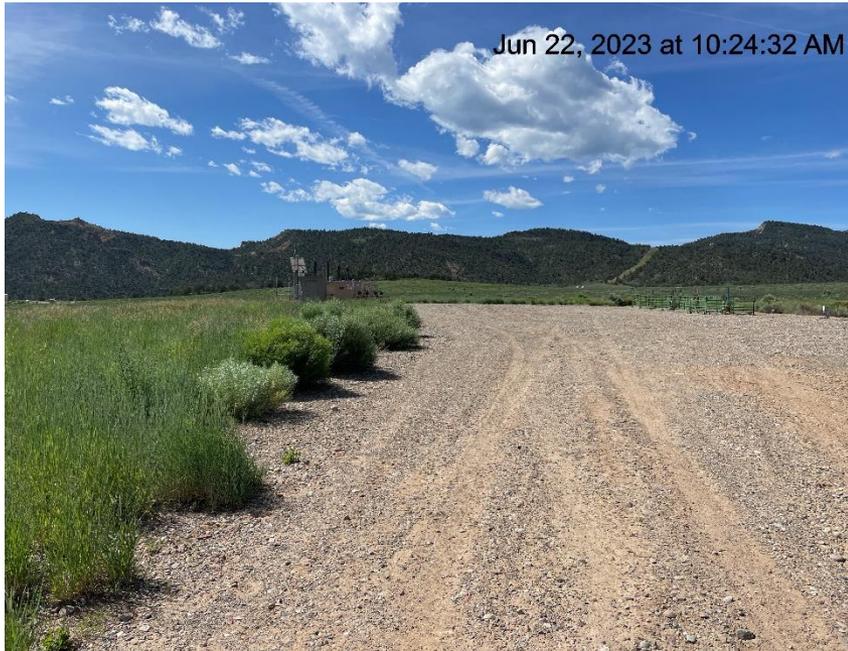
Photo # 1444 From entrance to location

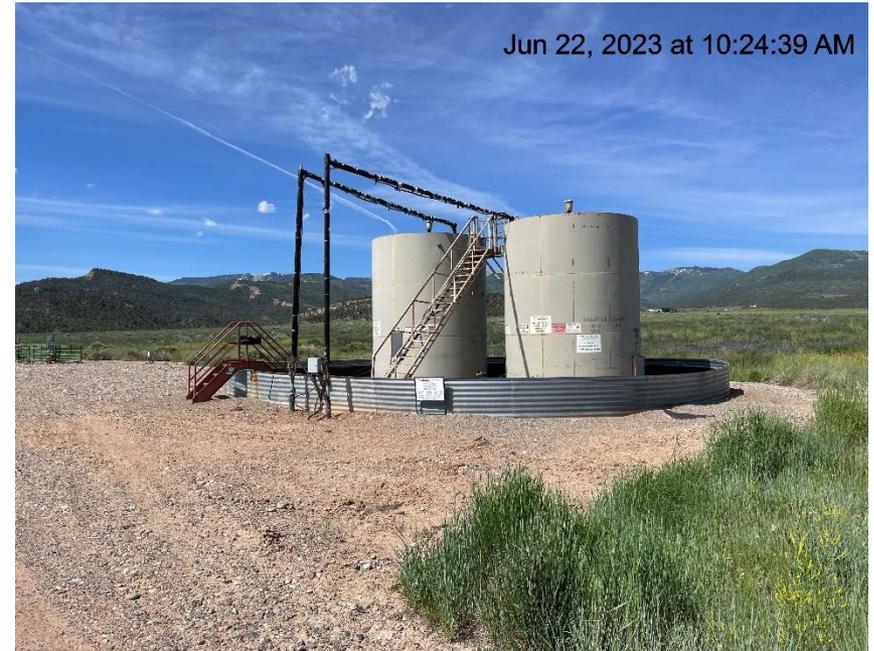
Photo # 1445 From entrance to location

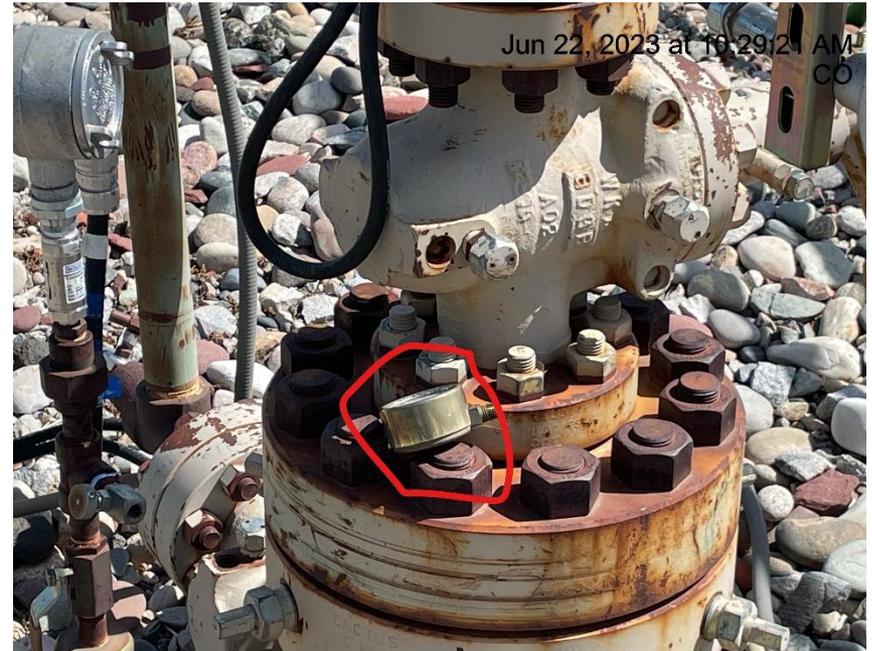
Photo # 1453 Debris

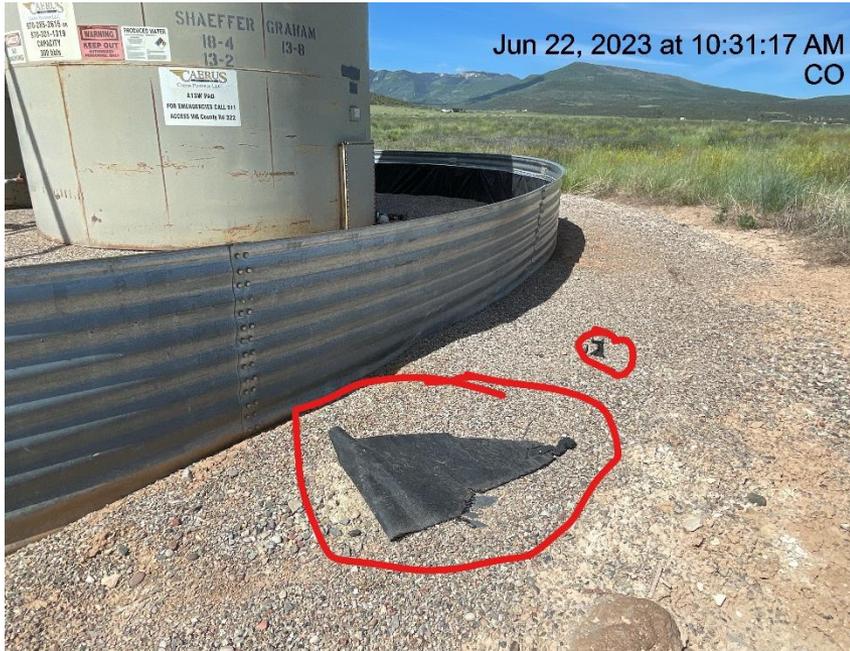
Photo # 1458 Debris

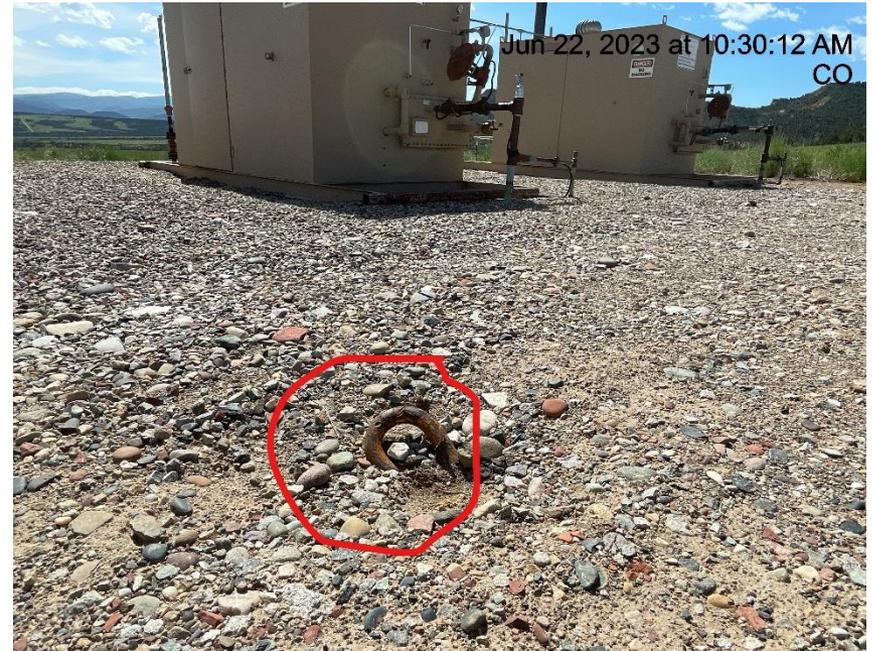
Photo # 1455 Unmarked deadman

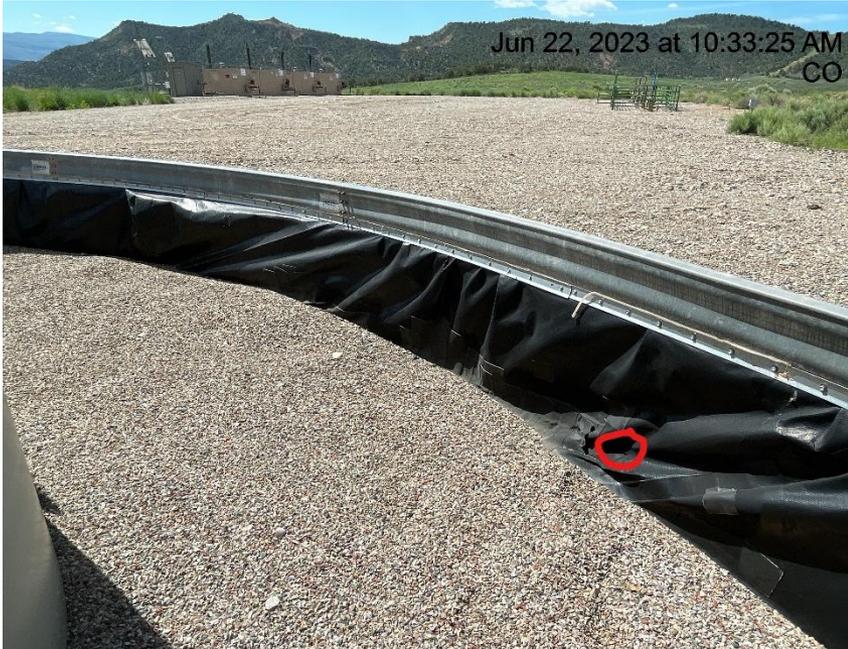
Photo # 1460 Hole in secondary containment liner/liner needs maintenance

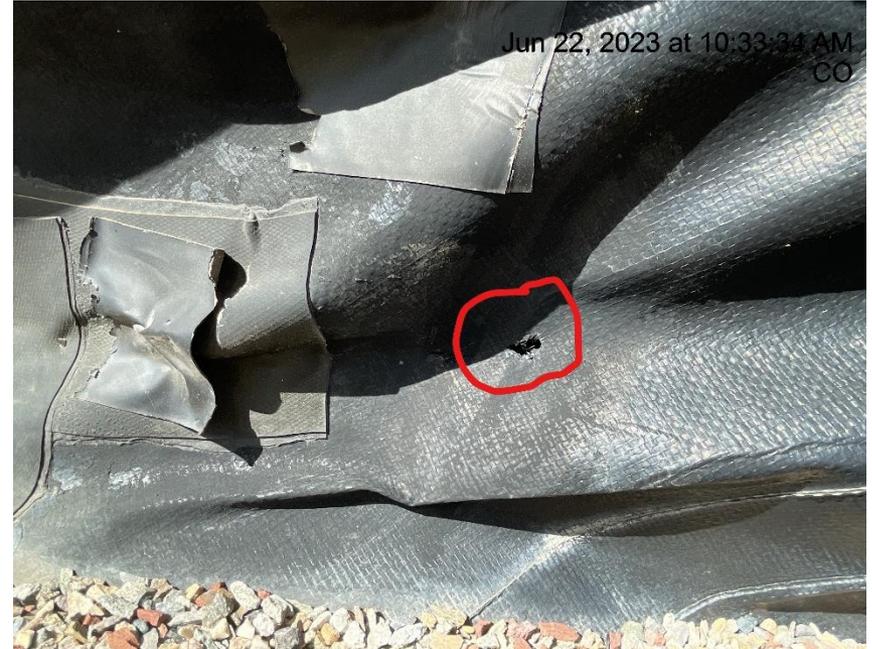
Photo # 1461 Hole in secondary containment liner/liner needs maintenance

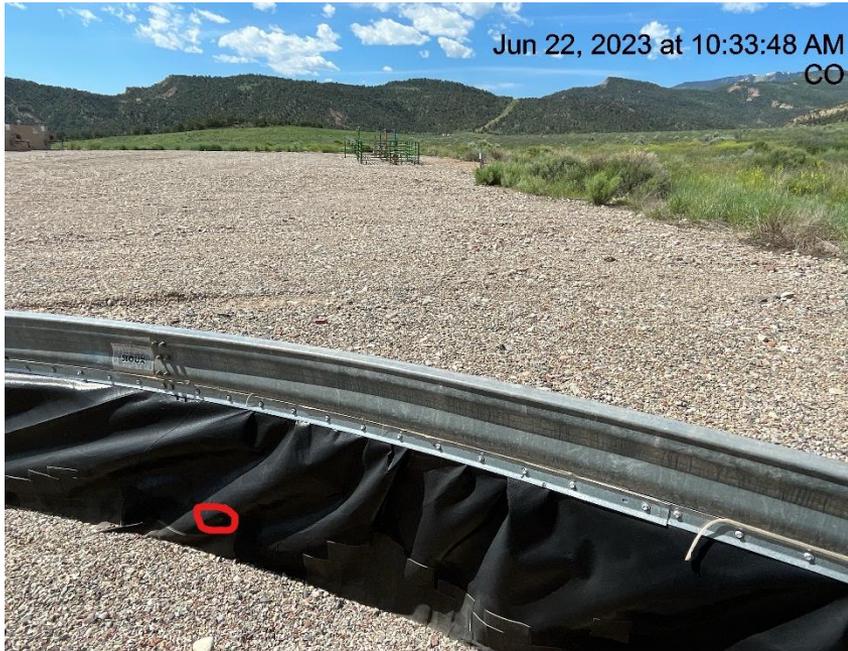
Photo # 1463 Hole in secondary containment liner/liner needs maintenance

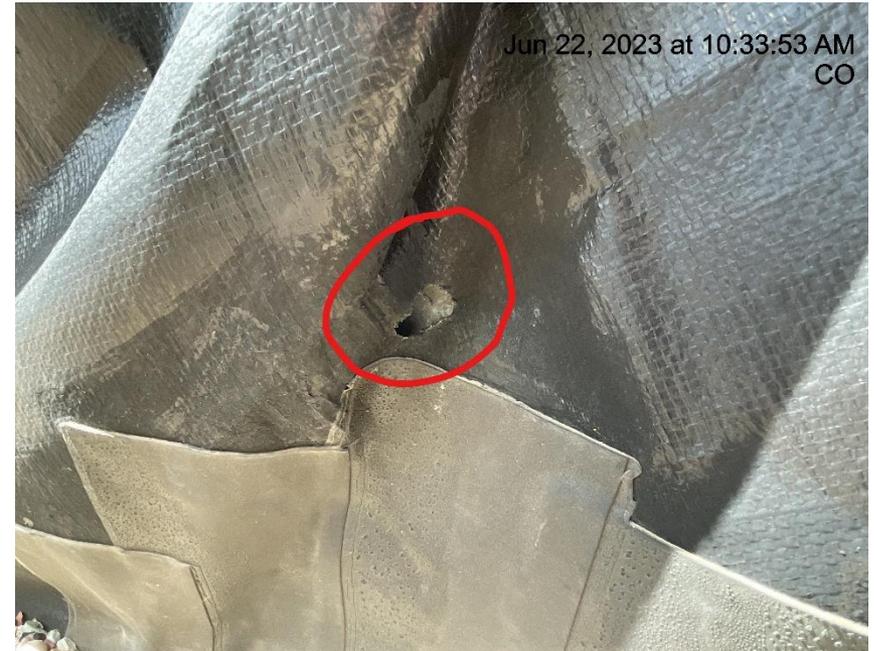
Photo # 1464 Hole in secondary containment liner/liner needs maintenance
