Inspection Photos

Loc: 325172

Operator: LOGOS OPERATING LLC

Inspection Date: 6/15/2023

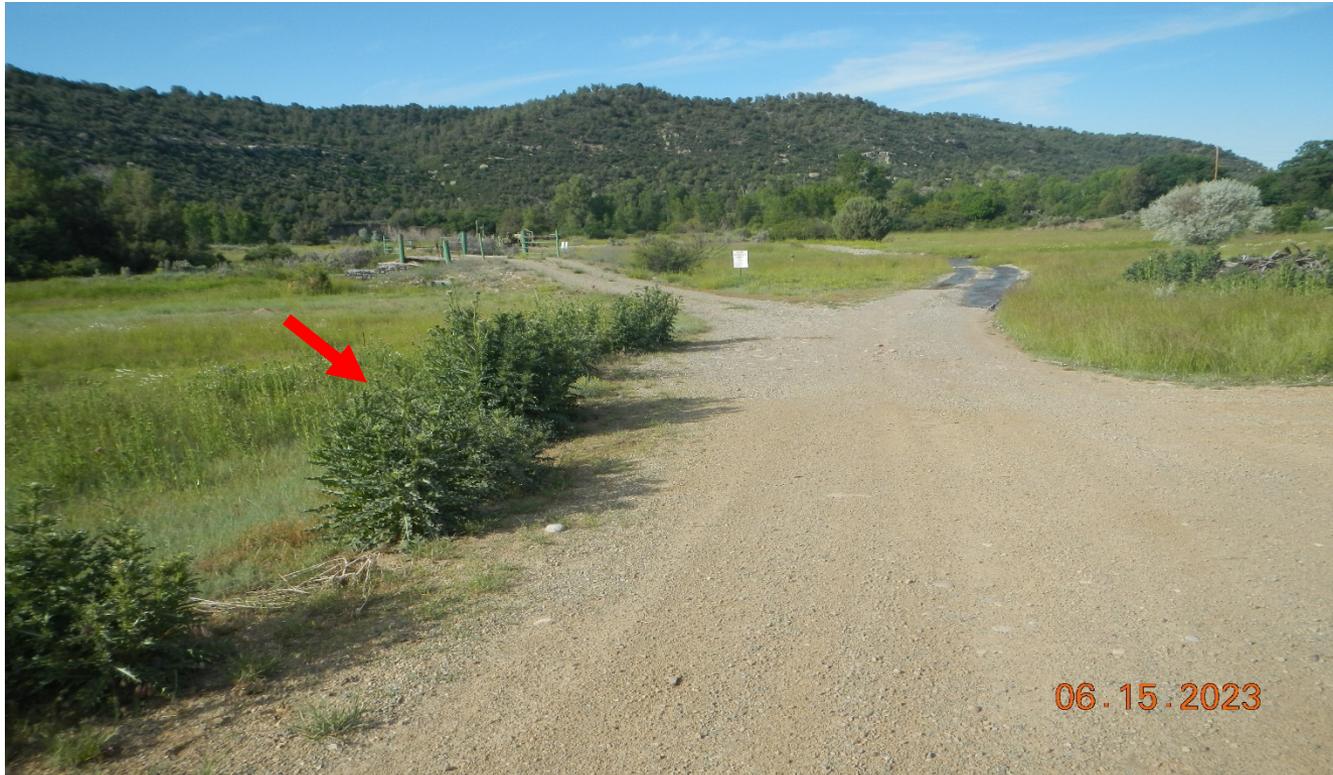
Photo 1. Facing southwest toward the access road. There are noxious weeds along the road that need to be controlled. Red arrow points to Musk thistle.

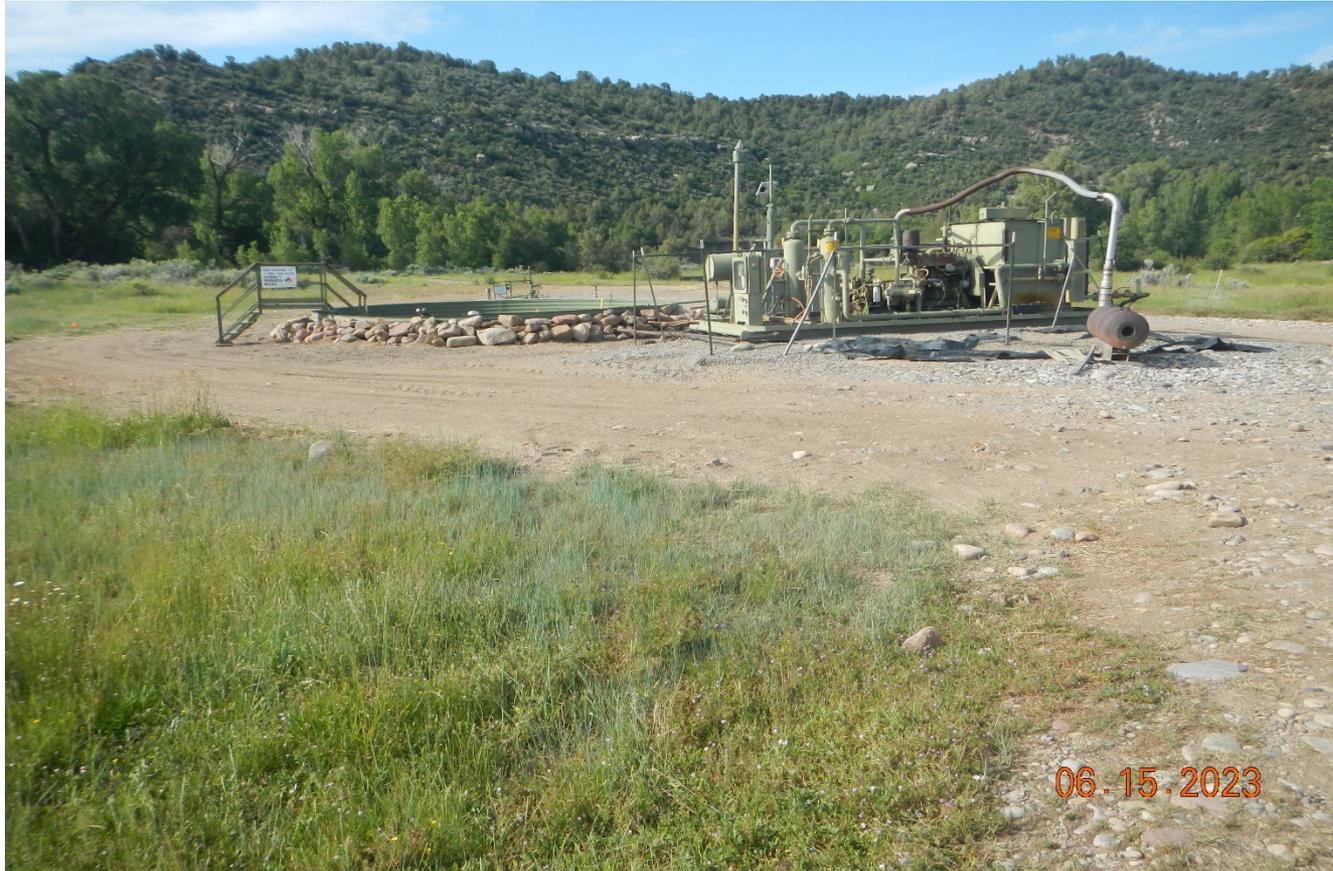
Photo 2. Facing southwest toward the location and production equipment.

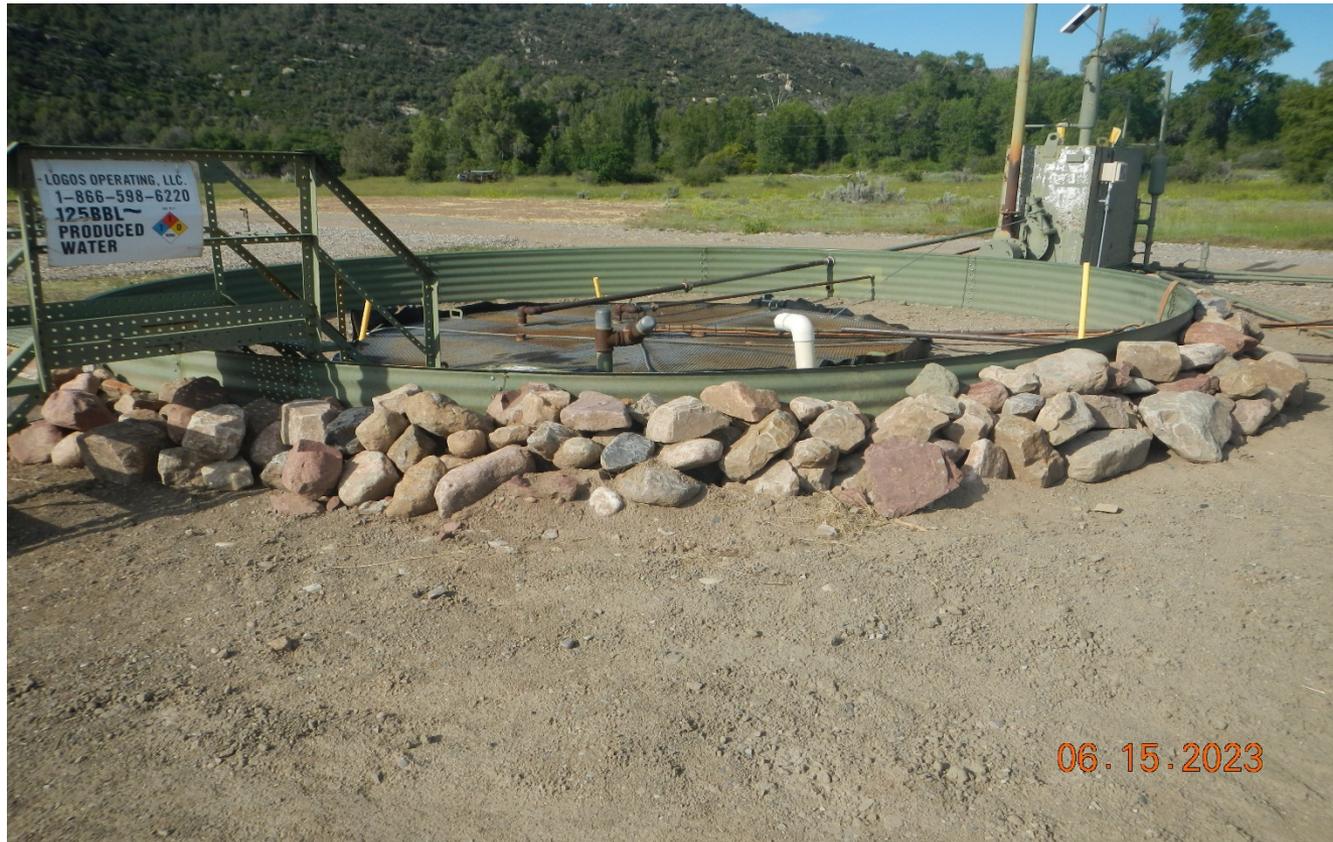
Photo 3. Facing toward the open top tank. The secondary containment has been reinstalled into the ground. Larger rock rip/rap has been placed around the containment.

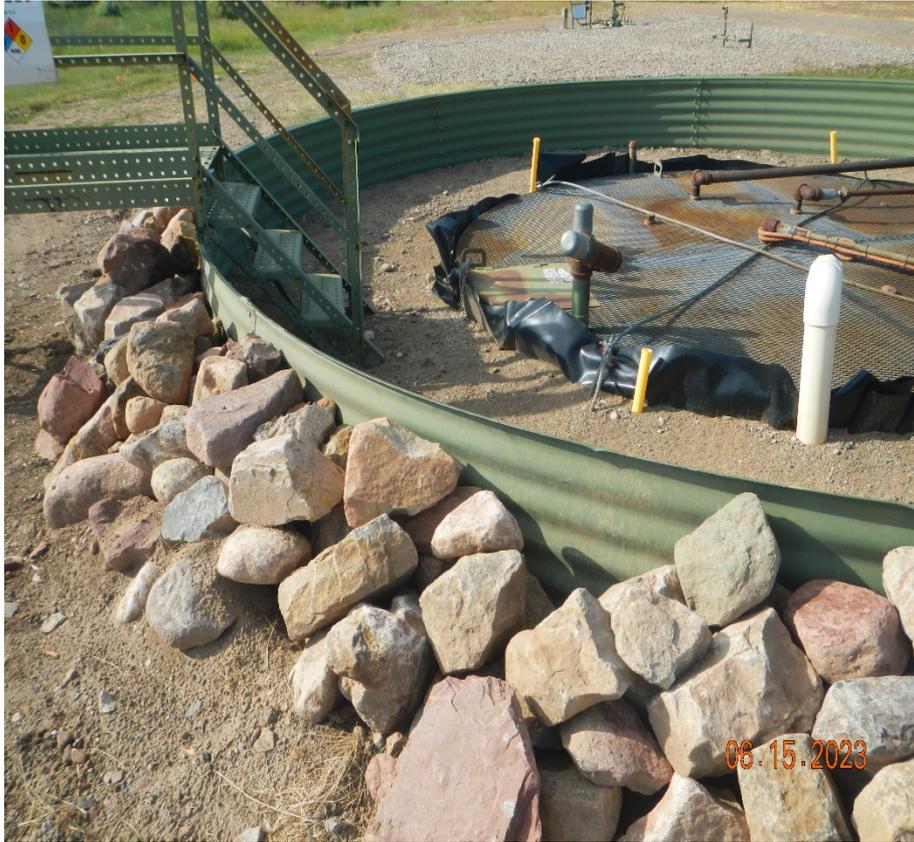
Photo 4. The secondary containment has been reinstalled into the ground. Larger rock rip/rap has been placed around the containment.

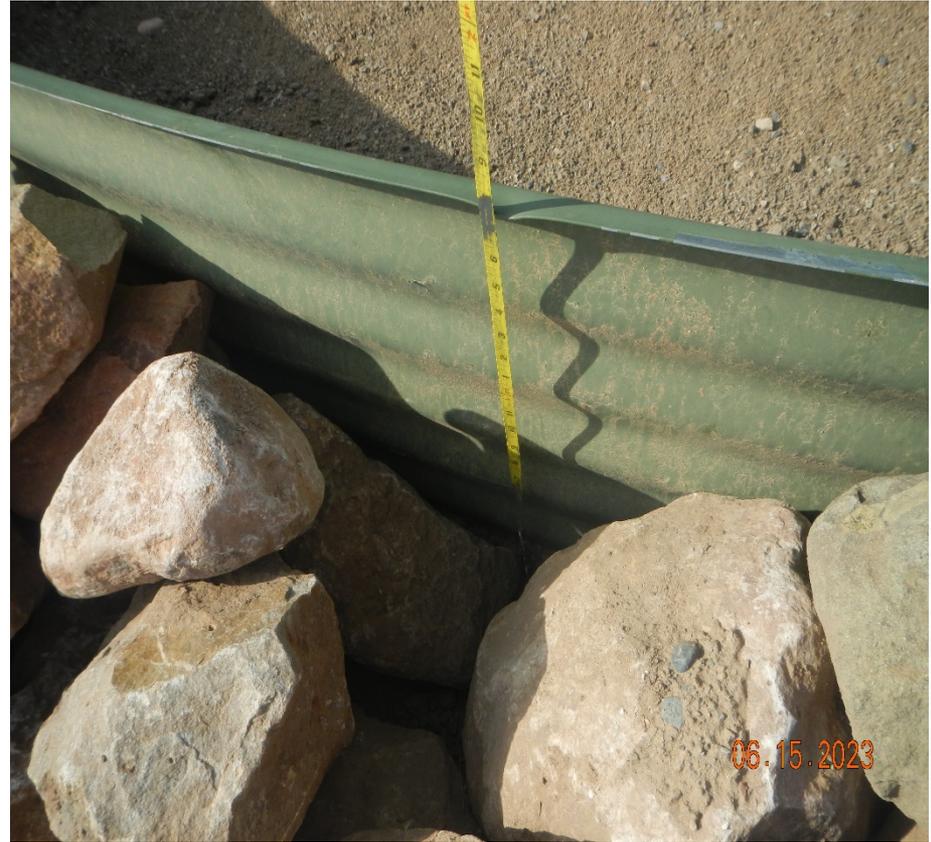
Photo 5. The lowest point of the containment sits approximately 1ft. 8 inches above ground level.

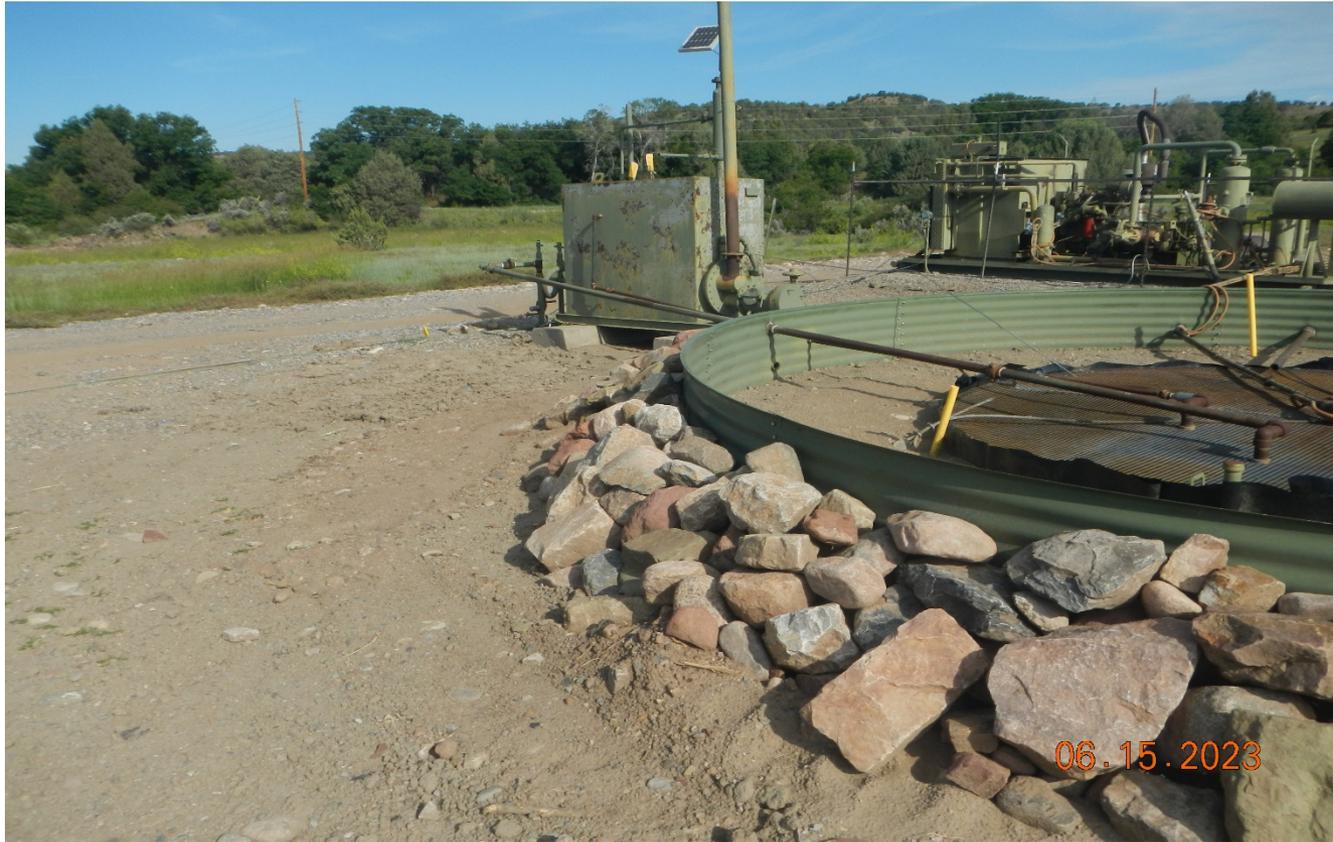
Photo 6. Facing toward the opposite side of the open top tank.

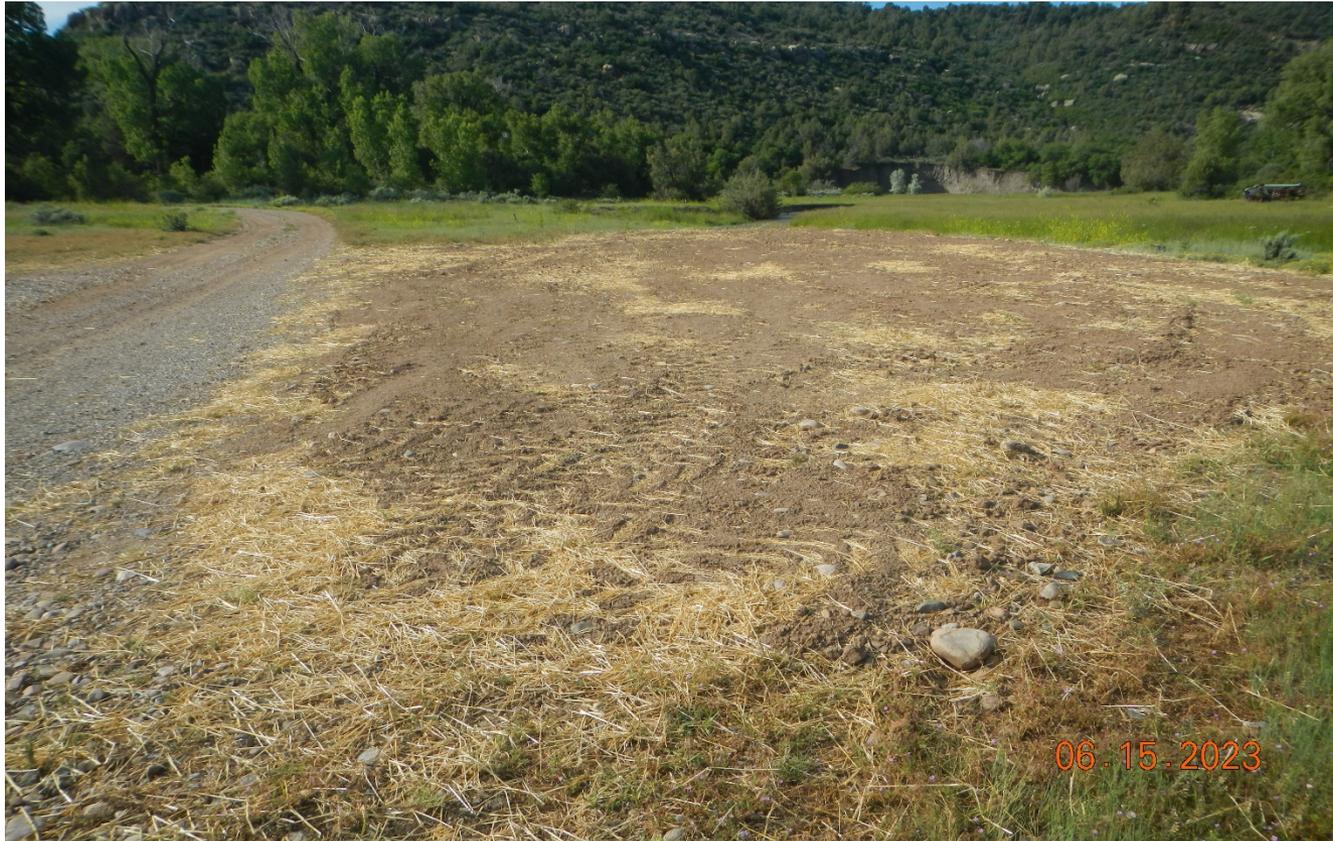
Photo 7. Facing toward the southwest side of the location. This area has been regraded and seeded. Most of the mulch has blown off and soils are not stabilized.

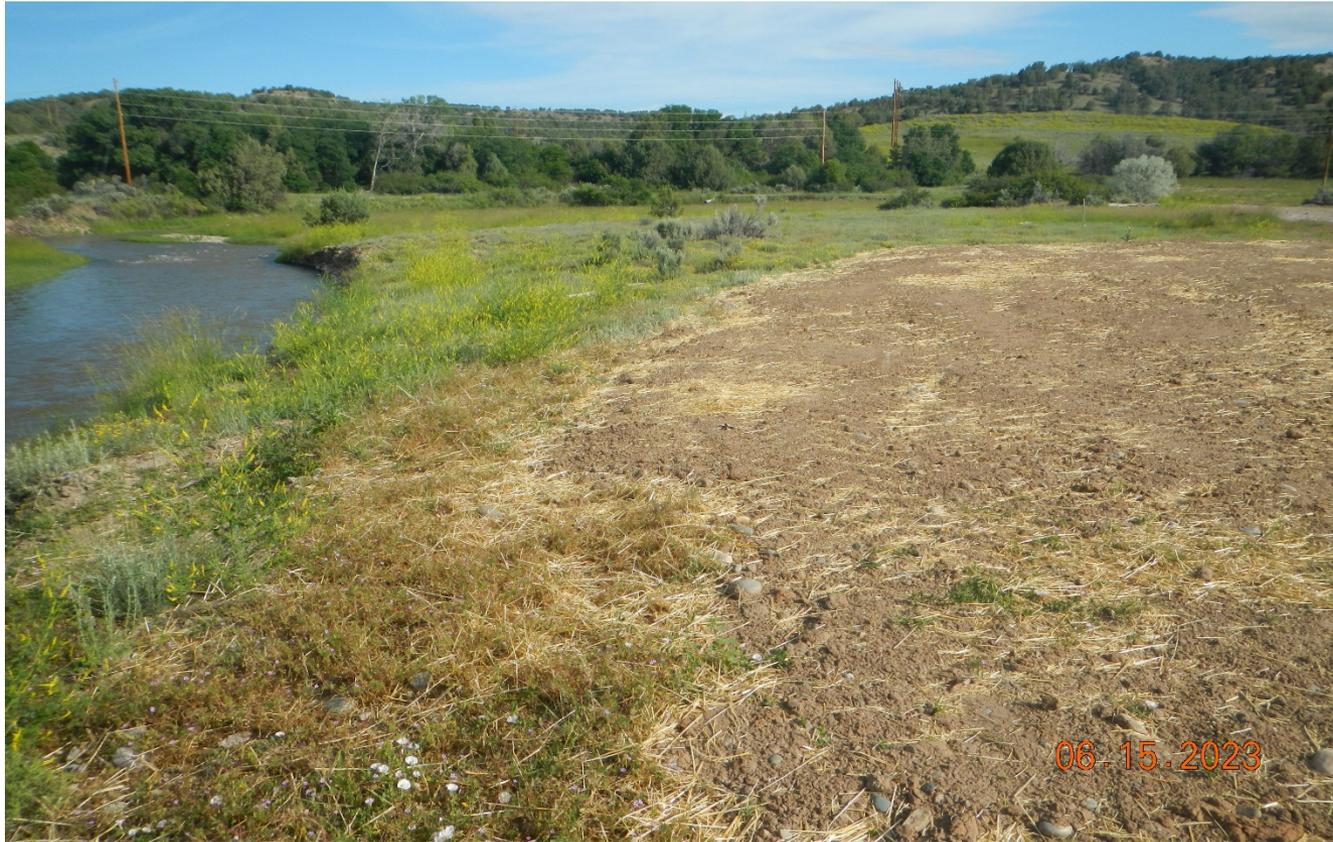
Photo 8. Facing north along the the Florida River. There is no stormwater controls installed along the disturbed soils adjacent to the river which is a concern.

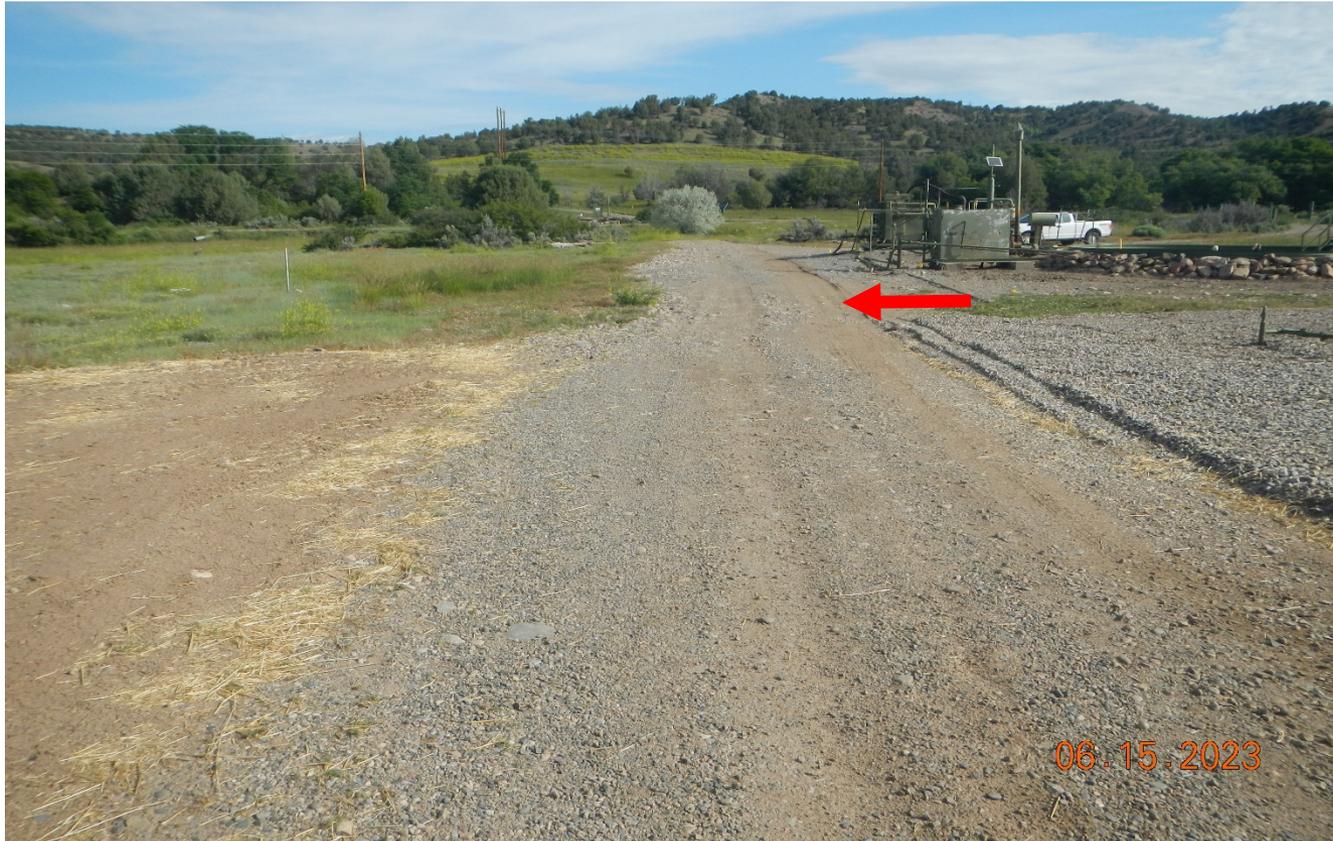
Photo 9. Facing north toward the location. The area of the road shows signs of scouring where flood flowed across the road from right to left towards the Florida River.

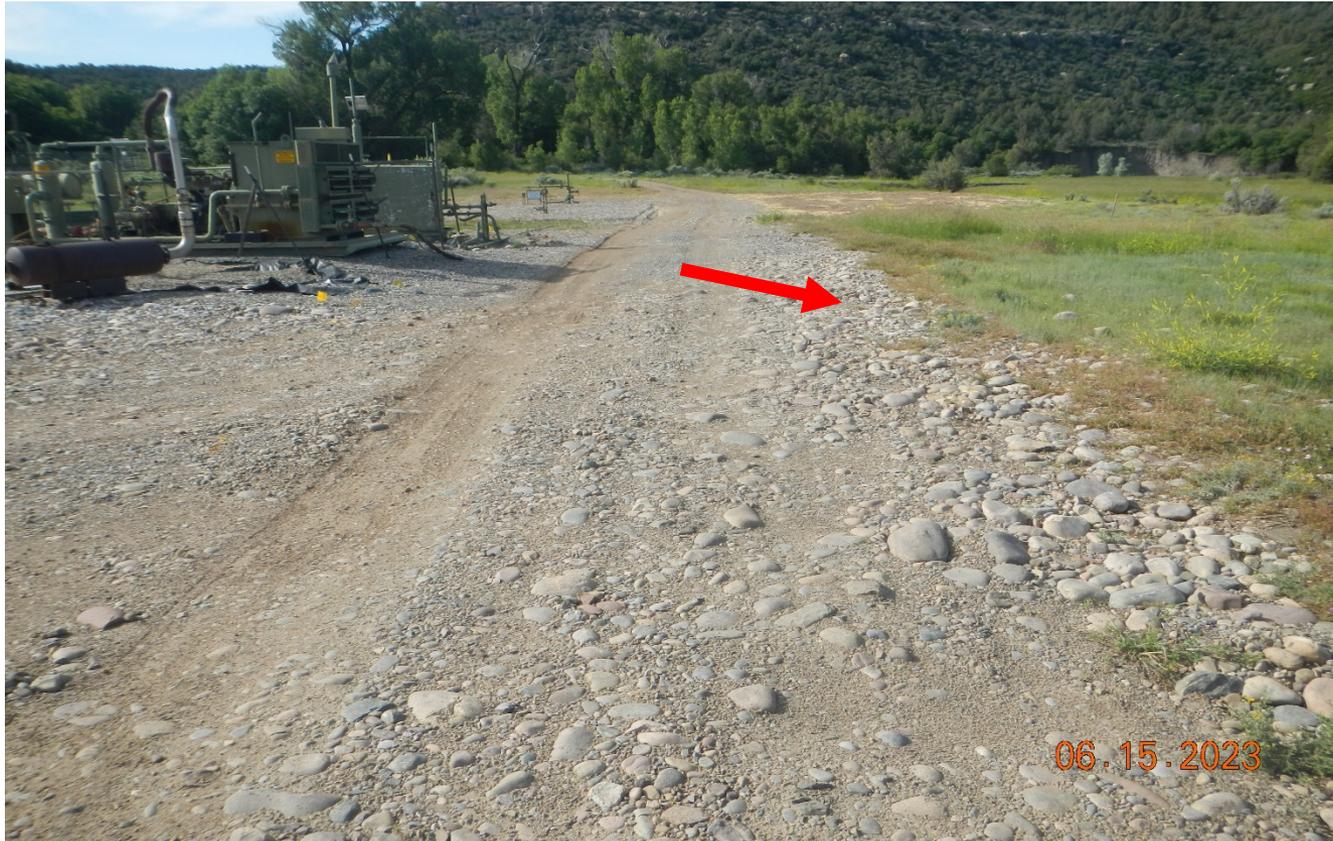
Photo 10. Facing south toward the location. The area of the road shows signs of scouring where flood flows across the road from left to right towards the Florida River. No BMPs have been installed in this area.
