Tiffany 5-2 and Tiffany 5-3
COGCC Inspection #690204125
Stormwater BMP Maintenance

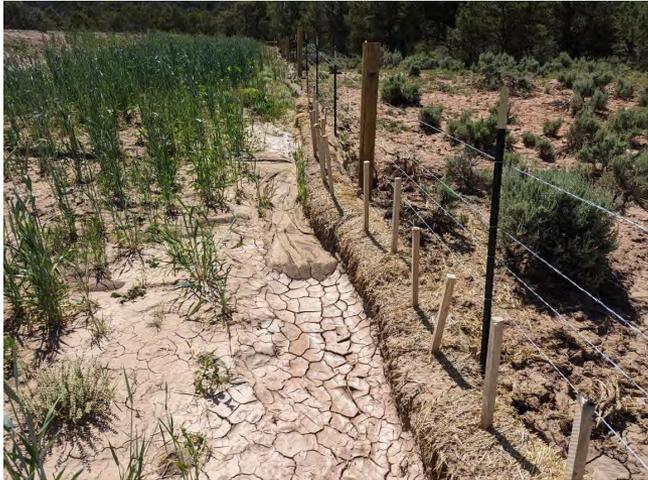
Inspection photo 8. Sediment removed from and around straw bales. Complete 6/05/2023.

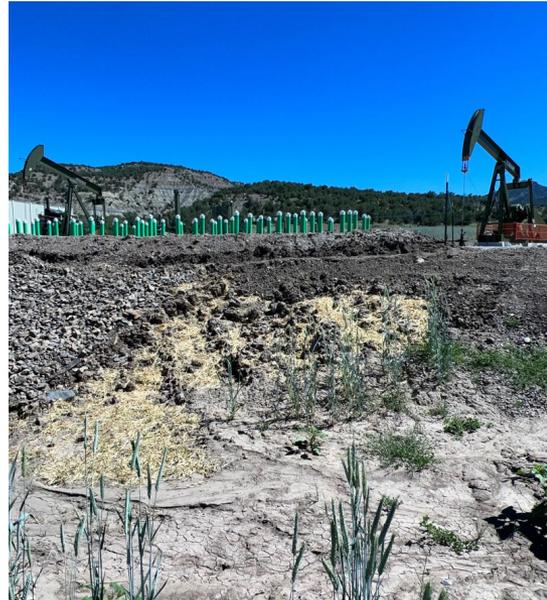
Inspection photo 9. BMPs in place to mitigate erosion. Completed 6/05/2023.

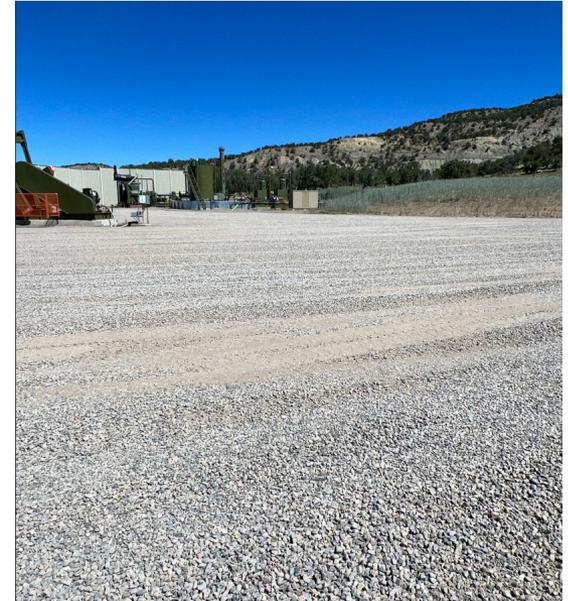
Inspection photo 4. Soil pile no longer present.

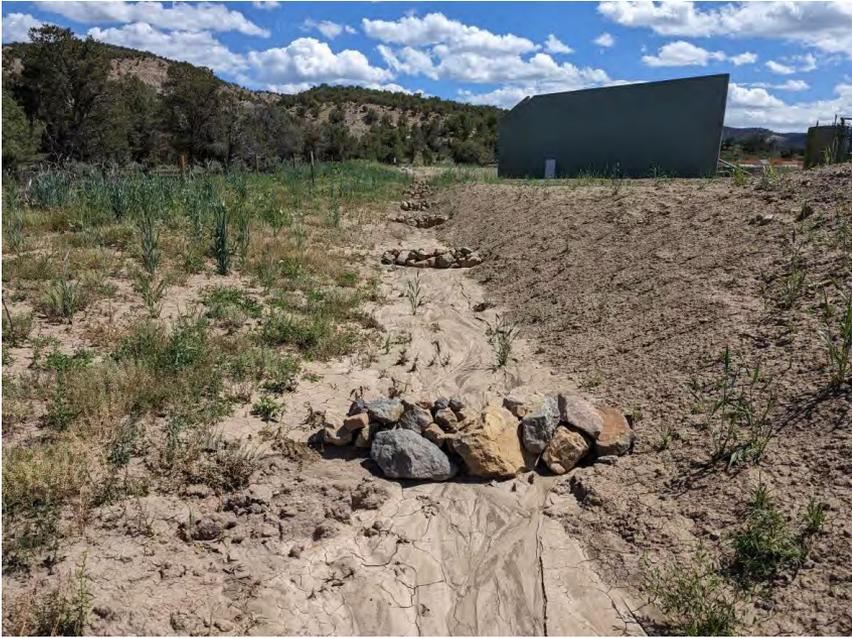
Inspection photo 10. Western swale rock check dams maintained; additional angular rip rap installed. Complete 6/05/2023.

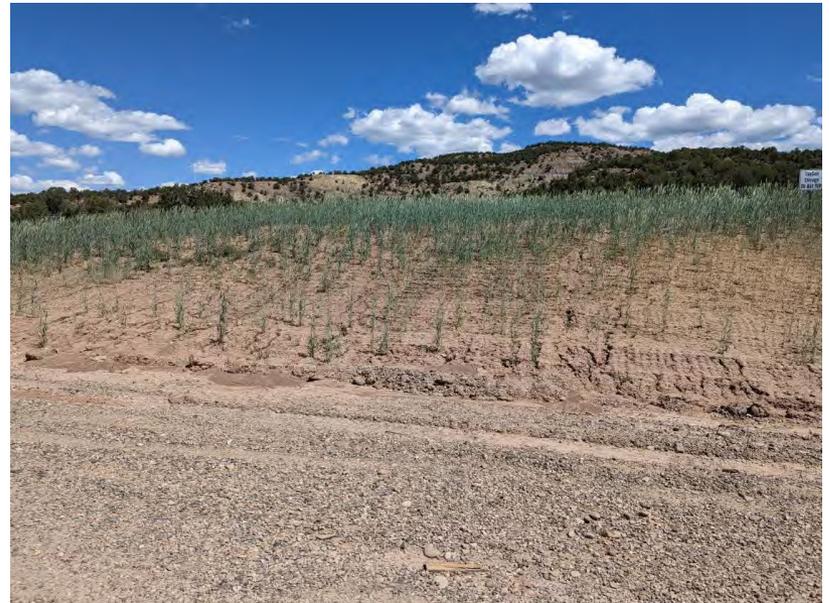
Inspection photo 14. Rilling addressed and BMPs added at top of slope. Completed 6/05/2023.
