**Scout Energy Management LLC  
Associated Unit A 2X  
Location #316438**

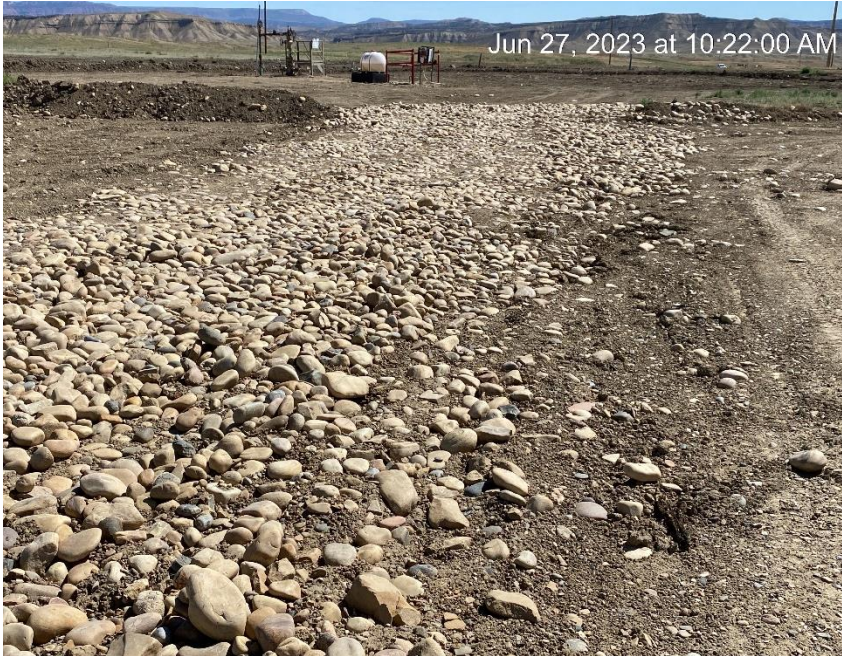
**Vehicle tracking pad added since last inspection**

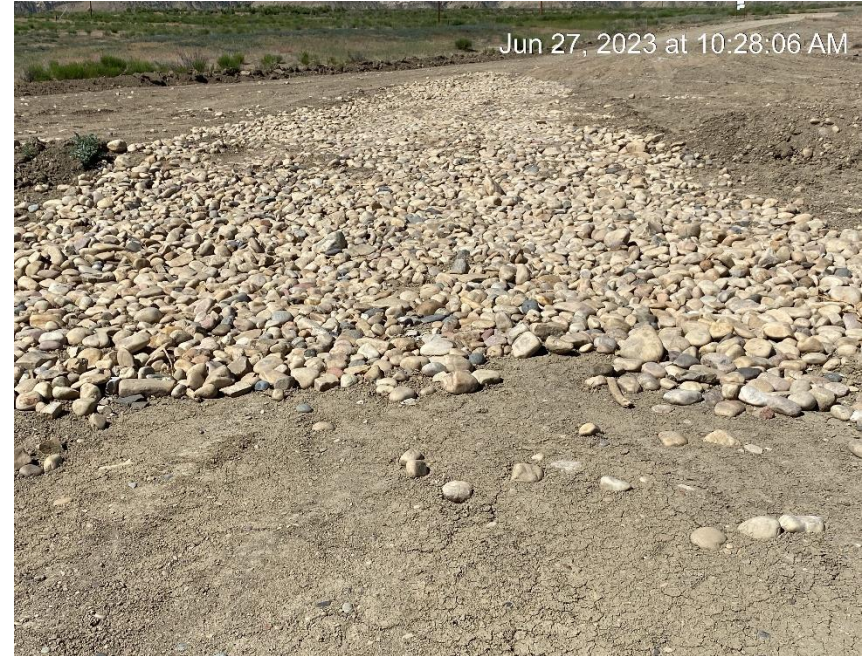
**Vehicle tracking pad added since last inspection**

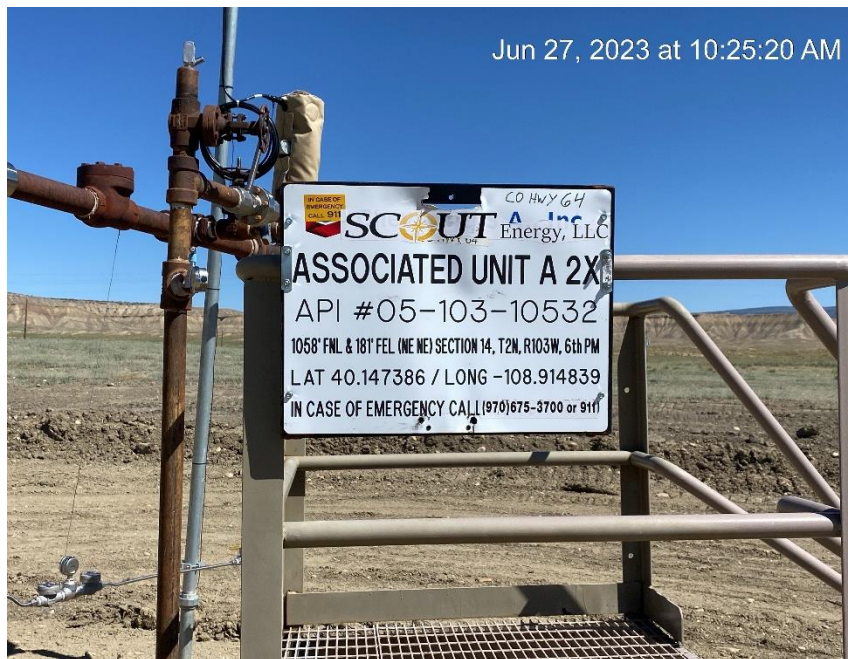
**Wellhead sign, no tank battery on location**

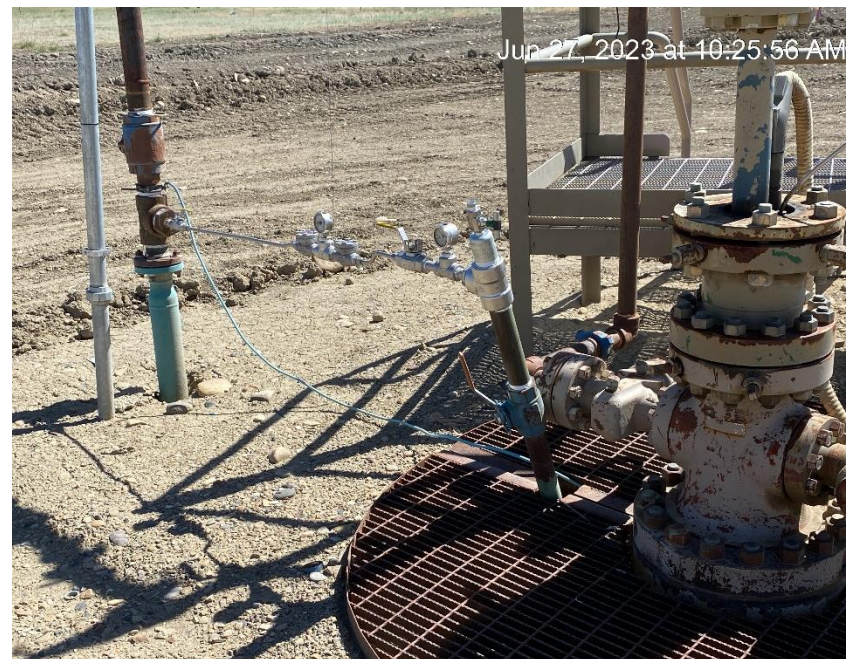
**Surface casing plumbed into flowline**

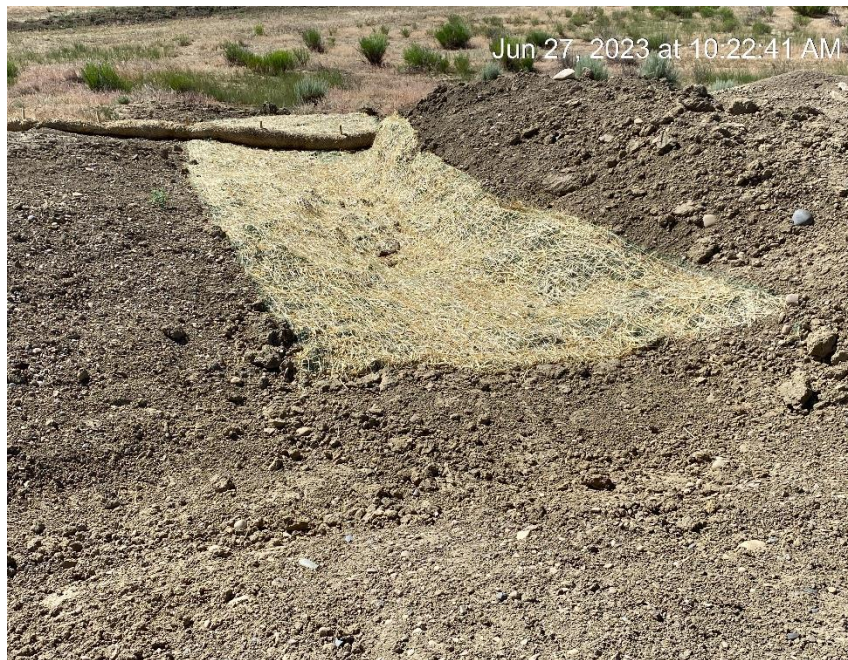
**Drainage repaired since last inspection**

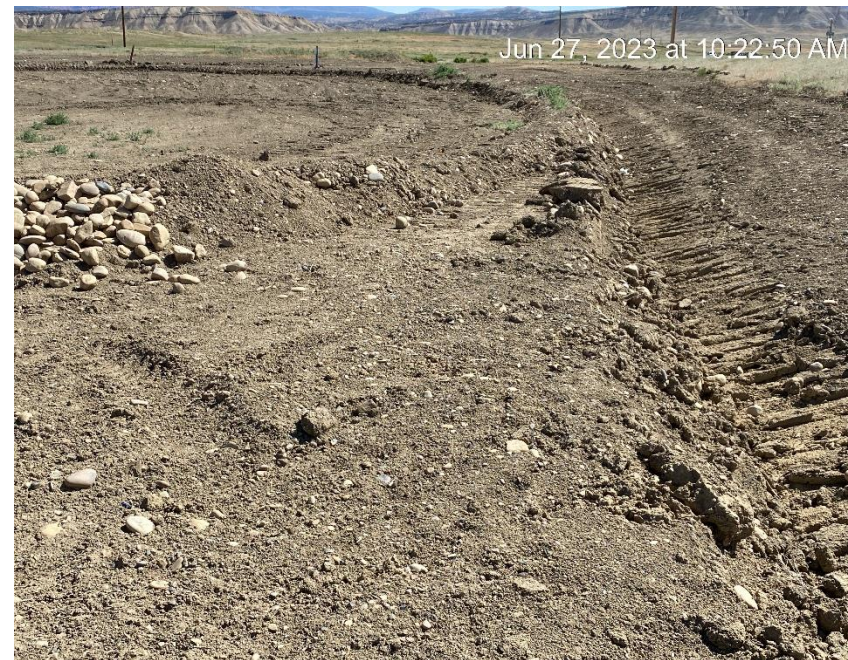
**Drainage repaired since last inspection**

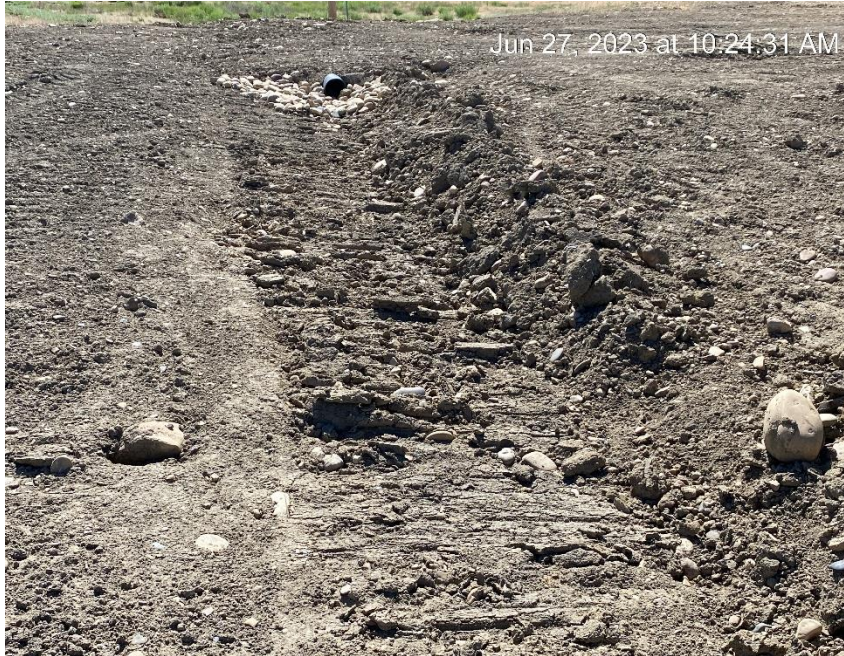
**Sediment trap added since last inspection**

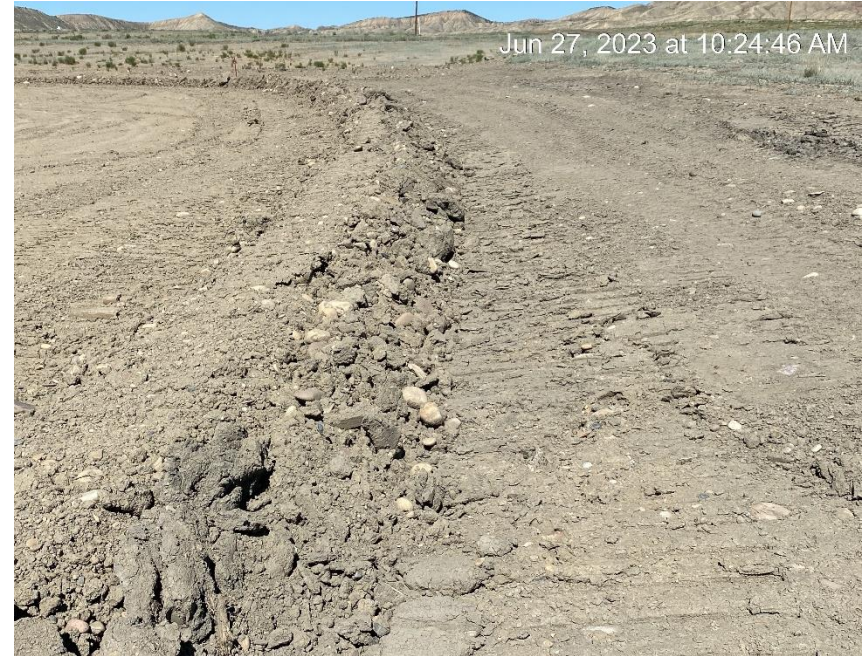
**Drainage repaired since last inspection**
