**Scout Energy Management LLC
McLaughlin 19
Location #311796**

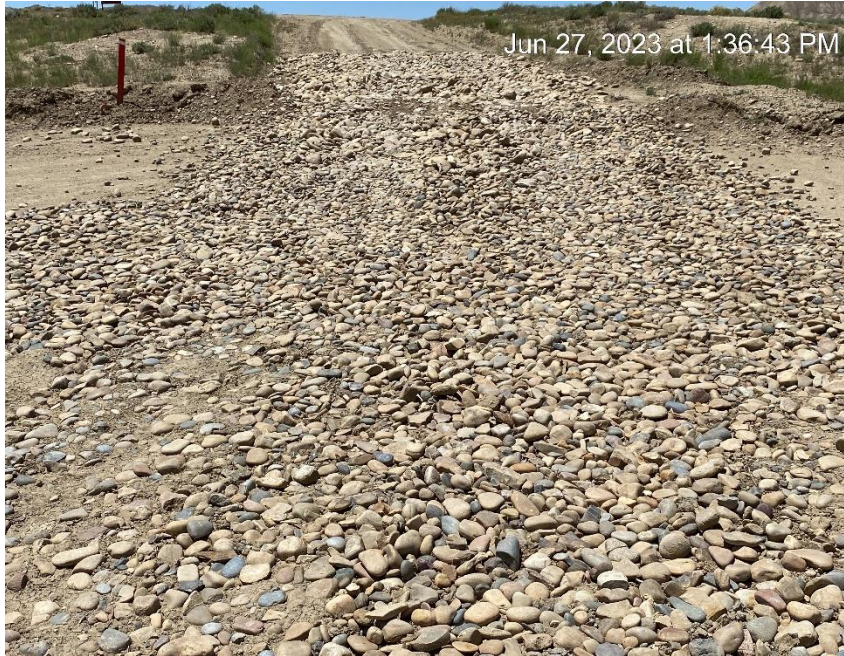
Northwest entrance tracking pad installed since last inspection

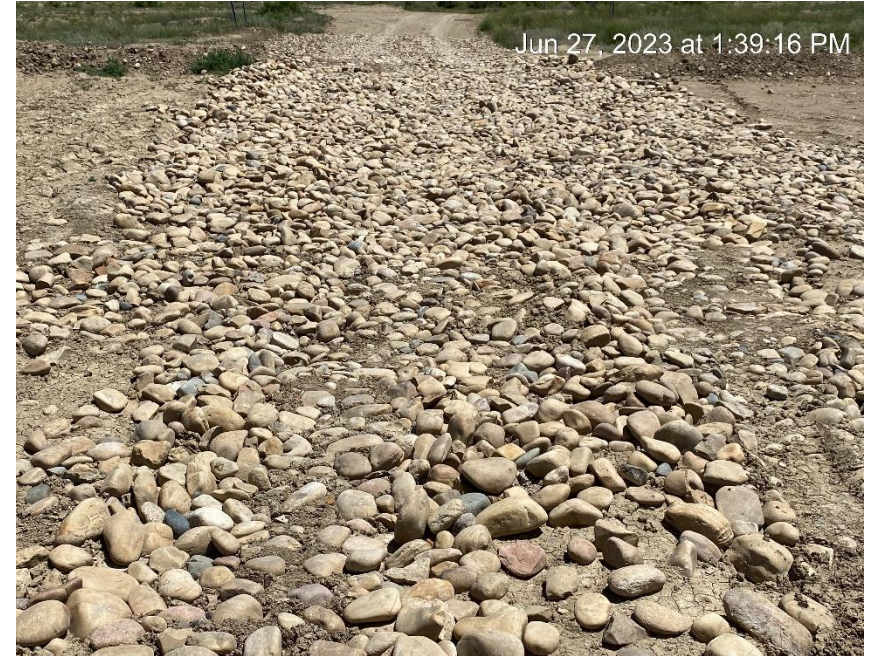
East entrance tracking pad installed since last inspection

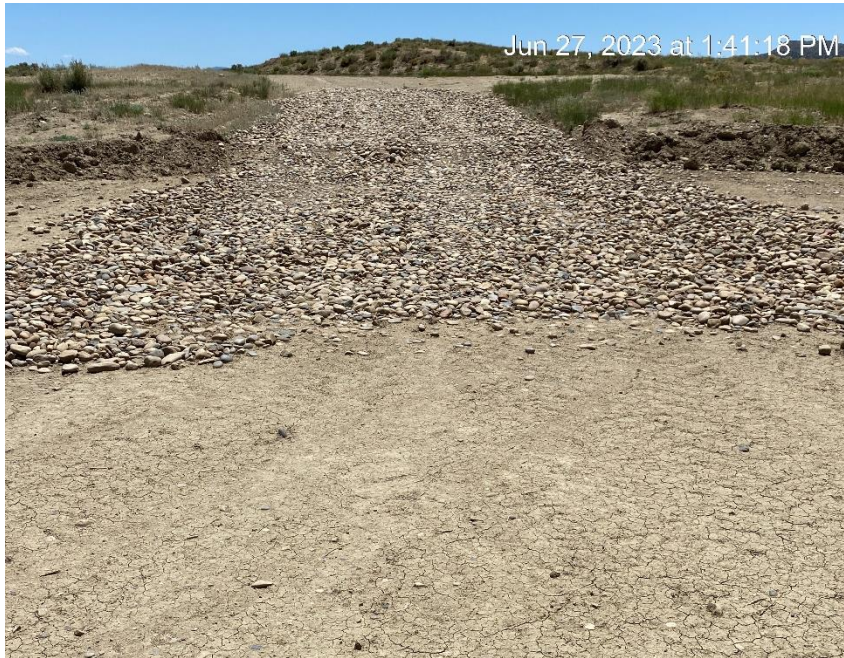
South entrance tracking pad installed since last inspection

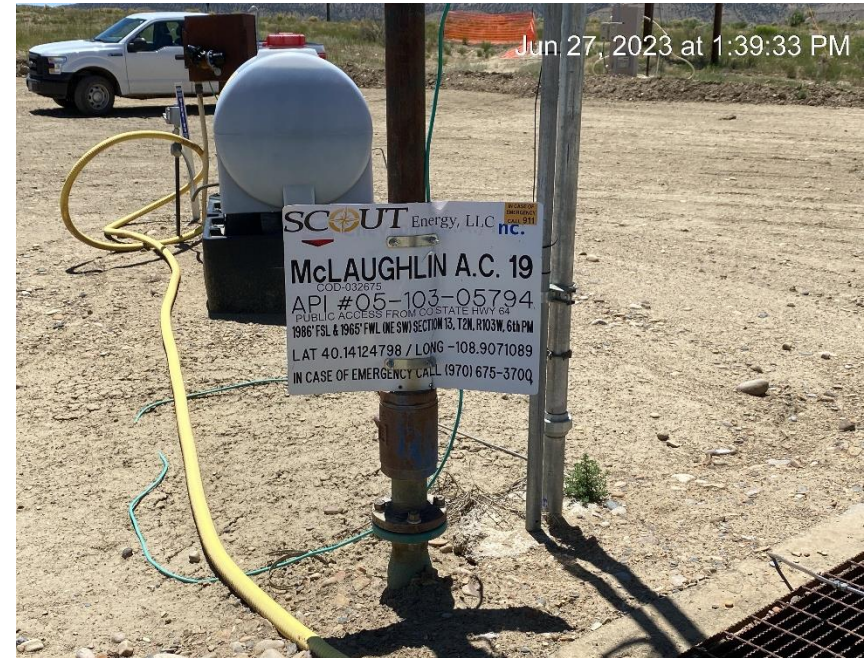
Well sign. No tank battery.
