Inspection Photos

Location Name: TEP ROCKY MOUNTAIN LLC BRYNILDSON ACCESS ROAD

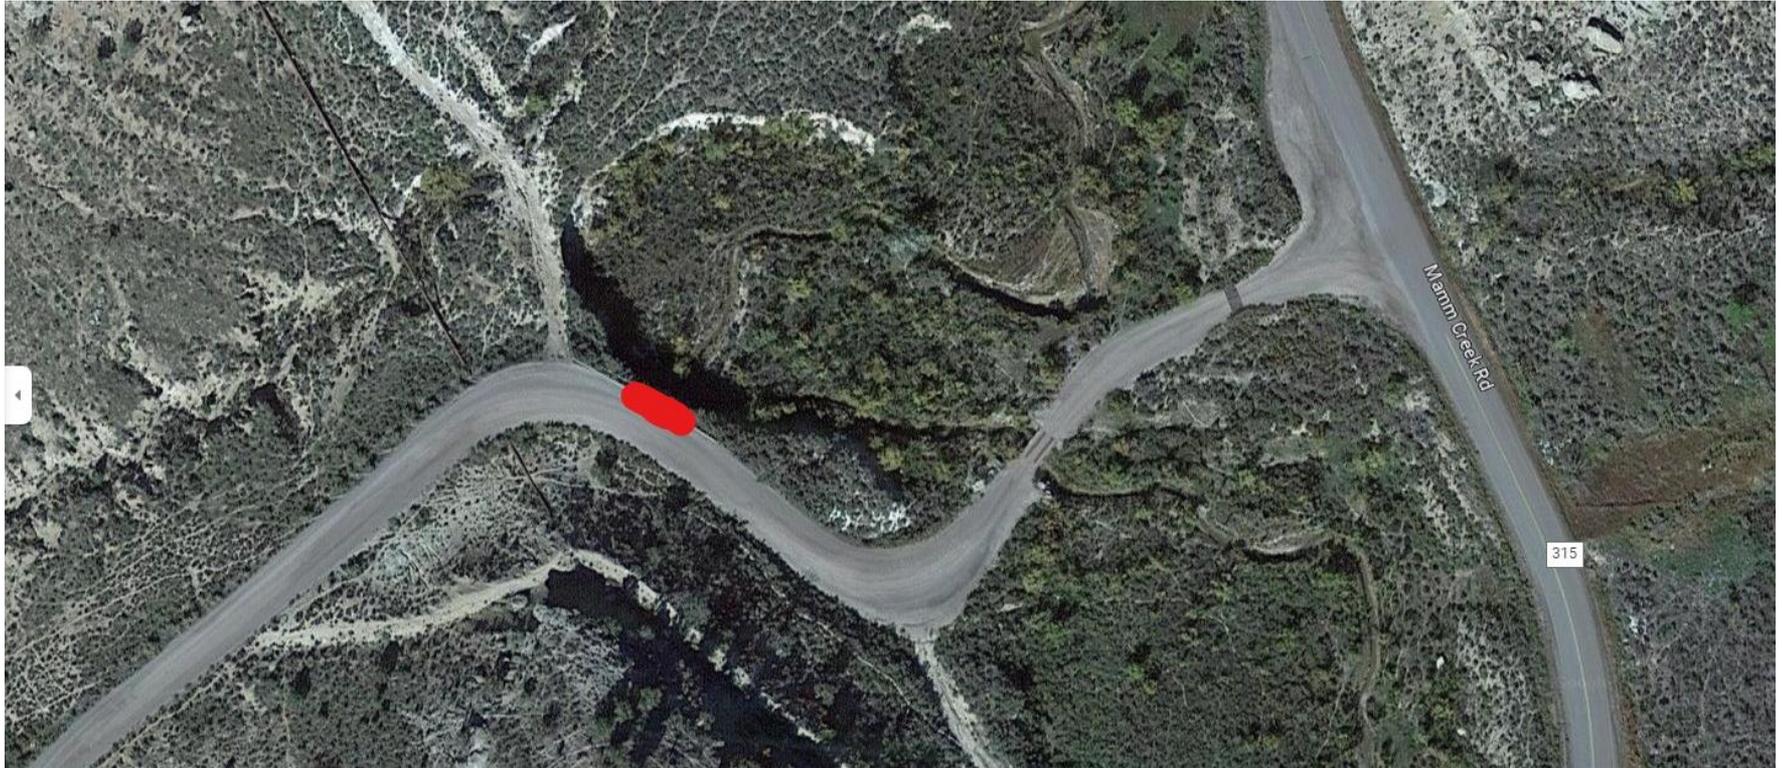
Approximate area where the road is damaged marked in red. The damaged portion of the road is approximately 50 yards from Mamm Creek & is within NSO/High Priority/Density/Black Bear Habitat areas. It's also within close proximity to 411a Surface Water External buffer & Mamm Creek contributes directly to the Colorado River.

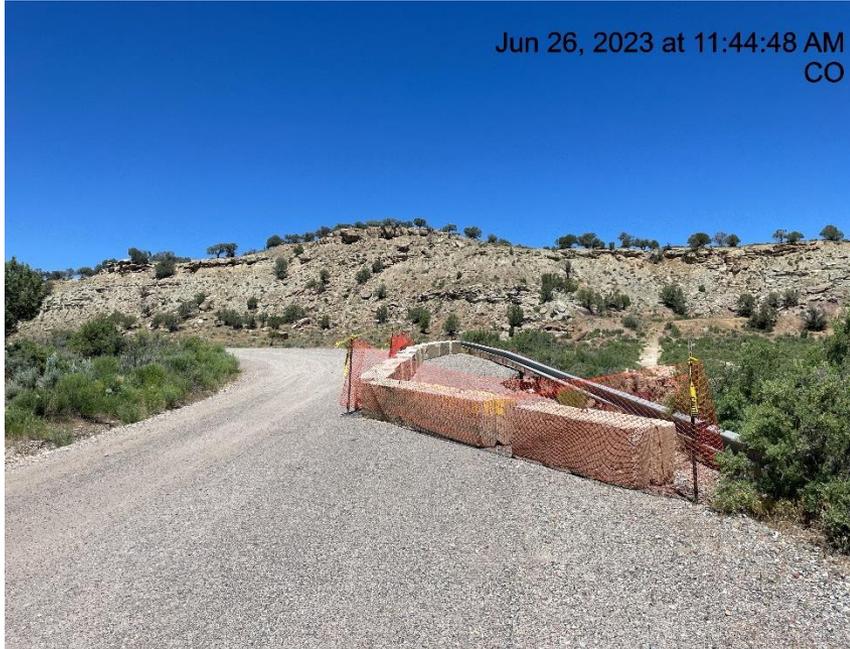
Photo # 1918 Damaged section of access road

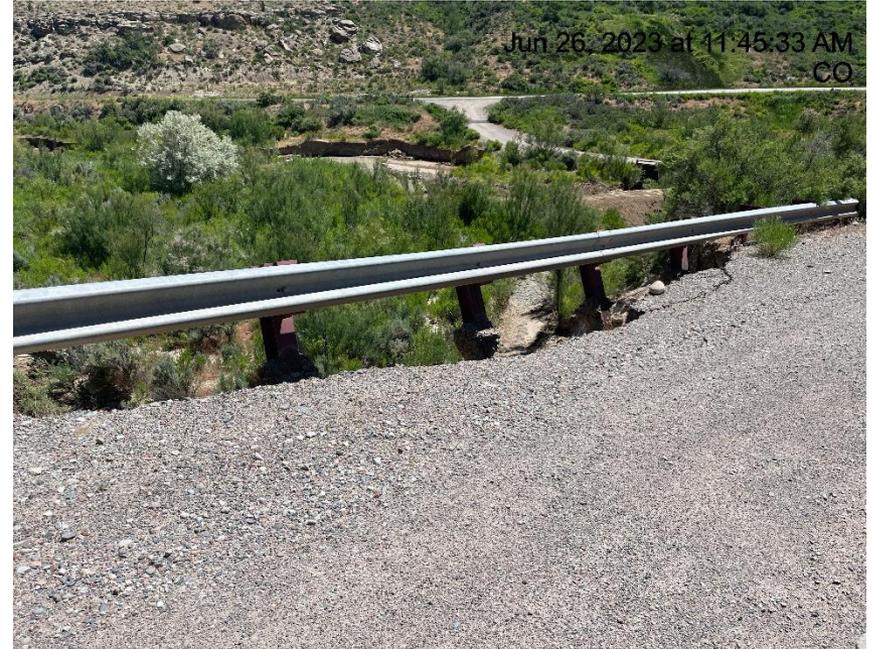
Photo # 1920 Damage to access road

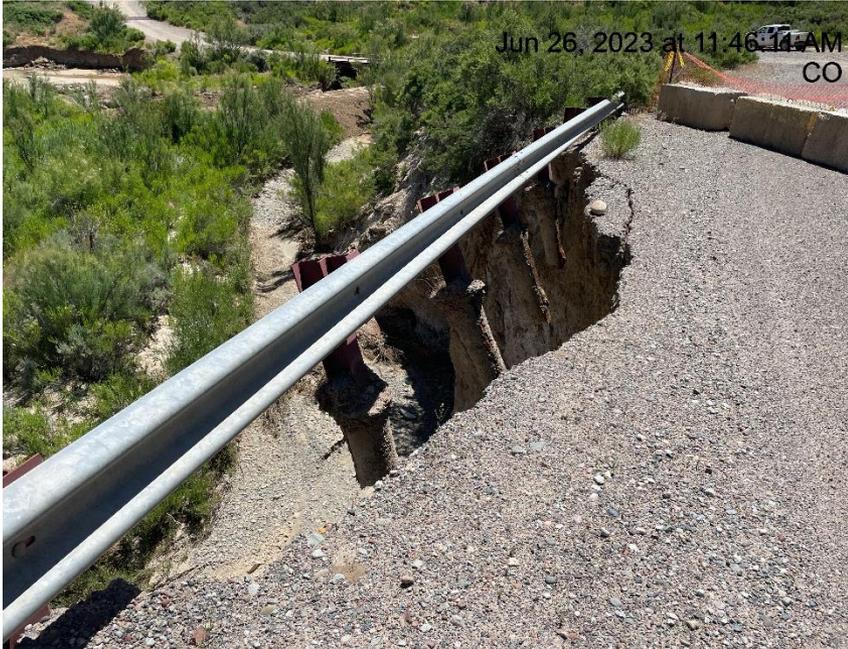
Photo # 1921 Damage to access road

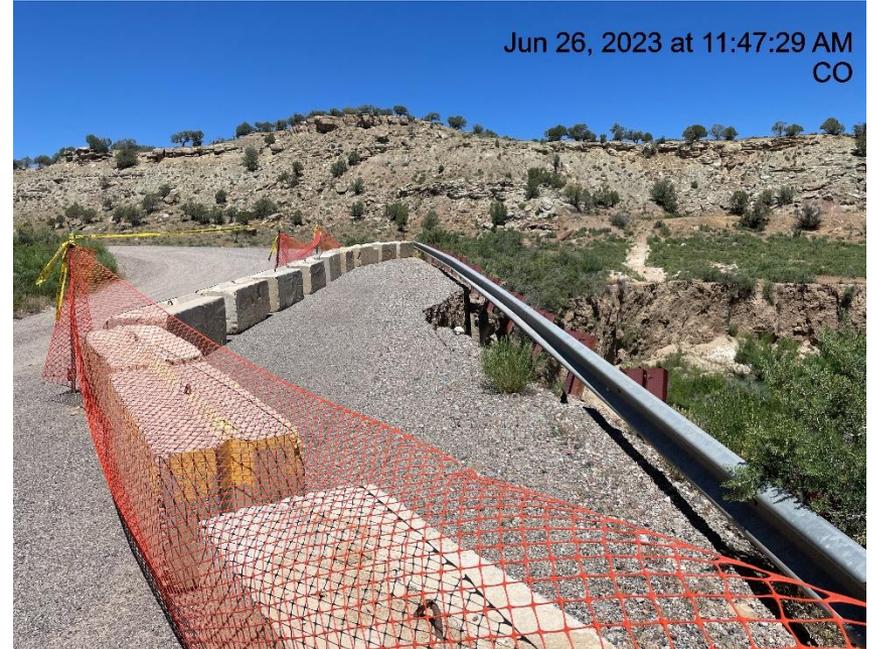
Photo # 1924 Damaged section of access road

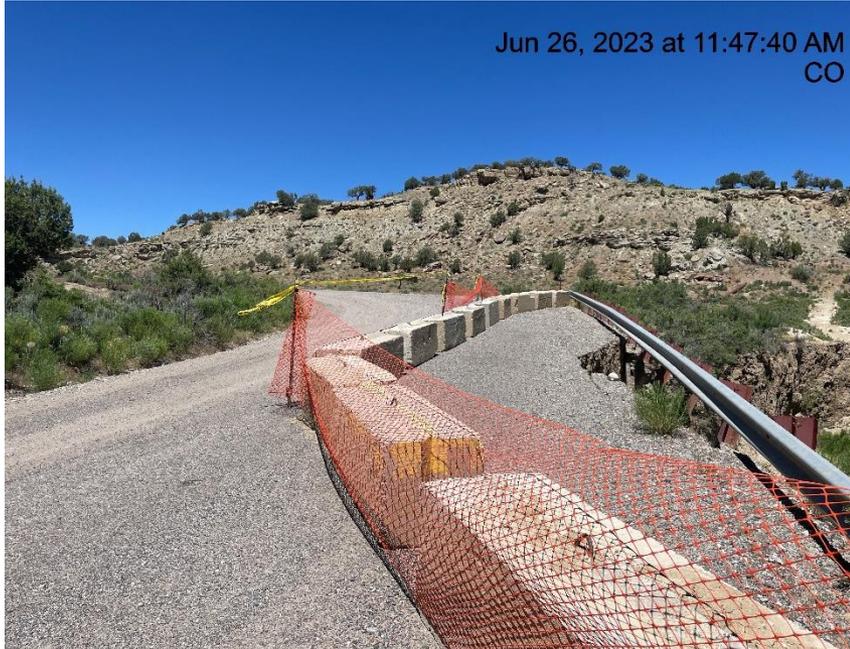
Photo # 1925 Damaged section of access road

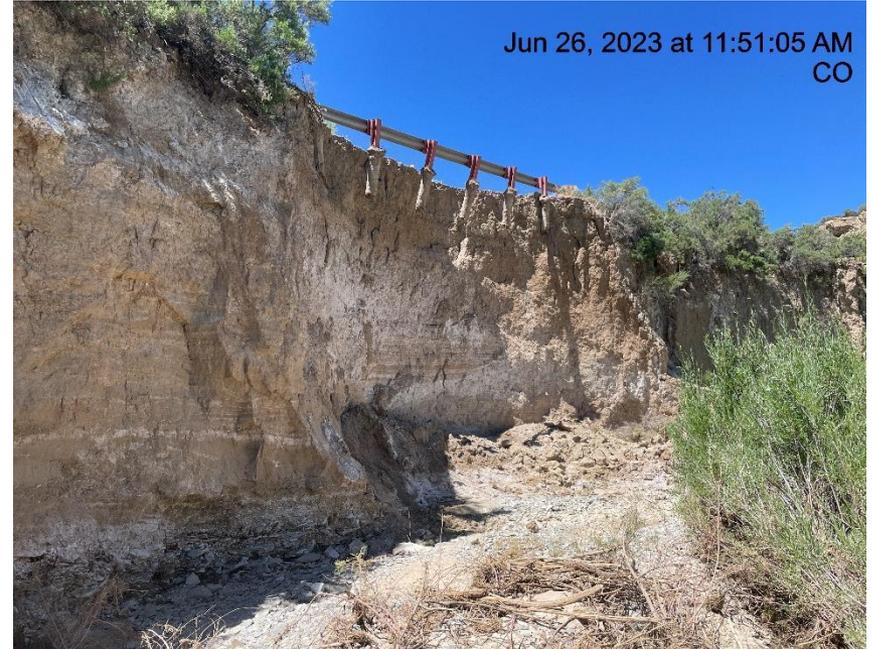
Photo # 1927 Below access road in the creek bed/destabilization of area supporting access road

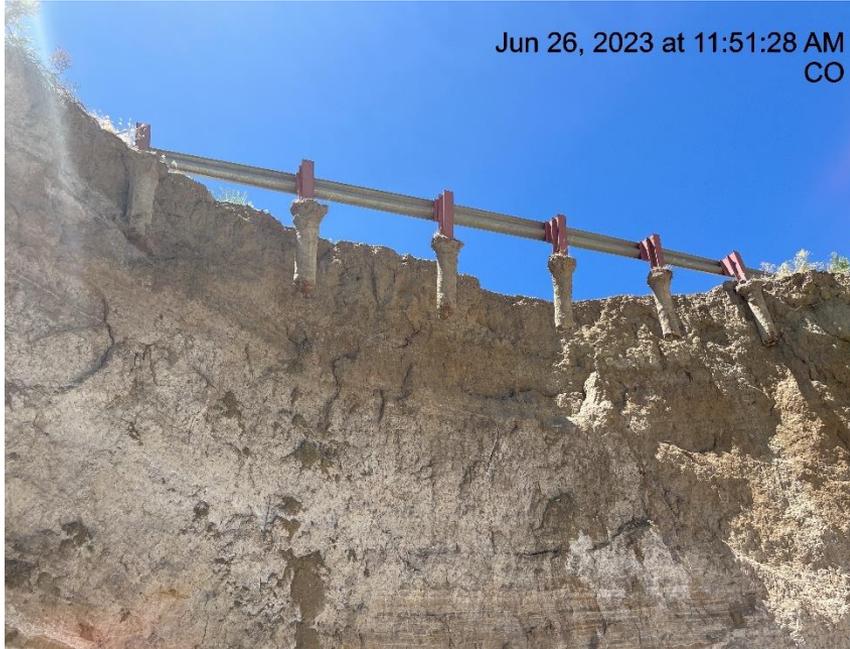
Photo # 1928 Below access road in the creek bed/destabilization of area supporting access road

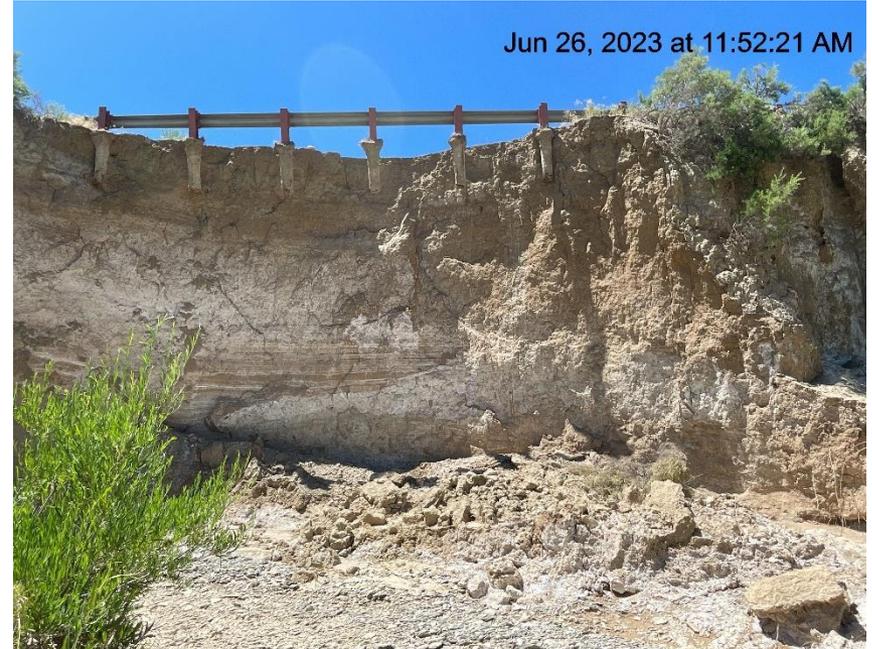
Photo # 1929 Below access road in the creek bed/destabilization of area supporting access road

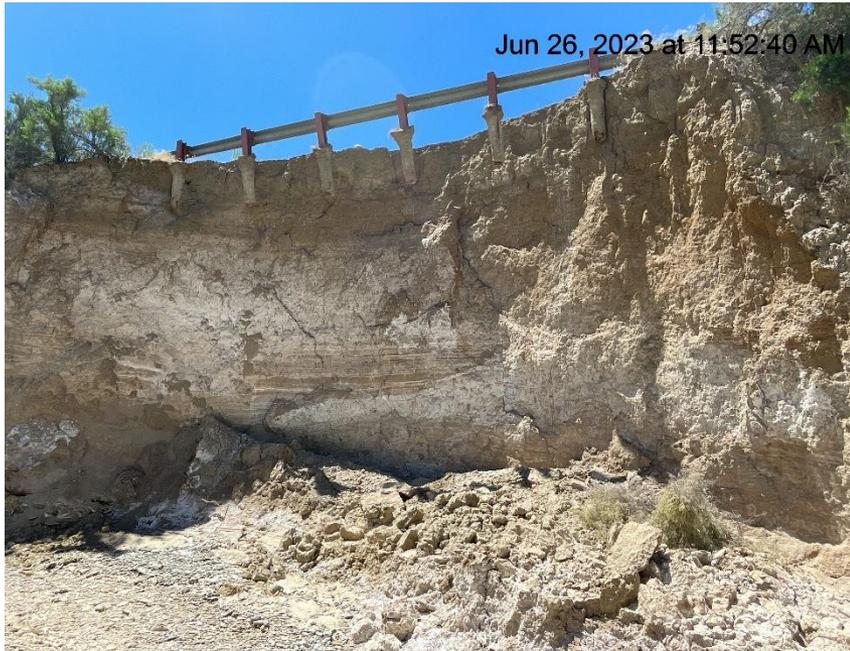
Photo # 1930 Below access road in the creek bed/destabilization of area supporting access road

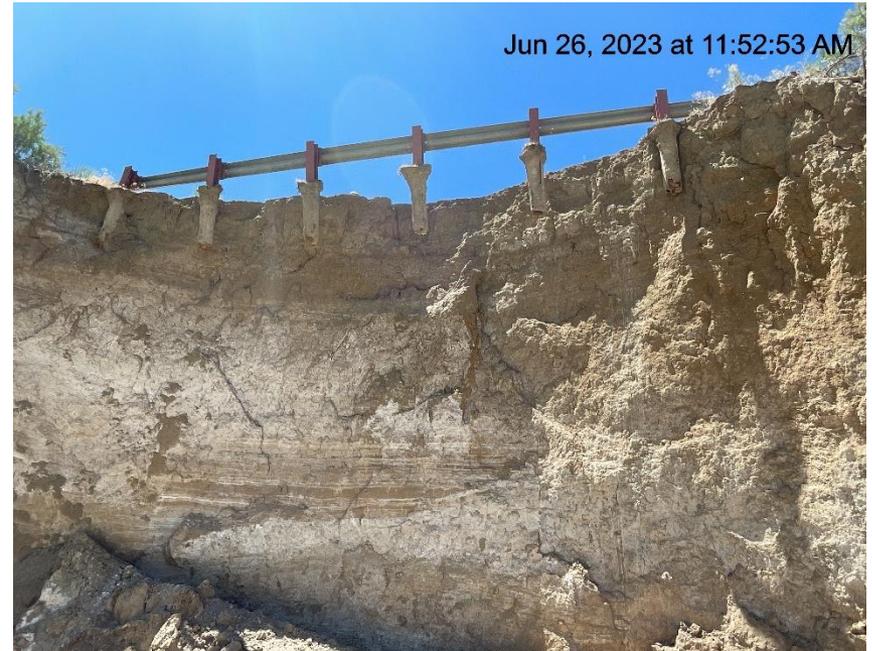
Photo # 1931 Below access road in the creek bed/destabilization of area supporting access road

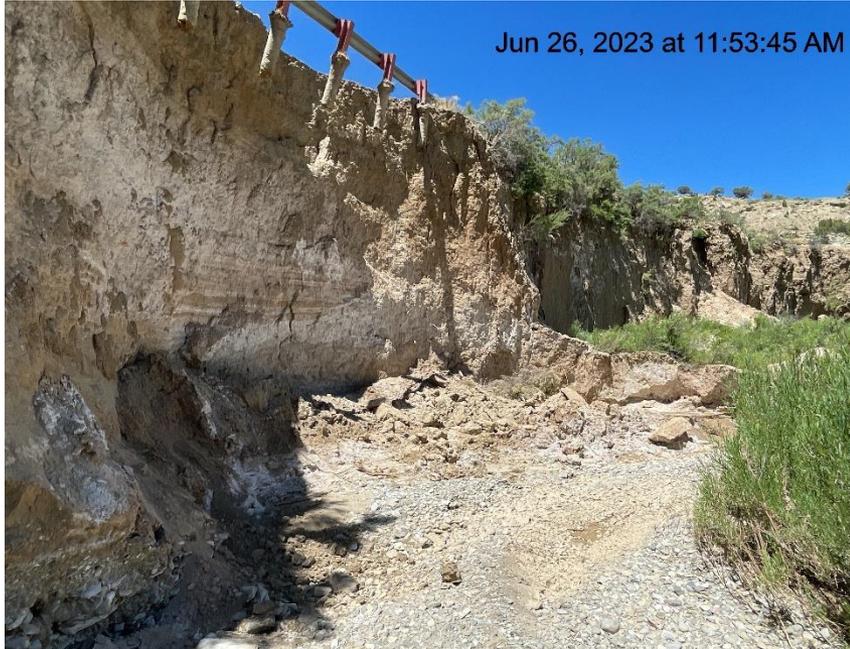
Photo # 1933 Below access road in the creek bed/destabilization of area supporting access road

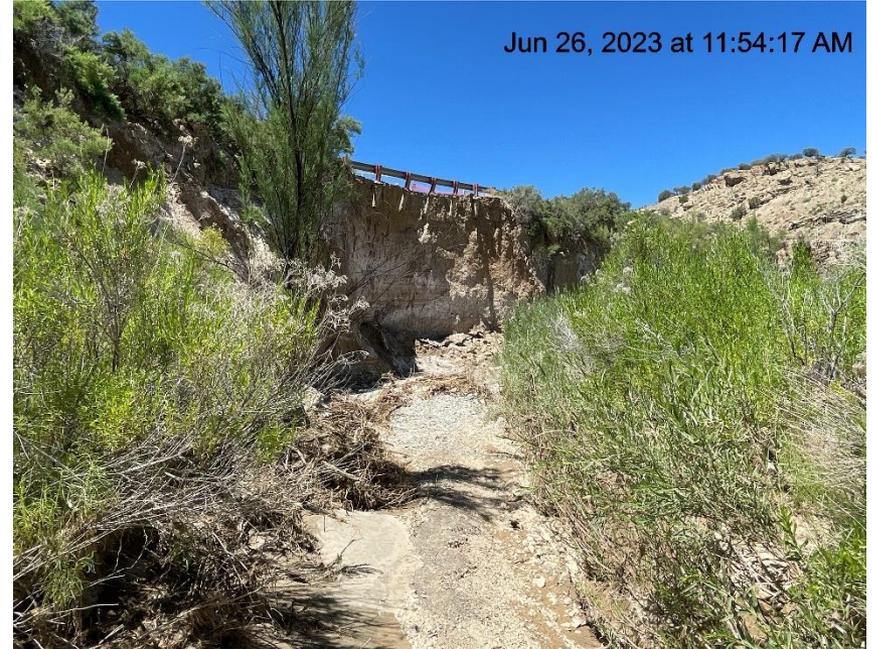
Photo # 1937 Below access road in the creek bed/destabilization of area supporting access road

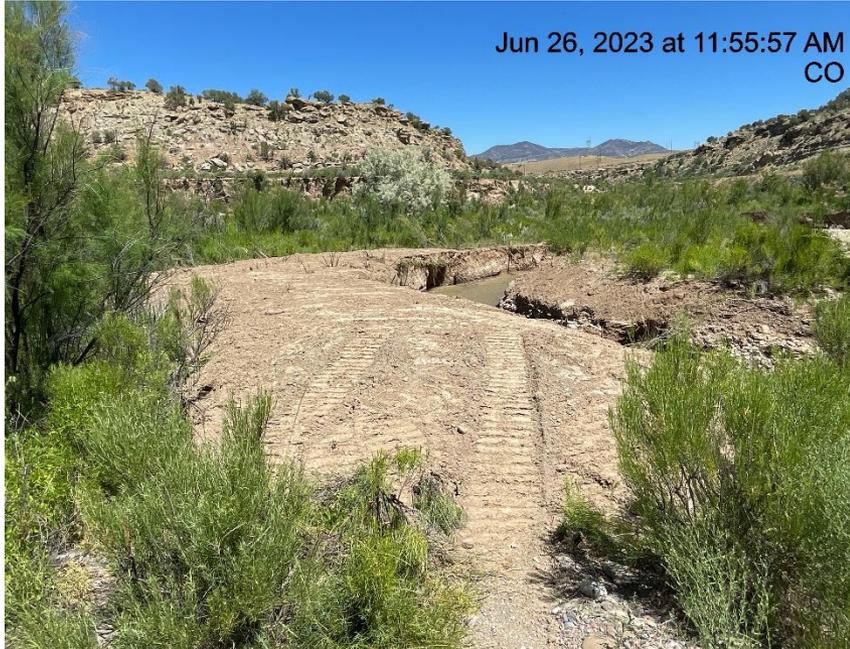
Photo # 1942 What appears to be heavy equipment tracks & dirt used to divert Mamm Creek

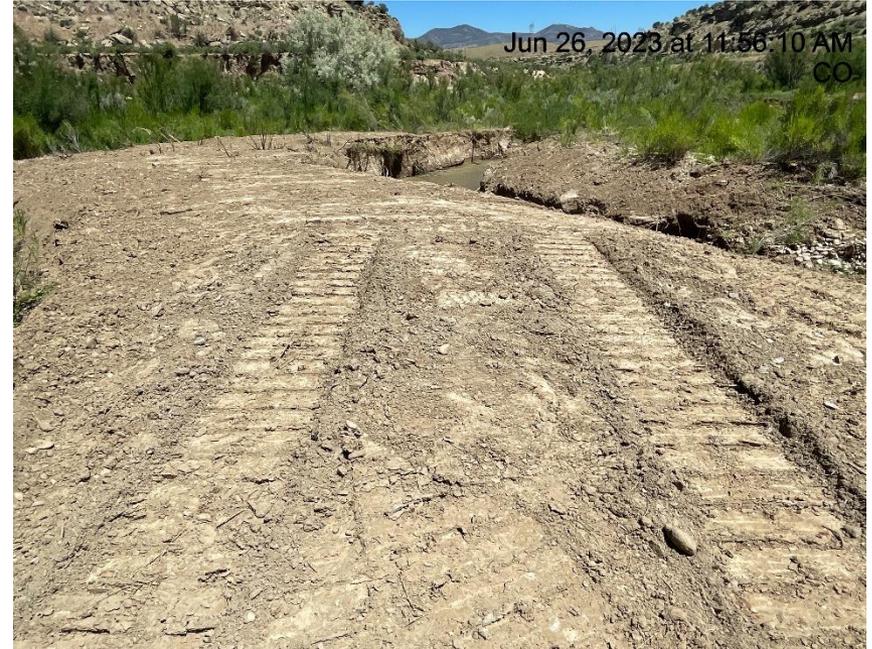
Photo # 1944 What appears to be heavy equipment tracks & dirt used to divert Mamm Creek

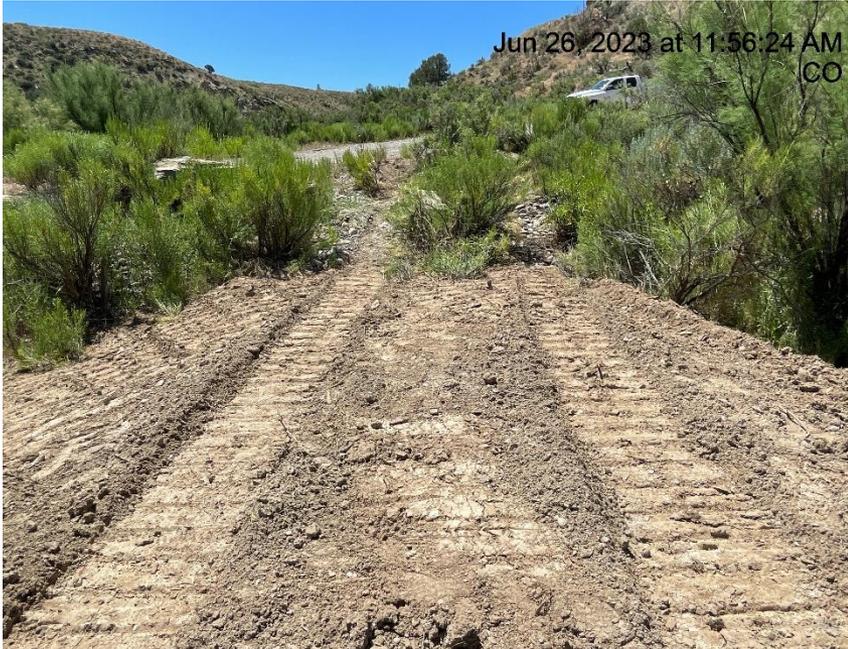
Photo # 1946 What appears to be heavy equipment tracks & dirt used to divert Mamm Creek

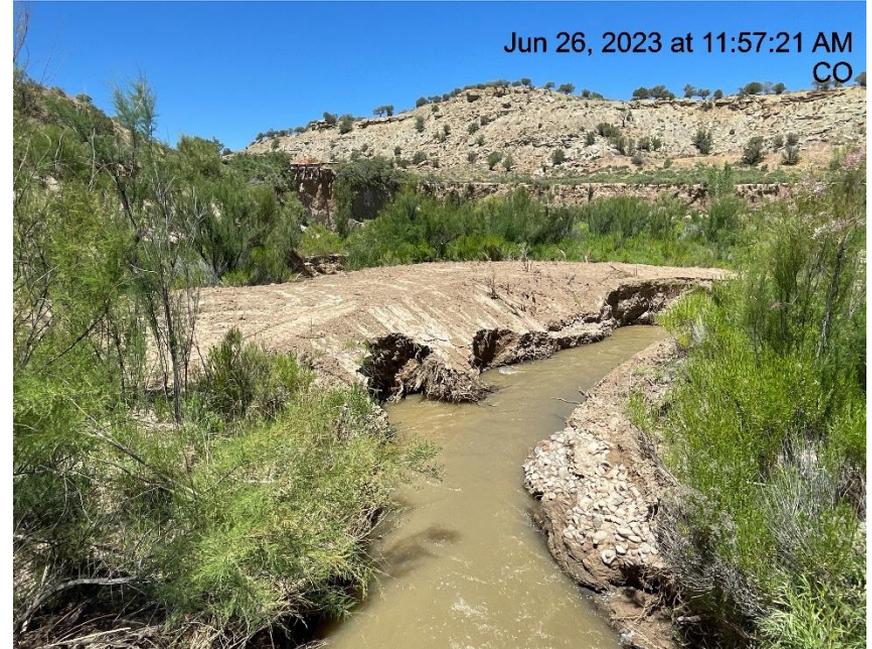
Photo # 1947 What appears to be the new path of Mamm Creek & dirt brought in to divert it

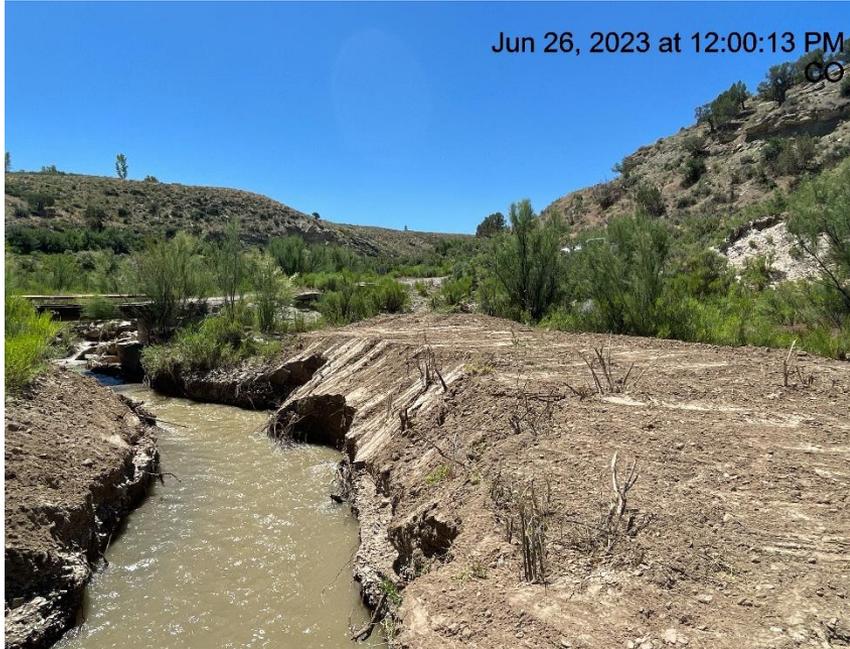
Photo # 1958 What appears to be the new path of Mamm Creek & dirt brought in to divert it

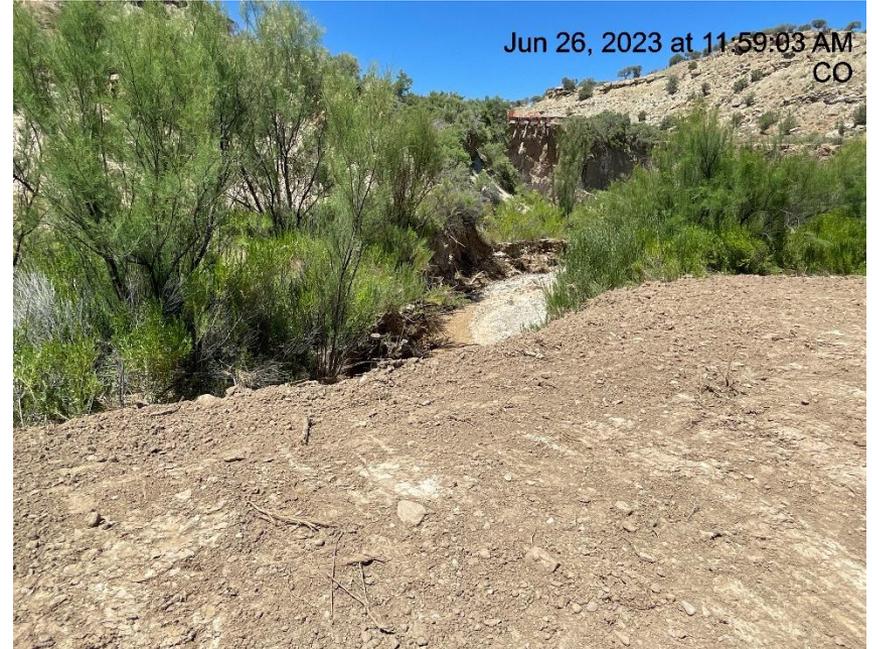
Photo # 1954 Dirt blocking path of creek & dry creek bed in the background

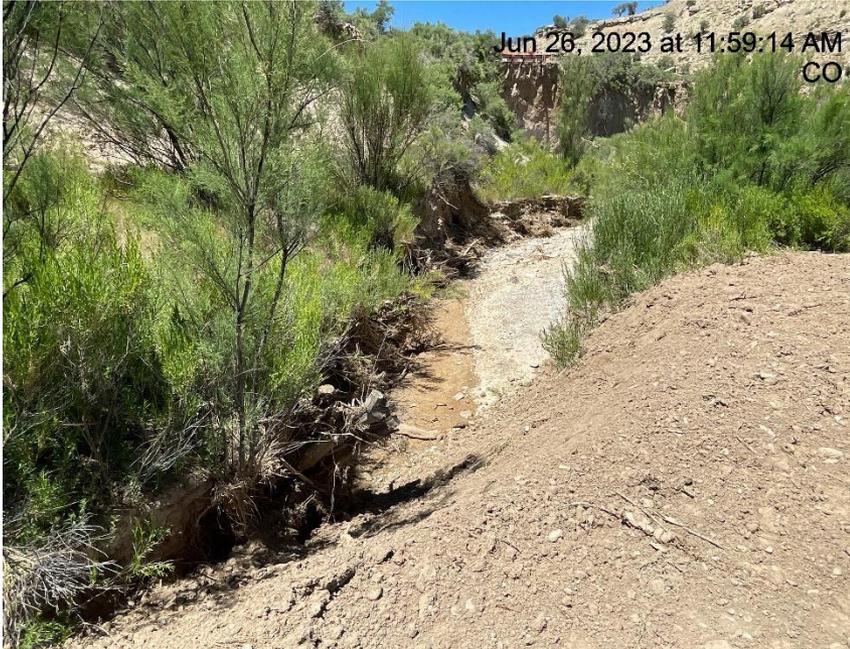
Photo # 1955 Dirt blocking/diverting path of creek & dry creek bed

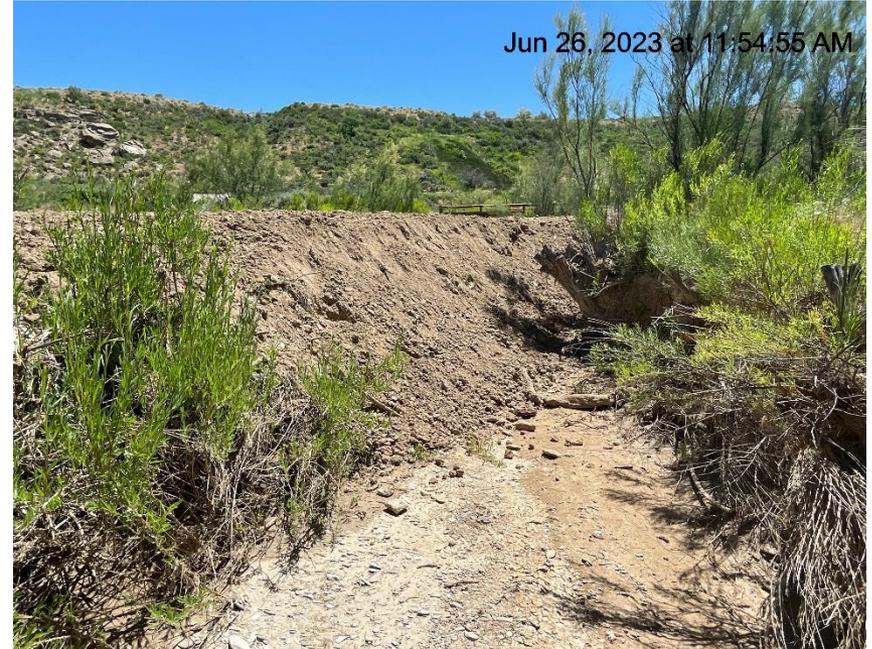
Photo # 1941 Dirt blocking/diverting path of creek & dry creek bed

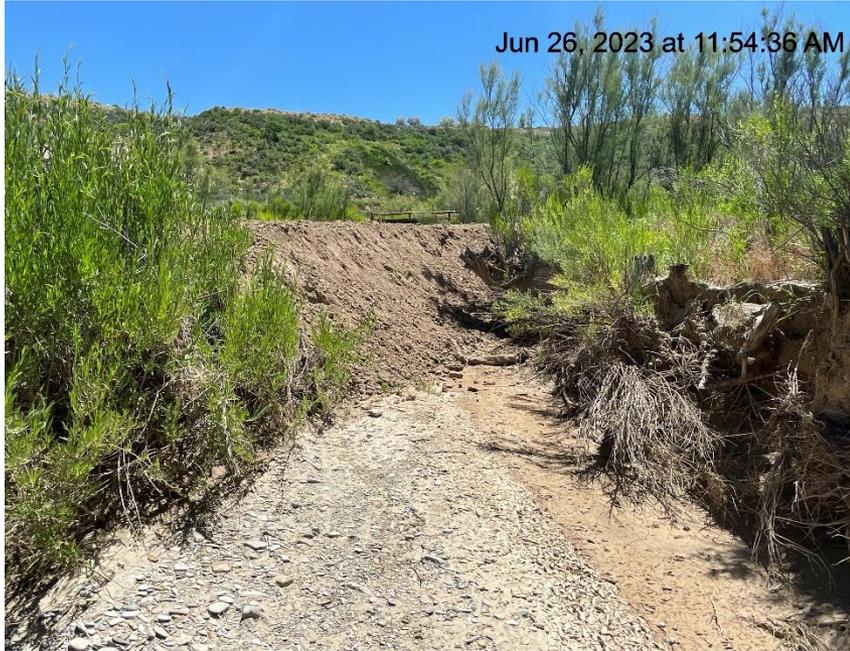
Photo # 1939 Dirt blocking/diverting path of creek & dry creek bed

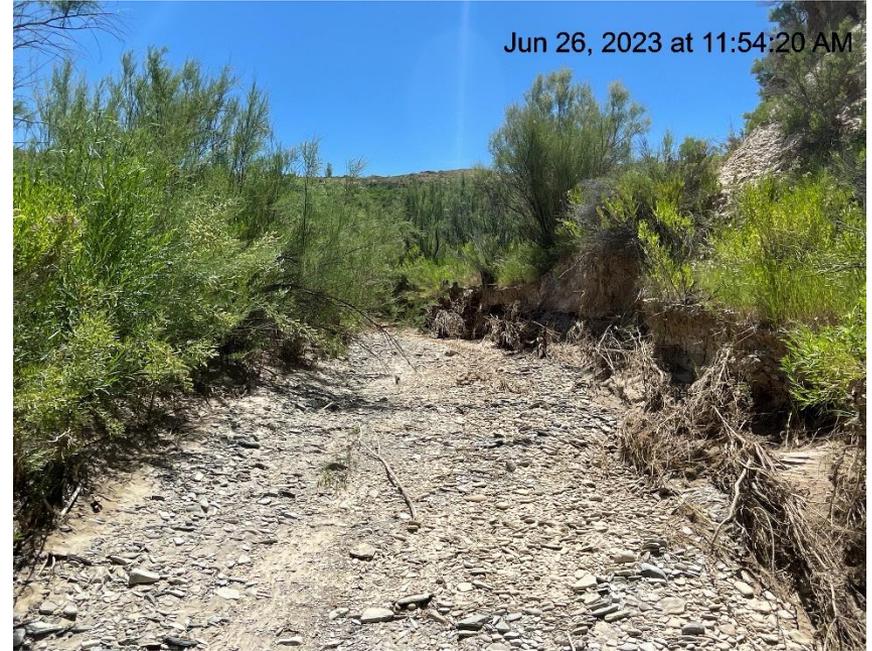
Photo # 1938 Dry creek bed

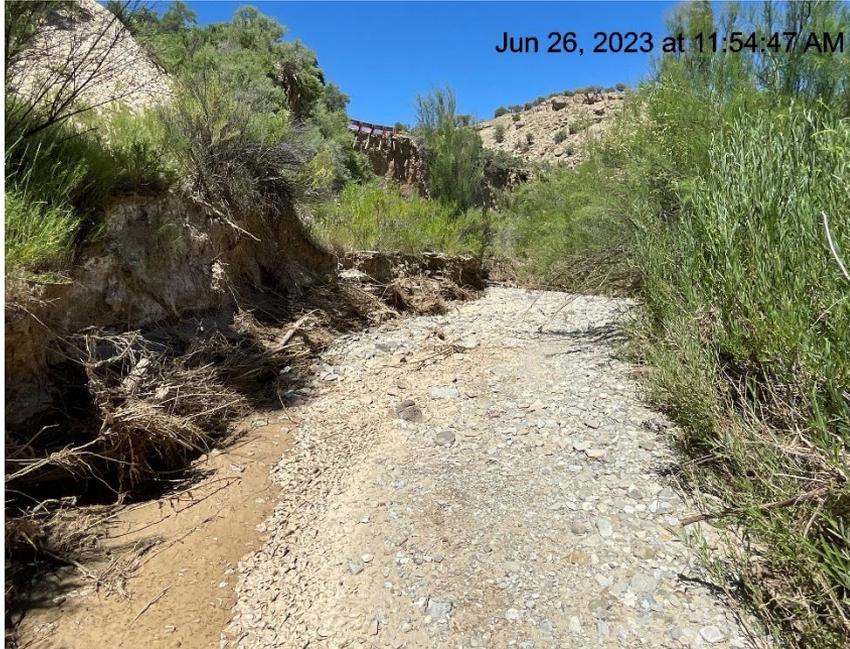
Photo # 1940 Dry creek bed

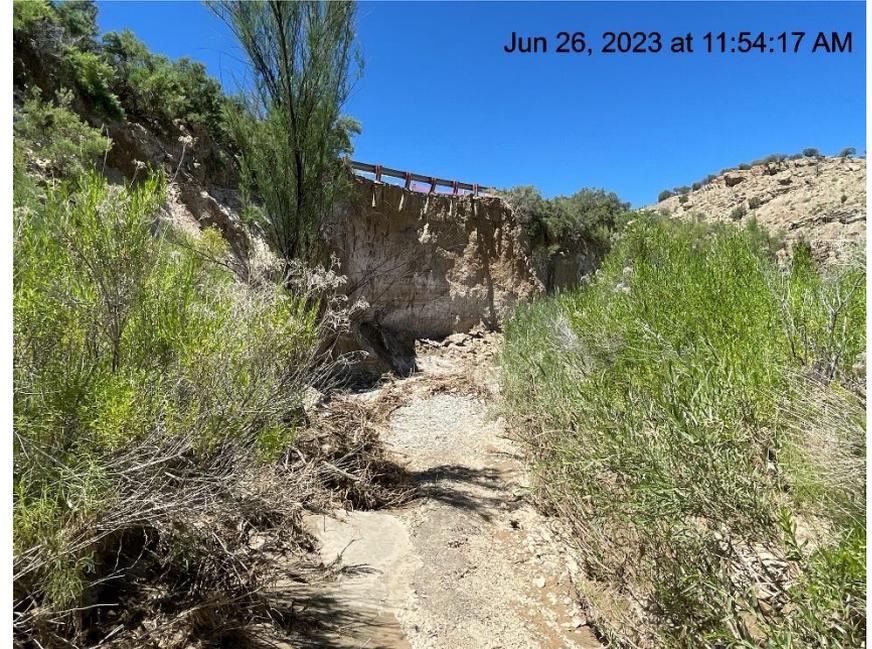
Photo # 1937 Dry creek bed & damage to slope supporting the access road in the background
