**Scout Energy Management LLC
A. C. McLaughlin 39A
Location #316423**

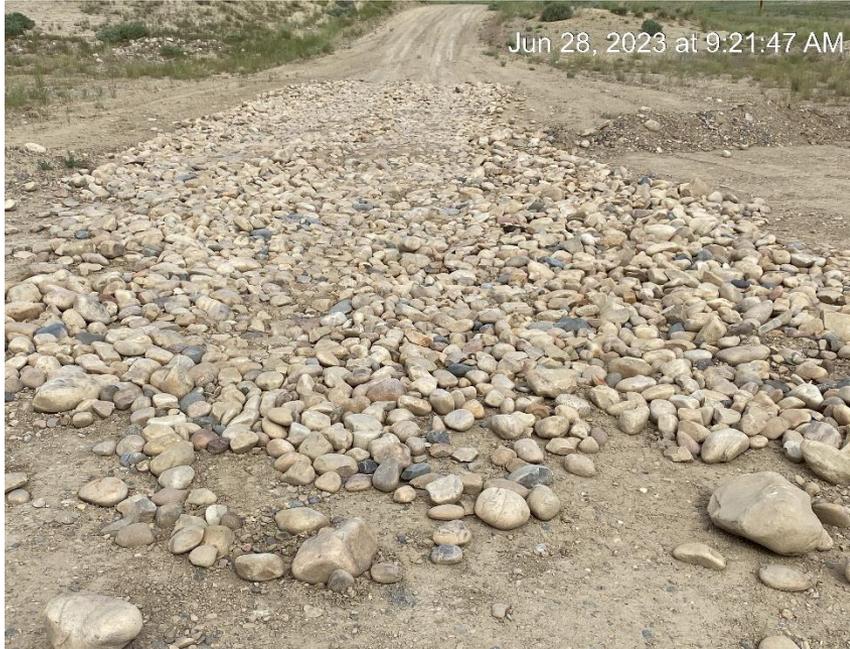
West entrance tracking pad installed since last inspection

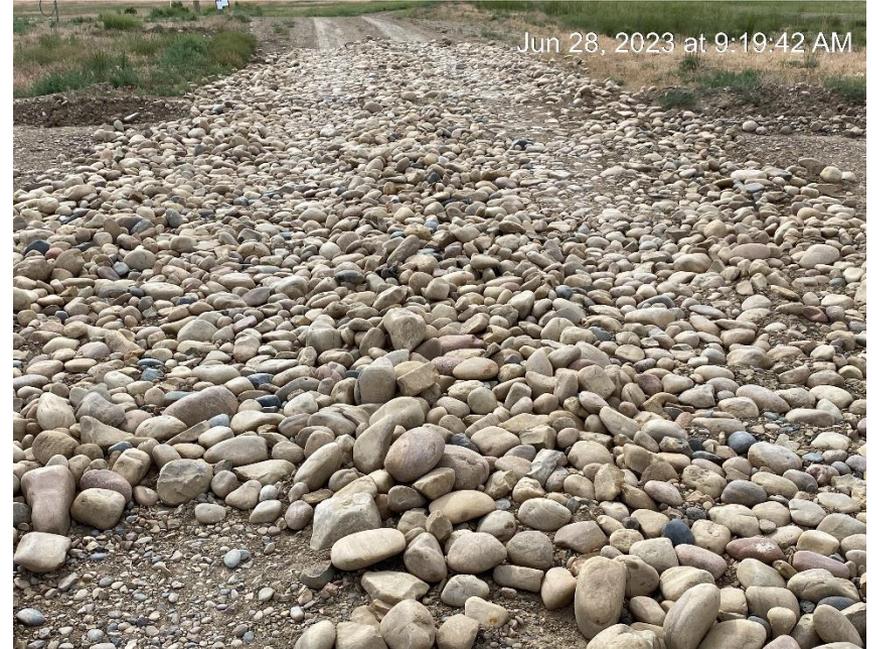
East entrance tracking pad installed since last inspection

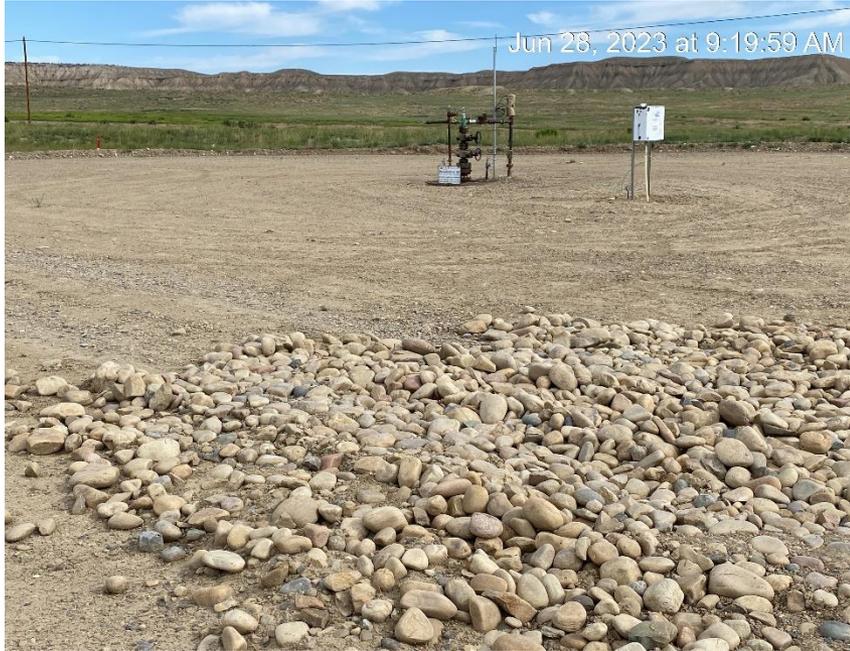
Location view from Southeast corner

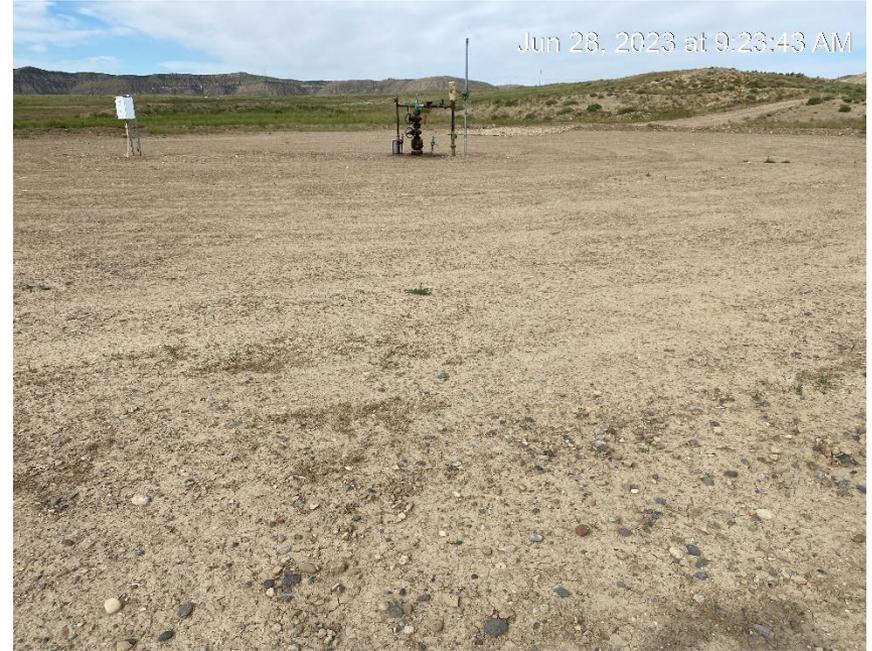
Location view from Northeast corner

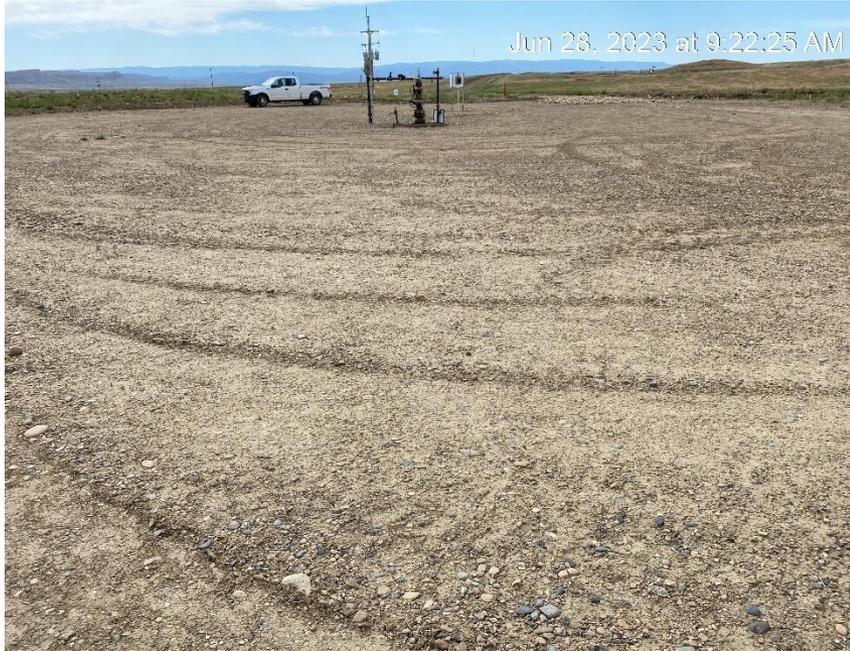
Location view from Northwest corner

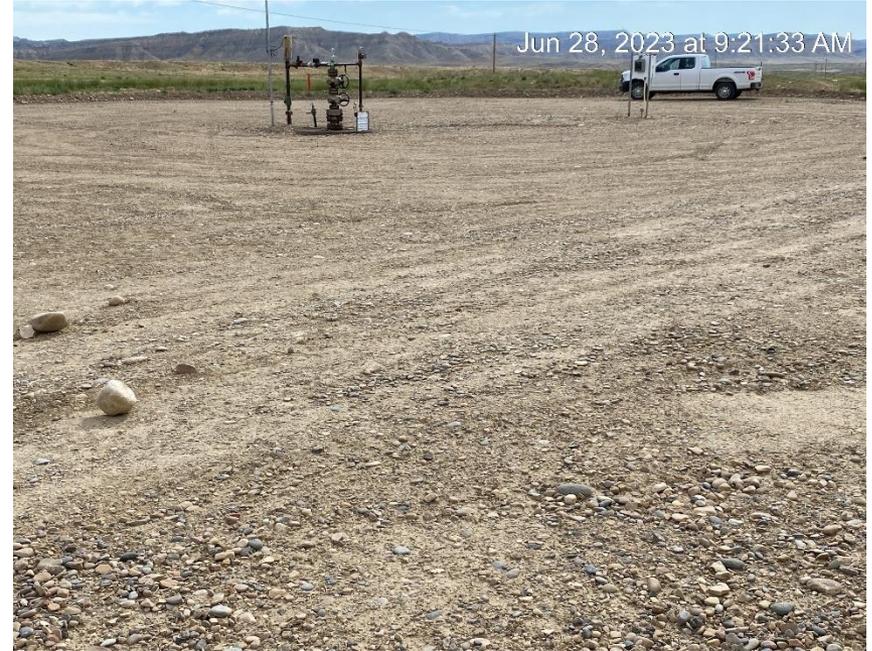
Location view from Southwest corner
