Inspection Photos
Location Name: FARM RANCH EXPLORATIONS#3
Location ID:320067

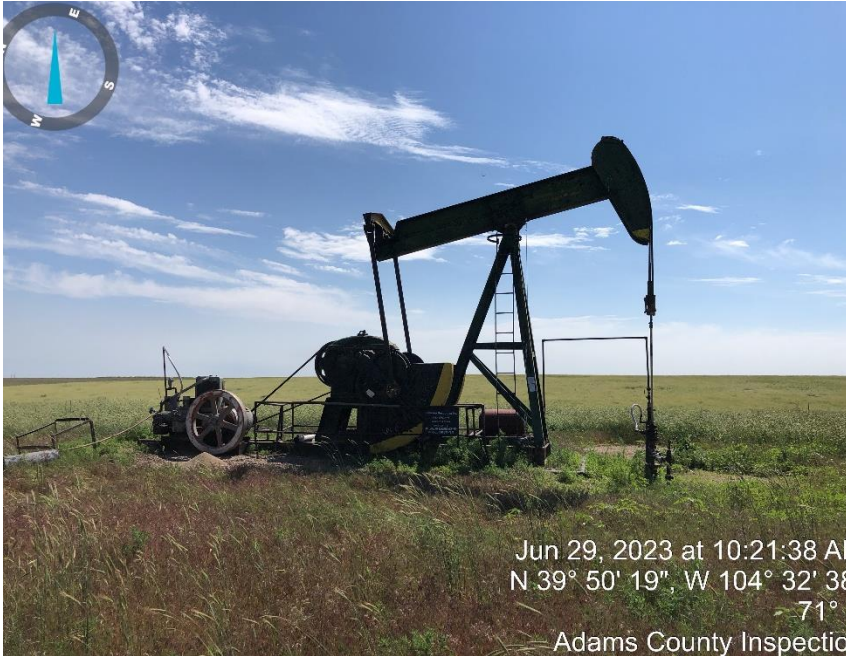
Photo# 1 Pump jack.

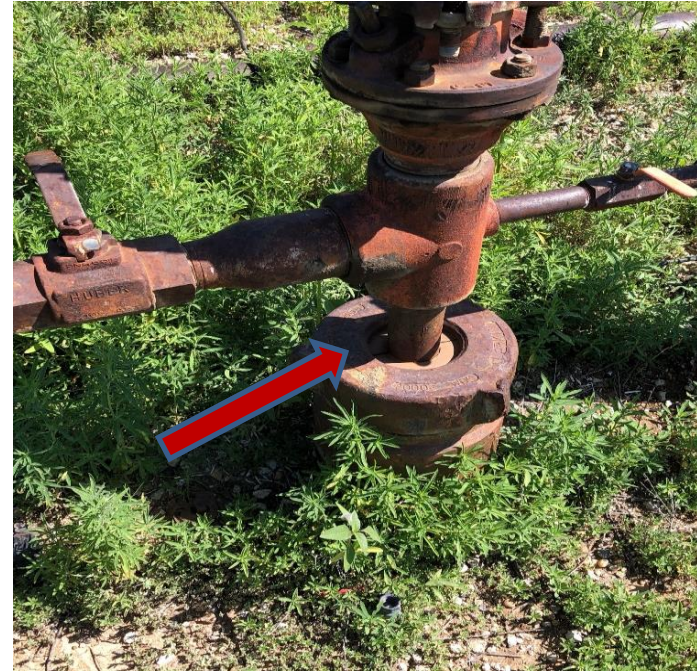
Photo# 2 Packing is leaking at well head.
