Inspection Photos

API: 061-06296

Operator: STRACHAN EXPLORATION INC

Inspection Date: 6/29/2023

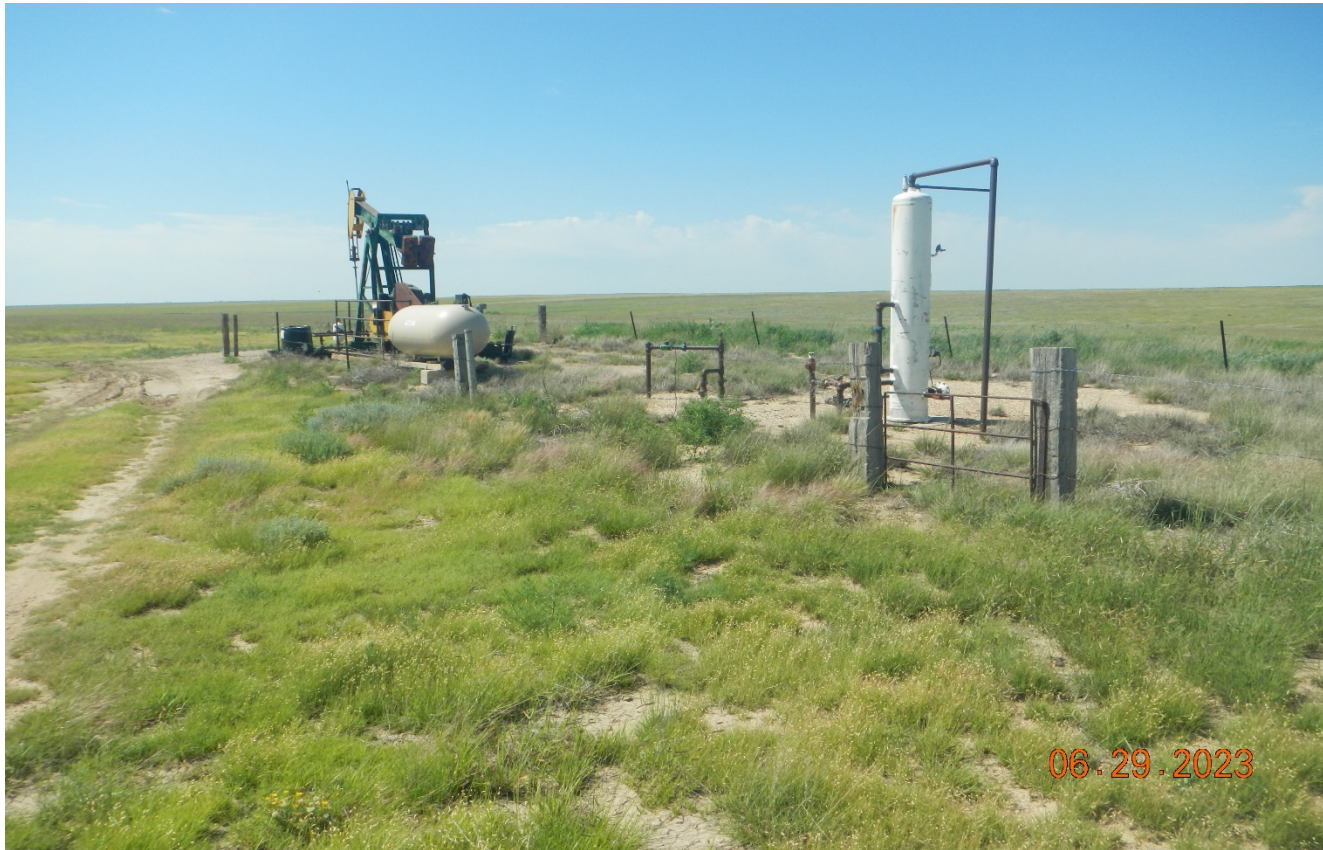
Photo 1. Facing southeast toward the wellsite.

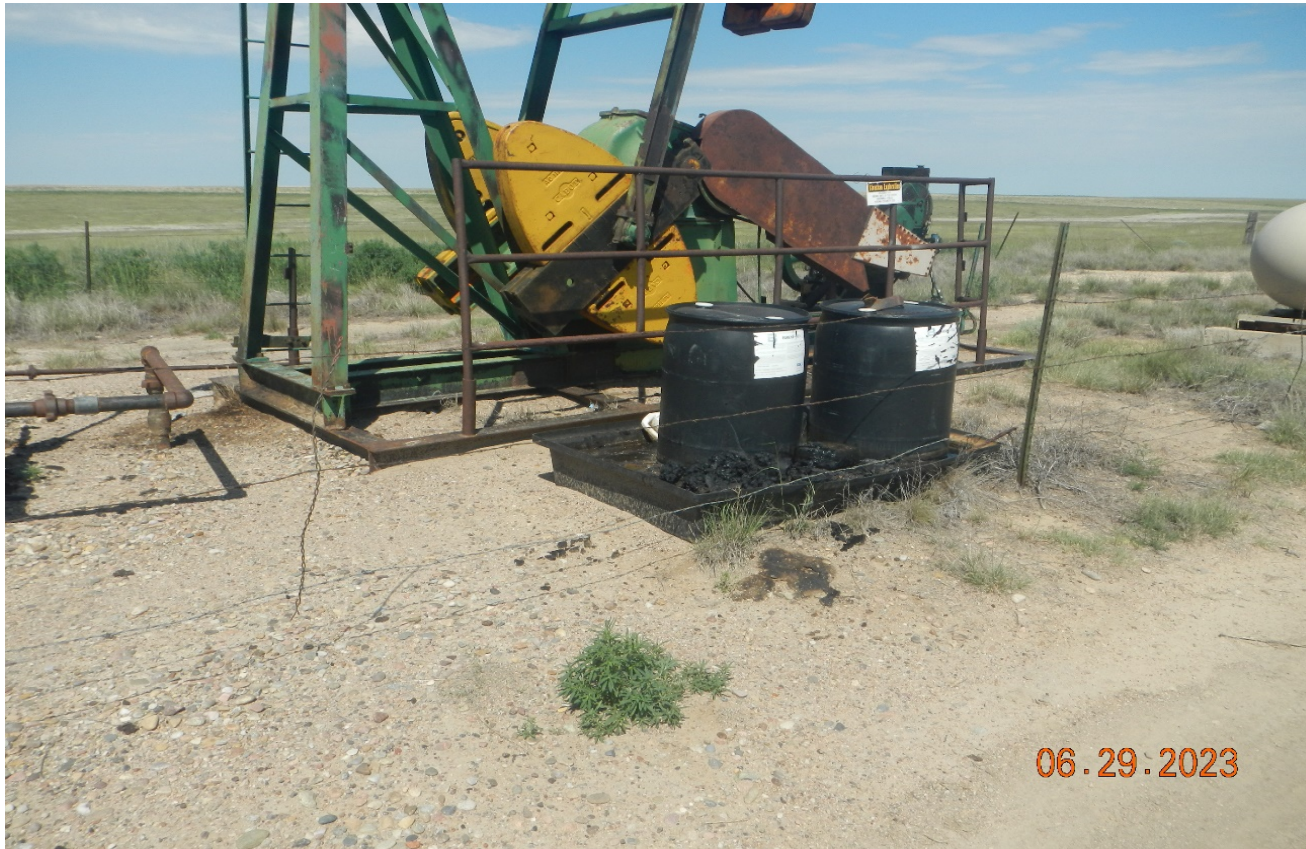
Photo 2. Facing toward the pumpjack. There are two barrel stored in containment with faded labeling.

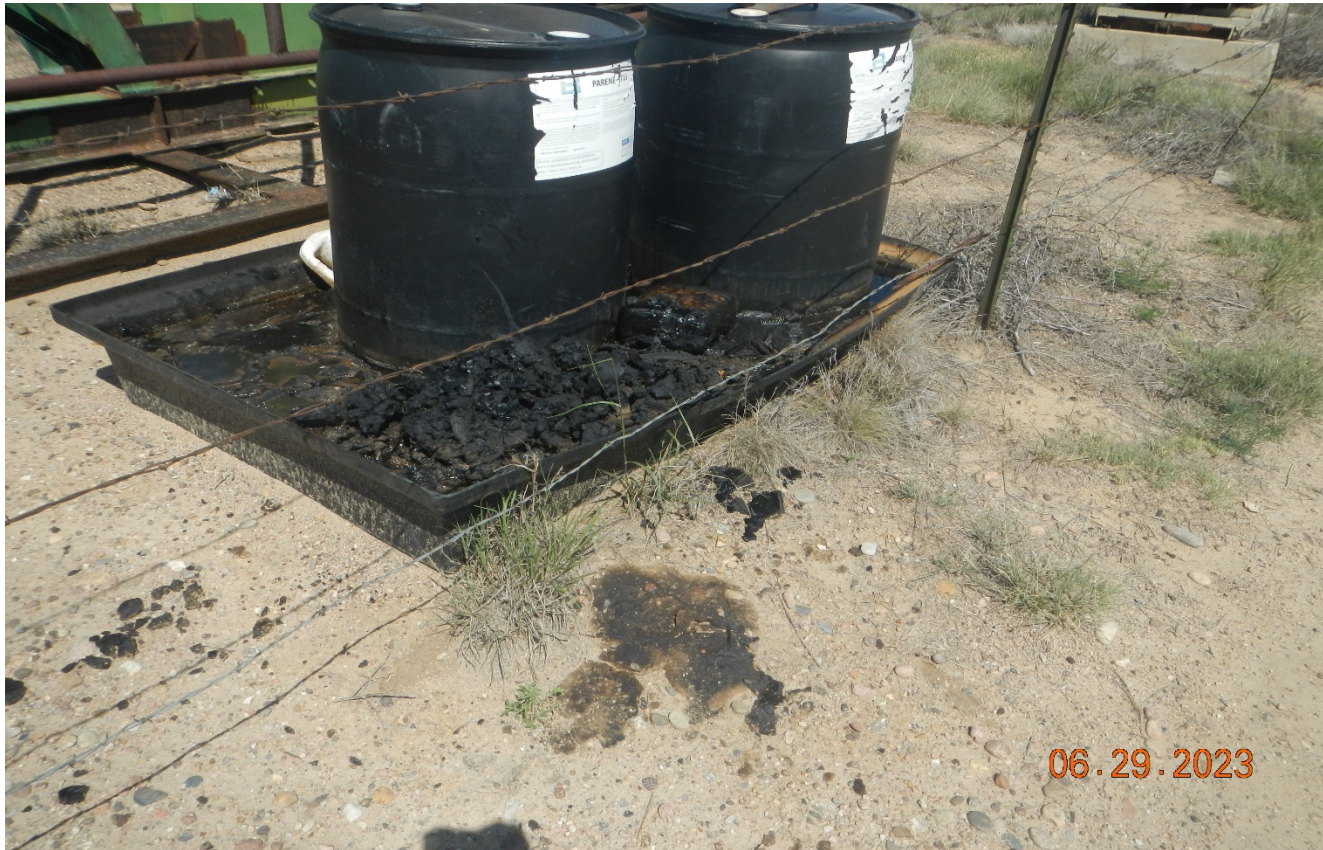
Photo 3. There is oily fluid and sludge that is overtopping the containment and needs immediate cleaned up and disposal.

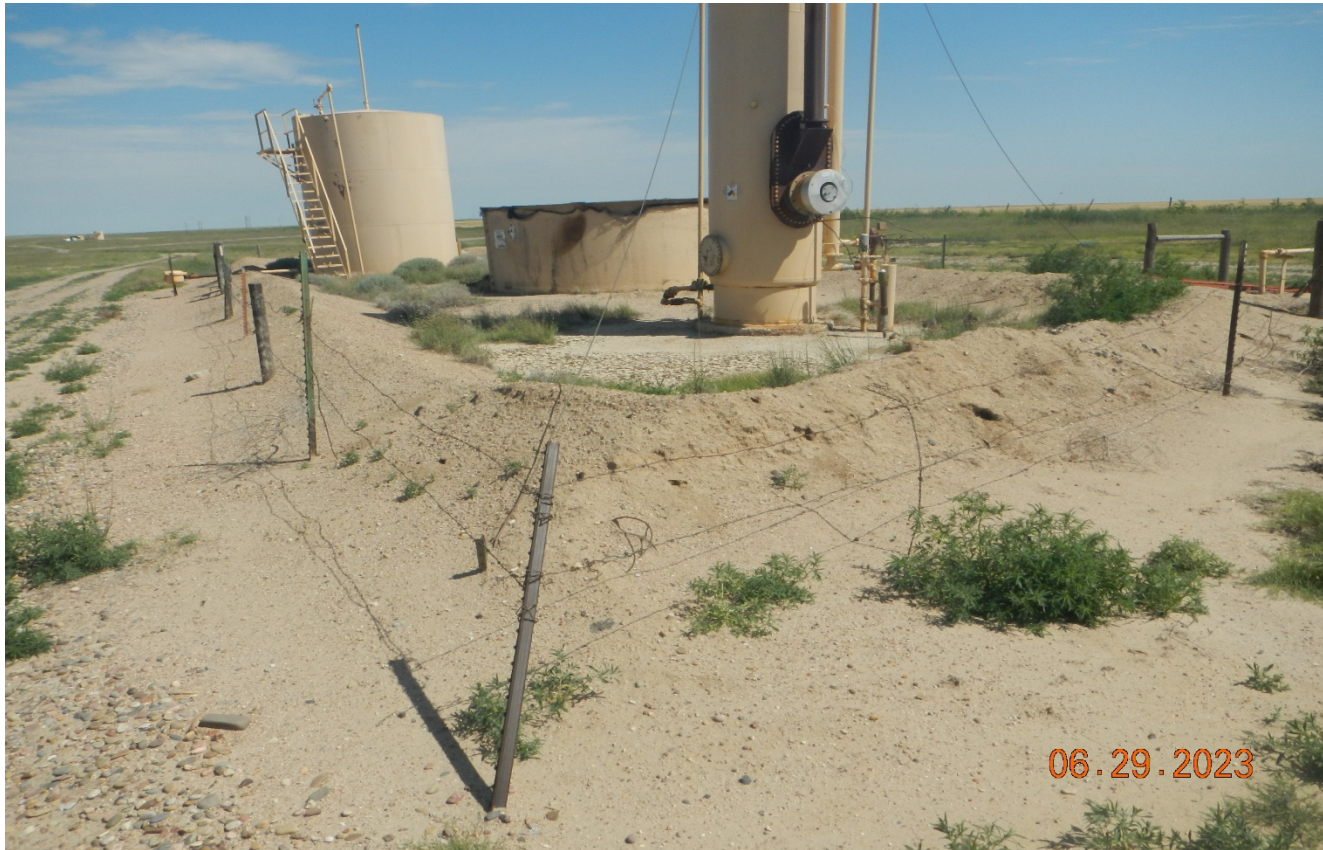
Photo 4. The fence around the tank battery is inadequate to prevent livestock entry and is not maintained. The berm around the tank has animal borrows and is compromised.

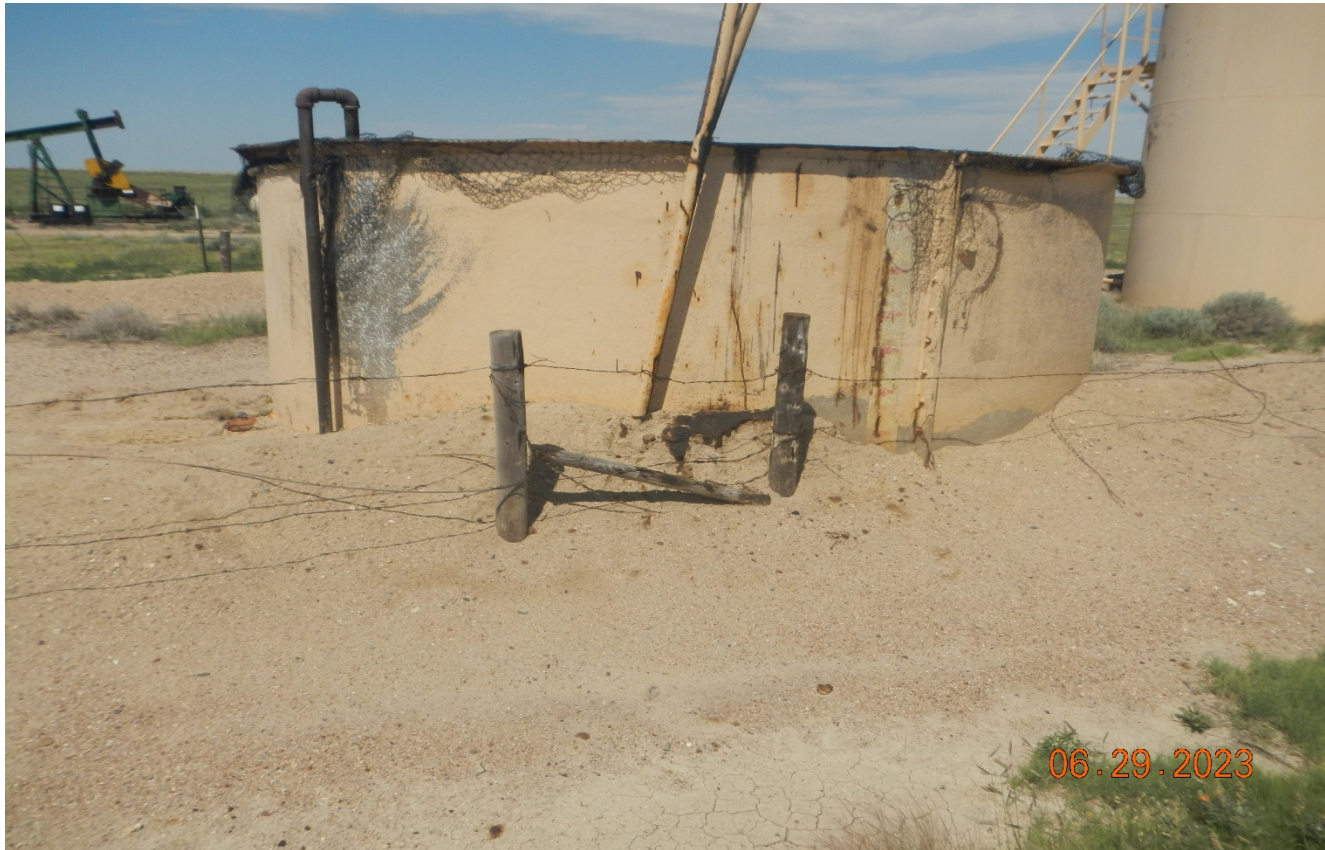
Photo 5. There is oily sludge that has overtopped the tank and berm. The berm is inadequate to contain a spill.

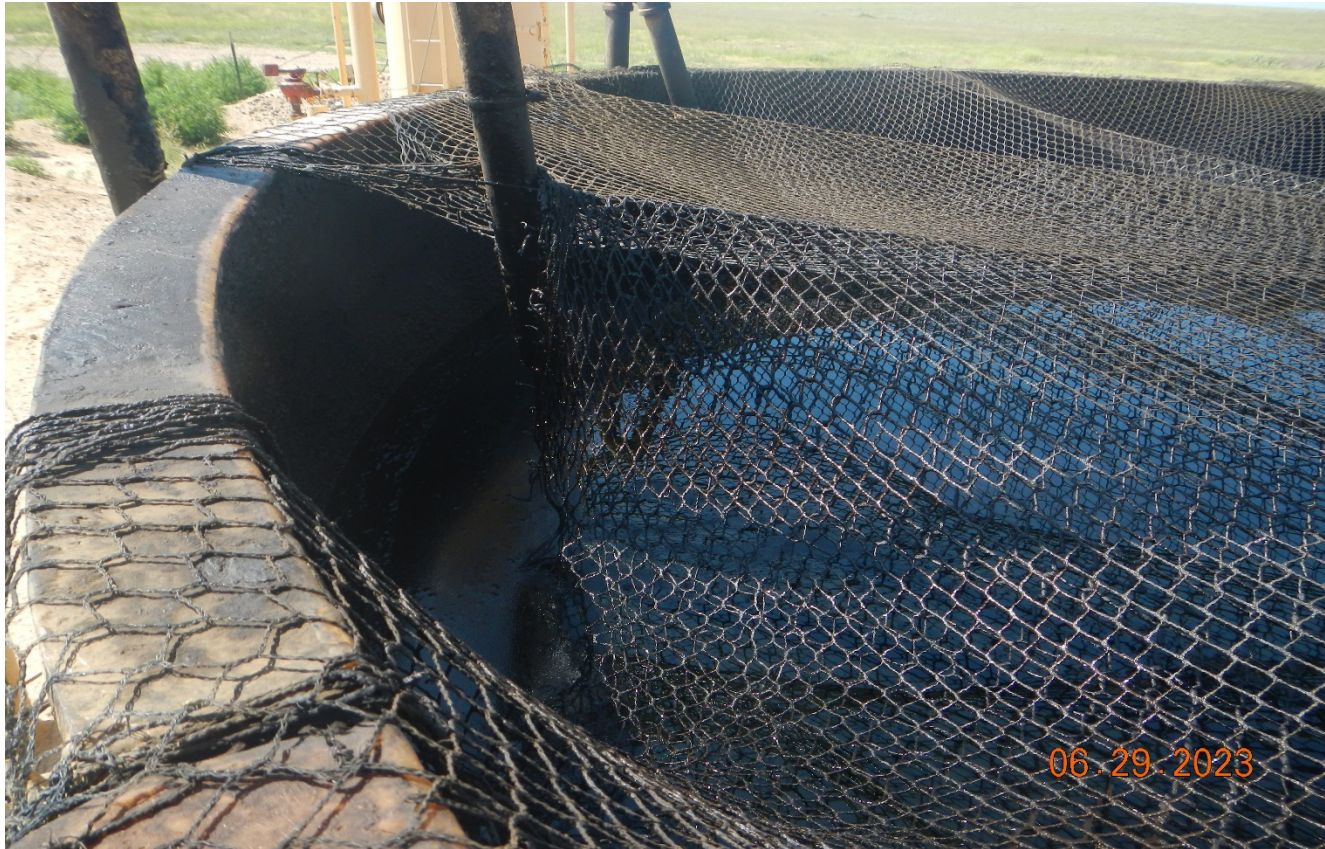
Photo 6. The netting on the open top tank is in disrepair.

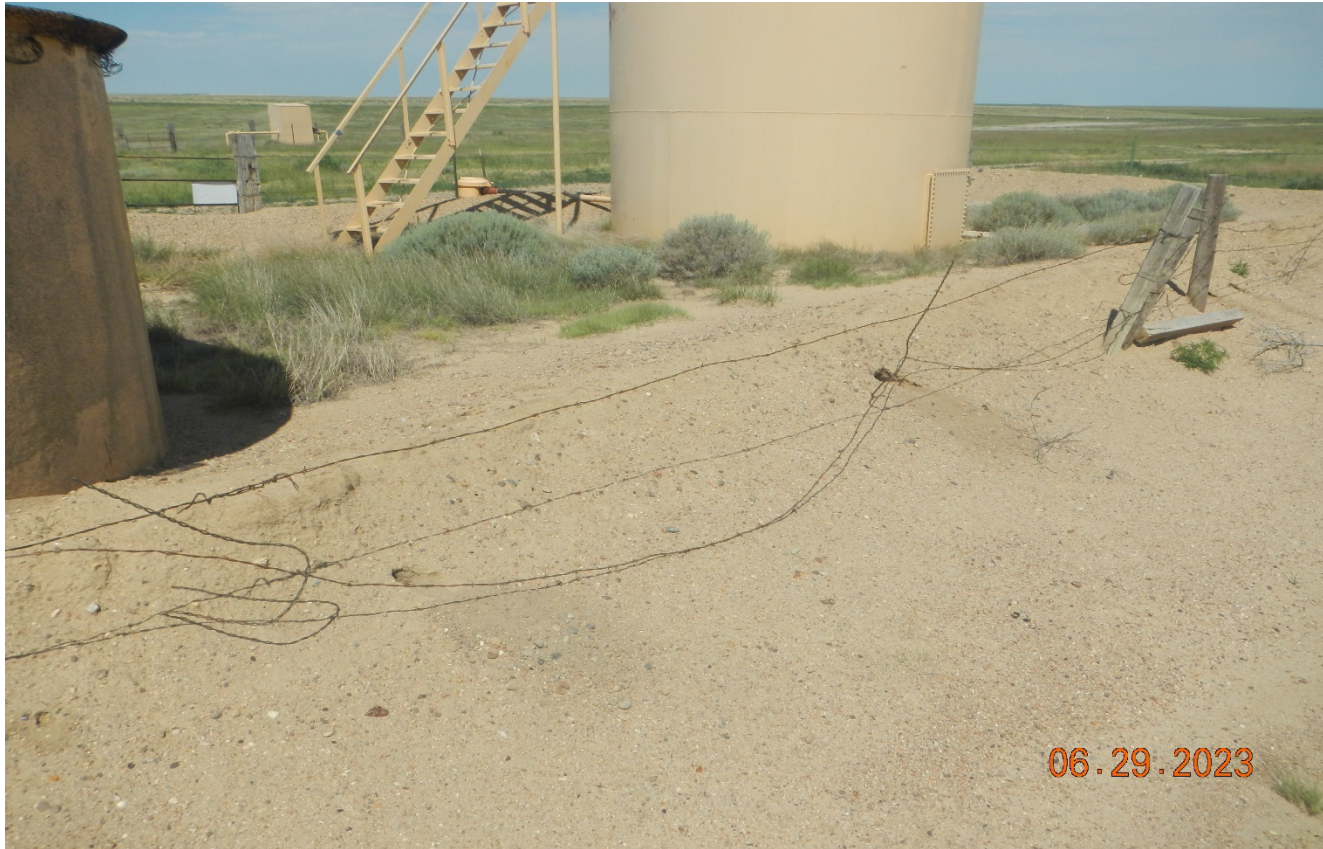
Photo 7. The fence around the tank battery is inadequate to prevent livestock entry and is not maintained.
