Inspection Photos

API: 061-06365

Operator: STRACHAN EXPLORATION INC

Inspection Date: 6/29/2023

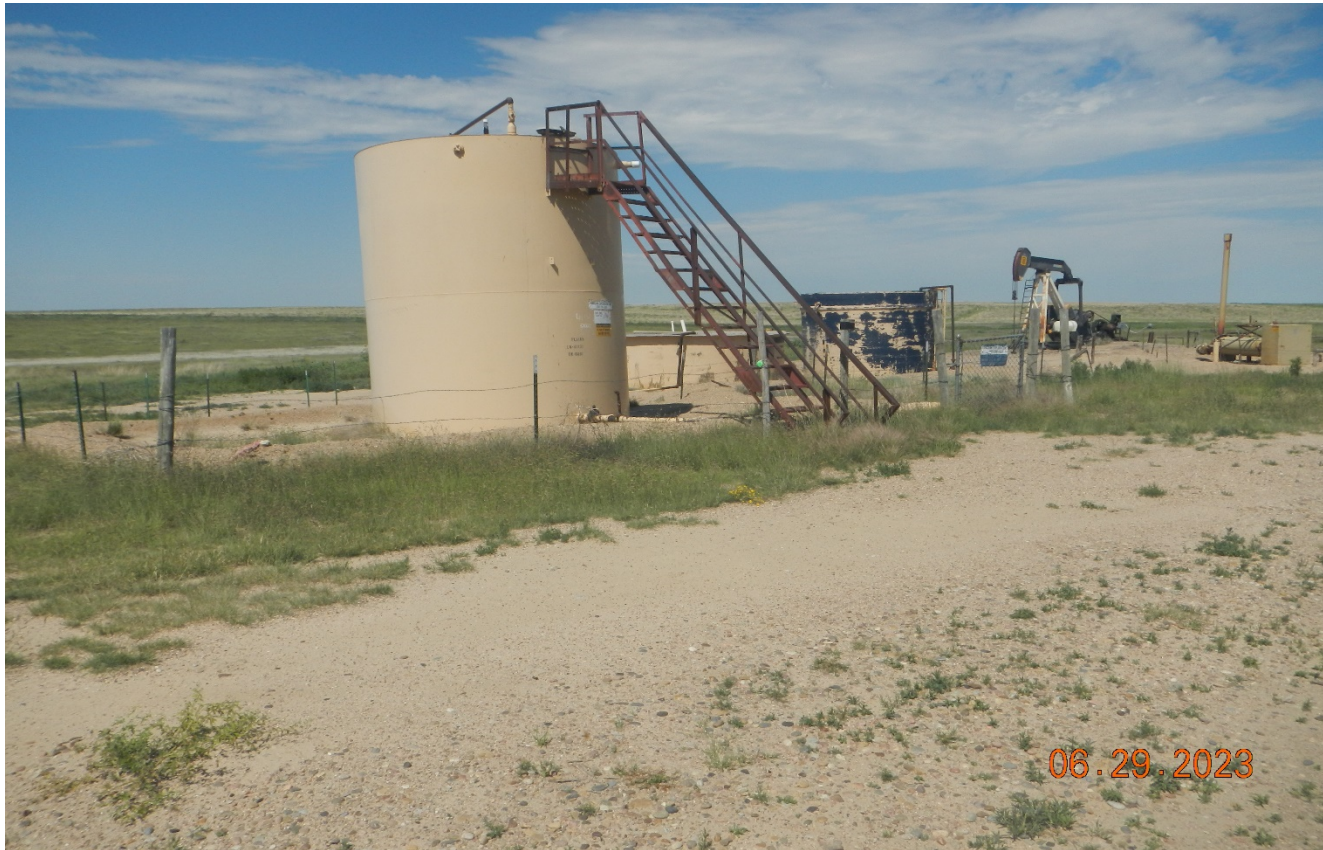
Photo 1. Facing southwest toward the wellsite.

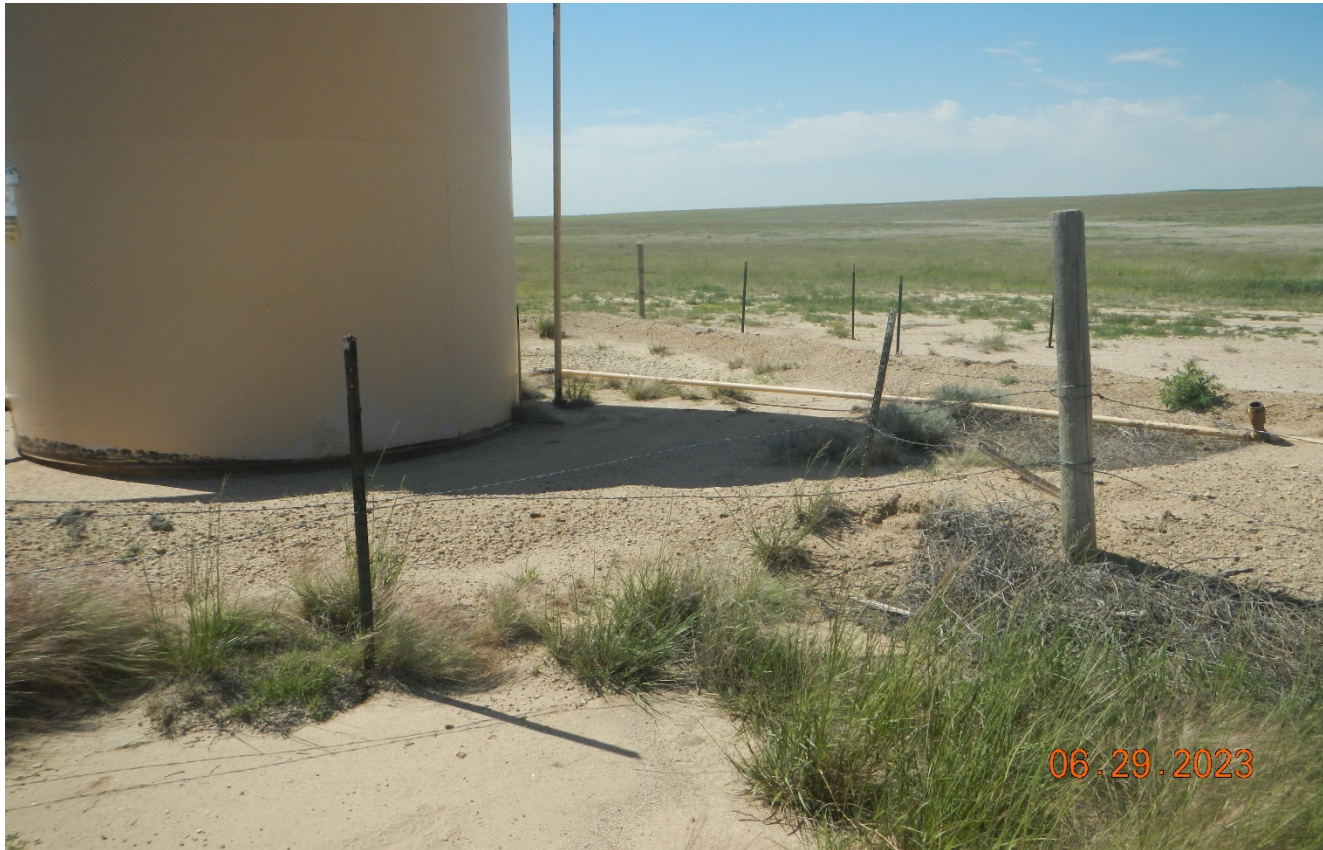
Photo 2. The fence around the tank is inadequate to prevent livestock entry and is not maintained. The berm around the tank is insufficient to contain a spill (150% of tank capacity).

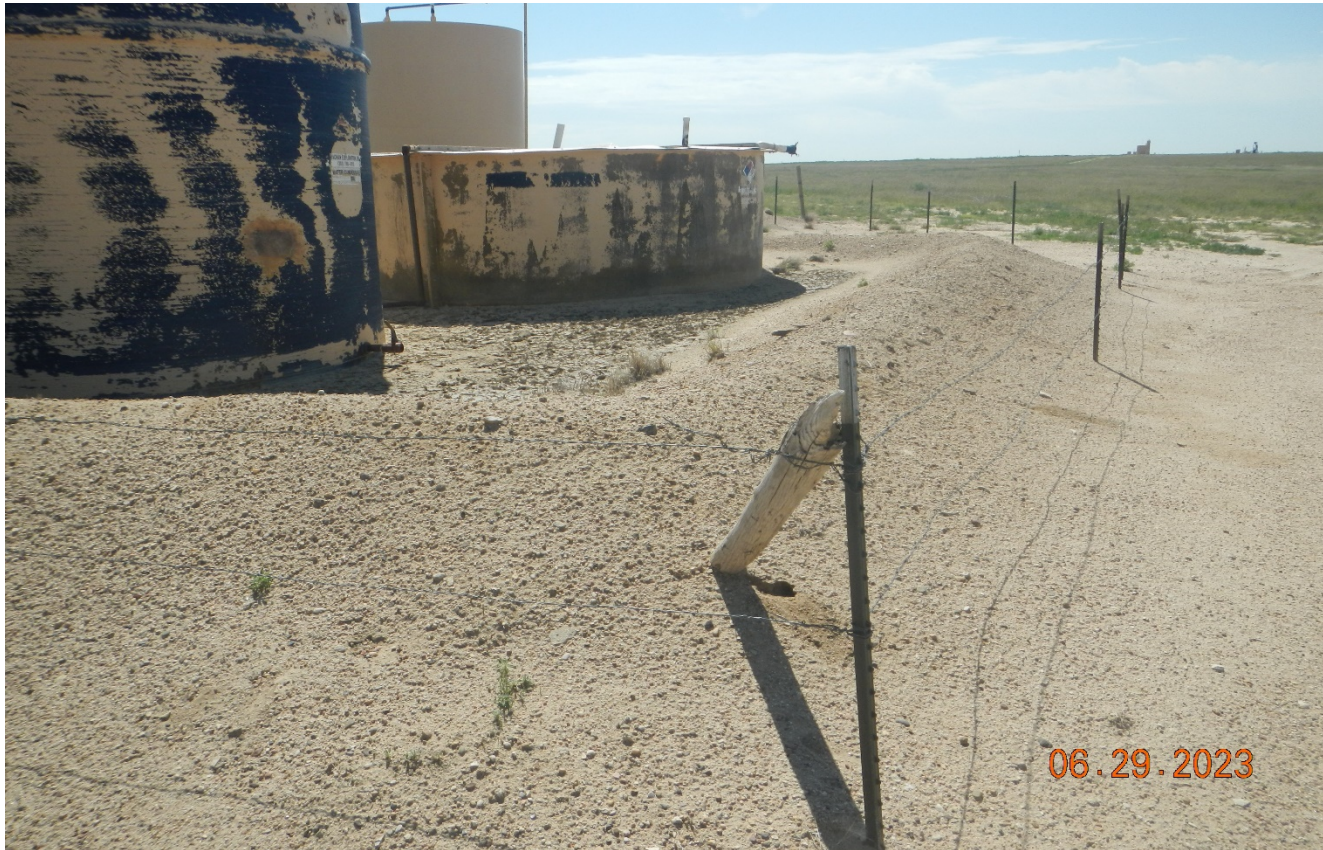
Photo 3. Facing at the backside of the open top tanks. The labeling on the tanks is missing and/or inadequate. The fence around the open top tank is inadequate to prevent livestock

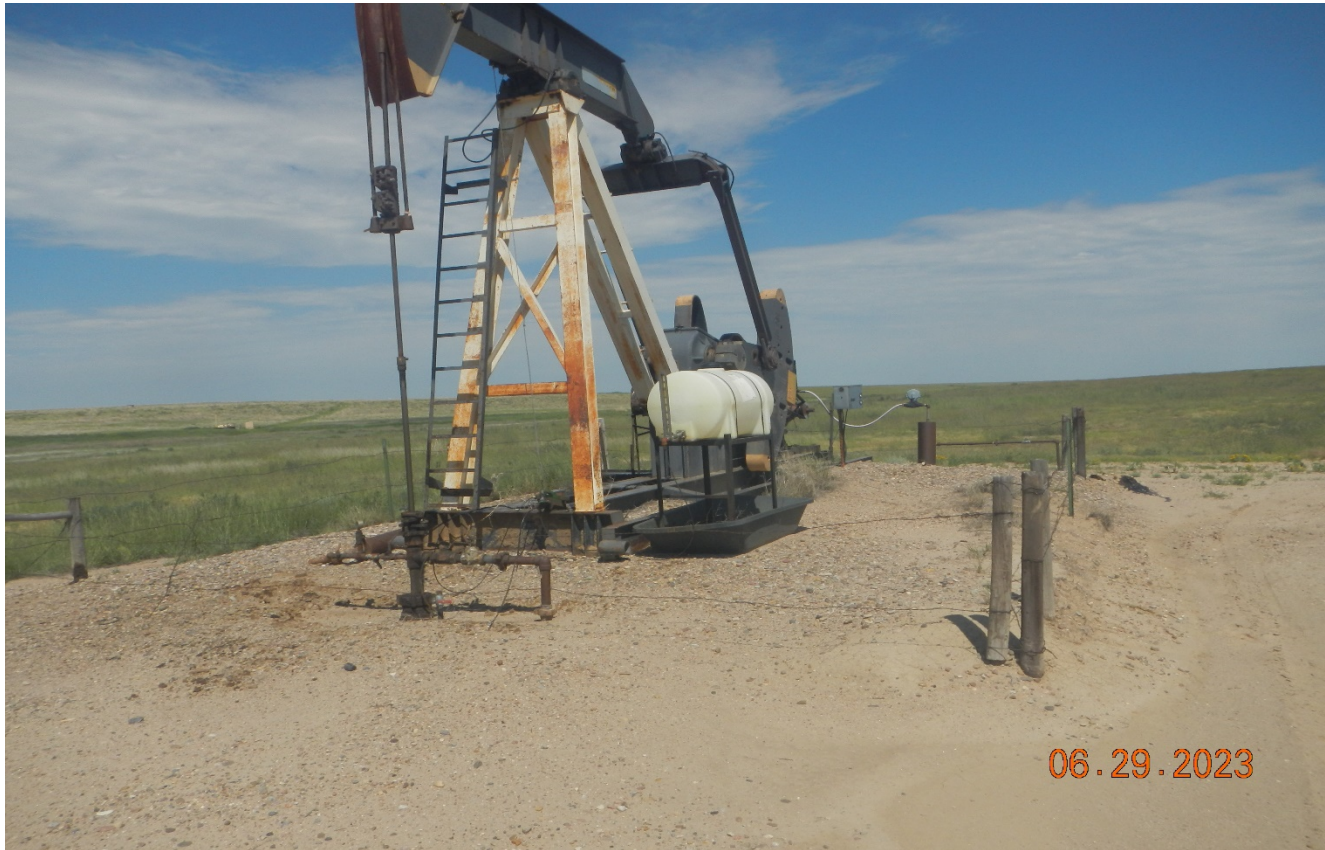
Photo 4. Facing toward the pumjack.

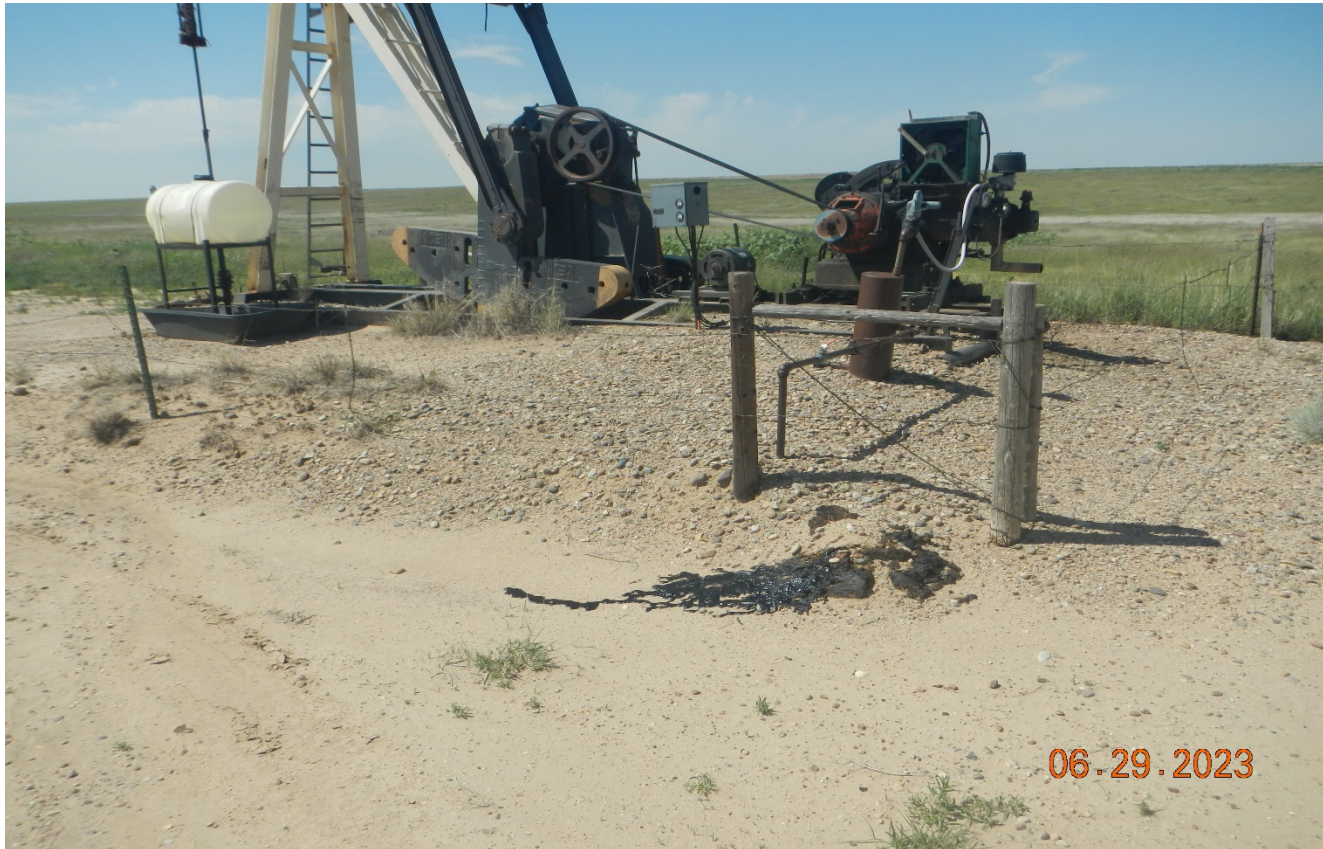
Photo 5. There is oily sludge that has spilt onto the ground that needs to be cleaned up.

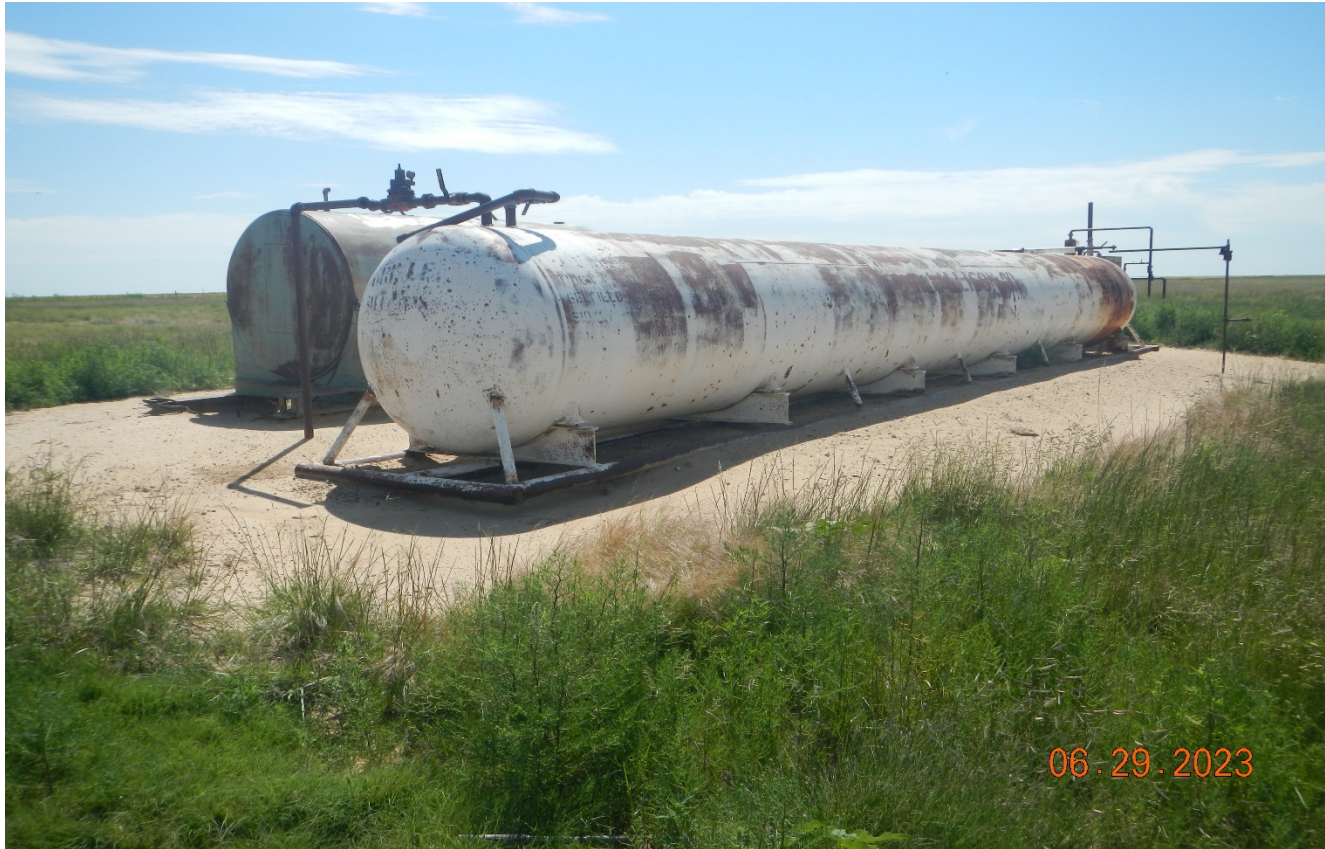
Photo 6. There is no labeling or secondary containment at these two large volume tanks.

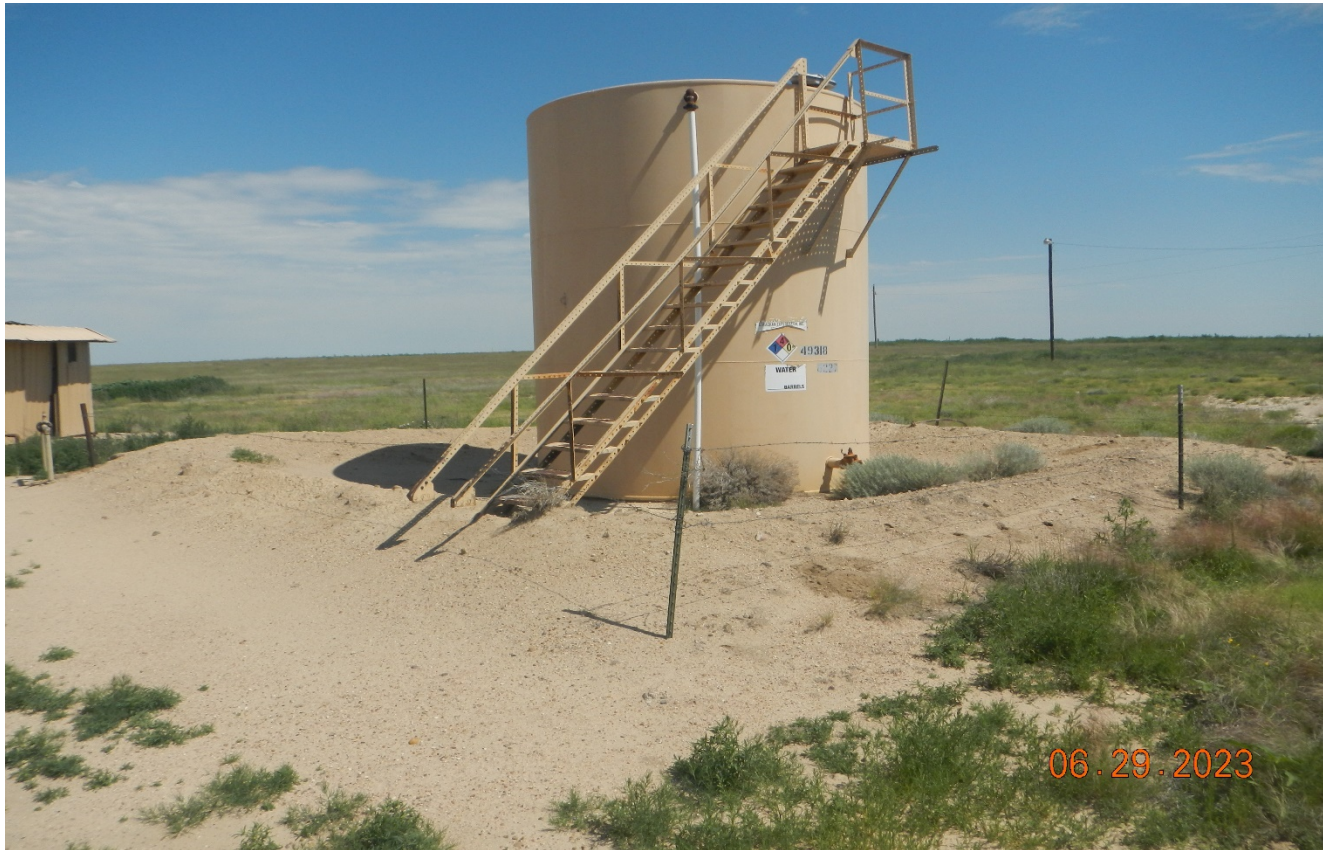
Photo 7. Facing at the north side of the location. The fence around the tank battery is inadequate to prevent livestock entry and is not maintained. Berm is insufficient to contain a spill (150% of tank capacity).
