Inspection Photos

API: 061-06459

Operator: STRACHAN EXPLORATION INC

Inspection Date: 6/29/2023

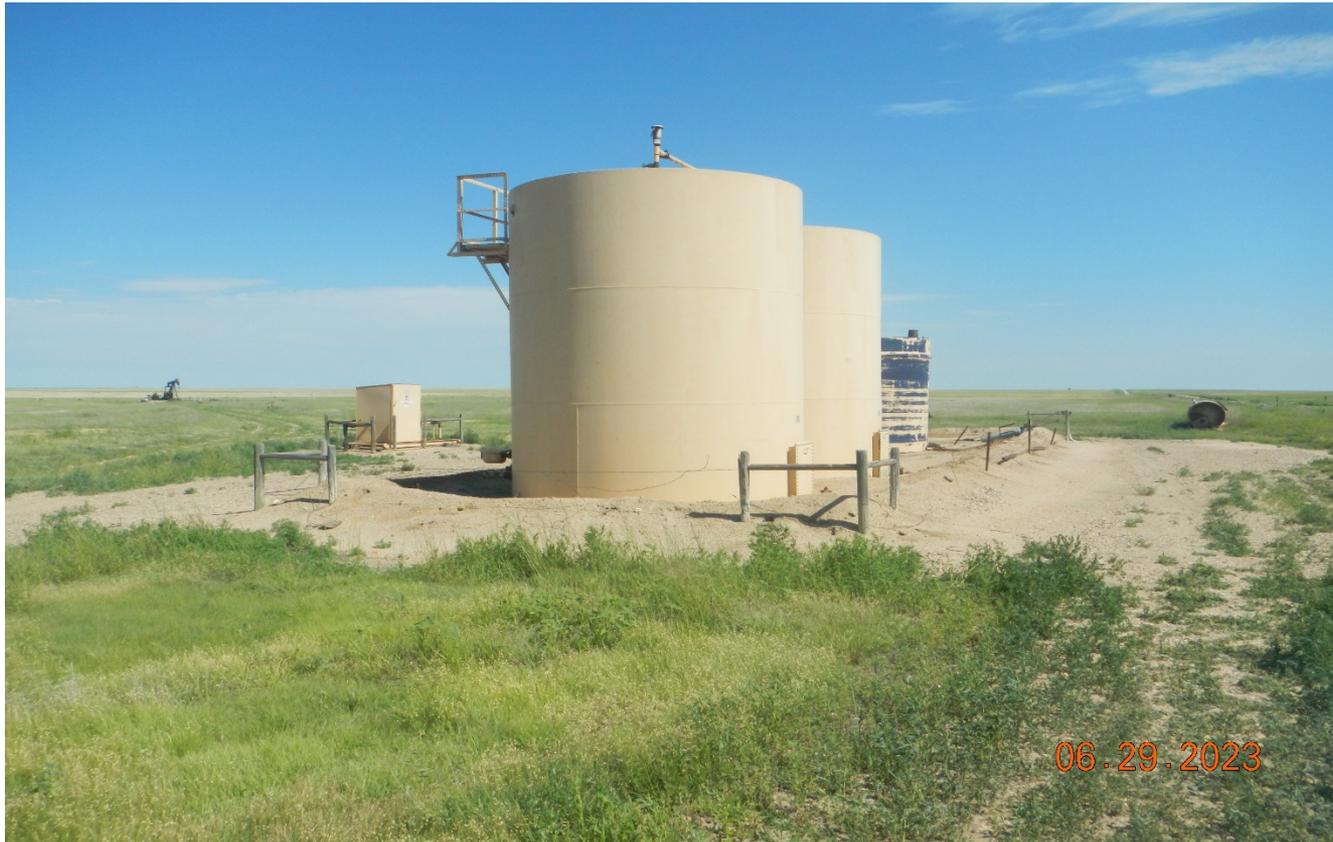
Photo 1. Facing toward the offsite tank battery.

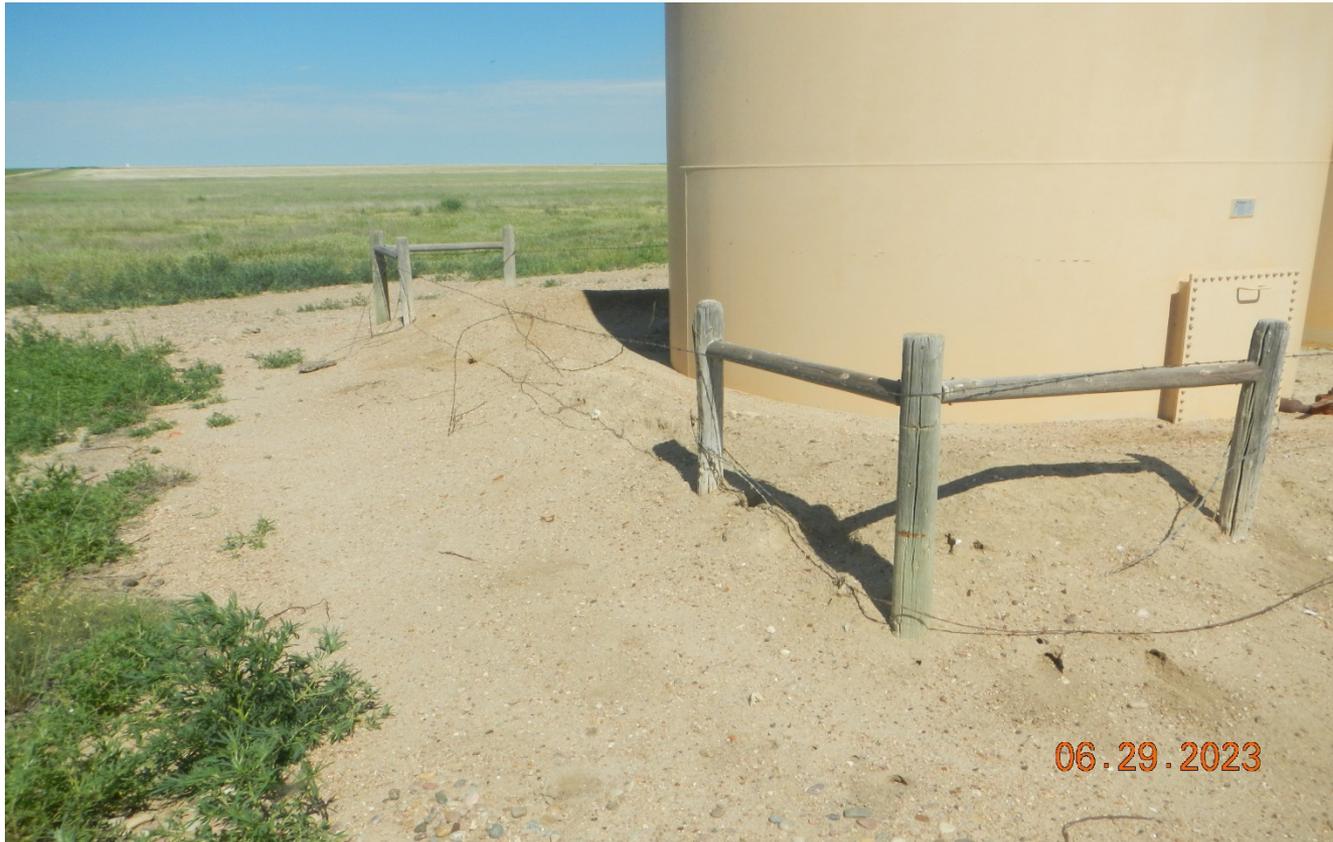
Photo 2. The fence around the tank is inadequate to prevent livestock entry and is not maintained. The berm around the tank is insufficient to contain a spill (150% of tank capacity) and has animal borroughs the sides.

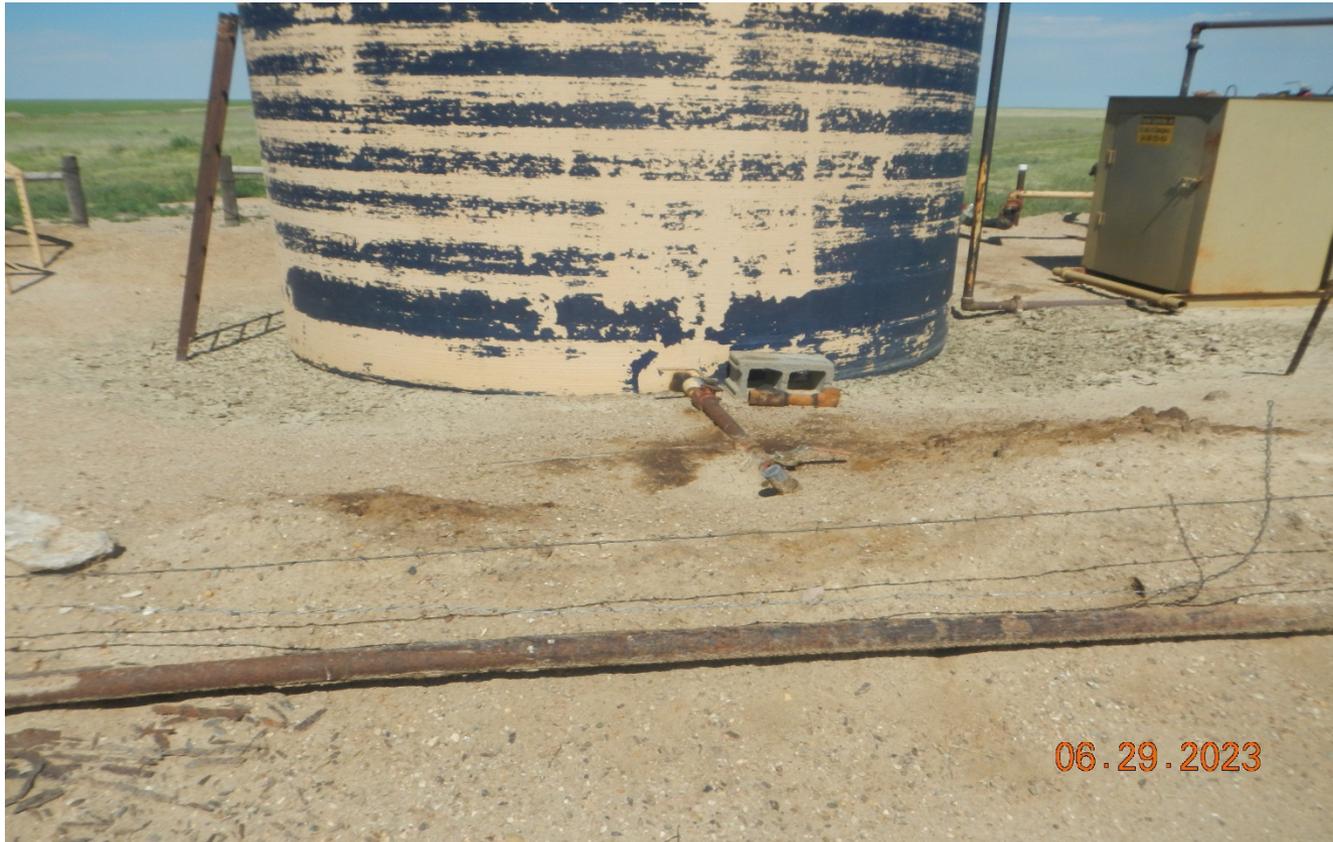
Photo 3. There is stained soils that need to be cleaned up.

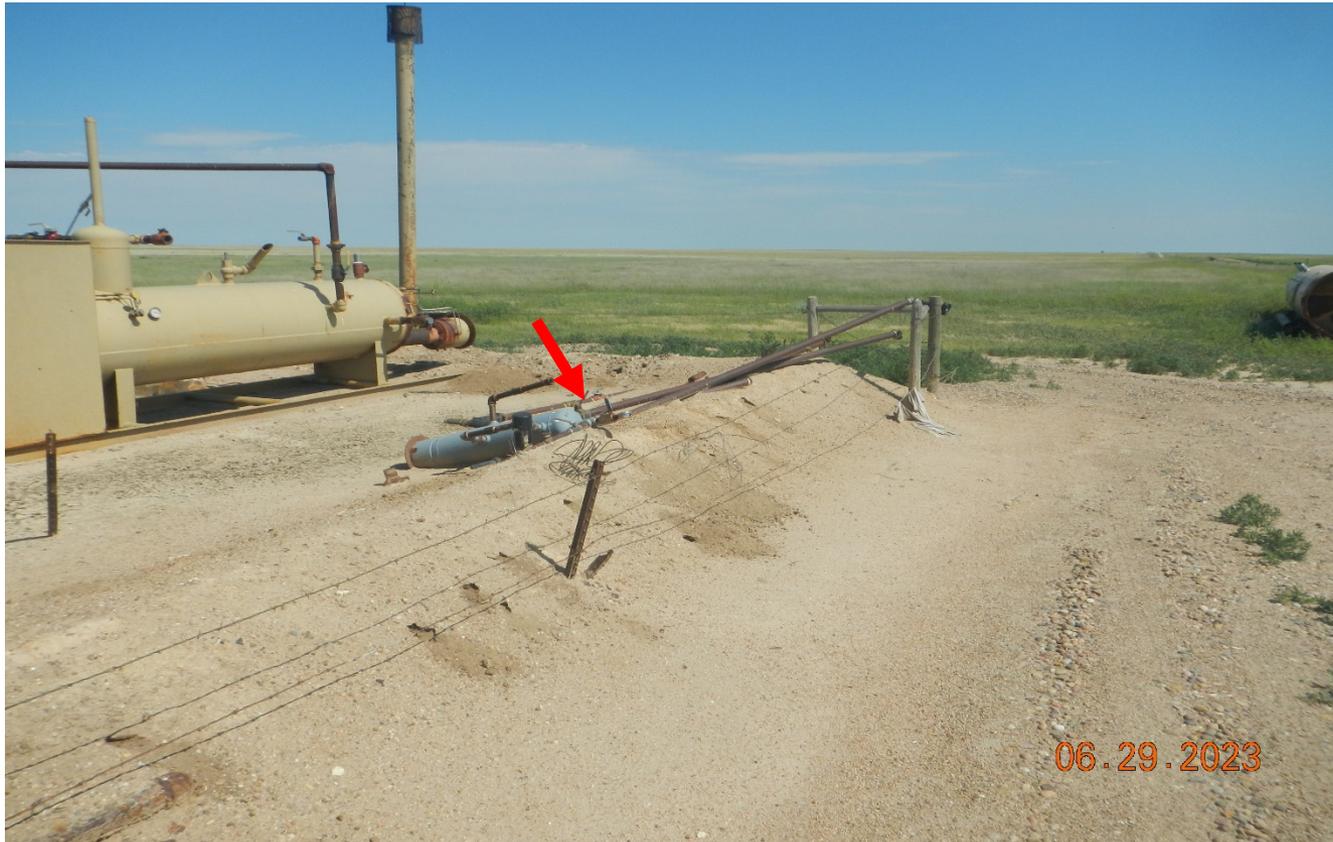
Photo 4. There is unused disconnected pipe that needs to be removed.

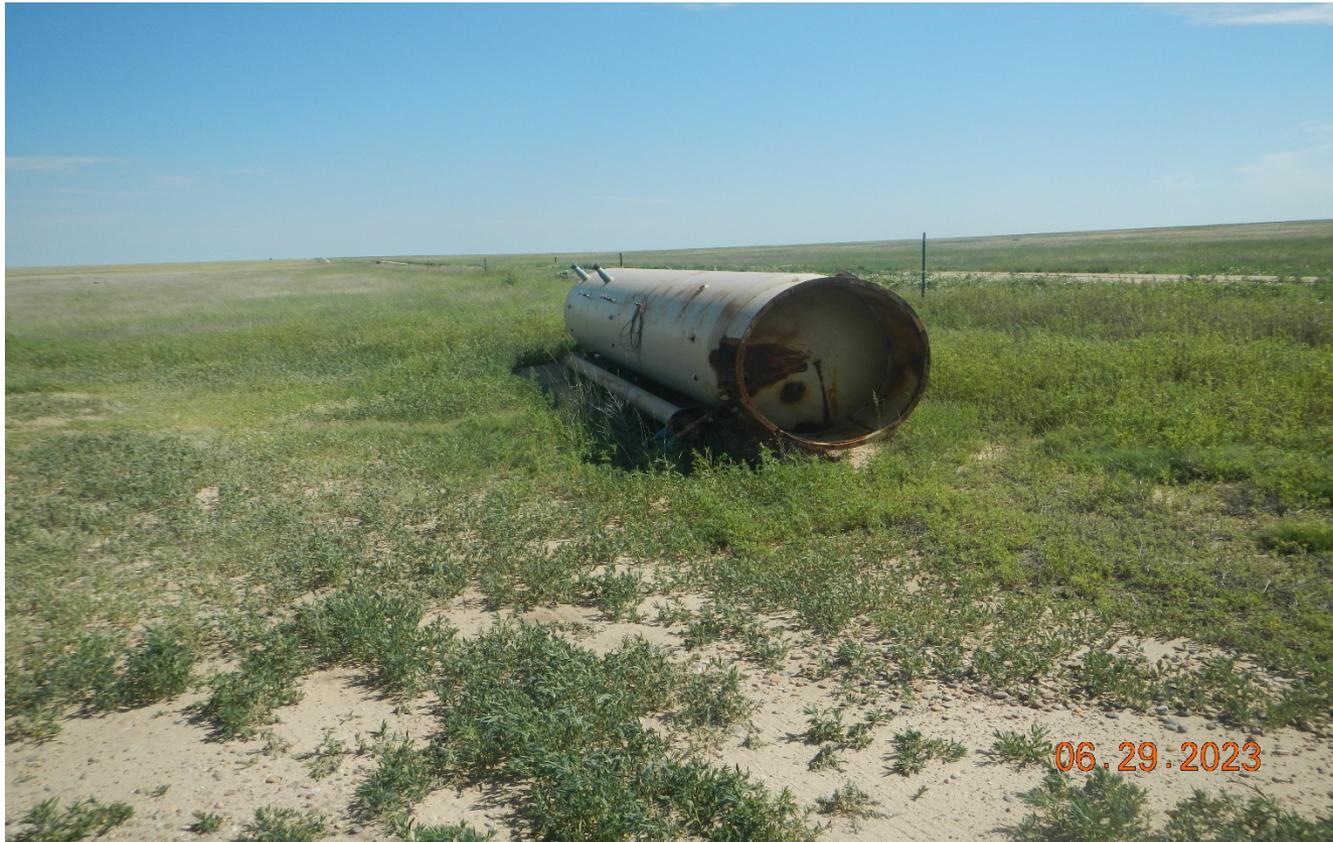
Photo 5. This tank is not in use and needs to be removed.

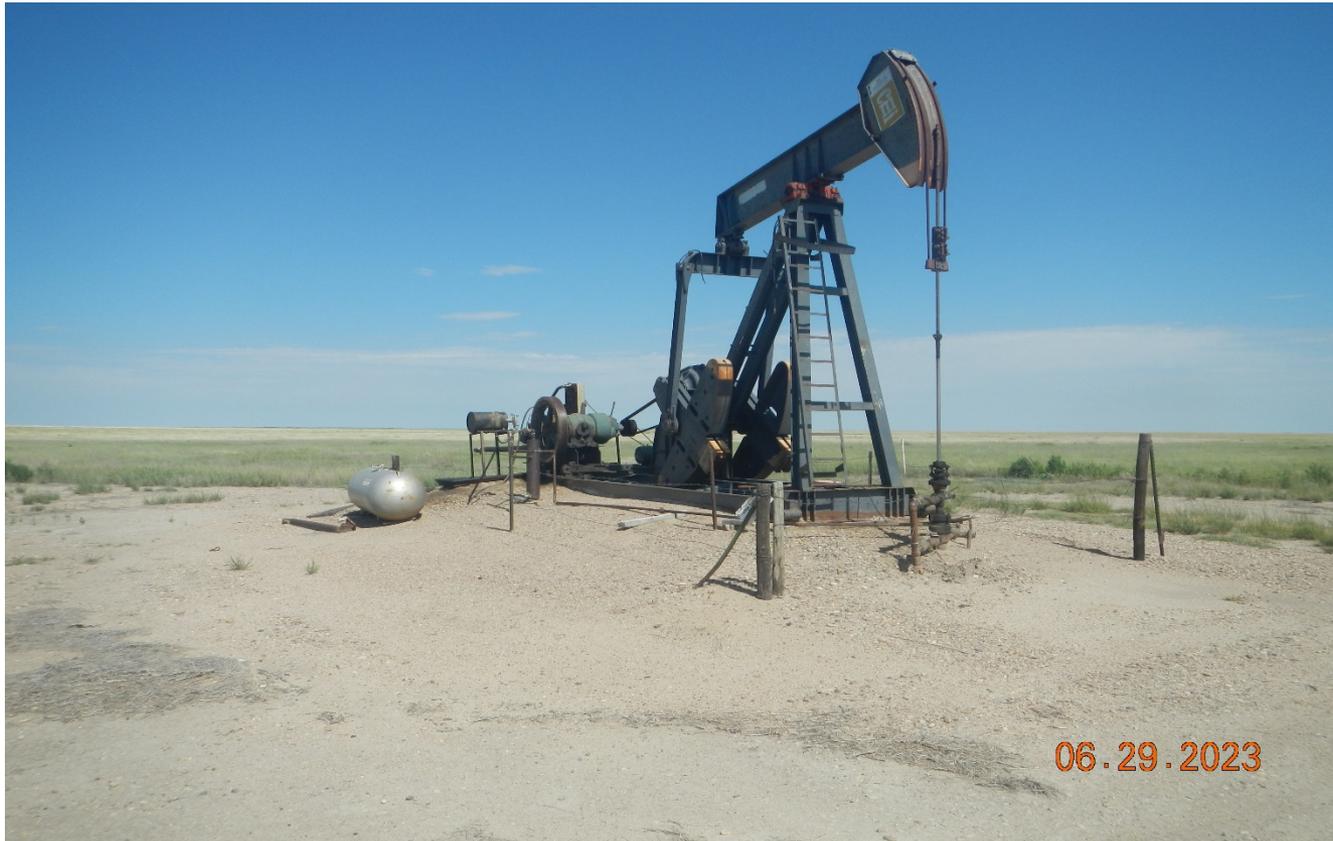
Photo 6. Facing toward the wellsite. There is no sign posted at the wellhead.

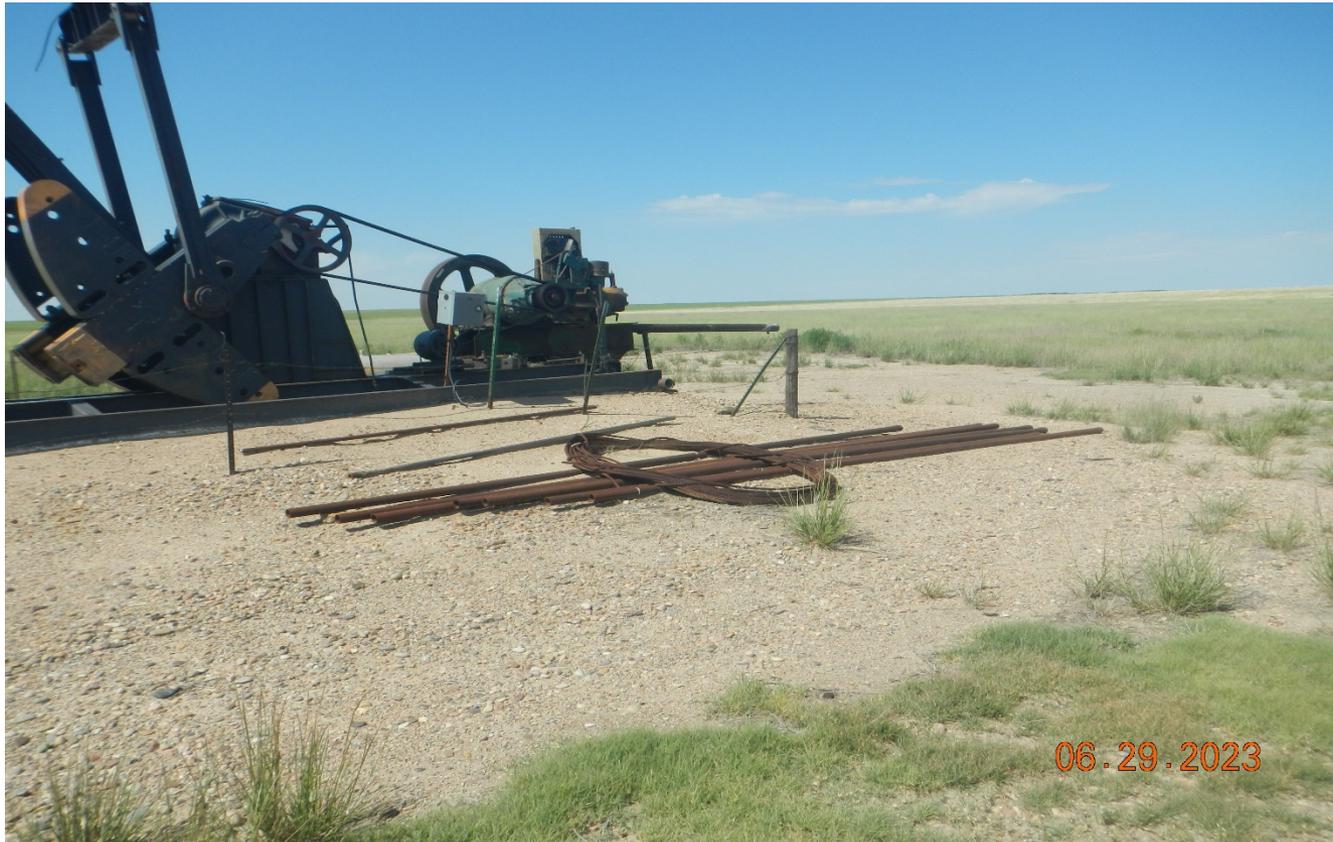
Photo 7. There is unused pipe and cable that need to be removed.

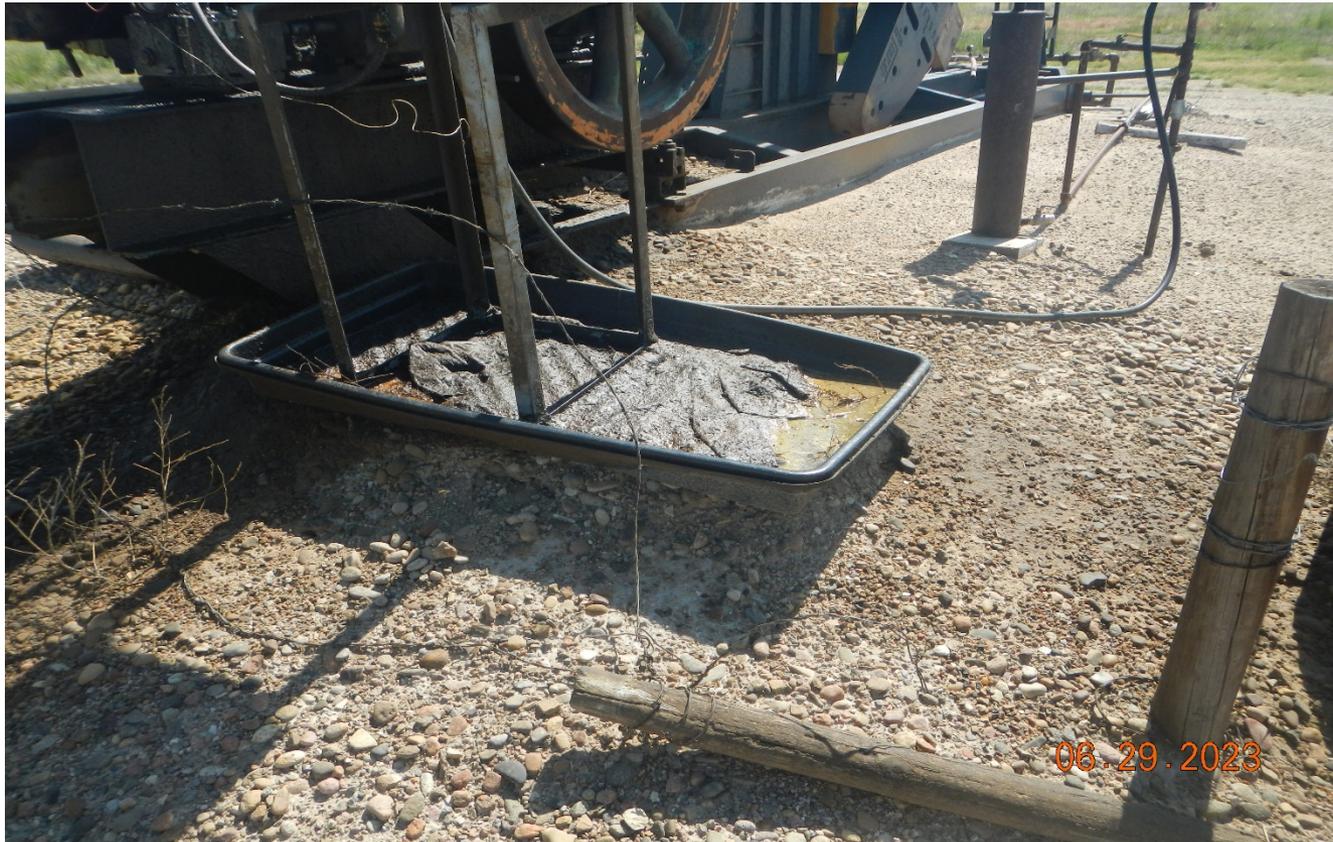
Photo 8. There is oily fluid in the containment next to the pump jack. Oily fluid has spilled onto the ground and needs to be cleaned up.
