Inspection Photos

Location
Well 081-06472
Inspection
Date:6/26/2023

All Photos taken
by Kris Neidel

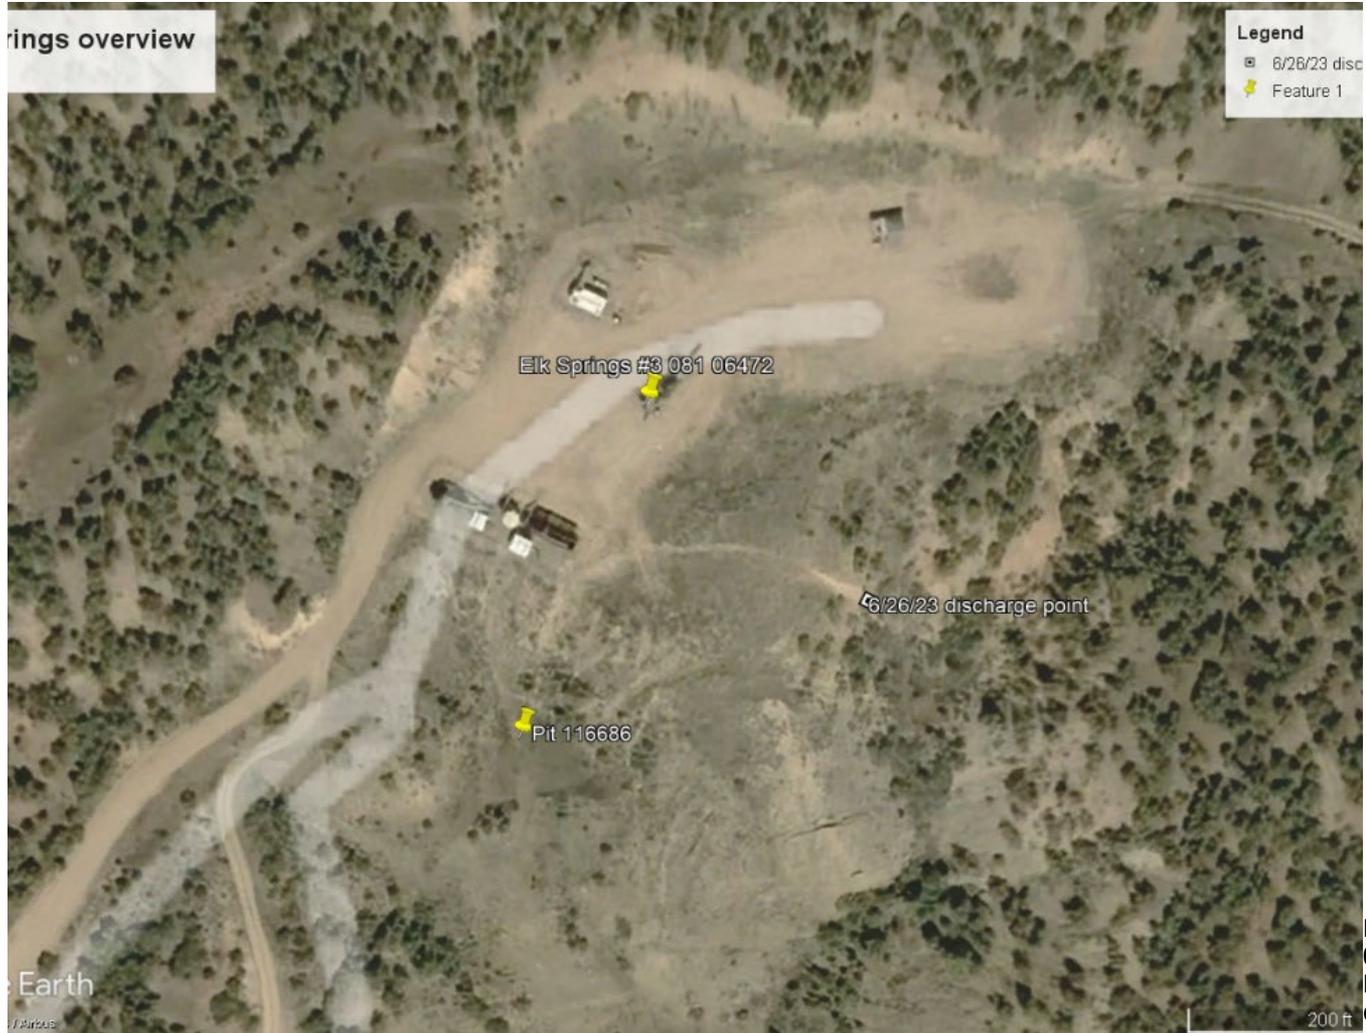
Figure #1, Overview of; API:05-081-06472 Elk Springs #3 well, Settling Pond (pit #116686) and Current discharge point.

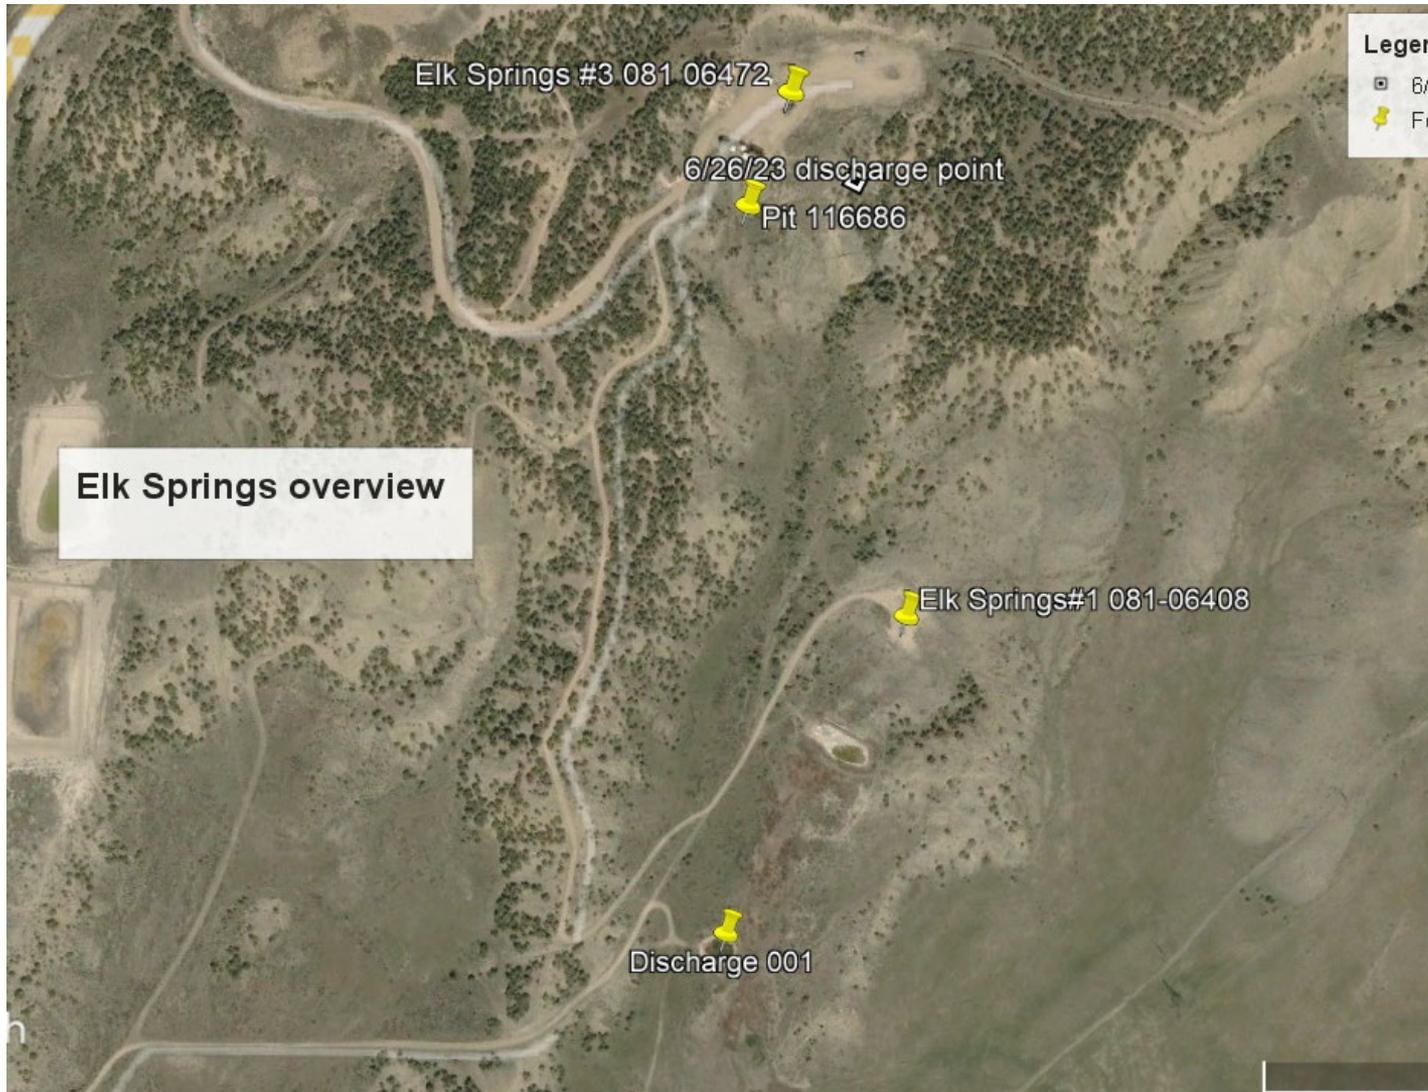
Figure #2 Same as Figure #1 with addition of Elk Springs #1 (API: 05-081-06408 well and area identified in original discharge permit as "Discharge 001"

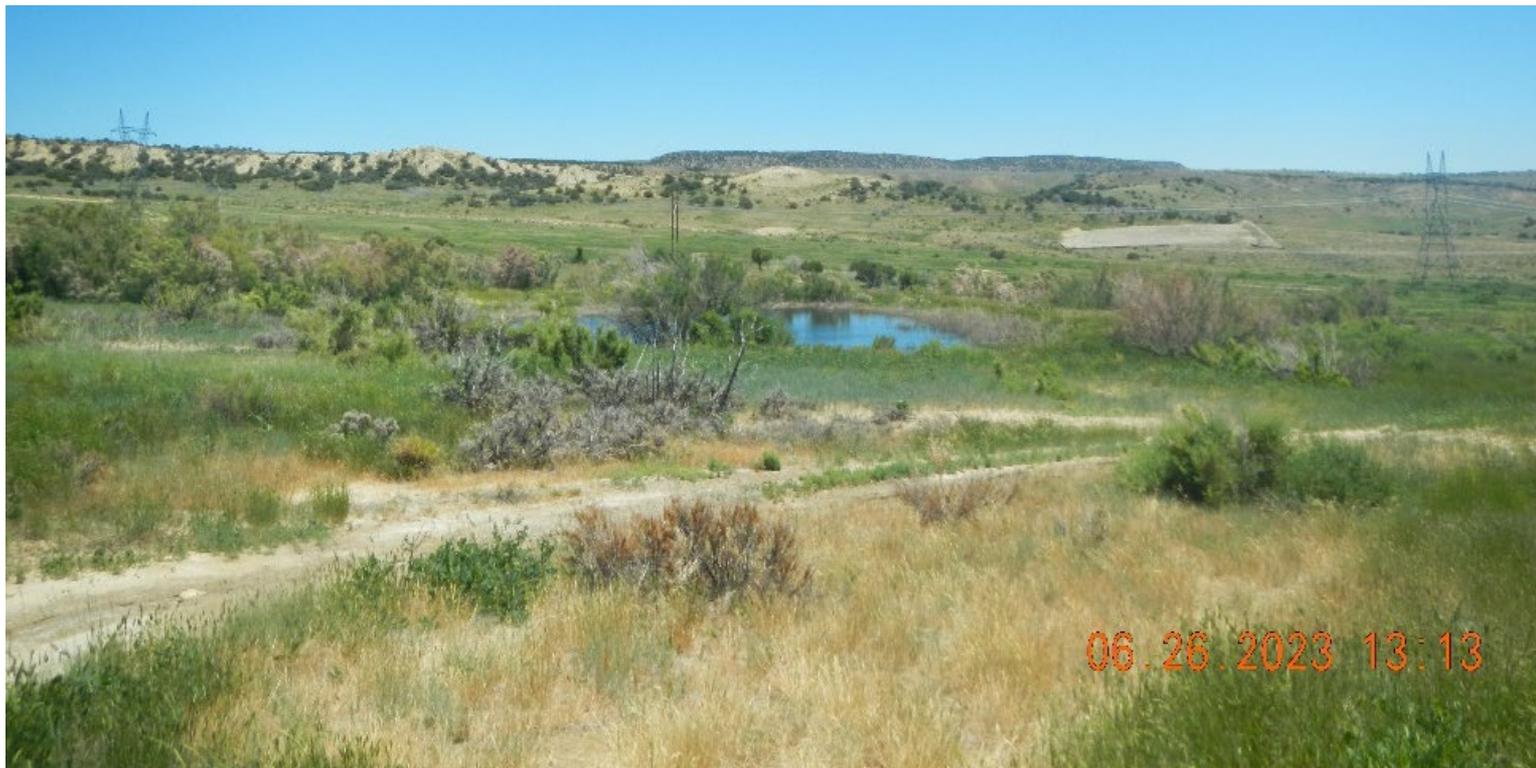
Photo #1 Area believed to be the pond identified as “Discharge 001” in the original Produced Water Discharge permit CO-0039683 “COGCC doc #657311”. The pond appeared clear and free of hydrocarbon.

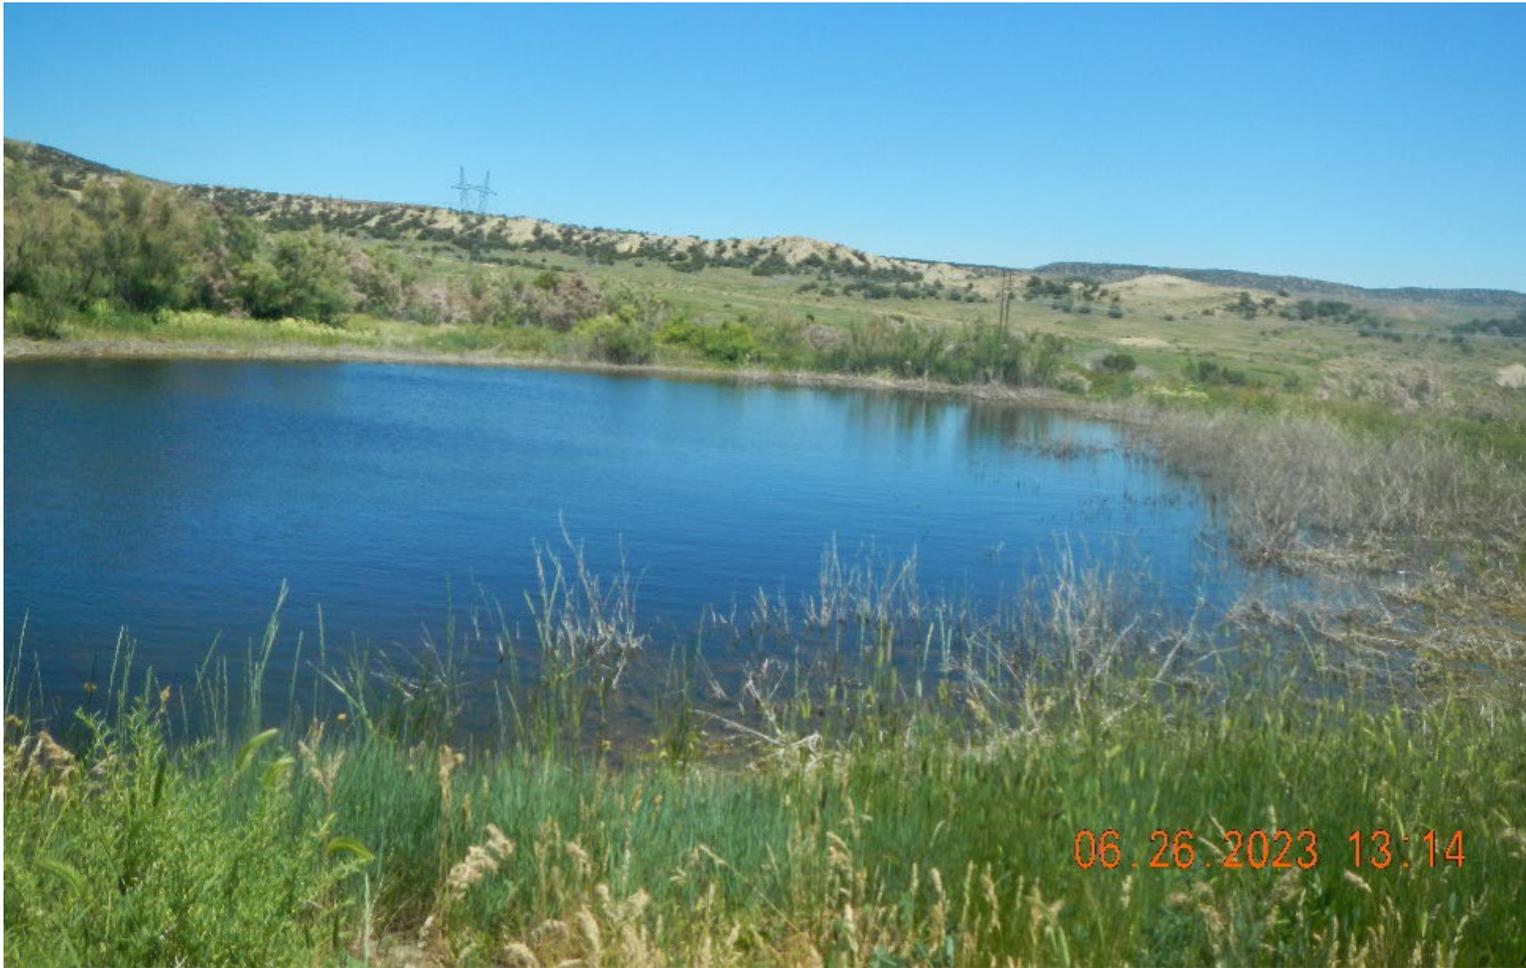
Photo #2 Close up of lower pond, near 40.34784,-108.445479. No matted vegetation or Hydrocarbon was observed in this pond.

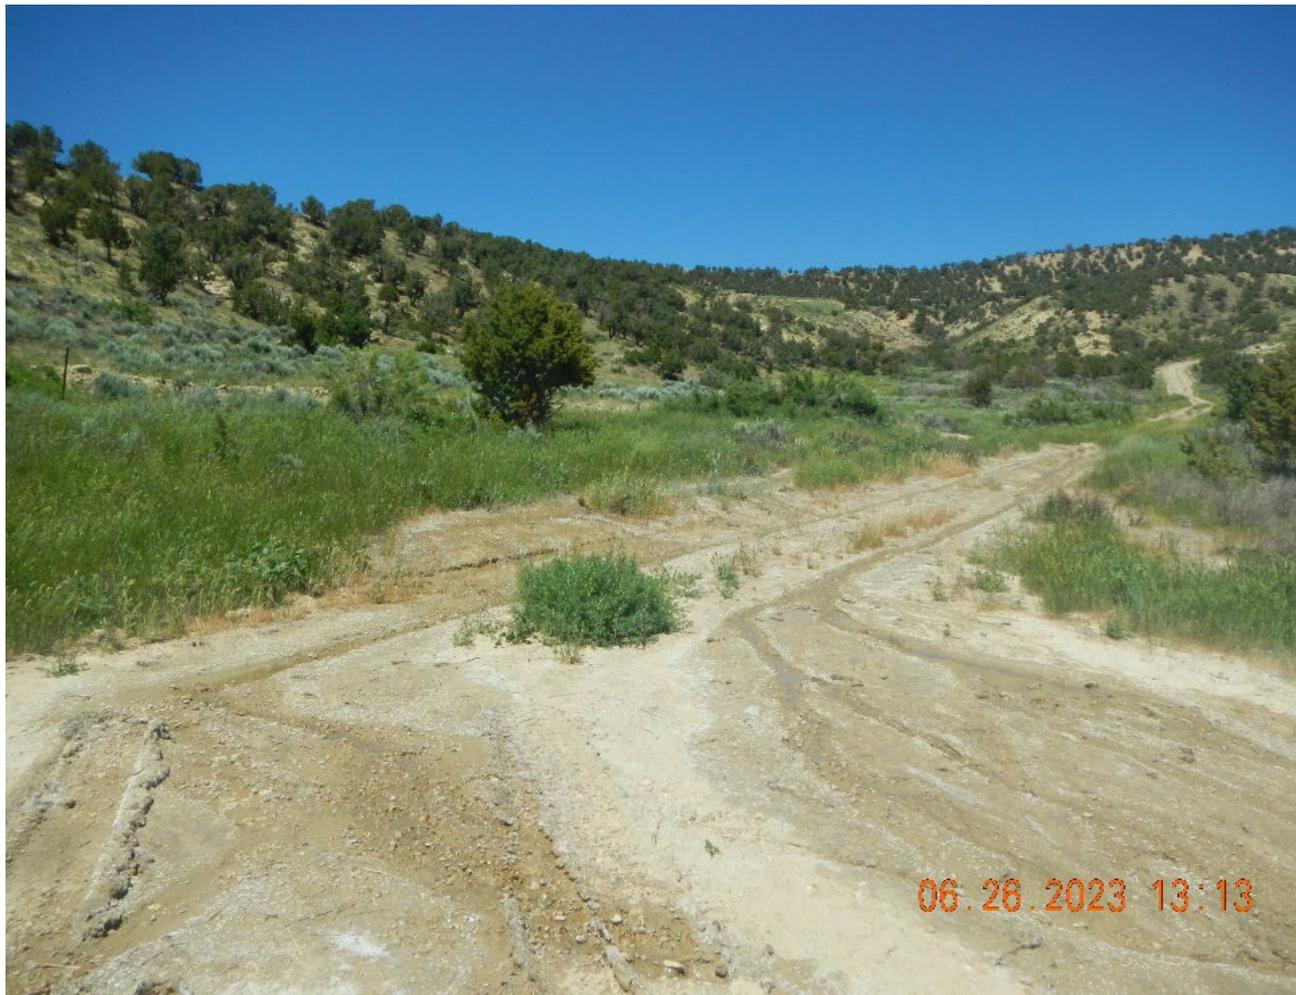
Photo #3 Water coming across the road. This is near the access road to lower pond. This water was traced up to it's source, the water is from the Produced Water discharge at the Elk Springs #3 API:05-081-06472. Note: water across road had apparent salt staining.

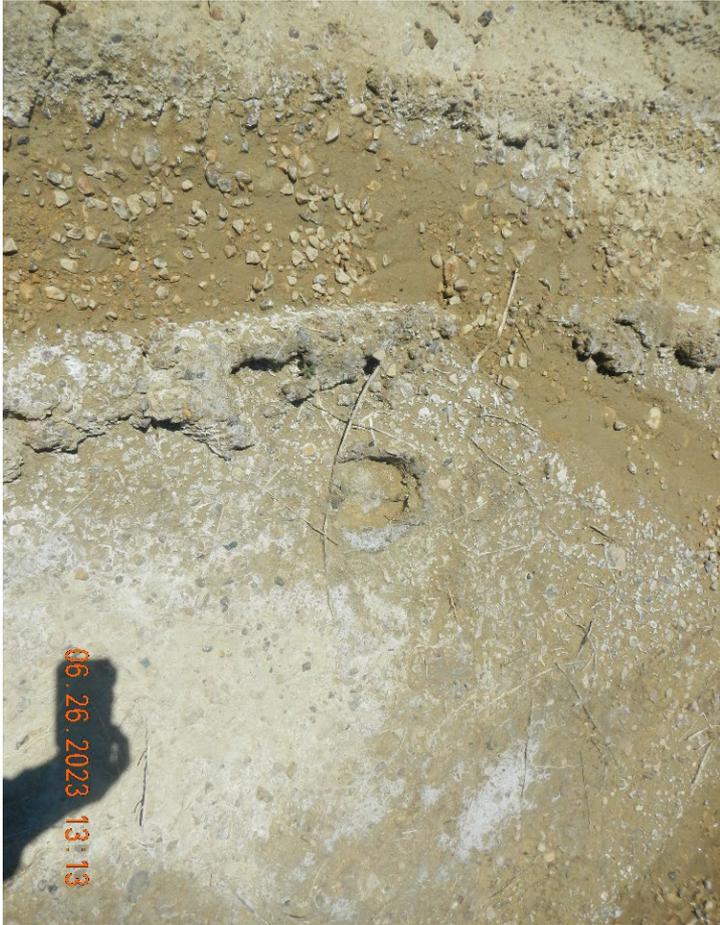
Photo #4 Wildlife track in soft dirt from water. Note: apparent salt staining.

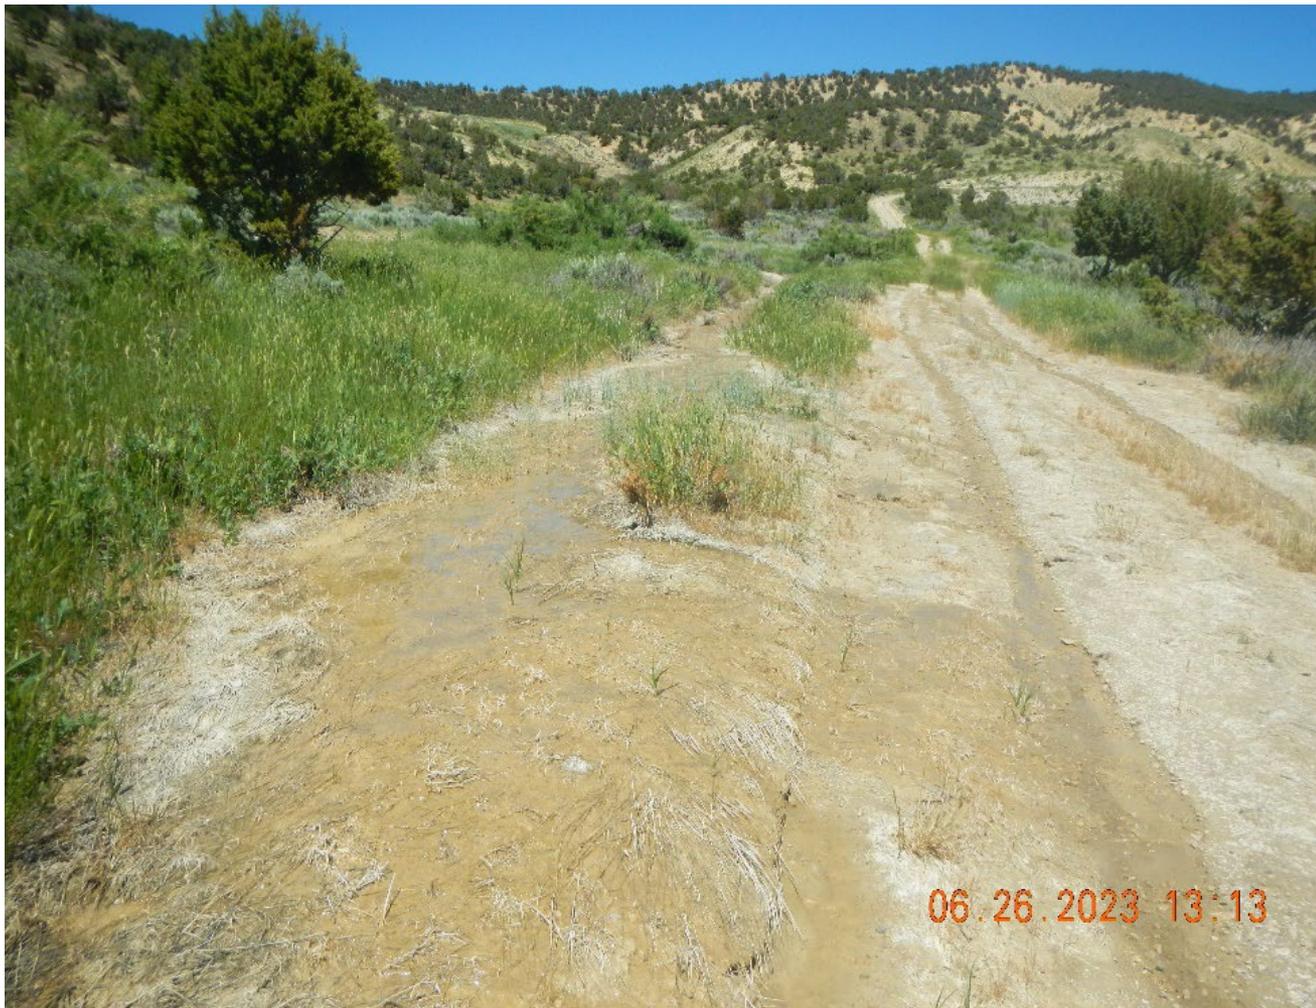
Photo #5 Area where discharge water is crossing the road. Note: apparent salt staining.

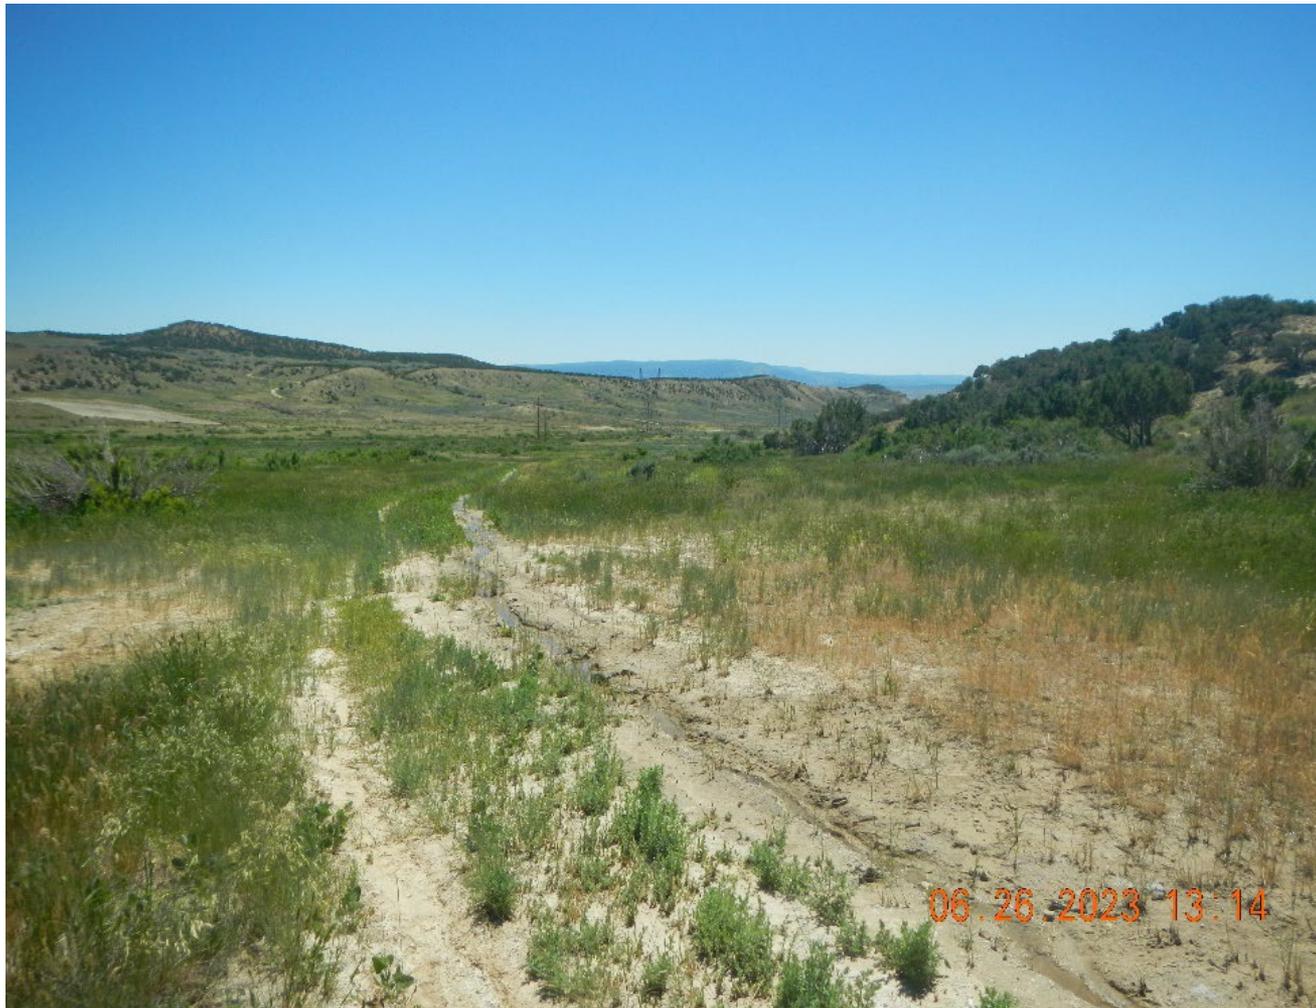
Photo #6 Looking down valley at discharge path on road to Elk Springs #1. The Elk Springs #1 API: 05-081-06408 is behind the Camera in this photo.

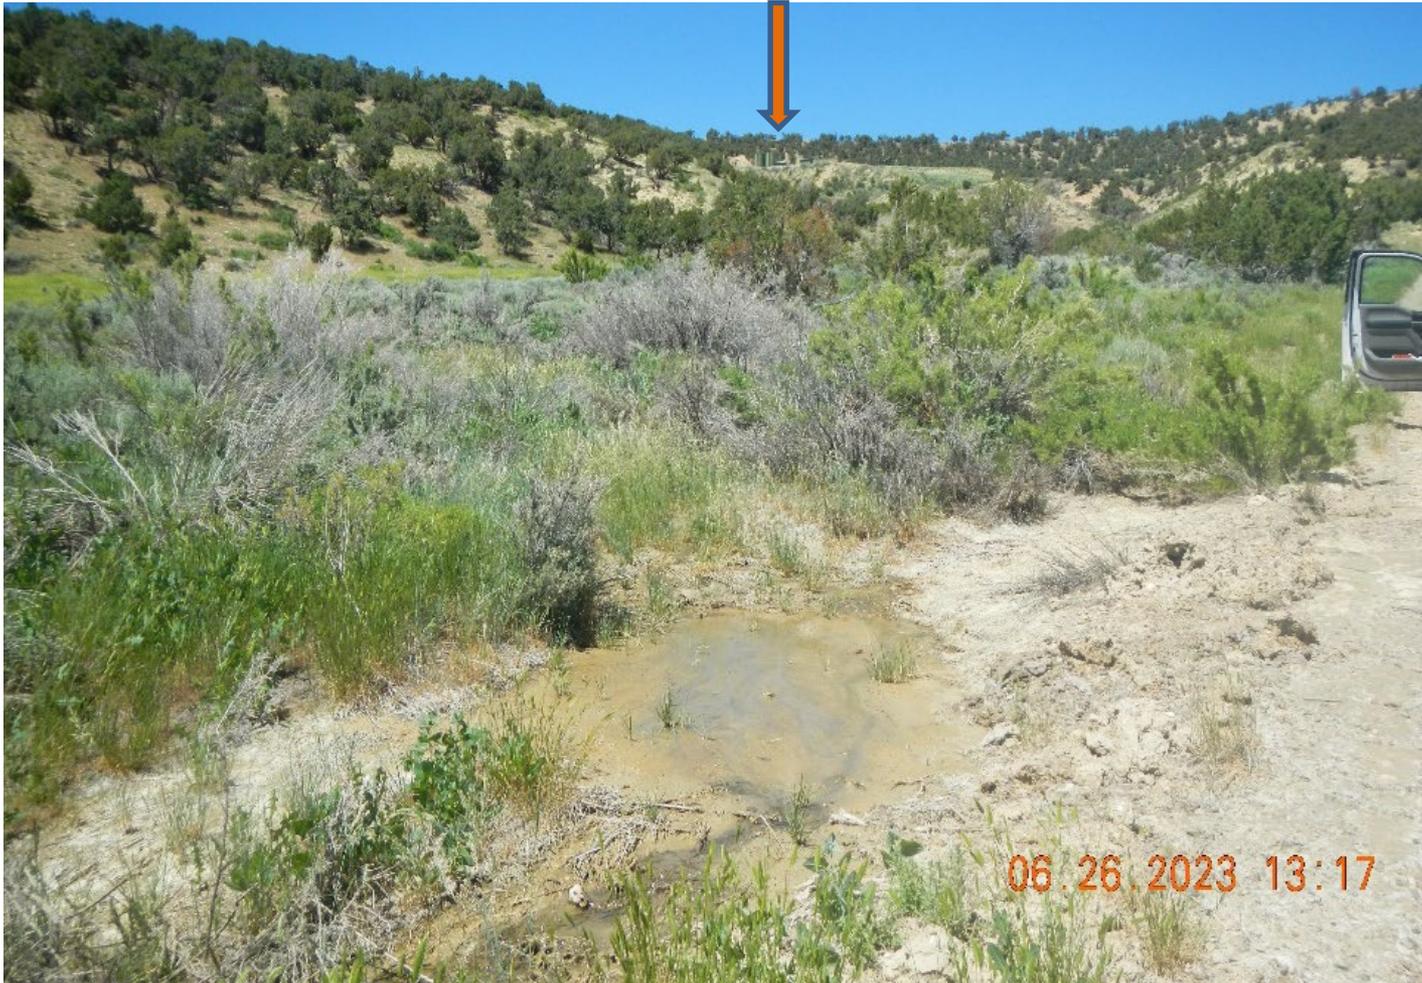
Photo #7 Pooling water on the west side of access road to the #1 (API:05-081-06408) well. Note: Tank battery for the Elk Springs #3 well is observable in the center of photo just below the tree line (orange arrow point). Note: apparent salt staining.

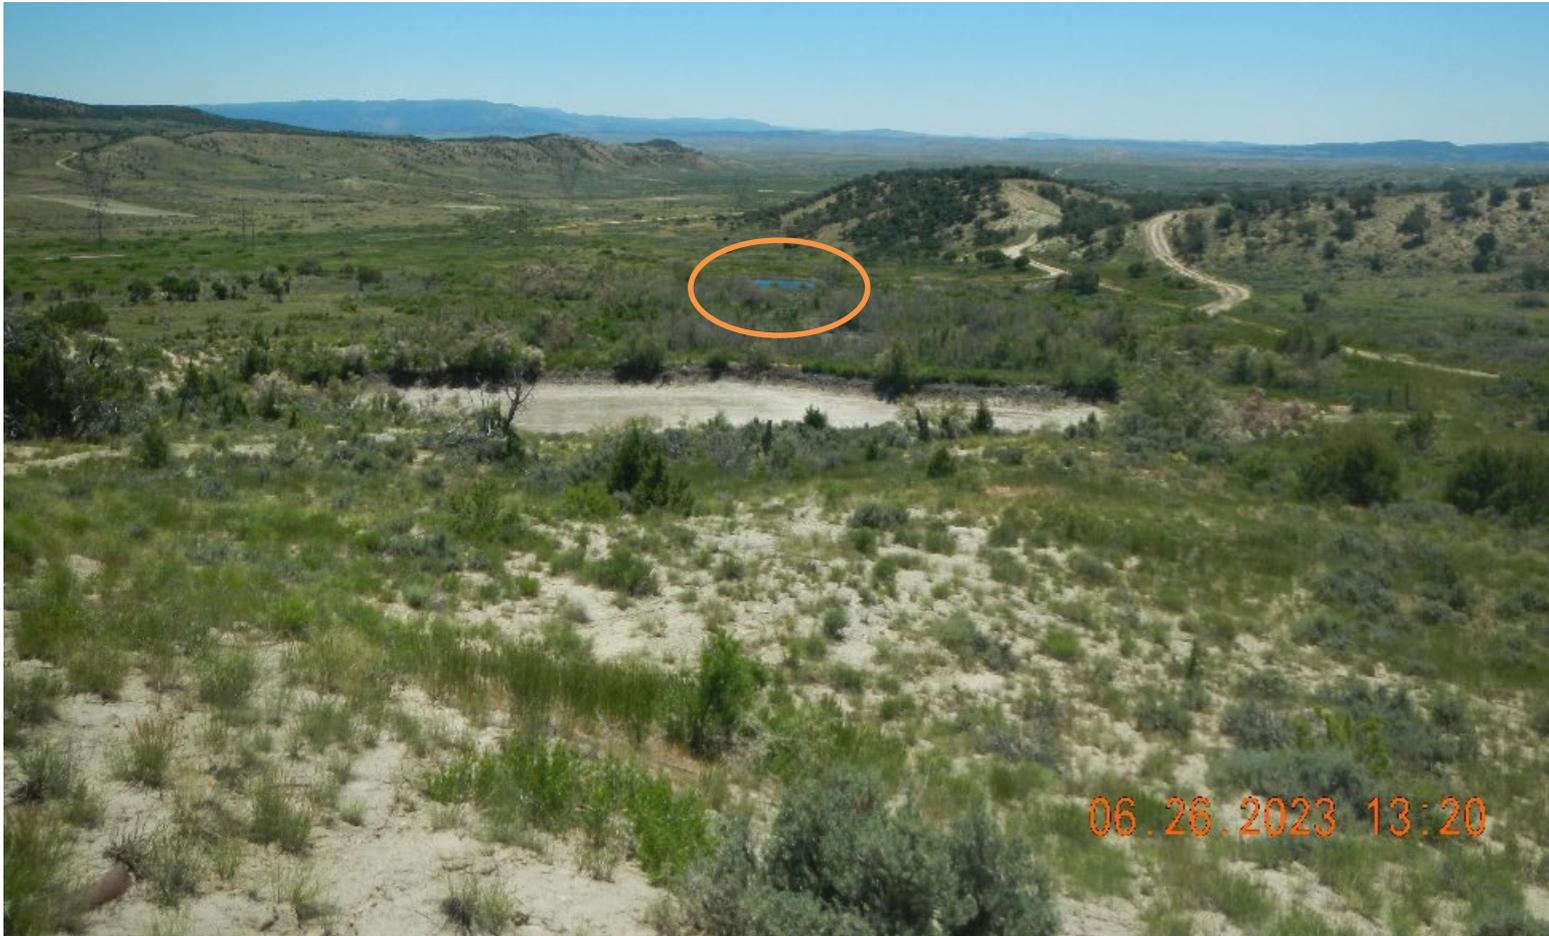
Photo #8 Looking southwest from the #1 (API:05-081-06408) pad at the upper pond. This pond, at one time was a part of the discharge from the #3 (API:05-081-06472) well. Note: the lower pond is observable in this photo.

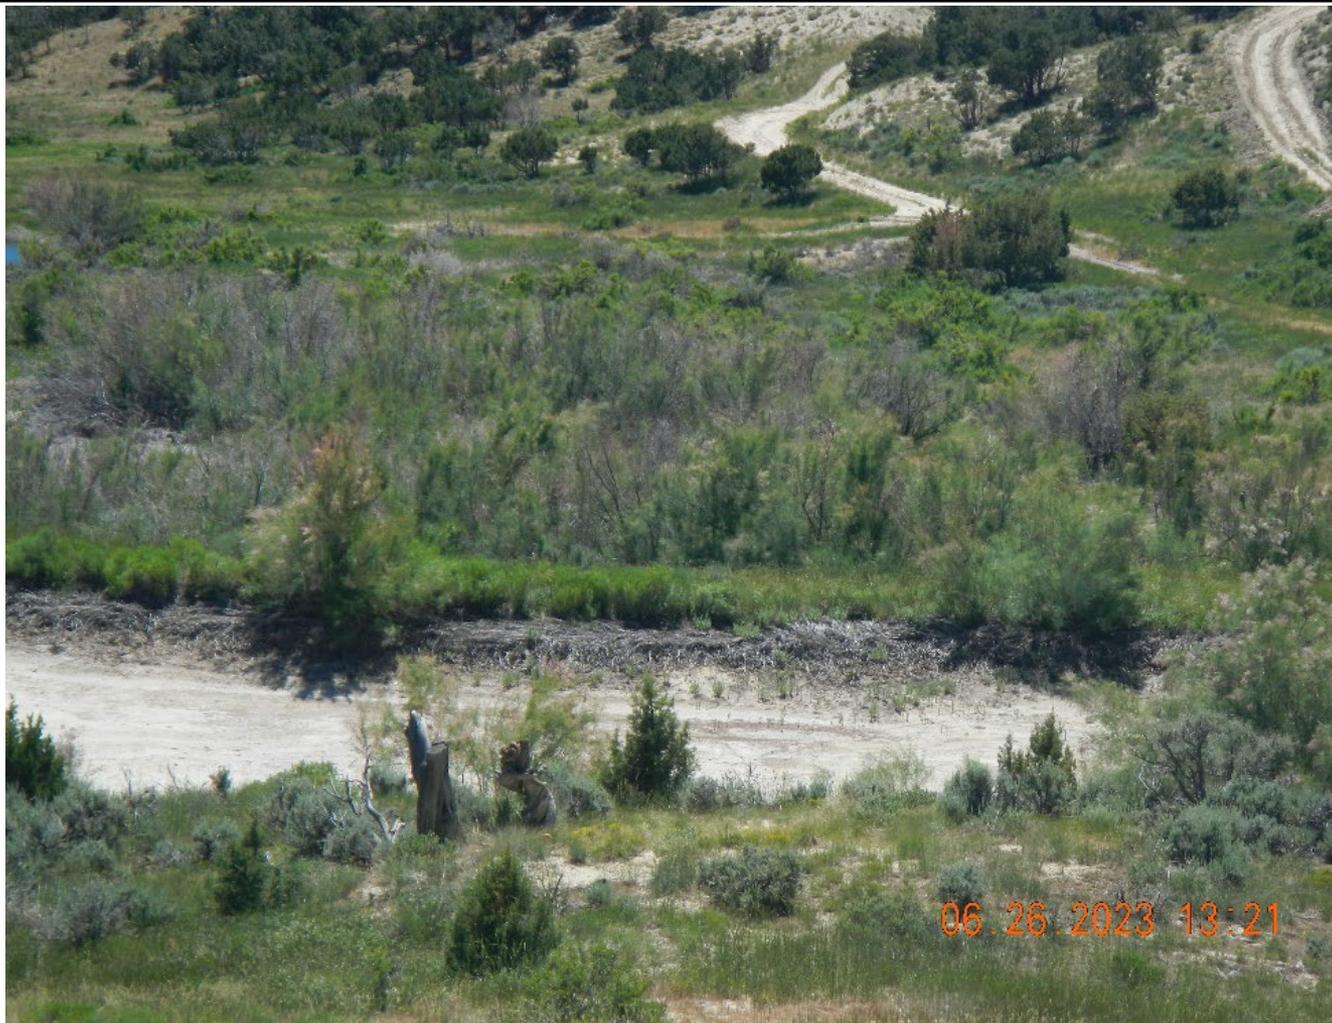
Photo #9 Looking southwest from the #1 (API:05-081-06408) pad at the upper pond. This is a close up of the western most side of pond. This pond used to be a part of the discharge from the #3 (API-05-081-06472) well.

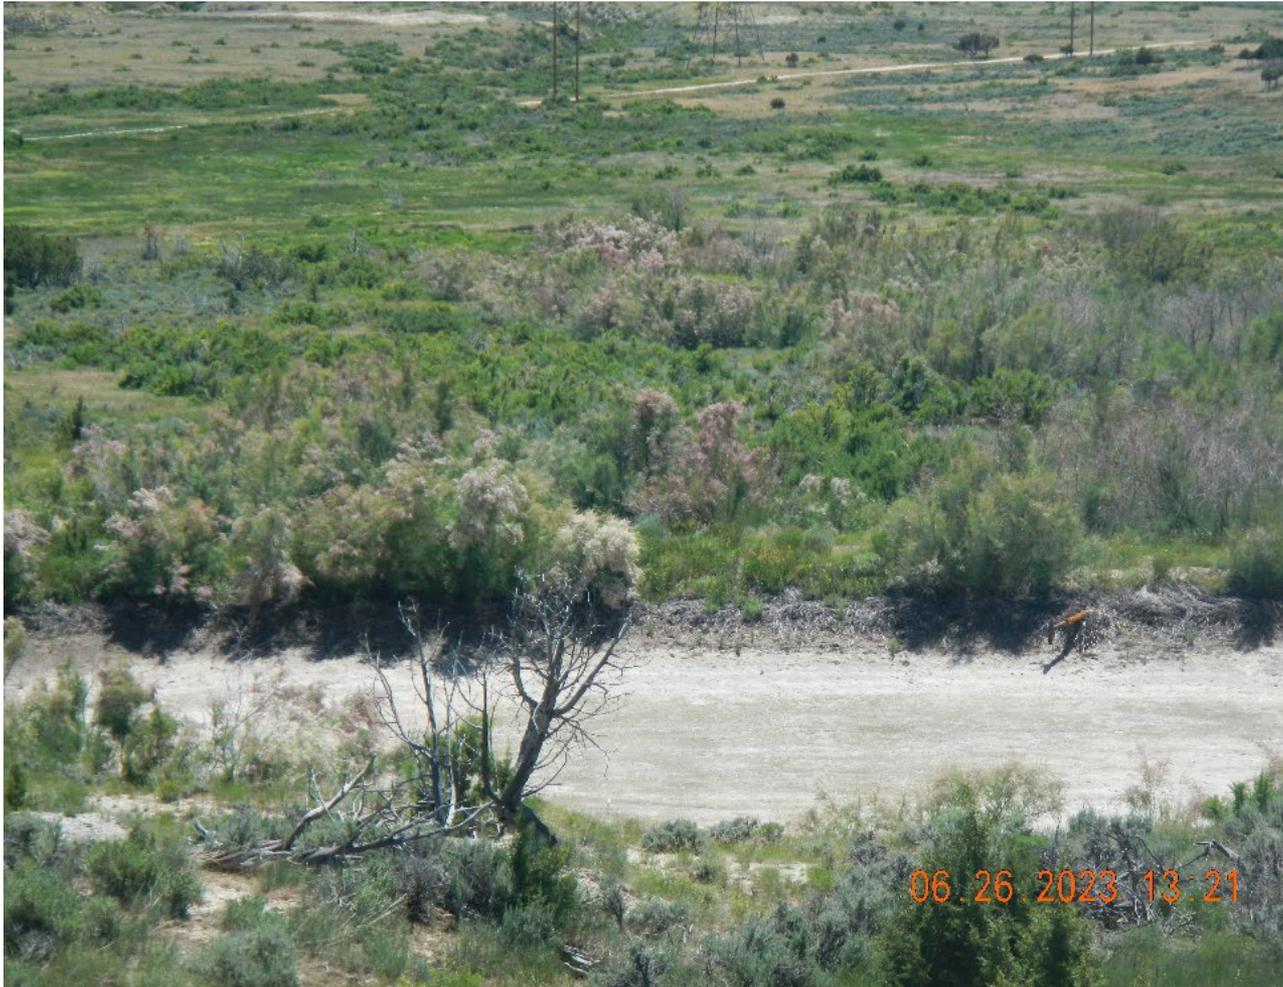
Photo #10 Looking southwest from the #1 (API:05-081-06408) pad at the upper pond. This is a close up of the eastern part of pond. This pond used to be a part of the discharge from the #3 (API:05-081-06472) well.

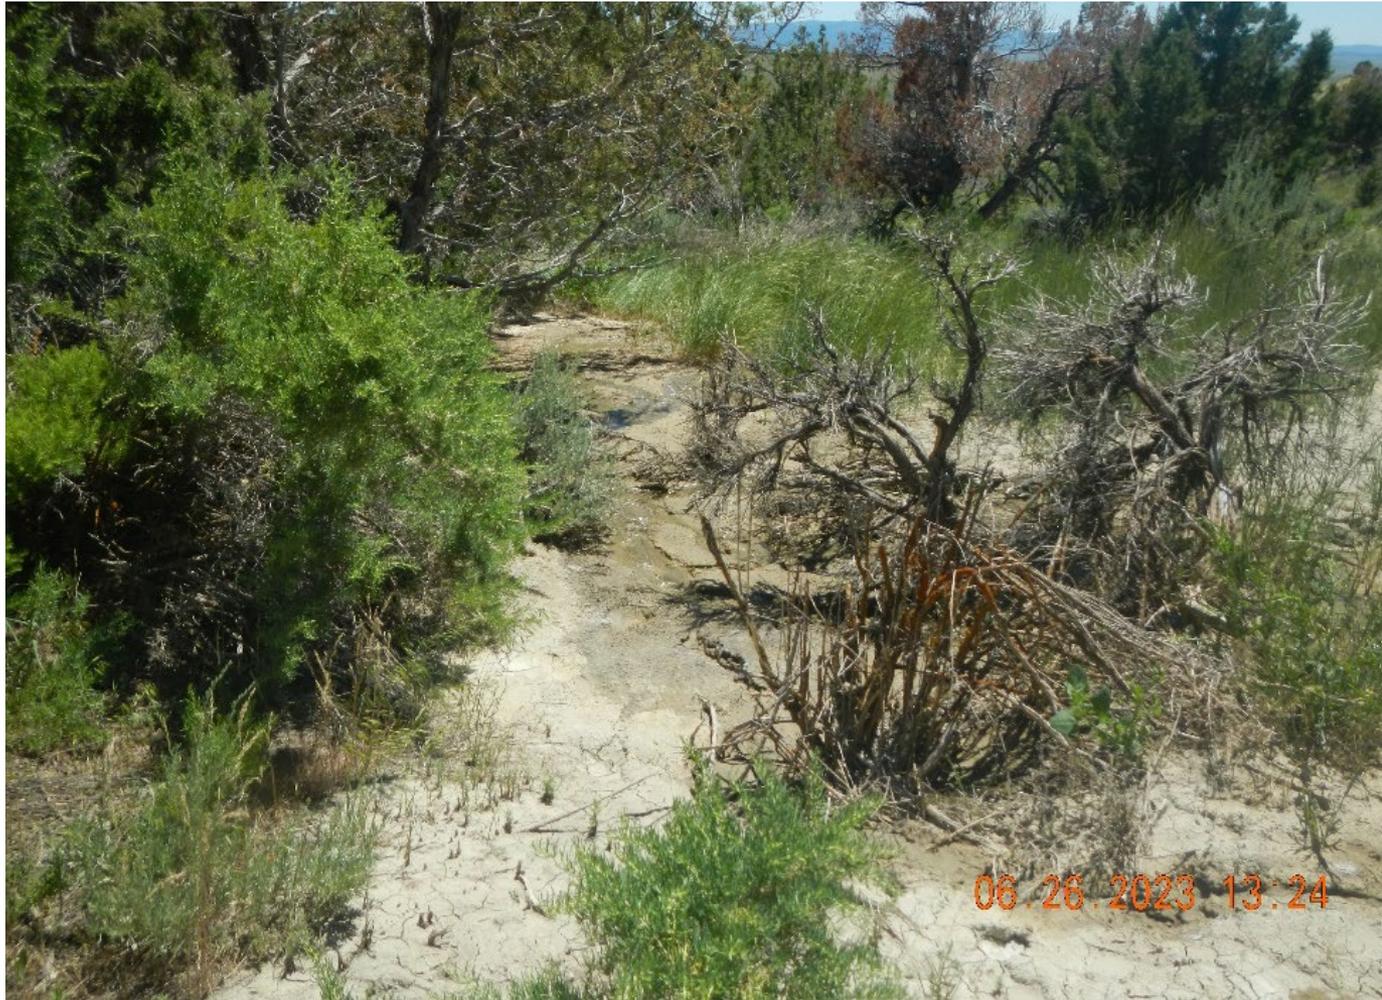
Photo #11 Flow path of discharge water, COGCC staff followed the spill path from the access road to the Elk Springs #1 (API:05-081-06408) well to the discharge point. Note: apparent salt staining.

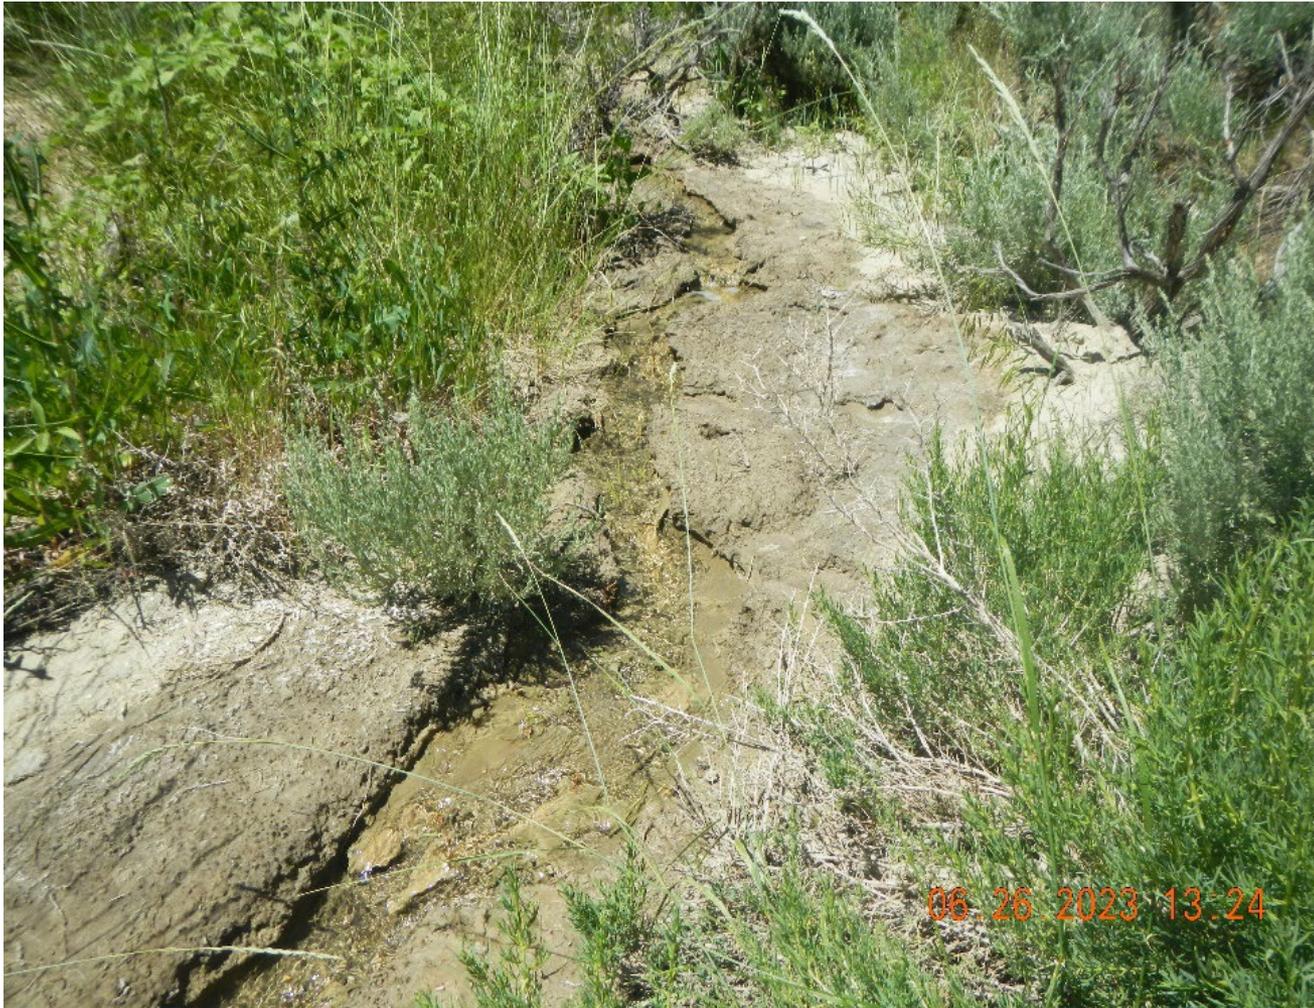
Photo #12 Flow path of discharge water, COGCC staff followed the spill path from the access road to the Elk Springs #1 (API:05-081-06408) well to the discharge point. Note: apparent salt staining.

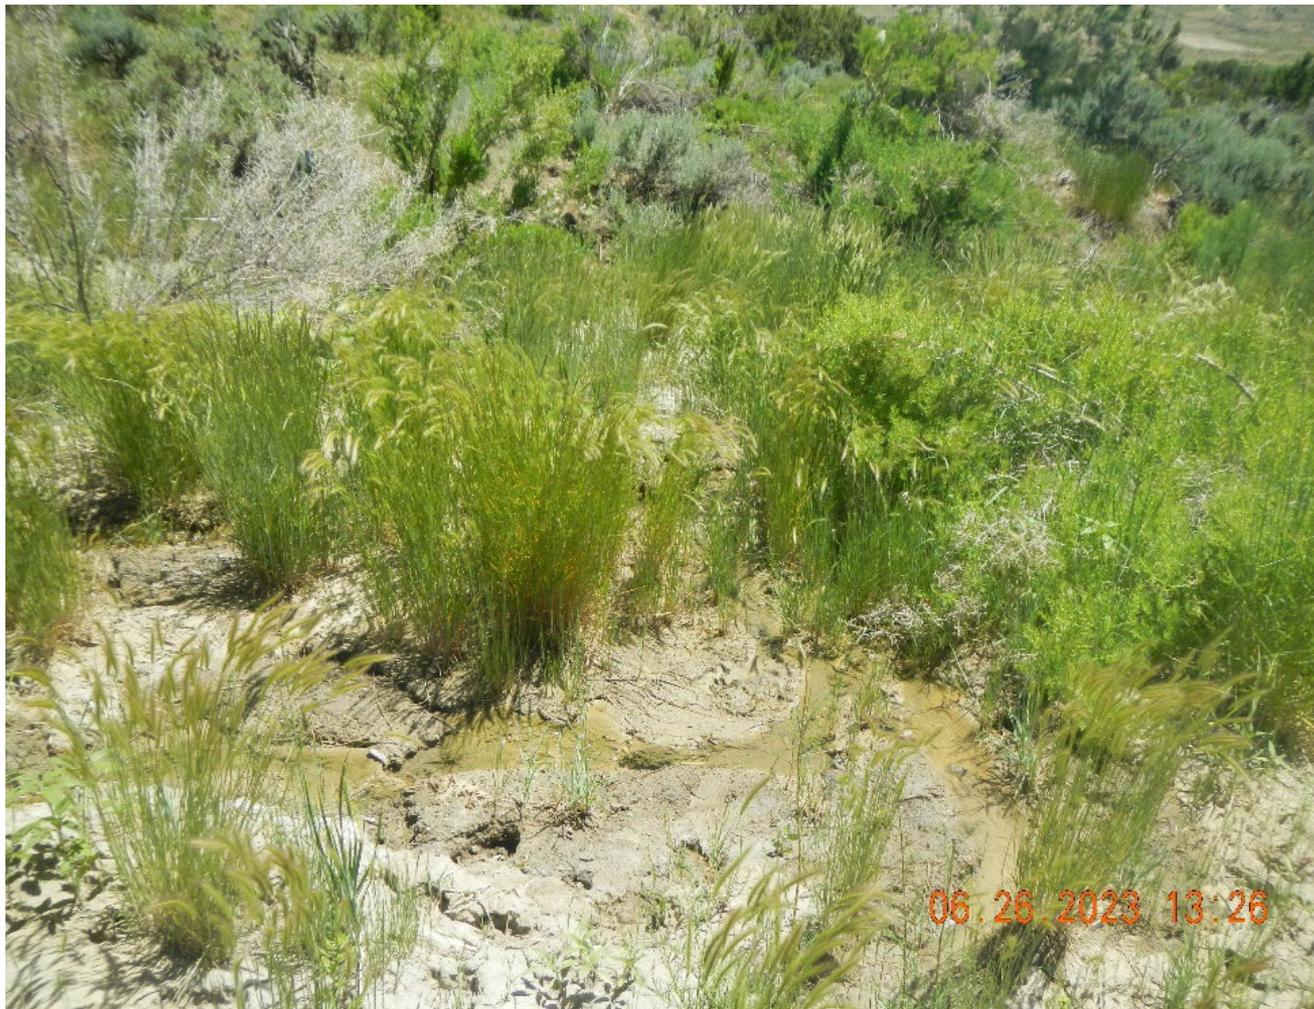
Photo #13 Flow path of discharge water, COGCC staff followed the spill path from the access road to the Elk Springs #1 (API:05-081-06408) well to the discharge point. Note: apparent salt staining.

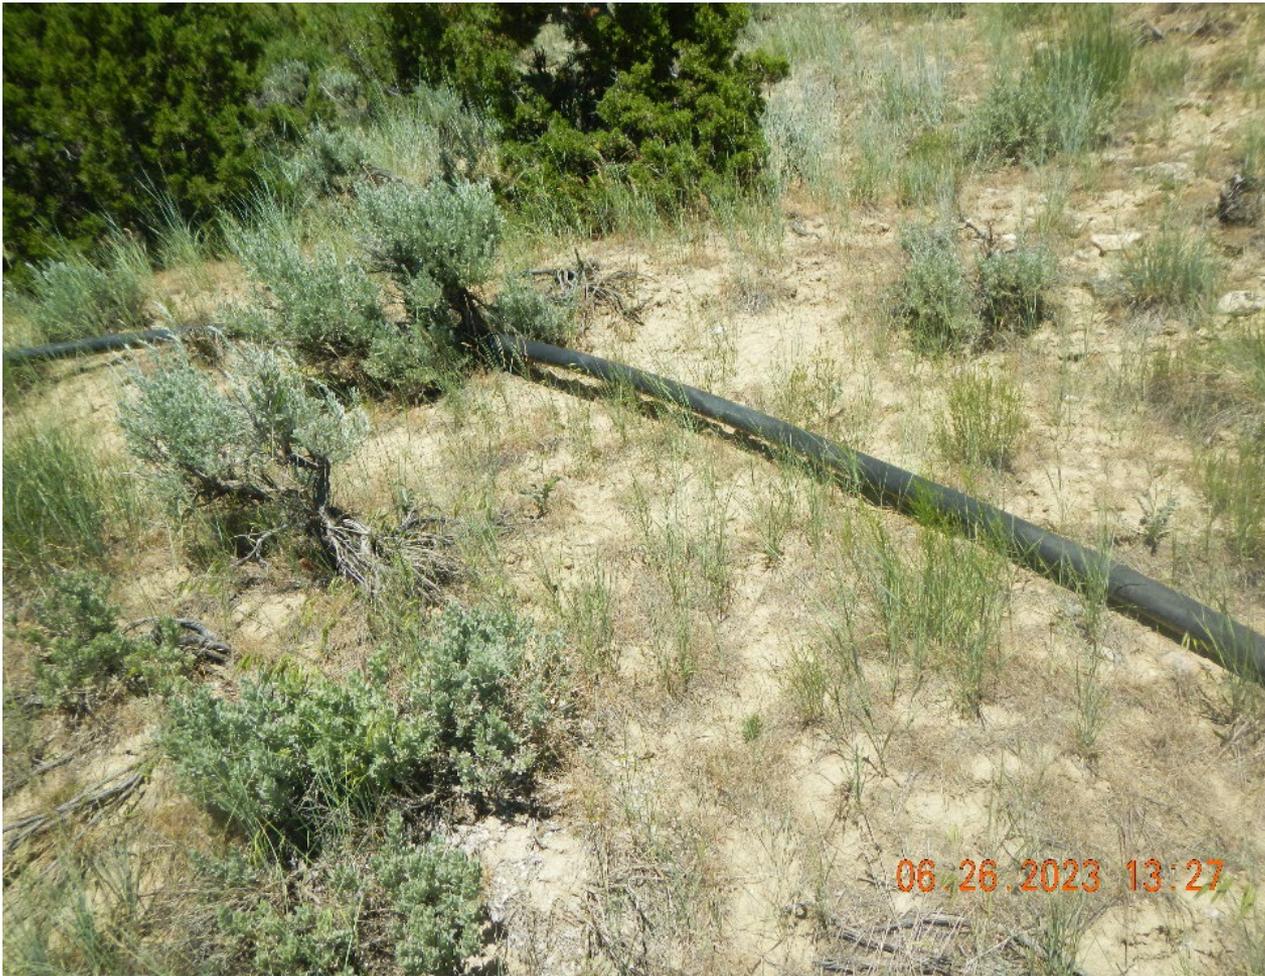
Photo #14 Flowline on surface, it appeared that no fluid was currently in this line.

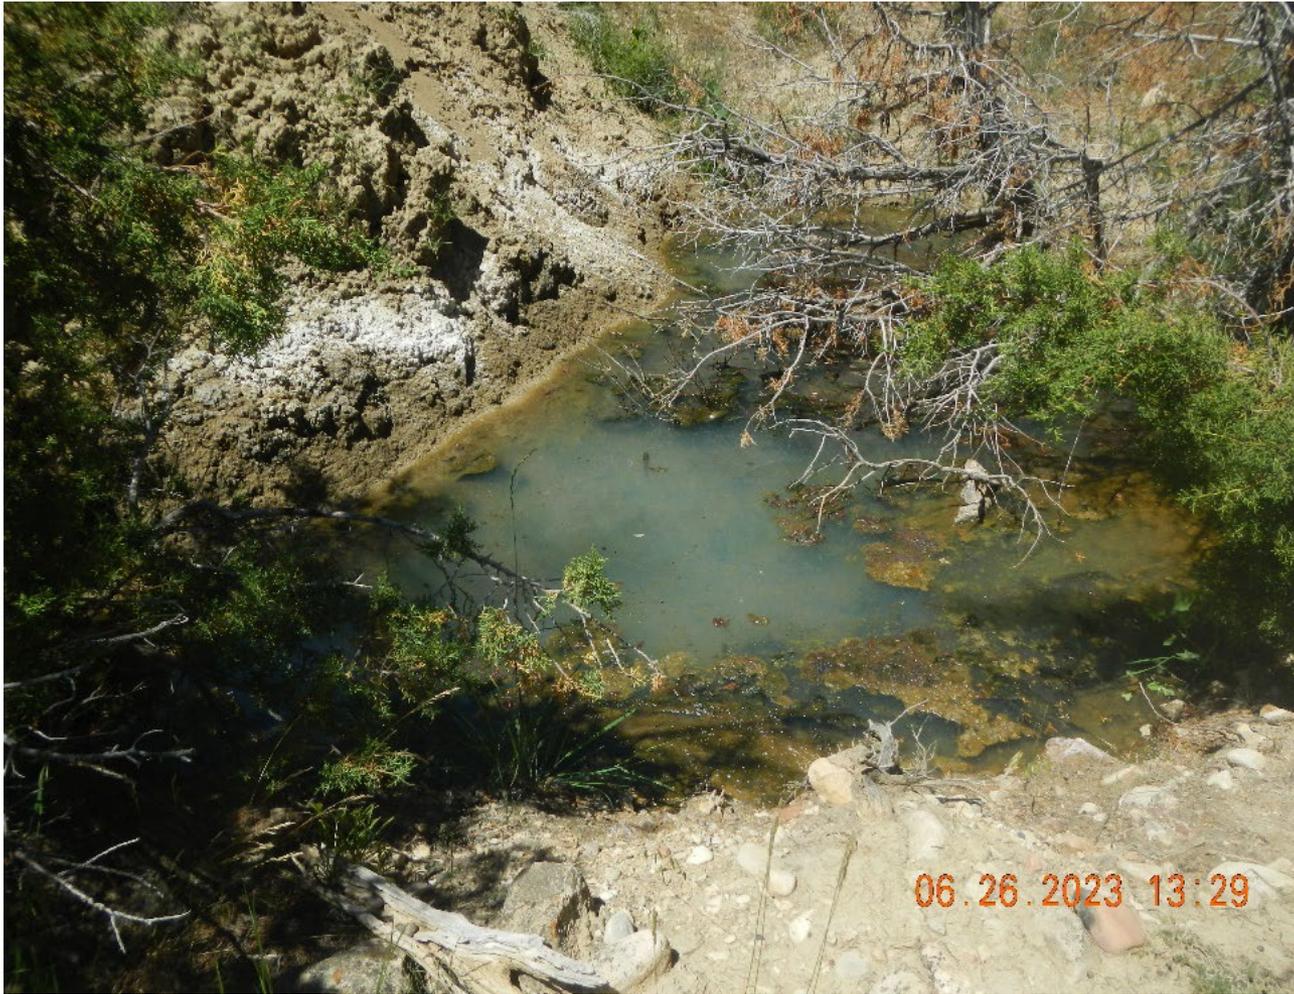
Photo #15 Pooled discharge water along the flow path. Approximate location is 40.351947,-108.444333. Observed at this location; algae growth, non clear water, strong sulfur odor, apparent salt staining.
