Inspection Photos

Location
Well 081-06472
Inspection
Date:6/26/2023

All Photos taken
by Kris Neidel

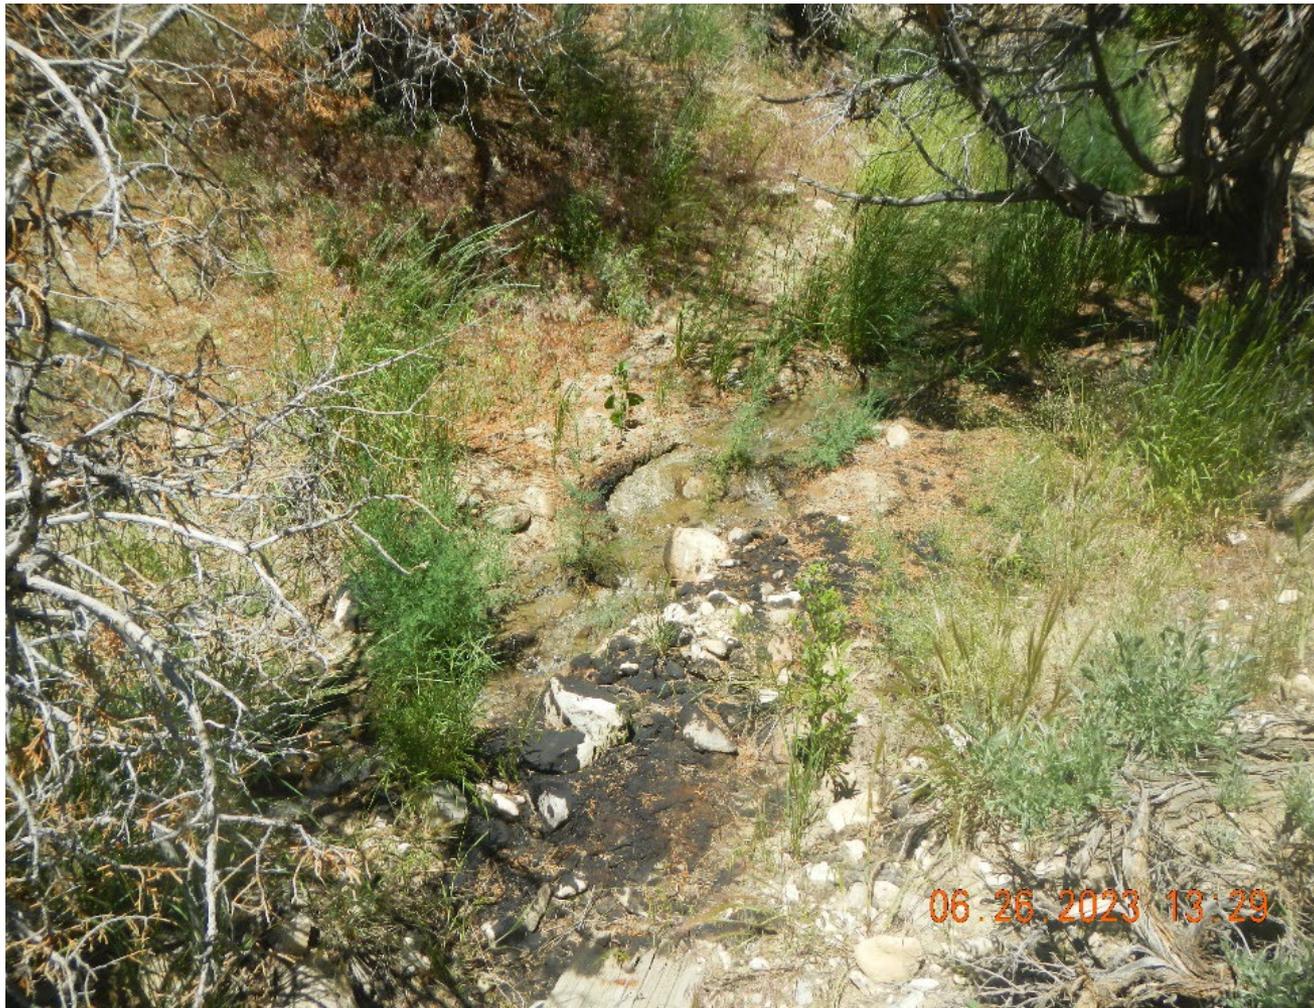
Photo #16 area near Photo #15. part of the flow path. Apparent weathered hydrocarbon was observed on rocks.

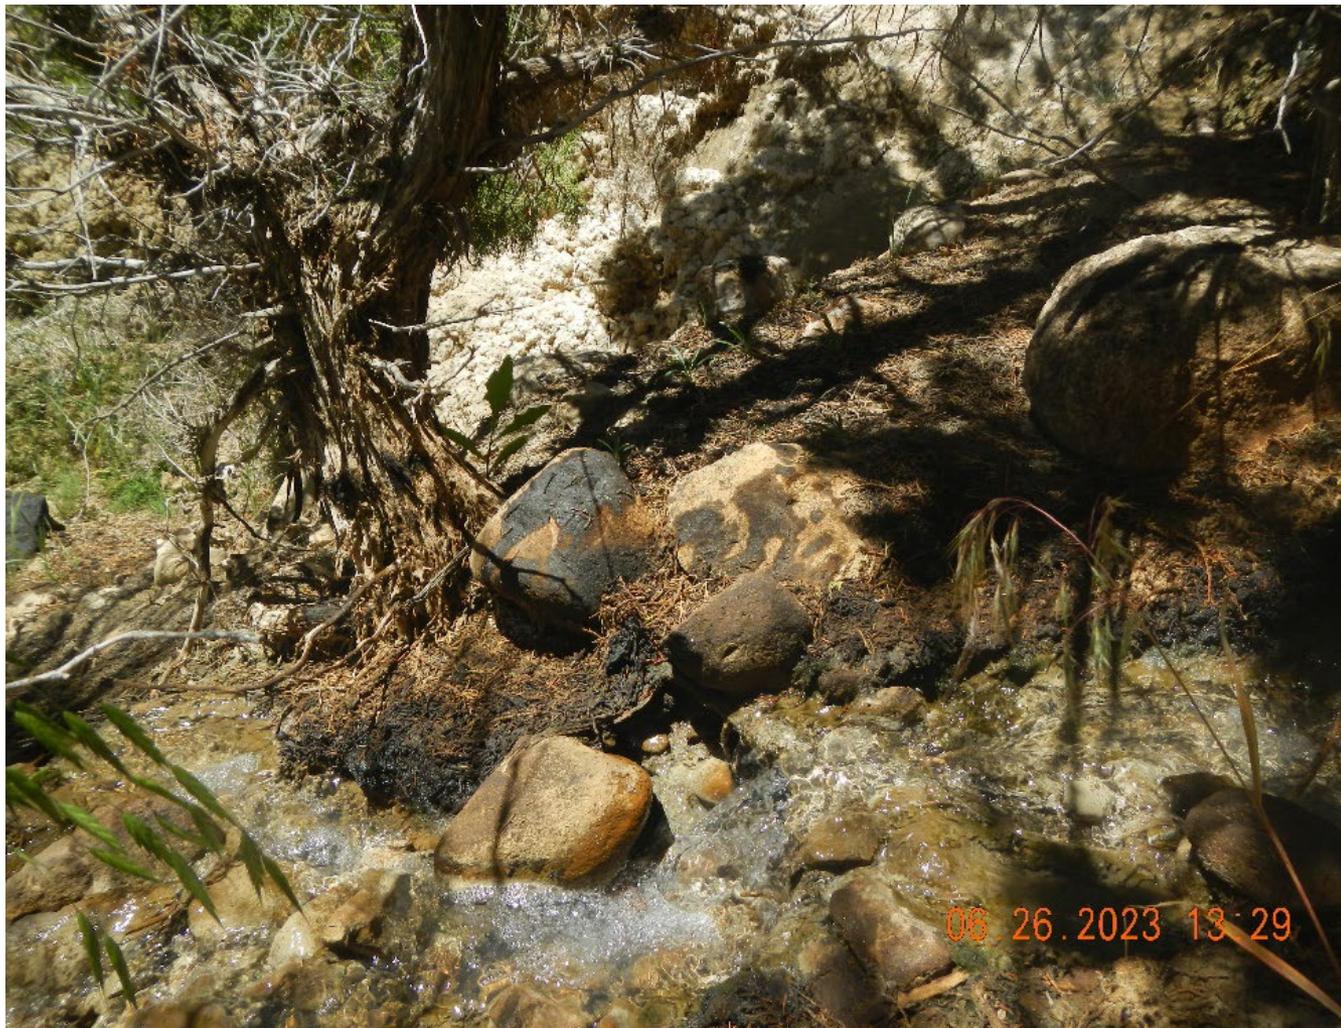
Photo #17 Part of the flow path at bottom of photo, upstream of Photo #15. Apparent hydrocarbon observed on rocks in center of photo.

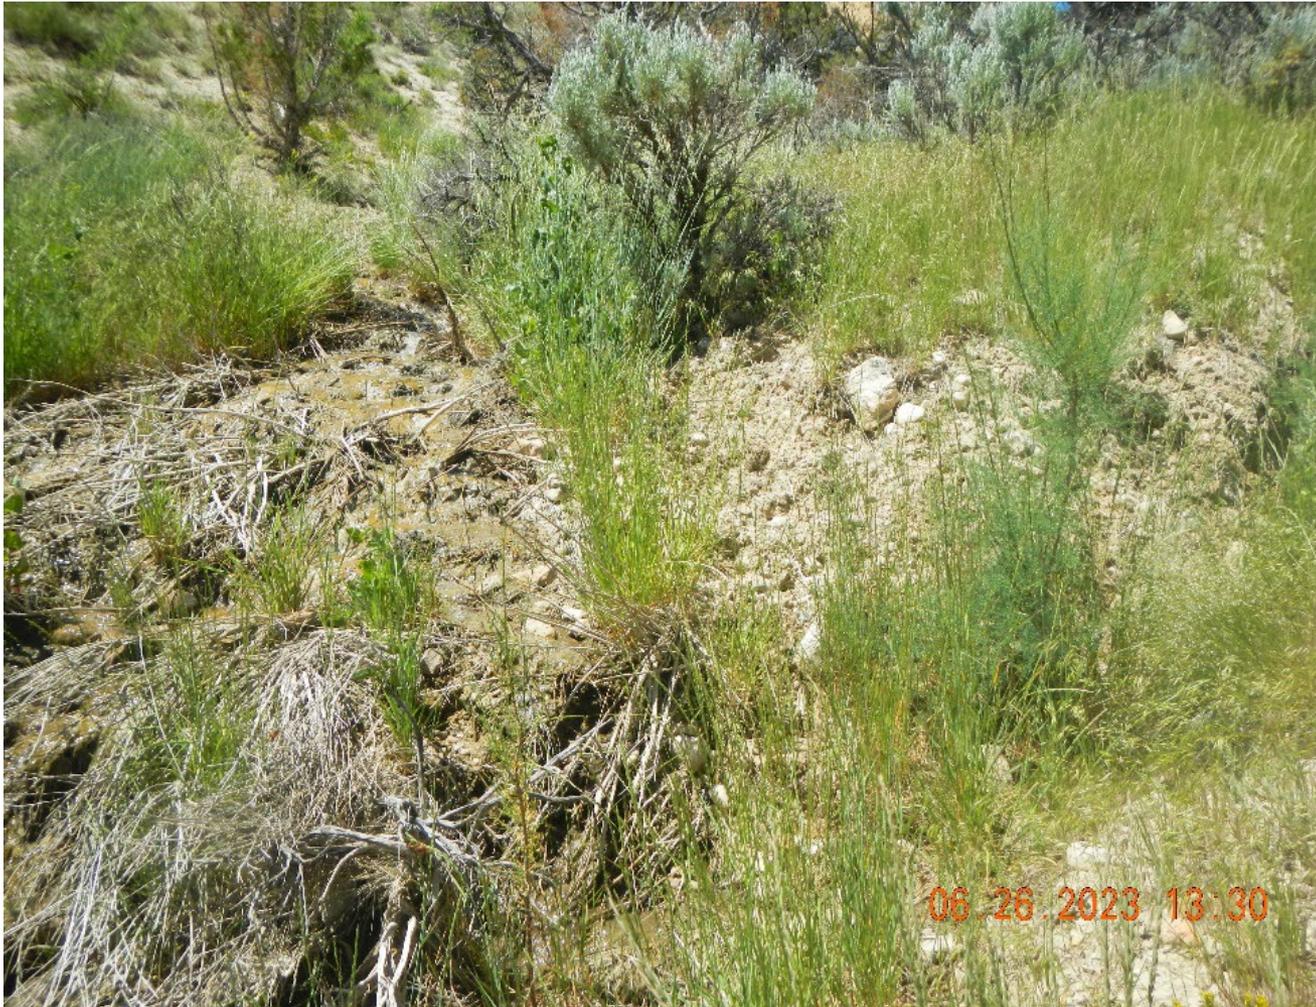
Photo #18 Flow path of discharge water.

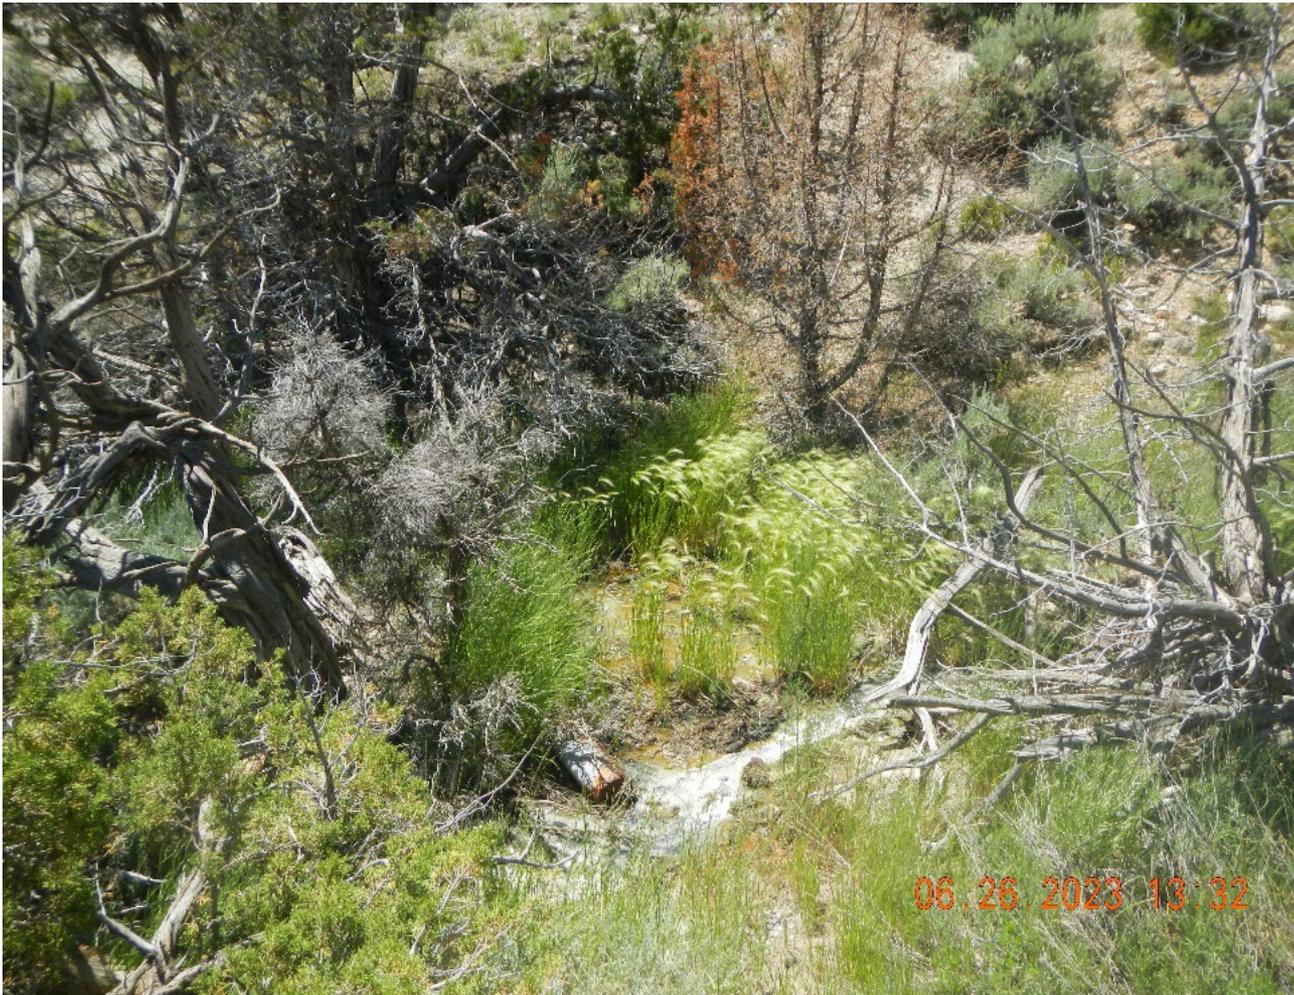
Photo #19 Part of the spill path, upgrade of photo 18. (Note: NO photo 20)

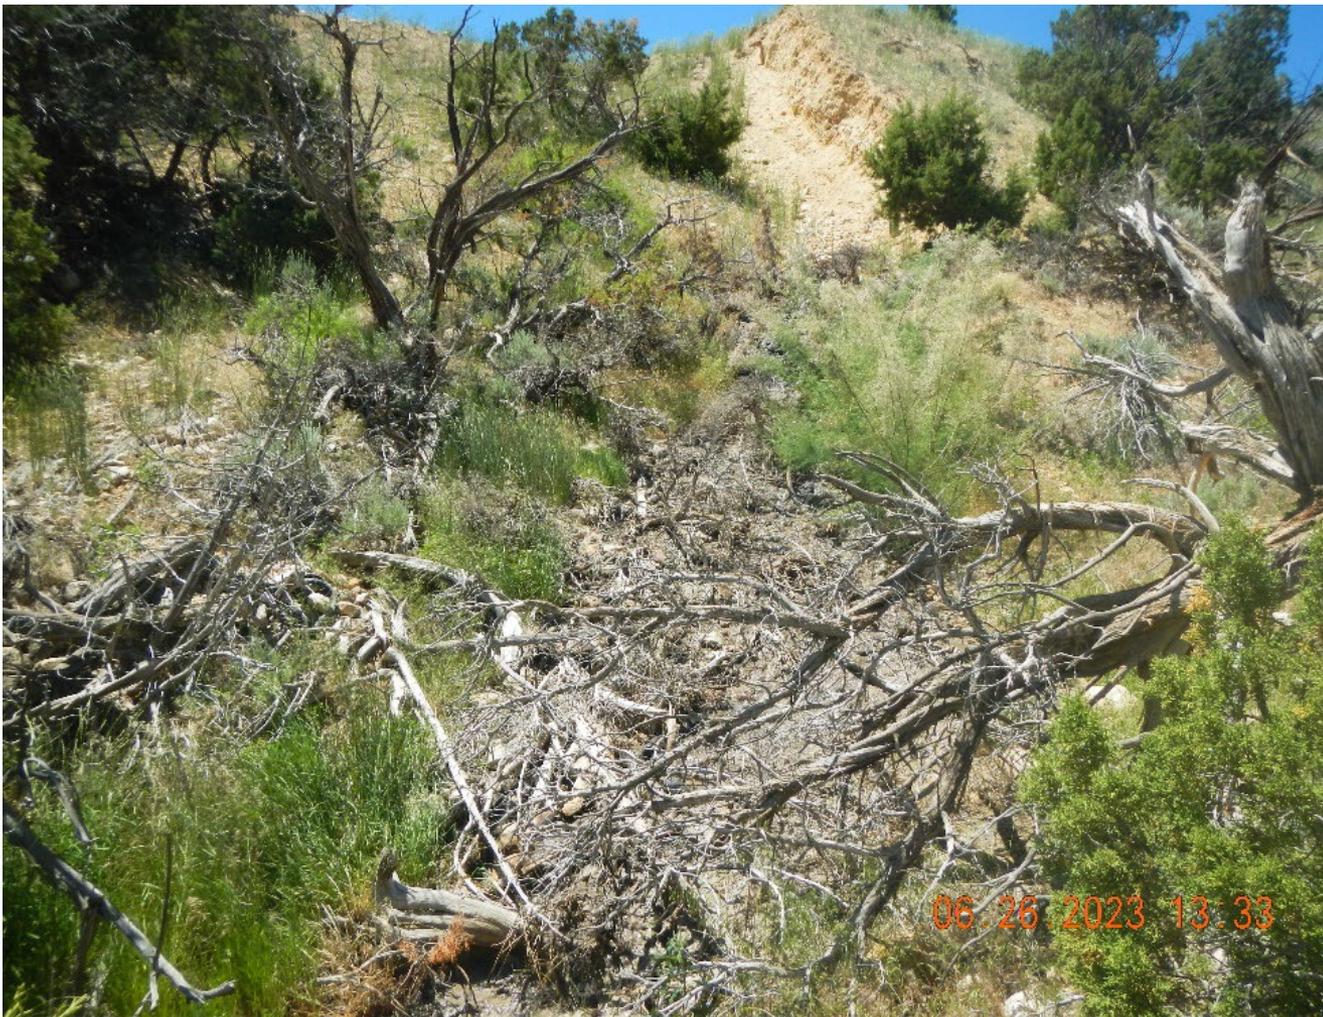
Photo #21 Looking up at area of current discharge. The discharge can be seen just below the gravel. This gravel leads to what this document refers to a the “dirt ridge”. A close up of discharge area can be found in Photo #24 and Photo #25

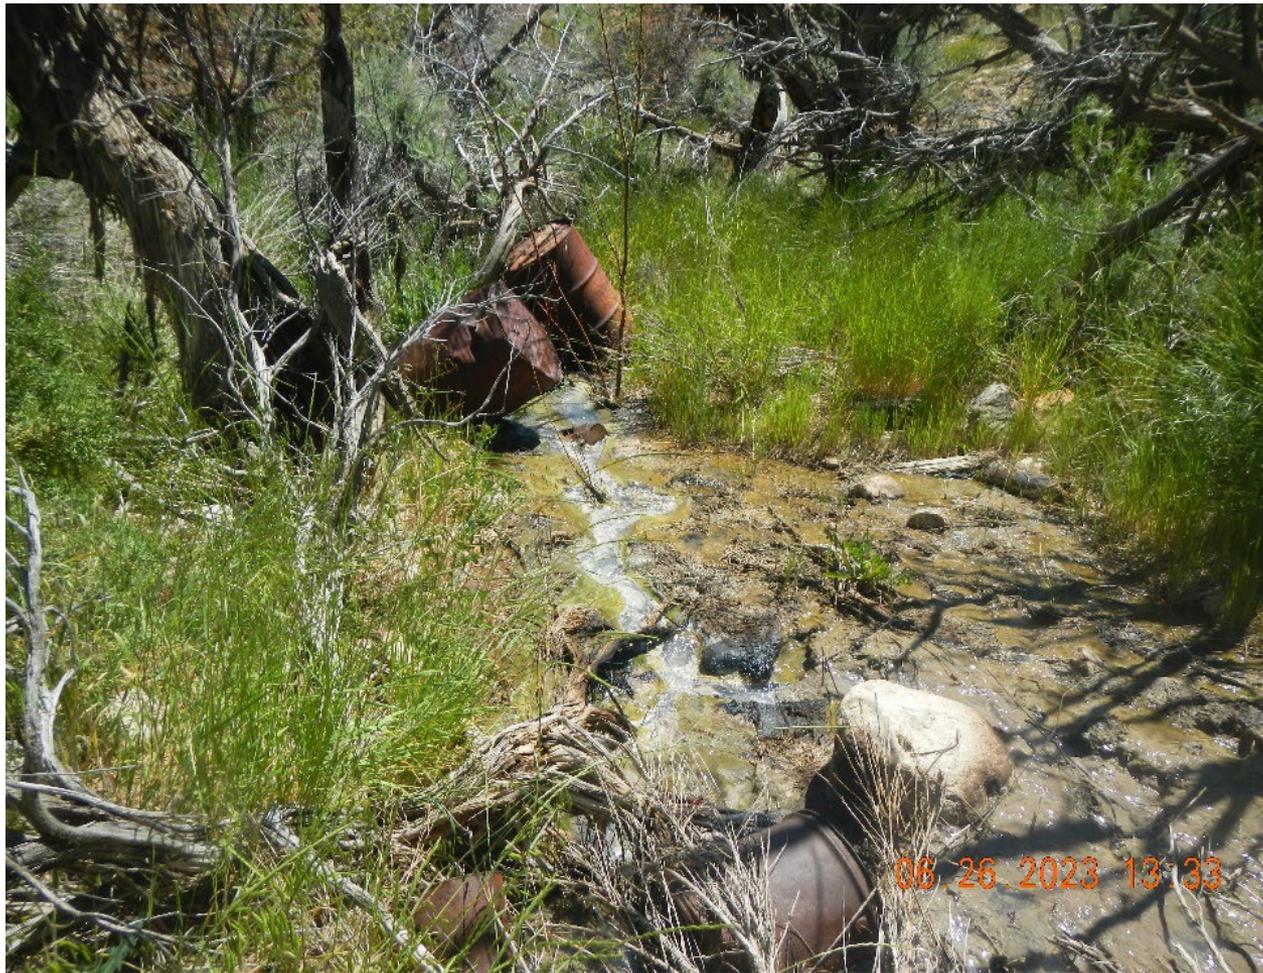
Photo #22 Discharge path was in contact with old debris. Apparent hydrocarbon was observed on rocks. Note, trash/debris, apparent hydrocarbon on rocks, algae growth.

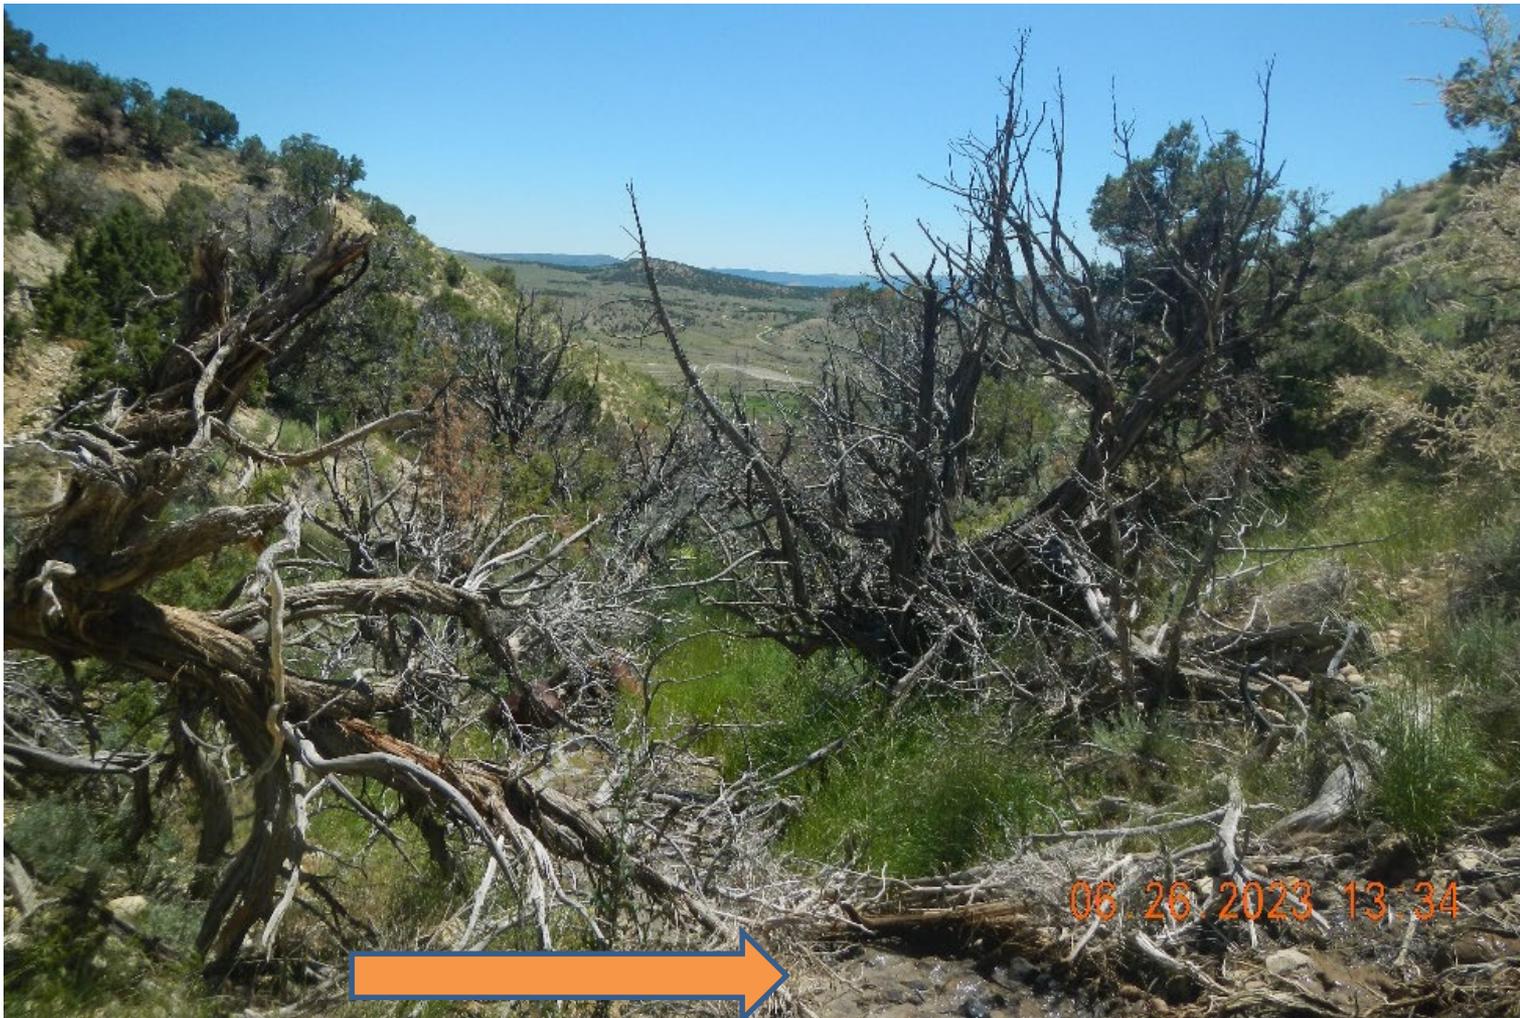
Photo #23 discharge path near current point of discharge. Arrow shows discharge.

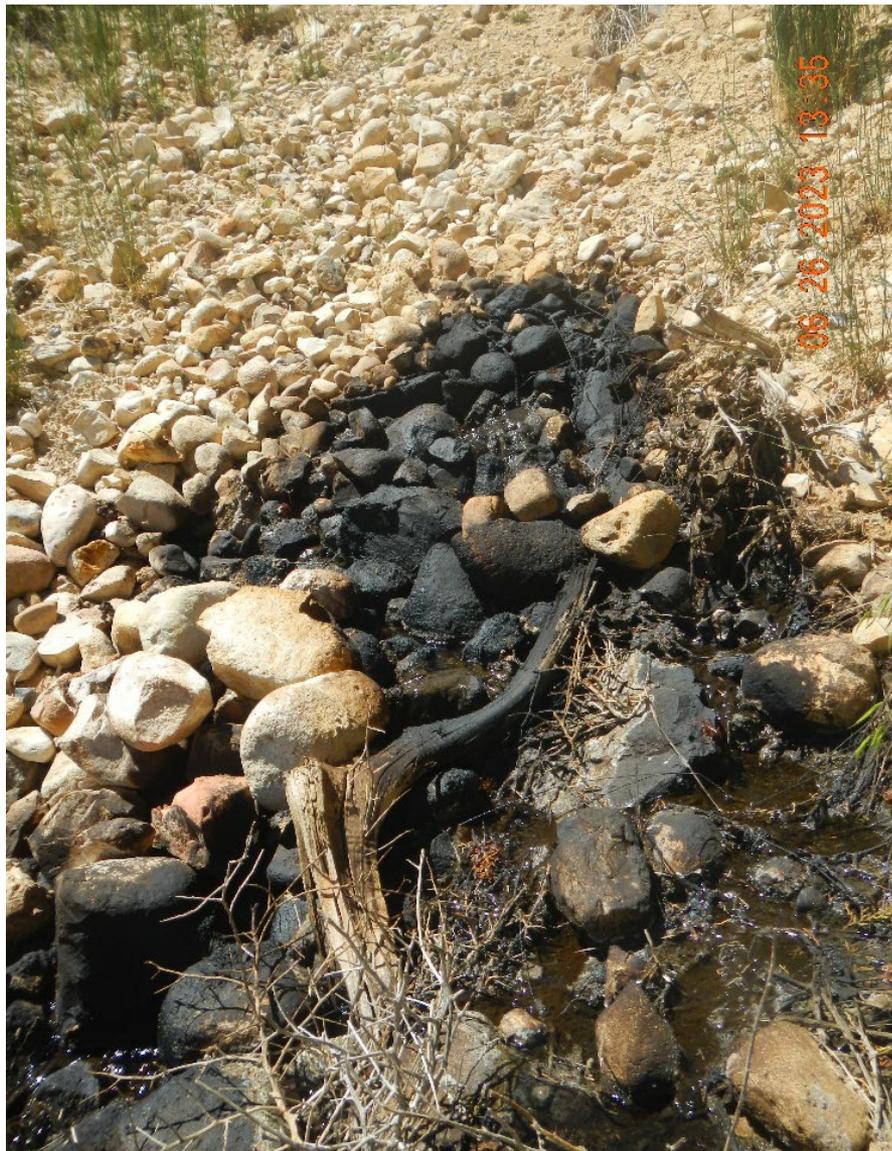
Photo #24 Current discharge point. Immediately below the “dirt ridge”. Fluids appear to be coming from a seep.
Approximate location
40.352743,-108.444347.
Apparent hydrocarbon staining
on rocks.

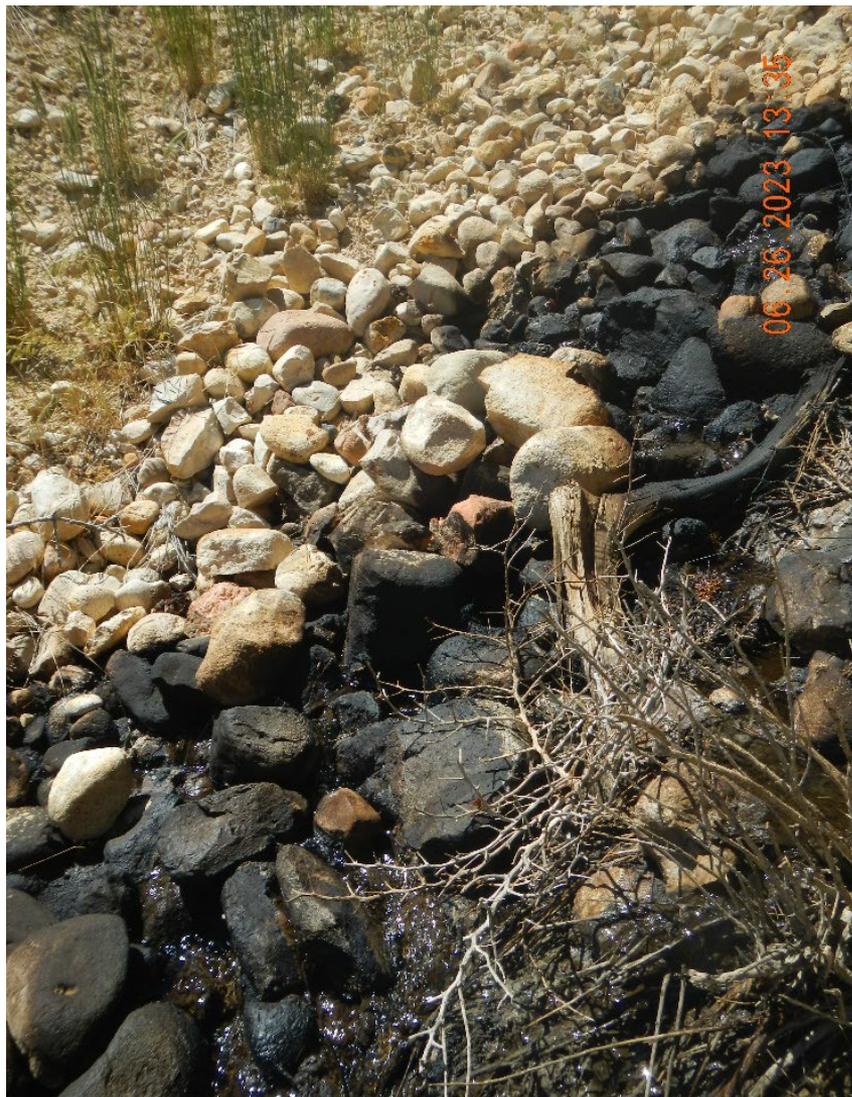
Photo #25 Current discharge point. Immediately below the “dirt ridge”. Fluids appear to be coming from a seep. Approximate location 40.352743,-108.444347. Apparent hydrocarbon staining on rocks.

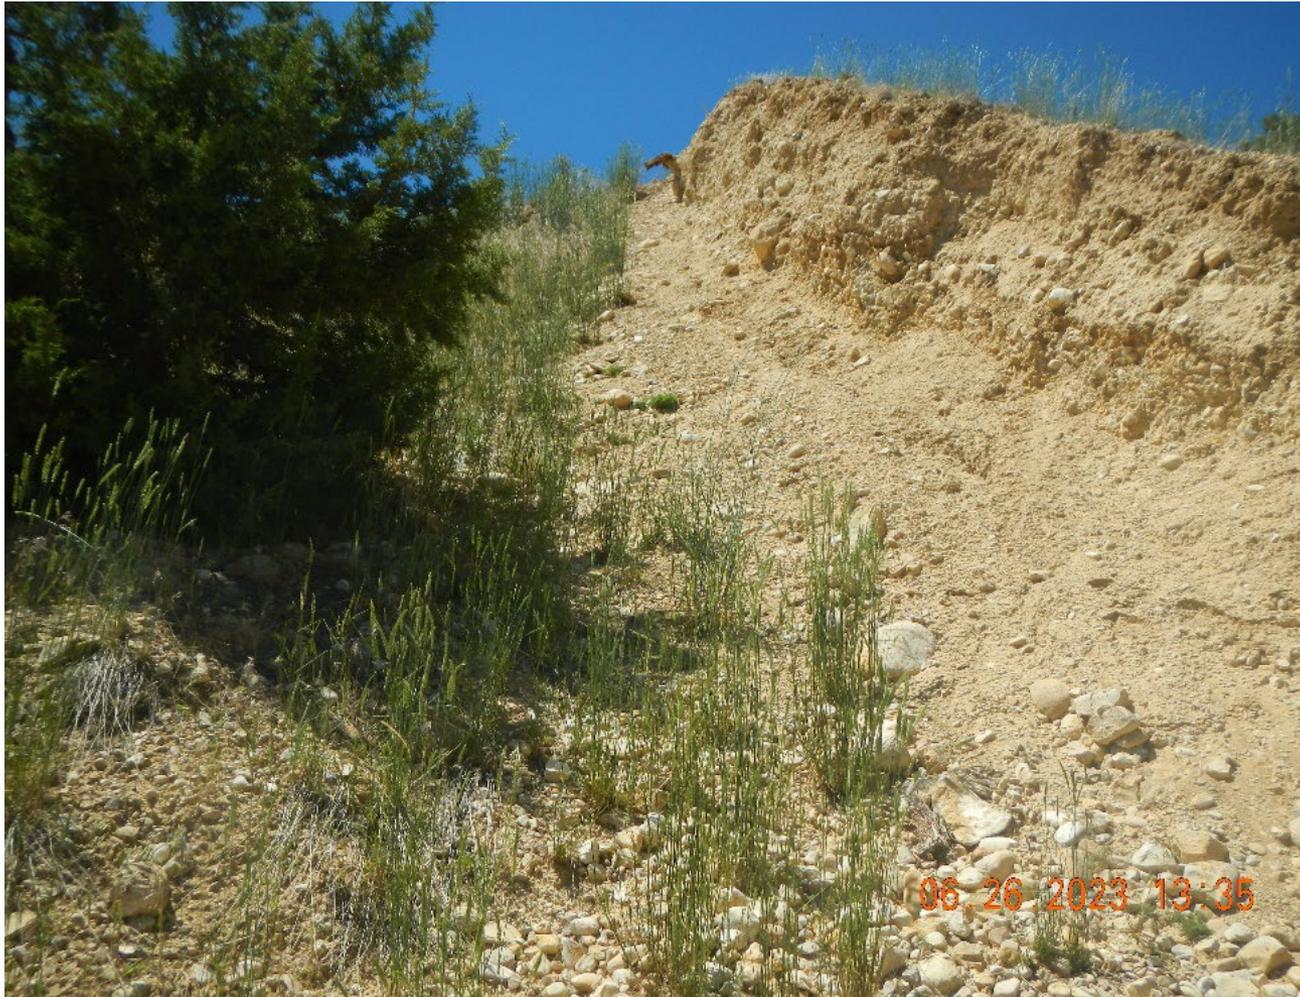
Photo #26 Photo is looking uphill from the discharge along the dirt ridge.

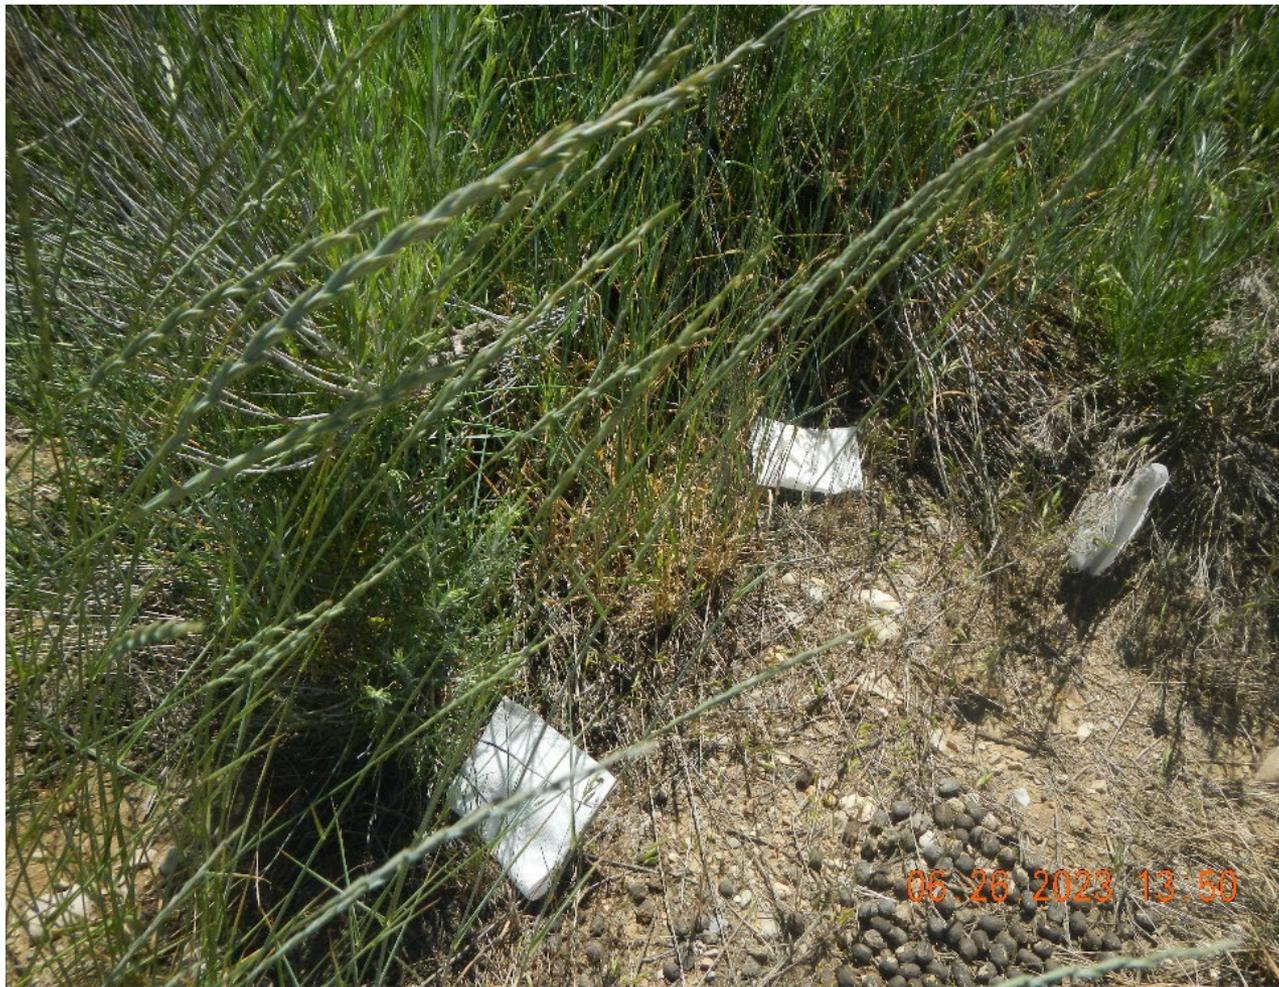
Photo #27 Trash found on ground near Elk Springs #3 API:05-081-06472 pad.

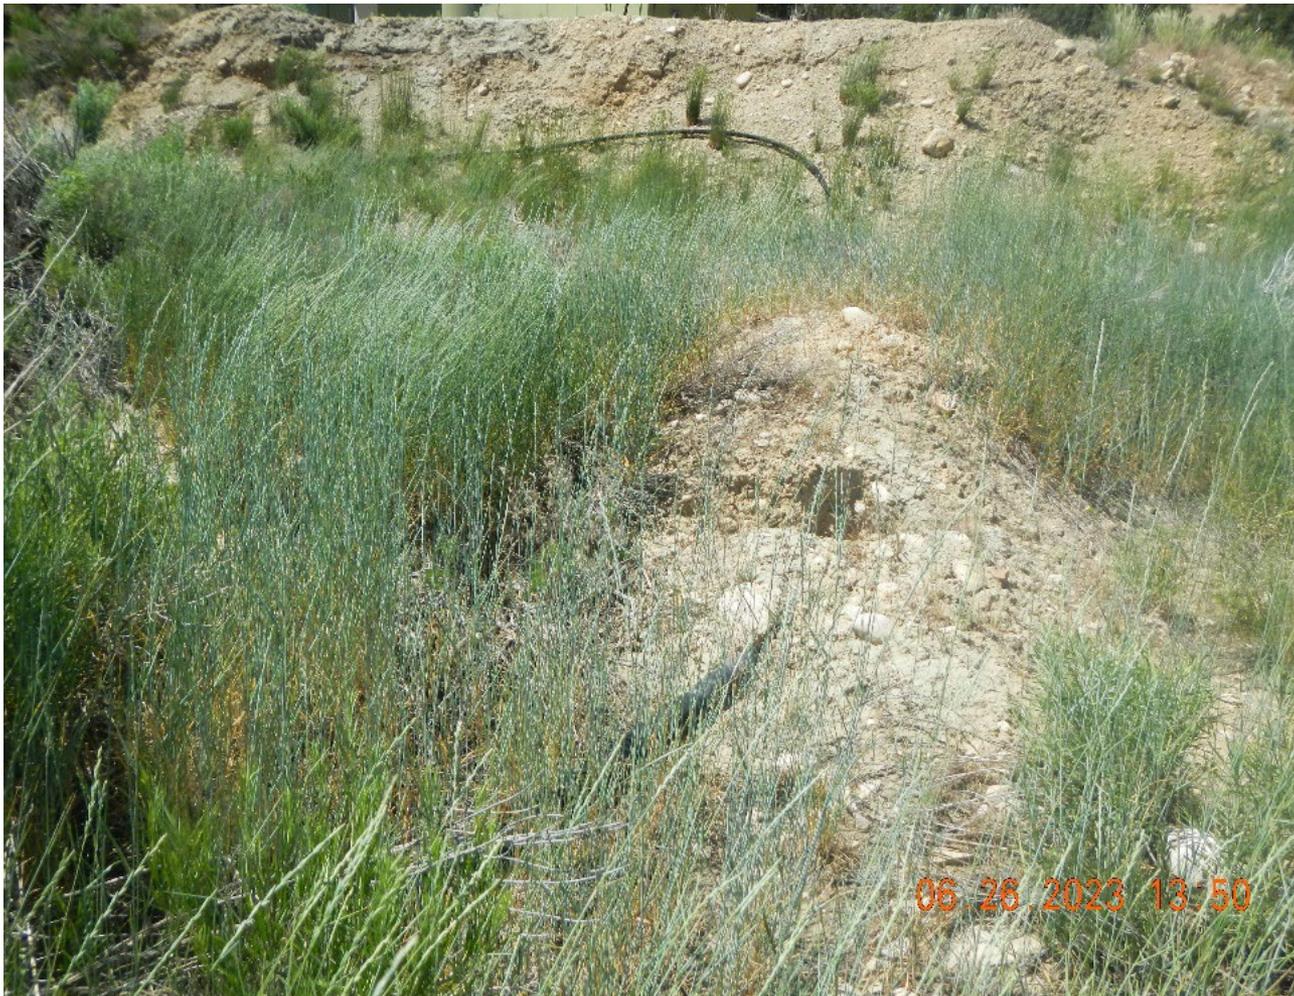
Photo #28 Photo taken south west of Elk Springs #3 (Loc 311768), just south of the tank battery. Desktop review of documents indicate that the Produced Water discharge had a “settling pond”, Pit #116686. The following was observed; remaining fencing, piping and berms and other O&G remnants. The settling pond is in the depression just south of the tank battery.

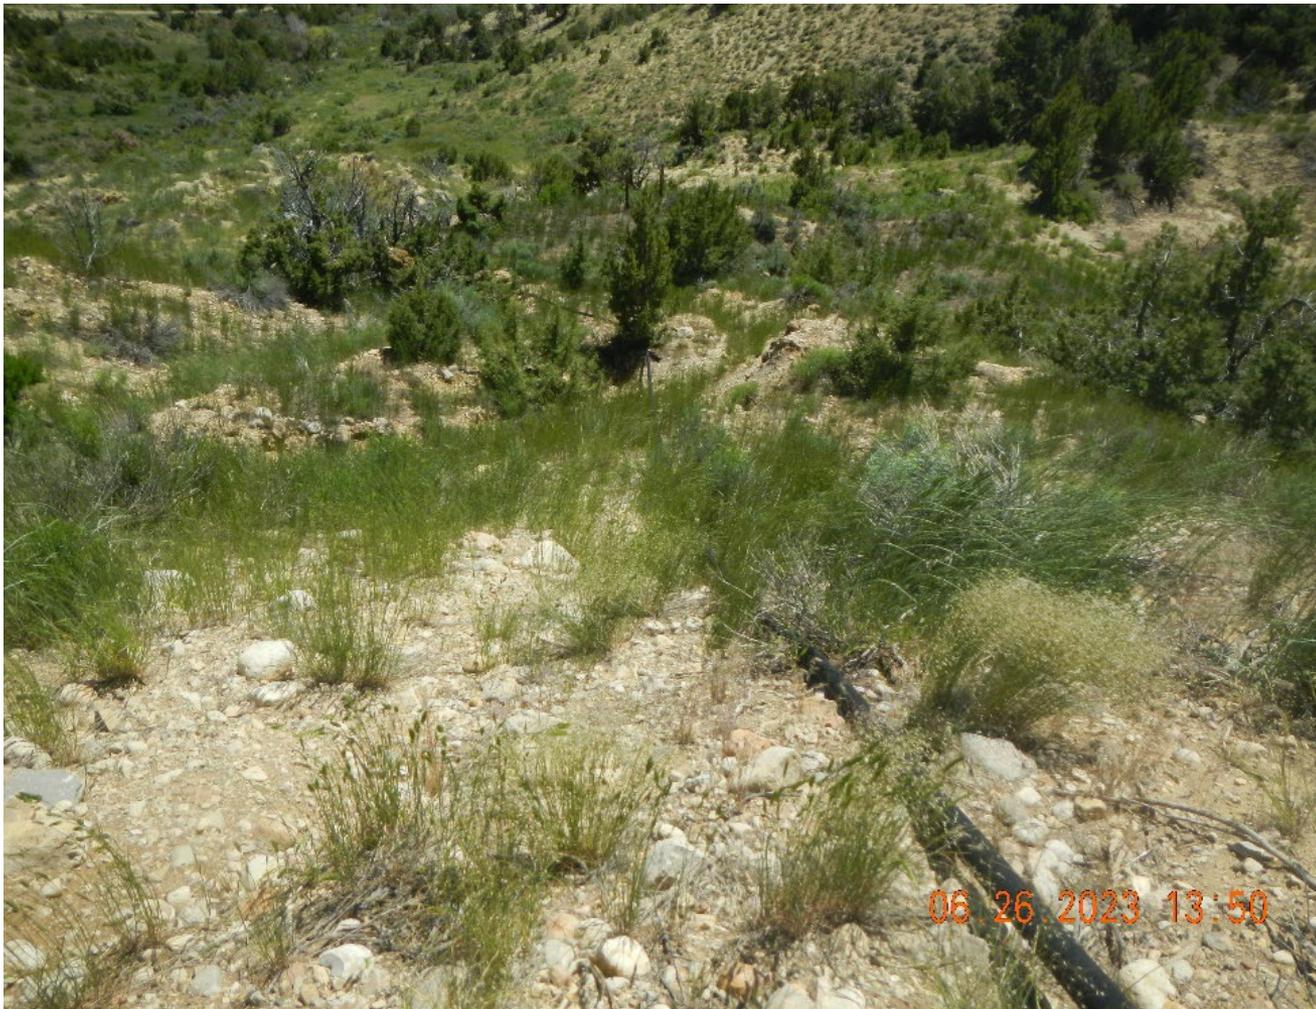
Photo #29 Pipe going down hill from the settling pond (Pit #116686).

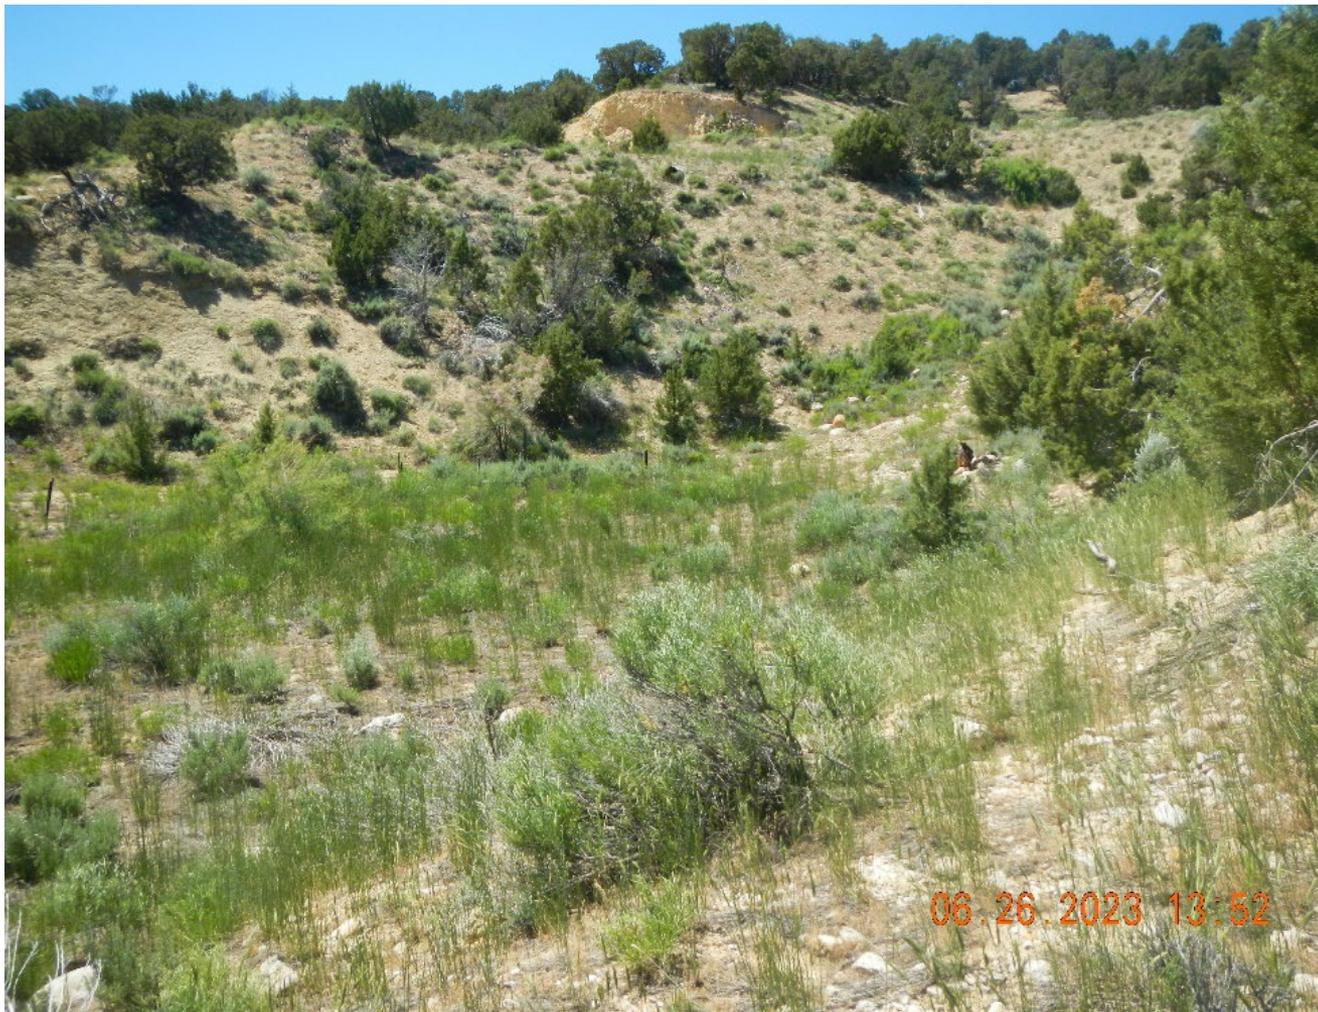
Photo #30 Looking mostly west across the settling pond area (Pit #116686).

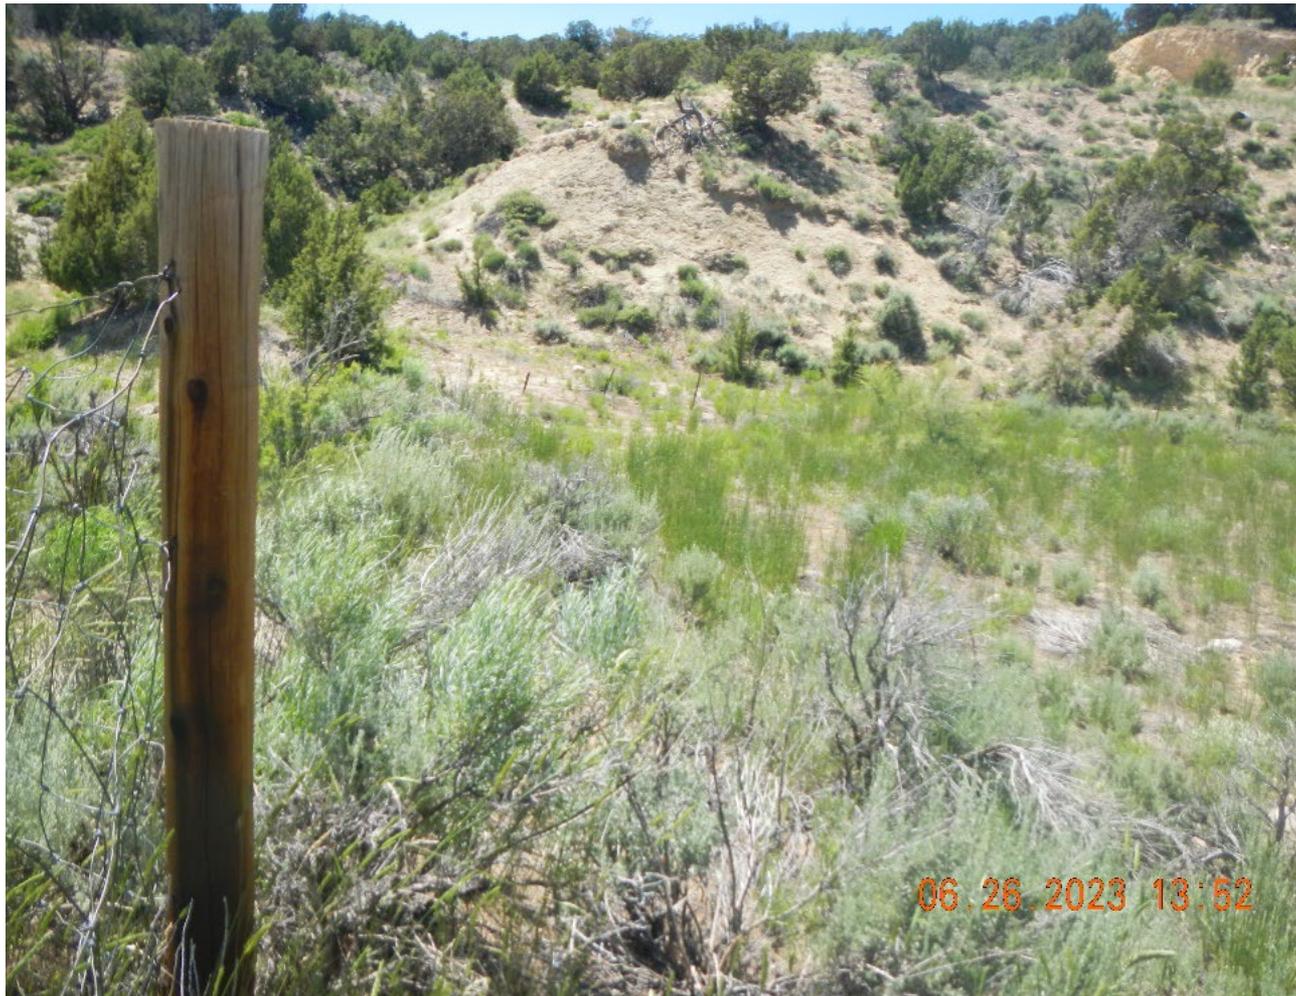
Photo #31 looking across the southern boarder of the settling pond (Pit # 116686).

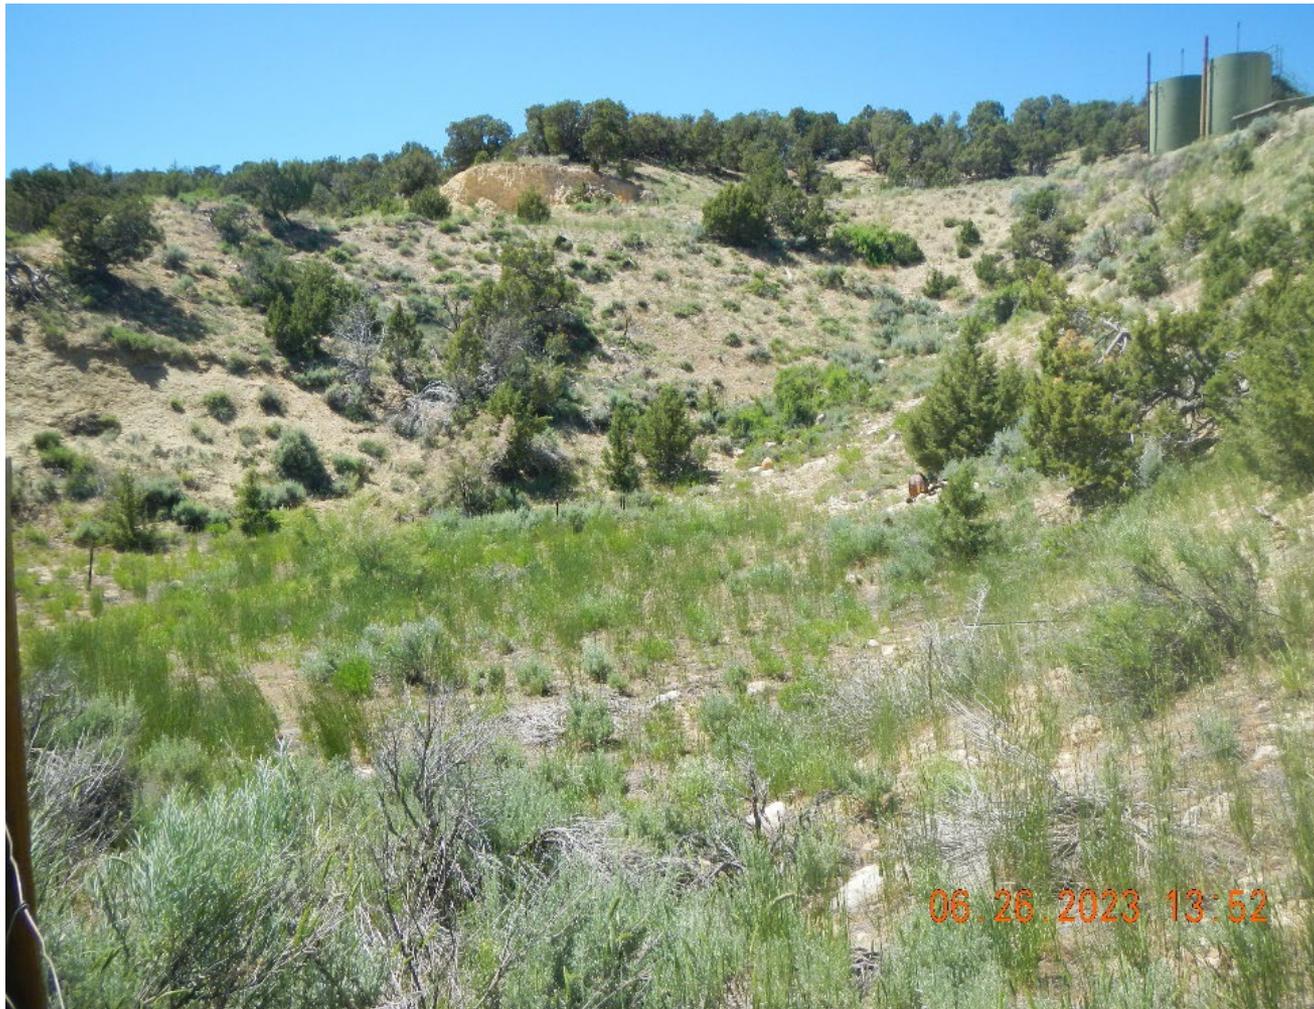
Photo #32 looking north west across bottom of settling Pond (Pit # 116686). Note: oil tanks at top right of photo.

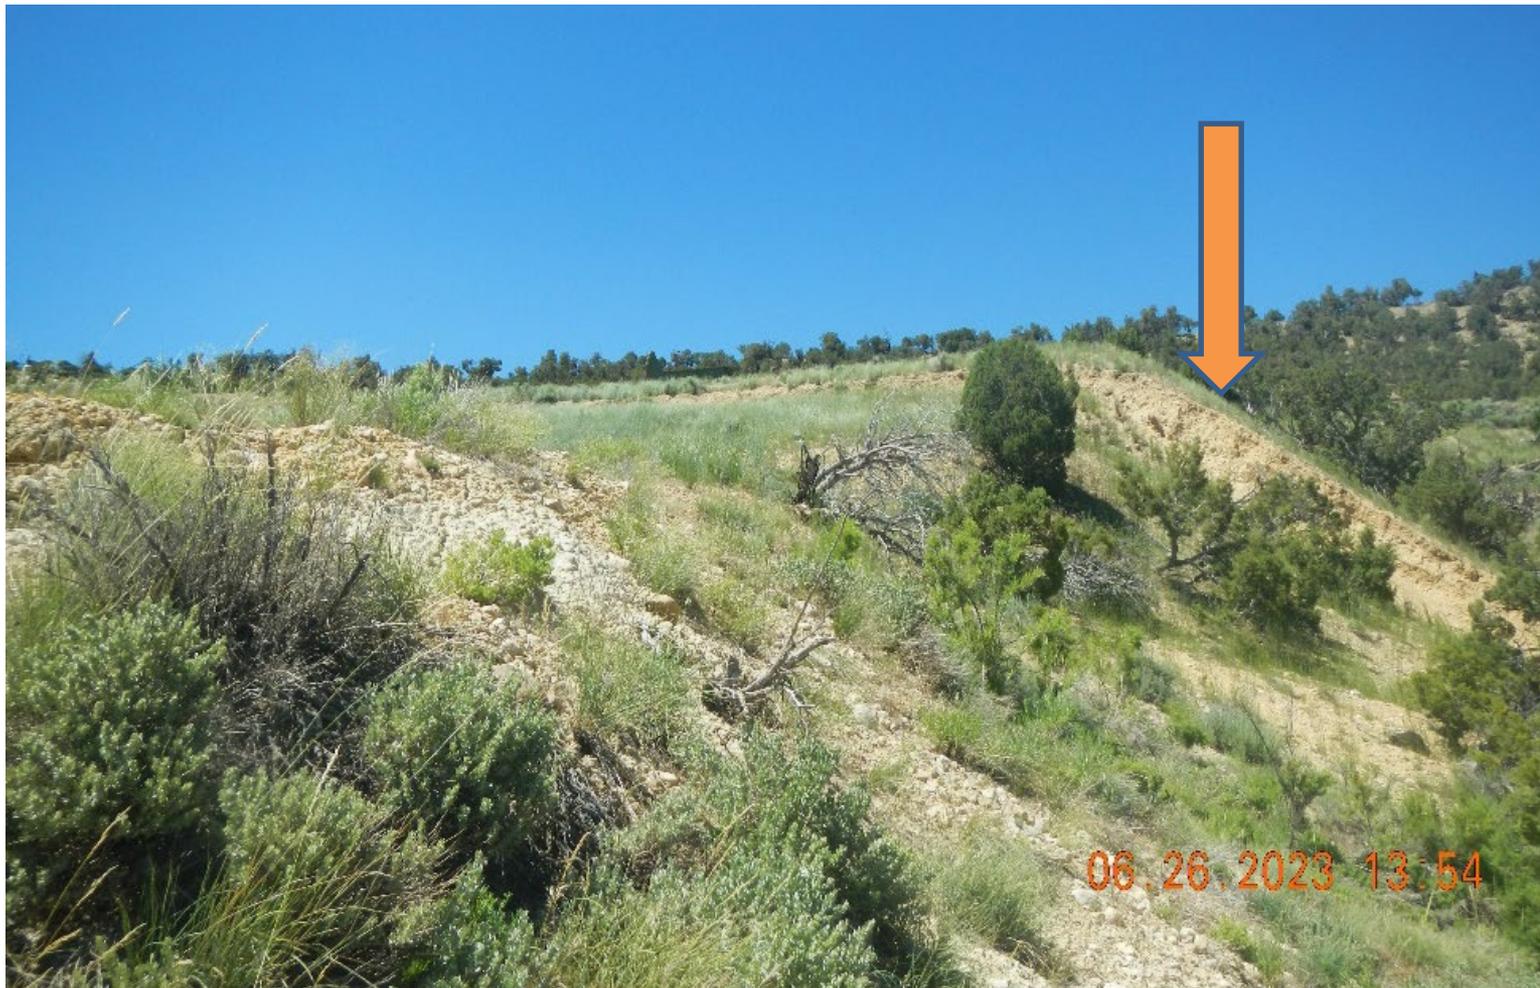
Photo #35 Photo taken from below and southwest of pad. Note: dirt ridge (arrow), Elk Springs #3 well pad is to the left of photo.
