Inspection Photos

Location
Well 081-06472
Inspection
Date:6/26/2023

All Photos taken
by Kris Neidel

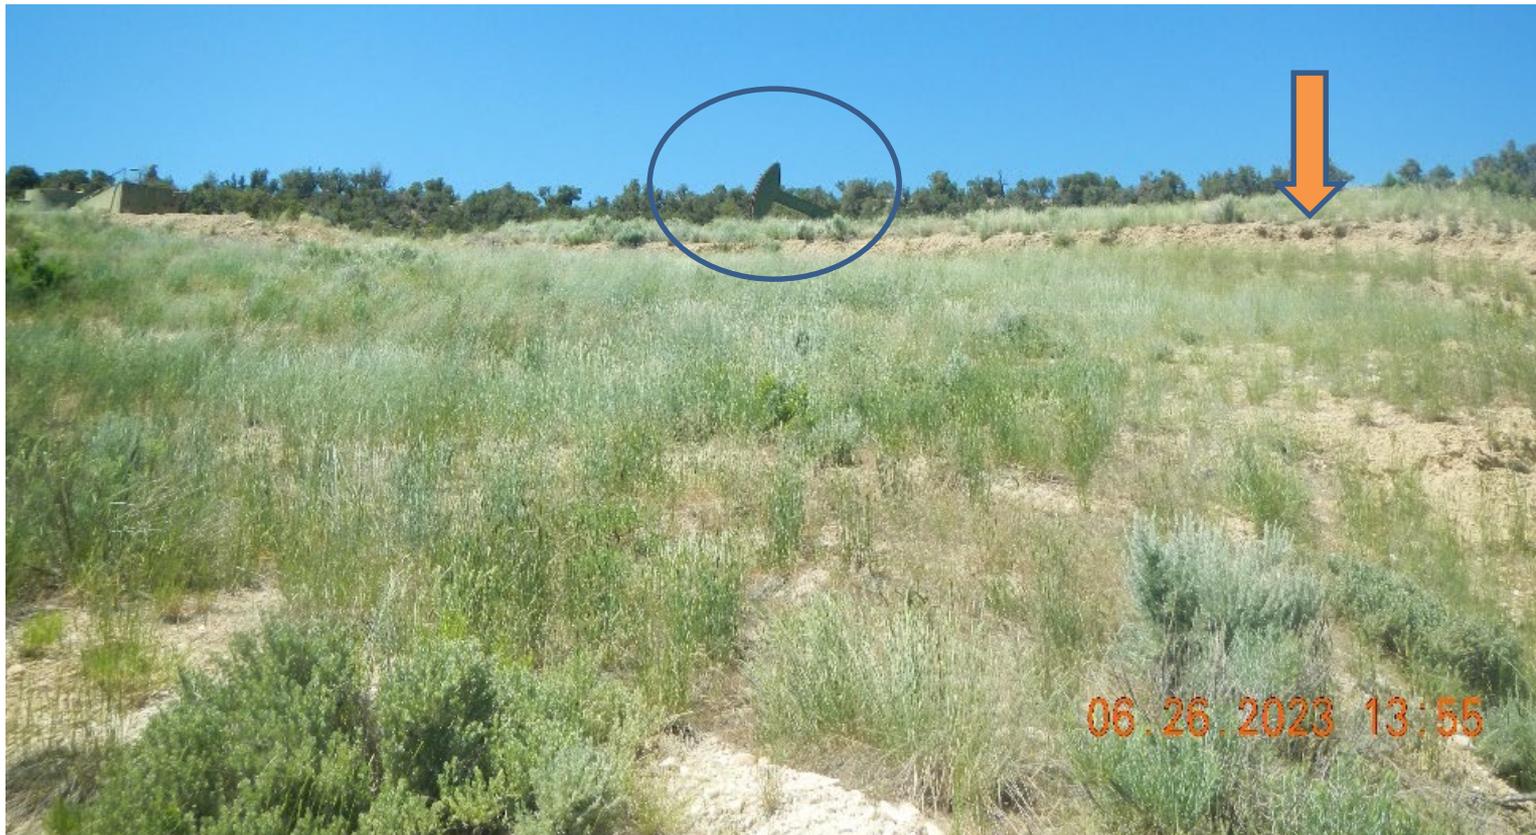
Photo #36 Photo taken from east of Elk Springs #3 (Api:05-081-06472)pad, below. Note: pumping unit (center of photo) and dirt ridge (in upper ¼ of photo).

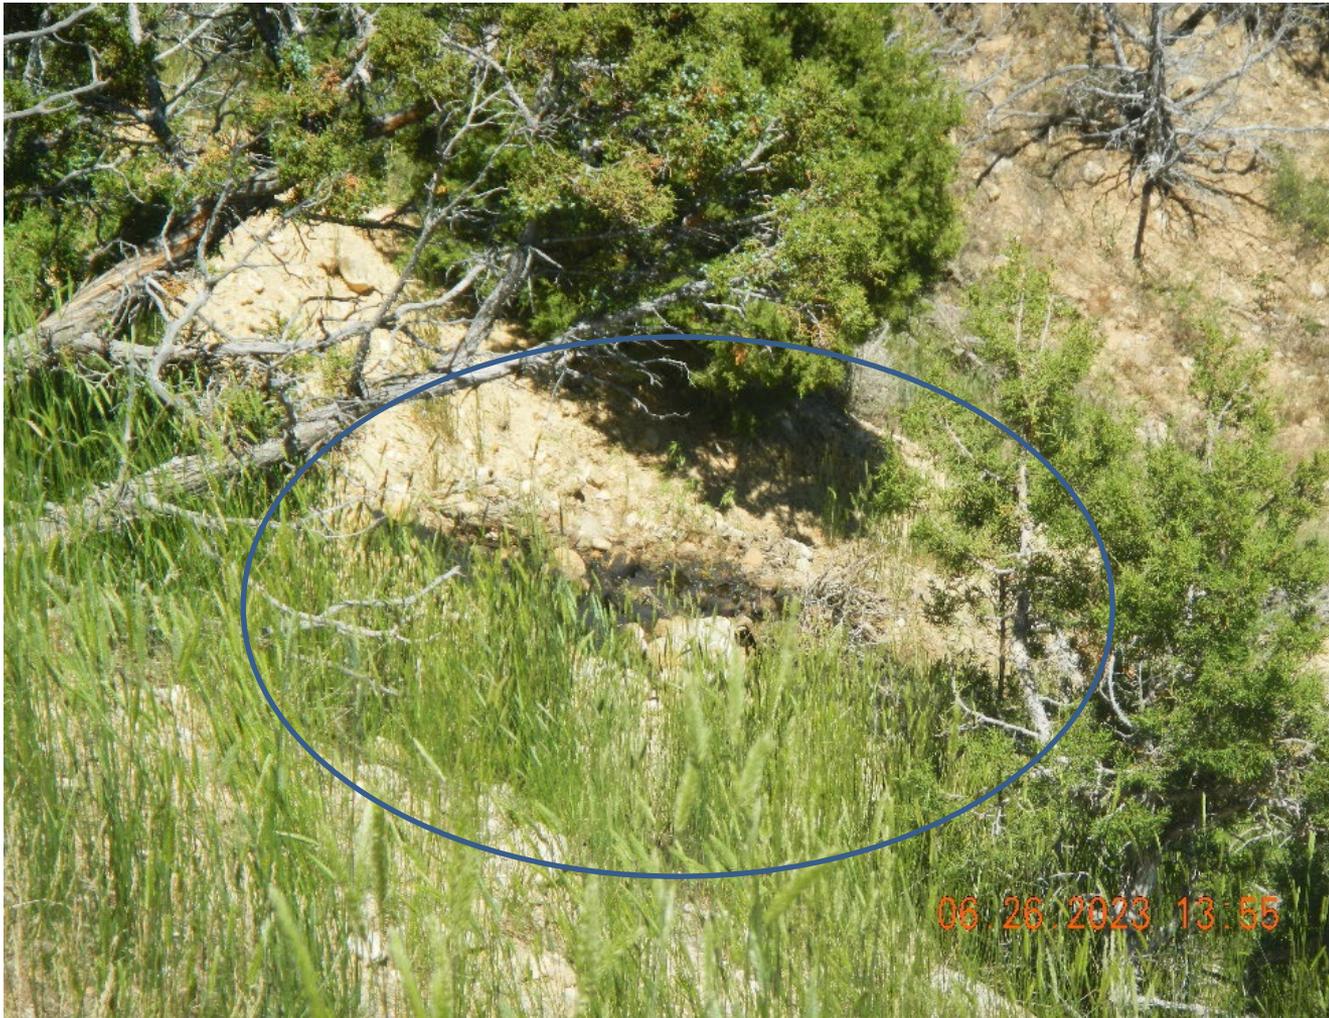
Photo #37 Close up of current discharge point. Photo taken from hill, looking south east, above discharge.

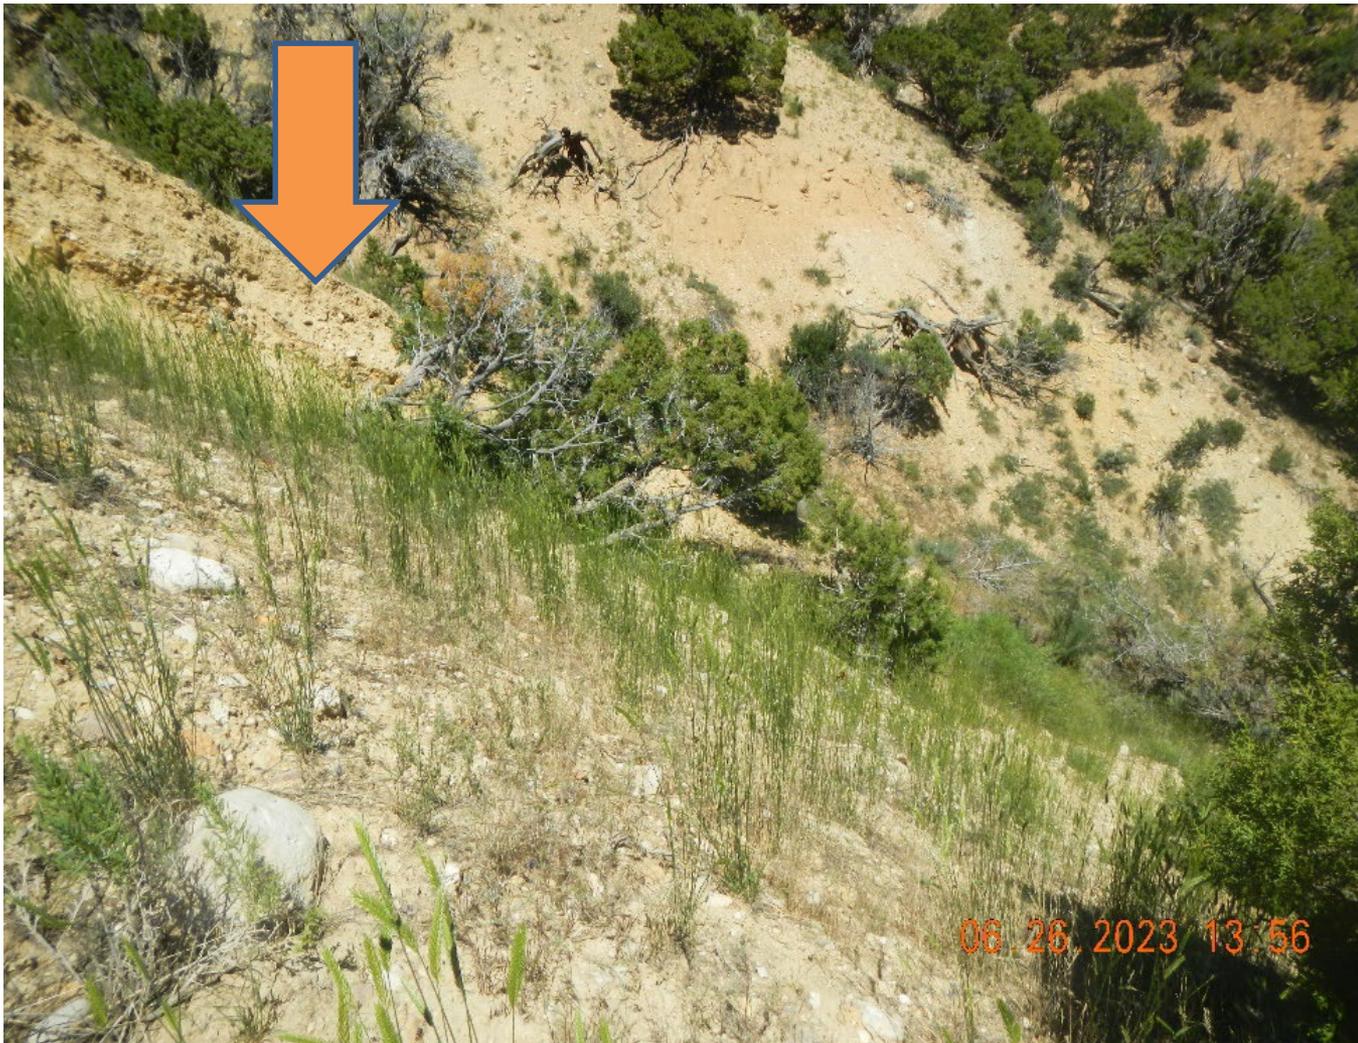
Photo #38 Center of photo is the discharge point. Note Dirt ridge on left of photo.

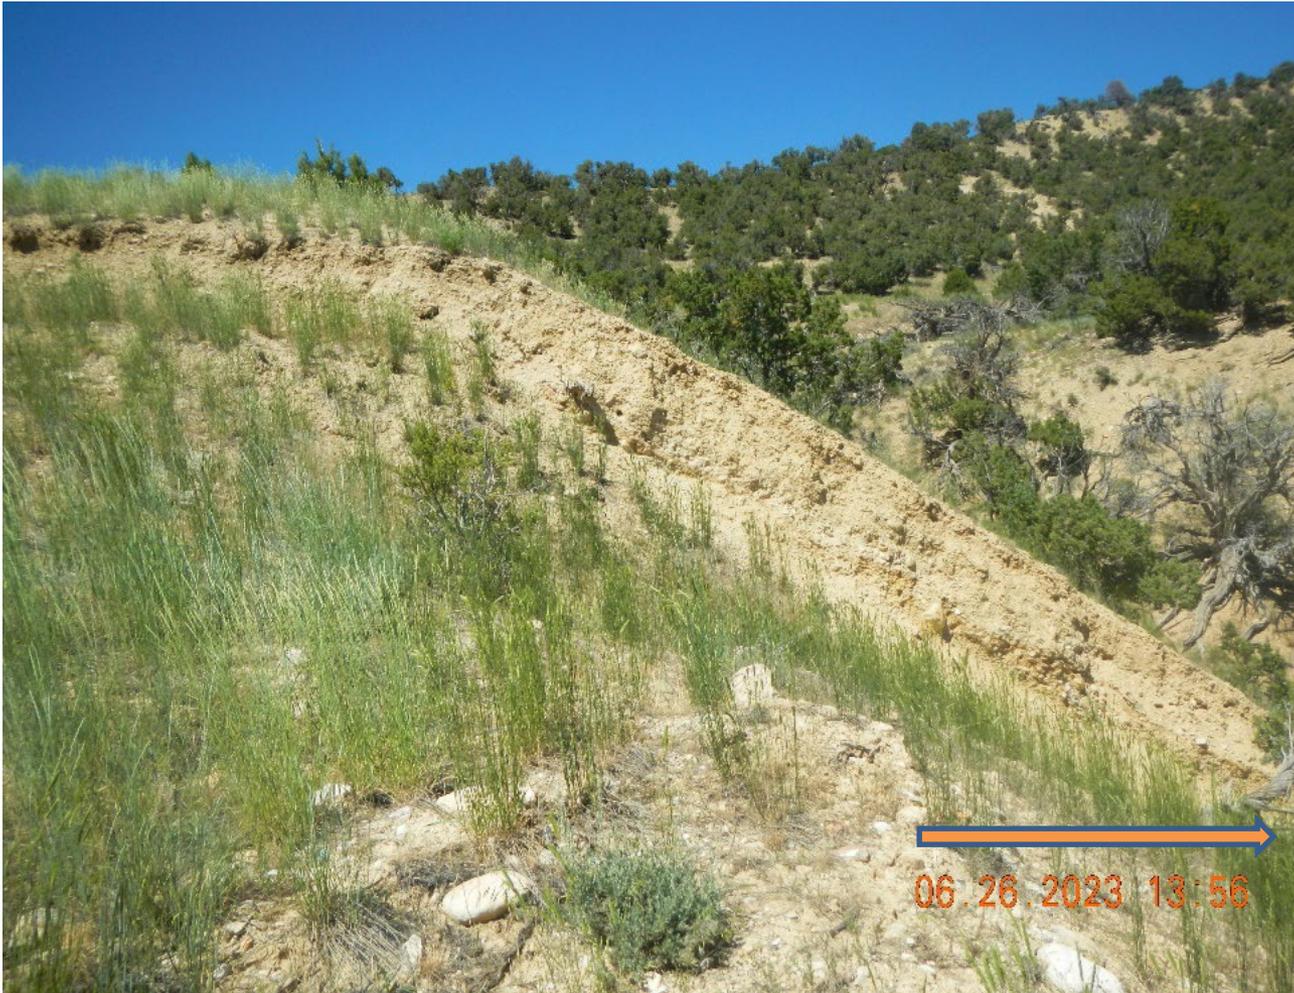
Photo #39 Eastern end of dirt ridge. The dirt ridge here is just above current discharge point.

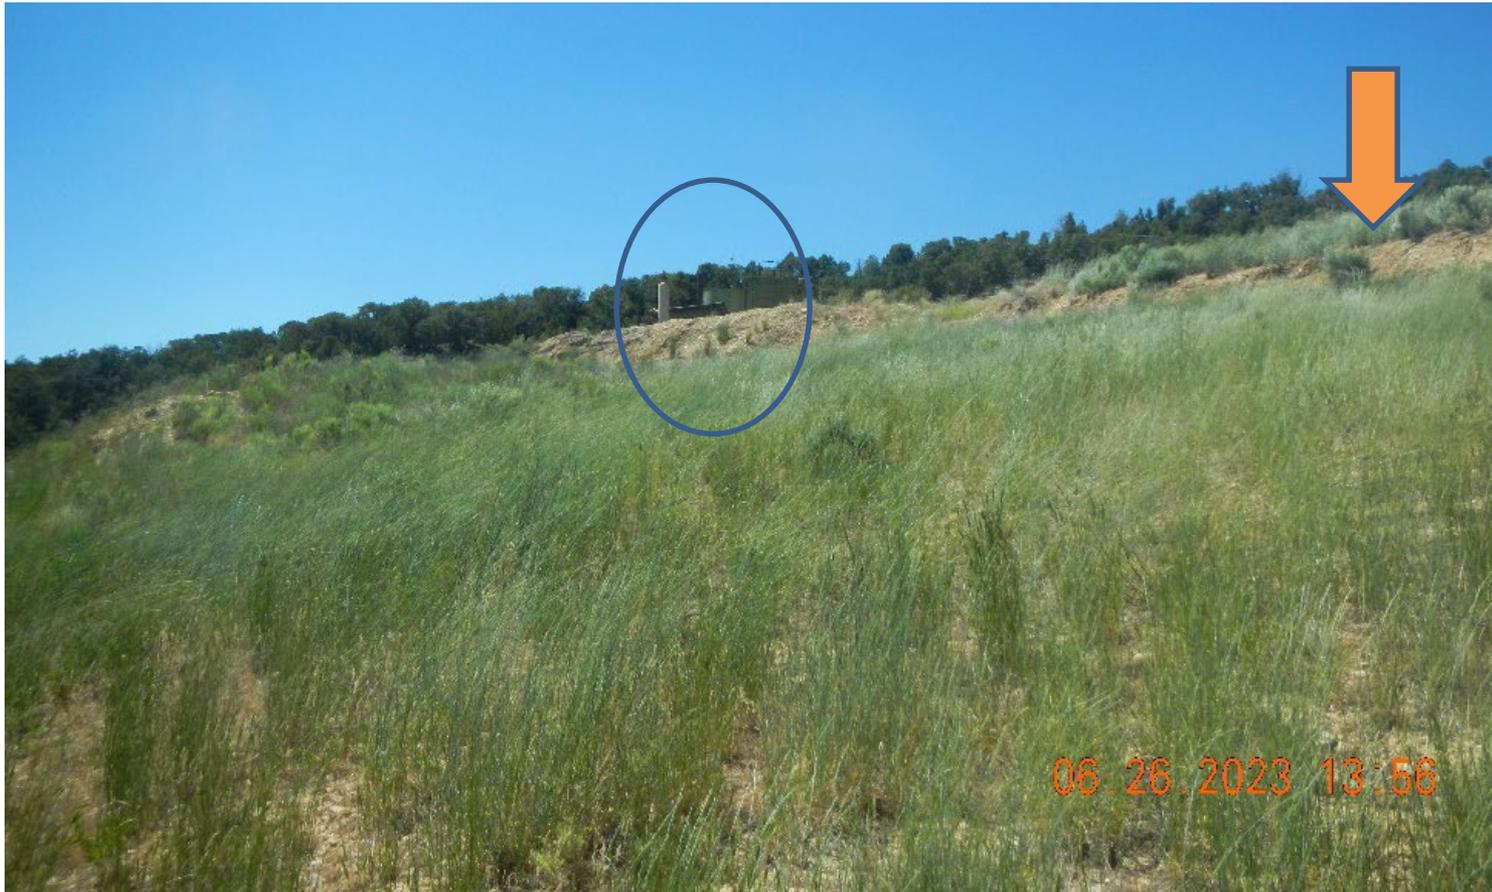
Photo #41 Photo of , Elk Springs #3 tank battery from below grade. Note; dirt ridge on right.

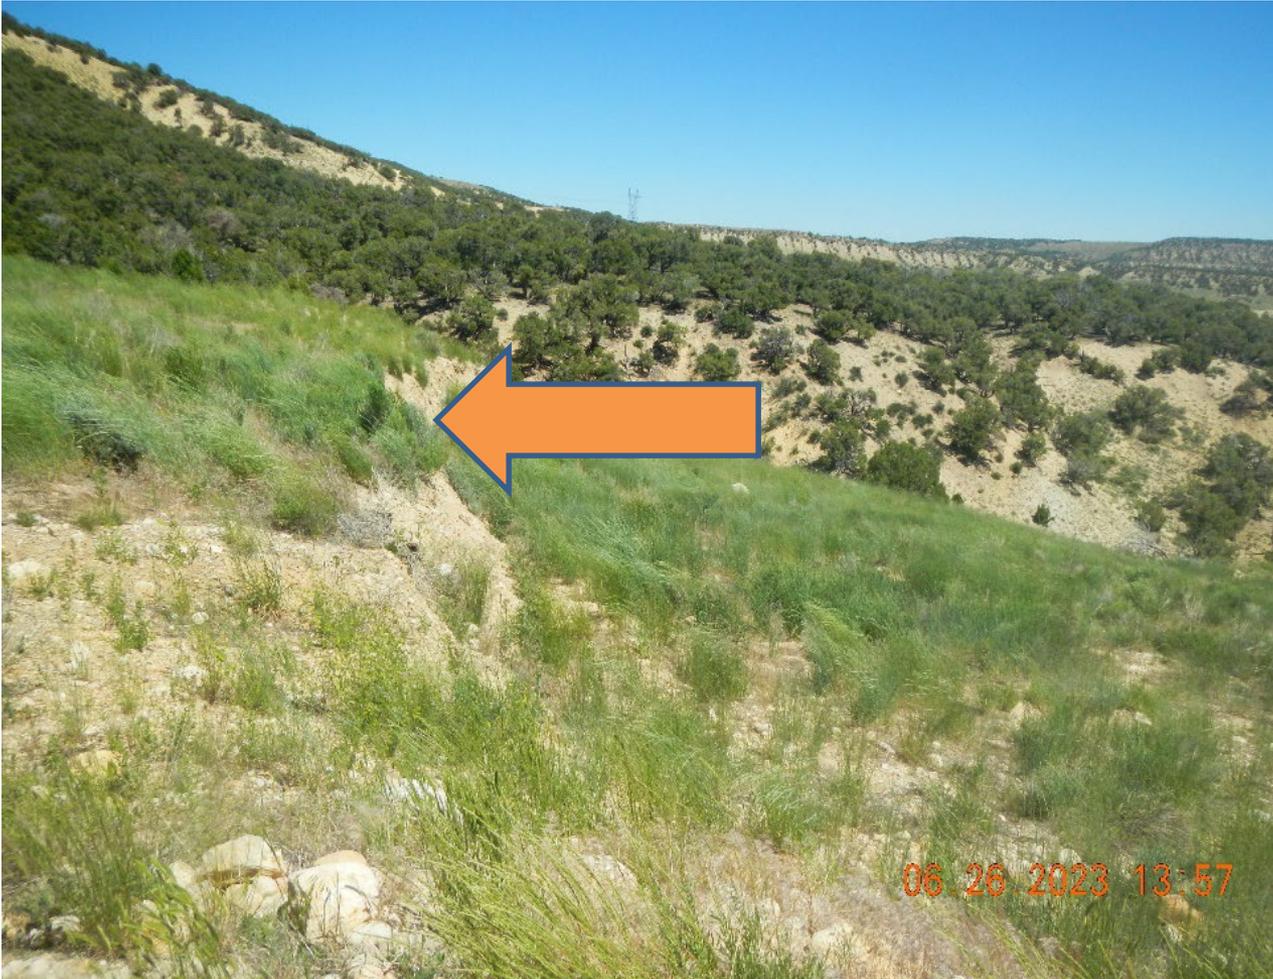
Photo #42 Photo Taken 40 feet off , Elk Springs #3 pad. Dirt ridge in left-center of photo is the dirt ridge seen in areal image.

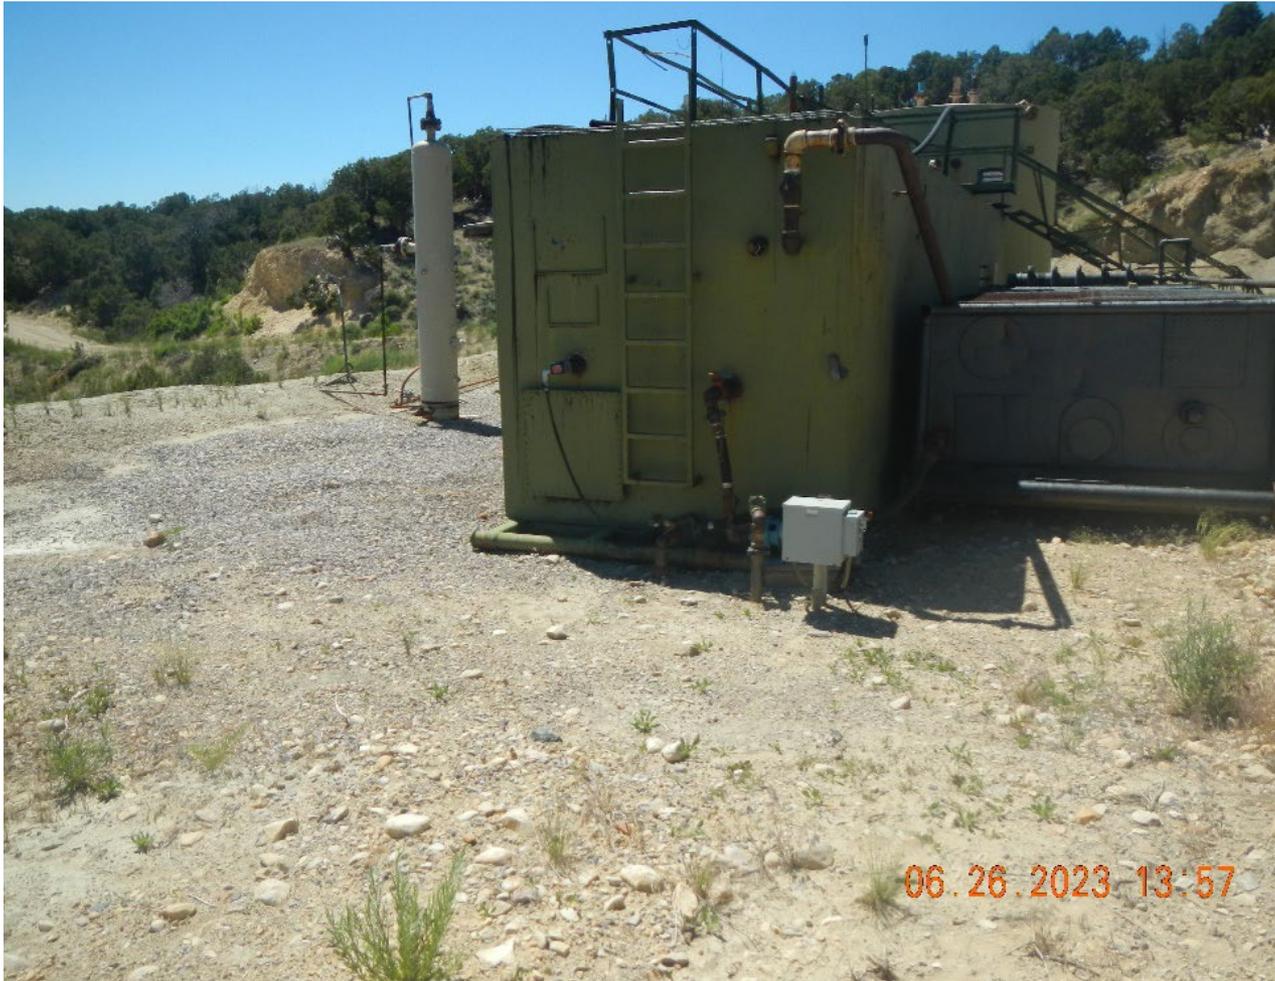
Photo #43 East side of the tank battery on , Elk Springs #3 , water treatment equipment.

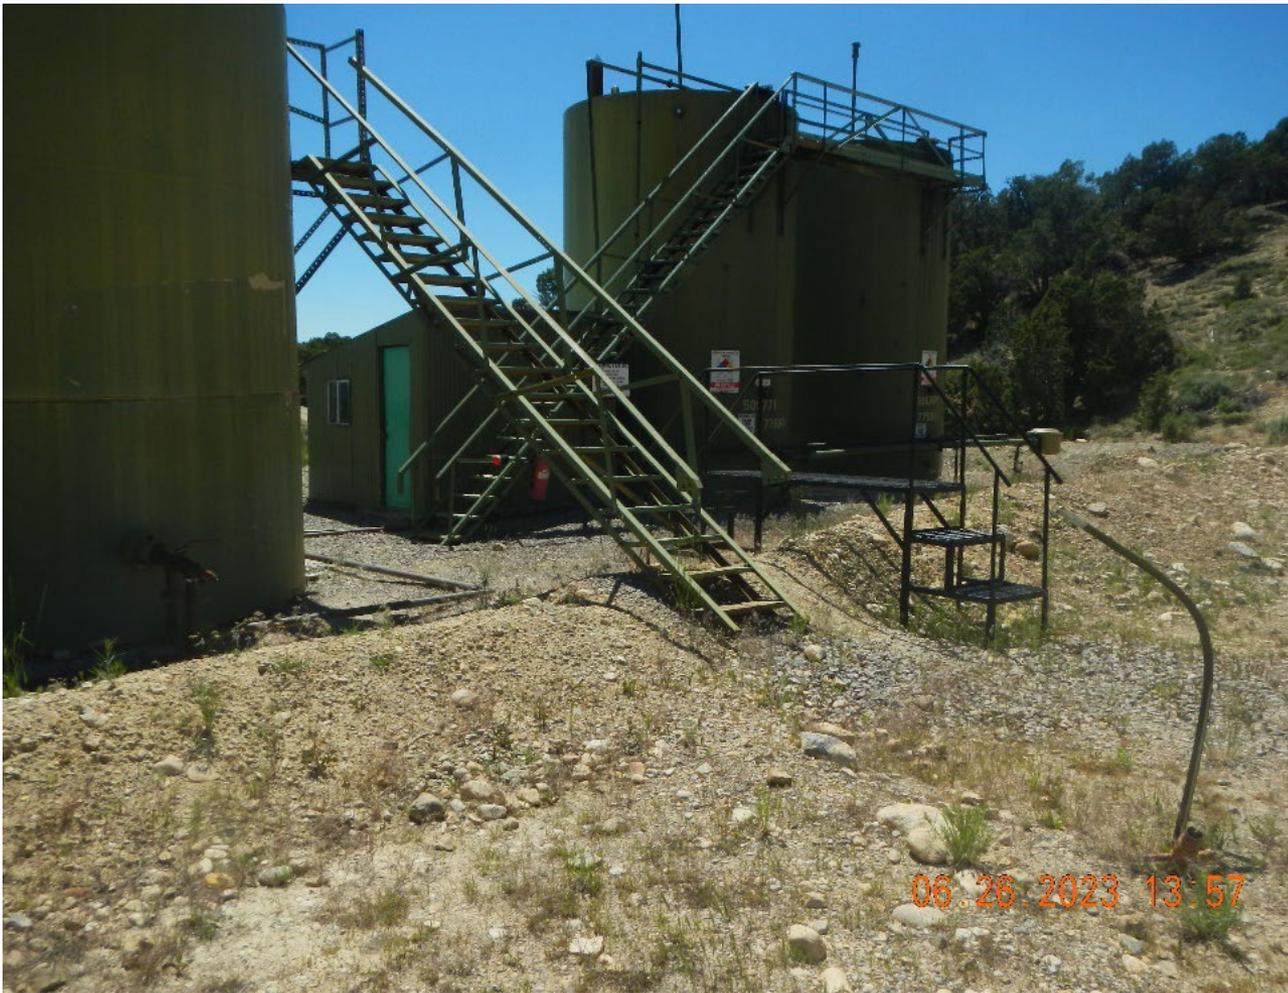
Photo #44 Oil storage tanks on the right.

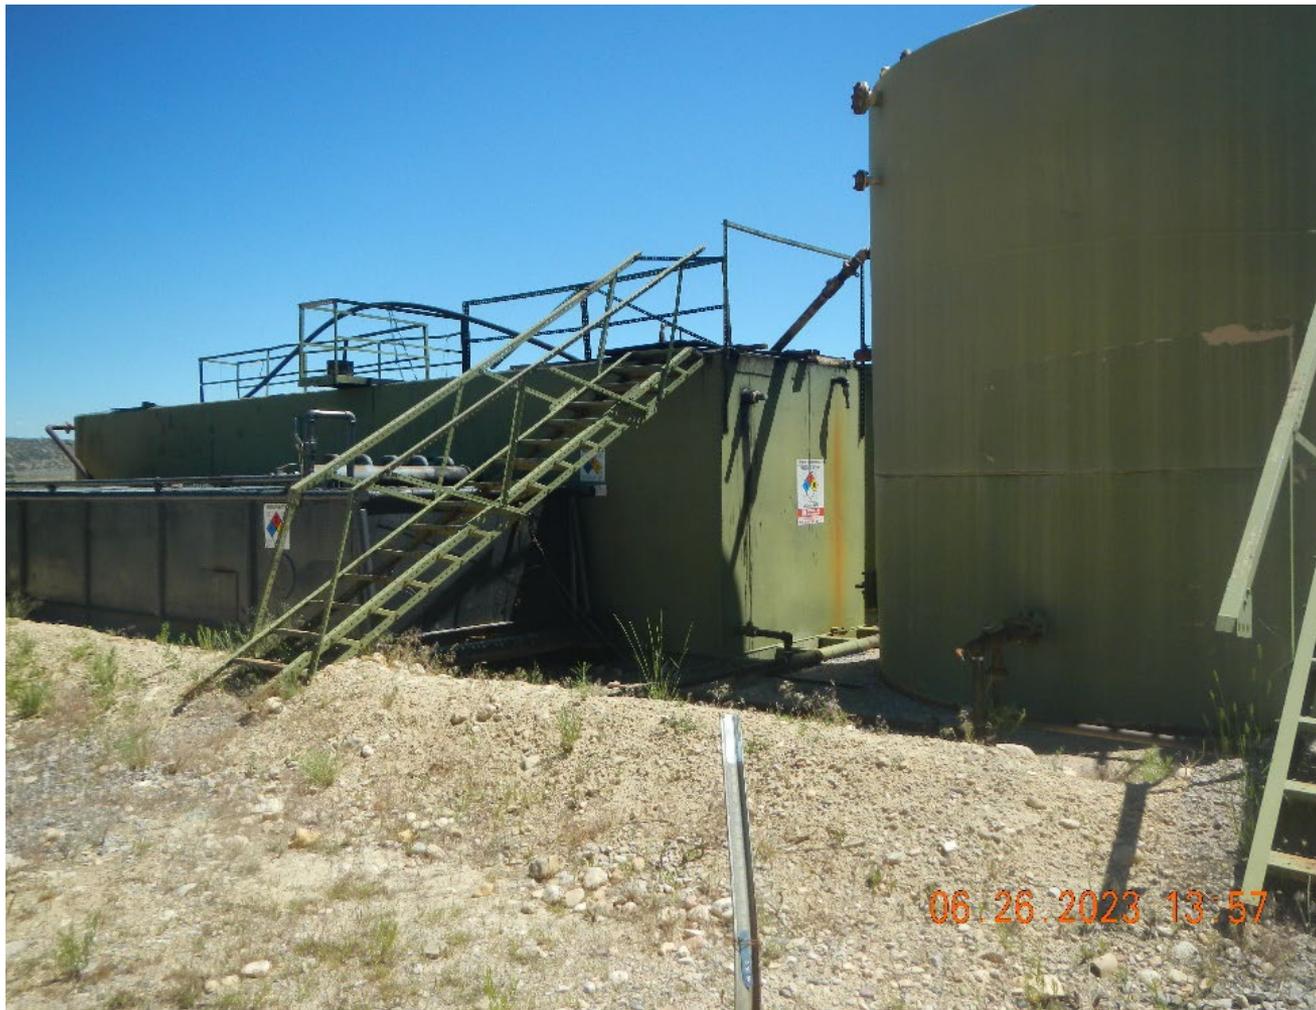
Photo #45 open top produced water treatment tanks.

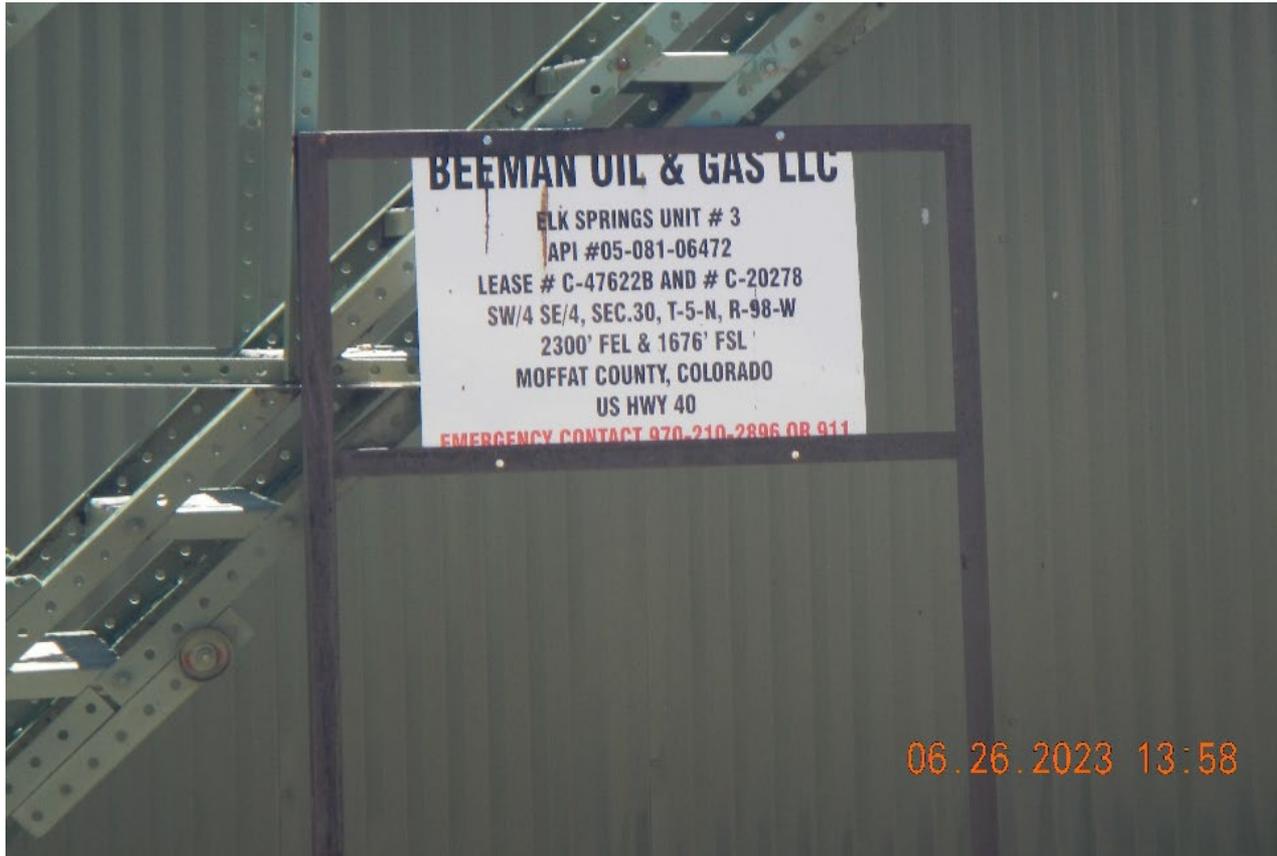
Photo #46 Well sign at Tank Battery , Elk Springs #3 . Note: Oil spilled on sign.

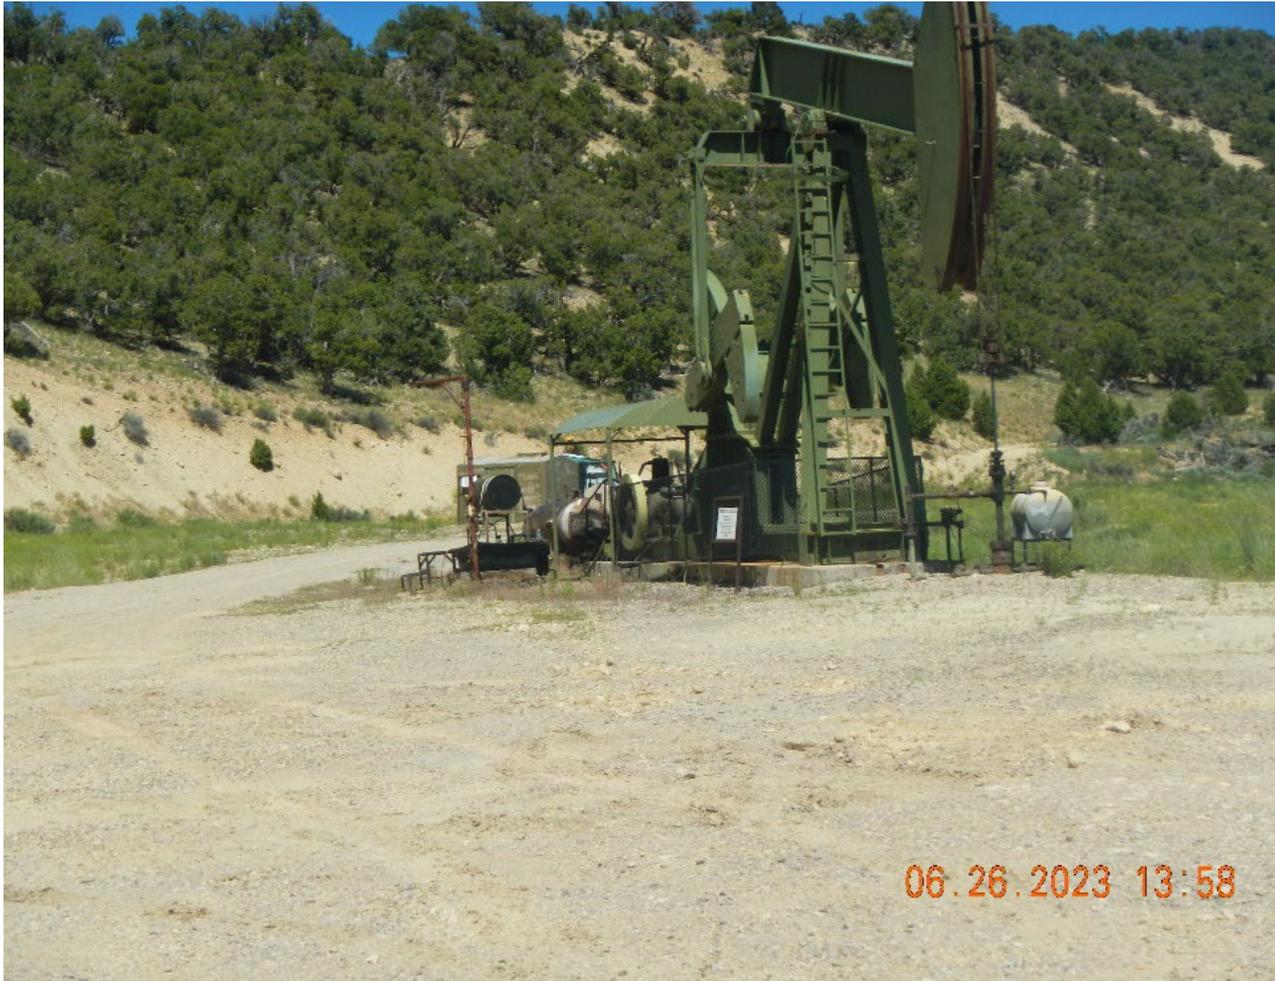
Photo #47 #3 wellhead, well was PR at time of inspection.
