Inspection Photos

6/28/2023

Operator: CAERUS PICEANCE LLC #10456

Location Number: 479215

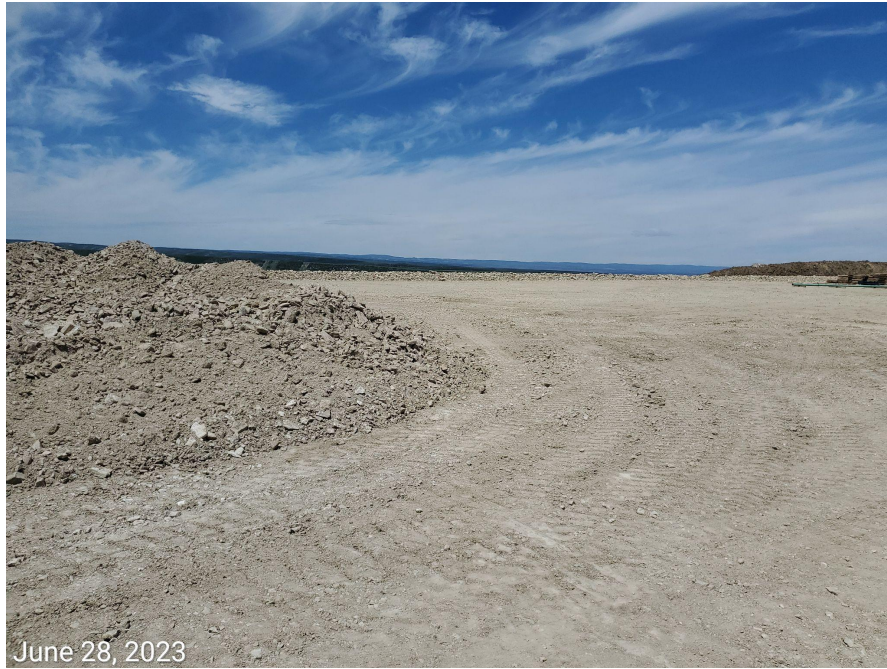
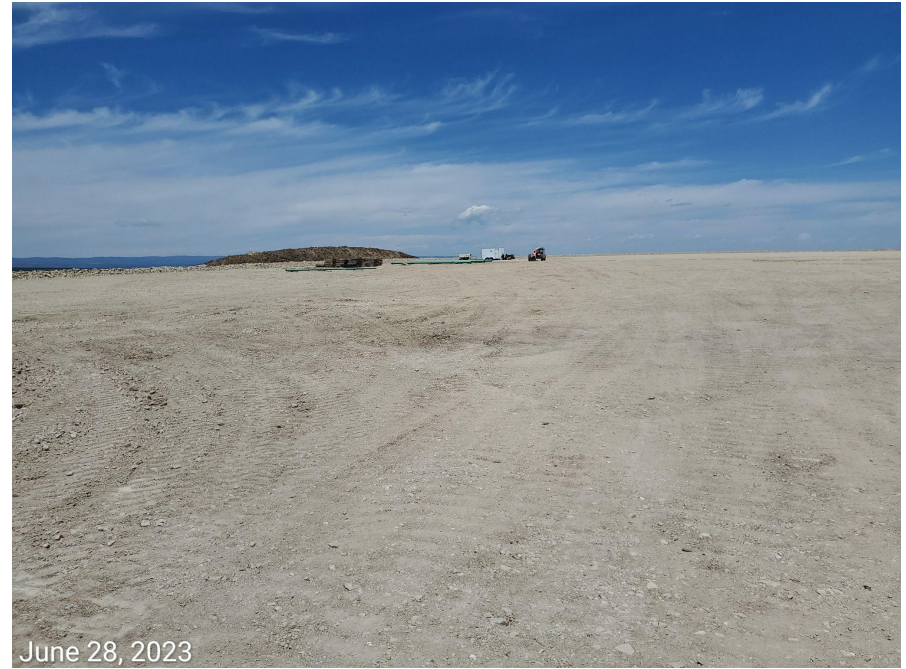
Photo 1: Photos 1-2 taken from the south end of the Location. Photos provide an overview of the Location from west, northwest, northeast to east.

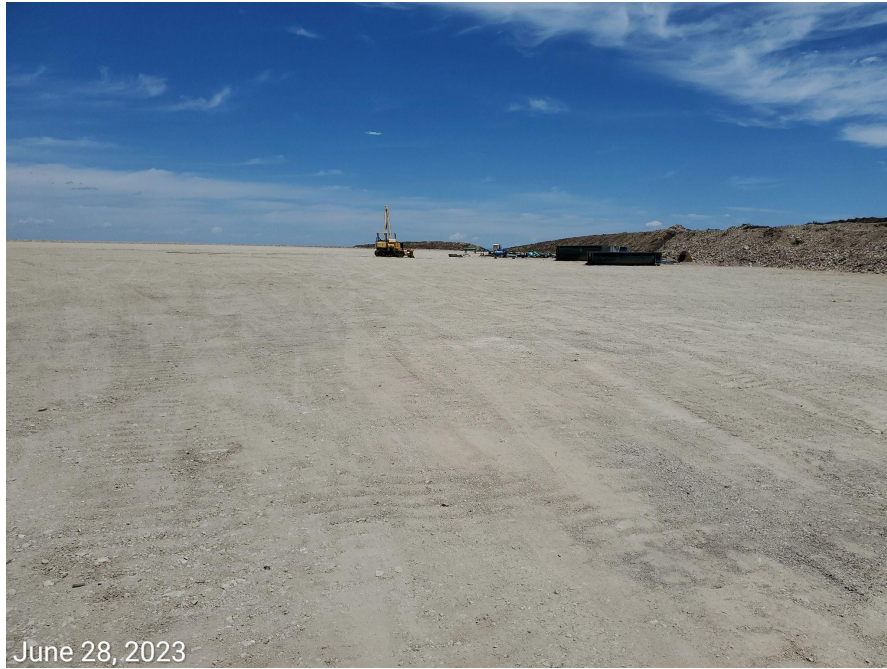
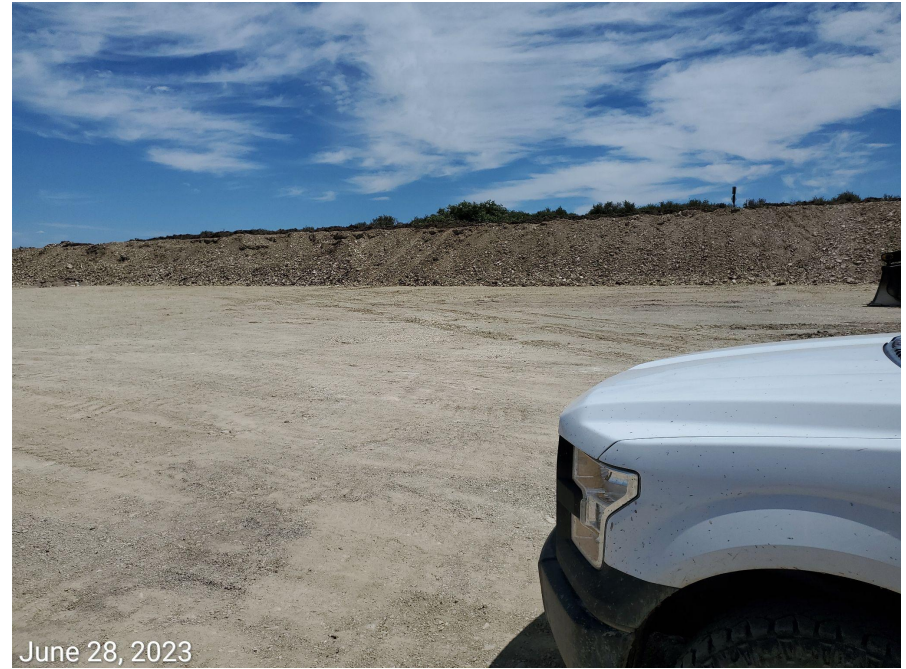
Photo 2: See comments under photo 1.

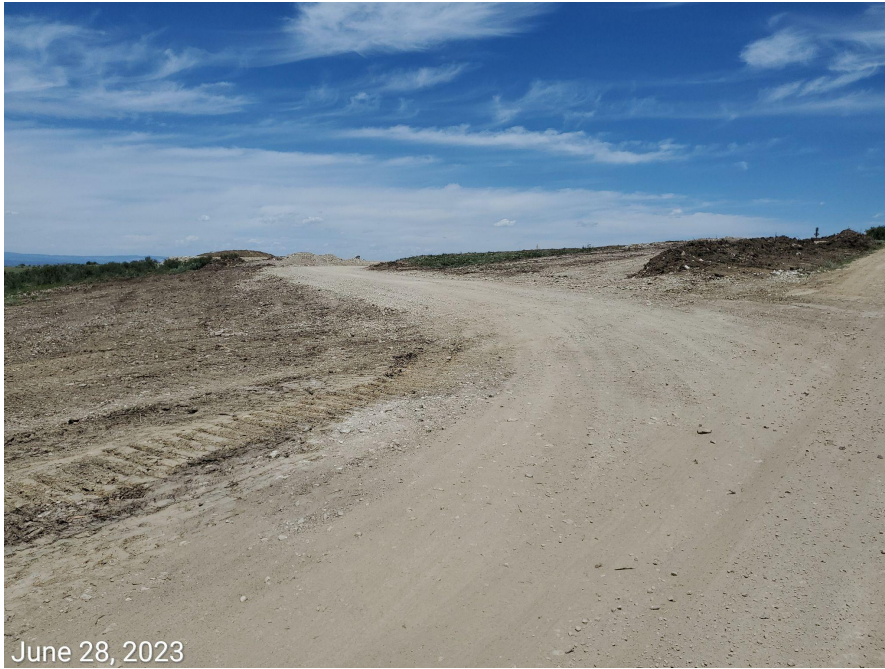
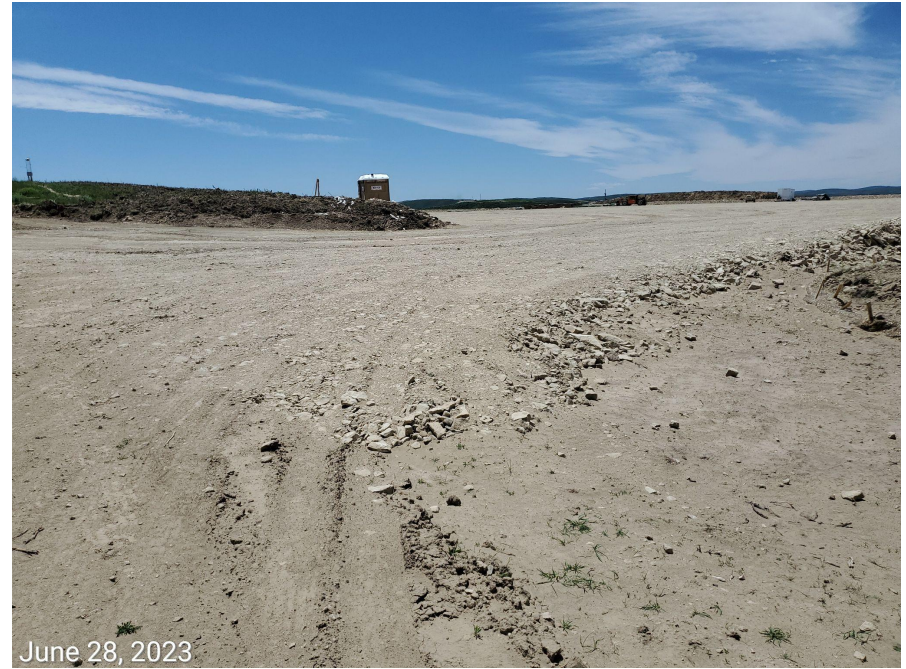
Photo 3: Photo left taken from the Location entrance on the south end of the Location, photo right taken from the Location entrance on the north end of the Location. Photos show signage has not been posted at either Location entrance.

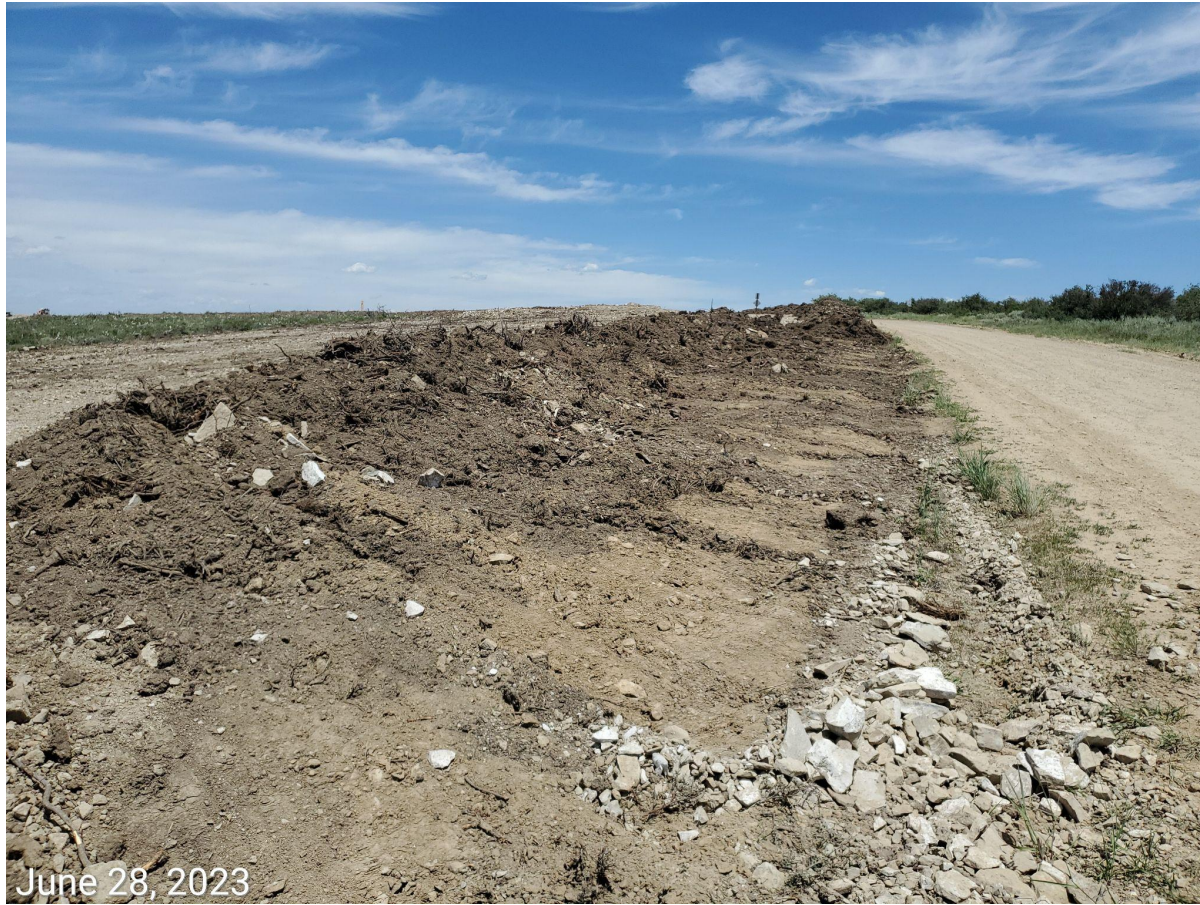
Photo 4: Photos 4-5 taken from the access road, to the east of the Location. Photos shows BMPs to properly protect, as well as to minimize erosion, degradation and sediment transport are missing or insufficient at the topsoil stockpiles along the east end of the Location.

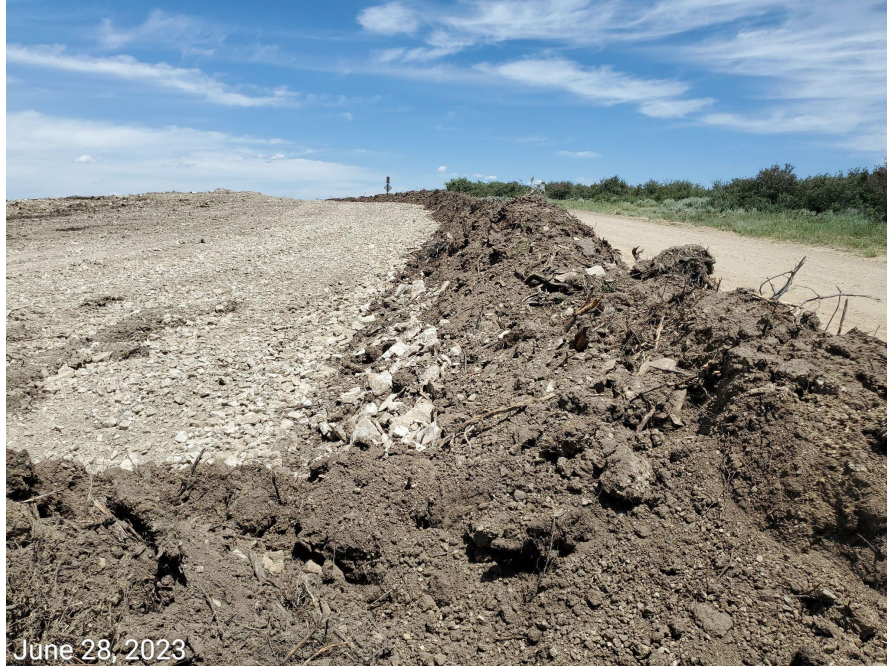
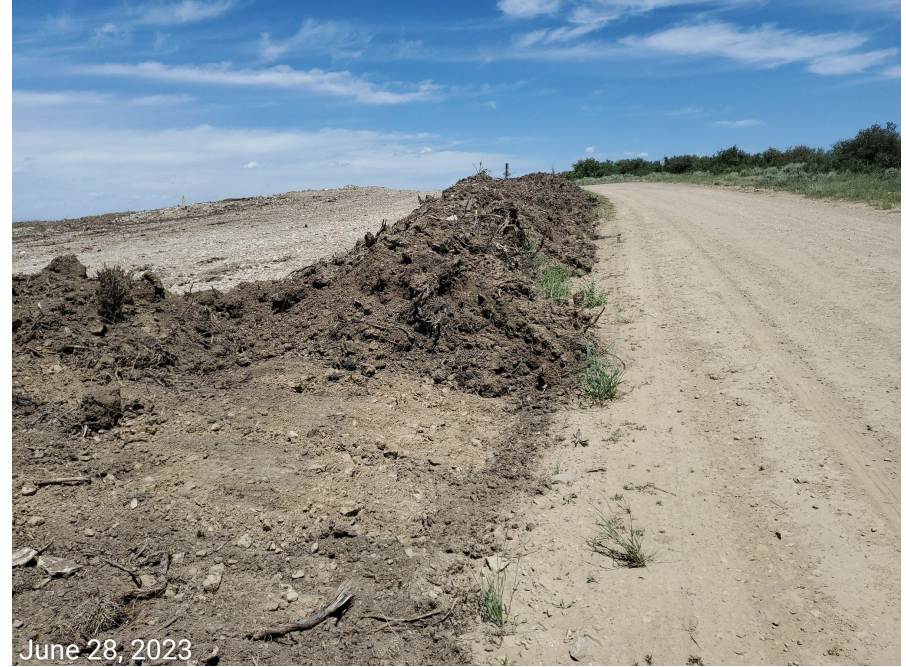
Photo 5: See comments under photo 4.

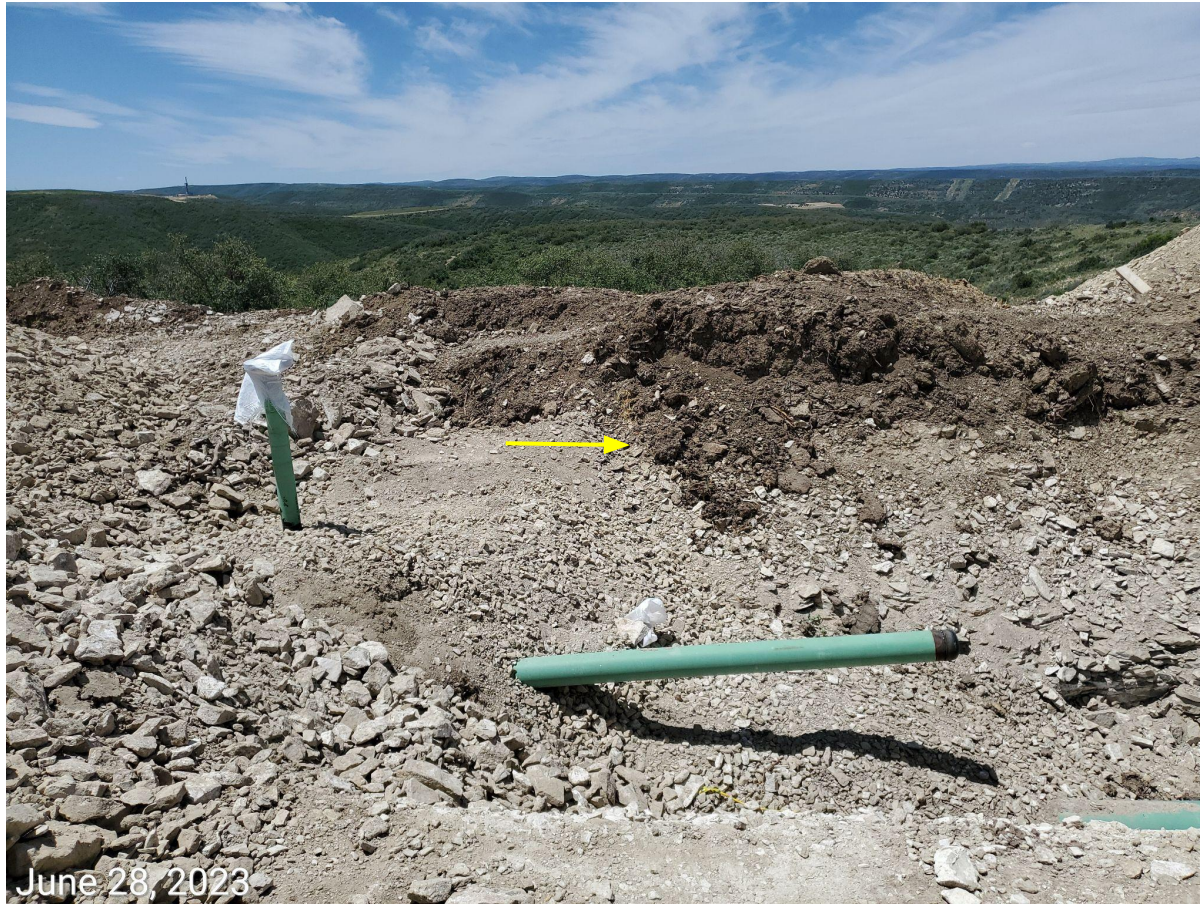
Photo 6: Photo taken from the south end of the Location. Photo shows topsoil eroding into the excavation. BMPs to properly segregate and protect the topsoil are missing or insufficient.

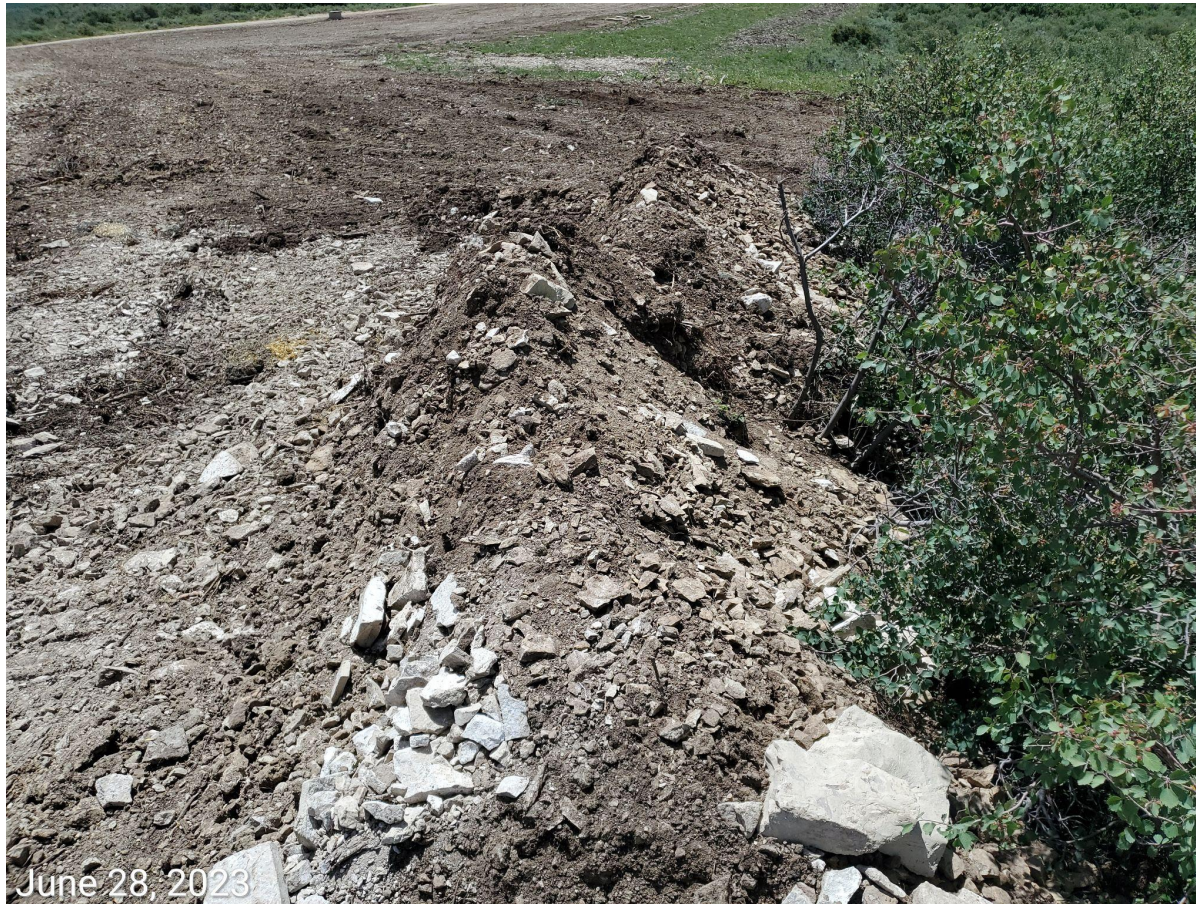
Photo 7: Photo taken from the south end of the Location. Photo shows BMPs to properly protect the topsoil, including BMPs to minimize erosion, degradation and sediment transport are missing or insufficient. Photo also show Operator appears to have mixed subsoils with the topsoil.

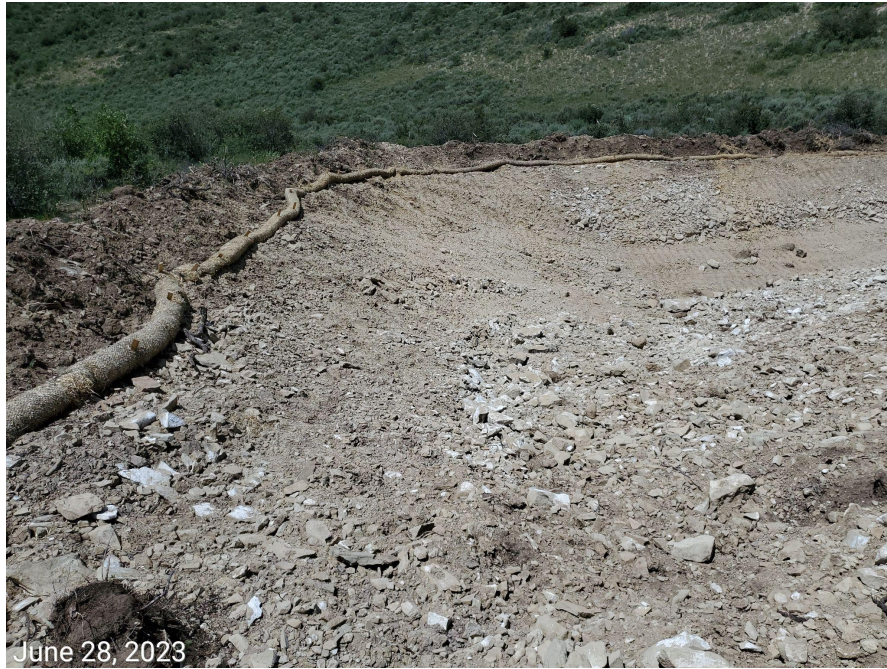
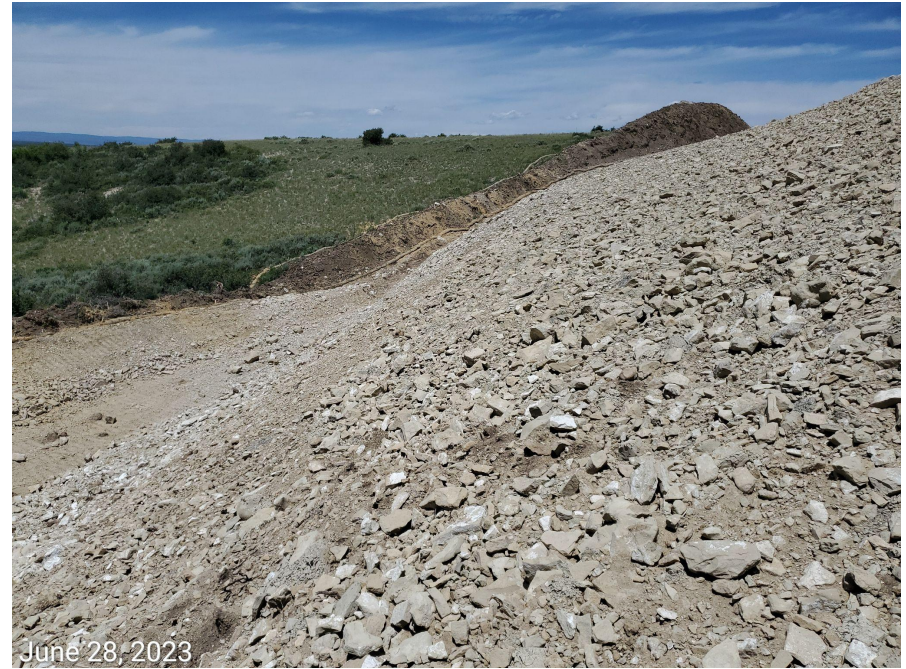
Photo 8: Photos show stormwater retention pond on the southwest end of the Location.

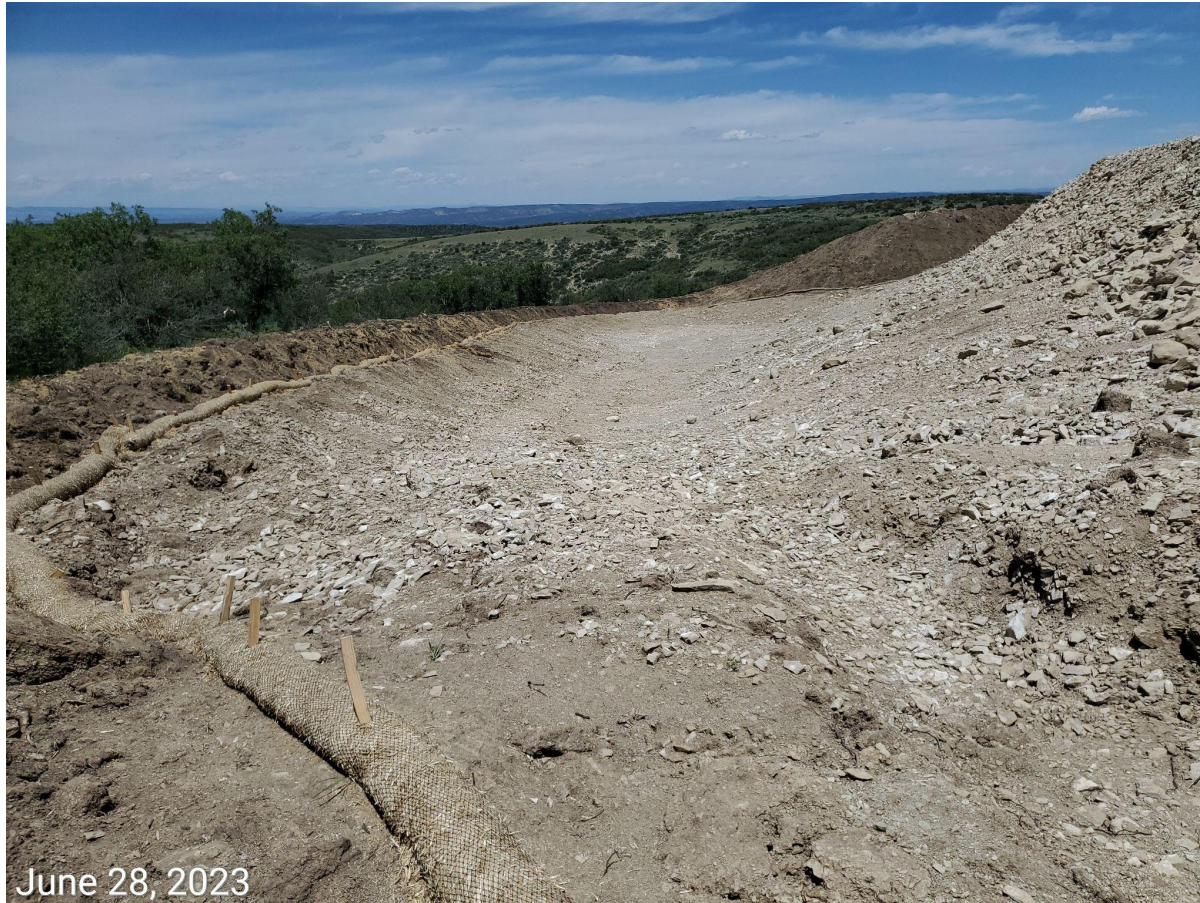
Photo 9: Photo shows stormwater retention pond on the northwest end of the Location.

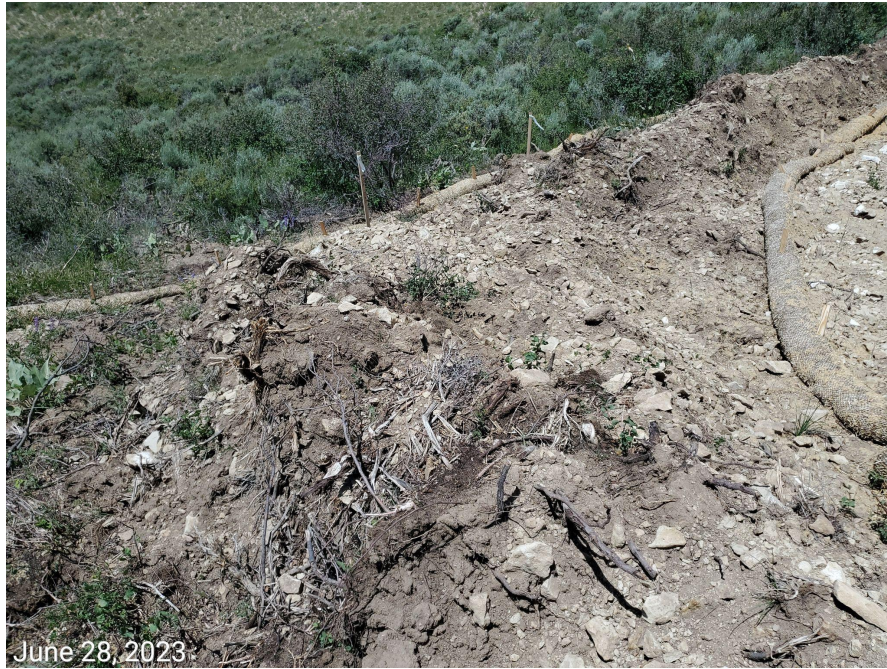
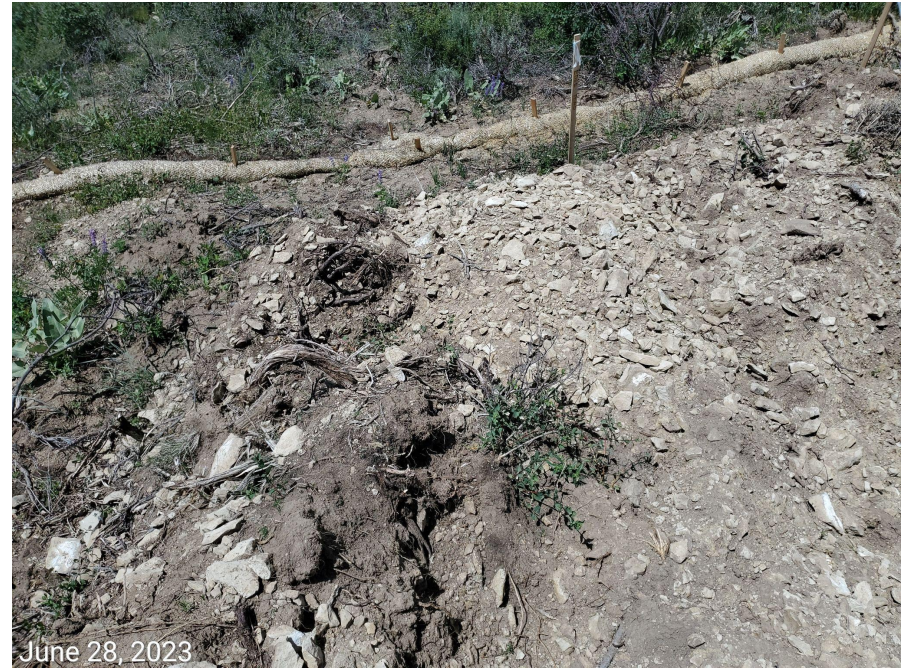
Photo 10: Photos taken from the topsoil stockpile on the southwest end of the Location. Photo shows Operator has mixed subsoils with the topsoil; Operator appears to have pushed subsoils on top of the topsoil stockpile during construction of the retention pond.

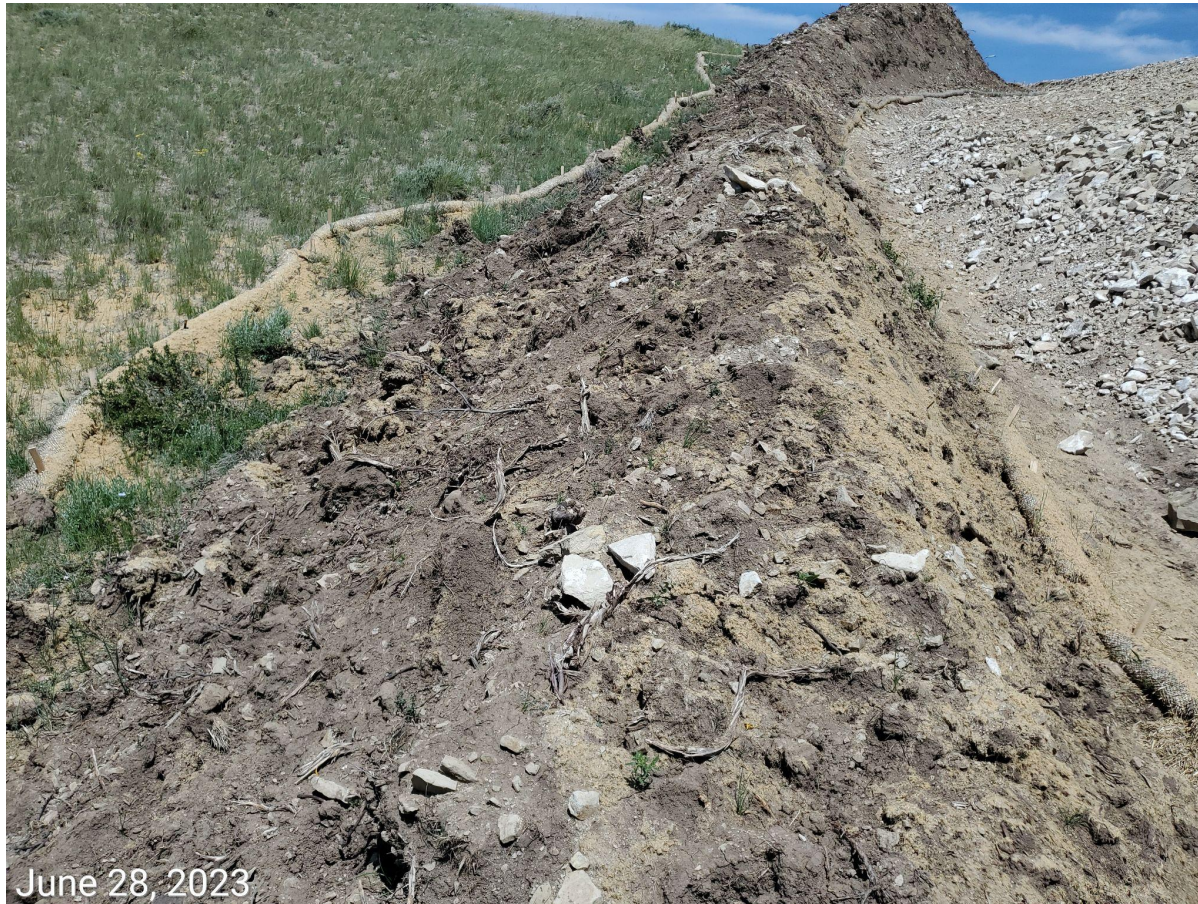
Photo 11: Photo taken from the topsoil stockpile on the west end of the Location. This photo is an example showing Operator had applied hydromulch to the soil stockpiles and slopes throughout the Location. Hydromulch only appears to have been applied to the east facing slopes, and/or has degraded throughout the majority of the areas where it has been applied; BMP is no longer in proper functioning condition to protect/stabilize the soil stockpiles/slopes.

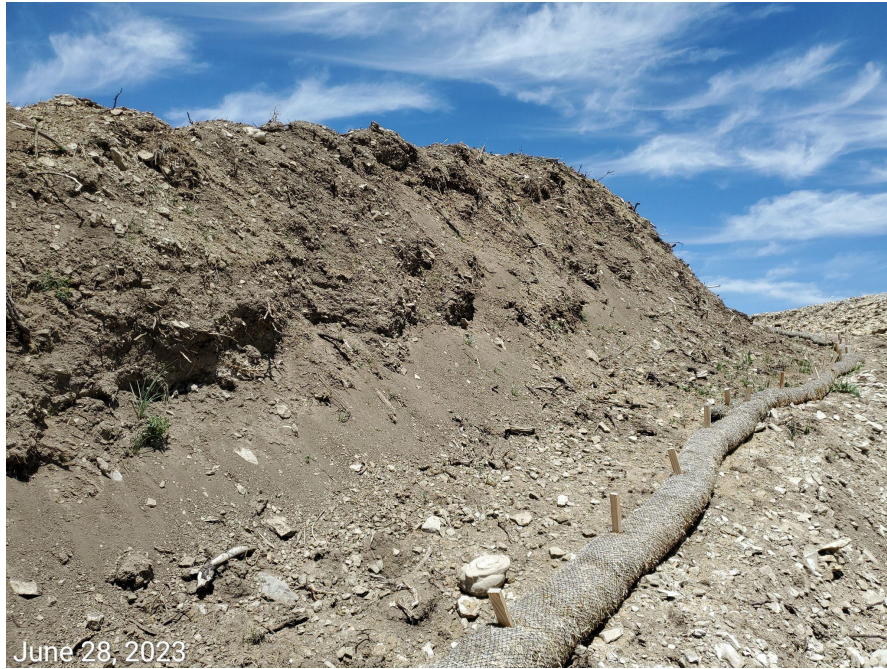
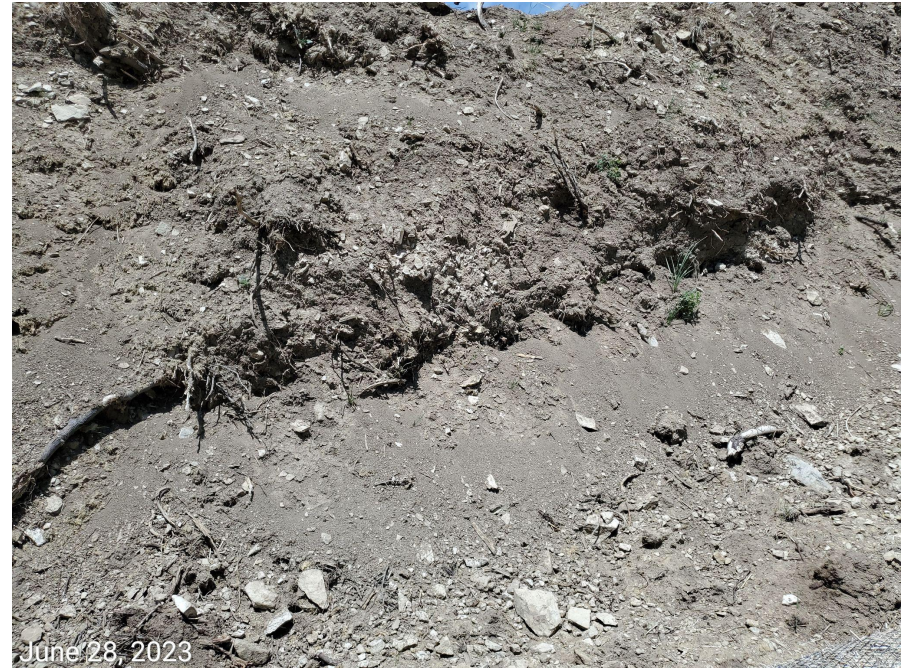
Photo 12: Photo taken from the topsoil stockpiles along the perimeter of the Location. Photos 12-15 examples showing Operator has constructed the topsoil stockpiles with steep slopes, including sections that were completely vertical, and have not been adequately stabilized/protected. This does not proper topsoil storage and protection; BMPs to protect, and to minimize erosion, degradation and sediment transport missing or insufficient at the topsoil stockpiles.

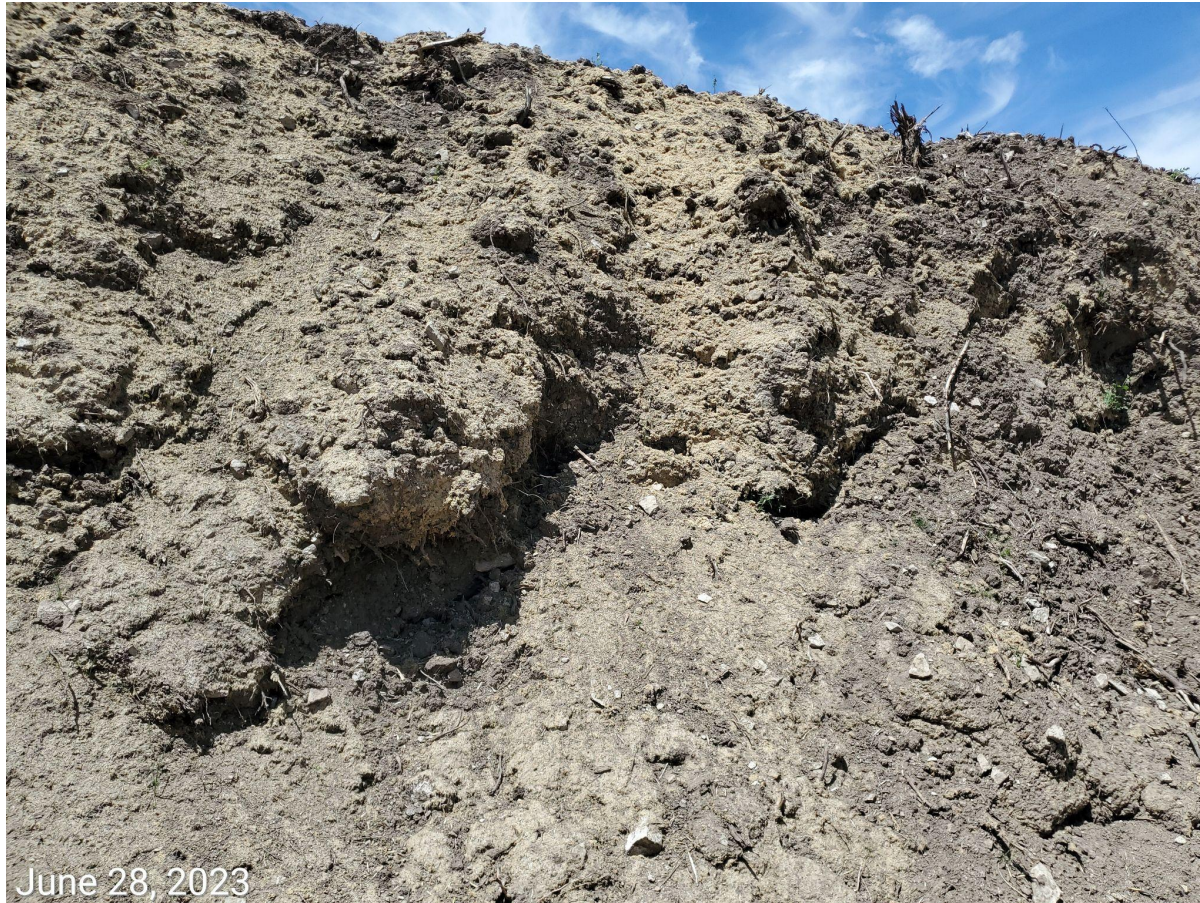
Photo 13: See comments under photo 12.

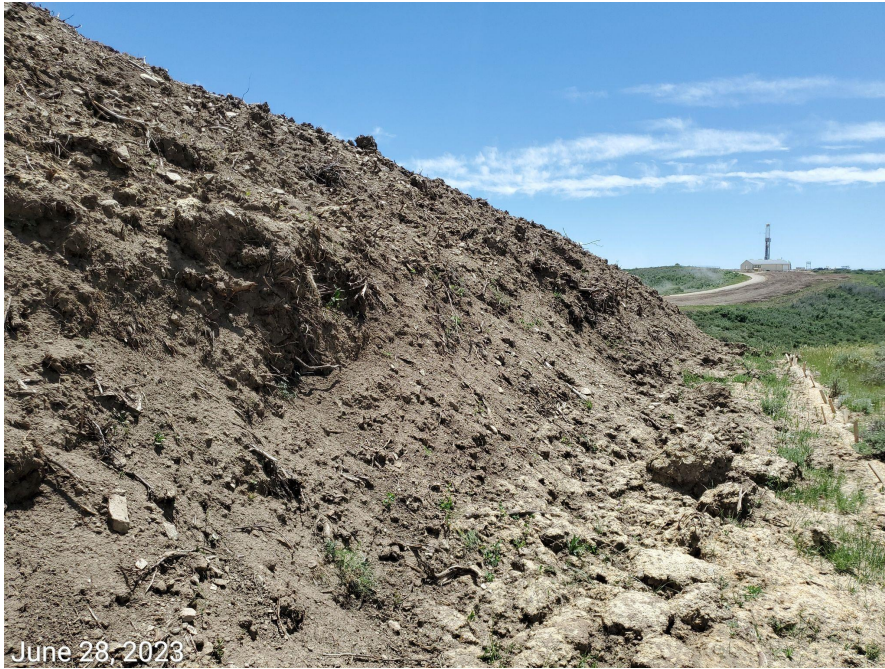
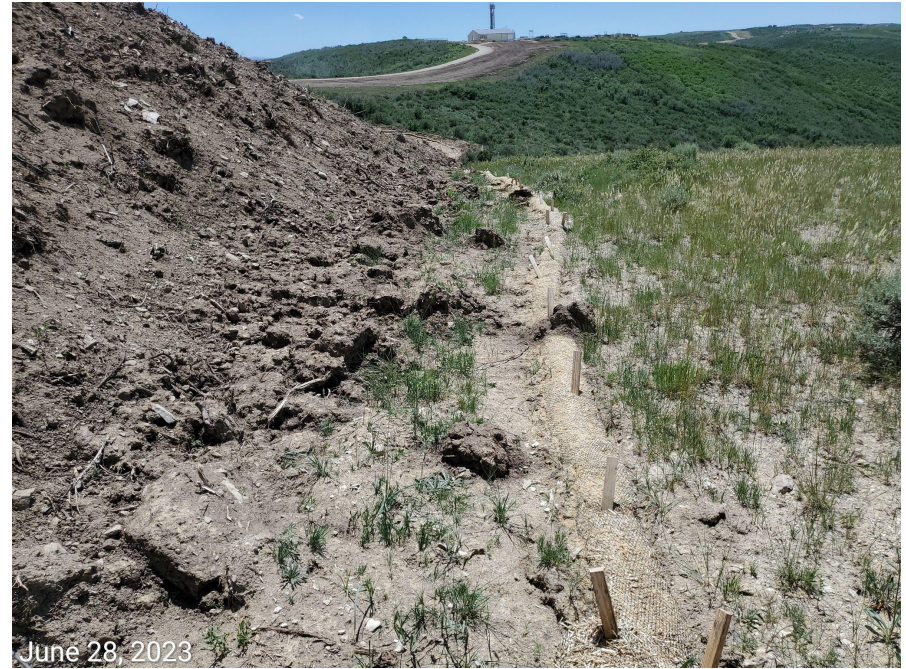
Photo 14: See comments under photo 12. Photo also shows areas where erosion/degradation at the topsoil stockpile has resulted in offsite sediment transport.

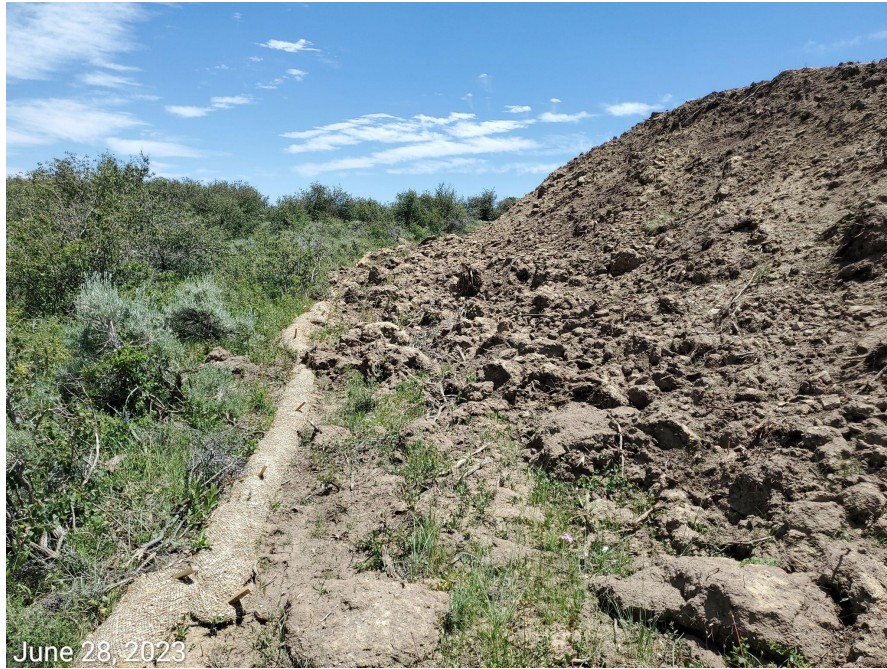
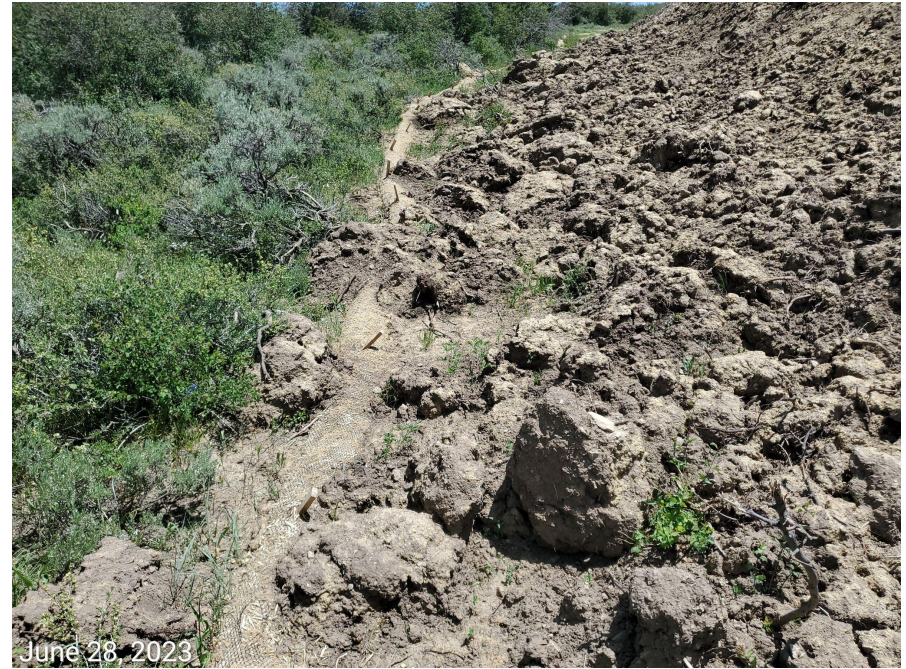
Photo 15: See comments under photo 12. Photo also shows areas where erosion/degradation at the topsoil stockpile has resulted in offsite sediment transport.

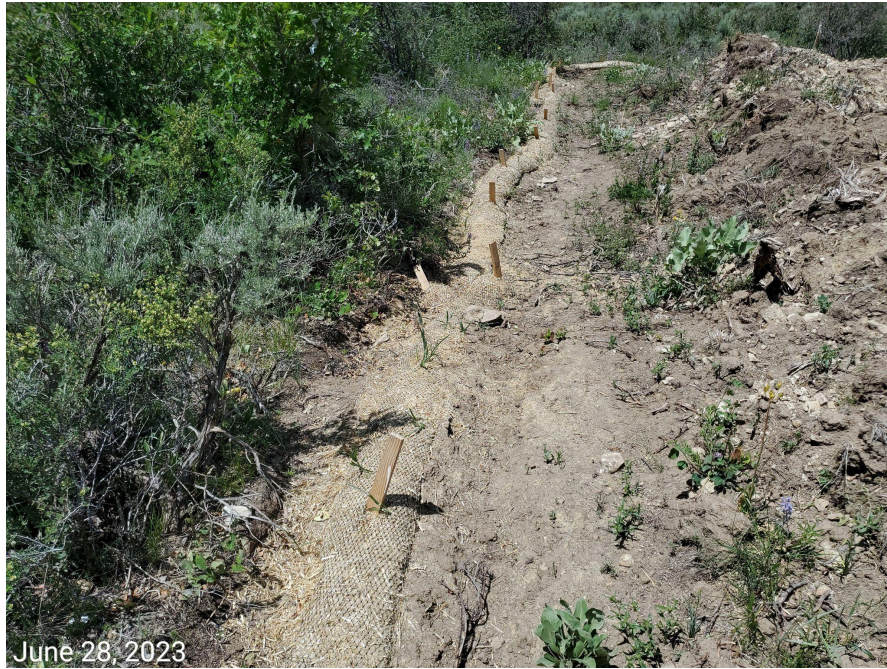
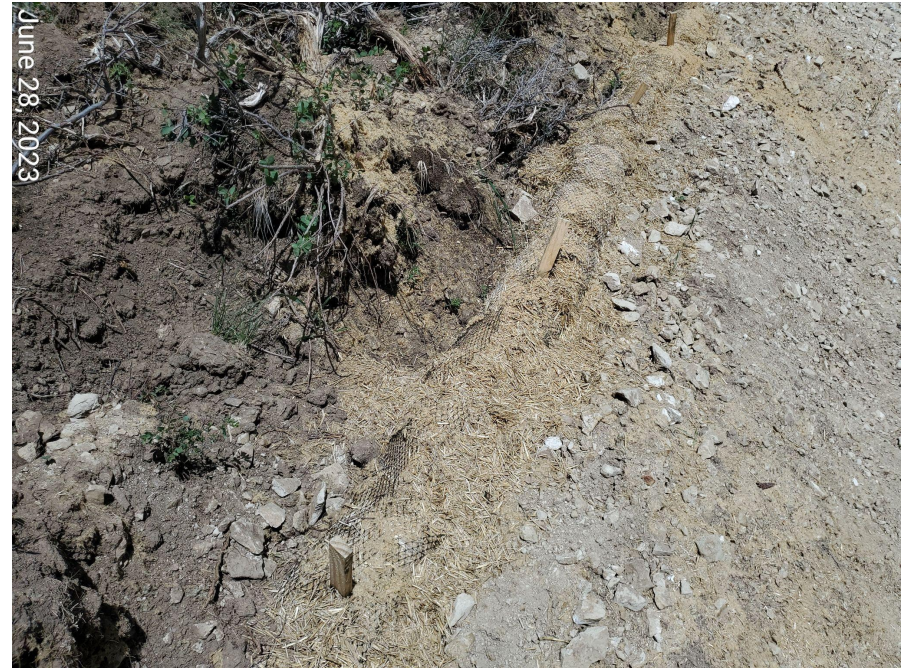
Photo 16: Photos 16-20 show erosion logs installed along the perimeter of the Location, and at the base of the soil stockpiles. Photos examples showing erosion logs have not been installed per good engineering requirements, or maintained in a proper functioning condition. Sections of wattles observed to have been flattened/compressed, have been filled/covered with sediment, and/or have been only placed on the soil surface rather than properly trenched and backfilled.

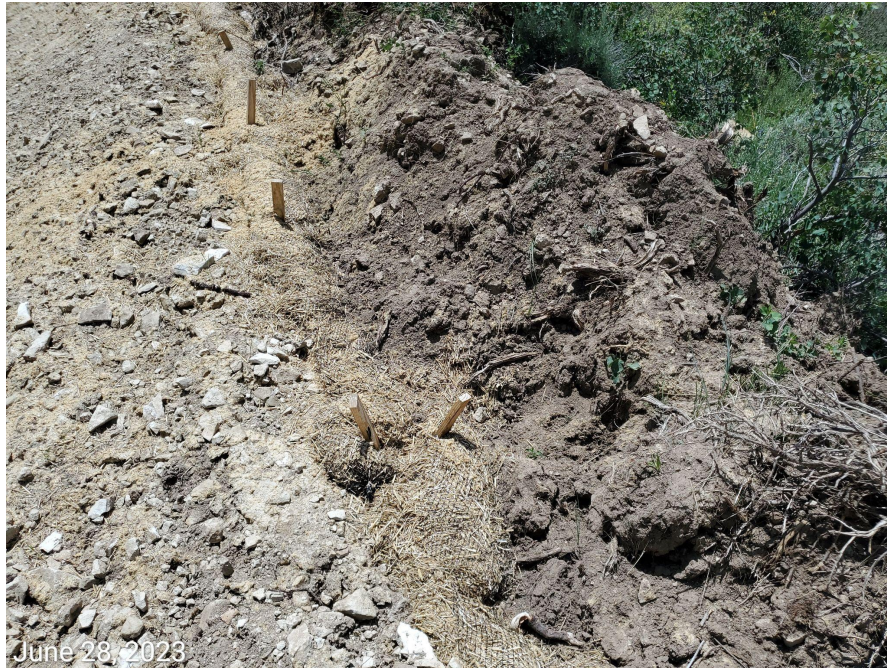
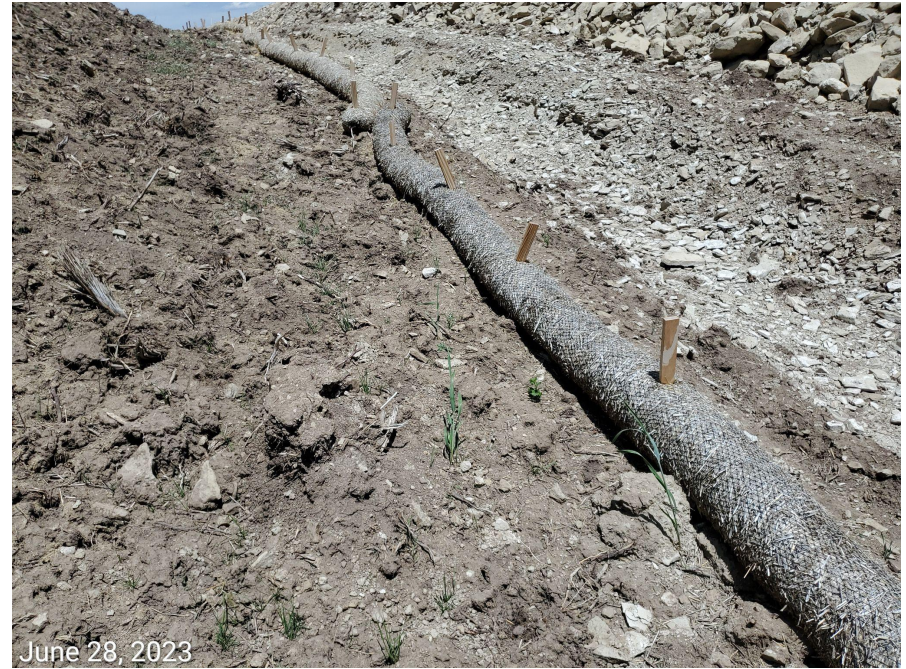
Photo 17: See comments under photo 16.

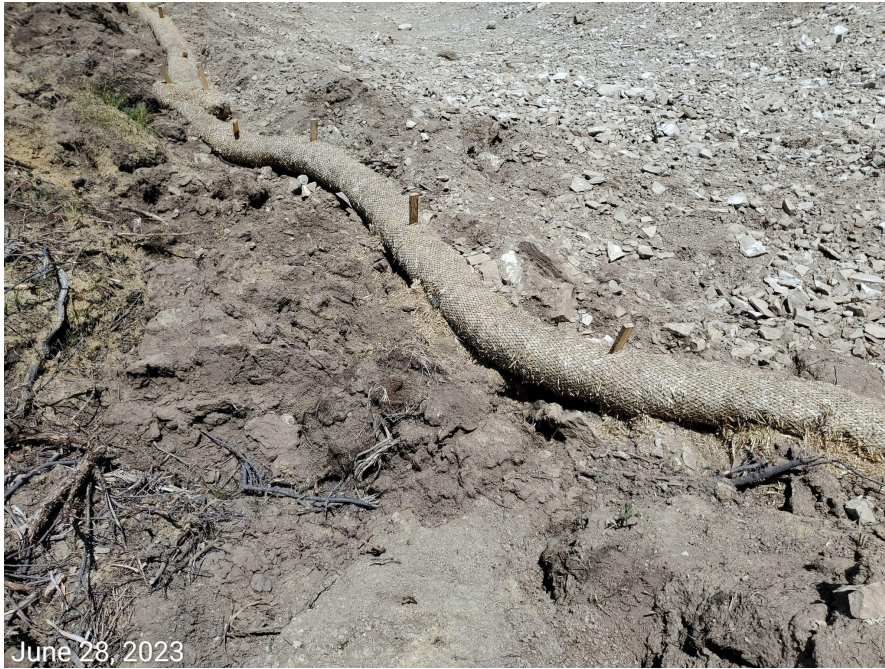
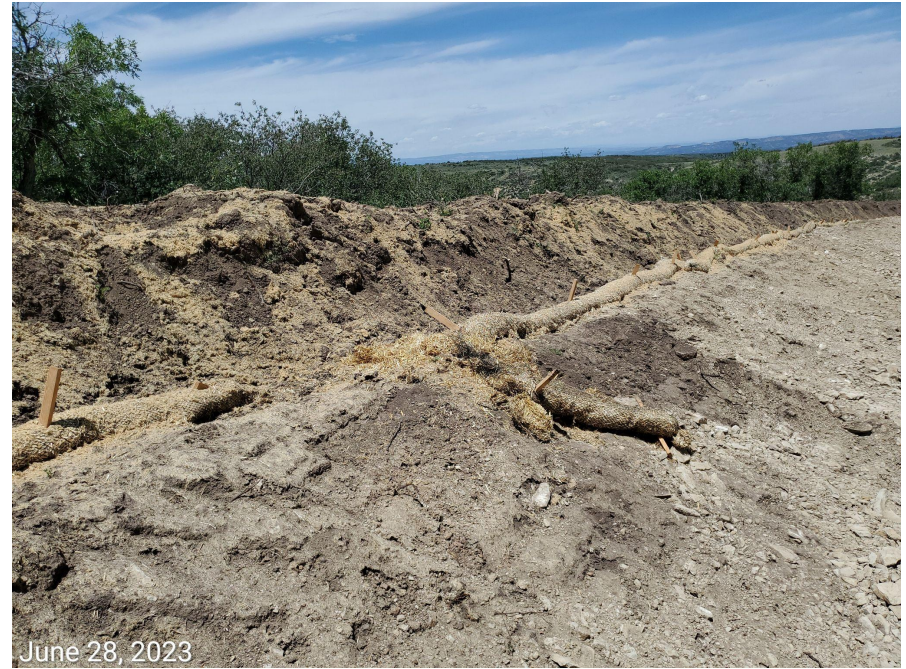
Photo 18: See comments under photo 16.

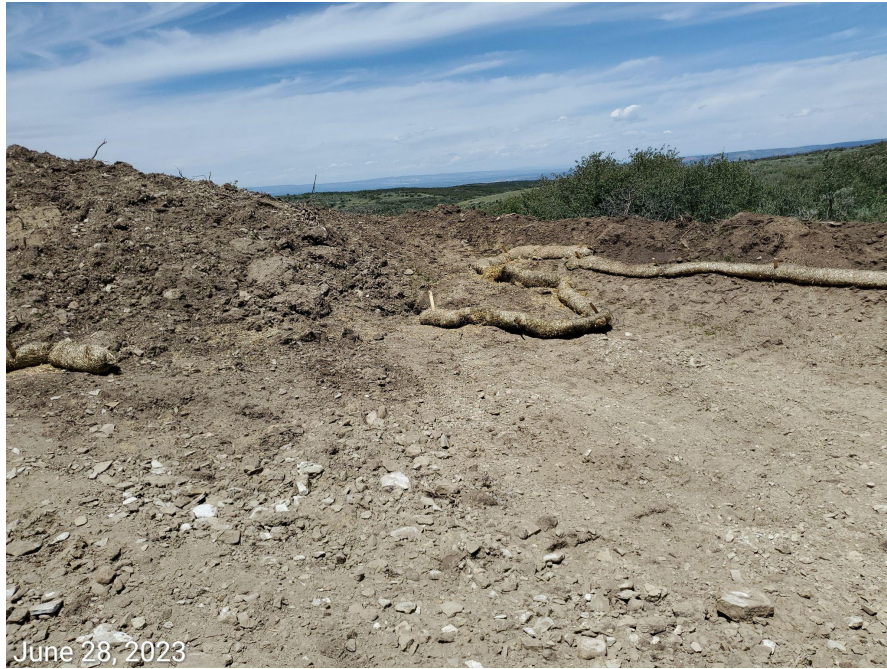
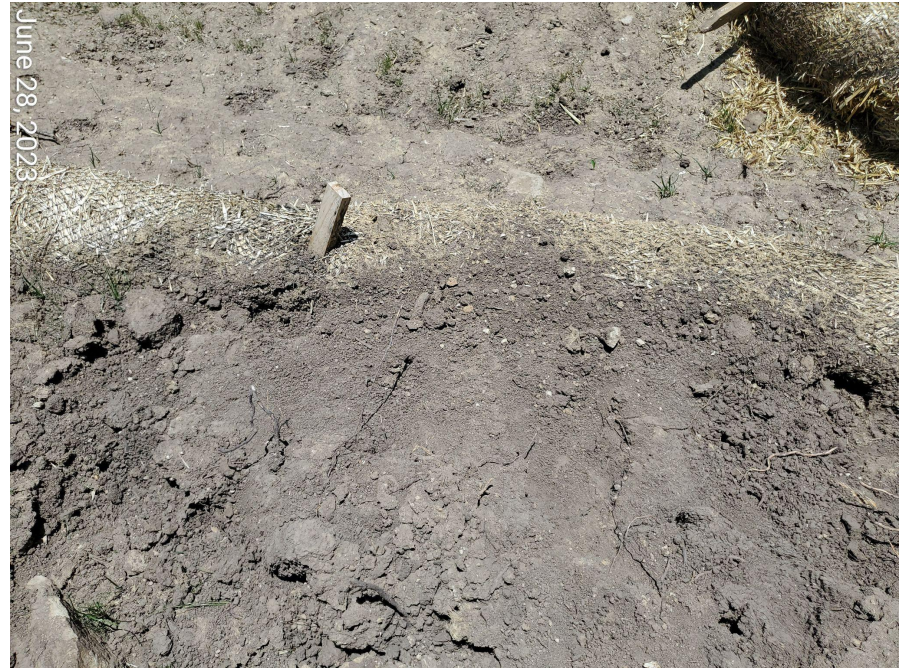
Photo 19: See comments under photo 16.
