Inspection Photos

6/28/2023

Operator: CAERUS PICEANCE LLC #10456

Location Number: 479215

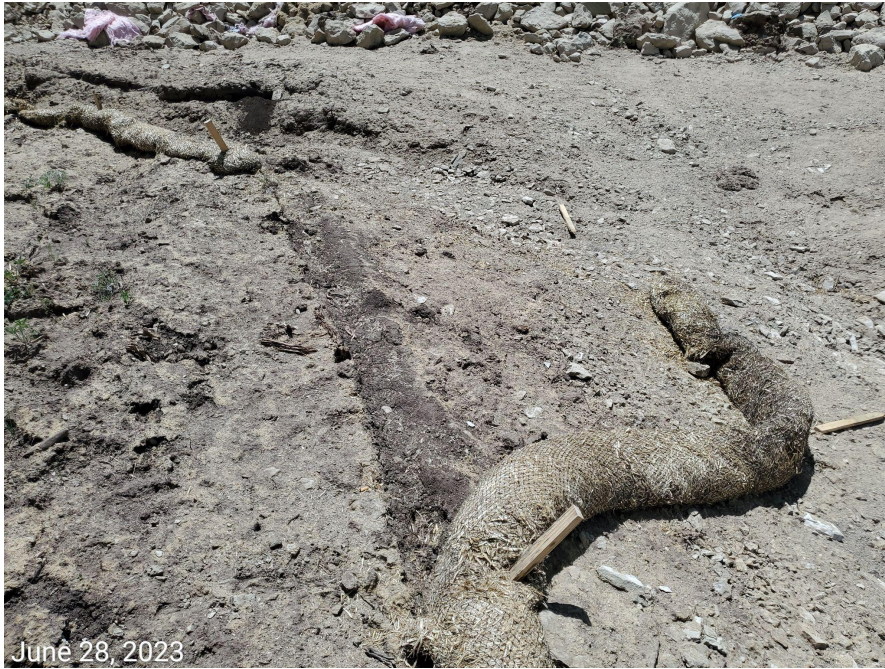
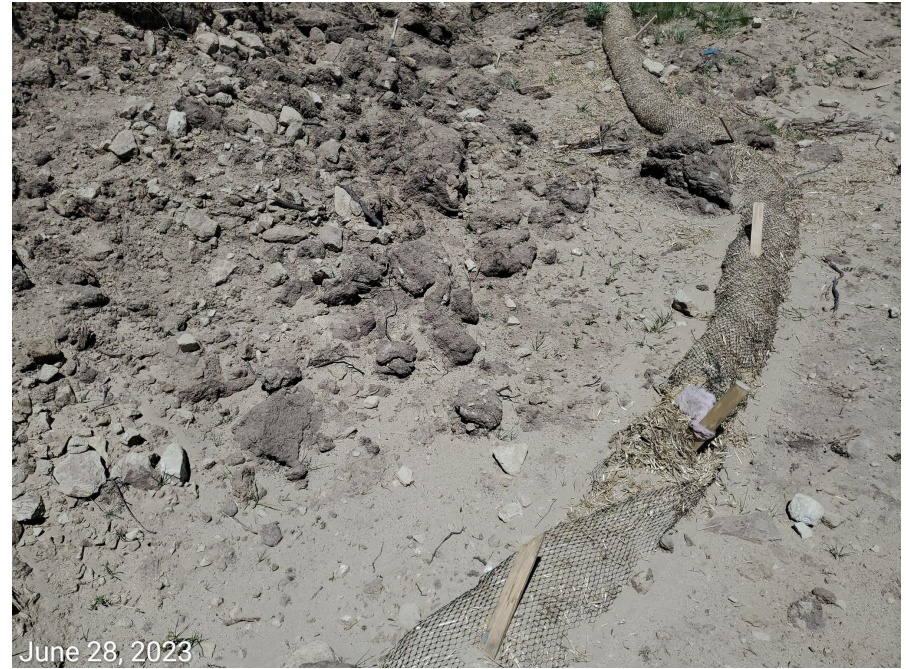
Photo 16: Photos 16-20 show erosion logs installed along the perimeter of the Location, and at the base of the soil stockpiles. Photos examples showing erosion logs have not been installed per good engineering requirements, or maintained in a proper functioning condition. Sections of wattles observed to have been flattened/compressed, have been filled/covered with sediment, and/or have been only placed on the soil surface rather than properly trenched and backfilled.

Photo 20: See comments under photo 16.

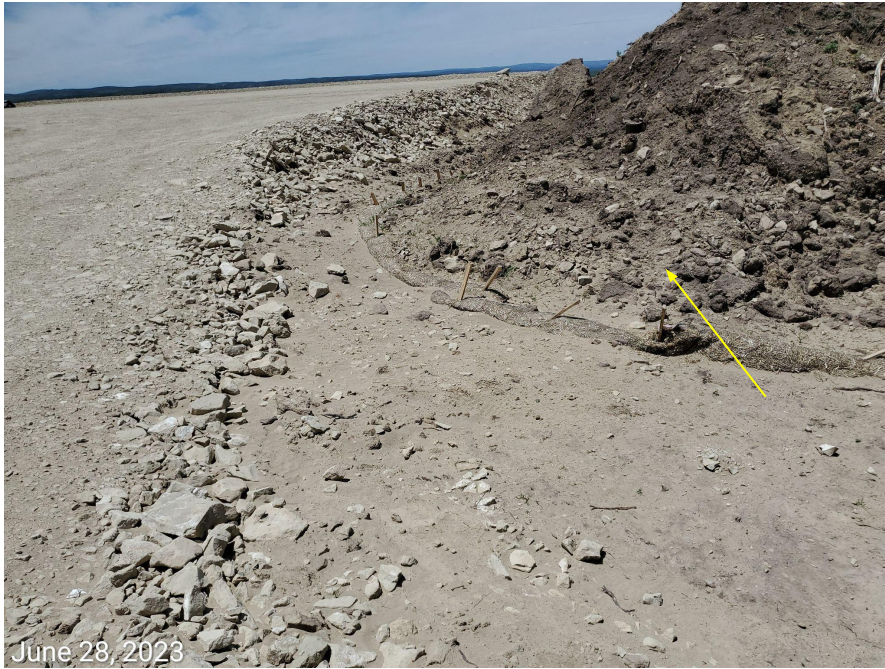
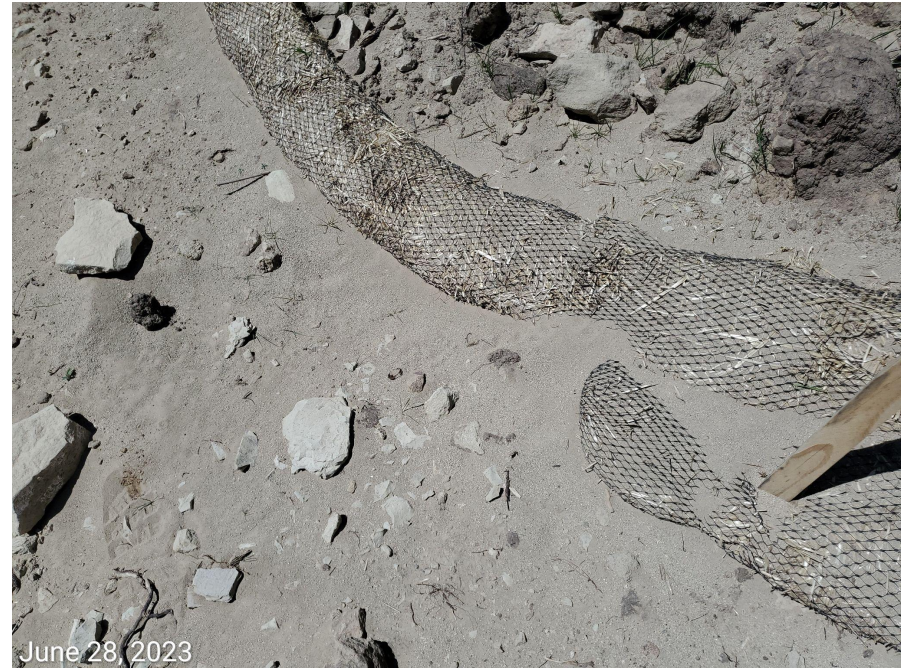
Photo 21: Photo taken from the topsoil stockpile adjacent to the northern Location. Photo shows fine soil/sediment materials appear to have been blown onto the soil stockpile (light colored soils, arrow) .

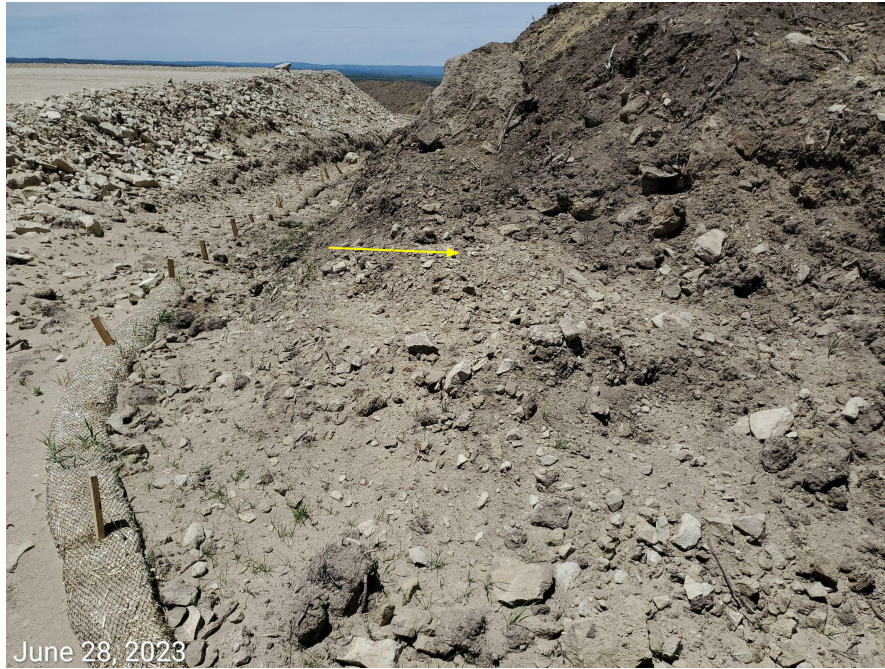
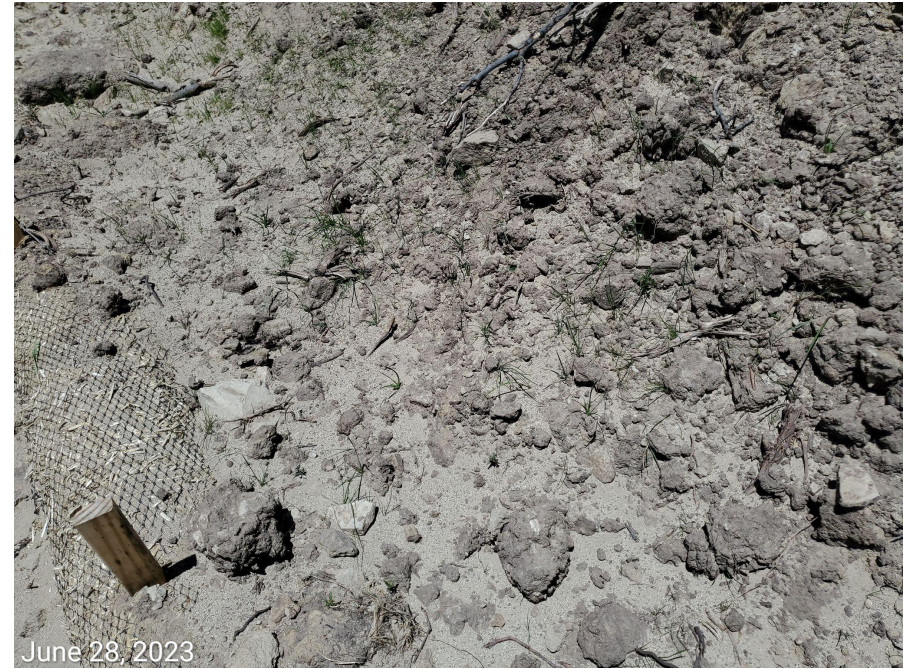
Photo 22: See comments under photo 21.

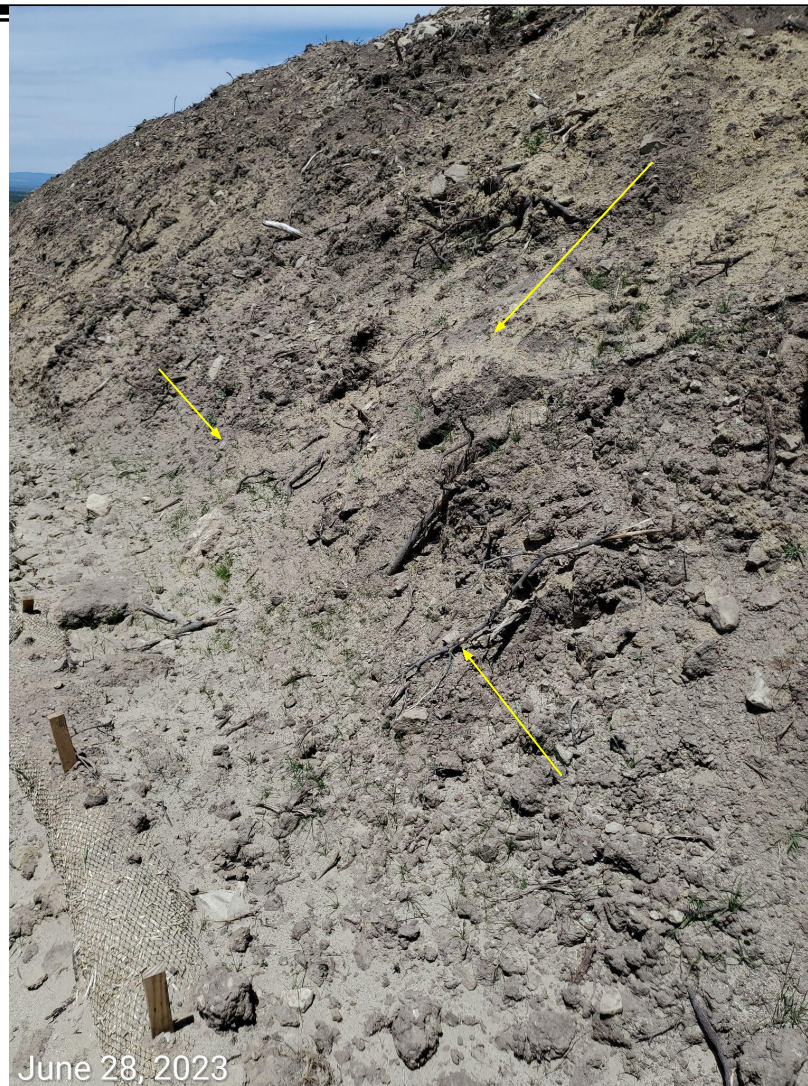
Photo 23: See comments under photo 21. Areas above top arrow include residual hydromulch, however, the fine soils (light colored soils) appear to have also been blown onto these areas of the soil stockpile as well.

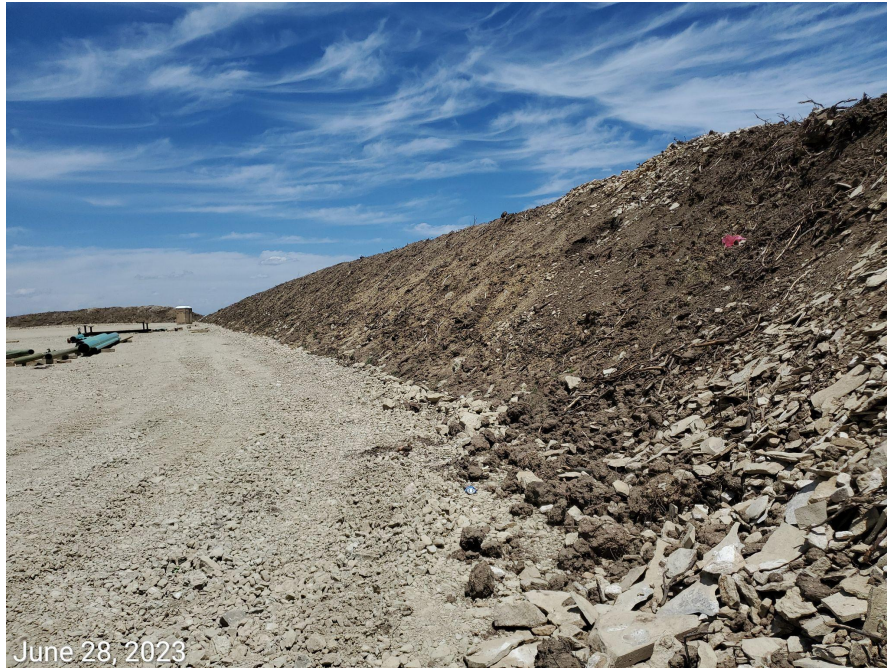
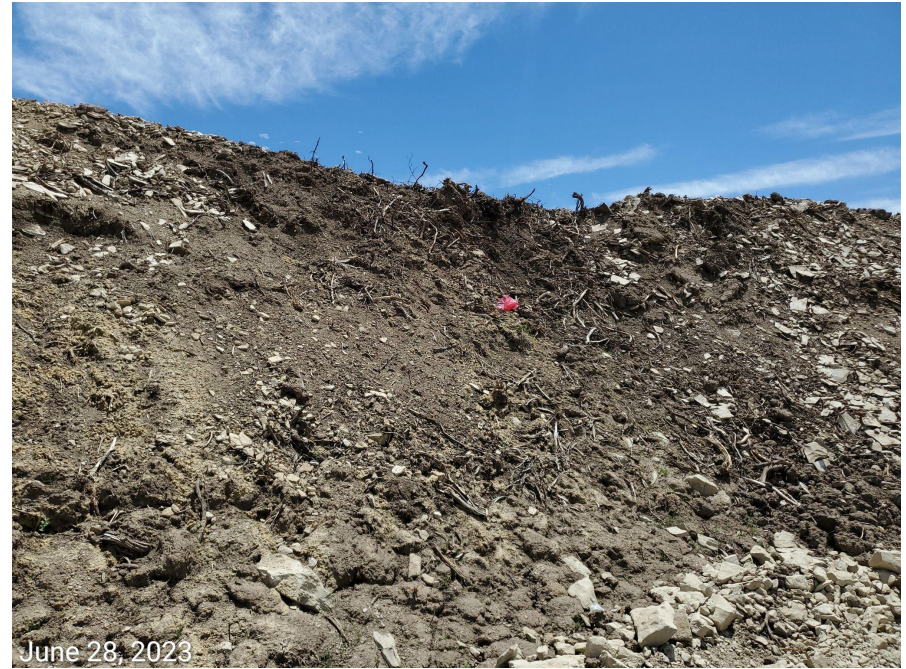
Photo 24: Photos taken from the cut slopes on the east end of the Location. Operator appears to have placed topsoil back onto the slopes. Operator also appears to have previously applied hydromulch to the slopes; BMP has degraded and is no longer in proper functioning condition.
