VISION ENERGY LLC, SULFUR GULCH 9-98-1-69S98W/1SWNE
Location #312658
Date: 7/3/2023

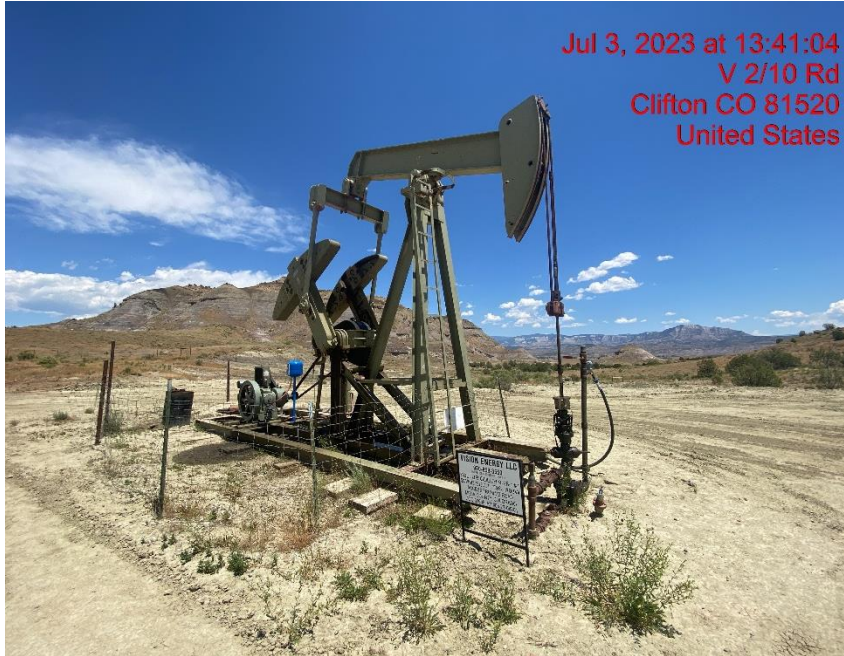
Wellhead/Weeds – Photo #04988

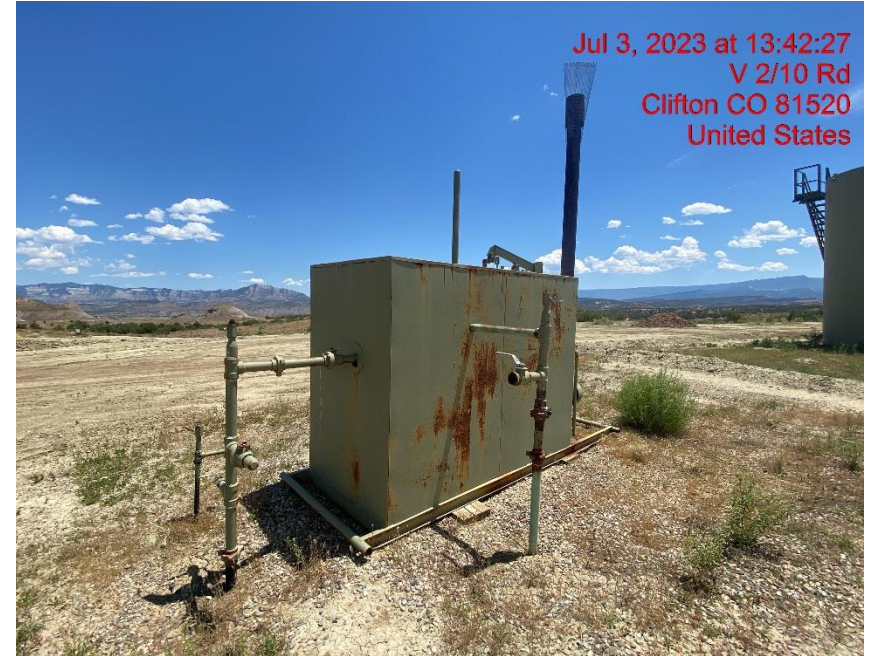
Separator/Weeds – Photo #04995

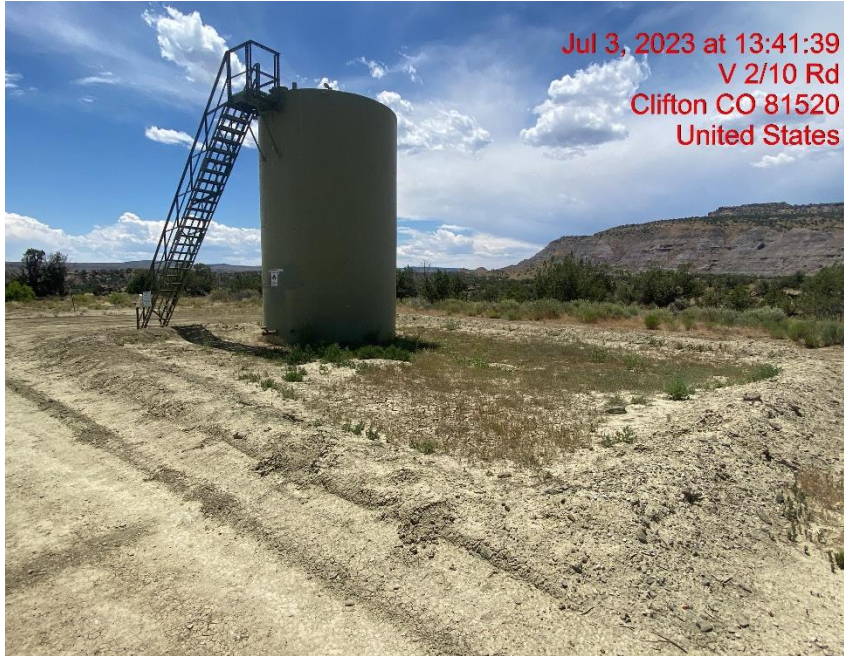
**Tank Battery/Insufficient Capacity & Permeability of
Secondary Containment – Photo #04992**

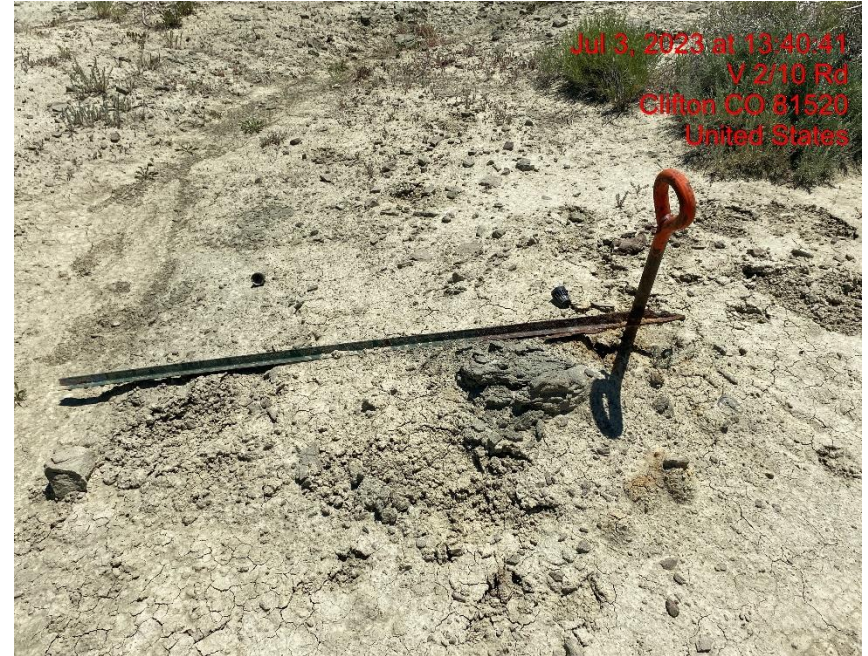
Anchor Not Properly Marked – Photo #04987

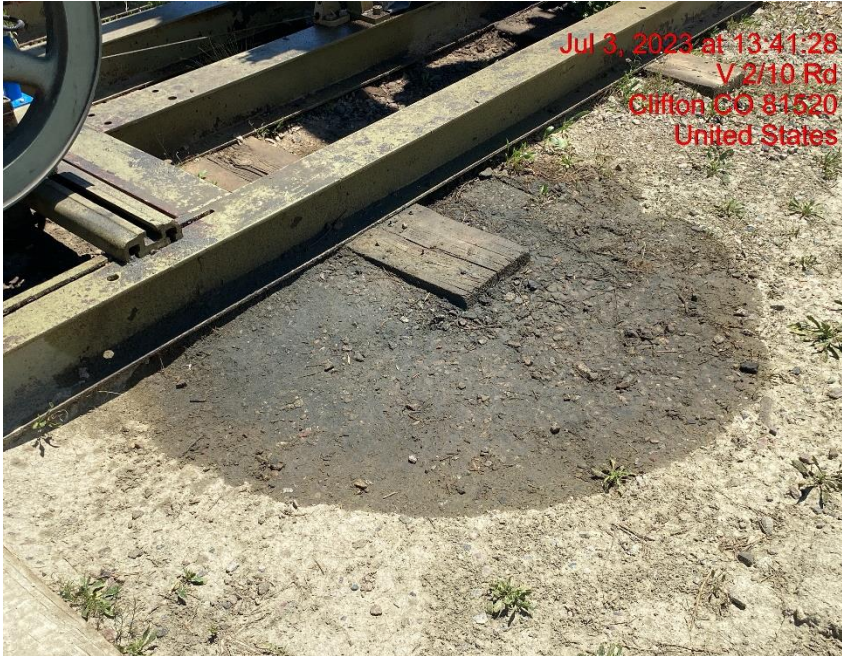
Stained Soil Near Pump Jack – Photo #04991

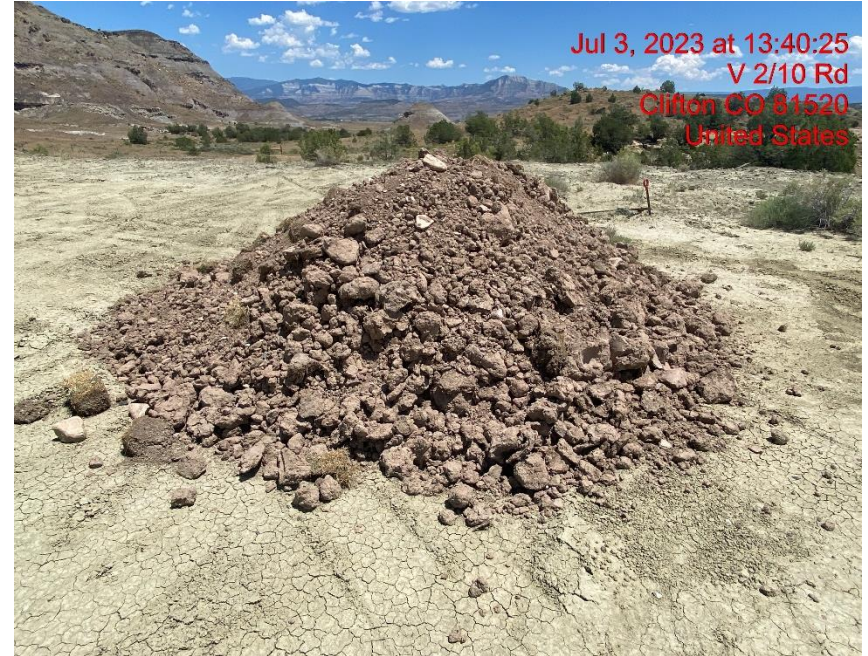
Unprotected Spoil Pile – Photo #04985

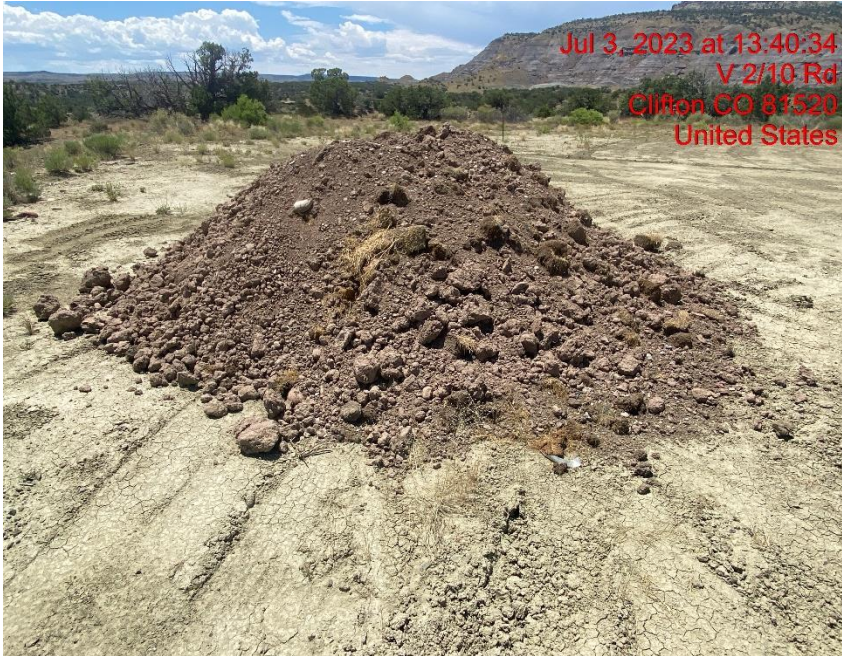
Unprotected Spoil Pile – Photo #04986
