**Inspection Photos**  
**Location Name: Ocoma 31-18**  
**API # 05-123-14803**

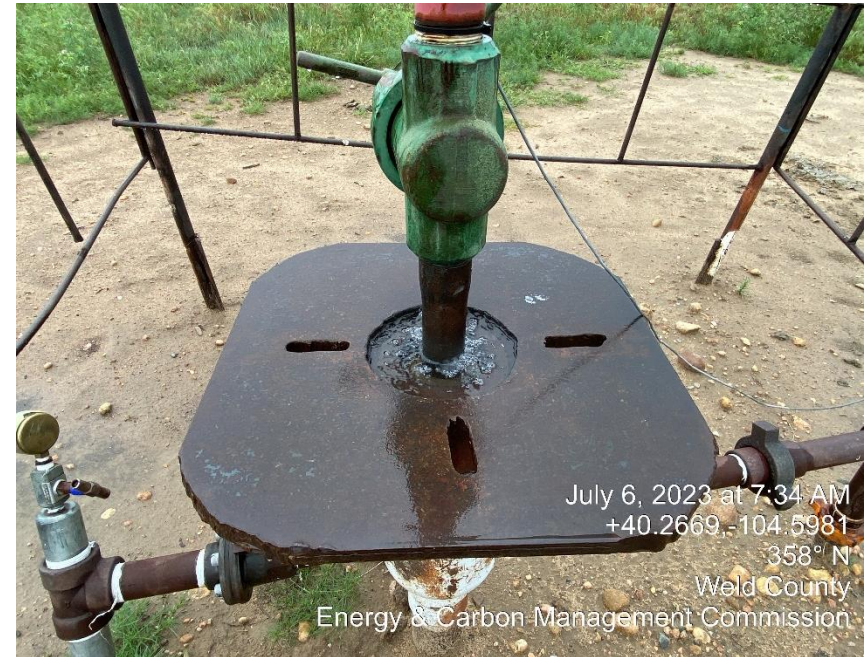
**Mechanical Conditions “leaking packing”**
