Inspection Photos
Location Name: Washburn GX15-62HN
Location ID: 428699

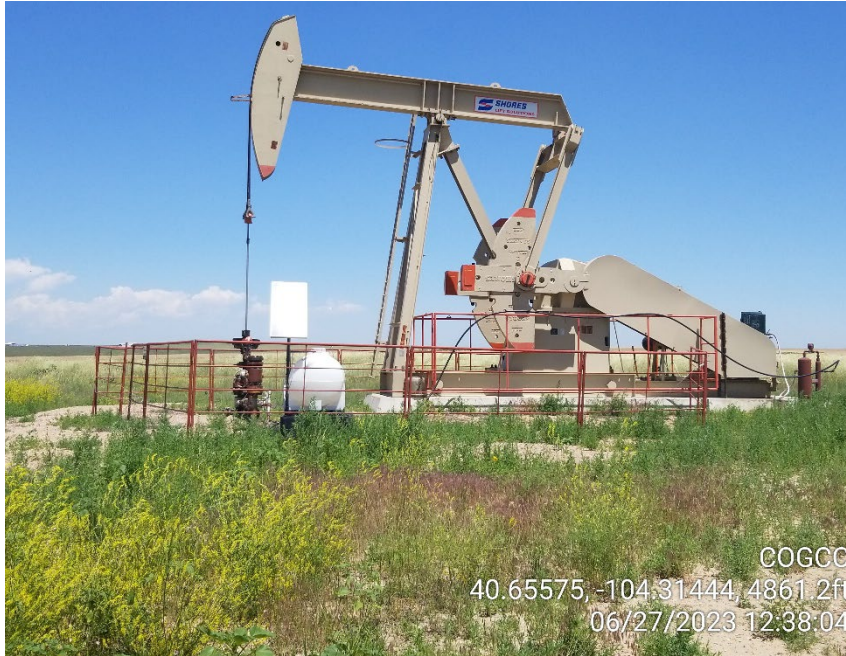
Photo 1 – Pumping Unit – WEEDS

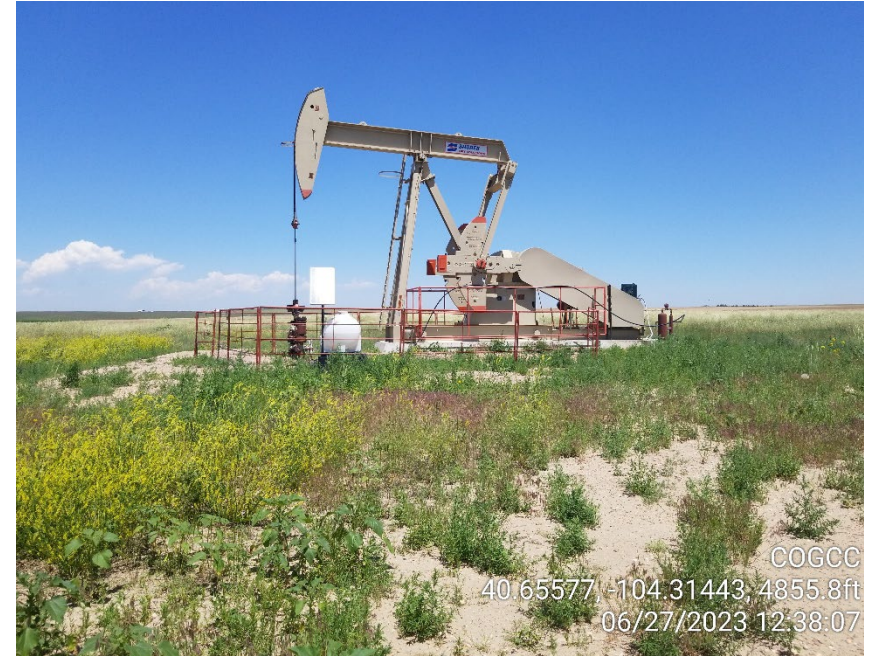
Photo 2 – Pumping Unit – WEEDS

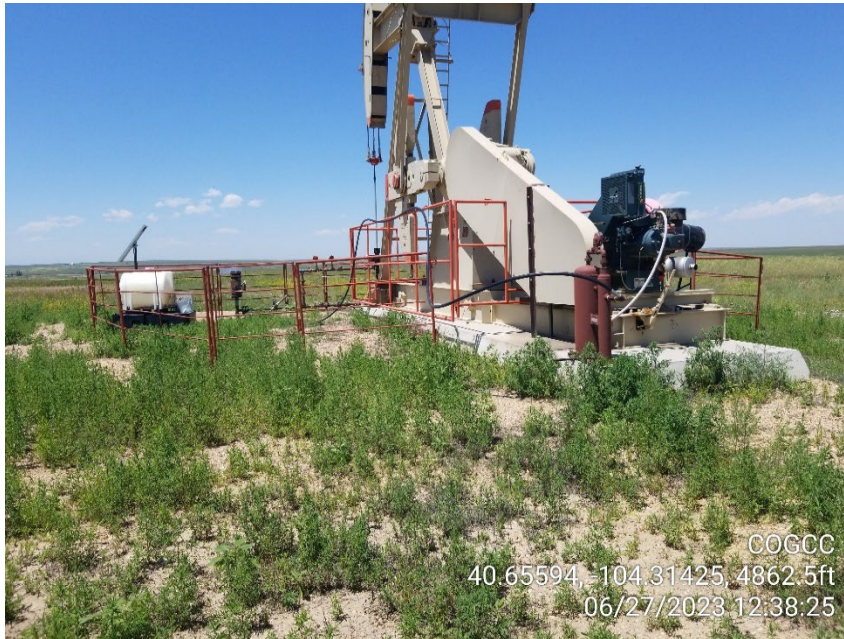
Photo 3 – Gas Engine – WEEDS

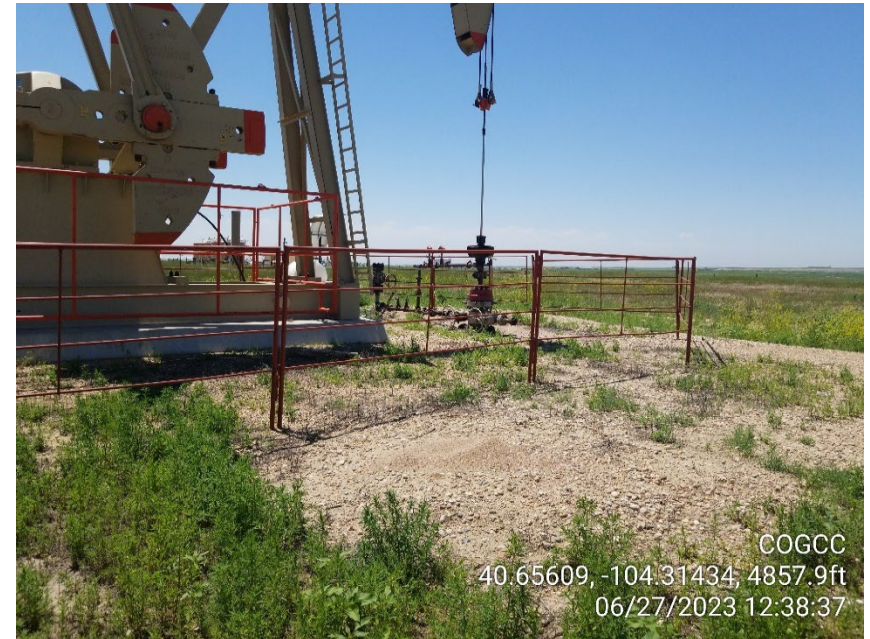
Photo 4 – Wellhead – WEEDS

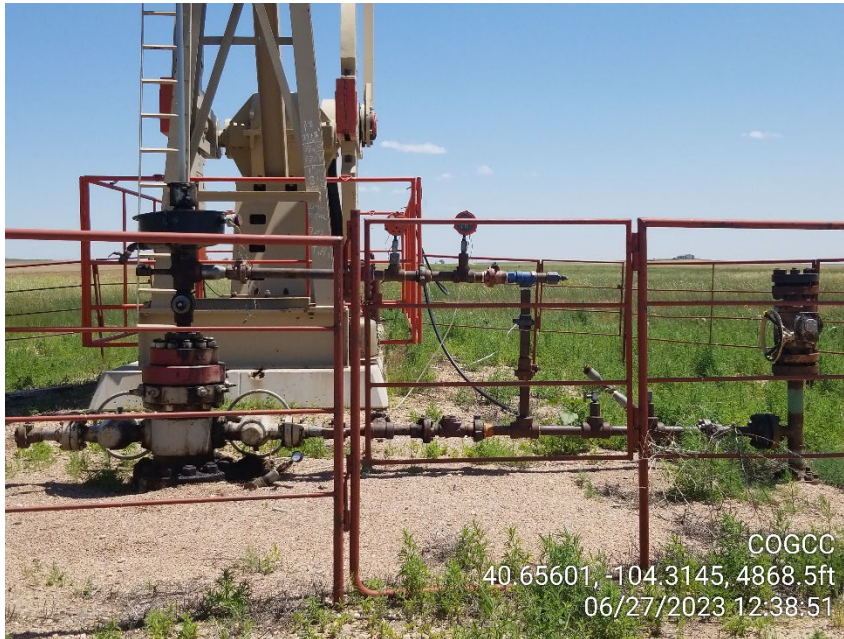
Photo 5 – Wellhead – WEEDS

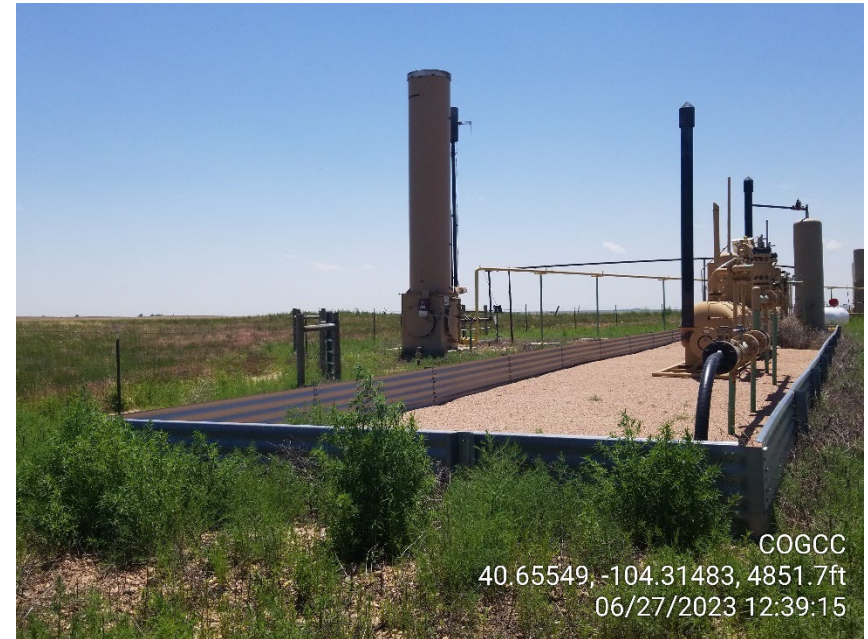
Photo 6 – ECD and Separator – WEEDS

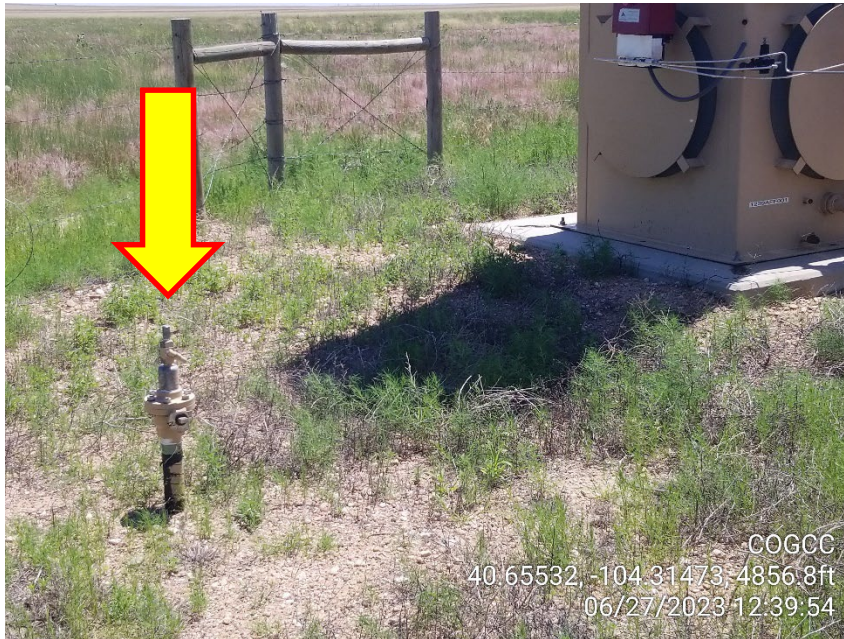
Photo 7 – Unmarked Riser at ECD – WEEDS

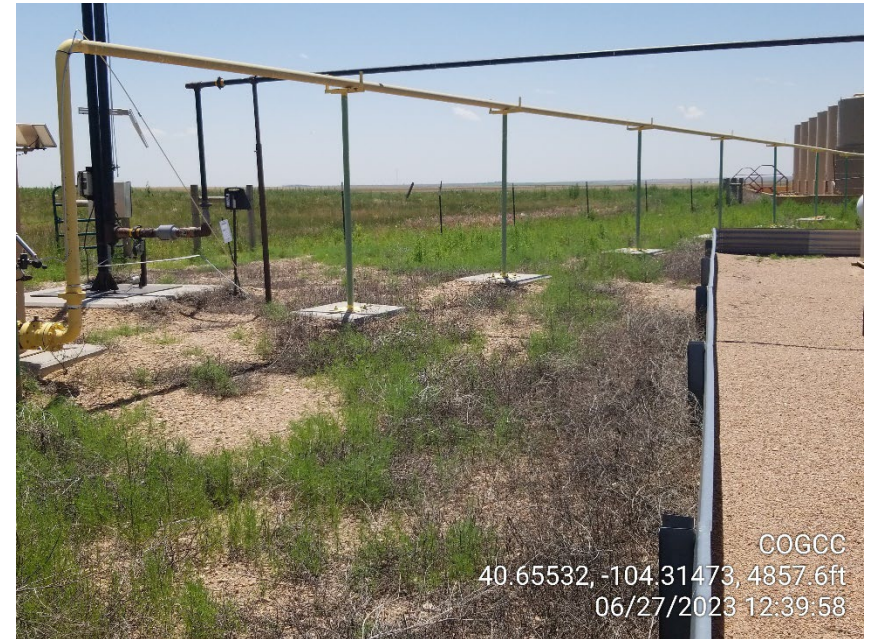
Photo 8 – Flare– WEEDS

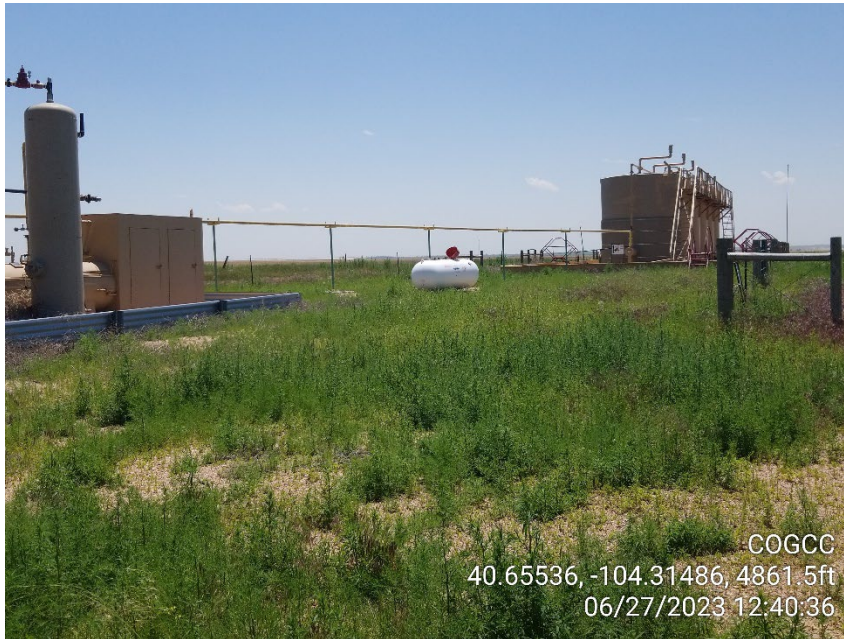
Photo 9 – WEEDS

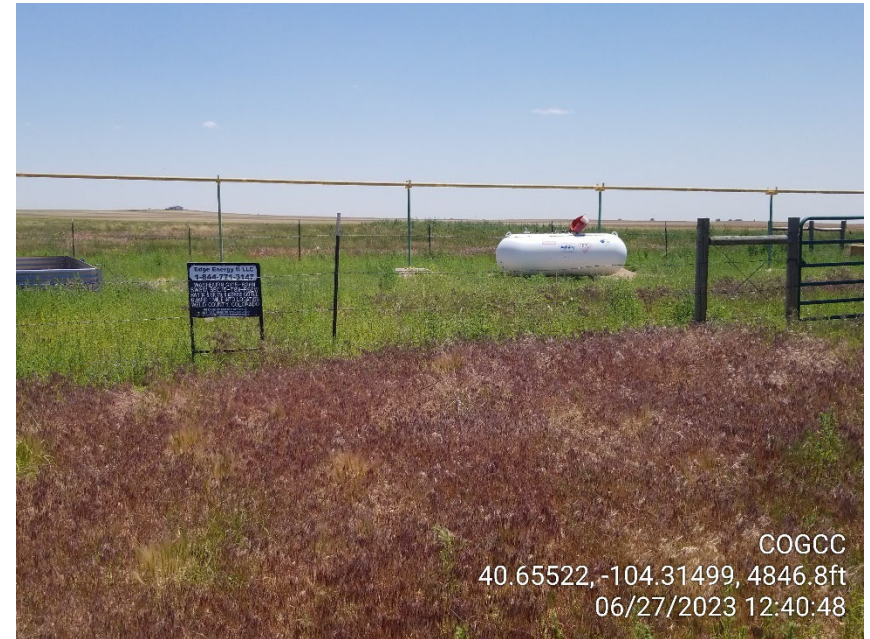
Photo 10 – WEEDS

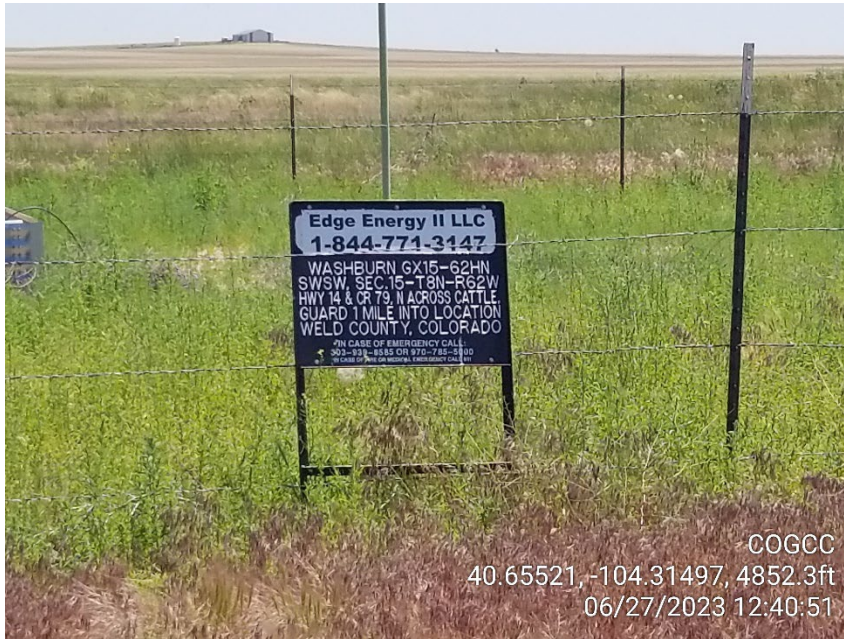
Photo 11 – Tank Battery Sign – WEEDS

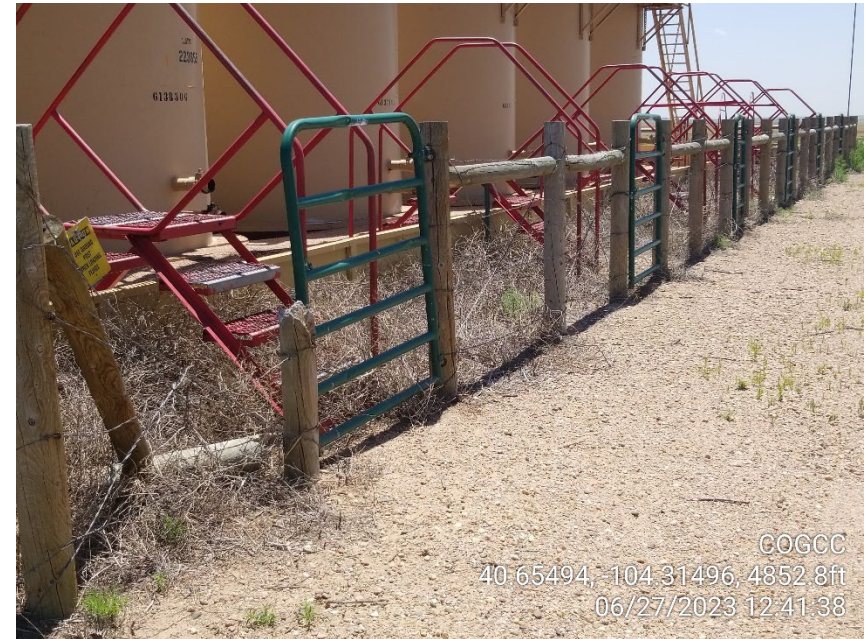
Photo 12 – Tumbleweeds

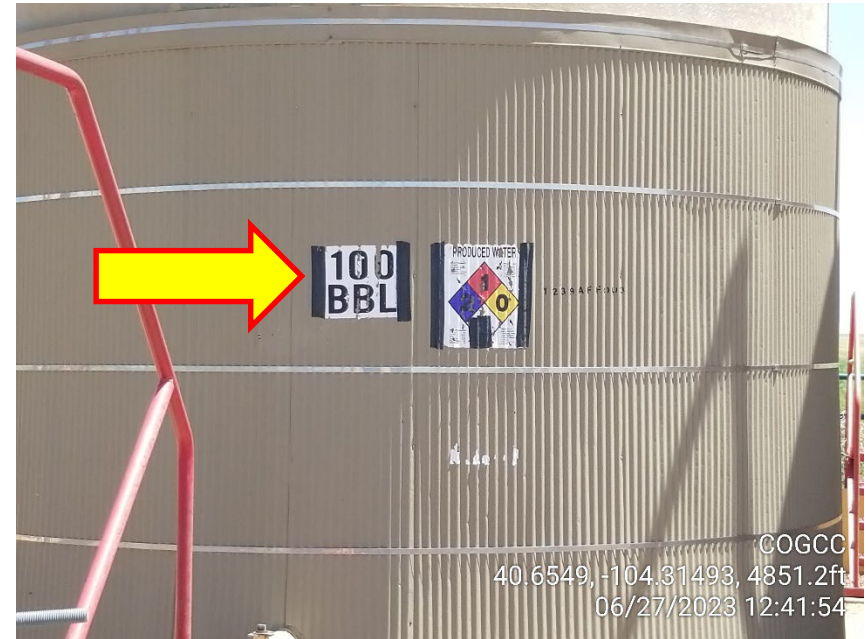
Photo 14 – Inadequate Capacity Label

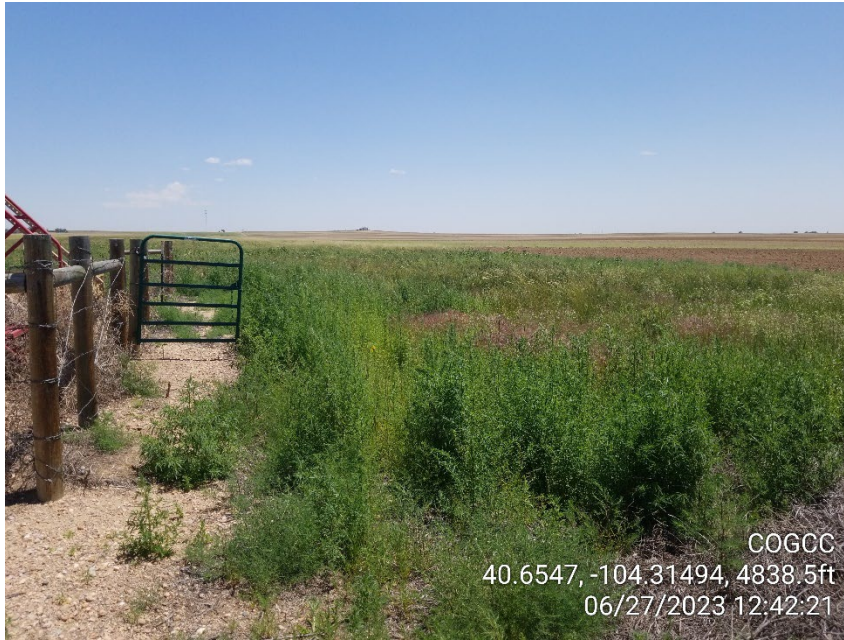
Photo 15 – Weeds
