Inspection Photos

API: 061-06041

Operator: WESTERN OPERATING COMPANY

Inspection Date: 7/6/2023

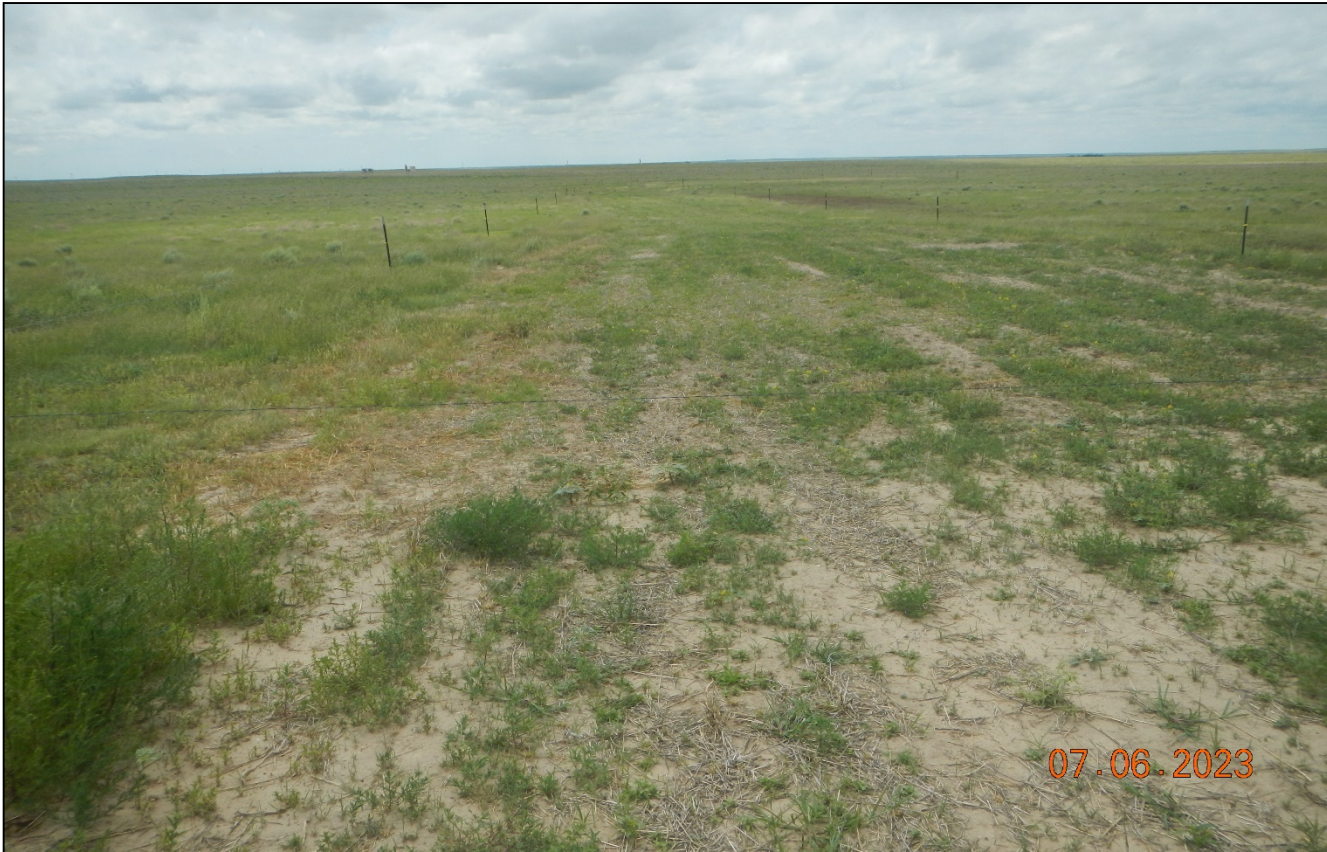
Photo 1. Facing west at the beginning of the access road. The cattleguard has been removed and the road regraded and reclaimed.

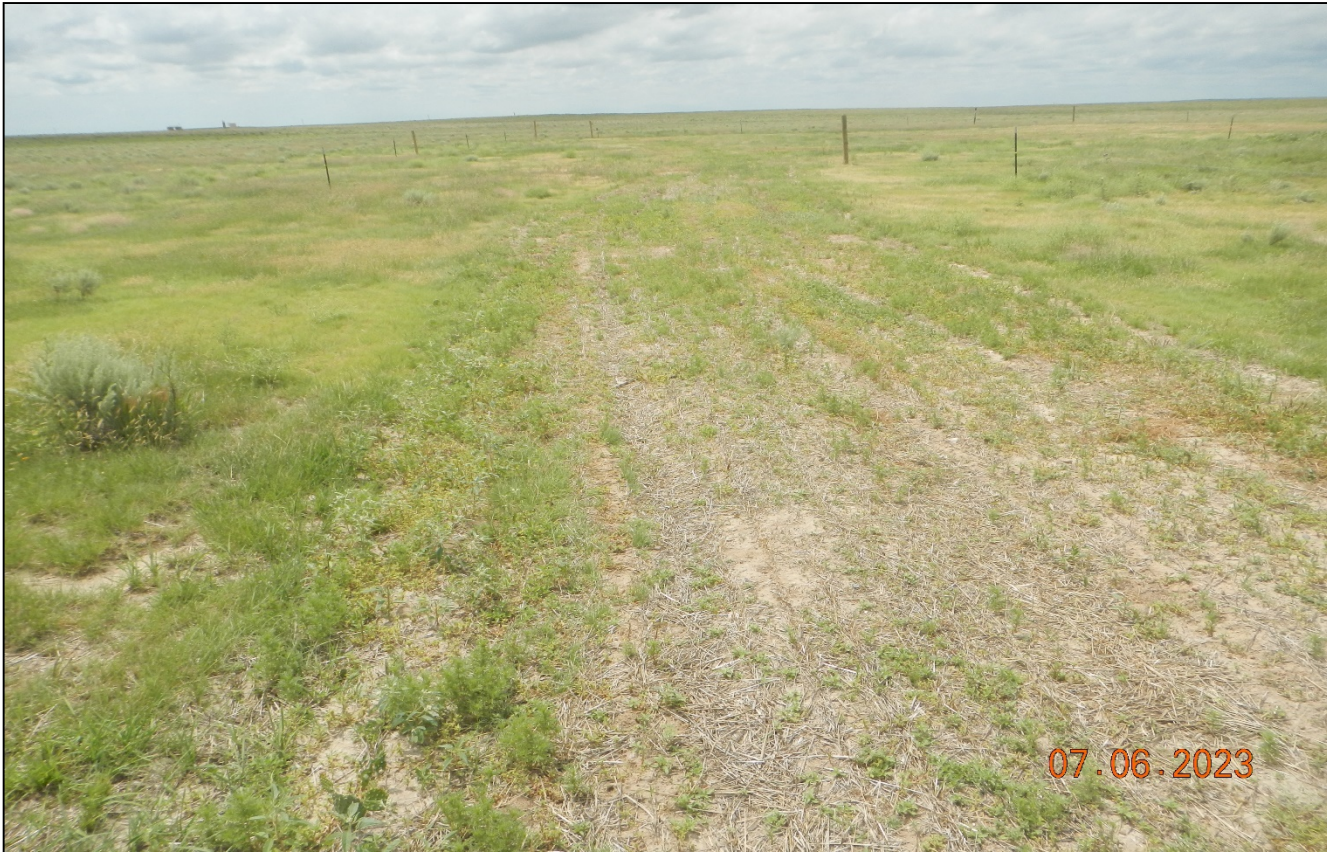
Photo 2. Facing west toward the access road which has been reclaimed. There is a 1 strand electric fence around the reclaimed area.

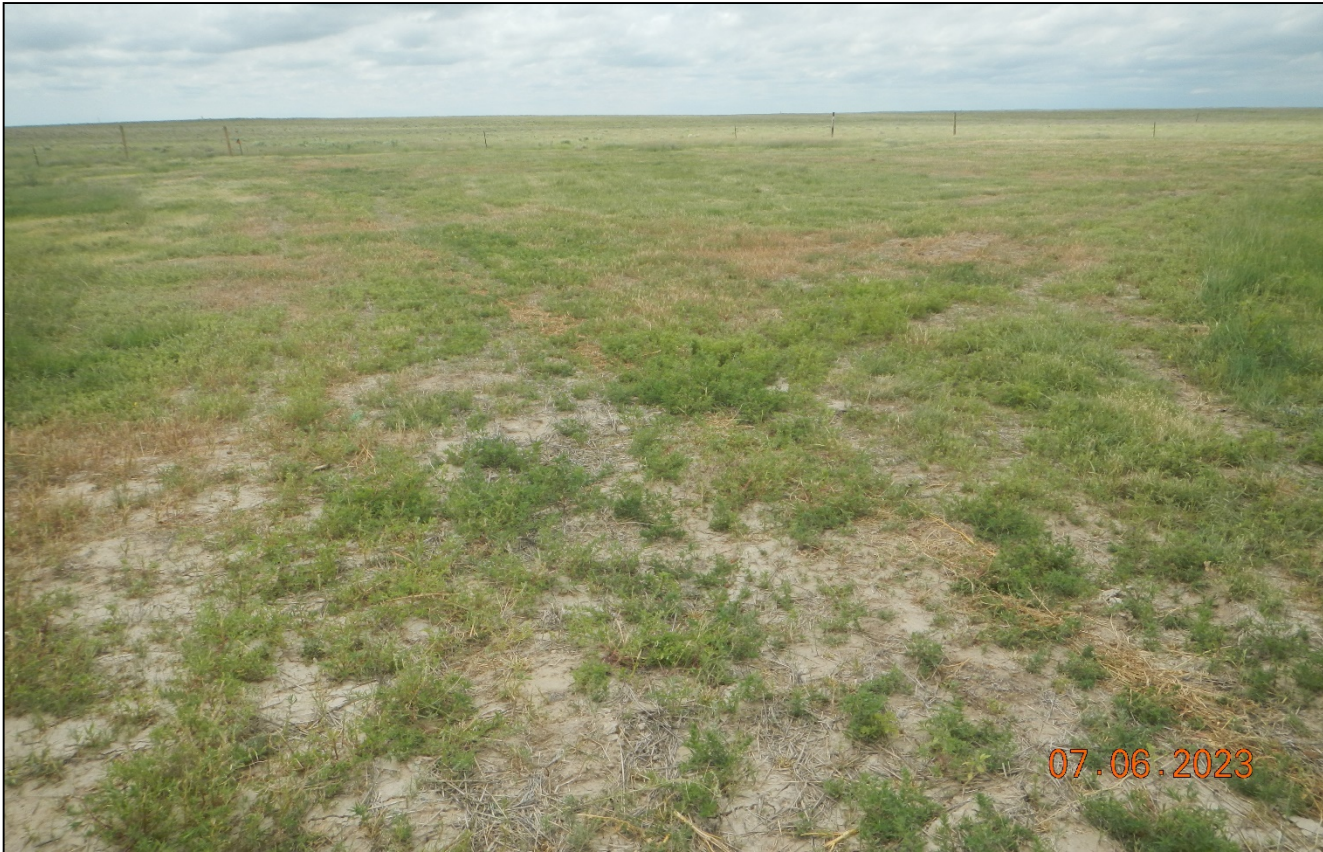
Photo 3. Facing northwest toward the location.

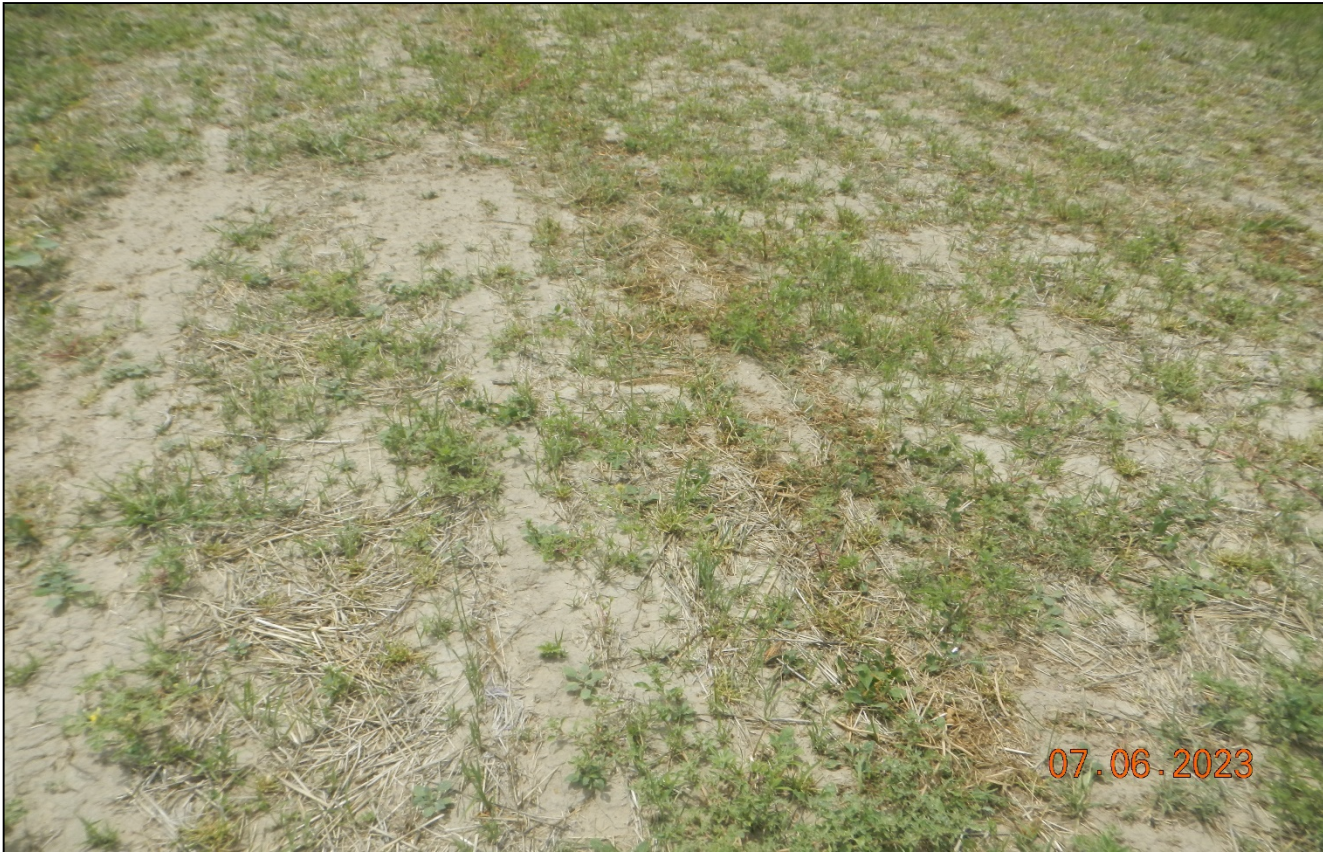
Photo 4. There is desirable and undesirable vegetation growing throughout the reclaimed area. It appears vegetation has been mowed for weed control.

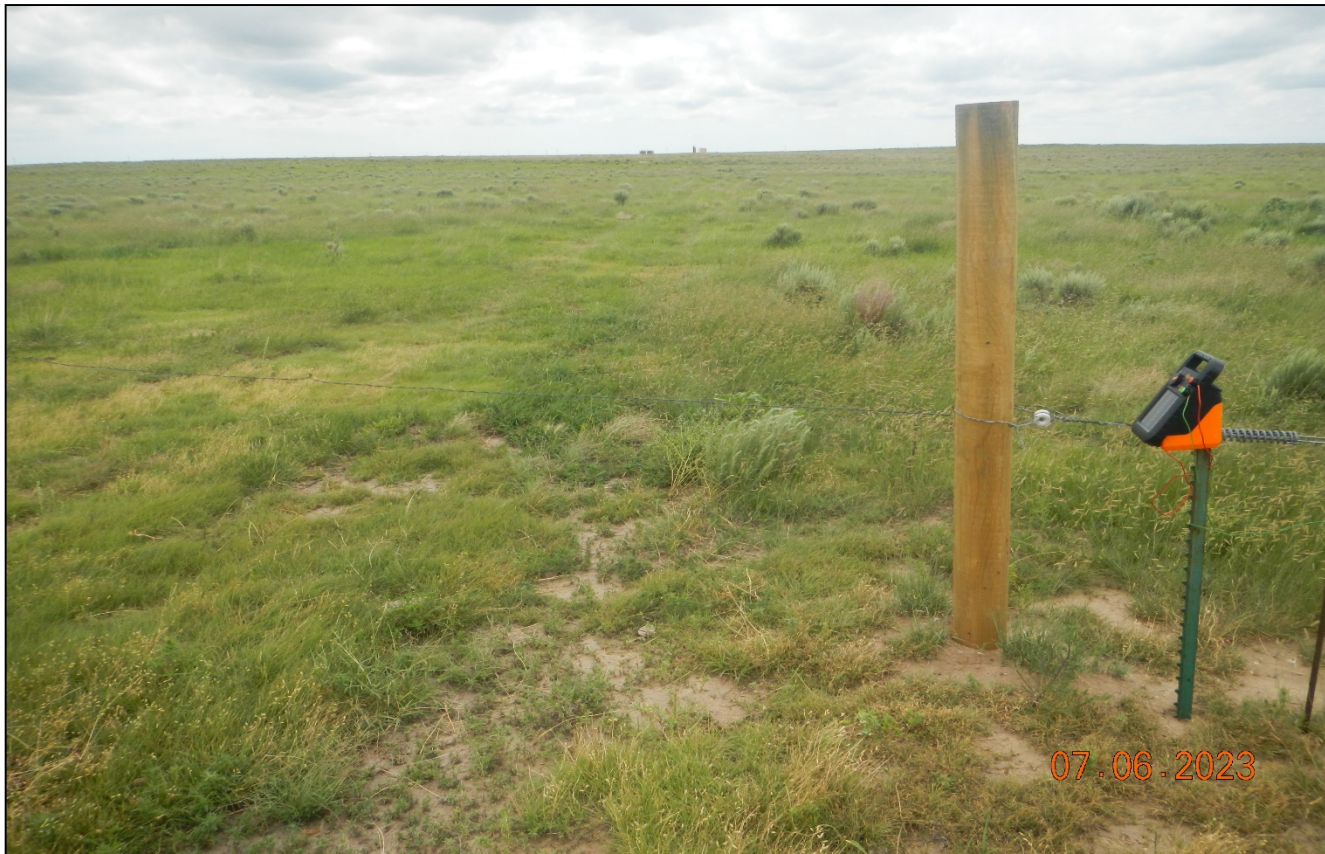
Photo 5. West side of the location facing west. There is signs of vehicle use from the west entering the location. This is not the permitted access and vehicles must stay off of adjacent land.
