# Construction and Stormwater Inspection

Operator: MDS ENERGY DEVELOPMENT - 10814

Location ID: 477495

Inspection Photos  
Location Name: Daffy Pad  
Location ID: 477495

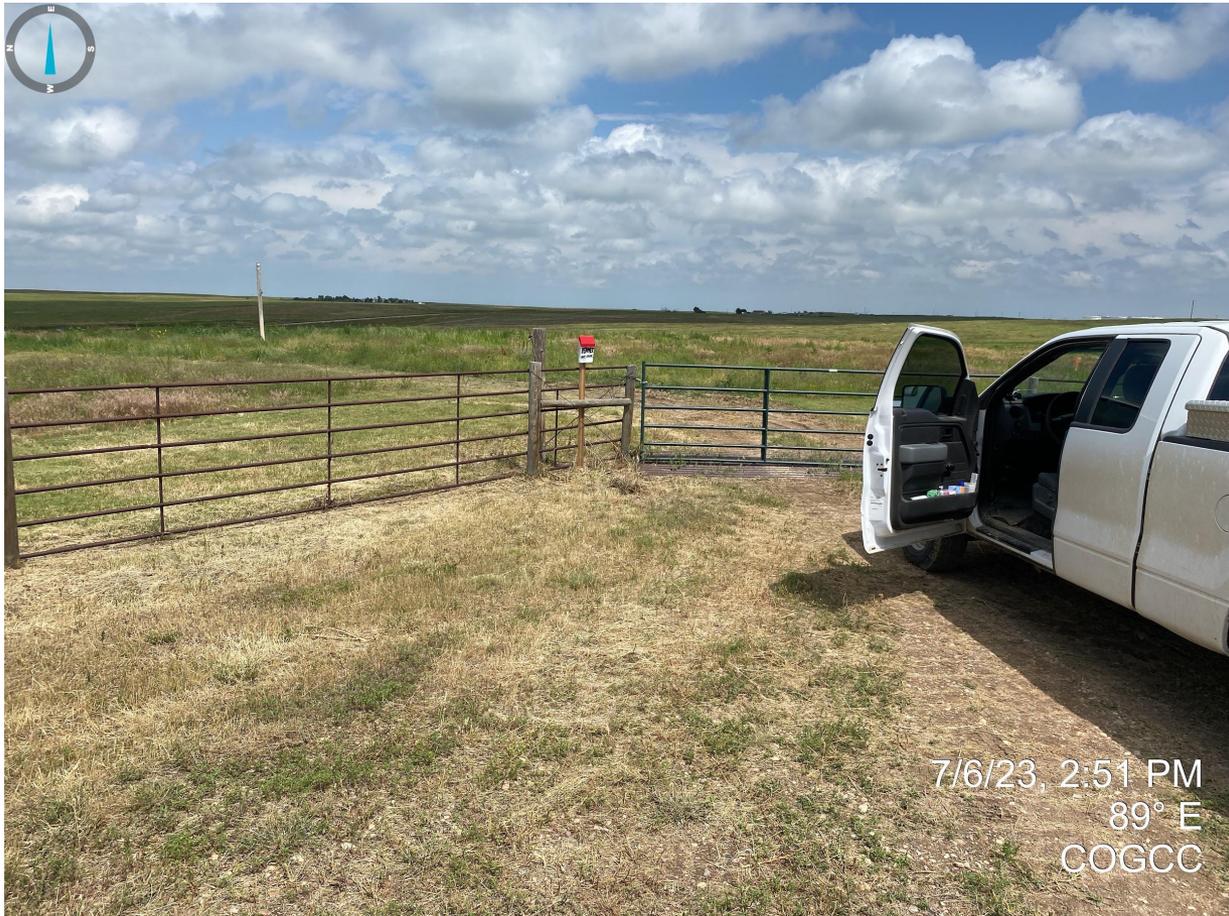
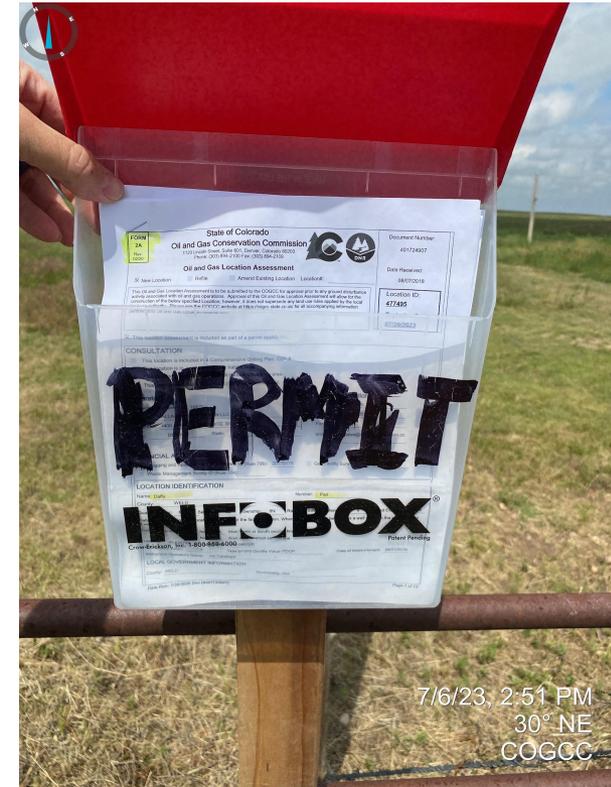
**Photo 1.** The approved Form 2A was posted in a conspicuous location at the entrance to the new construction. However, a location sign was not posted per Rule 605.a.

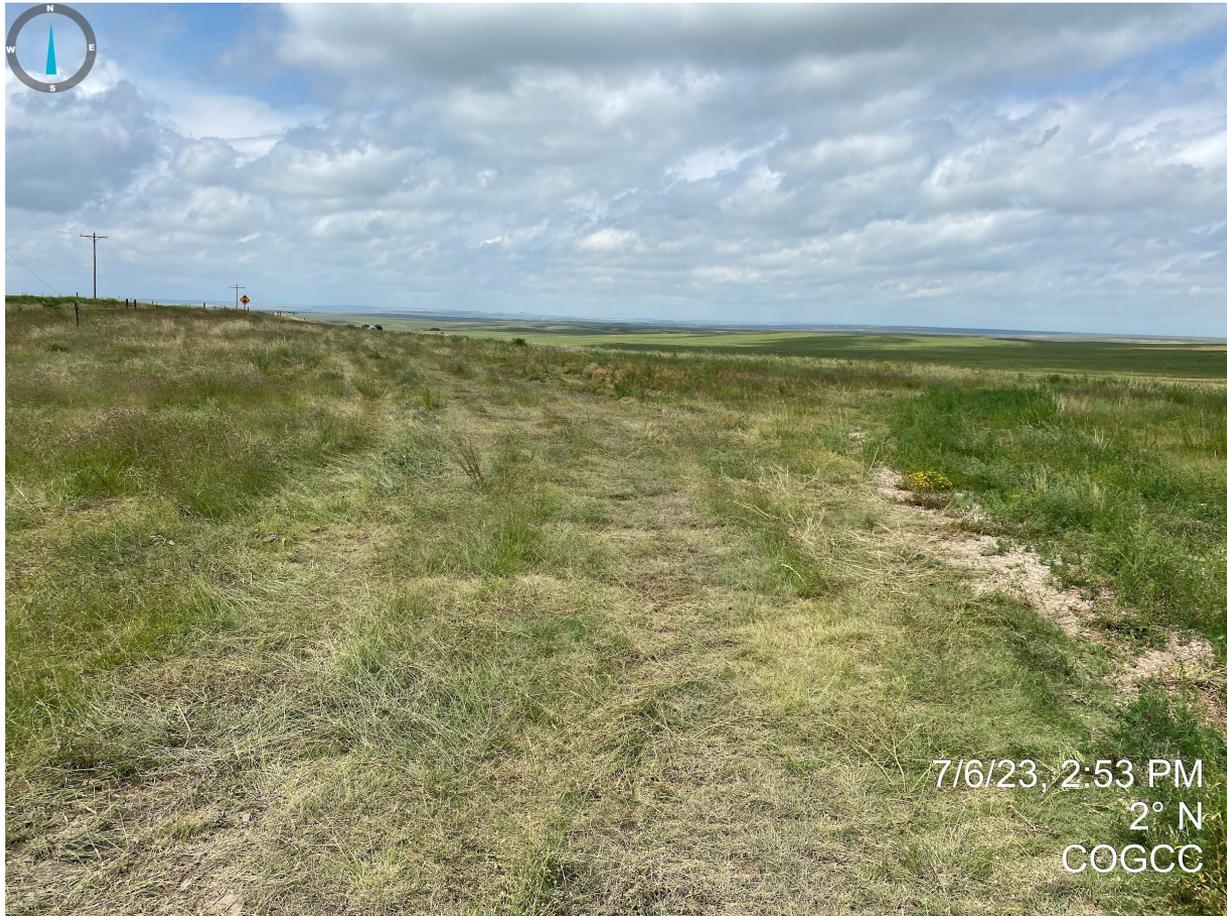
**Photo 2.** Facing north near the location entrance. Topsoil salvage has not occurred on the new access road; this will need to be completed per Rule 1002.b.

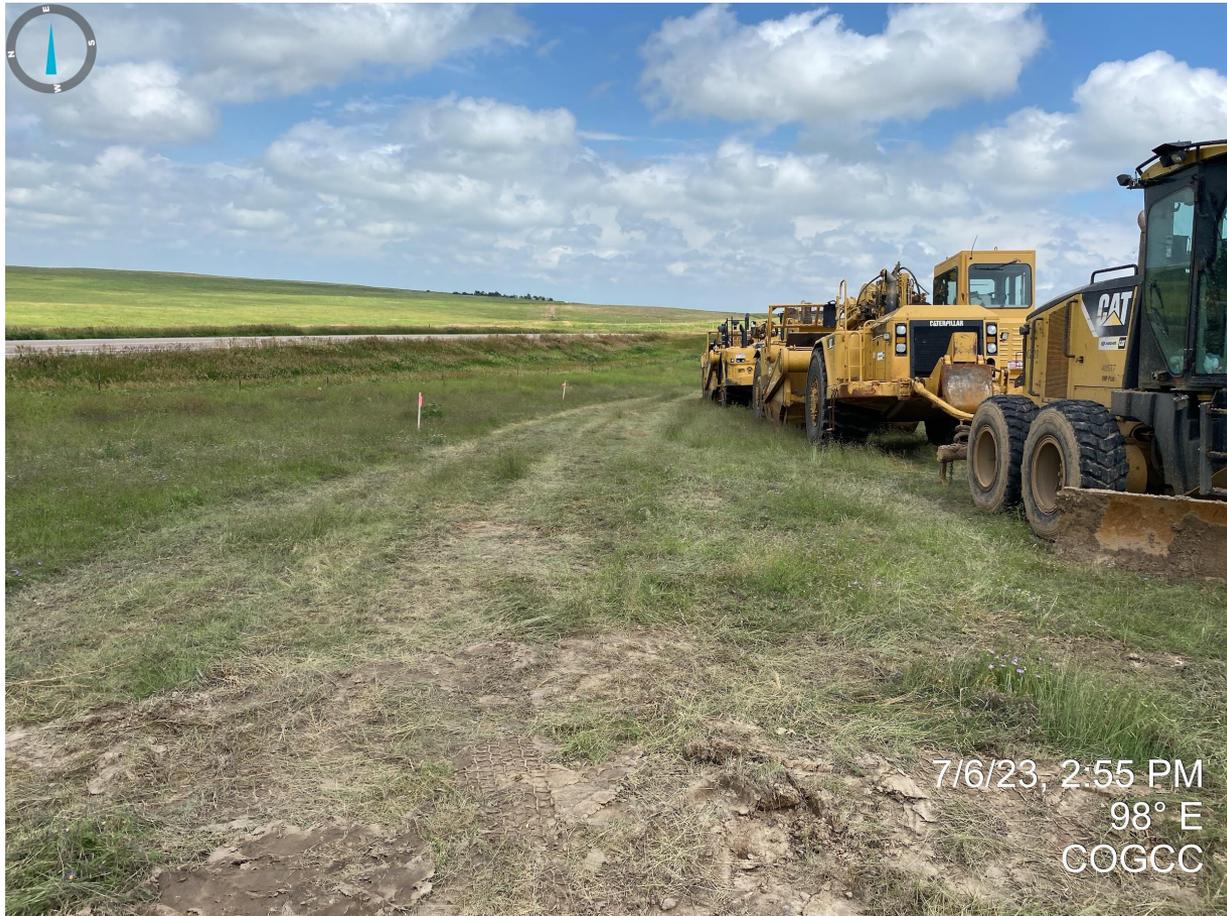
**Photo 3.** Facing east; see comments in Photo 2.

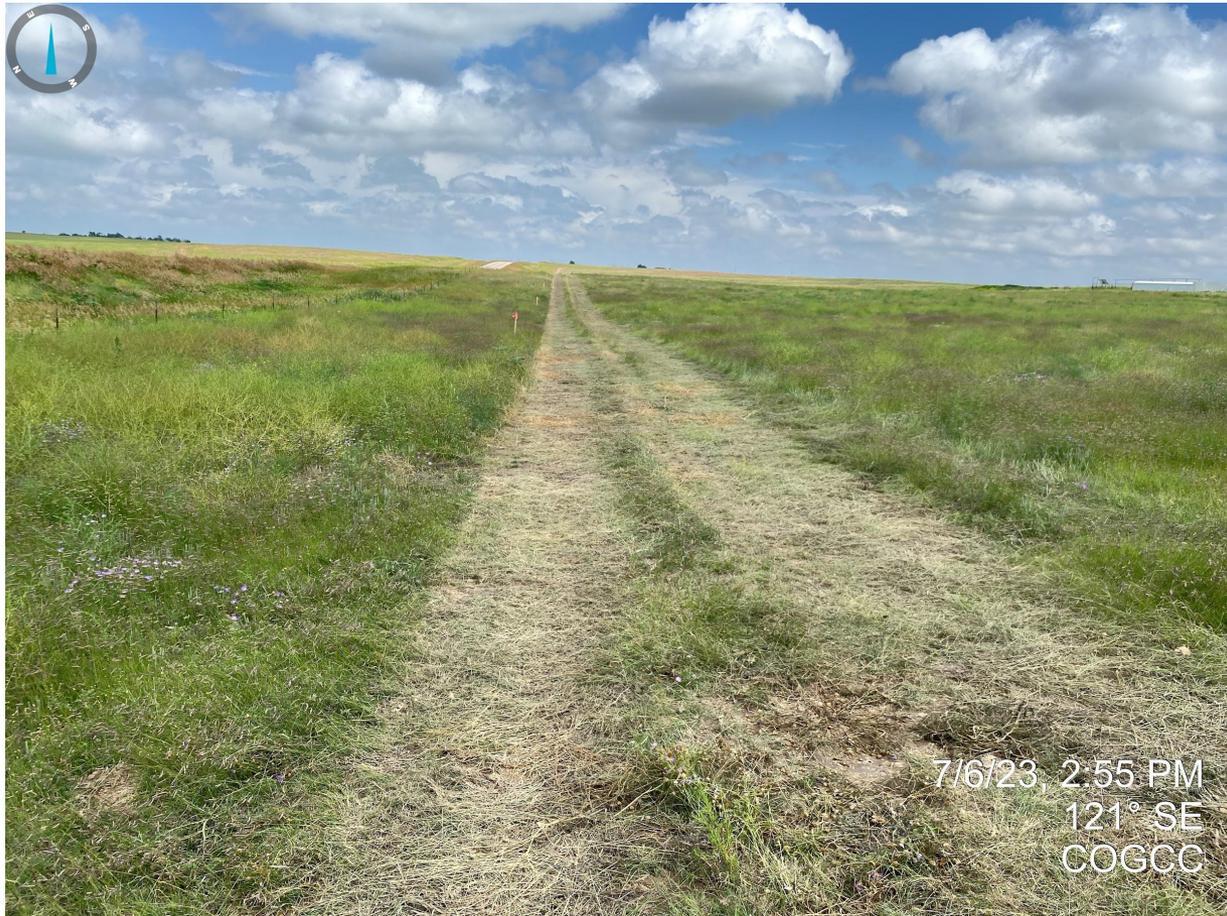
**Photo 4.** Taken northwest of the location, facing southeast. See comments in Photo 2.

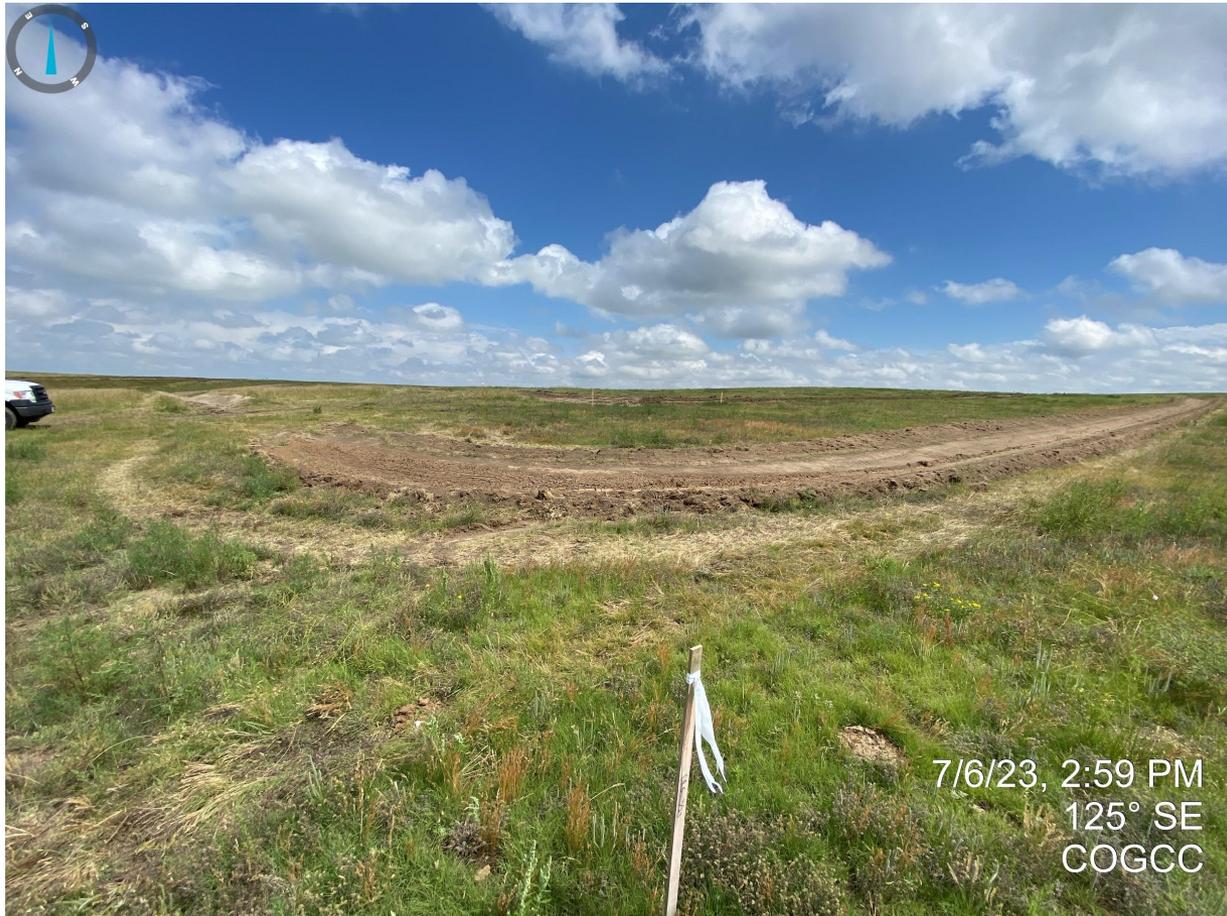
**Photo 5.** Taken from the northwest corner of the disturbance area. Photo illustrates that a perimeter ditch and berm has been constructed around the entire location.

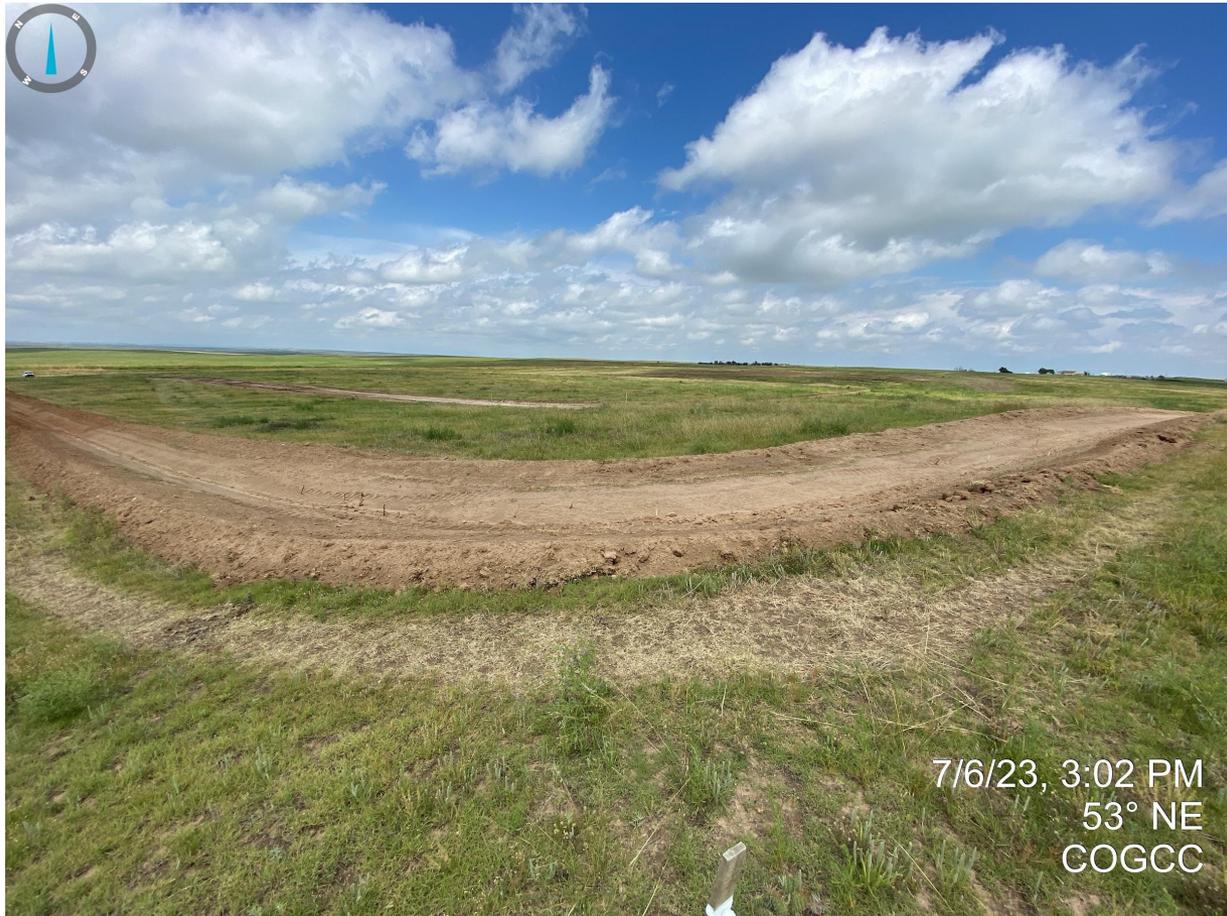
**Photo 6.** Taken from the southwest corner; see comments in Photo 5.

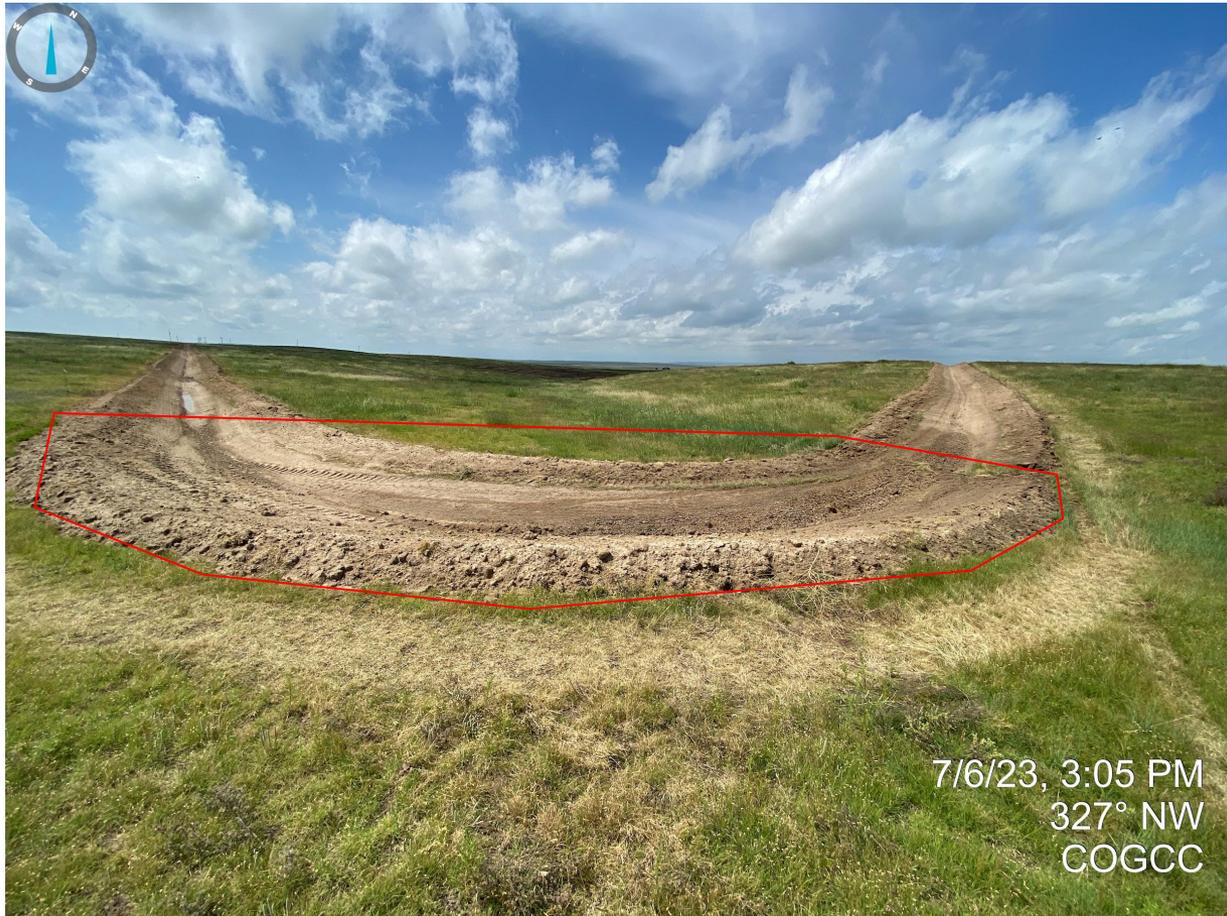
**Photo 7.** Taken from the southeast corner. Berm material does not appear to be properly stabilized with evidence of unconsolidated material.

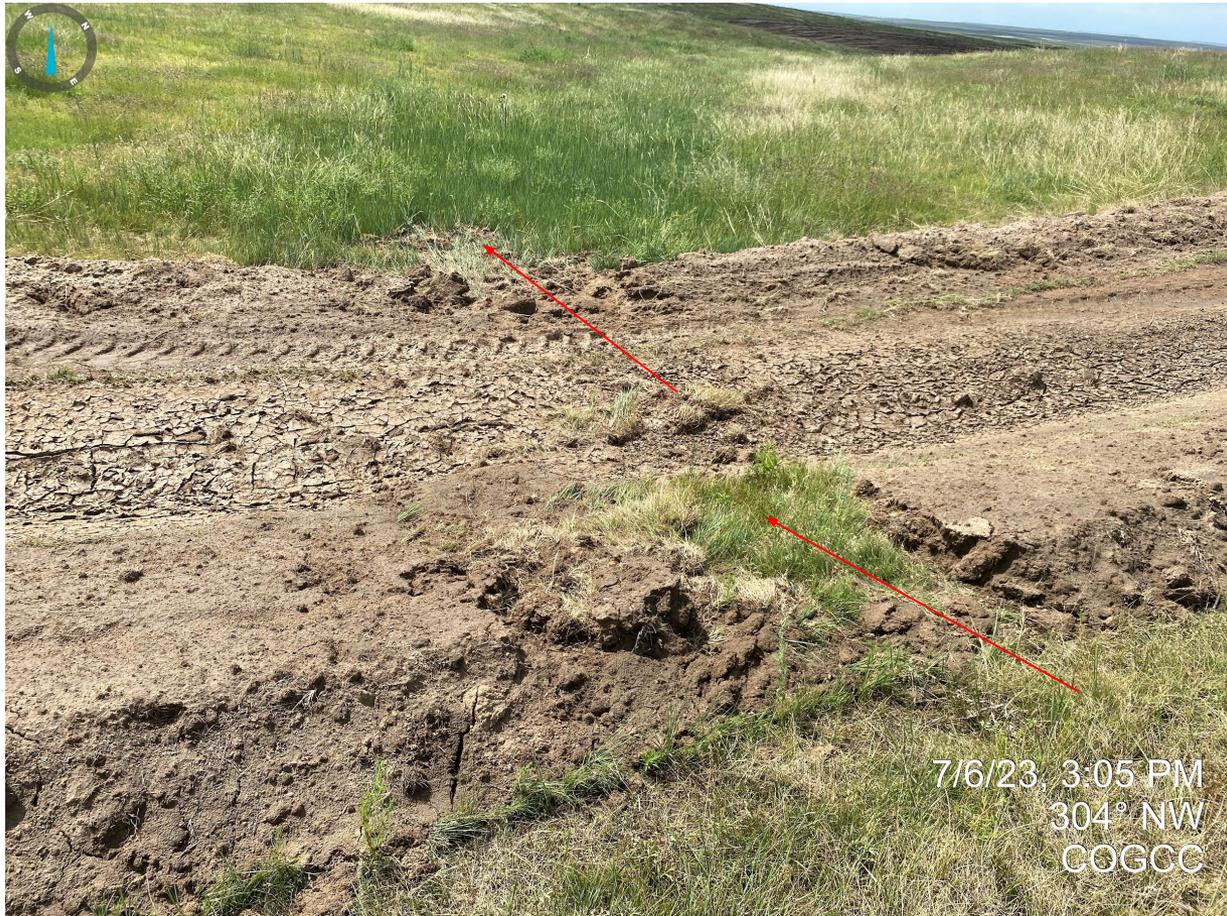
**Photo 8.** Taken near the southeast corner of the location. The berm material does not appear to be properly stabilized with evidence of unconsolidated material. It appears stormwater run-on has eroded a portion of the berm; additional maintenance or implementation of more robust BMPs is required.

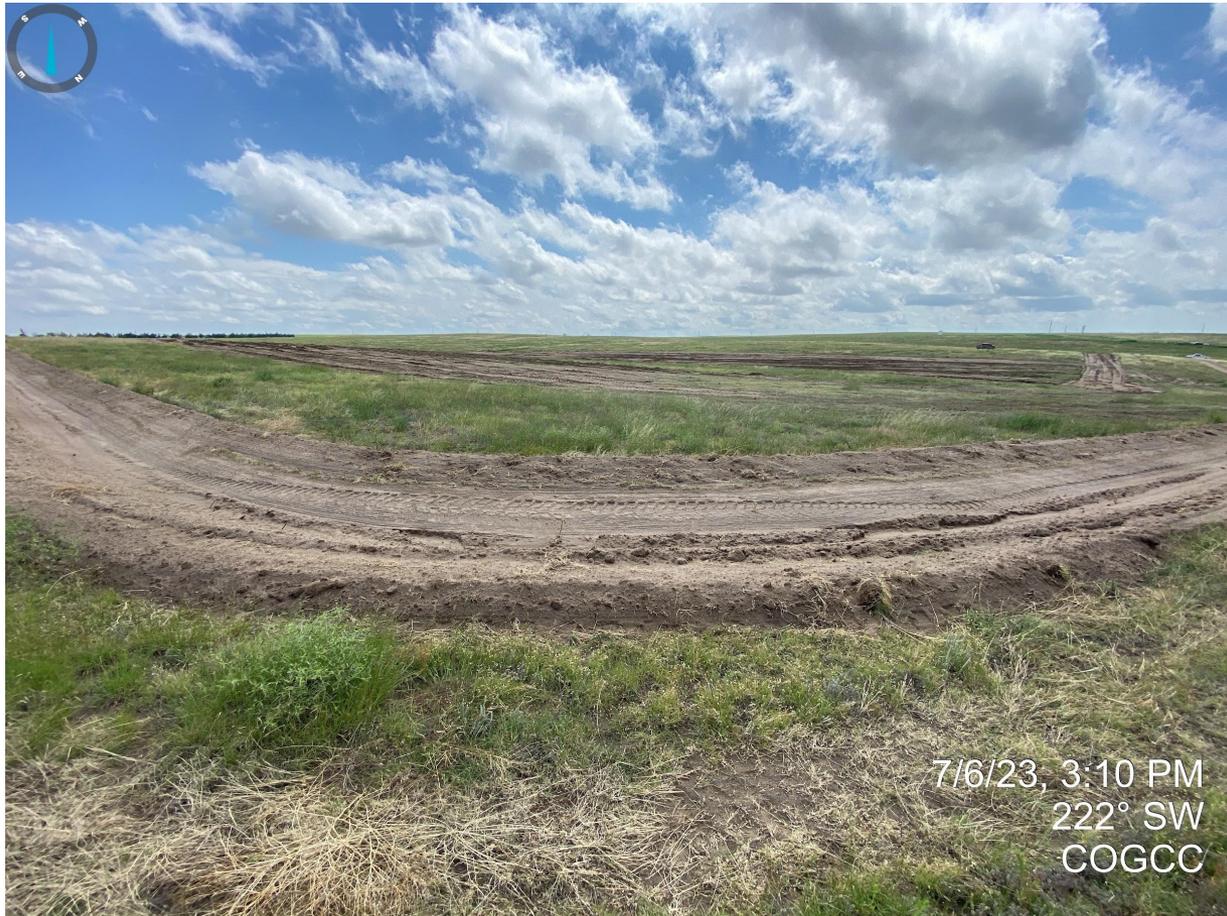
**Photo 9.** Taken from the northeast corner; see comments in Photo 5.

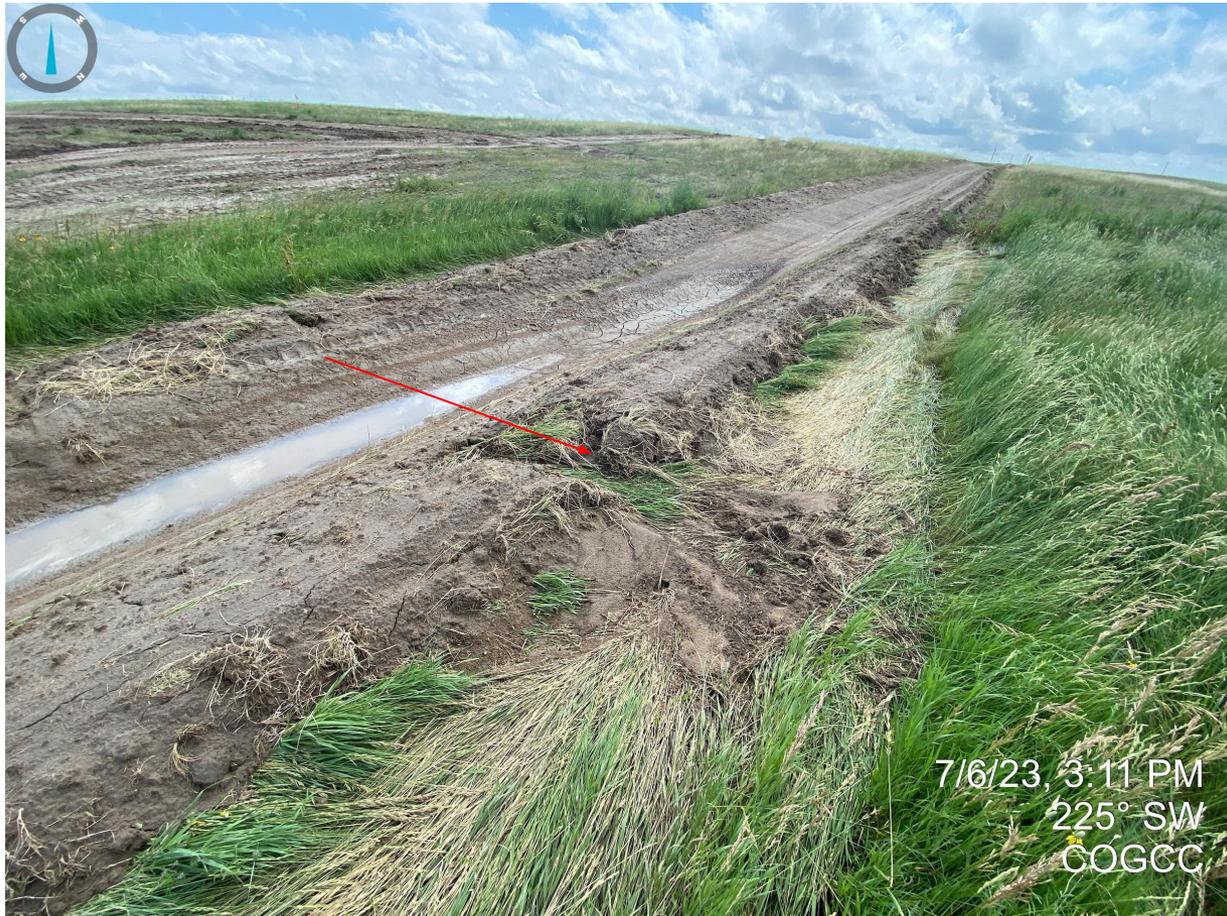
**Photo 10.** Taken from the northern, central, portion of the stormwater ditch and berm. The berm material does not appear to be properly stabilized with evidence of unconsolidated material. It appears stormwater runoff has eroded a portion of the berm; additional maintenance or implementation of more robust BMPs is required.

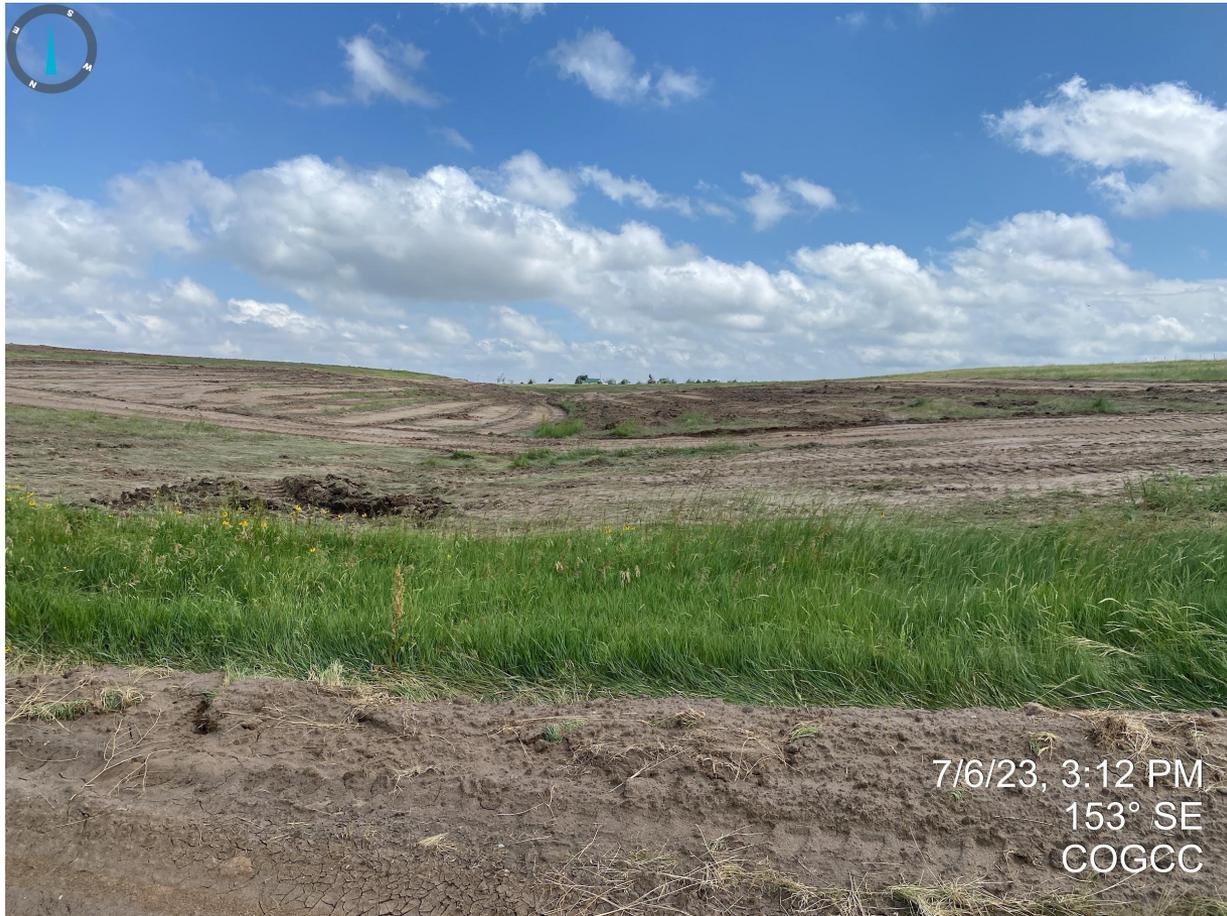
**Photo 11.** Taken from the northern, central portion of the location. It appears that grubbing activities have recently occurred. The Operator shall ensure that all topsoil has been separated and stored in accordance with Rule 1002.b. A follow-up inspection will be performed at a later date to verify compliance with topsoil salvage operations.

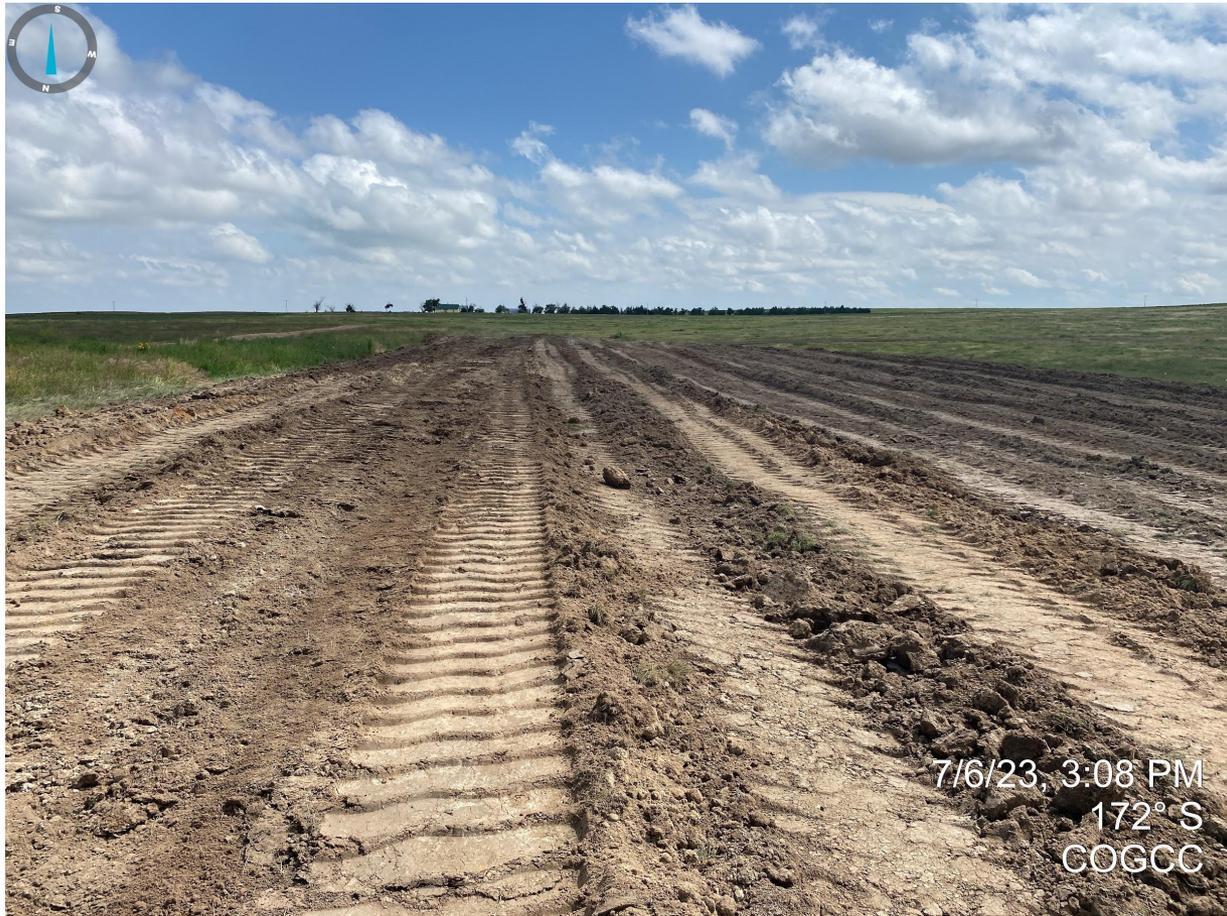
**Photo 12.** Taken from the western portion of the construction area, facing south. It appears that material from the grubbing activities is being positioned on the western half of the location, e.g. the topsoil stockpile area. A follow-up inspection will be conducted at a future date to verify all topsoil has been salvaged from the location.

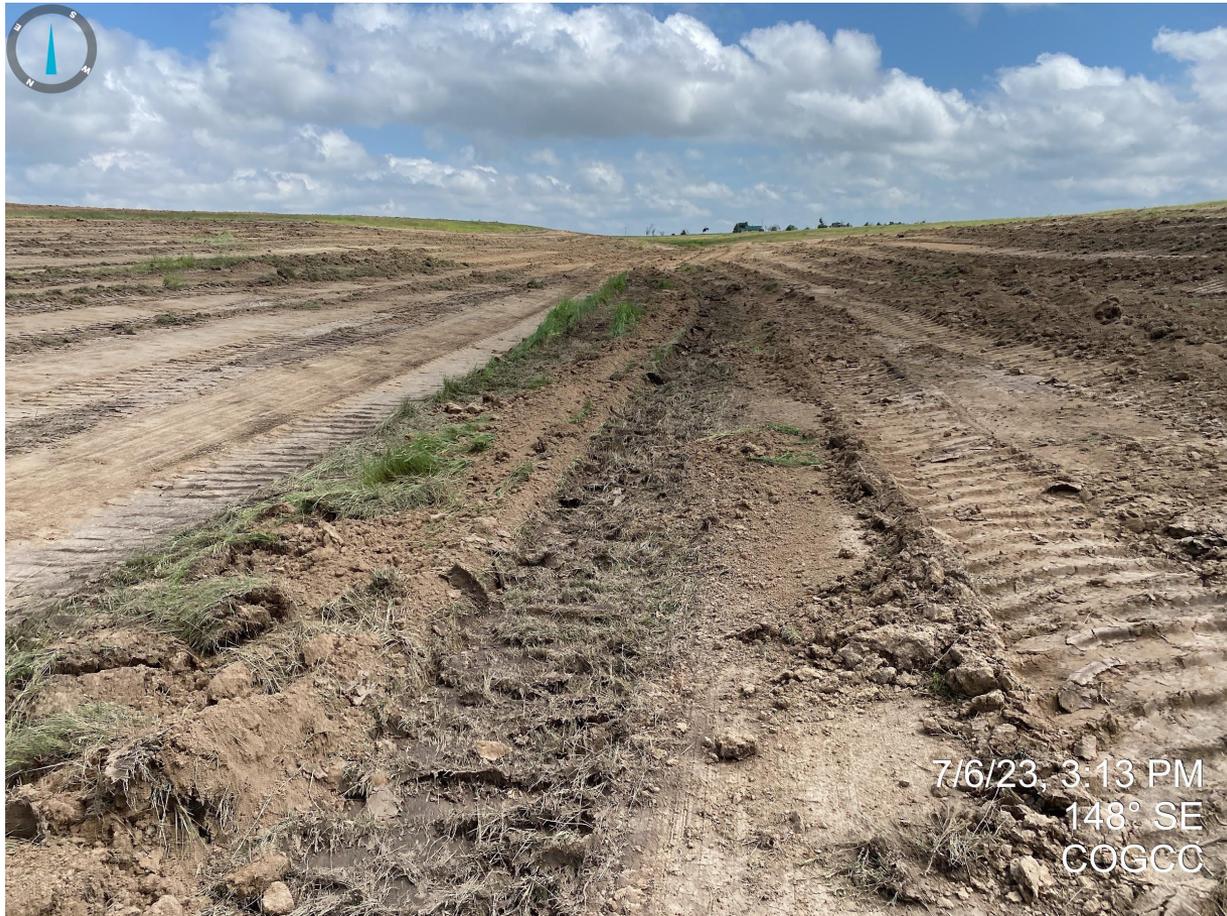
**Photo 13.** Taken from the center portion of the location; photo illustrates grubbing activities occurring within the fill areas.

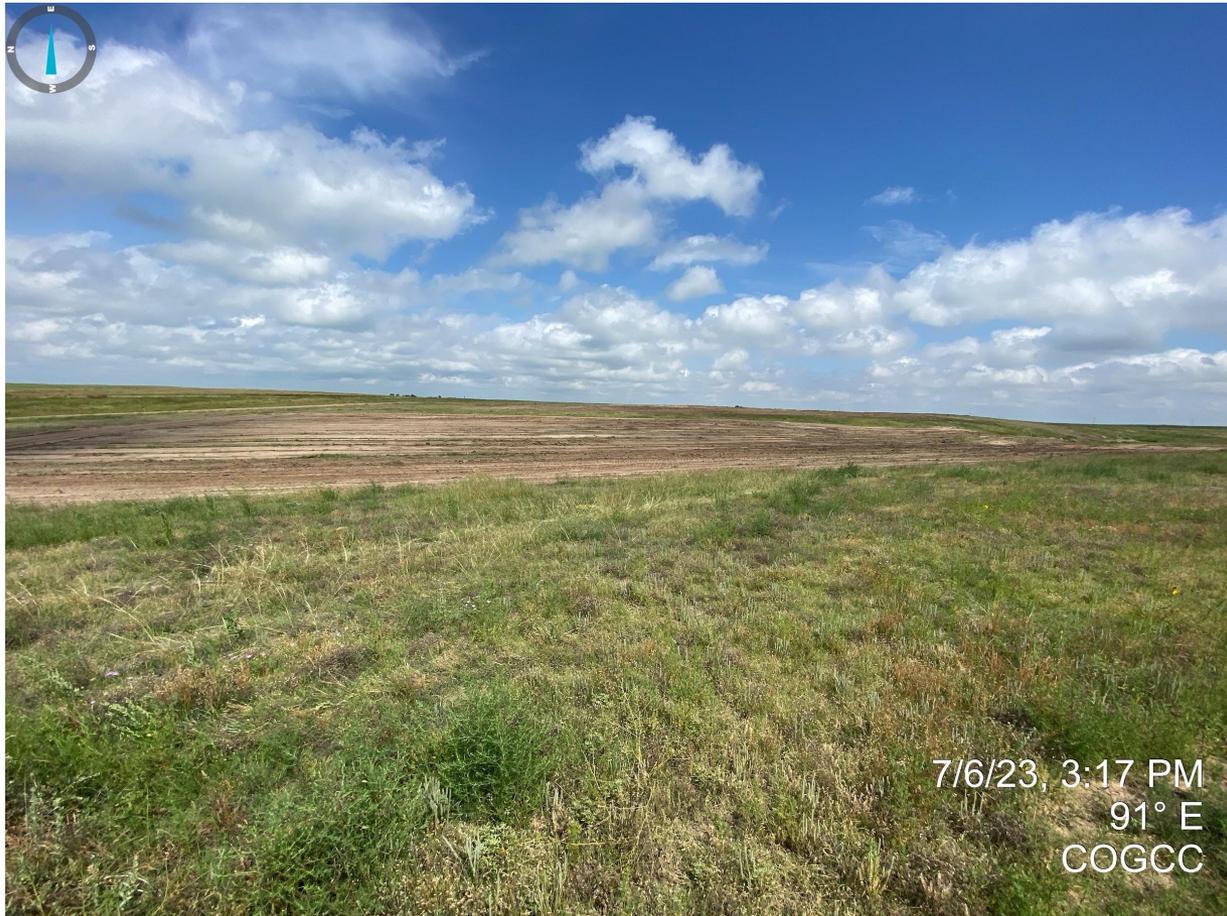
**Photo 14.** Overview of cut and fill areas within the disturbance area.
