# Inspection Photos

API: 061-05145

Operator: WESTERN OPERATING COMPANY

Inspection Date: 7/6/2023

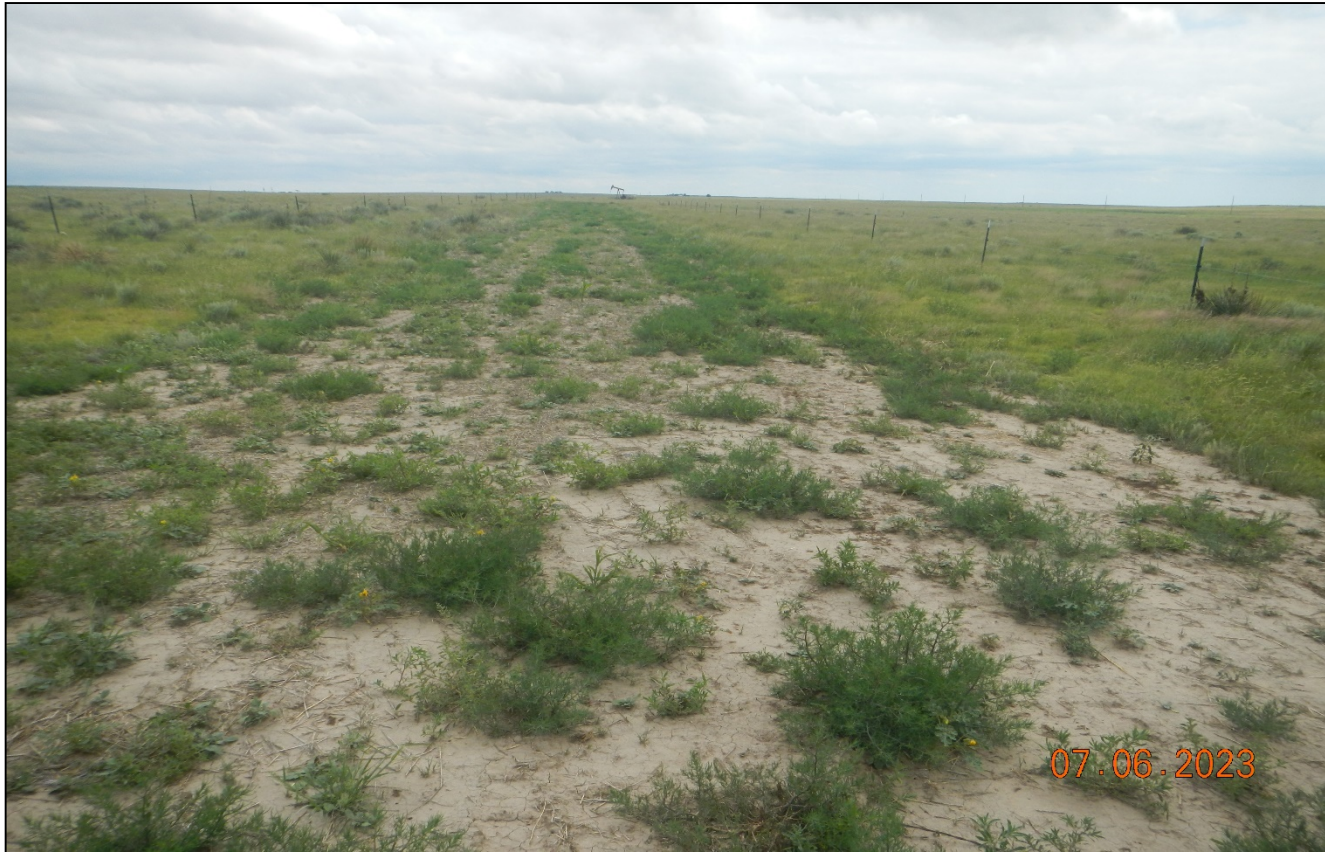
**Photo 1.** Facing south toward the access road. The access road has been recontoured and reclaimed. There is some desirable and undesirable growing along the reclamation area.

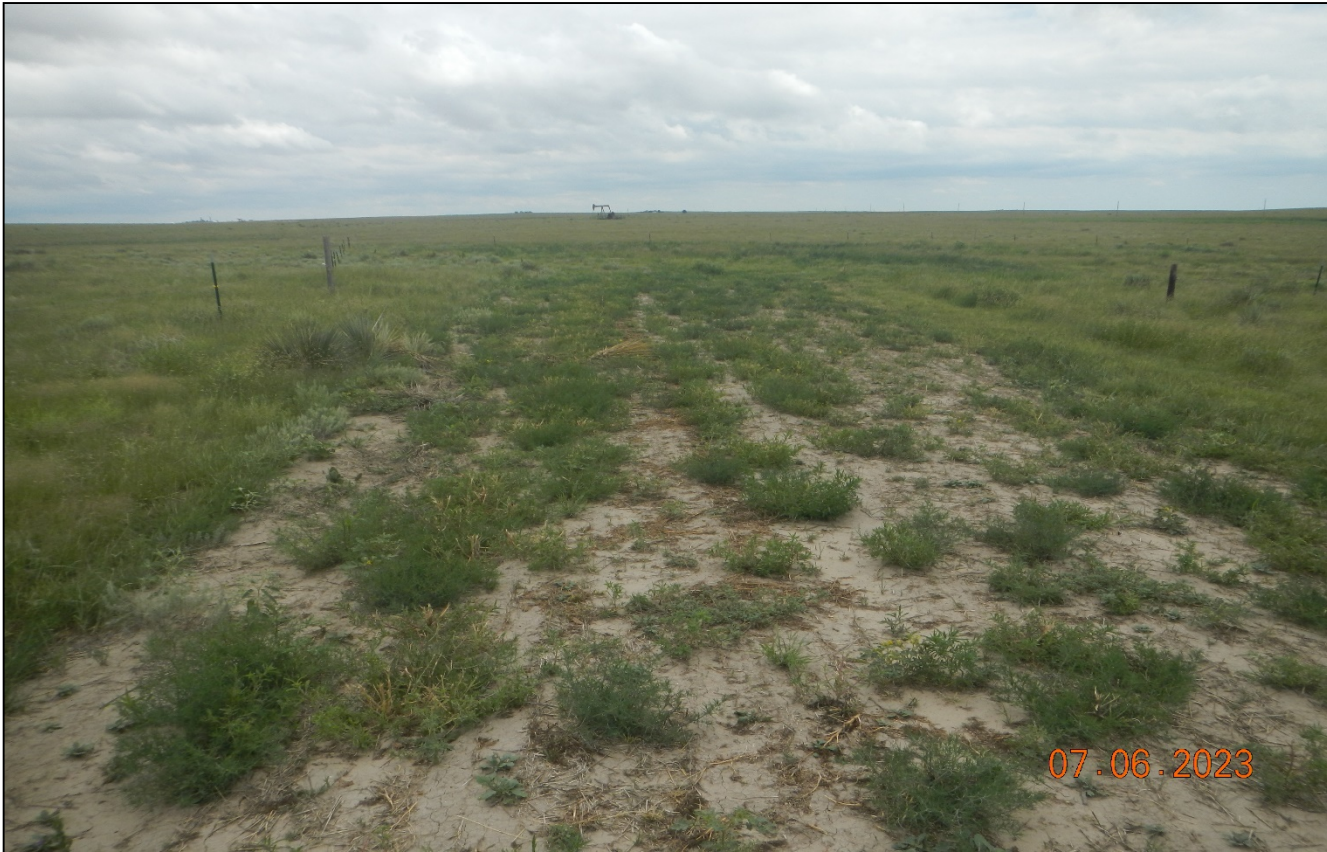
**Photo 2.** Facing south along the access road near the location. The electric transmission line has been removed.

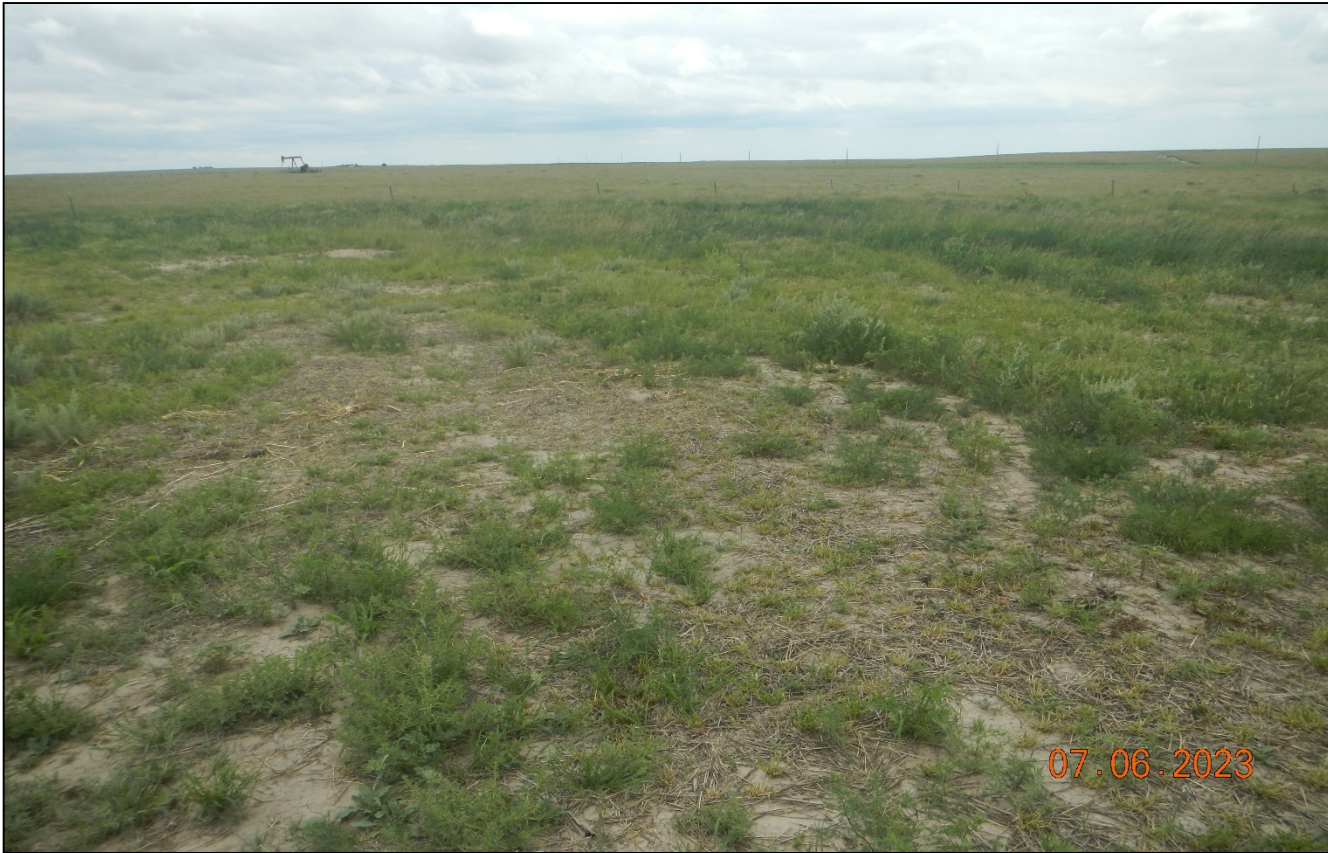
**Photo 3.** Facing south toward the location which has been reclaimed.

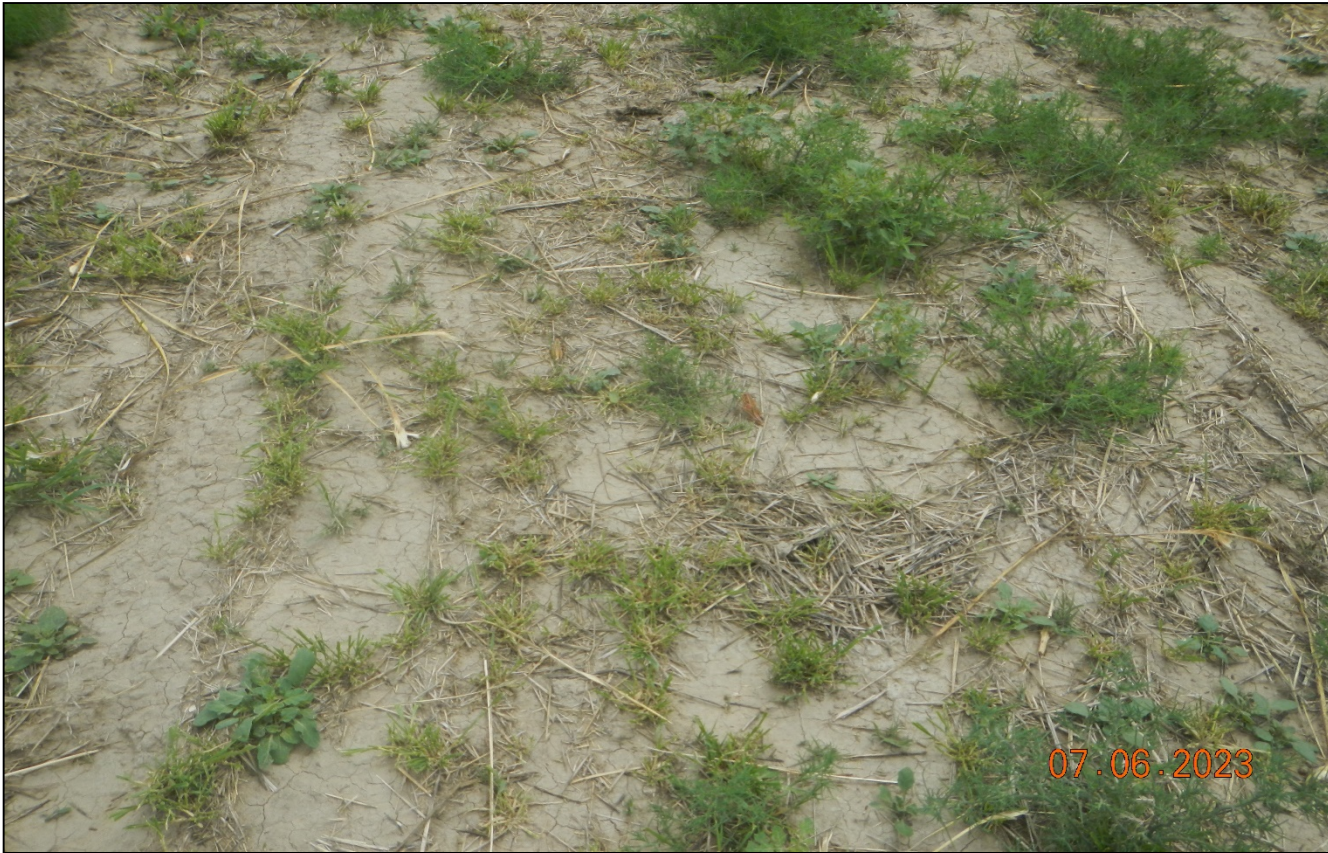
**Photo 4.** View of ground cover shows some desirable vegetation establishing.
