**Operator: CIVITAS NORTH LLC**  
**Location Name: Lamb 42-15 Facility**  
**Loc ID: 427430**  
**Inspection: 694100110**

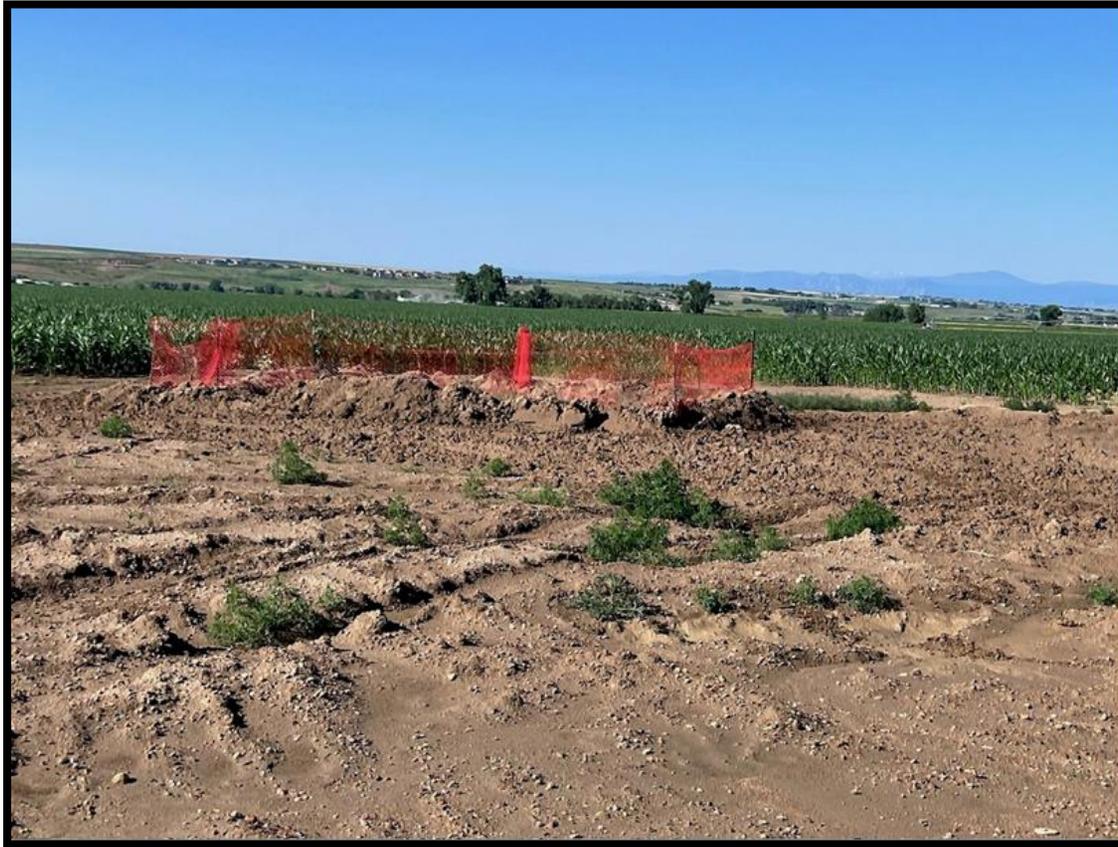
**Exhibit A**

**CA:** Open excavation on location. Approximately 10ft x 12ft x 5ft. Fill open excavation. Install safety fencing until excavation can be filled in. Comply with the fencing requirements per the 1002a rules.

**CA Resolution:** Operator has reported and provided photo evidence that fence has been installed as of Friday, 7/7/2023 to comply with Rule 1002.a.

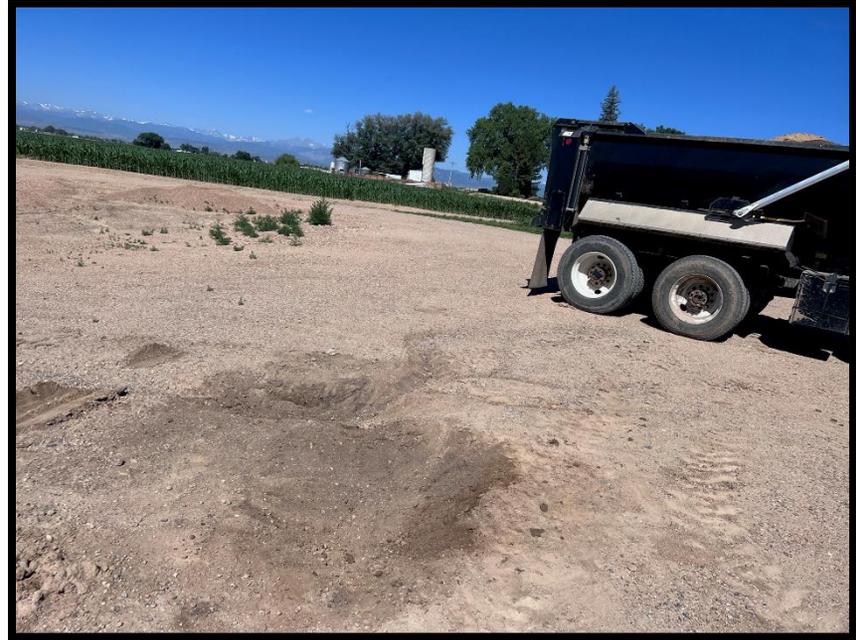
**Exhibit B**

**CA:** Oily substance was on location. Could be a small diesel or gasoline spill. "For localized stained soils or oily waste - ""Properly dispose of oily waste in accordance with 905.e."" For larger instances: "Properly dispose of oily waste in accordance with Rule 905.e and contact area COGCC EPS"".

**CA Resolution:** Identified stained soil has been properly addressed. Operator has disposed of stained soil (removed/hailed to the front range landfill in Erie) and cleaned the area. Operator will continue to monitor and maintain location appropriately to remain in compliance with Rule 1002.(2).d. Operator also reports that reclamation has started on that facility pad as of 7/12/2023.
