# Inspection Photos

API: 043-06122

Operator: JAVERNICK OIL

Inspection Date: 7/13/2023

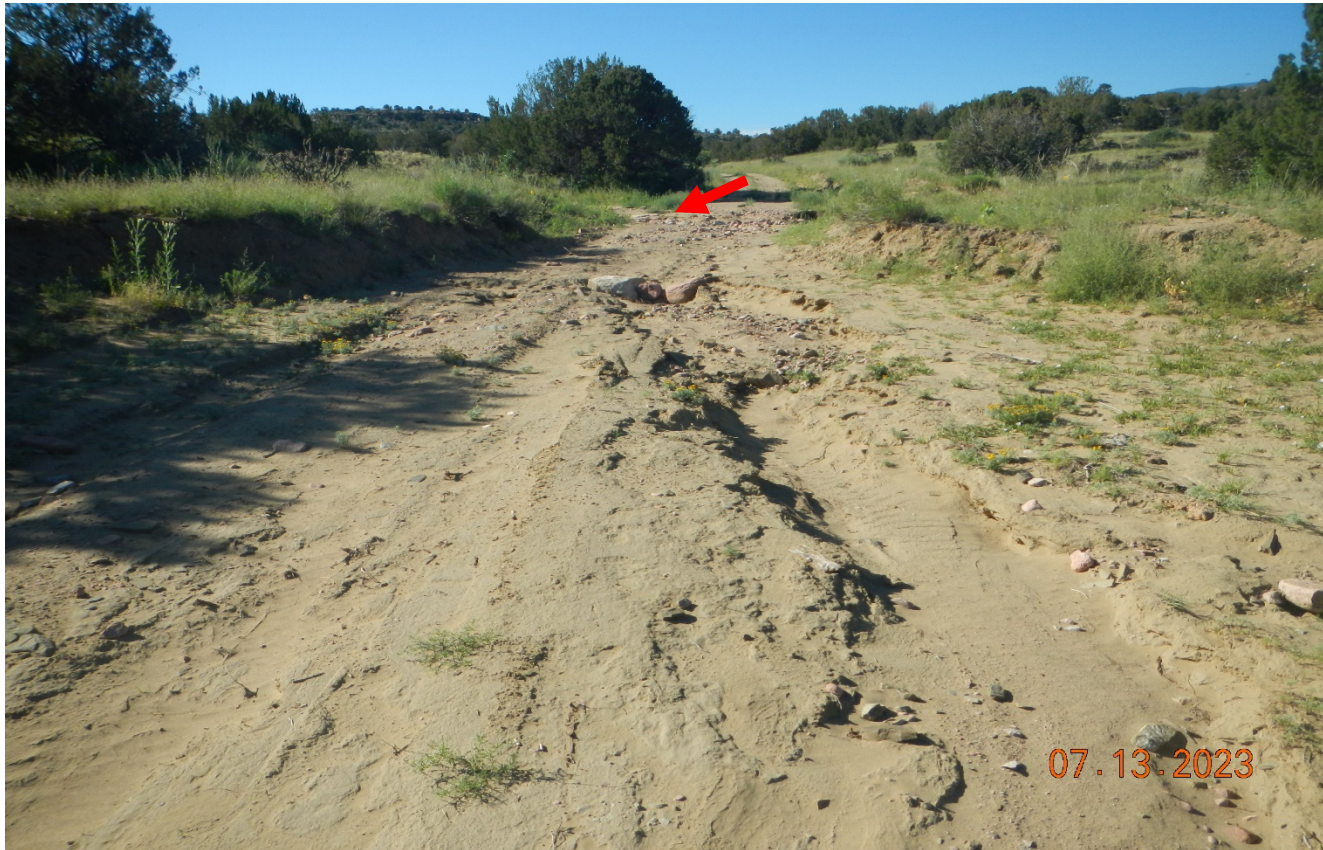
**Photo 1.** Facing southeast long the access road. Erosion has occurred from a recent storm event which washed down from the drainage at red arrow. Previous corrective action required culvert or other BMP to be placed at the drainage which may have prevent erosion of the road. Previous corrective action was not completed.

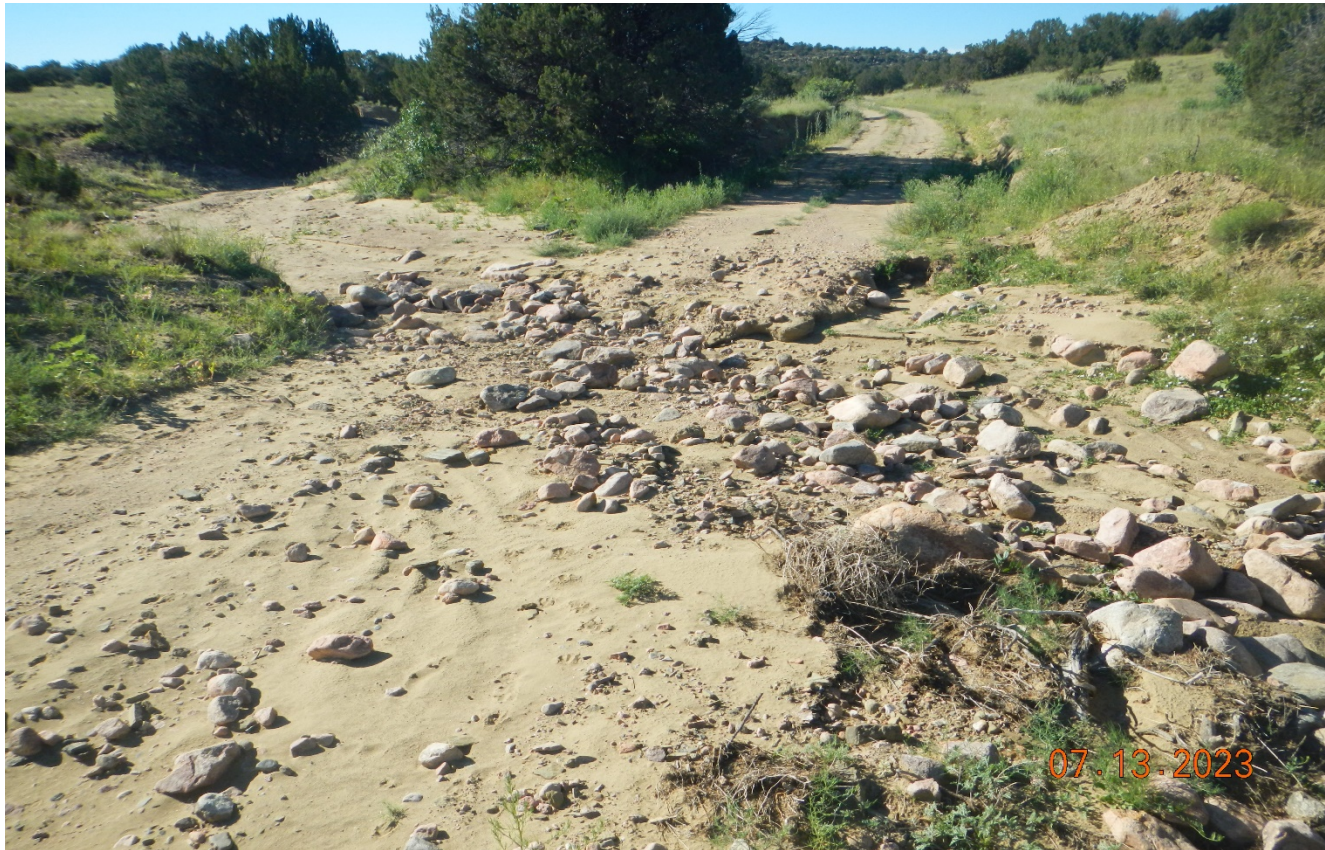
**Photo 2.** Facing southeast long the access road. This drainage crossing must have BMP's installed to accommodate seasonal storm event to prevent material from washing out. BMP may include culvert, rip/rap, ect. Previous corrective action not completed. Storm events have caused further erosion of the road since previous inspection.

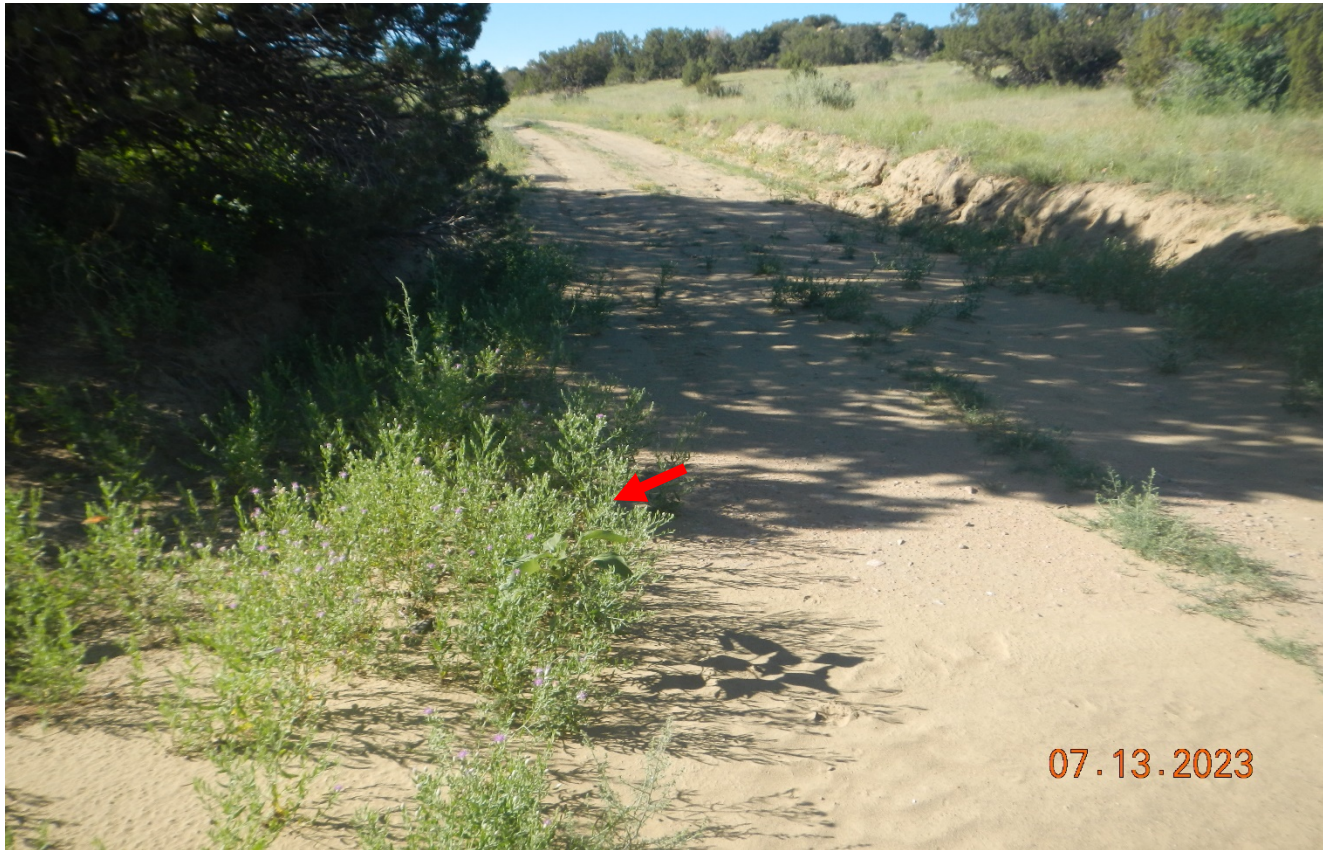
**Photo 3.** There are list B noxious weeds Diffuse knapweed shown at red arrow that must be controlled right away before seed dispersal and further infestation occurs.

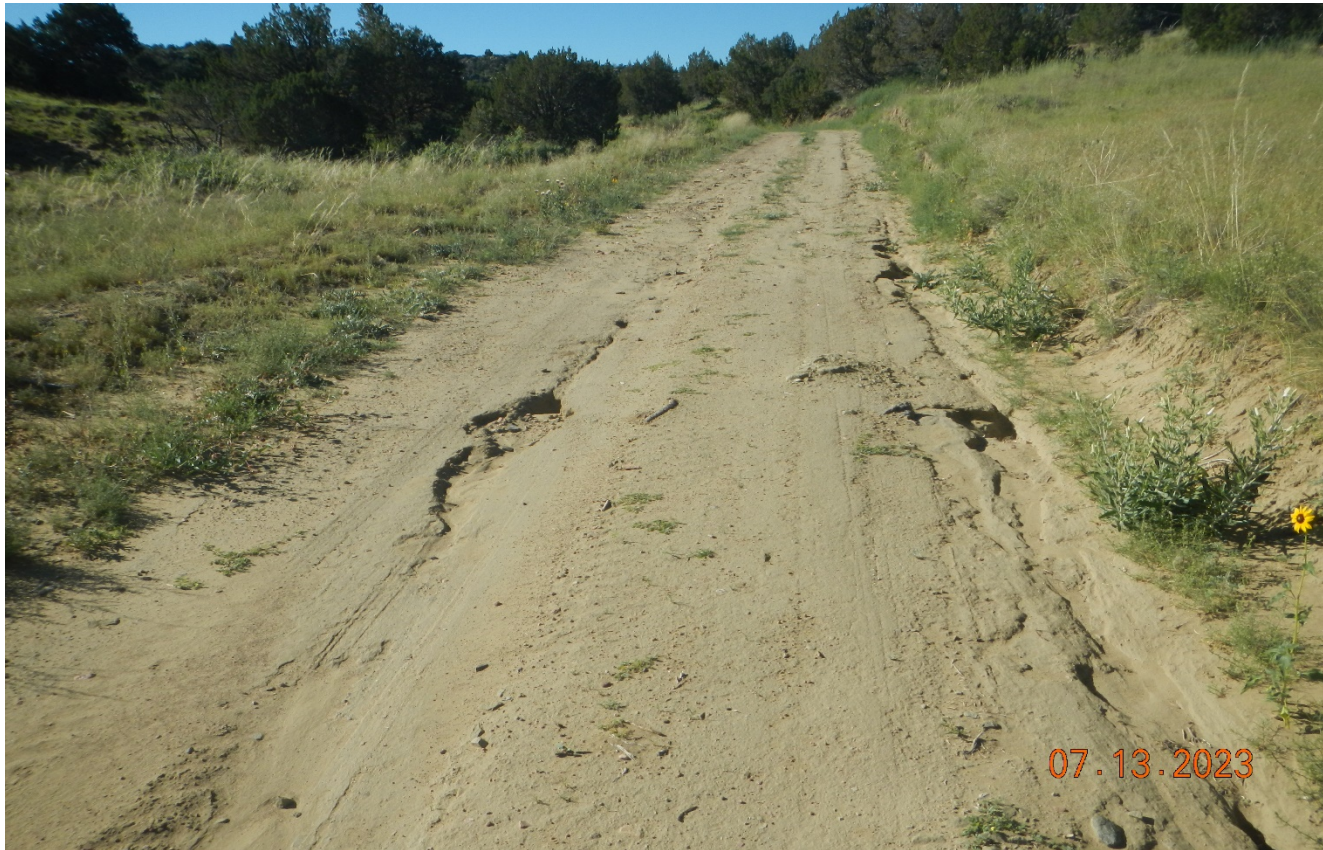
**Photo 4.** Facing southeast long the access road. There is erosion along the access road which is not stabilized and no BMP's have been installed. Previous corrective action was not completed.

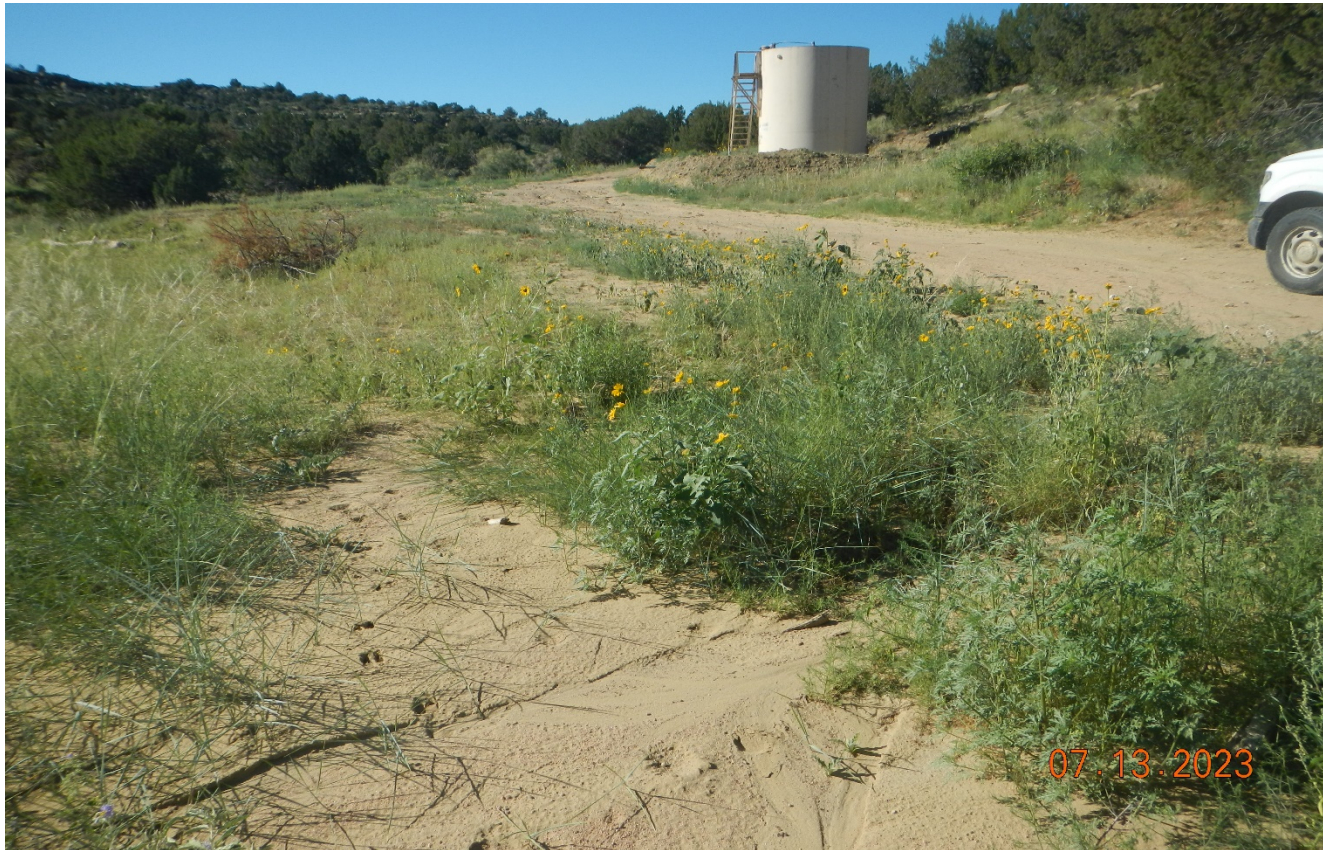
**Photo 5.** Facing southeast long the access road near the tank battery site. Recent storm event has washed sediment down the road and offsite into the stream drainage.

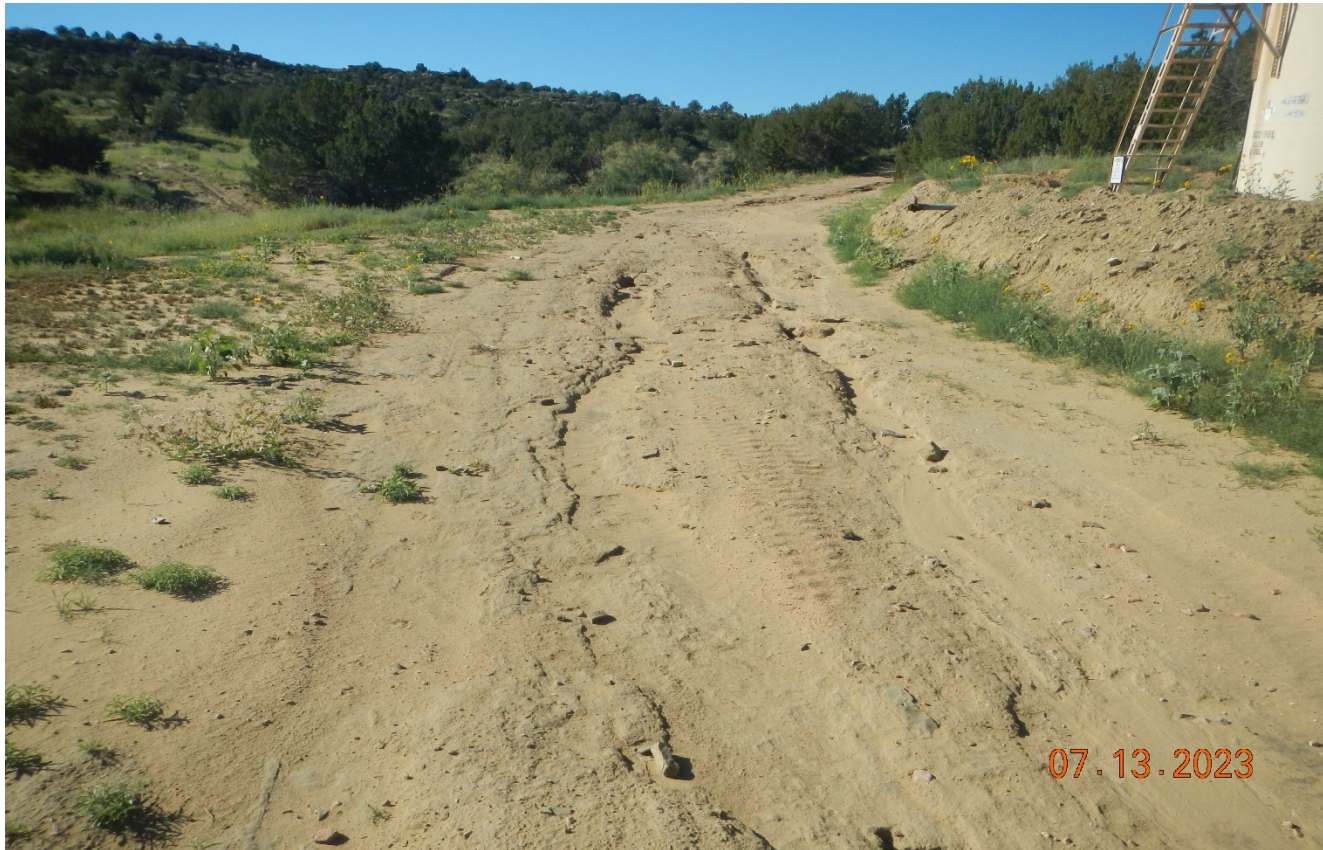
**Photo 6.** Facing southeast at the tank battery site. The equipment that was stoered along the east side of the road was removed. The disturbed area along the road side needs to be reclaimed and stabilized. There is erosion along the road that needs to be repaired and stabilized. Previous corrective action was not completed.

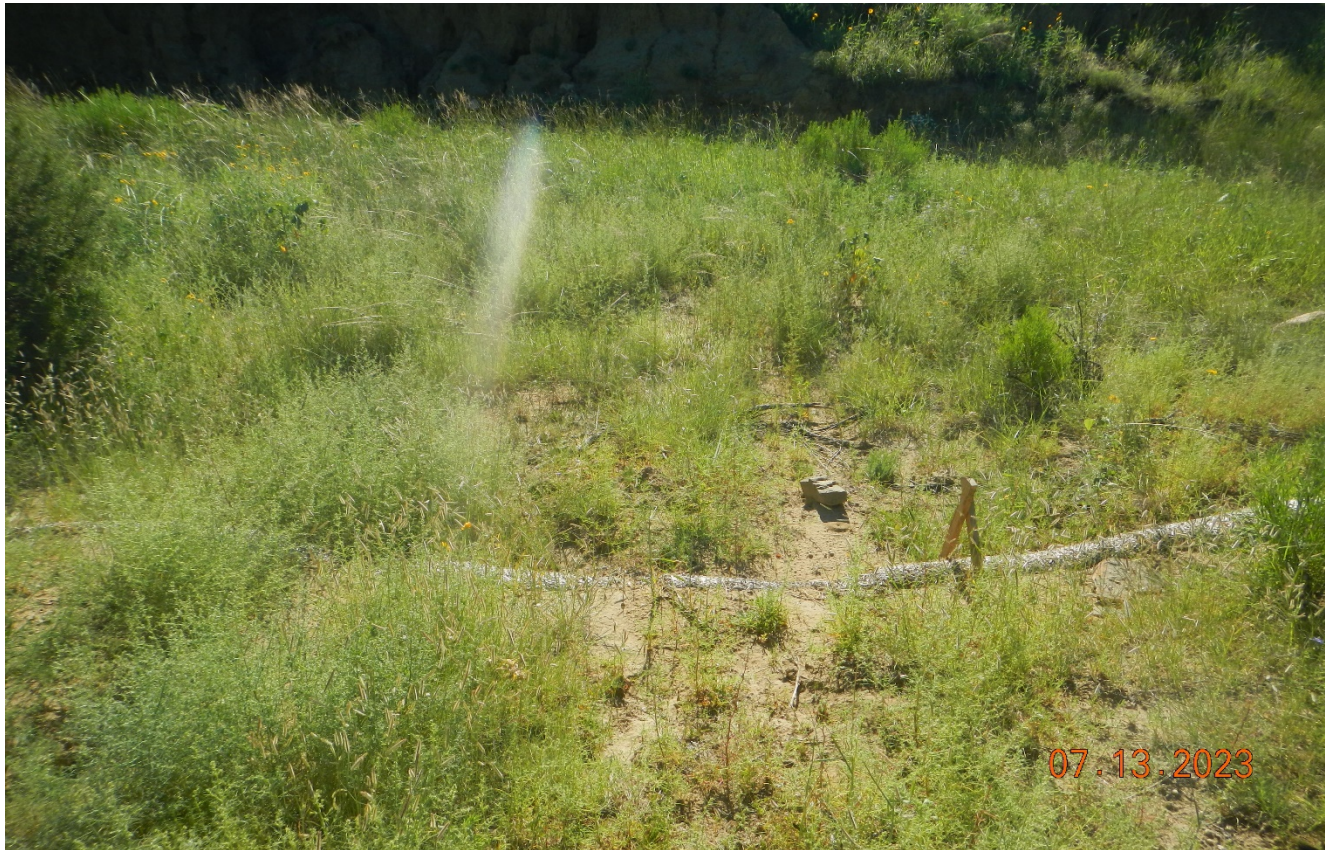
**Photo 7.** Facing southeast at the perimeter of the disturbance at the east side of tank battery. The wattles are not maintained and are filled in with sediment. corrective action was not completed.

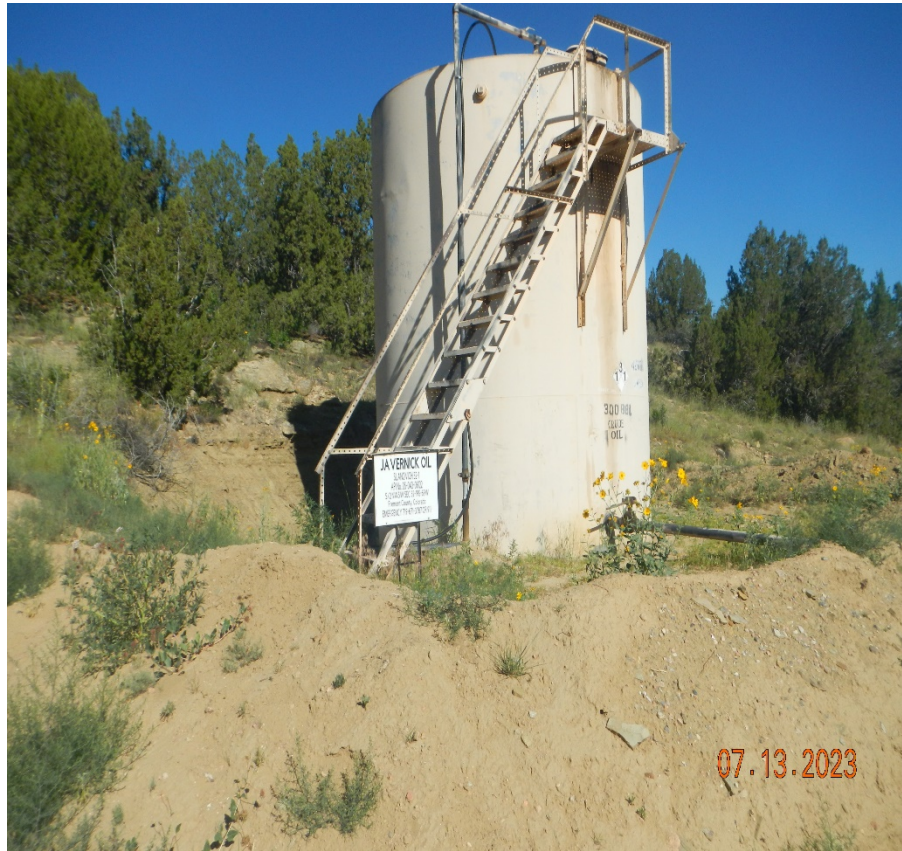
**Photo 8.** Facing toward the tank battery. The tank appears to be empty. There was a previous dripping leak observed at backside of the tank.

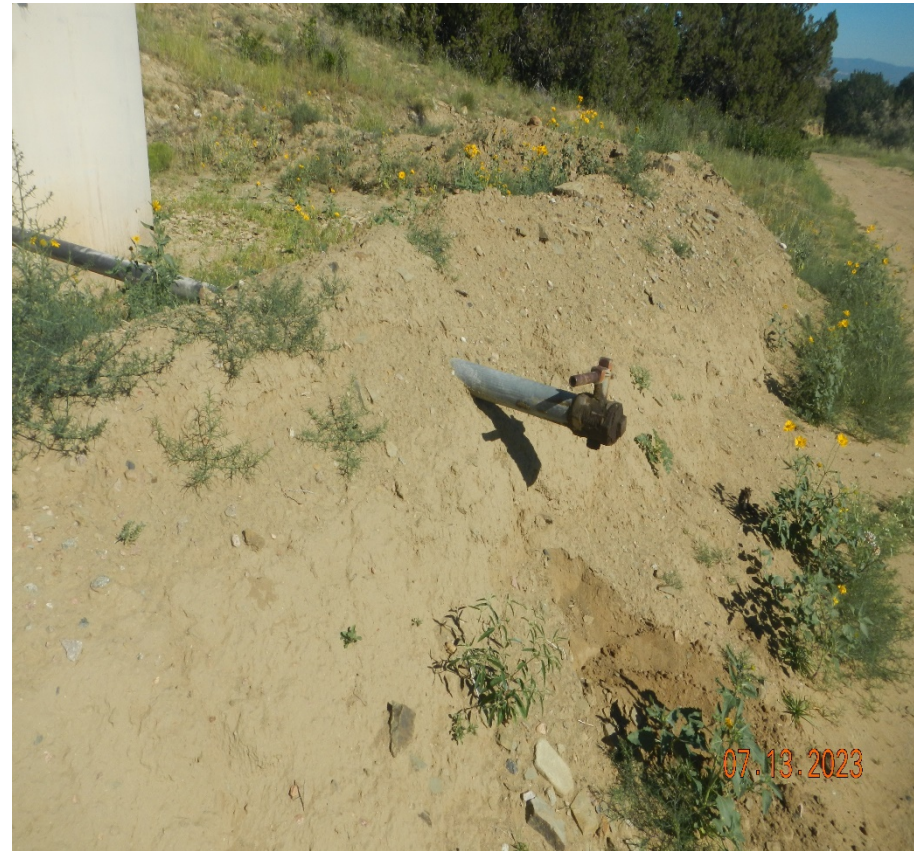
**Photo 9.** The oil stained soils were removed at the outlet since previous inspection.

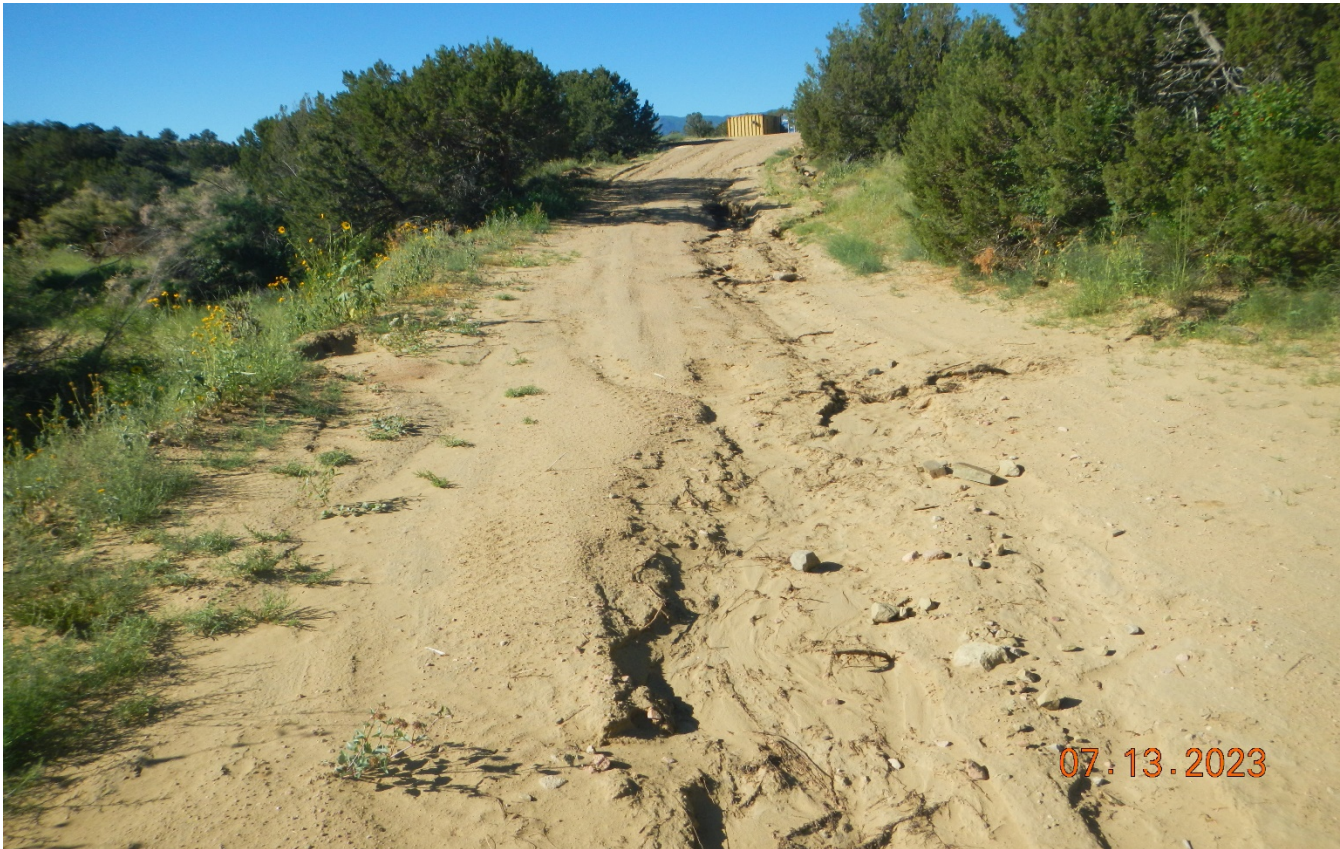
**Photo 10.** Facing south along the access road to the wellsite location. The road was never stabilized with BMP's and has continued to erode since previous inspection. .

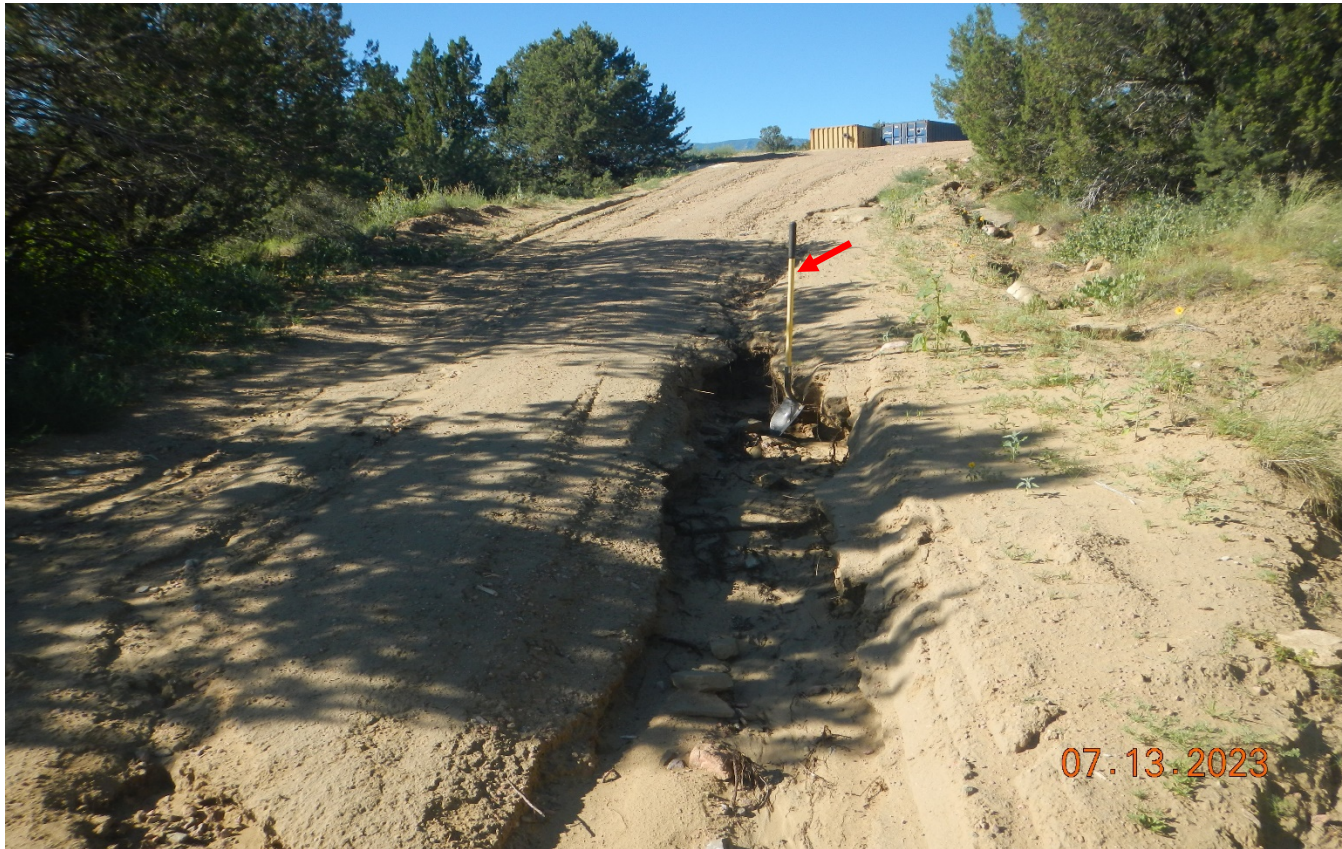
**Photo 11.** Facing south along the access road to the wellsite location. The road was never stabilized with BMP's and has continued to erode since previous inspection. Red arrow points to 4.5 ft. shovel for scale of erosion gully on the road.

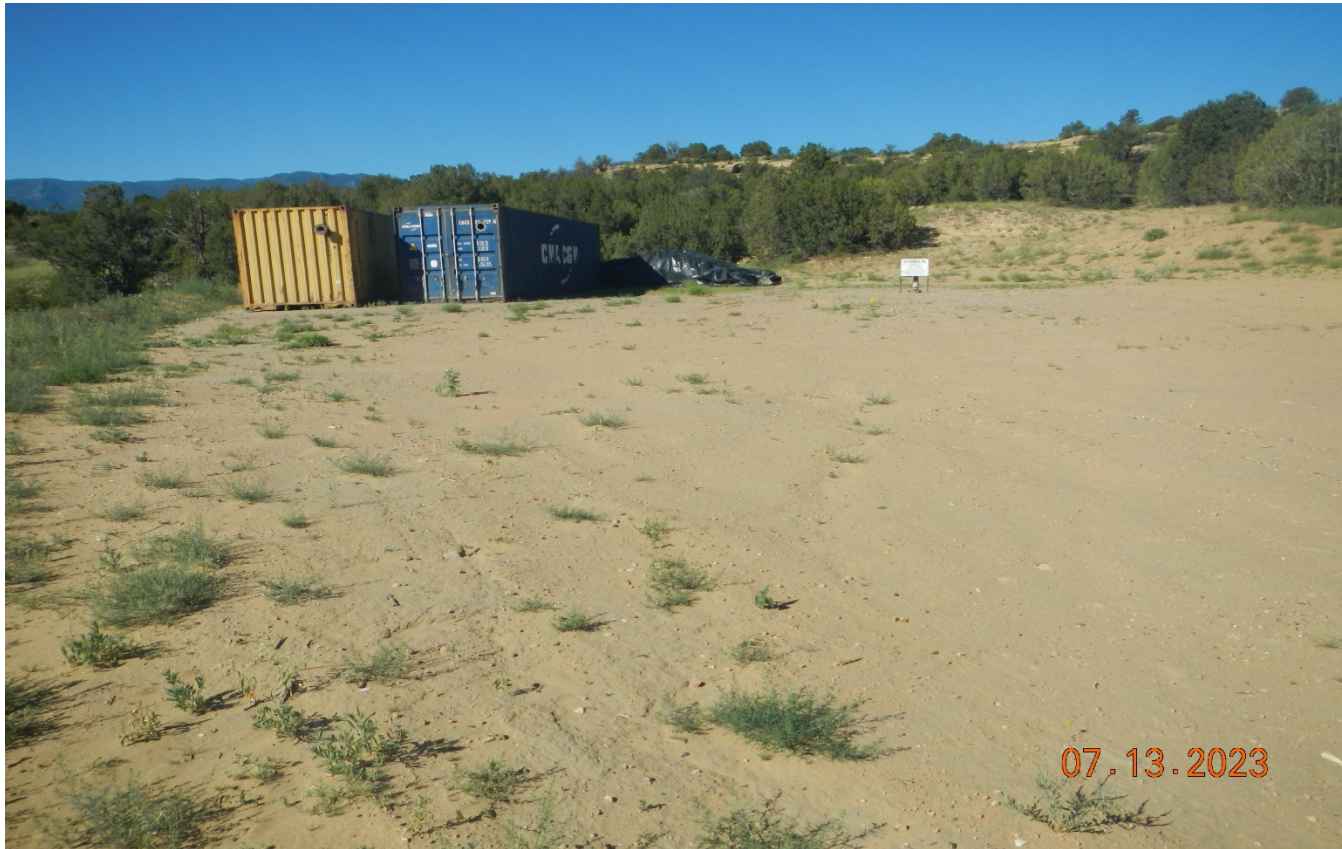
**Photo 12.** Facing southwest toward the well site. The drill rig has been removed since previous inspection however there is still equipment conex containers that need to be removed.

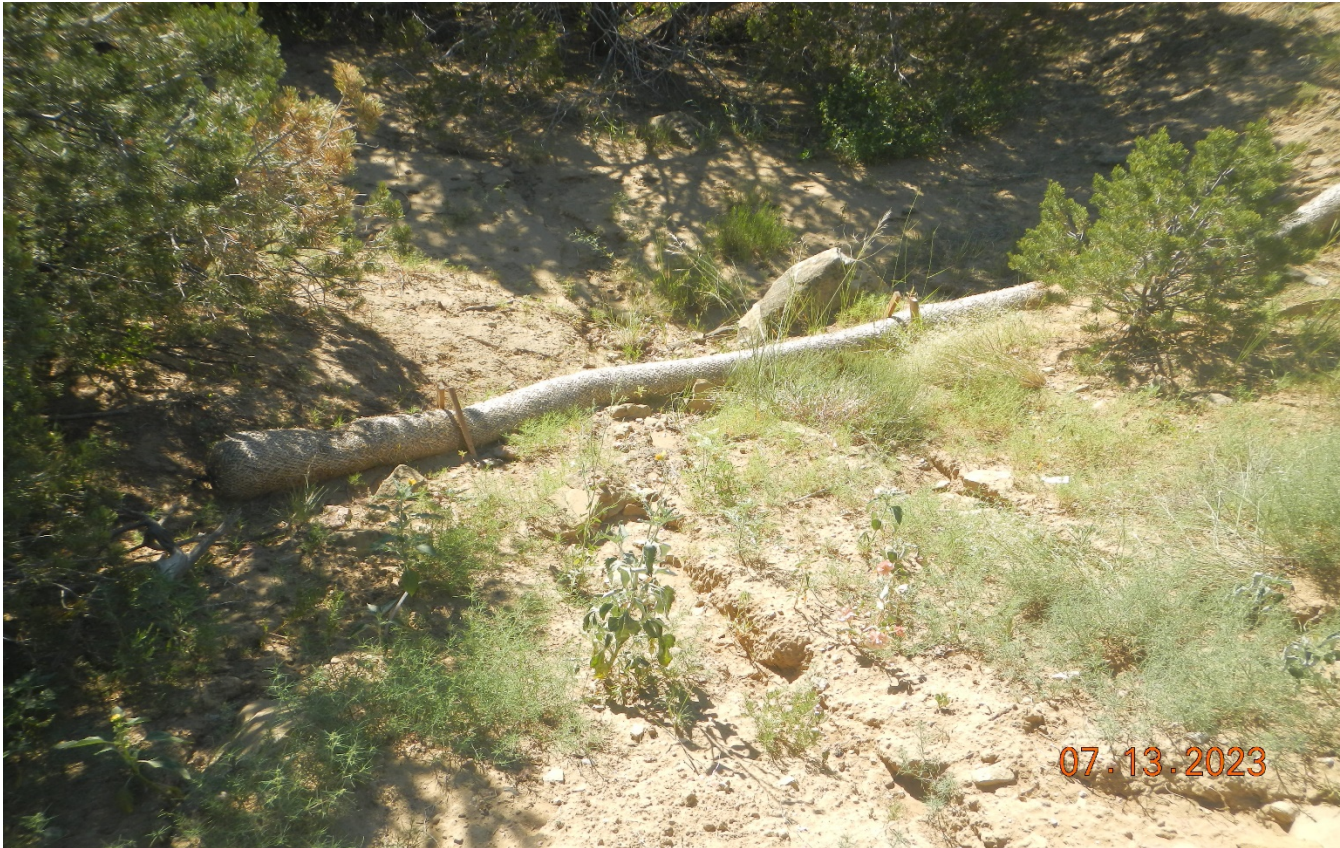
**Photo 13.** The wattles at the east perimeter were not properly installed and stormwater eroded underneath the wattles transporting sediment offsite. This issue still has not been fixed since previous inspection.

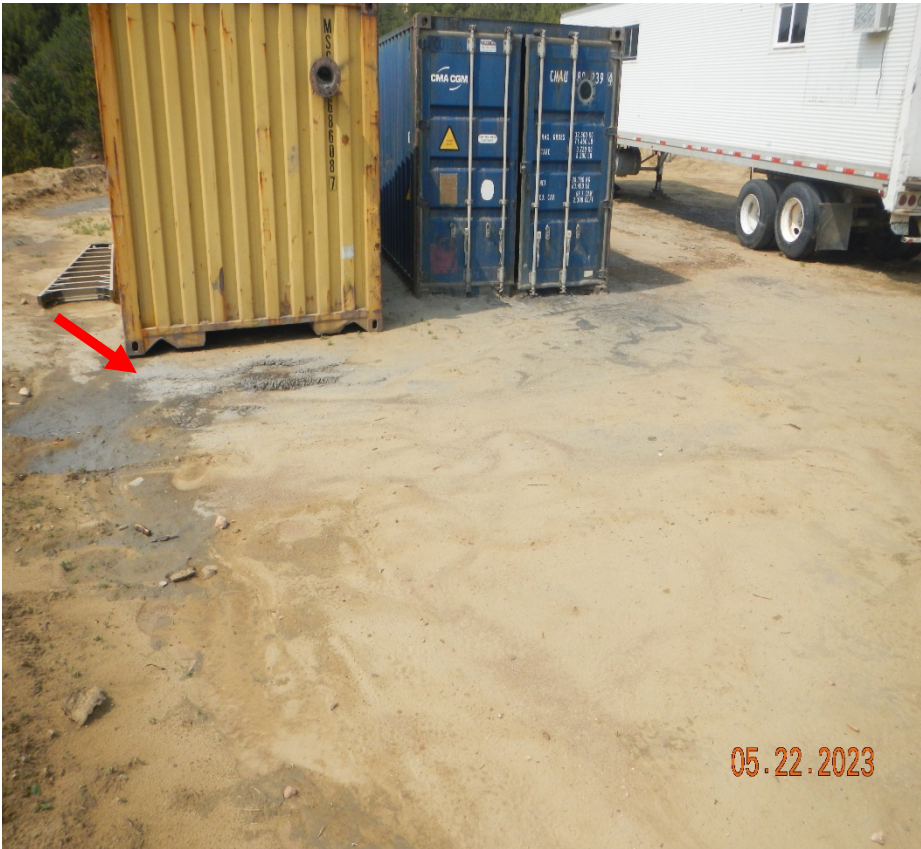
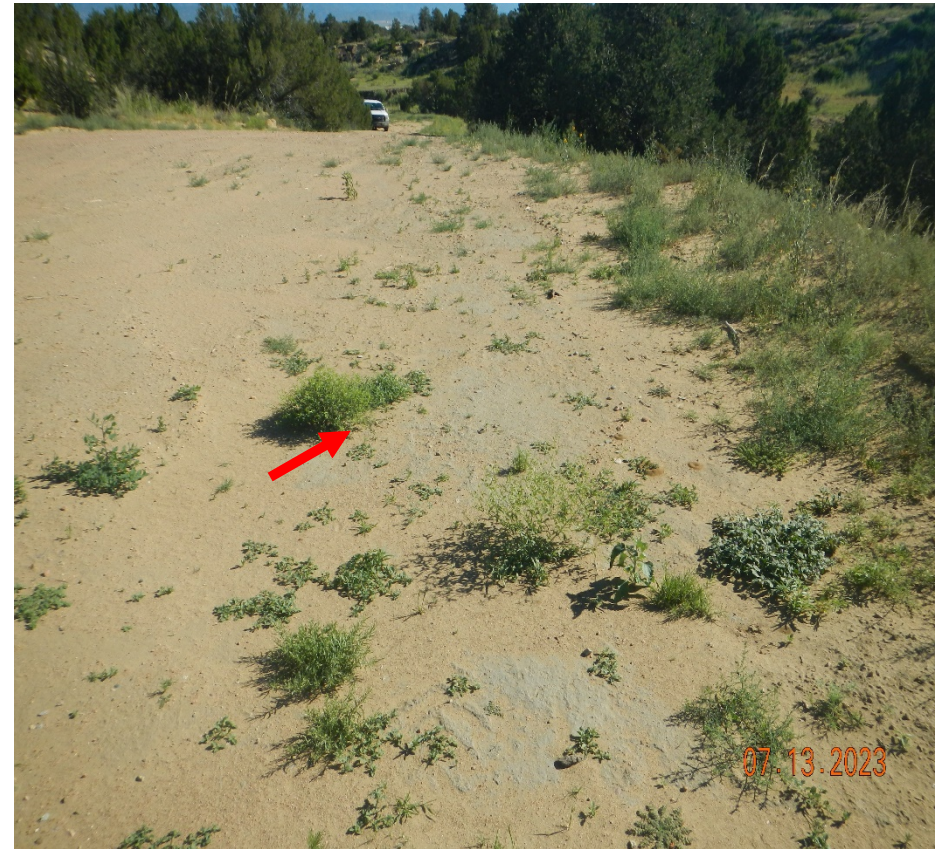
**Photo14&15.** There is gray cuttings material at the conex shown at the left photo which appears to have washed northeast along the pad shown at the right photo.

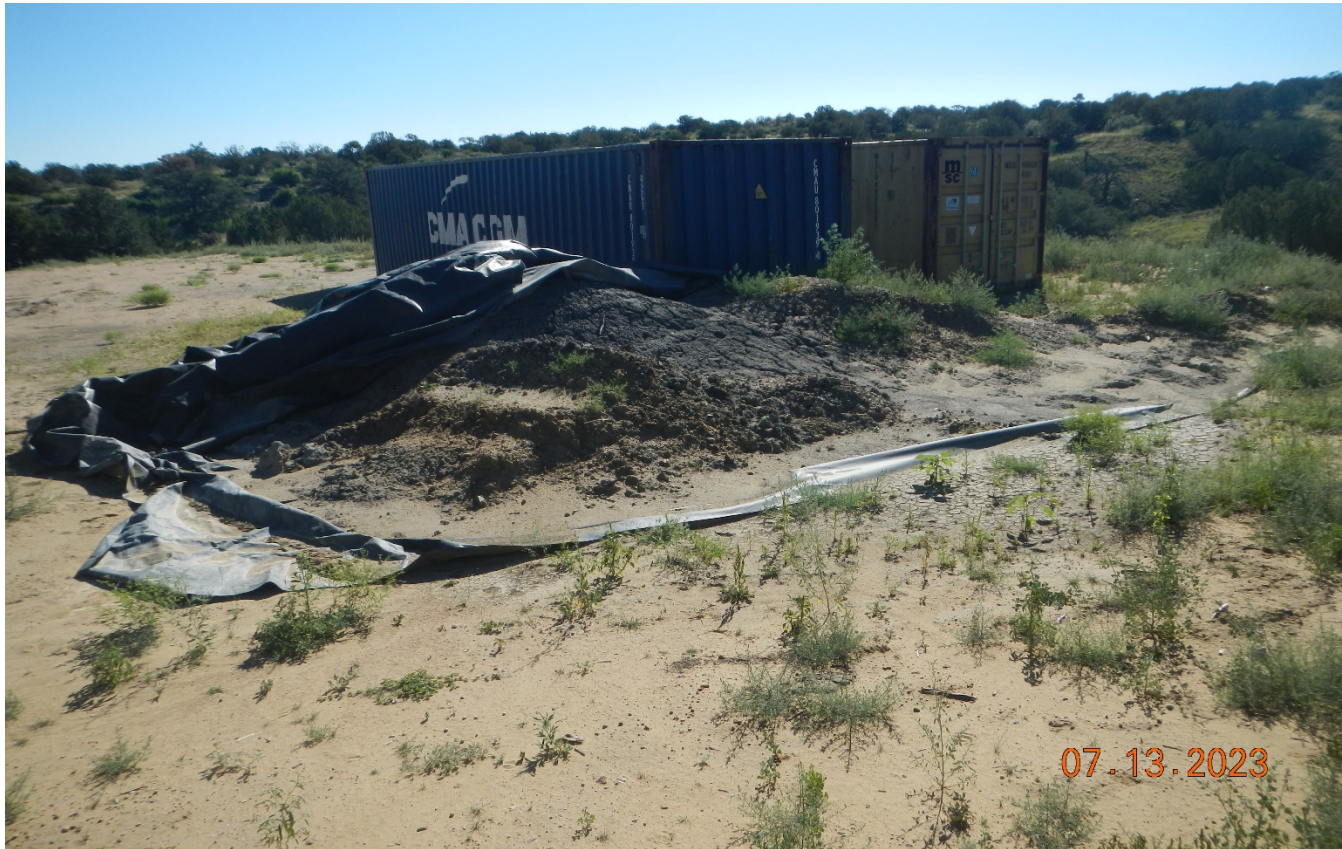
**Photo 16.** There is drill cuttings on the surface not properly stored and contained which is piled up behind the storage containers. The plastic liner does not contain the drill cutting and stormwater has transported the cutting off the liner toward the area shown in previous photos. Previous corrective action was not completed.

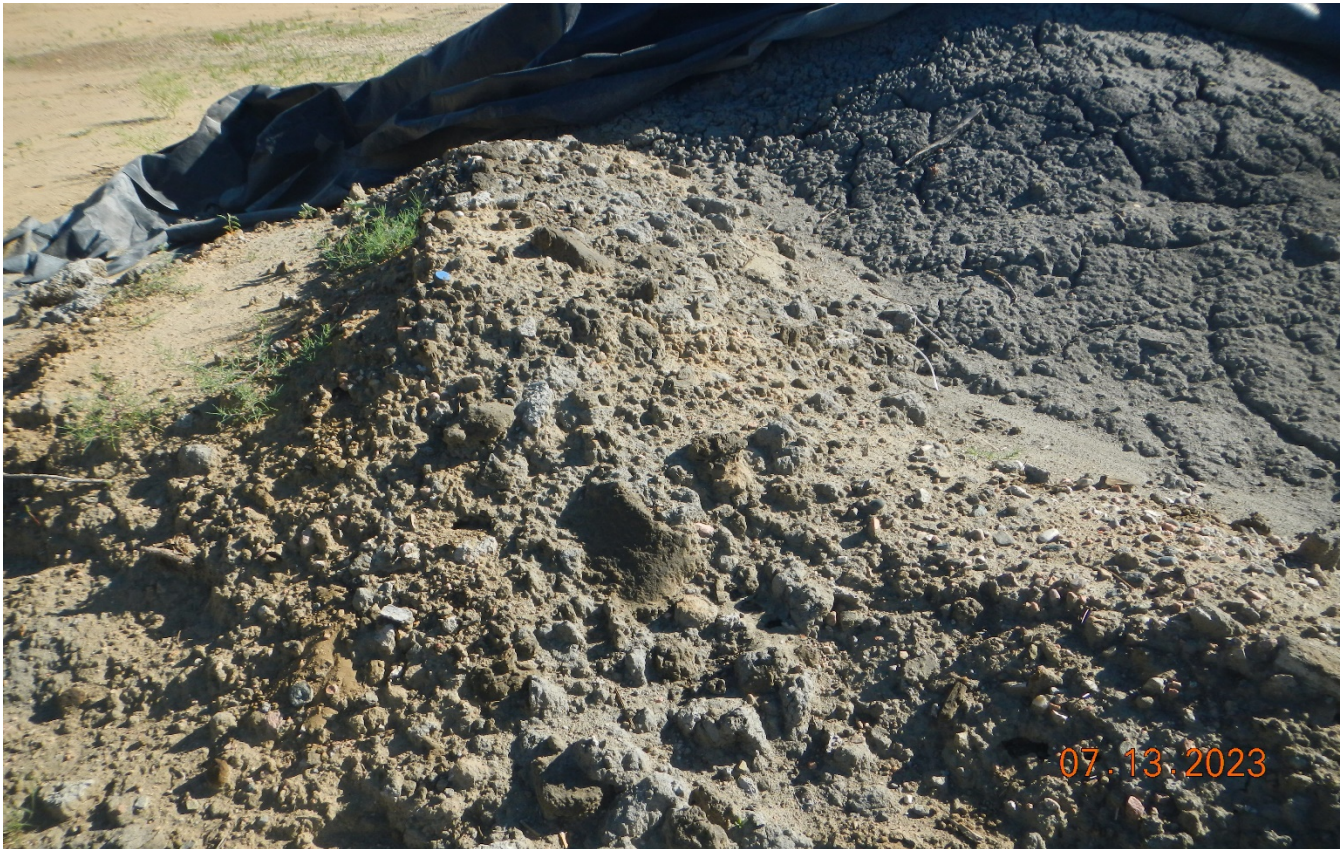
**Photo 17.** There is also oily soils that are mixed in with the drill cuttings. This was not previously observed and may have come from clean up of the oily soils at the tank battery. The E&P waste are not properly stored and contained.

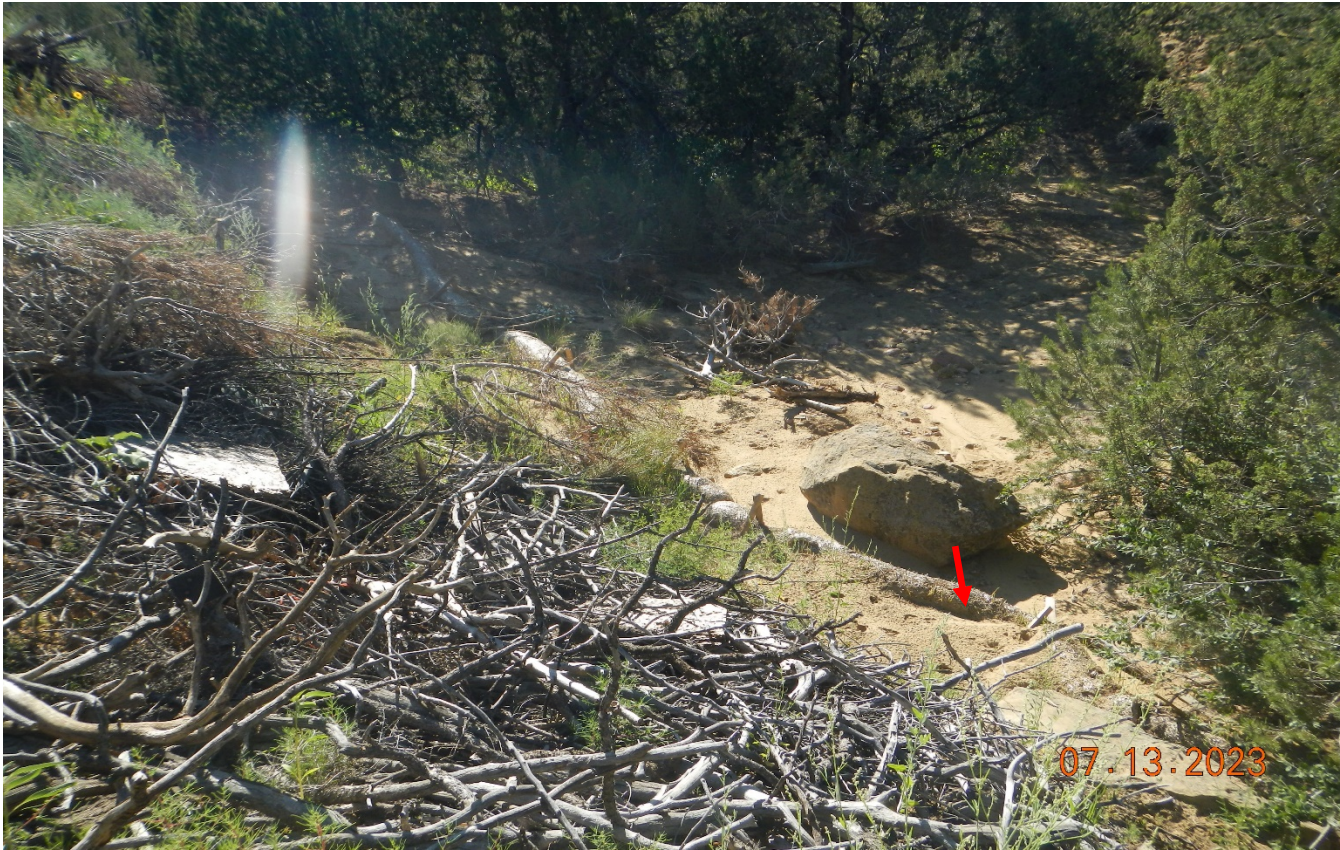
**Photo 18.** The wattles at the south side base of the fill slope have filled in with sediment and are not maintained. The wood debris dumped along the side of the fill slope has not been removed. Previous corrective action was not completed.

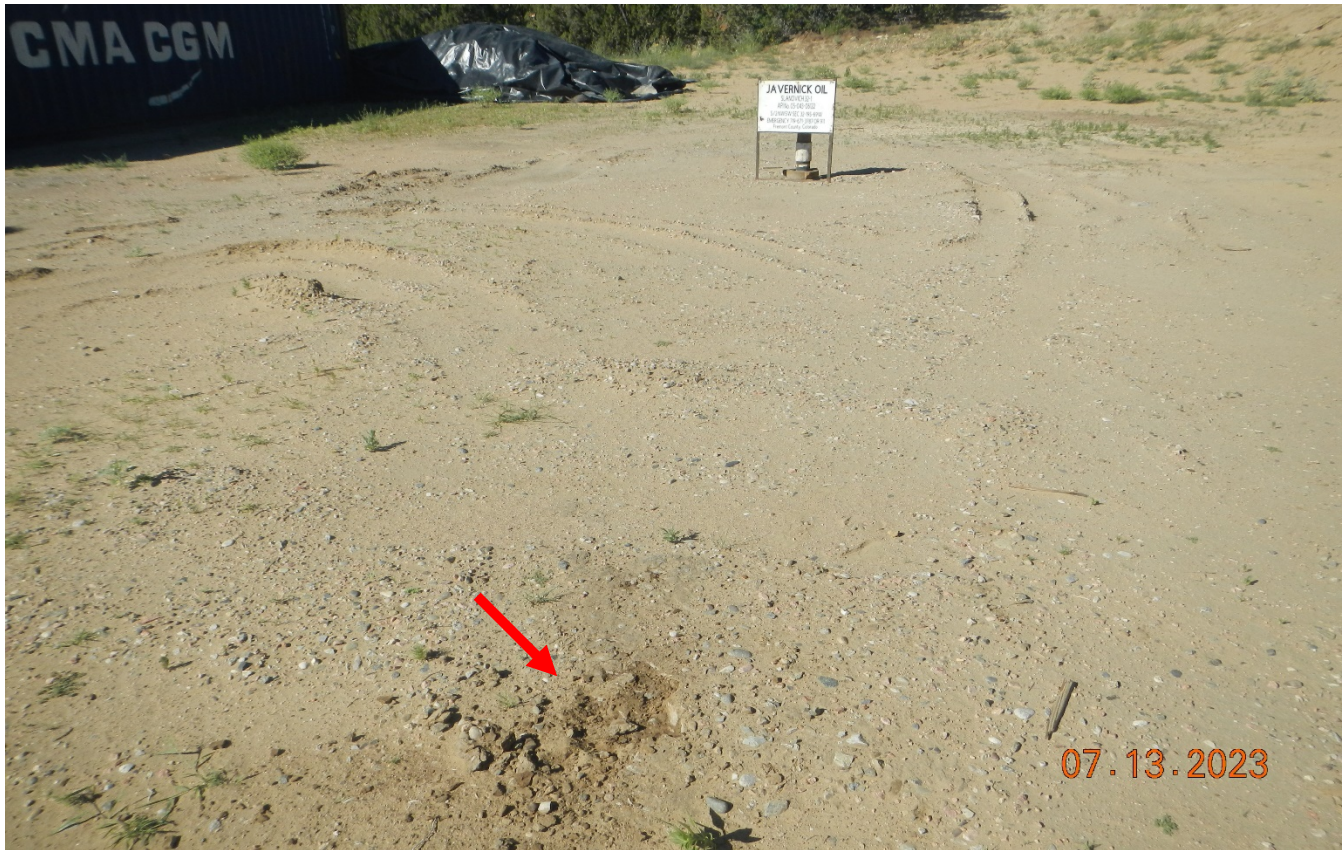
**Photo 19.** Facing southwest toward the wellsite. Sign is posted at the wellhead. The area at the red arrow has hardened oil stained soil from where the drilling rig was parked. Areas of contaminated soil must be cleaned up.

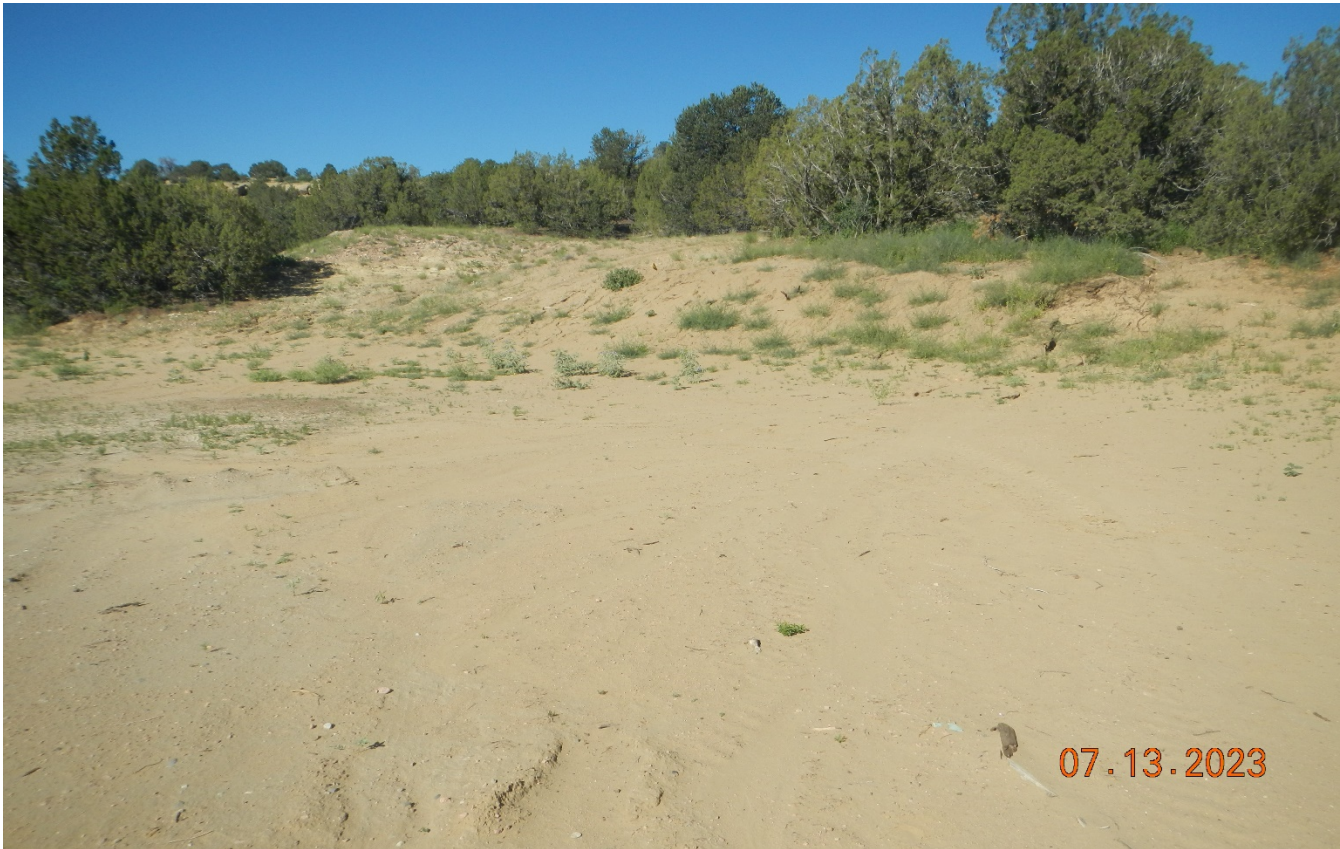
**Photo 20.** Facing southwest at the location. There are no stormwater run-on controls along the west side of the location. Recent storm event has caused erosion of the cut slope and stormwater was directed down the access road causing further erosion. Previous corrective action was not completed to install stormwater run-on controls.
