# Inspection Photos

API: 043-06122

Operator: JAVERNICK OIL

Inspection Date: 7/13/2023

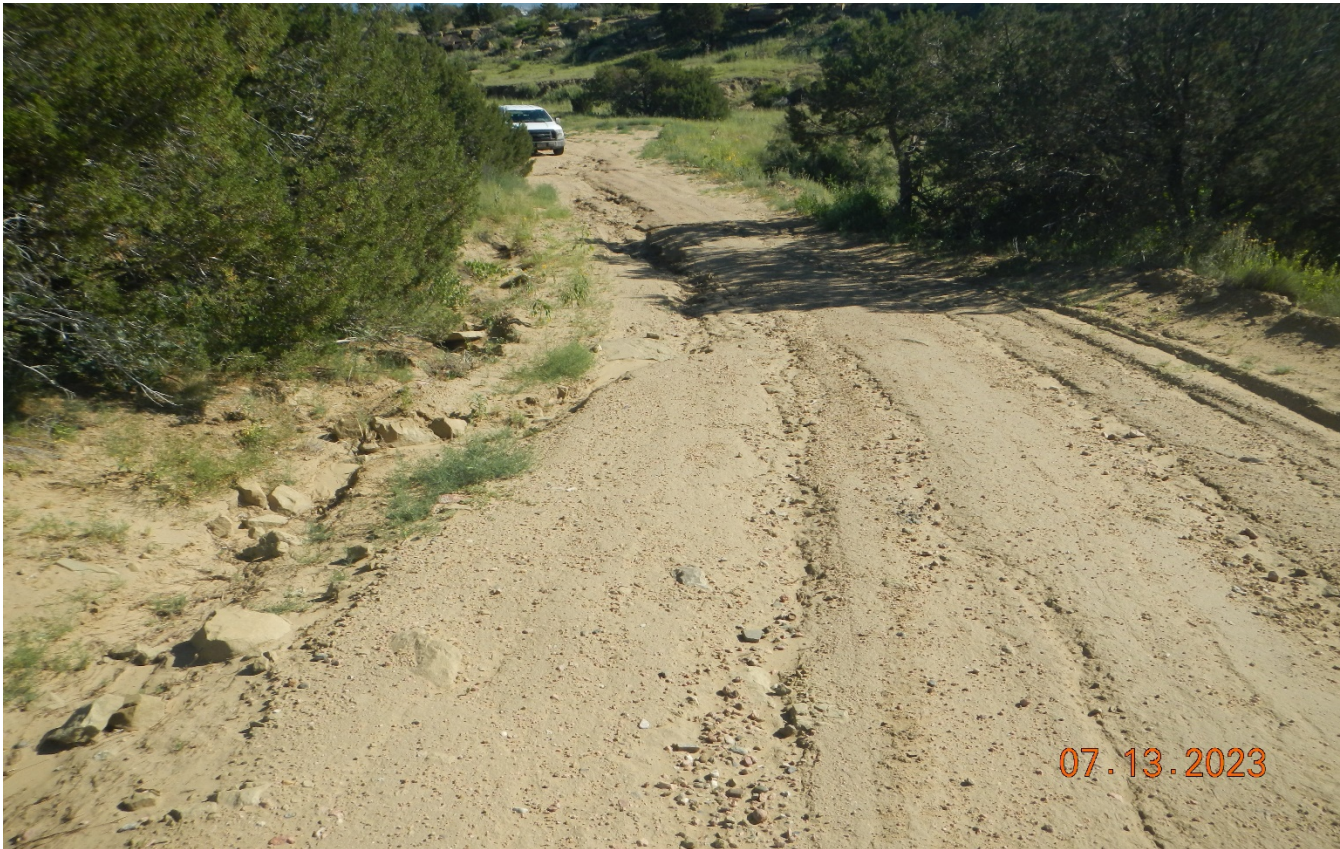
**Photo 21.** Facing back to the northeast toward the access road. Stormwater directed from the location shown in previous photo caused erosion of the access road which transported sediment off site.
