Inspection Photos

API: 043-06124

Operator: JAVERNICK OIL

Inspection Date: 7/13/2023

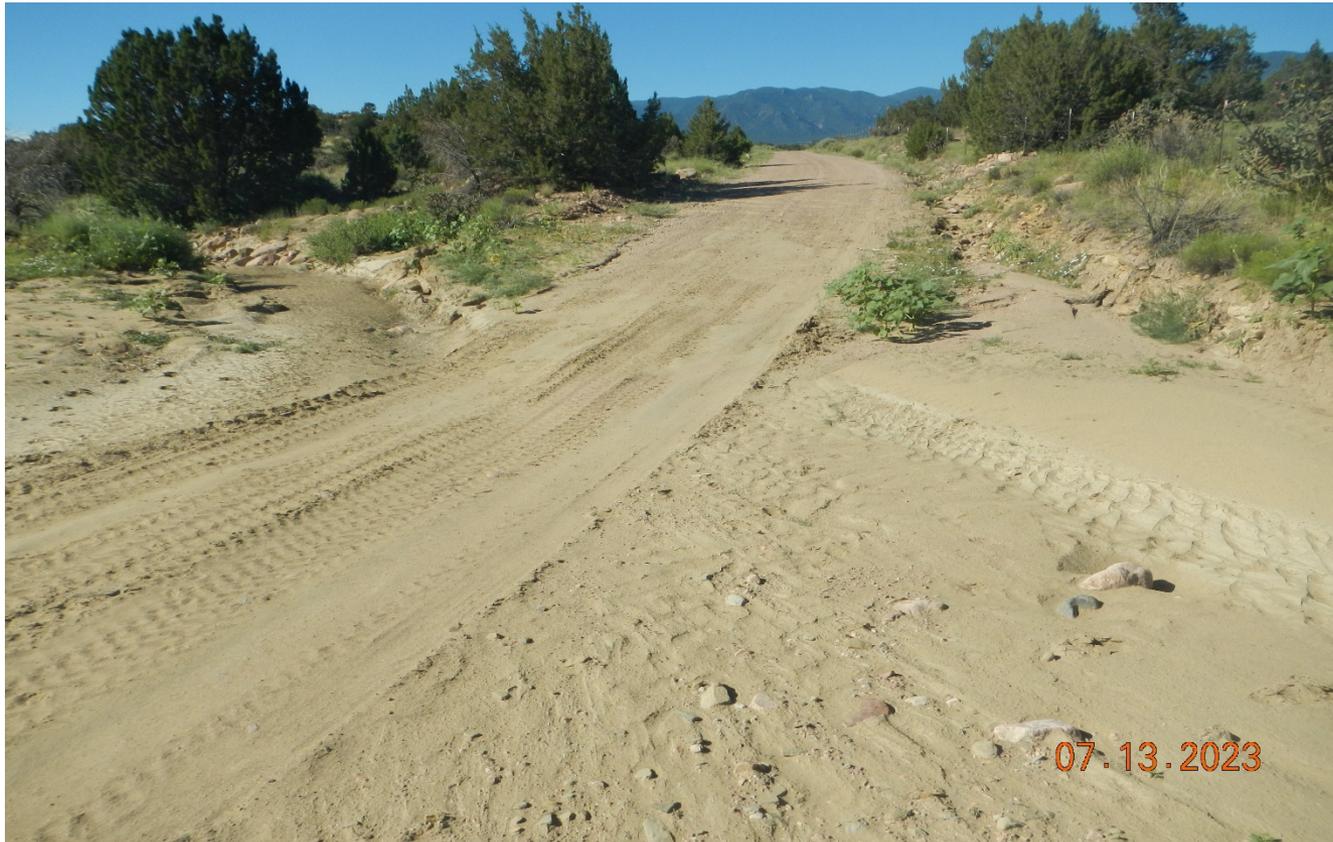
Photo 1. Facing south along the access road. There is erosion that occurred at the drainage crossing from recent storm event. The road has been washed out and needs to be repaired and BMP's need to be installed at the drainage crossing such as an adequately sized culvert. Previous corrective action was not completed.

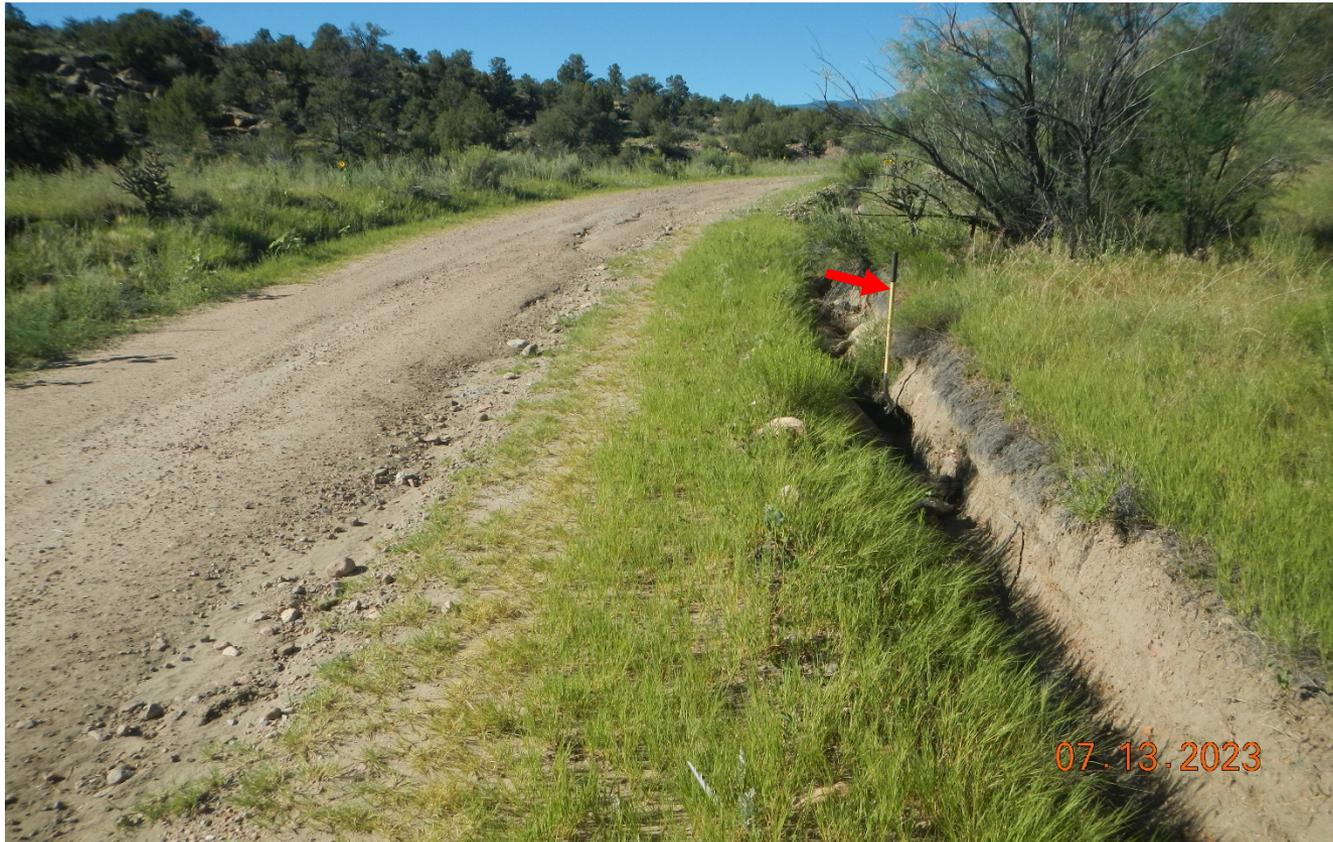
Photo 2. There is erosion along the road side that needs to be repaired and stabilized with BMP's. Red arrow points to 4.5' shovel for scale. There is a long stretch from this point further along the road with no culverts to divert stormwater off the road. Additional BMP's need to be installed along the road. Previous corrective action was not completed.

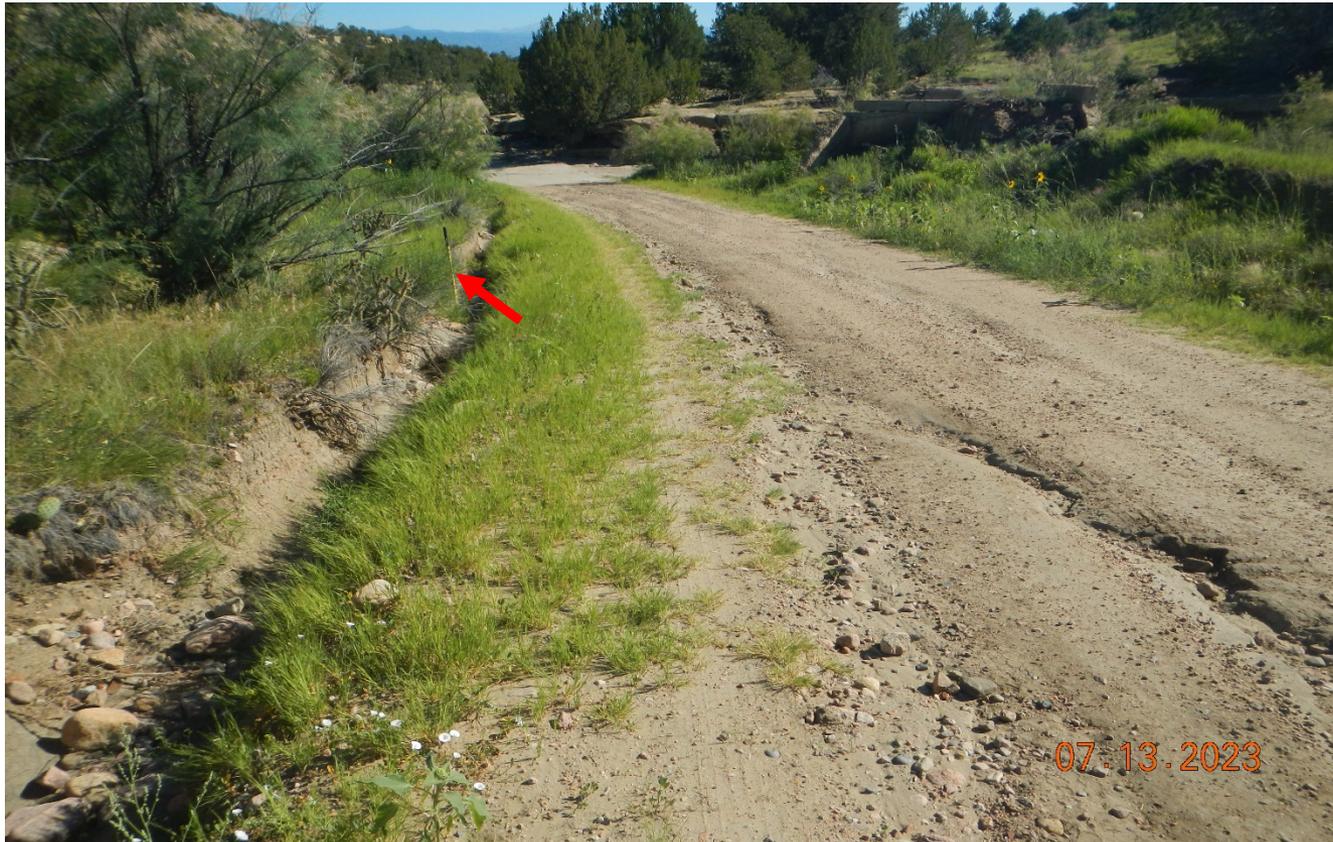
Photo 3. Facing back north at same area of erosion shown in previous photo. Stormwater and sediment is directed toward the creek drainage and needs to be repaired and stabilized to prevent erosion. Previous corrective action was not completed.

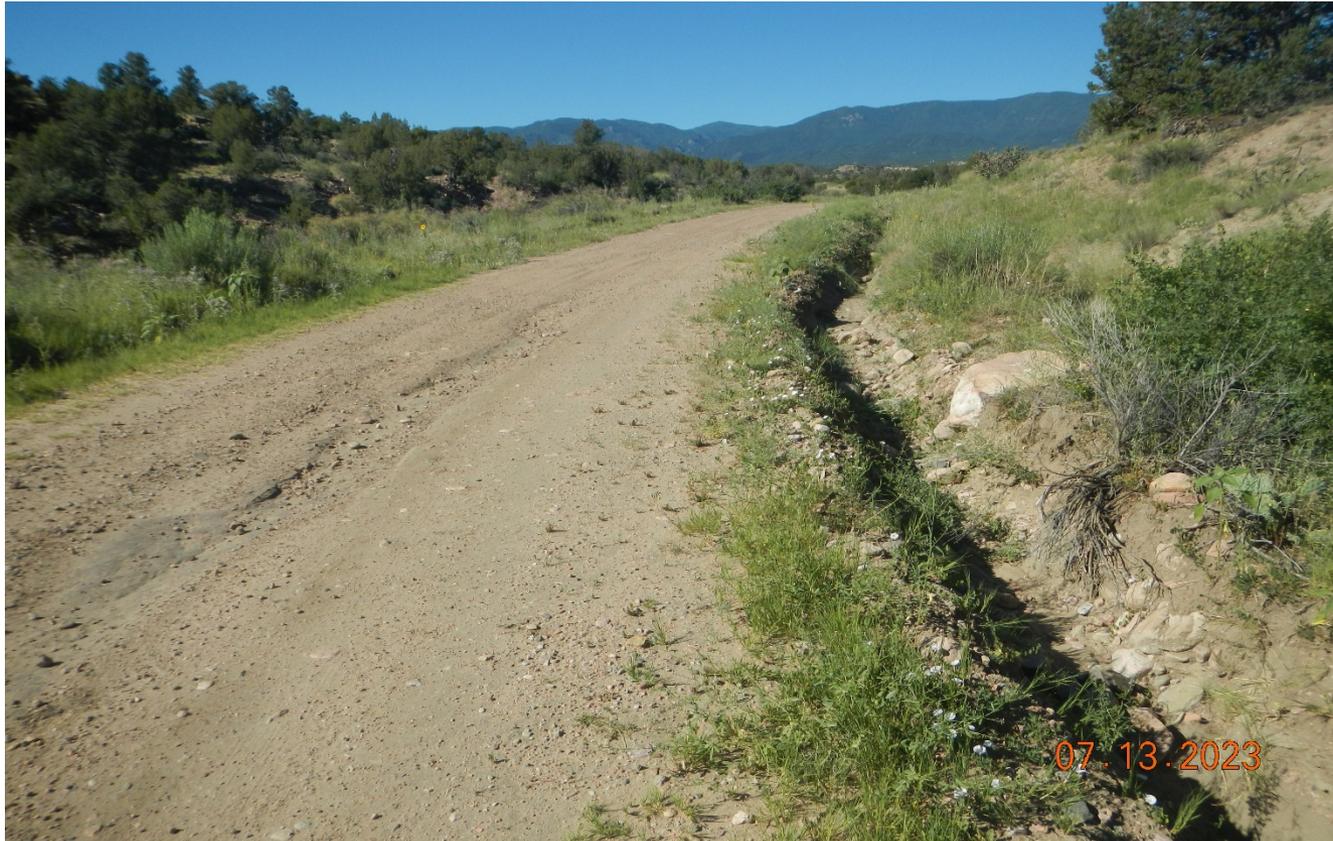
Photo 4. Further along the road is additional erosion on the road side that needs to be repaired and stabilized with BMP's. Previous corrective action was not completed.

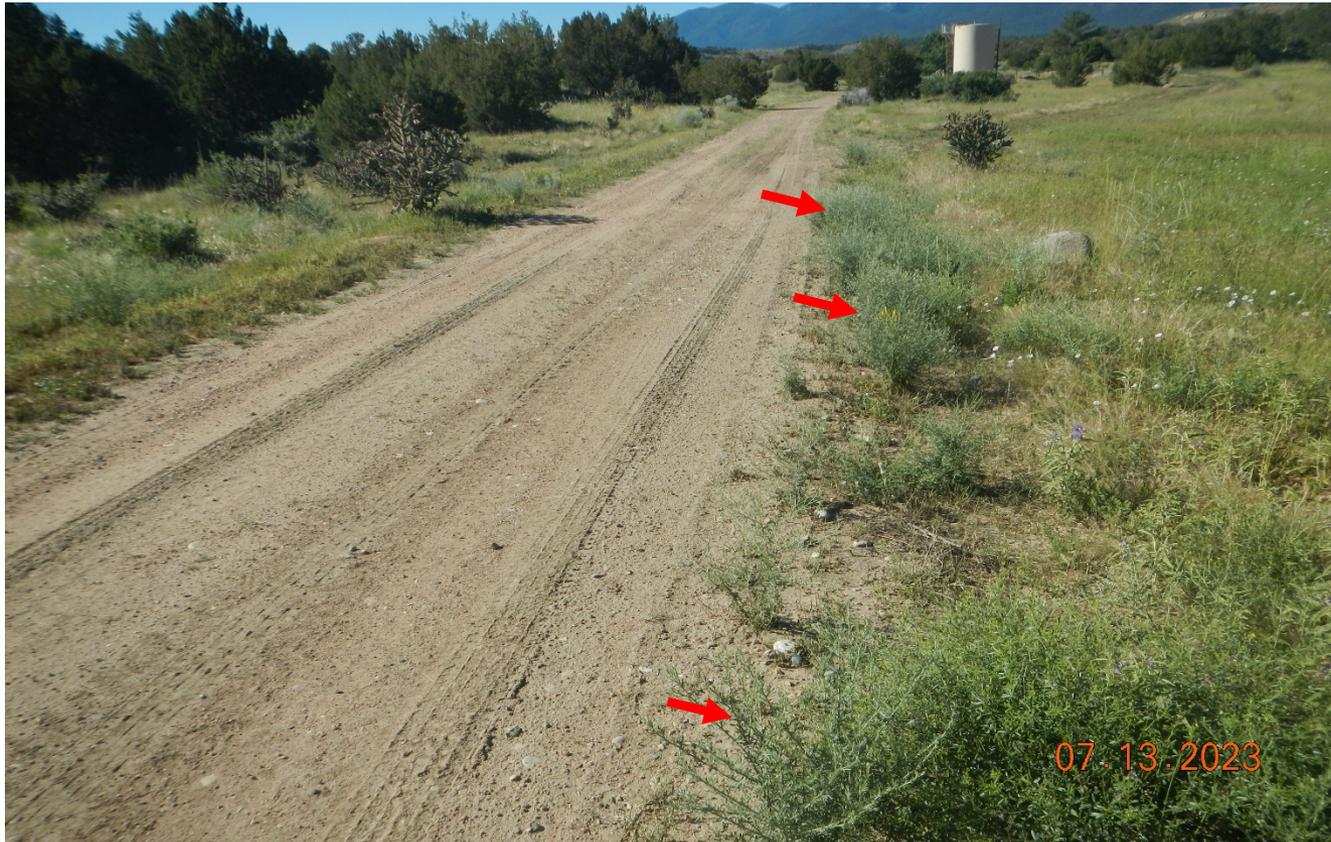
Photo 5. Facing south along the access road near the tank battery. There are List B noxious weeds along the is area of the road that need to be controlled. Red arrows points to Diffuse knapweed.

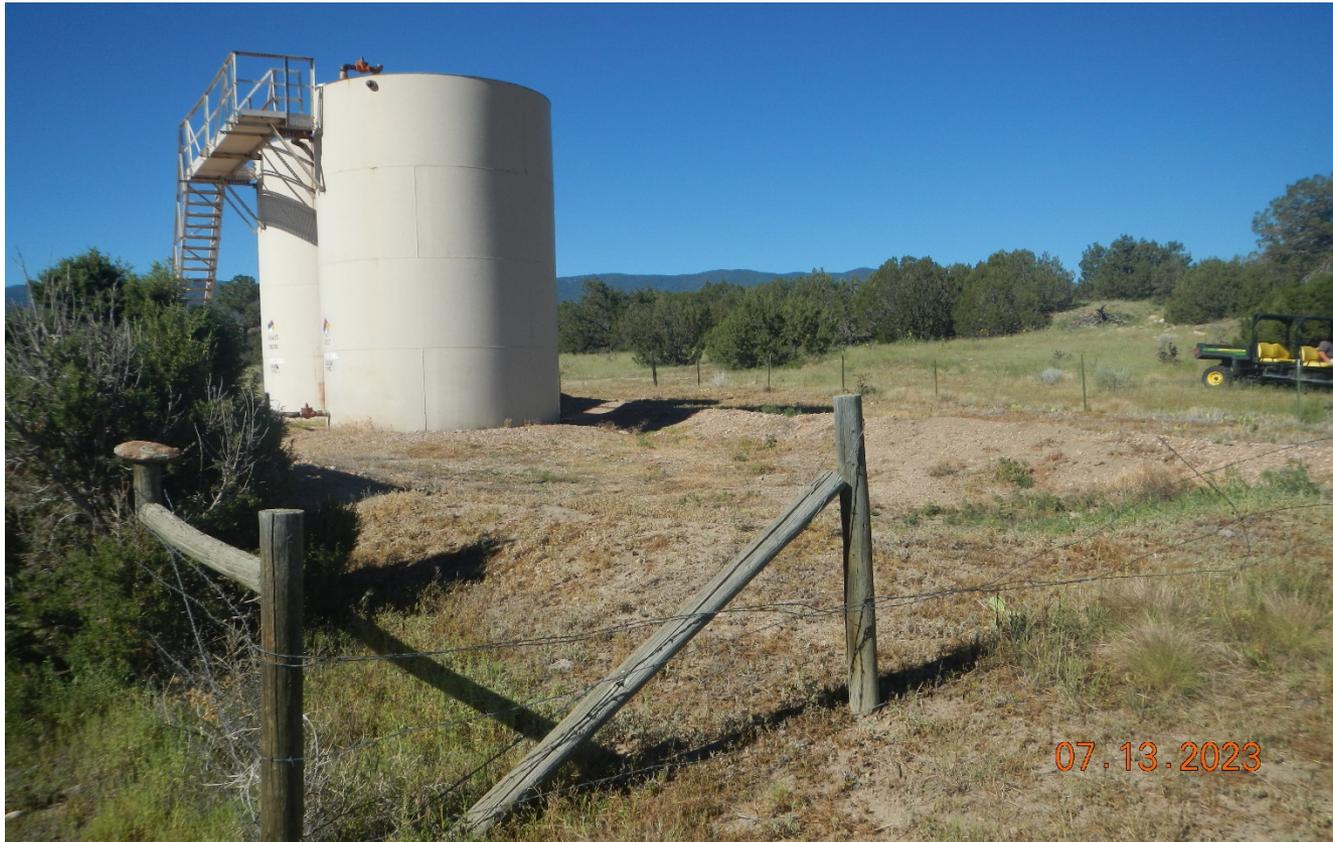
Photo 6. Facing southwest toward the tank battery. The fence around the tank is not maintained to prevent wildlife entry.

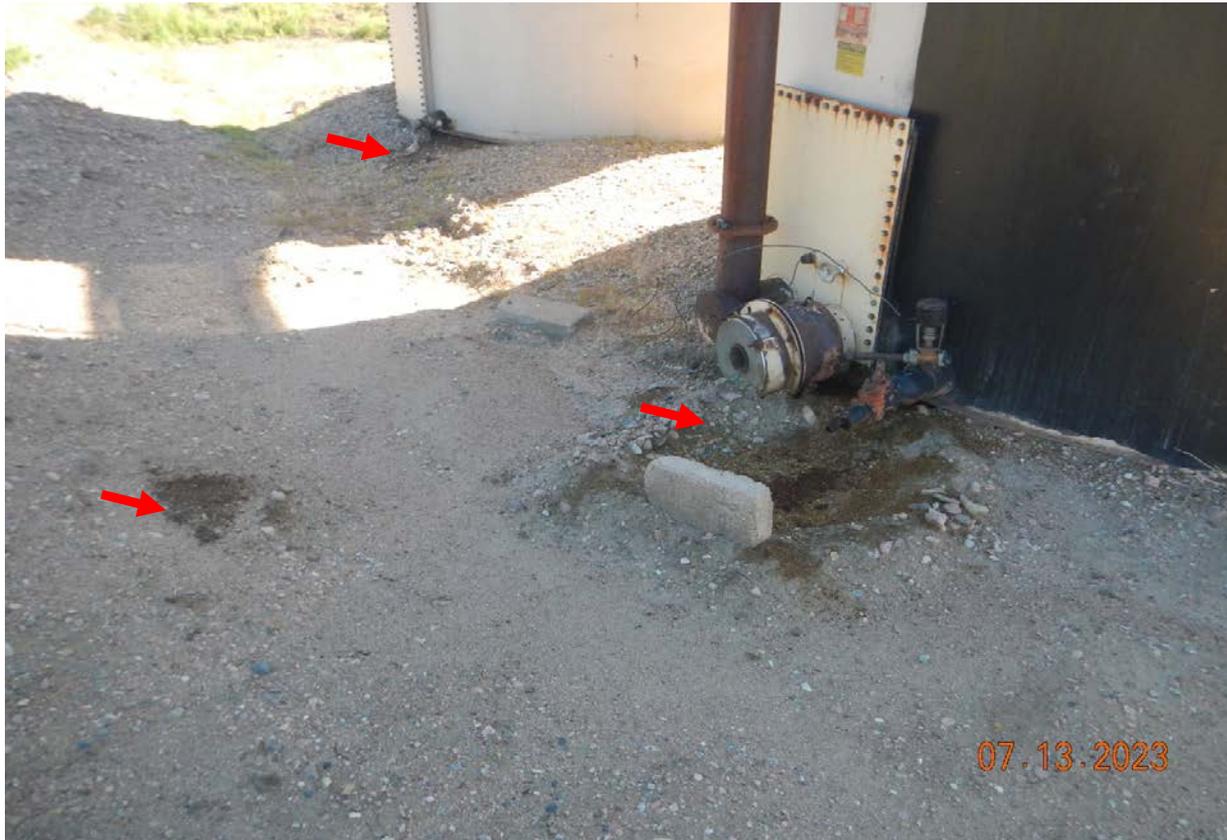
Photo 7. There is oil stained soils at back side of tanks shown at red arrows. Previous corrective action was not completed.

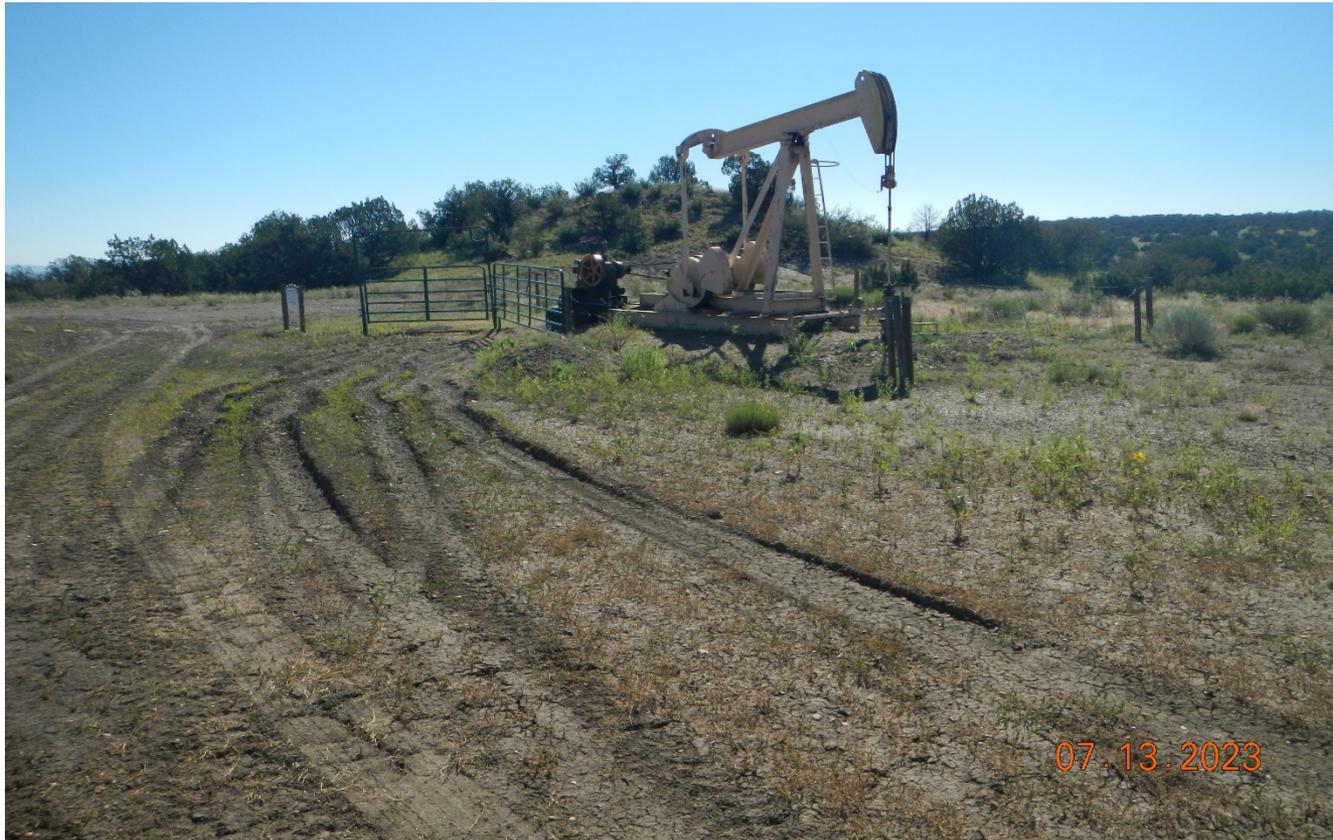
Photo 8. Facing northeast toward the wellsite. There is vehicle rutting at the location which is not stabilized. Previous corrective action was not completed.
