# Inspection Photos

Loc: 429093

Operator: AUSCO PETROLEUM INC

Inspection Date: 7/13/2023

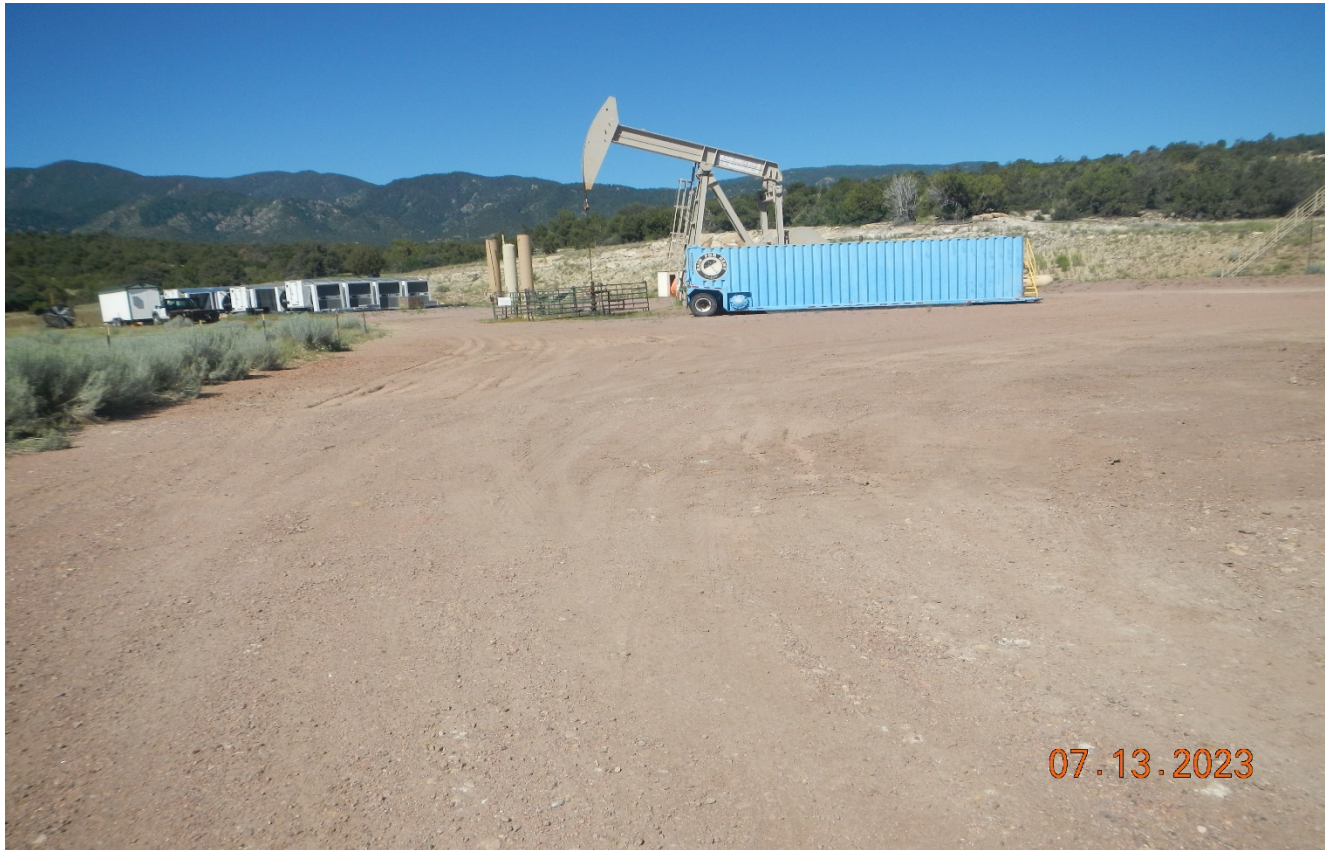
**Photo 1.** Facing southwest toward the location. The blue frac tank does not have secondary containment and needs to be removed. Previous corrective action was not completed.

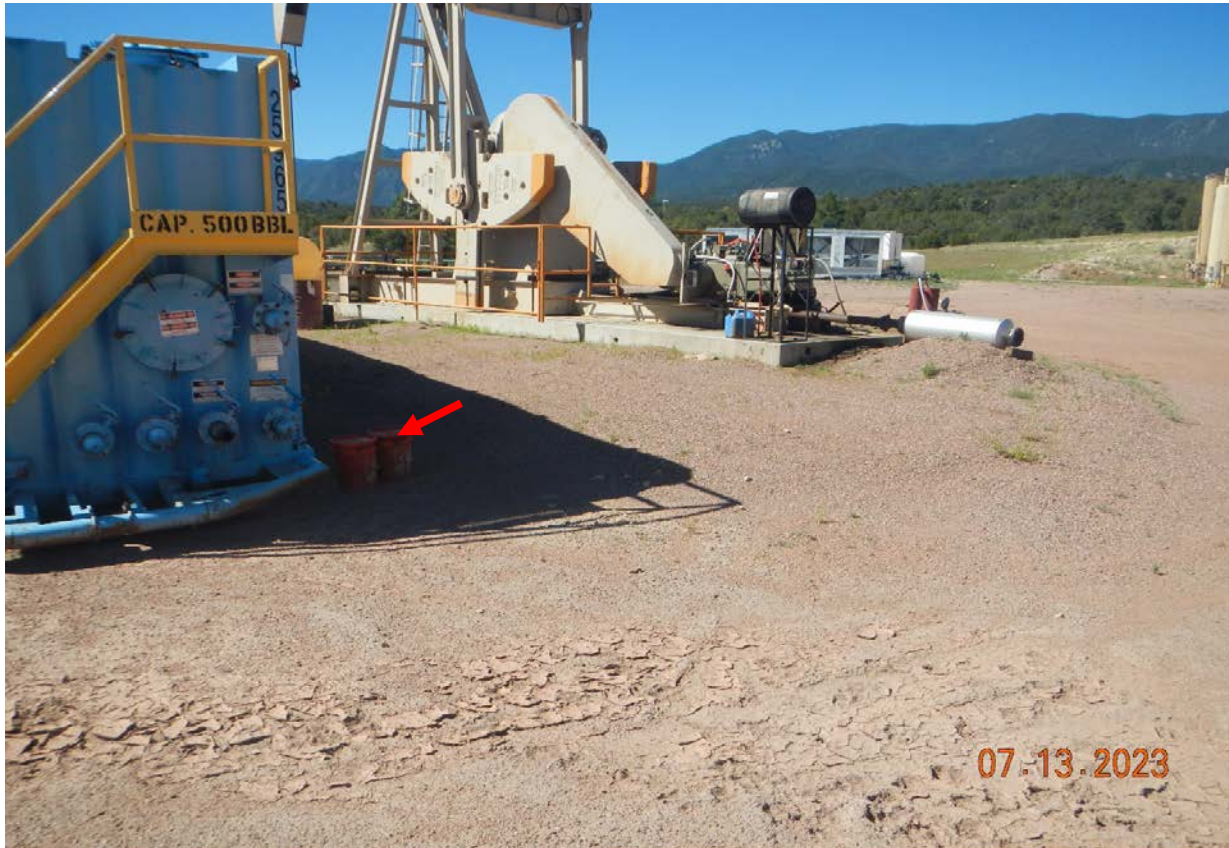
**Photo 2.** There are 2 orange buckets that appear to have oil with no labeling and no containment. Previous corrective action was not completed.

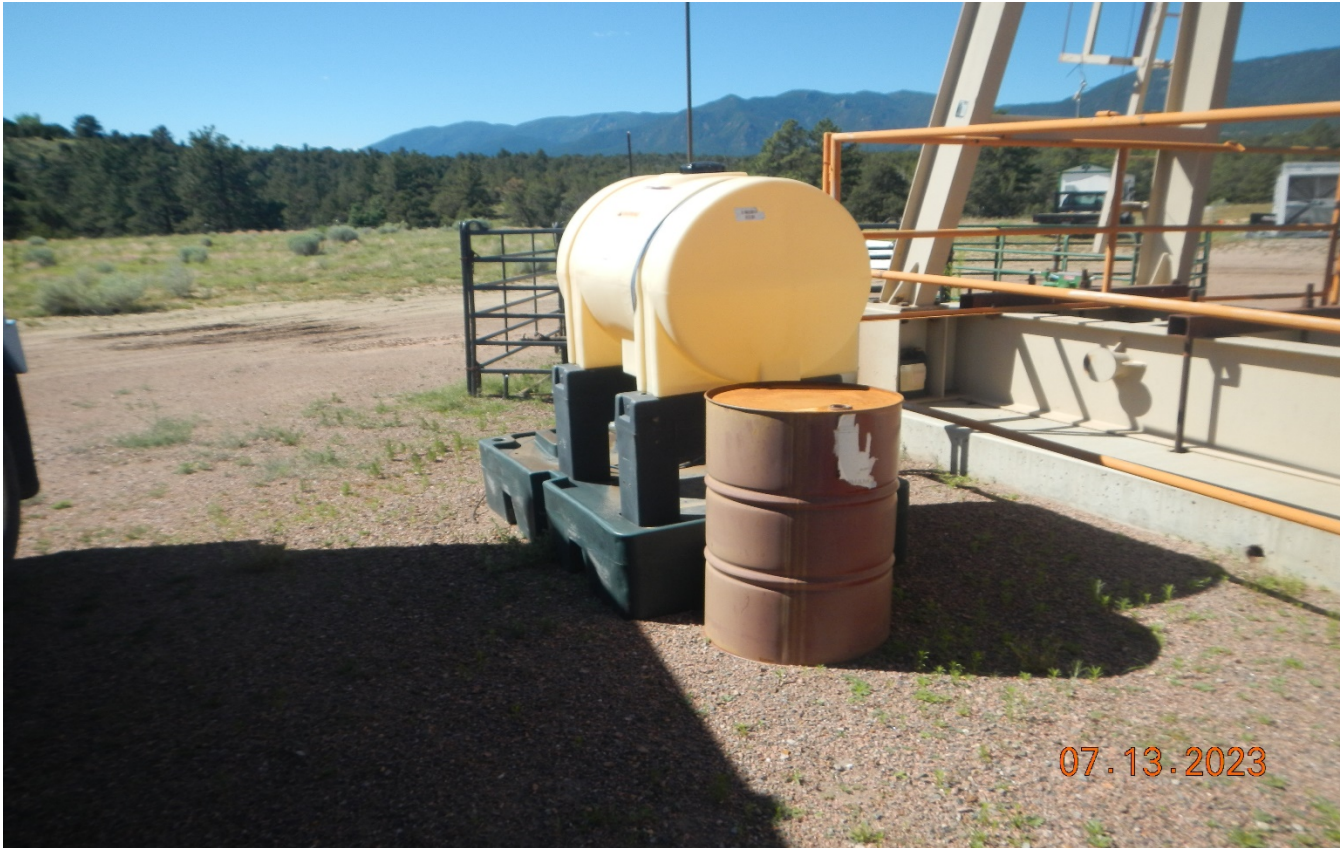
**Photo 3.** There is an unknown barrel with no labeling or containment. Previous corrective action was not completed.

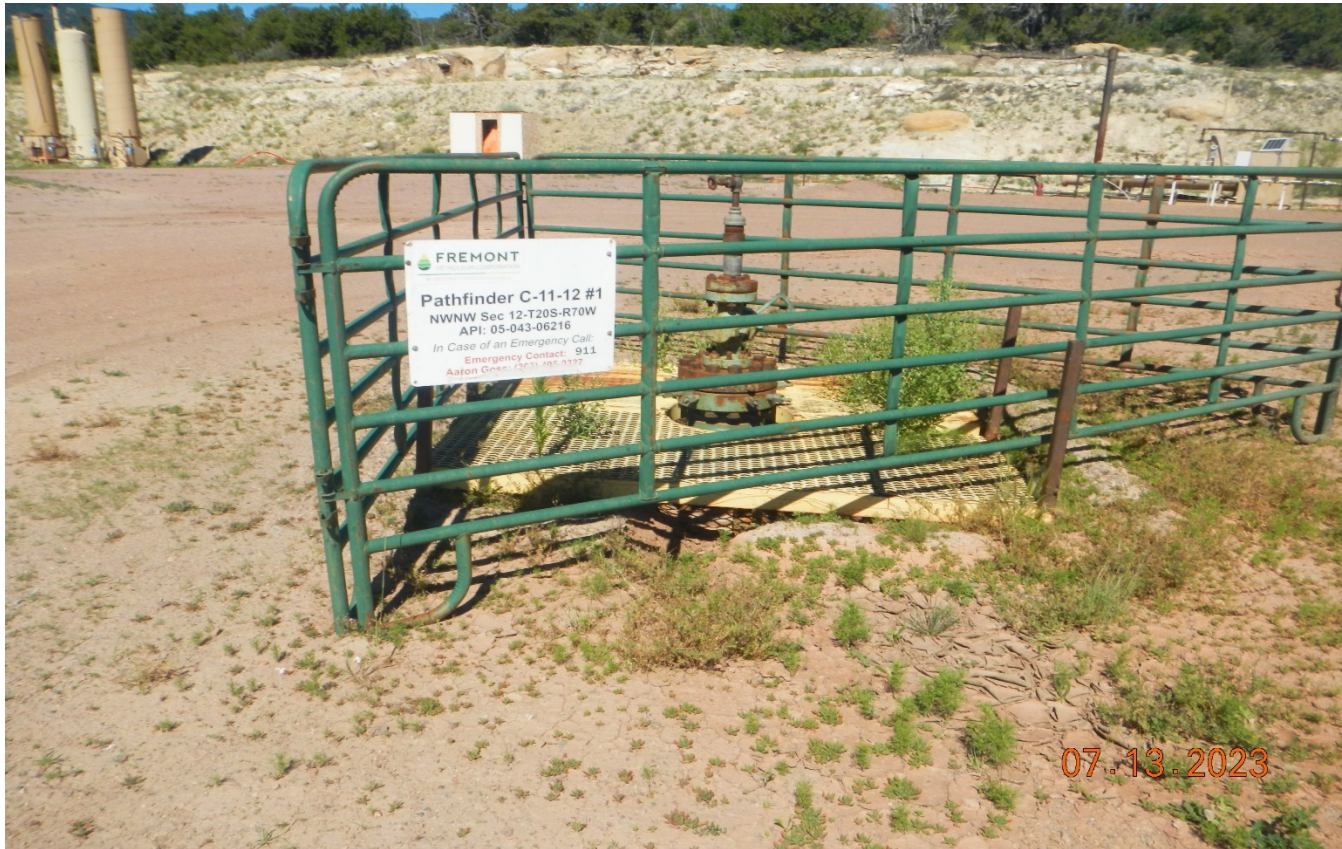
**Photo 4.** Well sign is posted at wellhead.

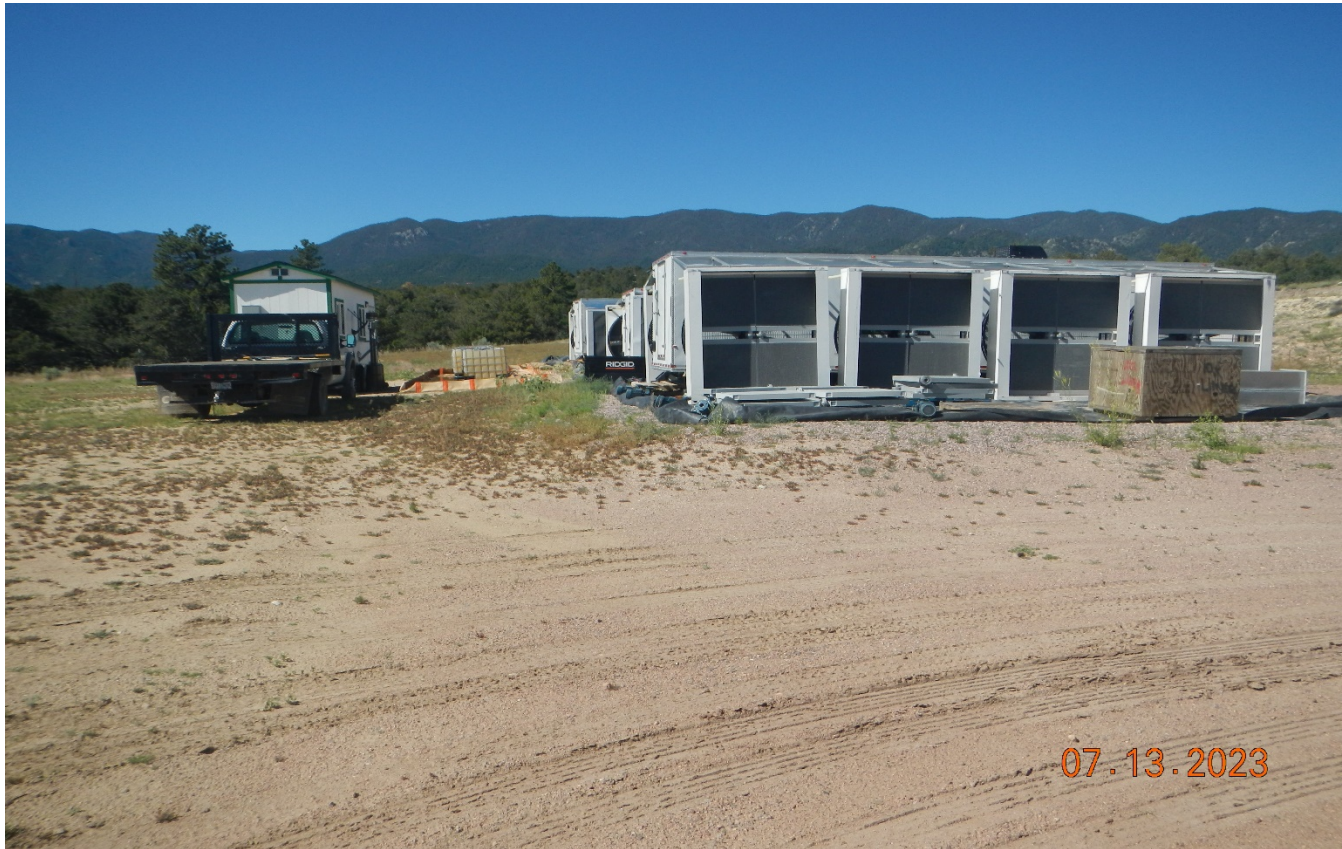
**Photo 5.** Facing southwest toward the bitcoin equipment which is not in operation.

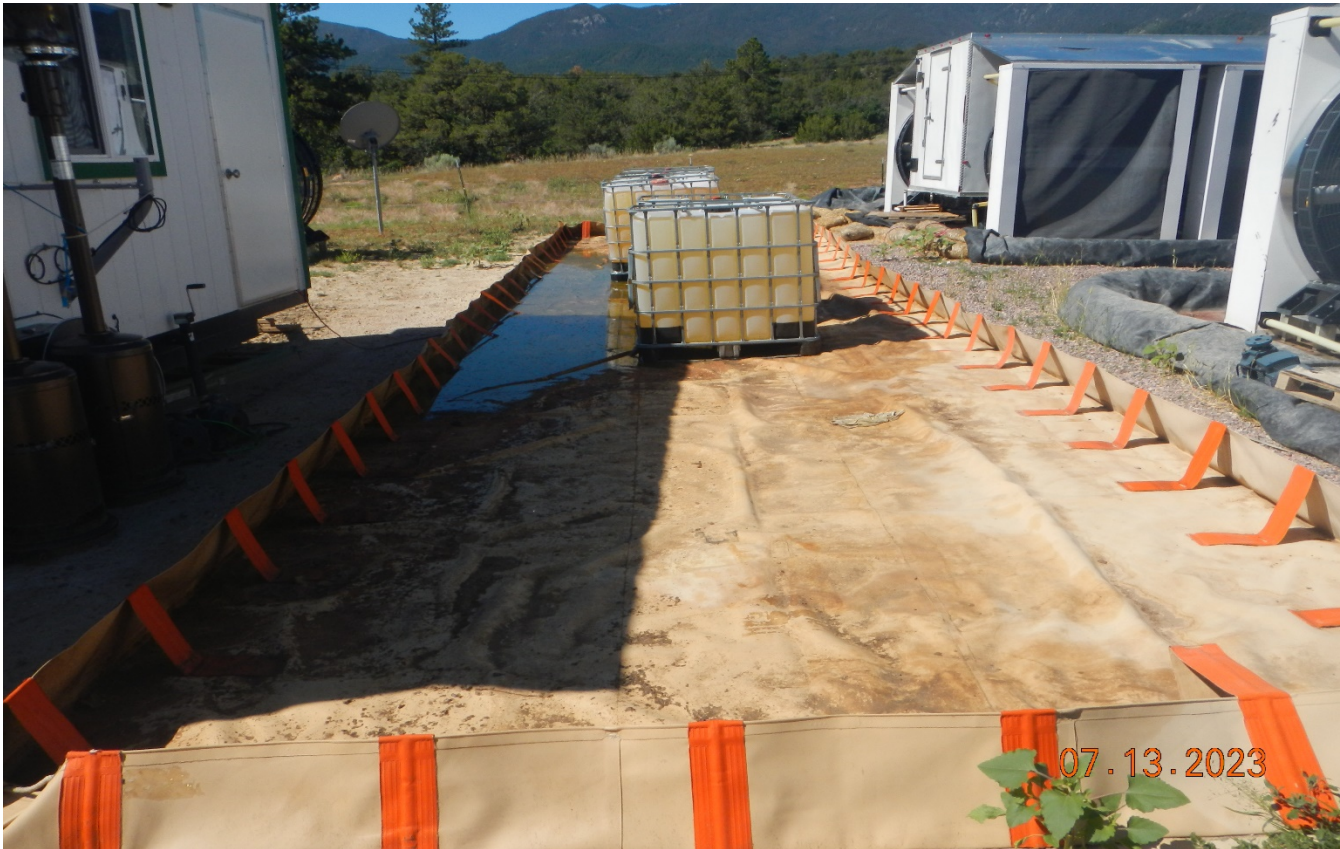
**Photo 6.** There is a portable secondary containment installed for the 2 chemical totes.

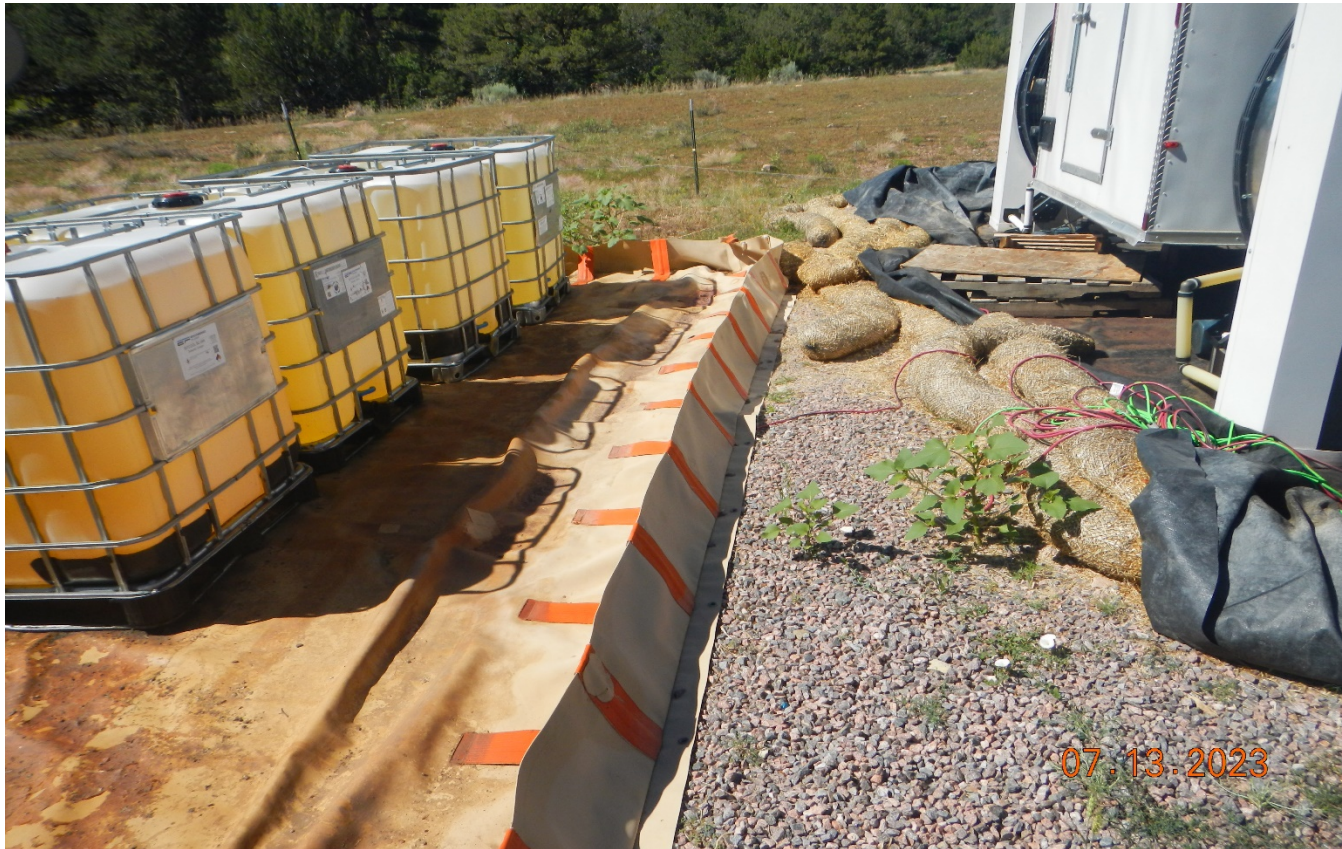
**Photo 7.** The plastic liner has become folded over needs to be repaired.

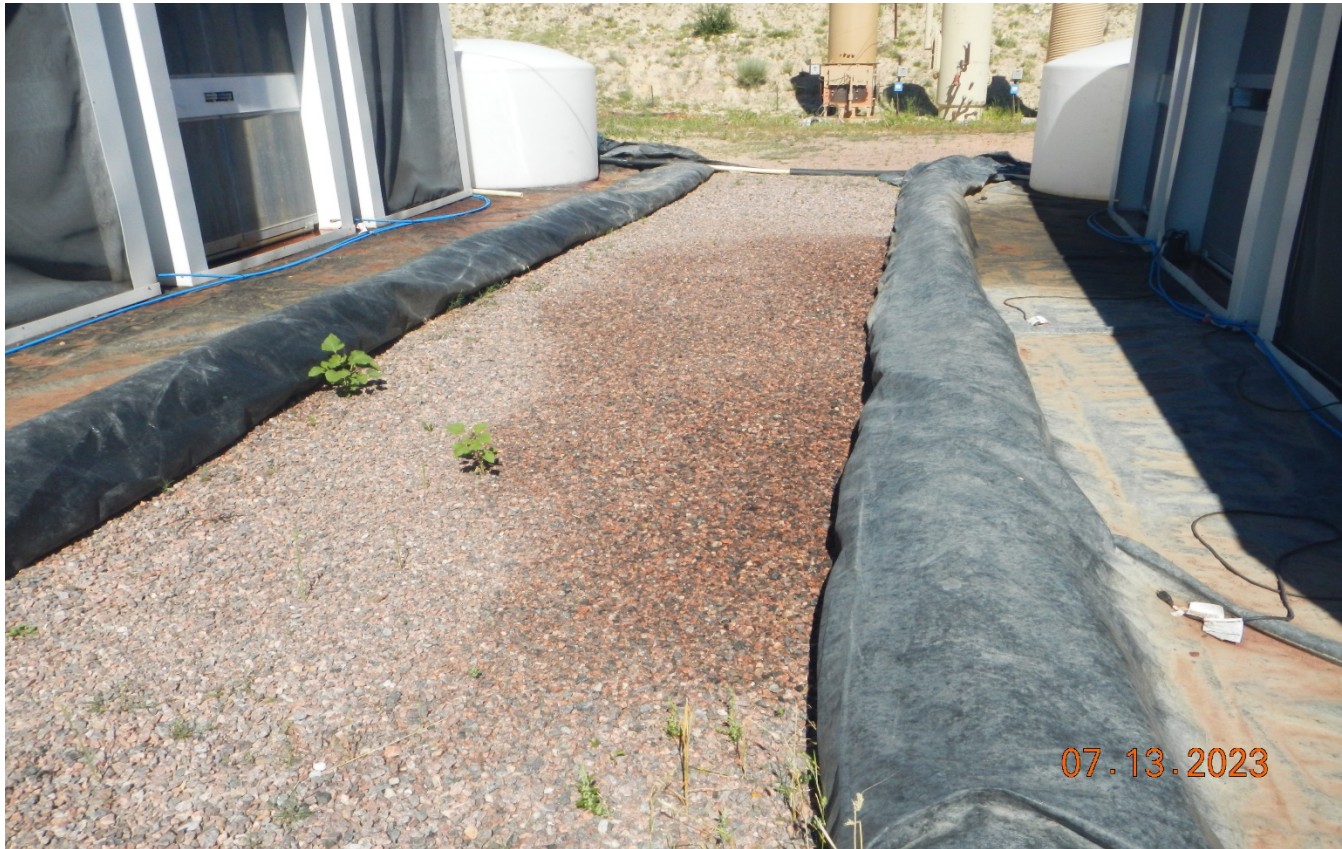
**Photo 8.** It appears in between the equipment there is darkened gravel from a possibly leak. Previous corrective action was not completed.

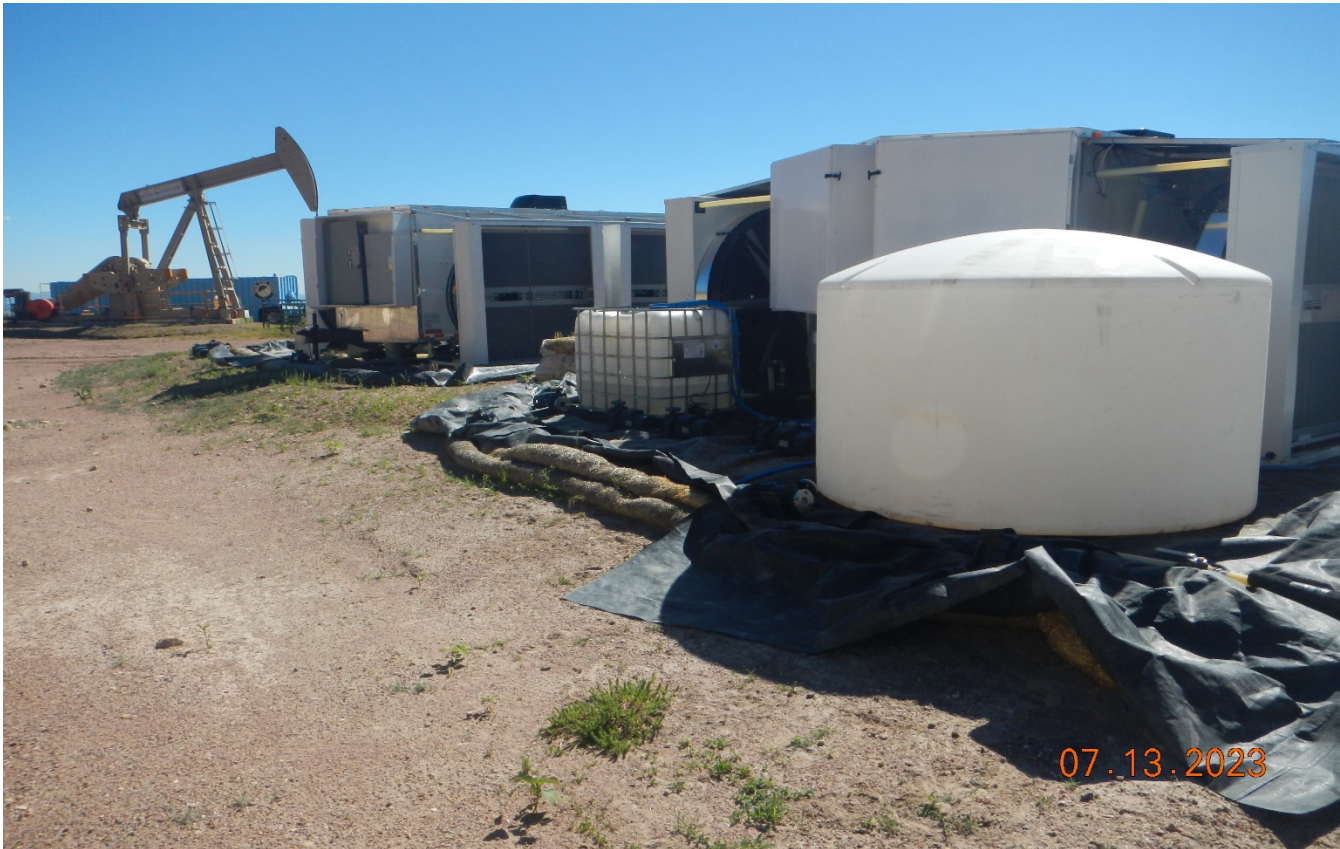
**Photo 9.** Northeast toward the bitcoin equipment. There are multiple tanks and secondary containment is not sufficient or maintained to contain a spill.

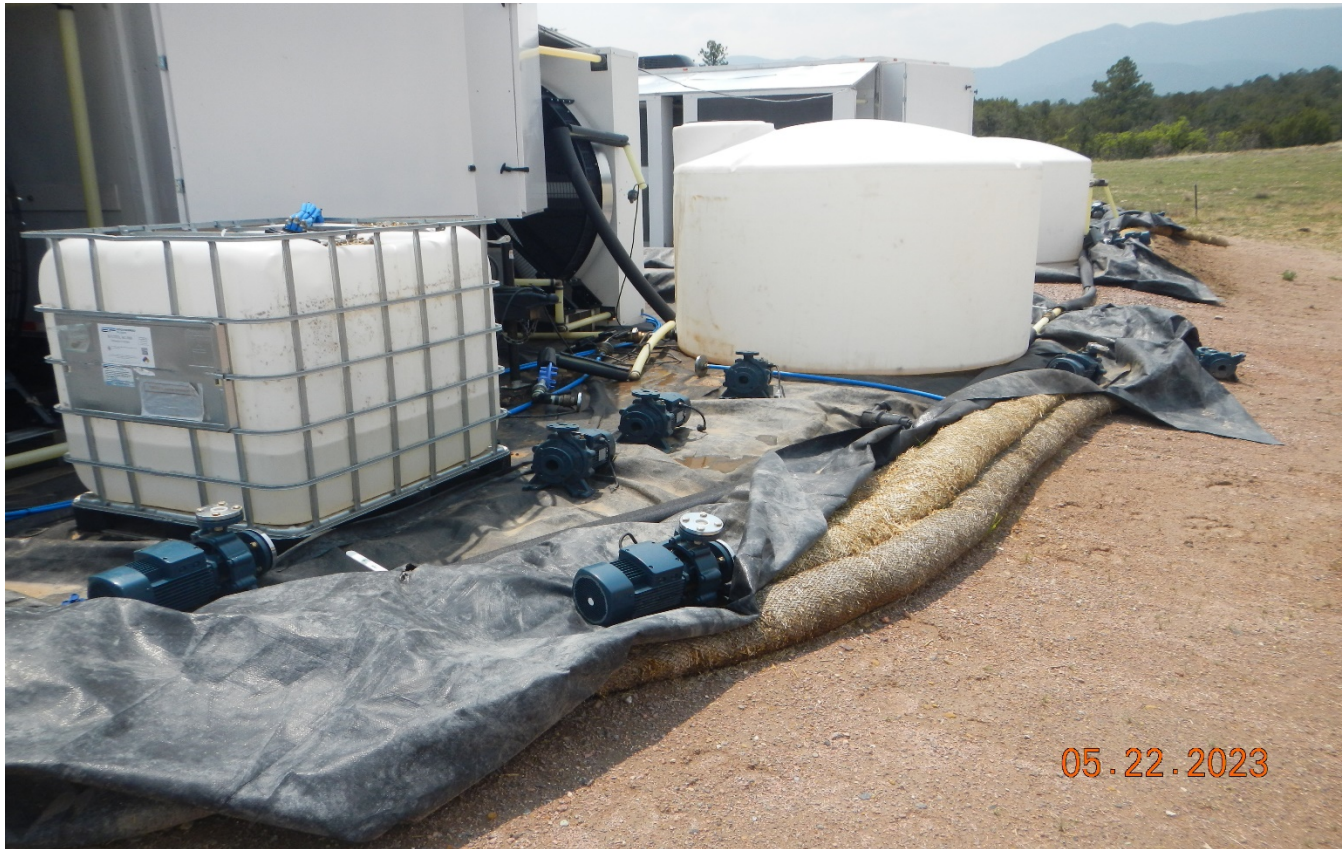
**Photo 10.** The plastic liner has become folded over needs to be repaired. There are water pump used to hold down the liner and should be removed if not need. Liner should be properly staked down.

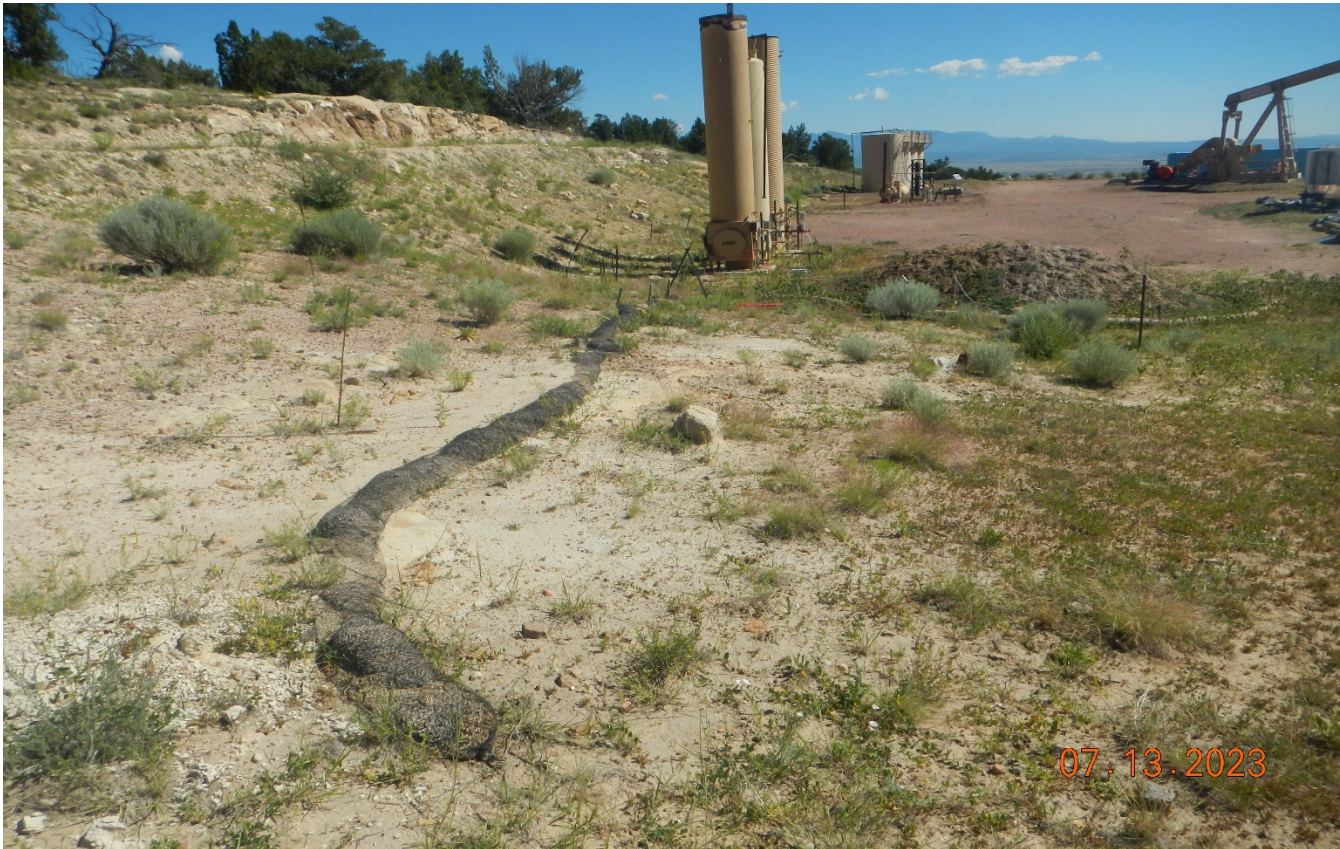
**Photo 11.** South side of the location facing northeast. The old wattles in this area need to be replaced or removed. Previous corrective action was not completed.

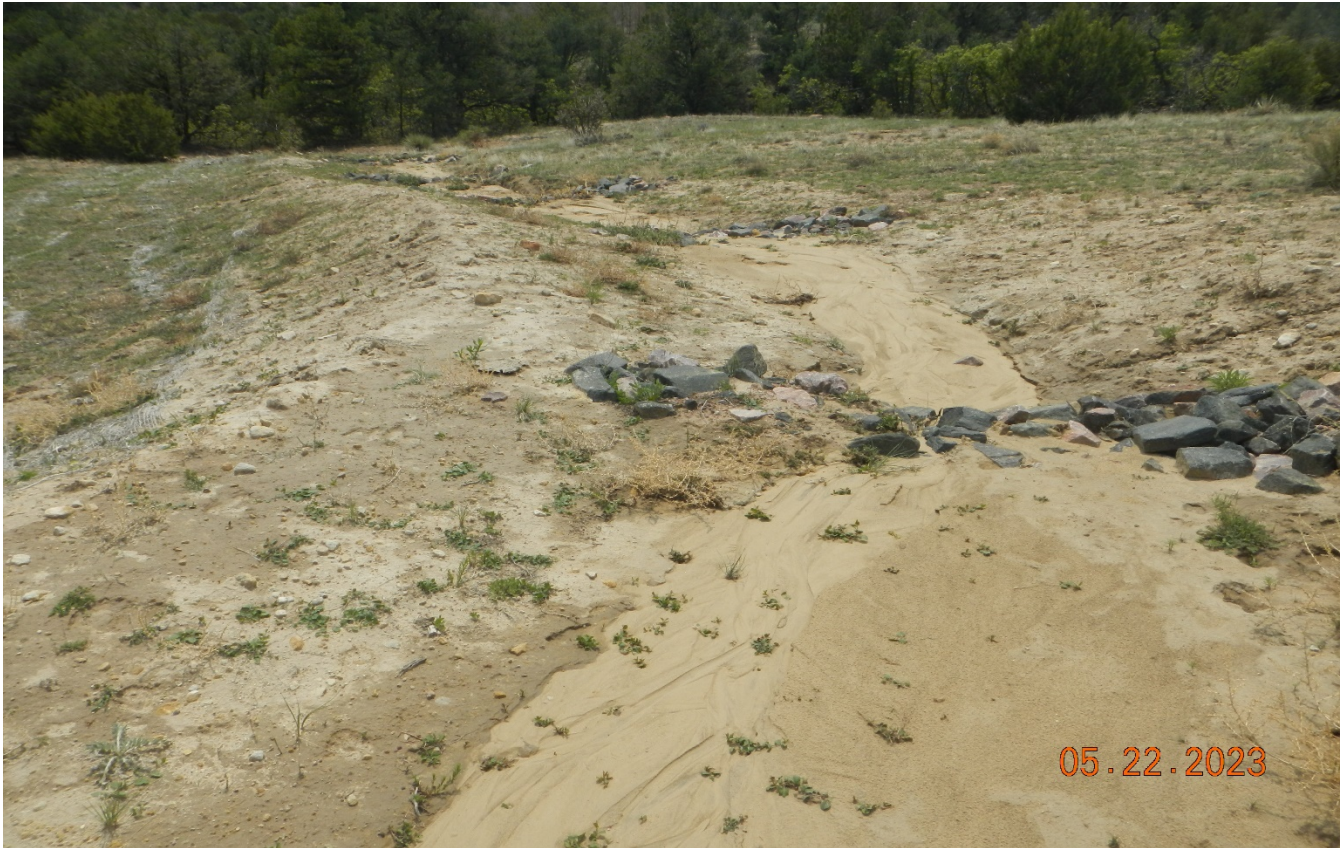
**Photo 12.** Facing south at the perimeter ditch. The check dams have filled in with sediment and need to be cleaned out.

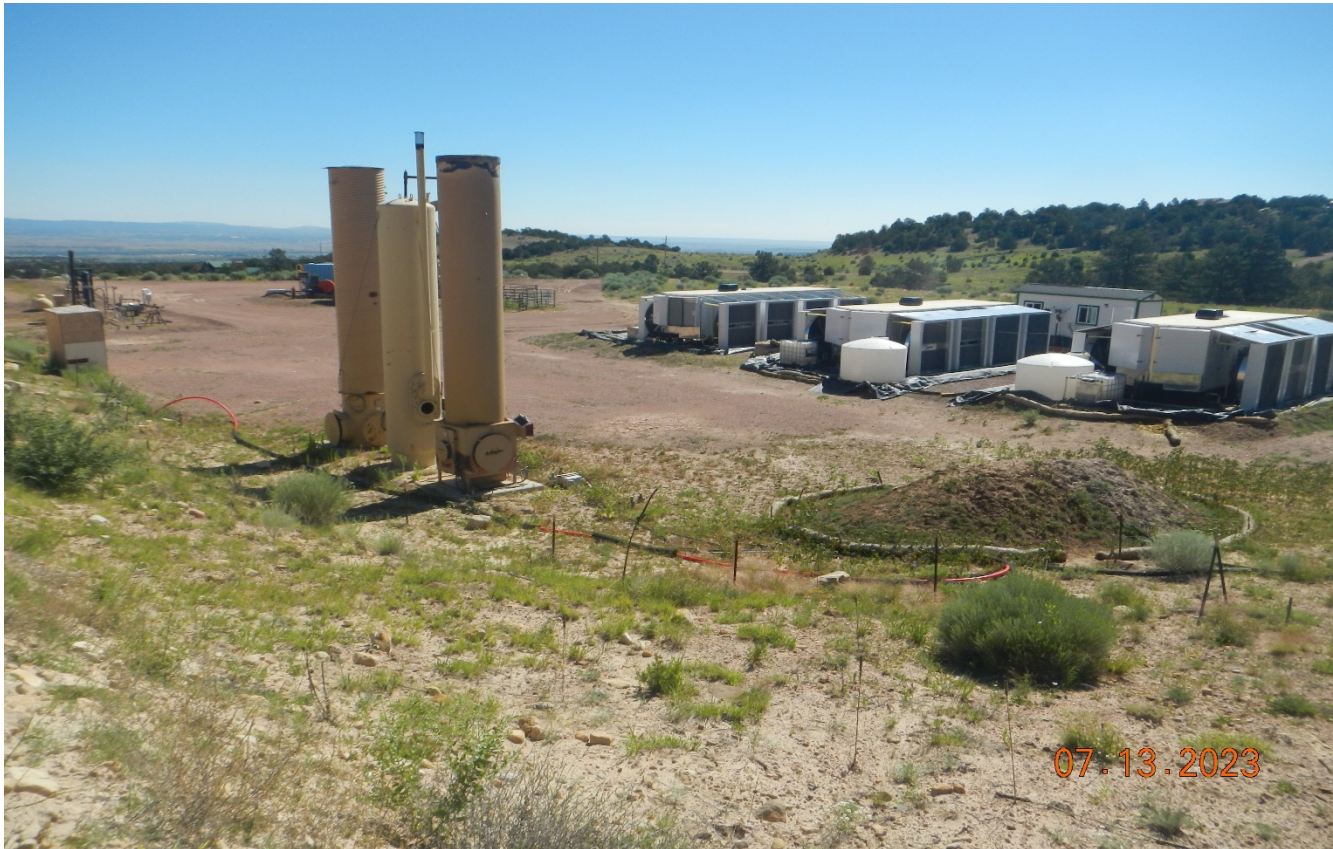
**Photo 13.** Facing northeast overlooking the location.

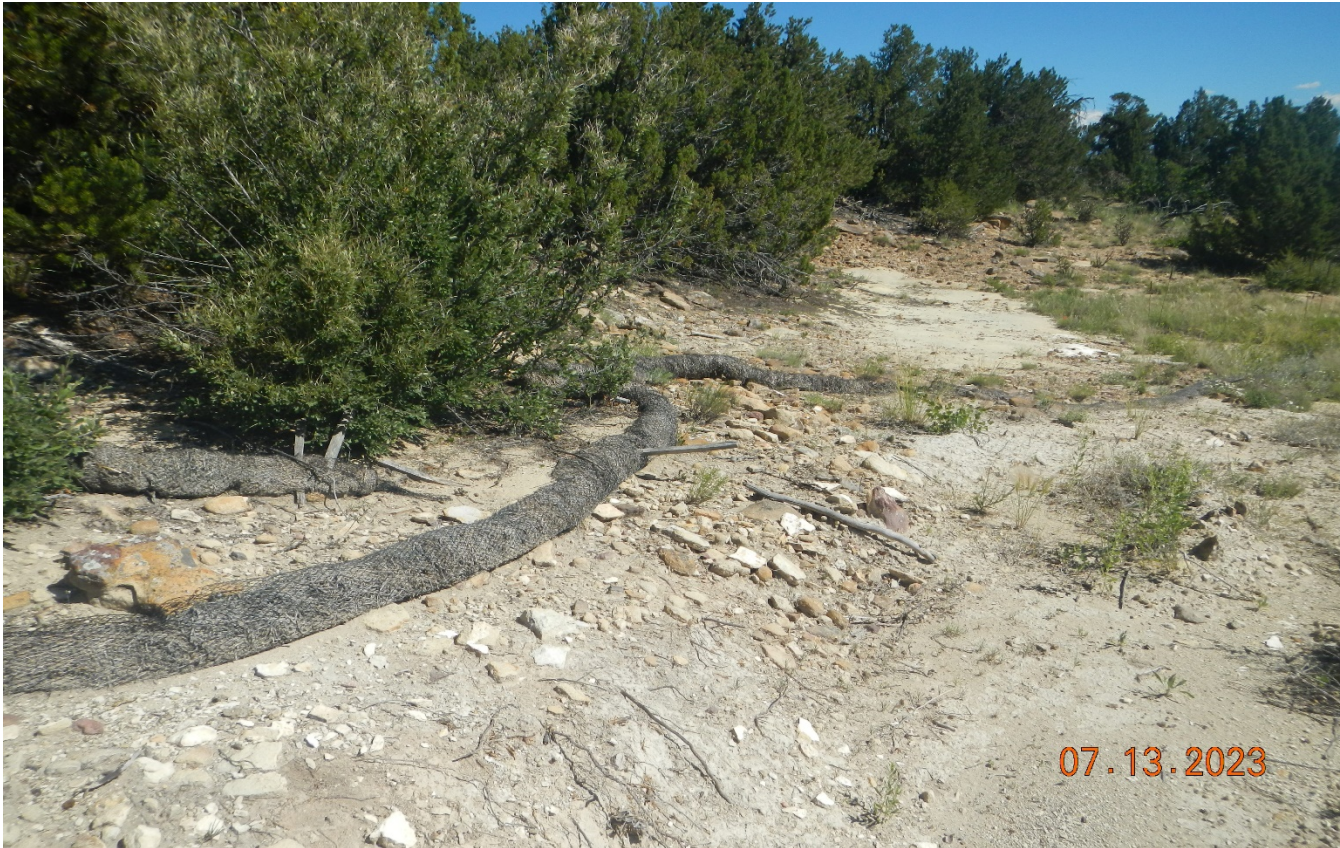
**Photo 14** The wattles along the west perimeter of the location are degraded and need to be replaced or removed.

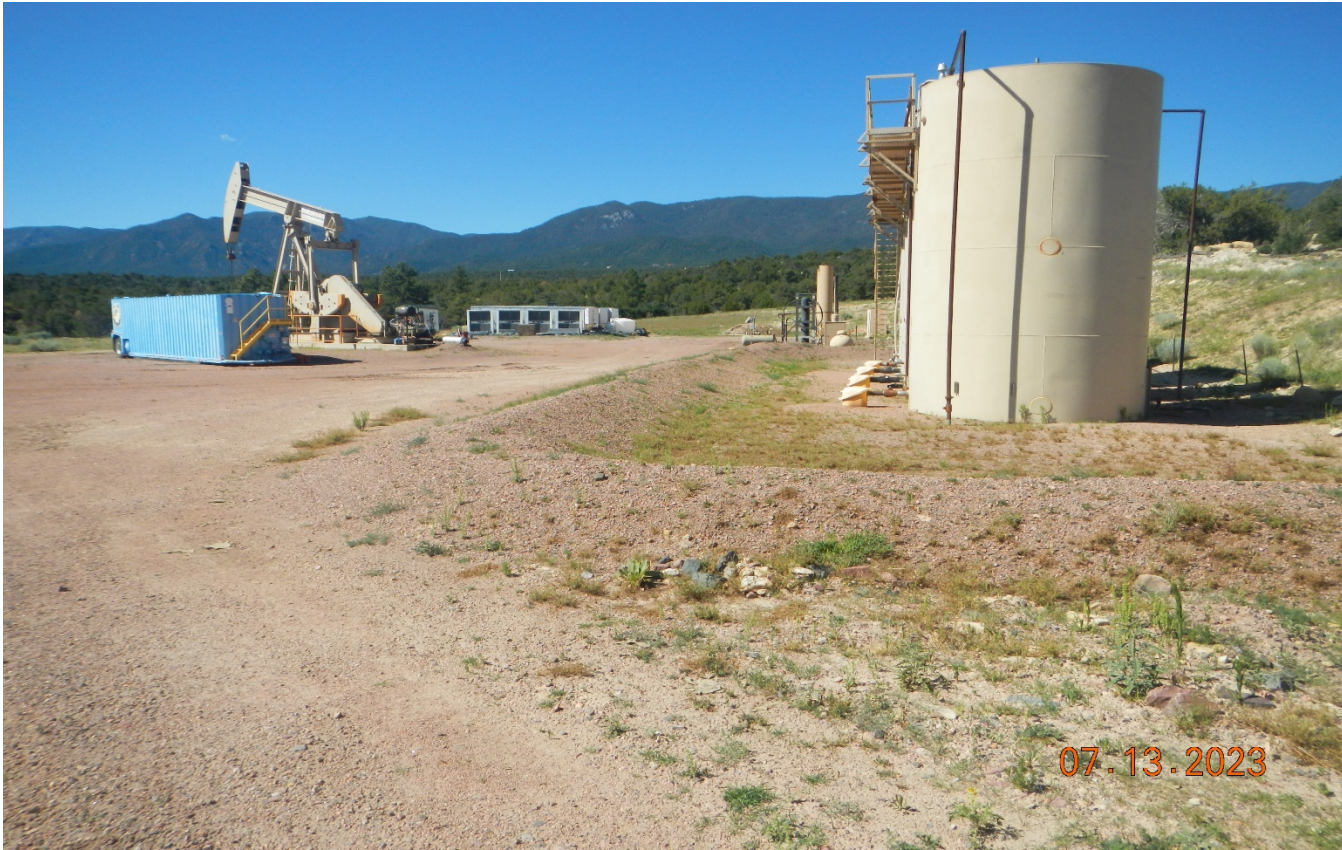
**Photo 15.** Facing south at the location.
