# Final Reclamation and Stormwater Inspection

Operator: MARKUS PRODUCTION, INC - 53790

Location ID: 327257

Inspection Document #: 708200376

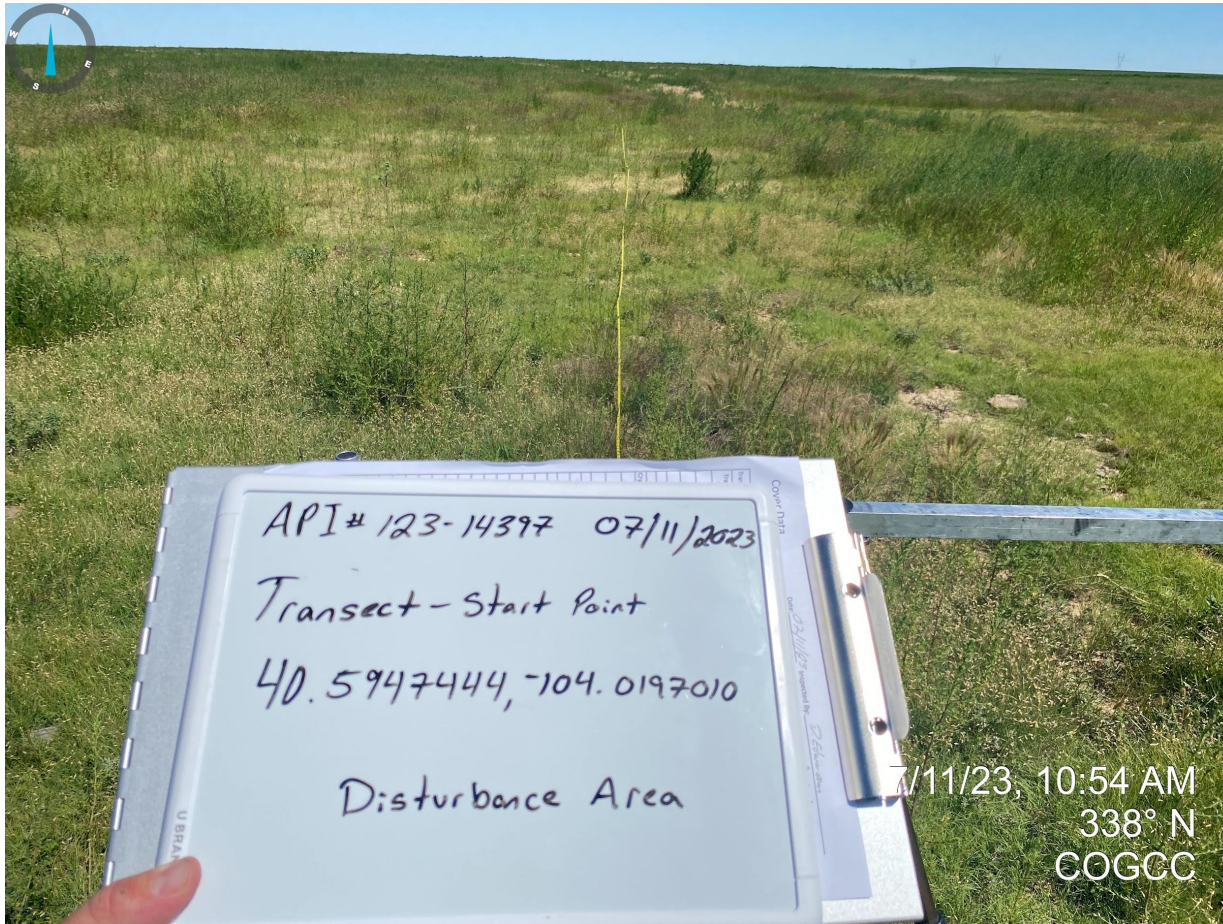
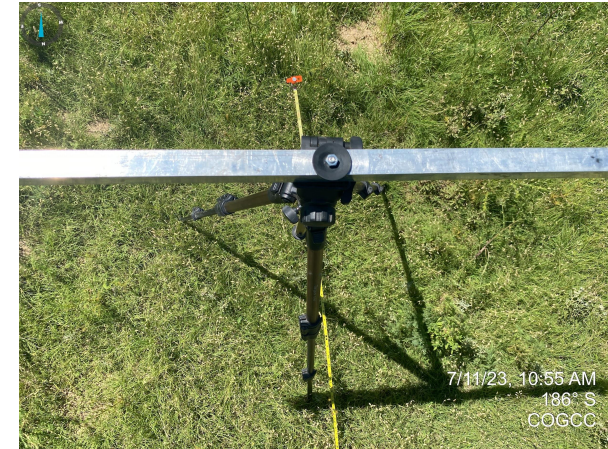
Photo 1-2. Transect start point of disturbance area, facing north.

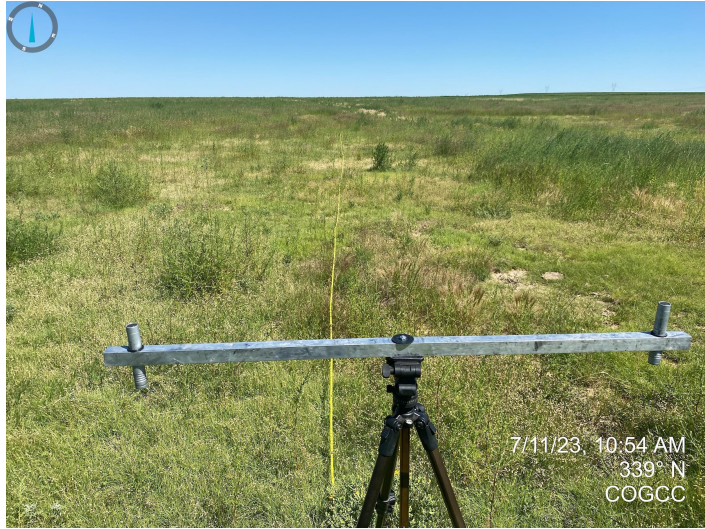
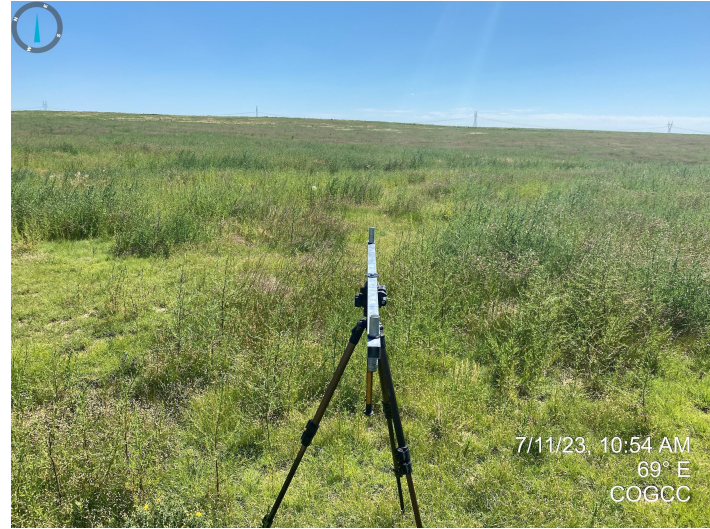
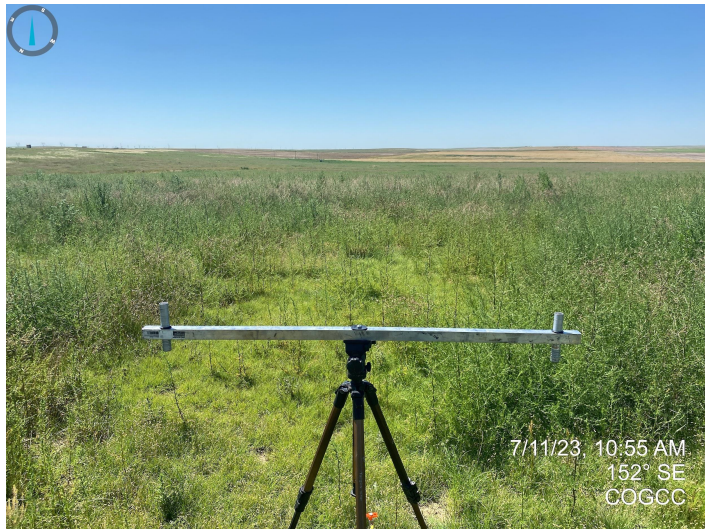
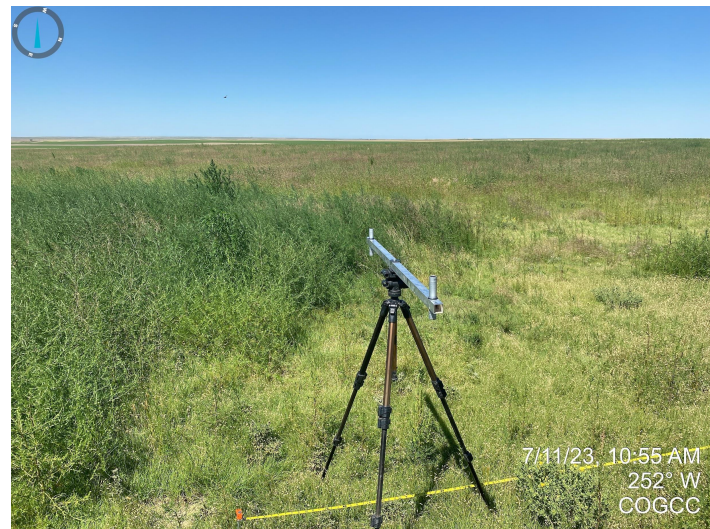
**Photo 3-6.** Transect start point of disturbance area, facing all cardinal directions.

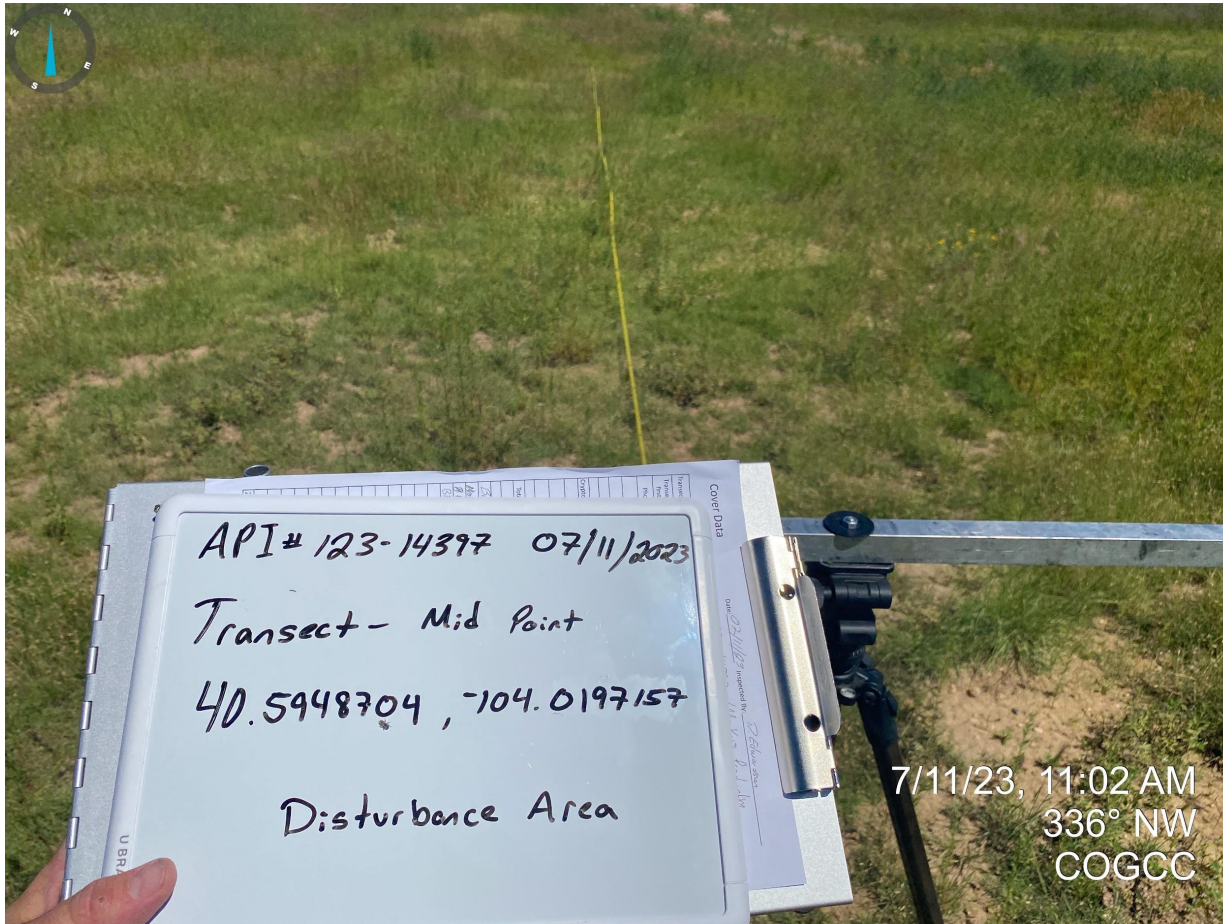
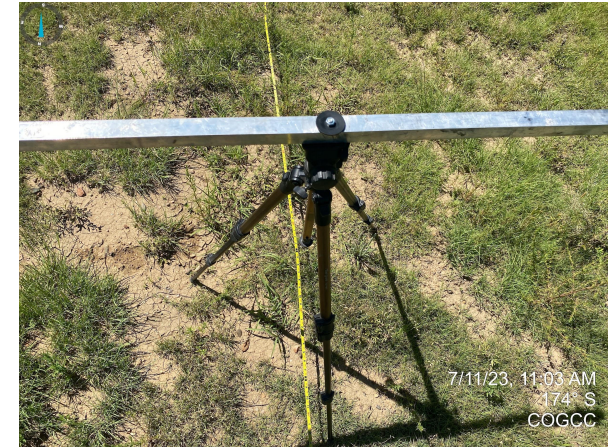
Photo 7-8. Transect midpoint within disturbance area (50th point).

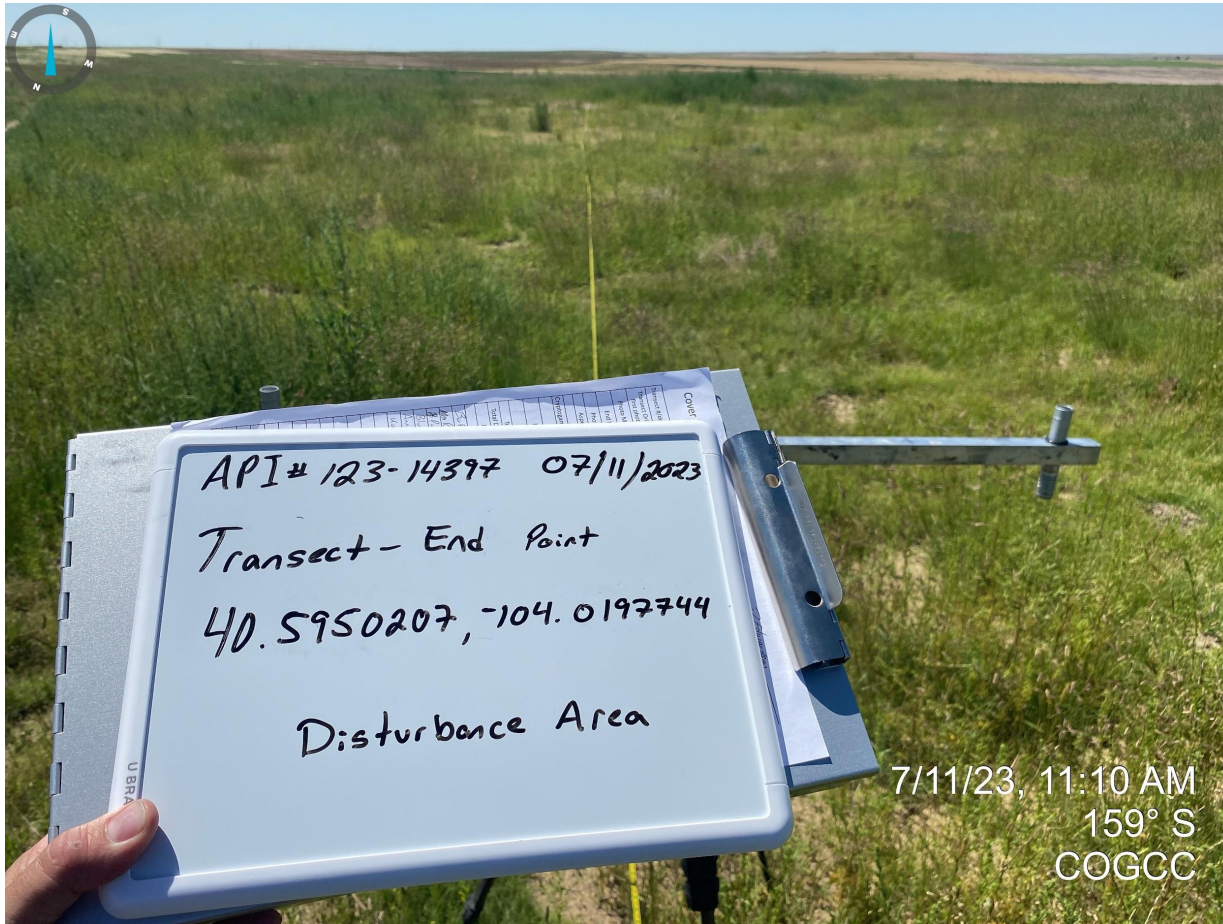
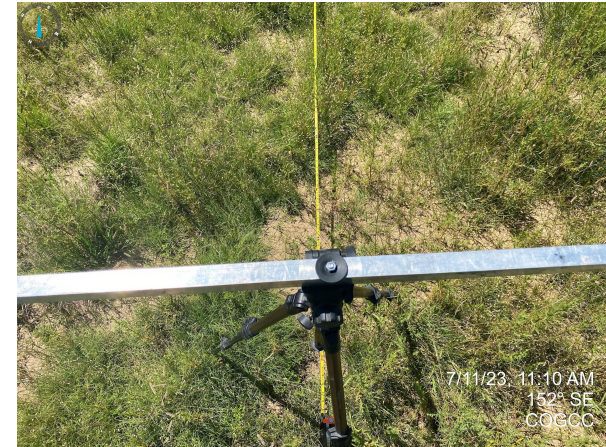
Photo 9-10. Transect endpoint within disturbance area (100th point).

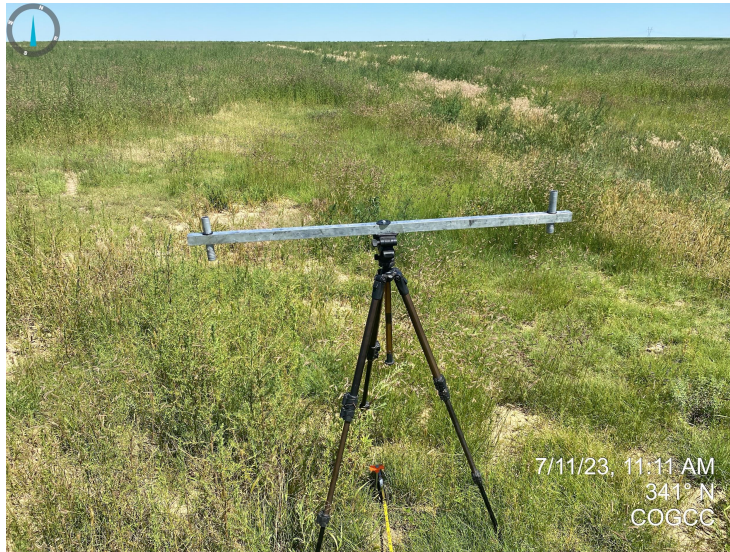
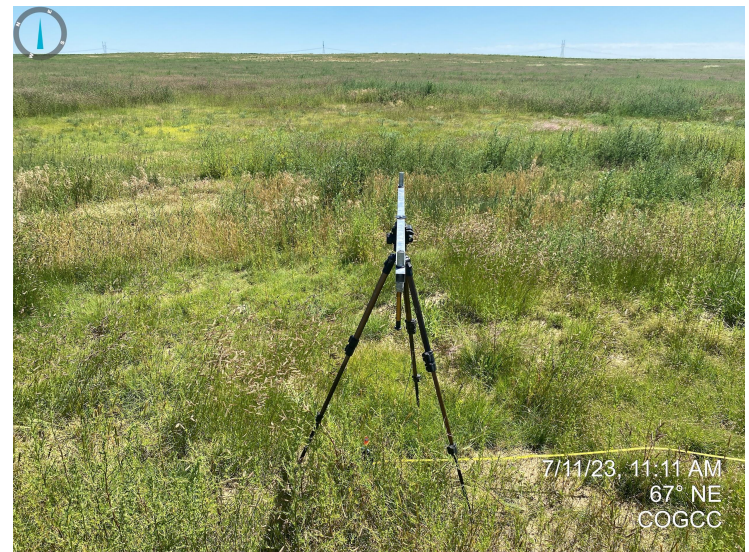
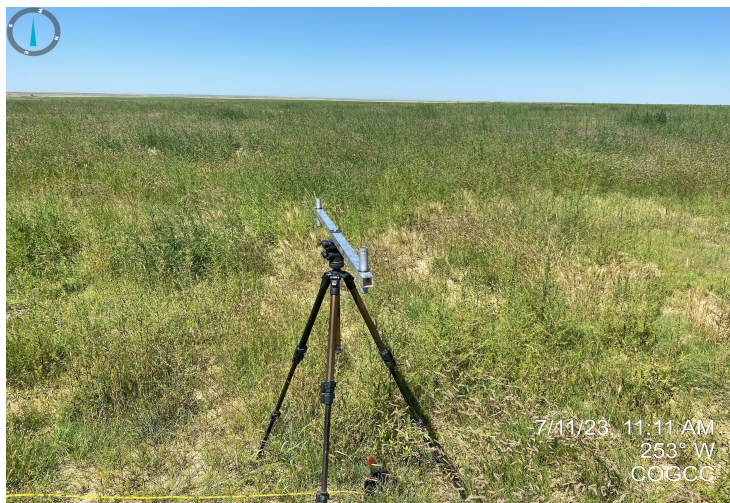
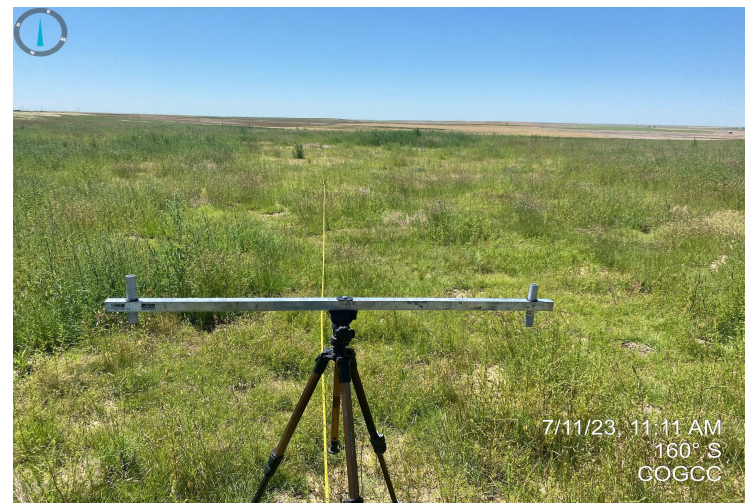
**Photo 11-14** . Transect endpoint within disturbance area (100th point), facing all cardinal directions.

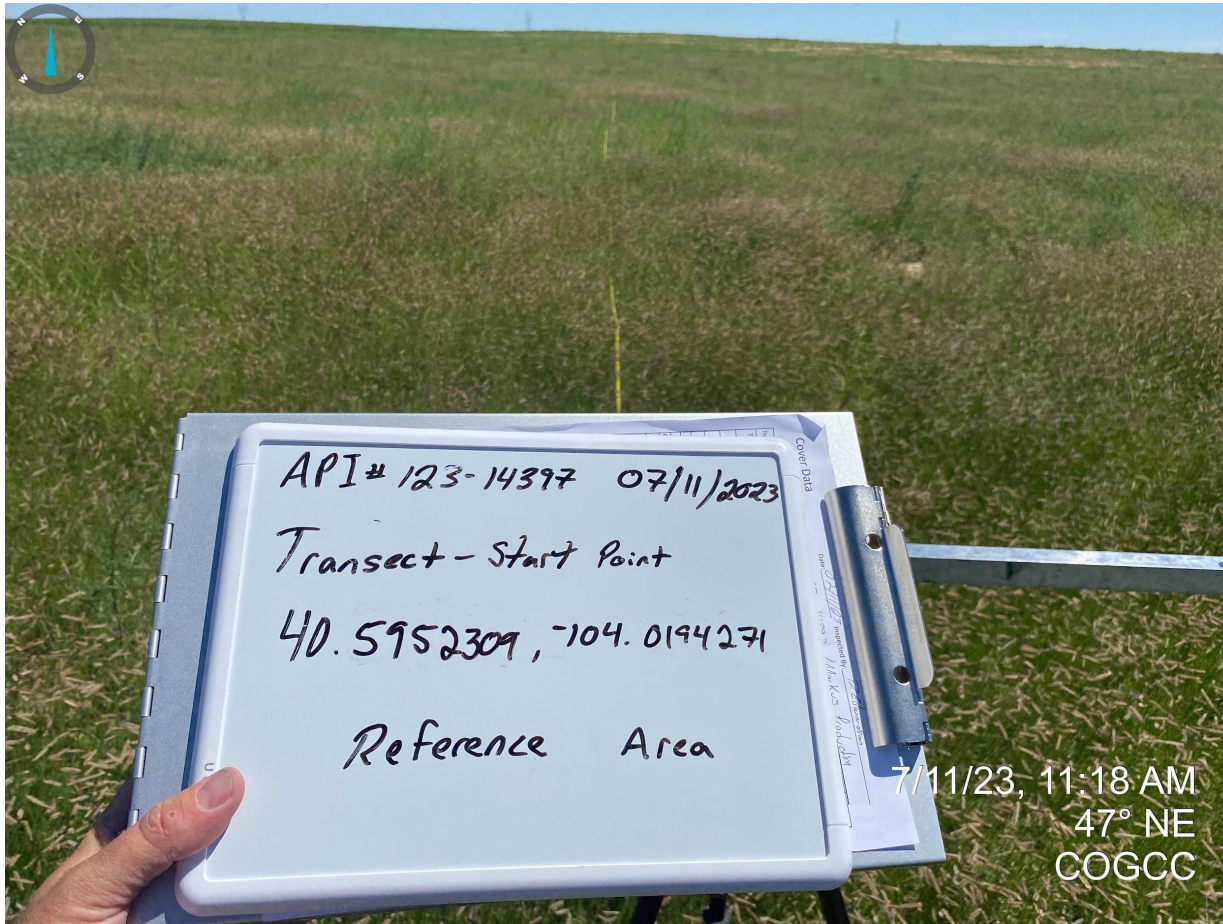
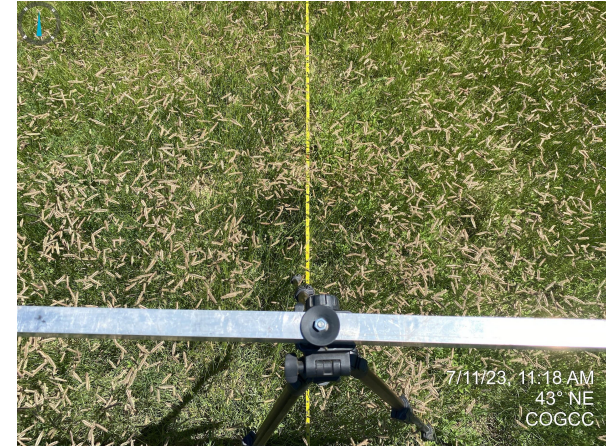
Photo 15-16. Reference area transect start point, facing northeast.

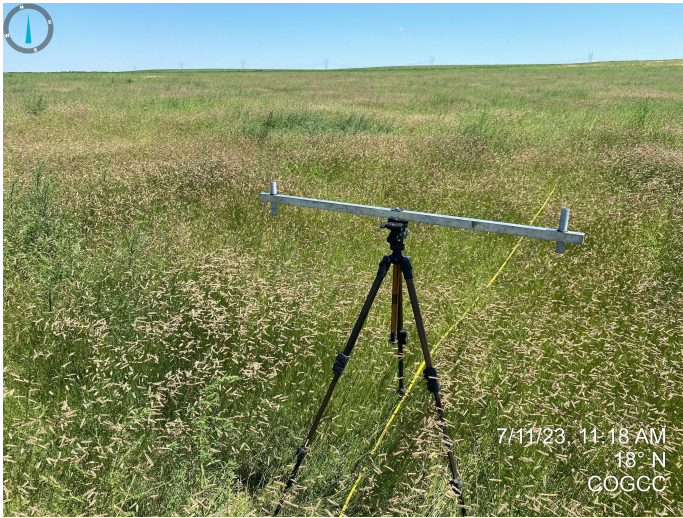
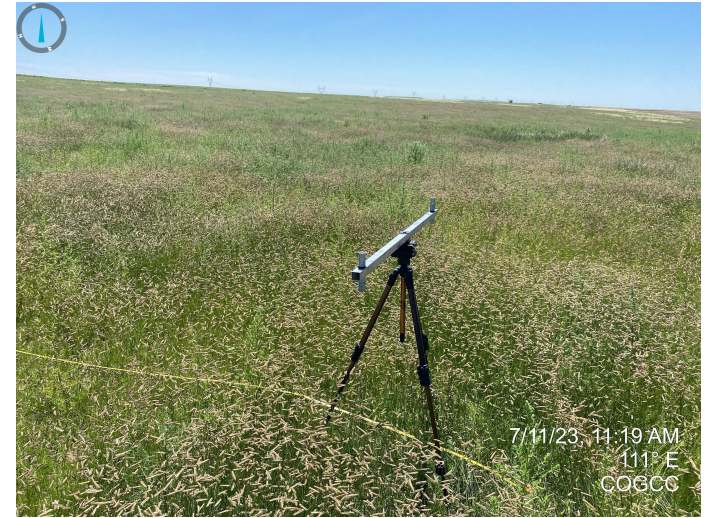
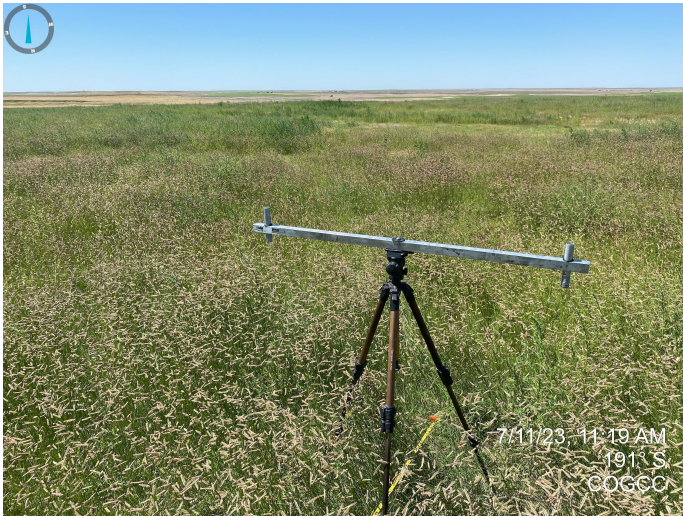
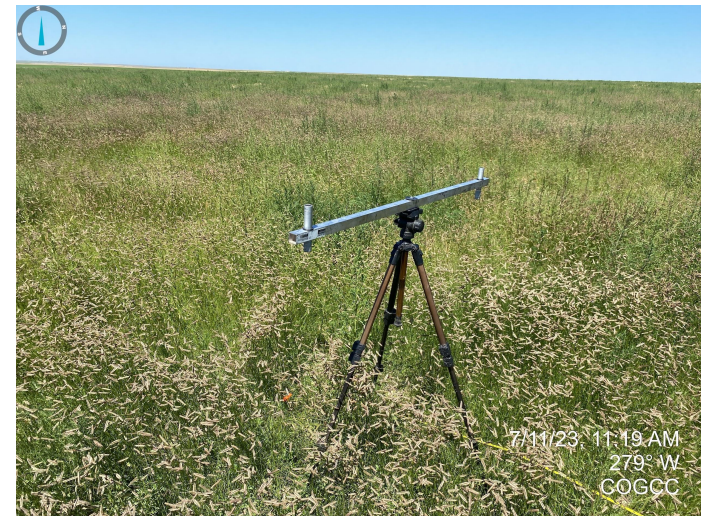
Photo 17-20. Reference area transect start point, facing all cardinal directions.

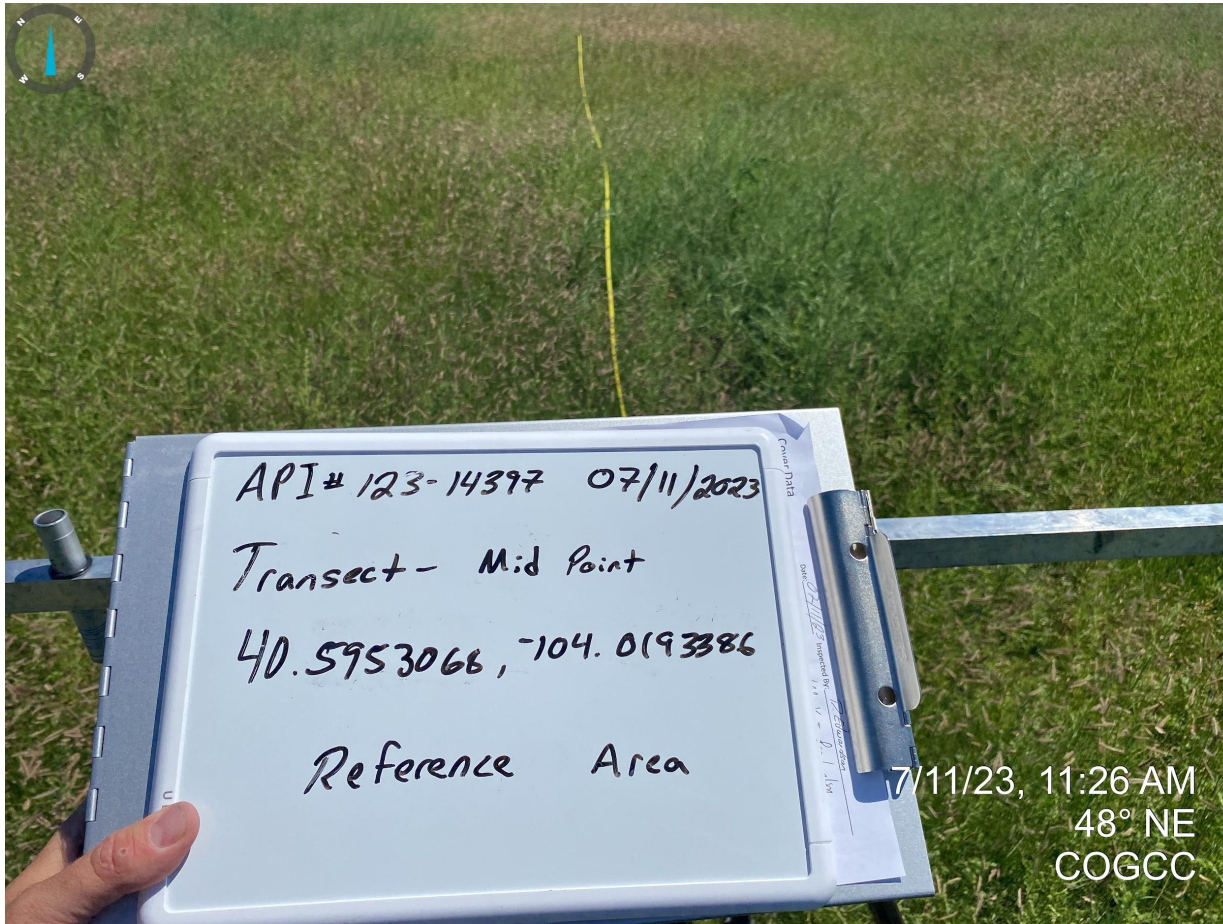
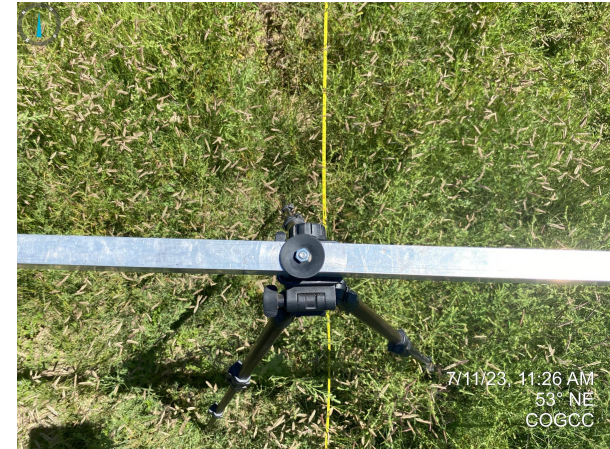
Photo 21-22. Reference area transect midpoint (50th point).

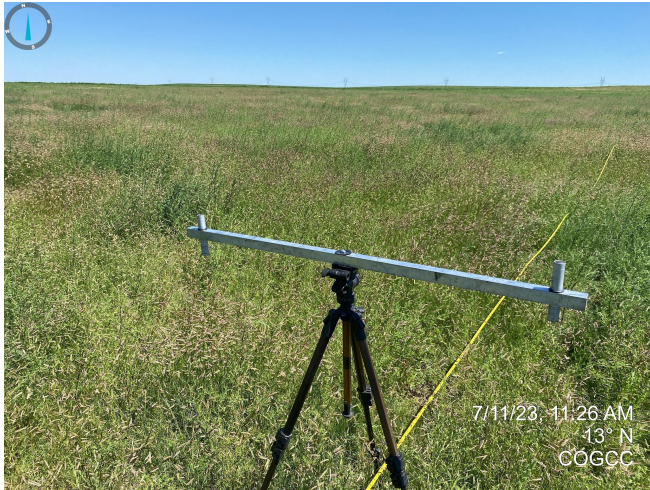
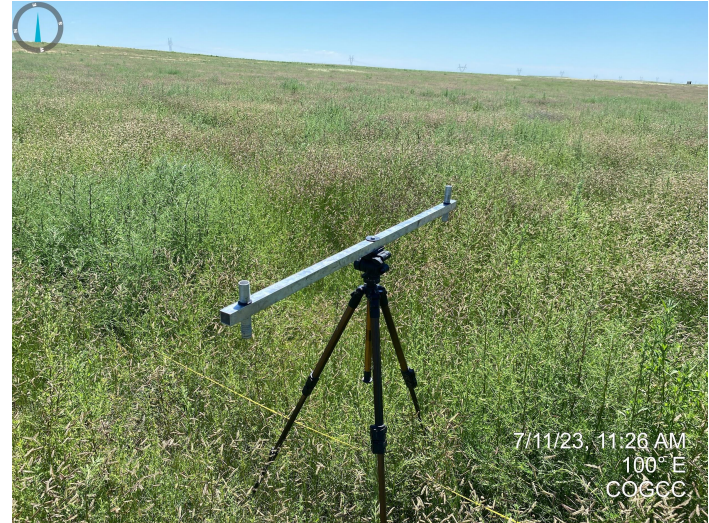
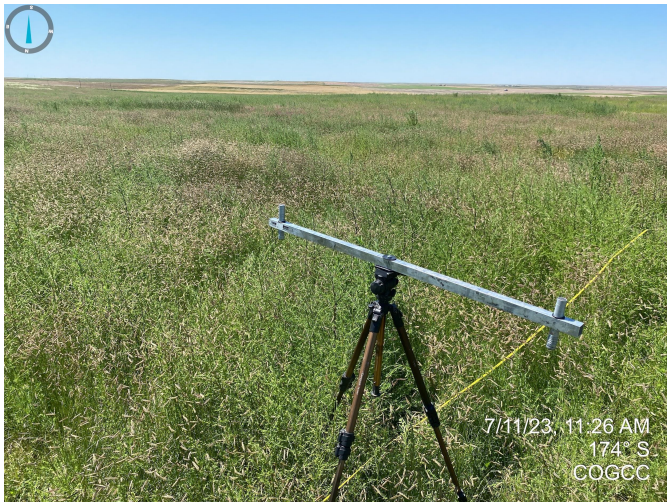
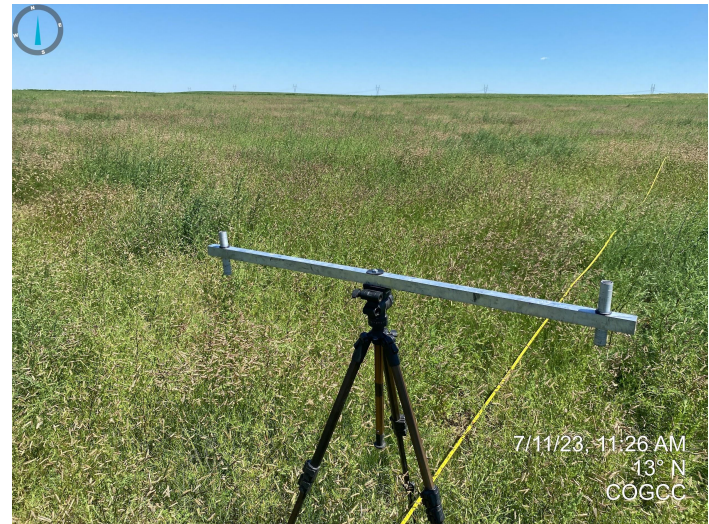
**Photo 23-26.** Reference ares transect midpoint (50th point), facing all cardinal directions

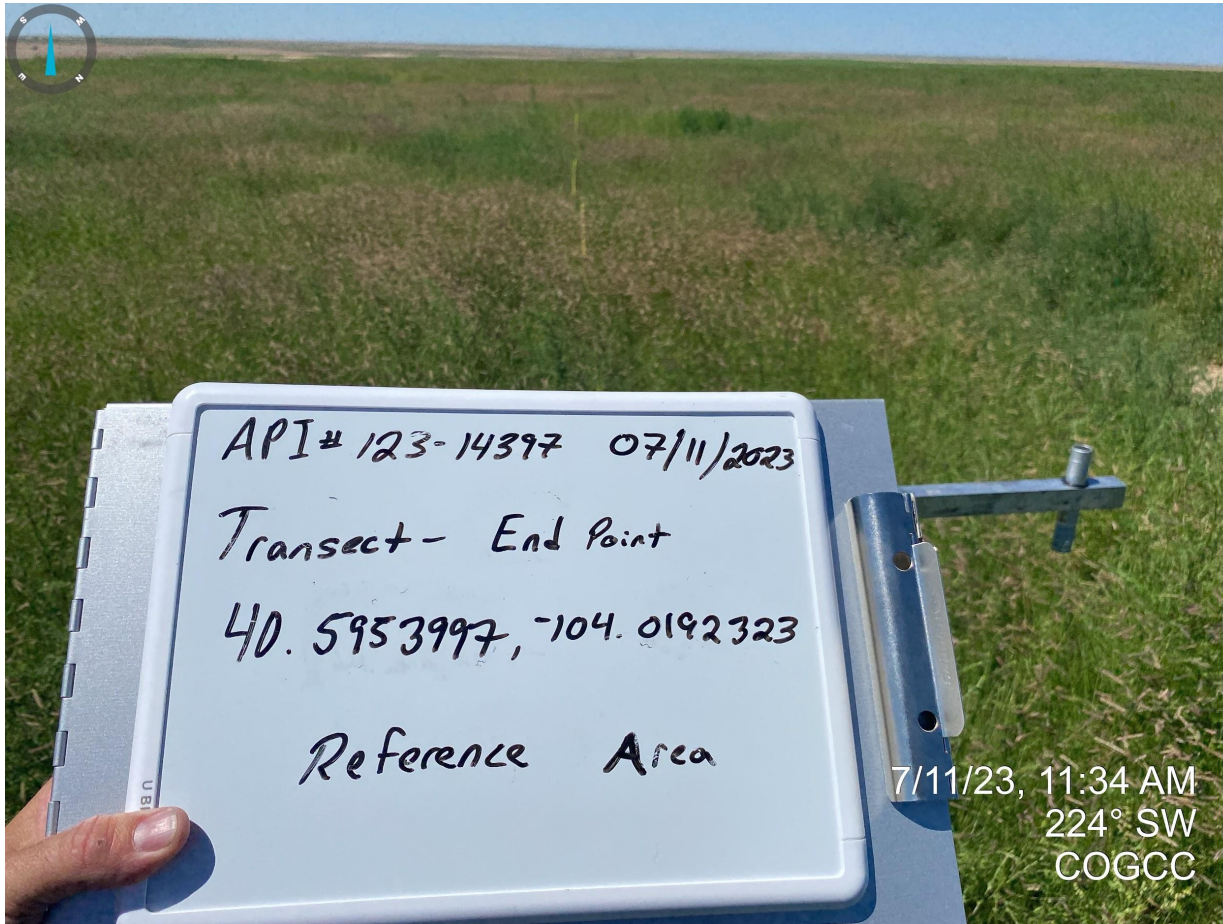
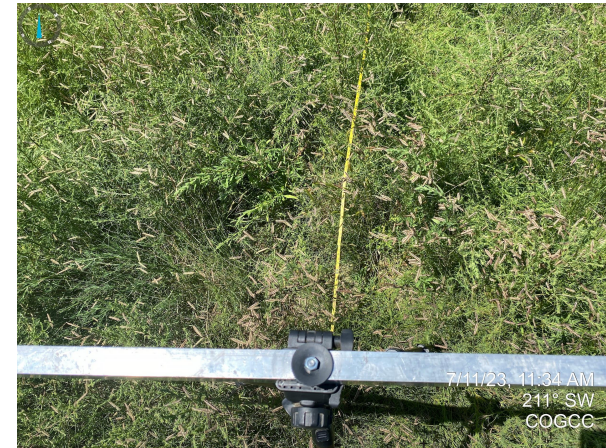
Photo 27-28. Reference area transect endpoint (100th point).

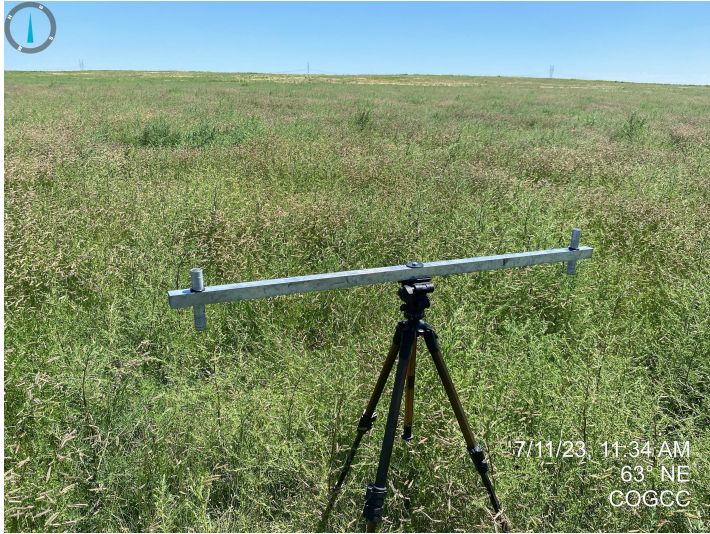
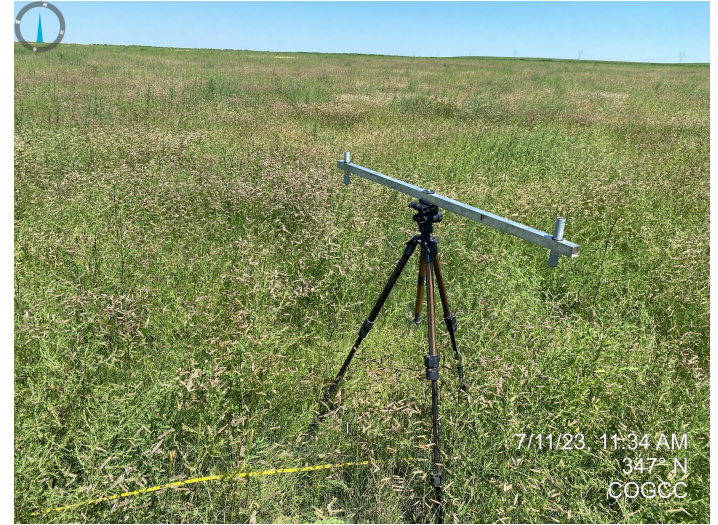
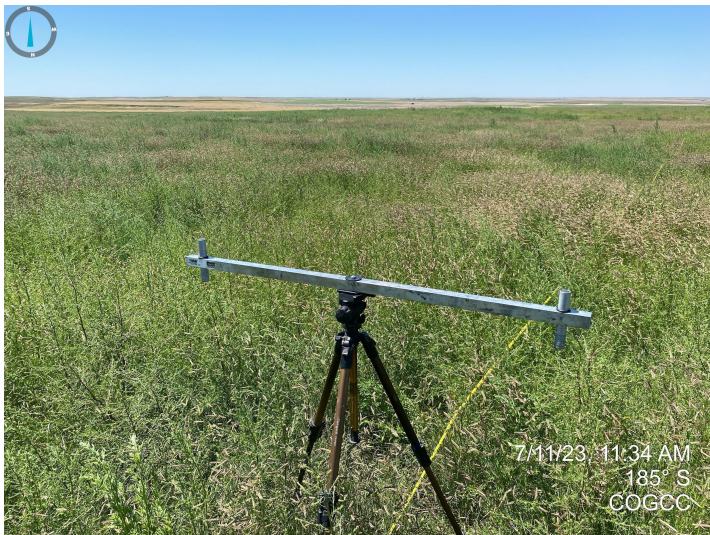
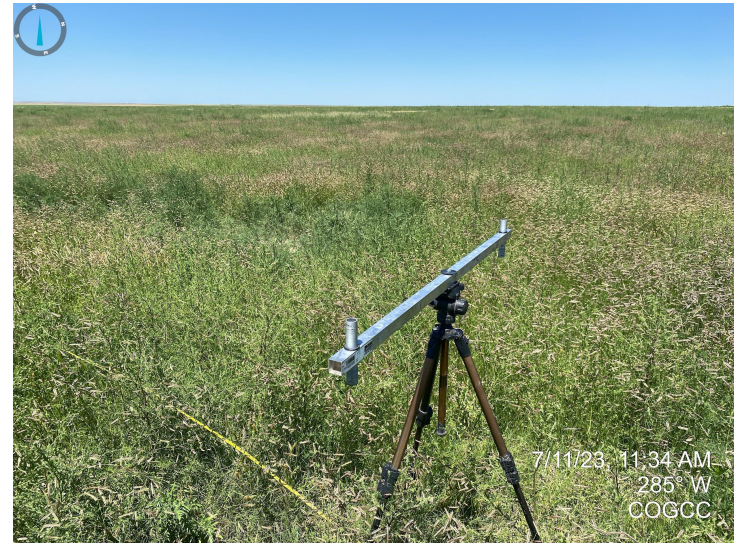
**Photo 29-32.** Reference area transect endpoint (100th point), facing all cardinal directions.

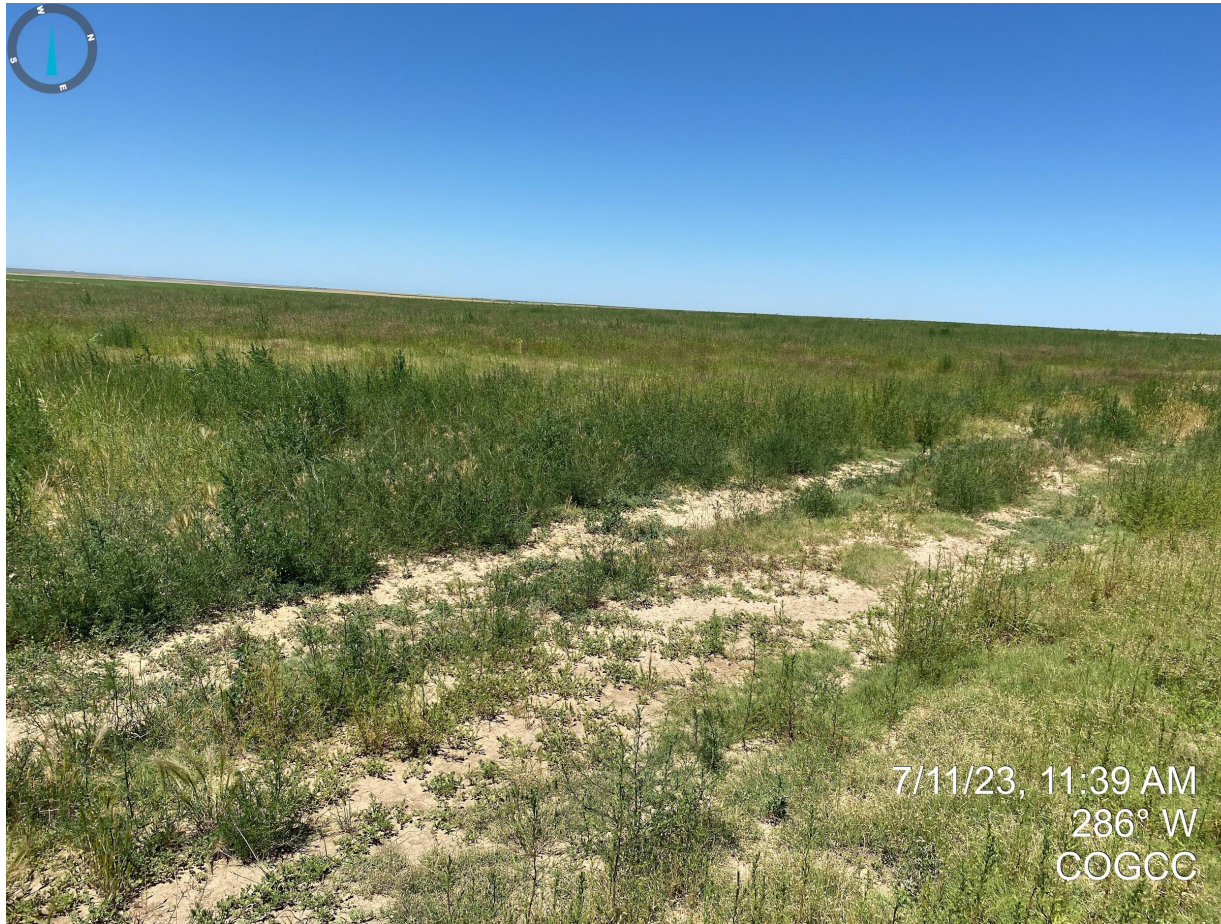
**Photo 33.** Taken from the reclaimed location, facing west towards the southern access road. The access road does not appear to have been reclaimed; further reclamation activities are required in order to meet Rule 1004 standards.

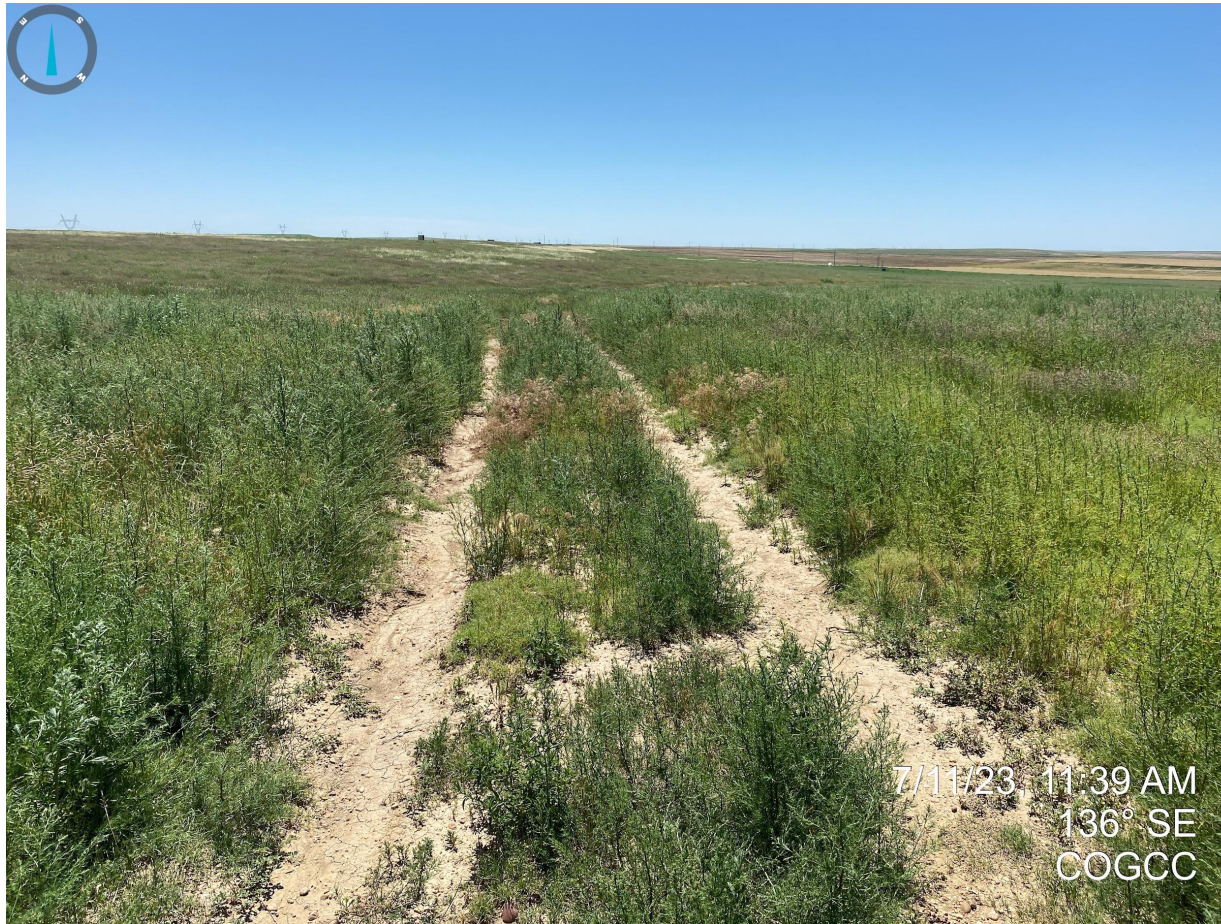
**Photo 34.** See comments in Photo 33.

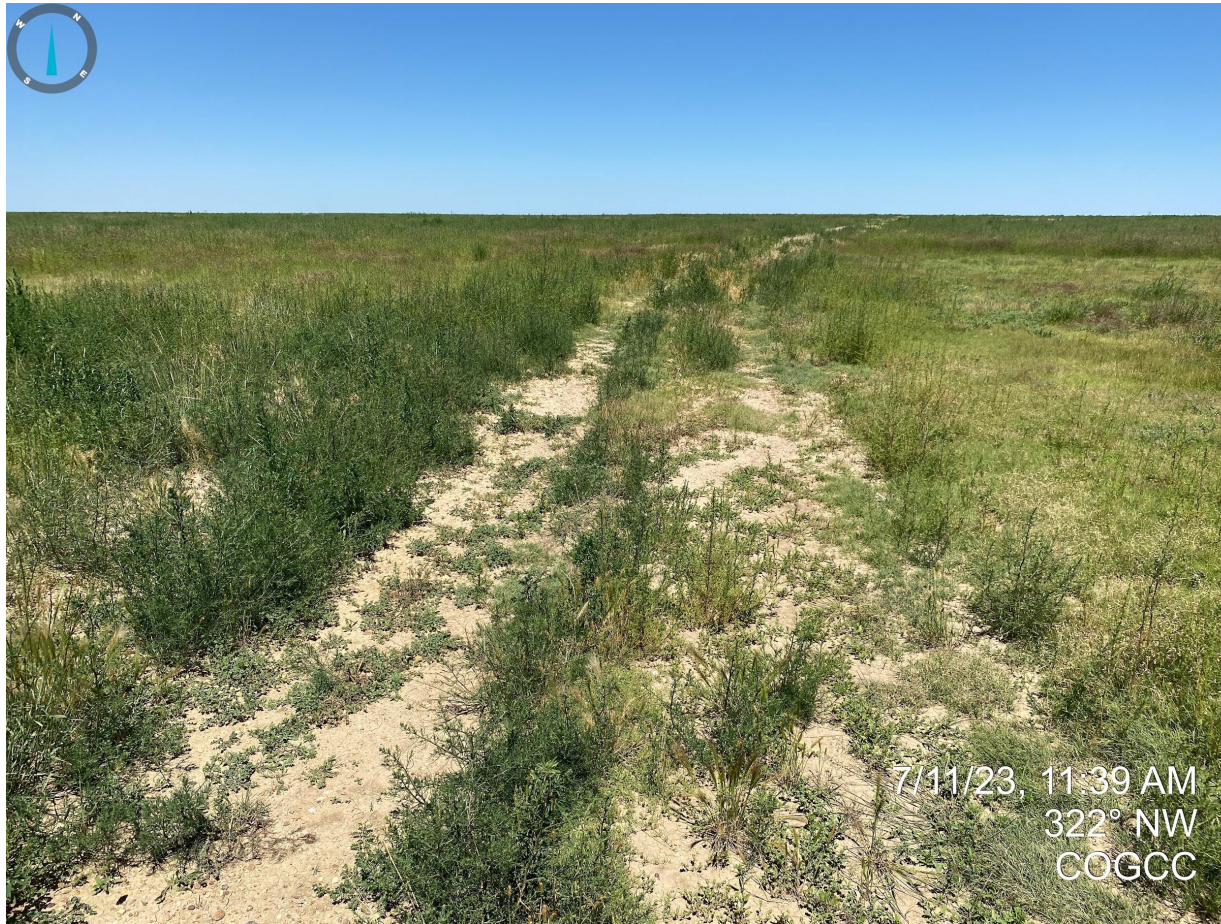
**Photo 35.** Facing north from the reclaimed portion, northern access road; see comments in Photo 33.

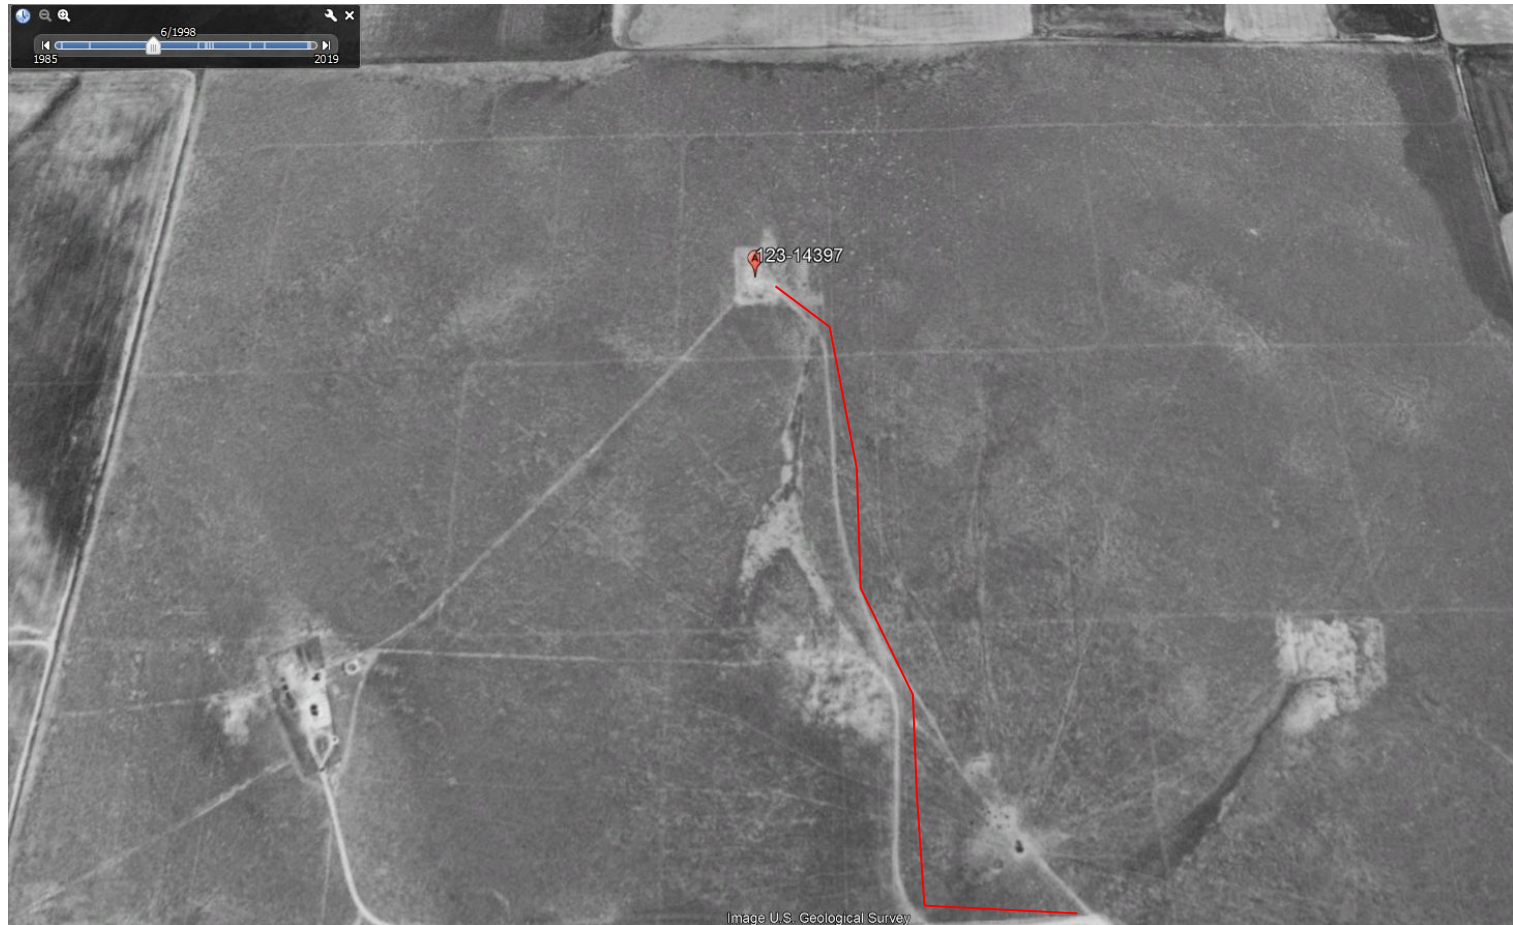
**Photo 36.** Google Earth aerial imagery taken circa 1998, illustrating the southern access road to the location that will need to be reclaimed.

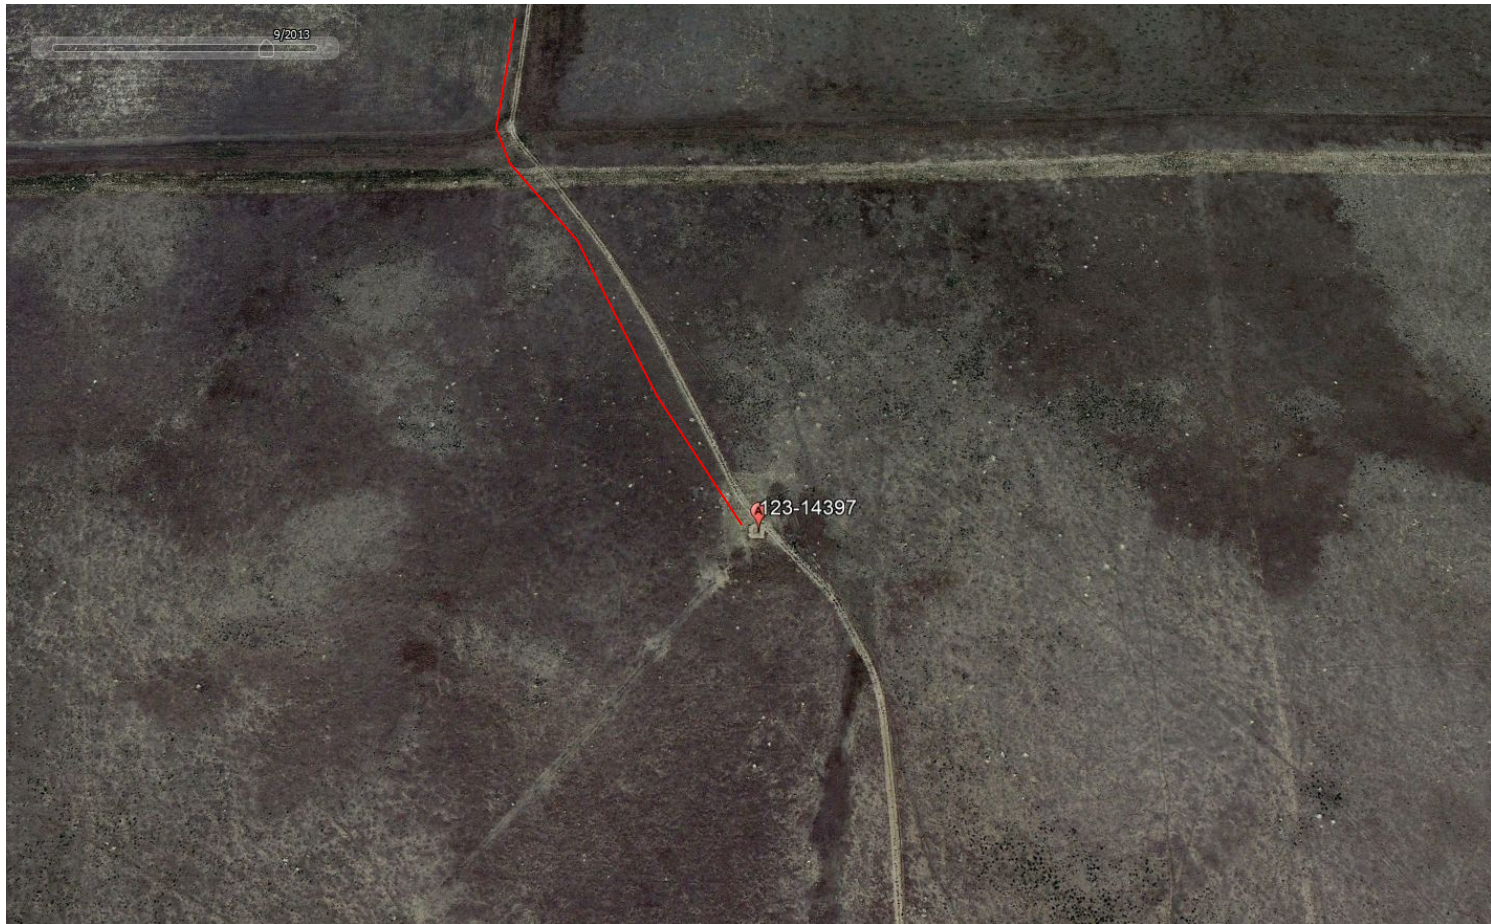
**Photo 37.** Google Earth aerial imagery taken circa 2013, illustrating the access road north of the location that will need to be reclaimed. NOTE: the access road continues north, out of frame from this photo. The Operator will need to reclaim the entire access road system associated with this location.
