Inspection Photos
Location Name: Bledsoe 13-17-3-43
Location ID: 125-02378

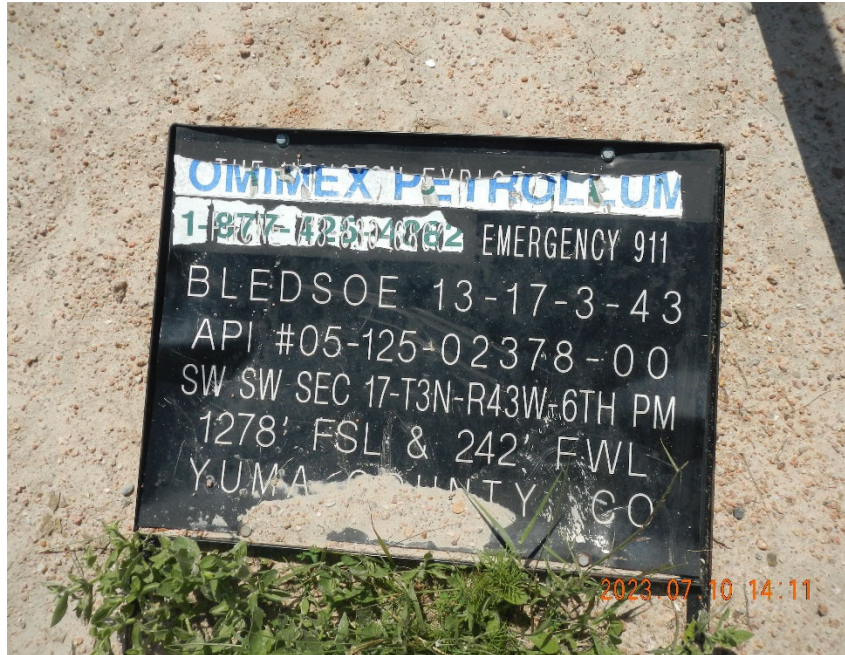
1. Well Sign located inside fencing.

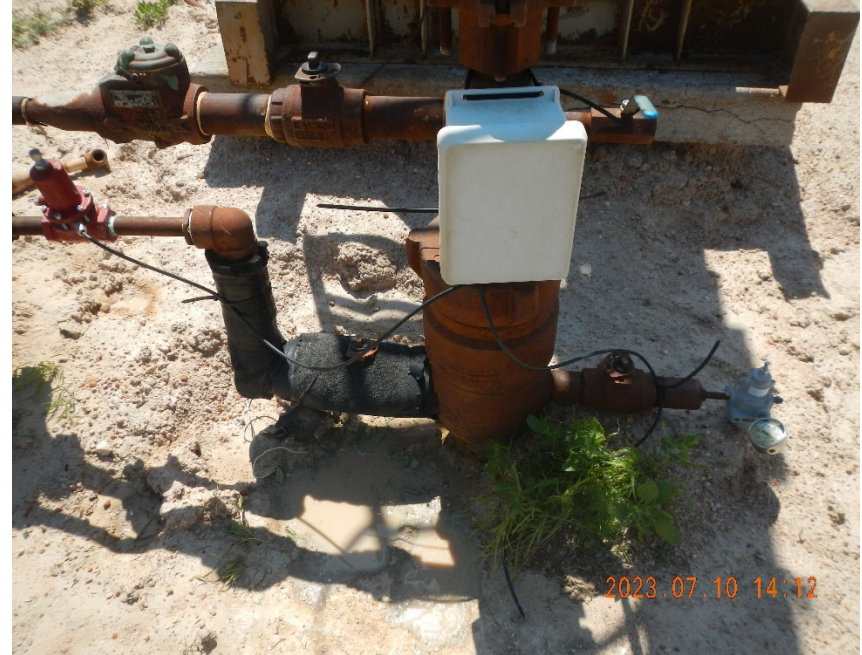
2. View of Wellhead.

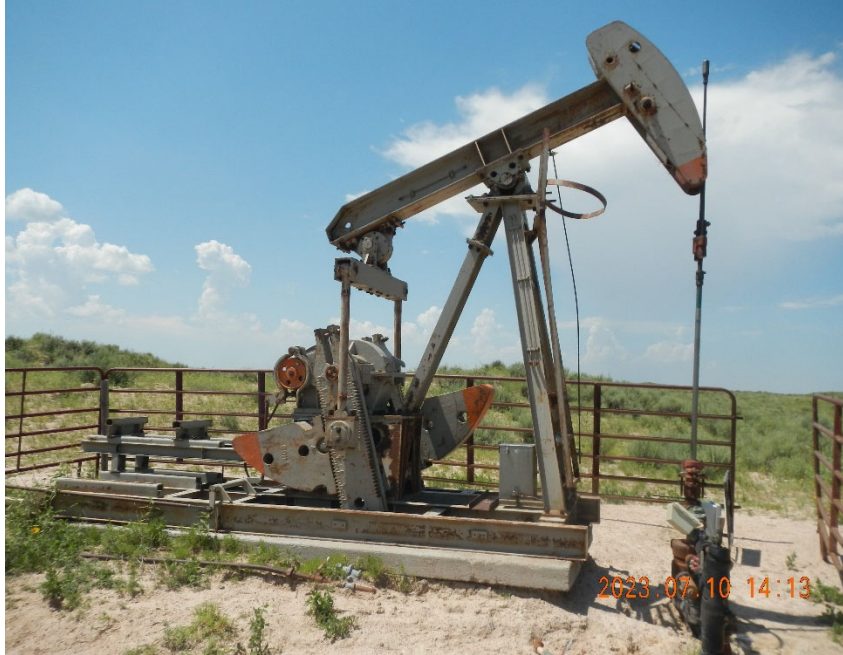
3. View of Pump Jack. Note vegetation.

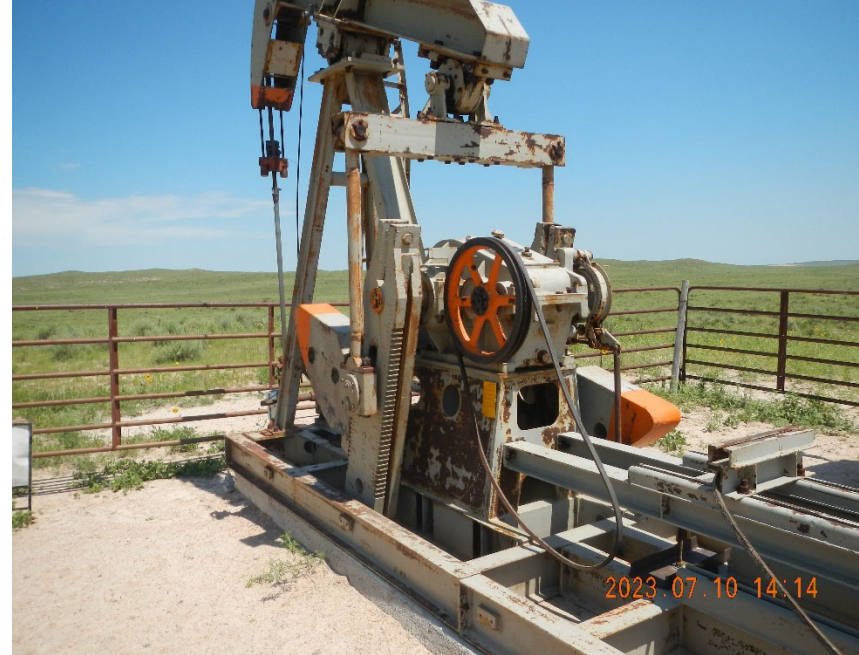
4. Motor removed from Pump Jack.

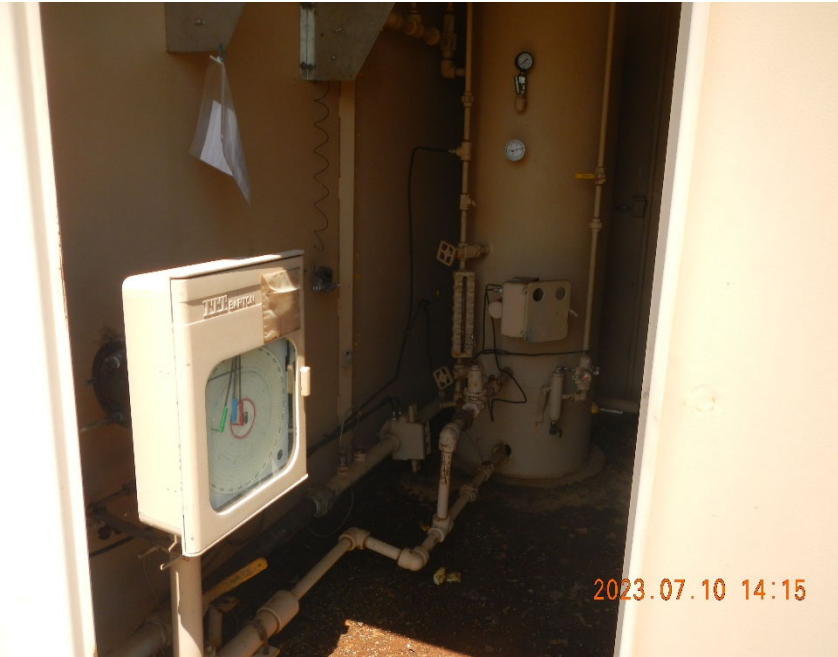
5. View of Gas Meter Run and Vertical Separator inside shed.

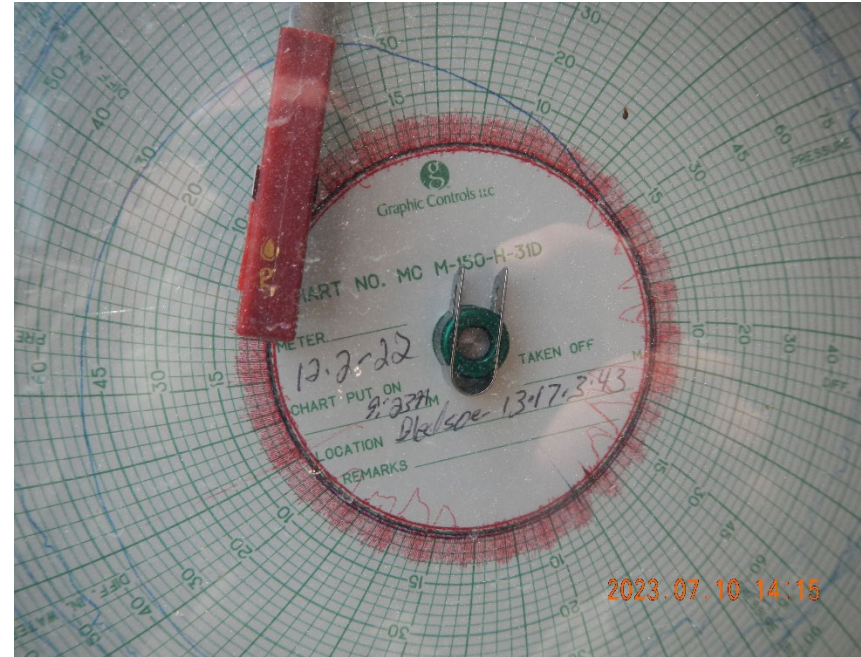
6. Gas Meter Chart in Meter Box at time of inspection dated 12-2-22.

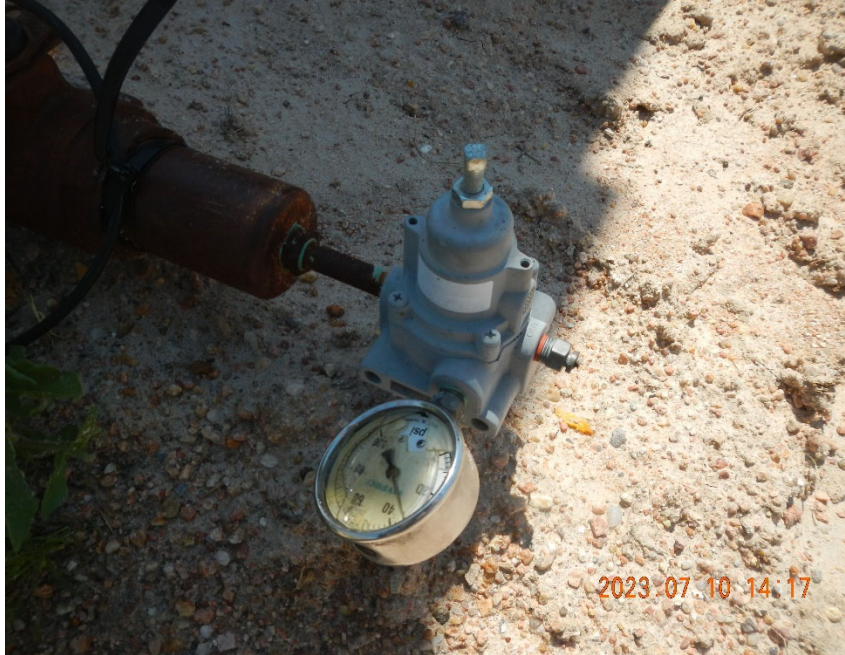
7. Venting Regulator at wellhead.

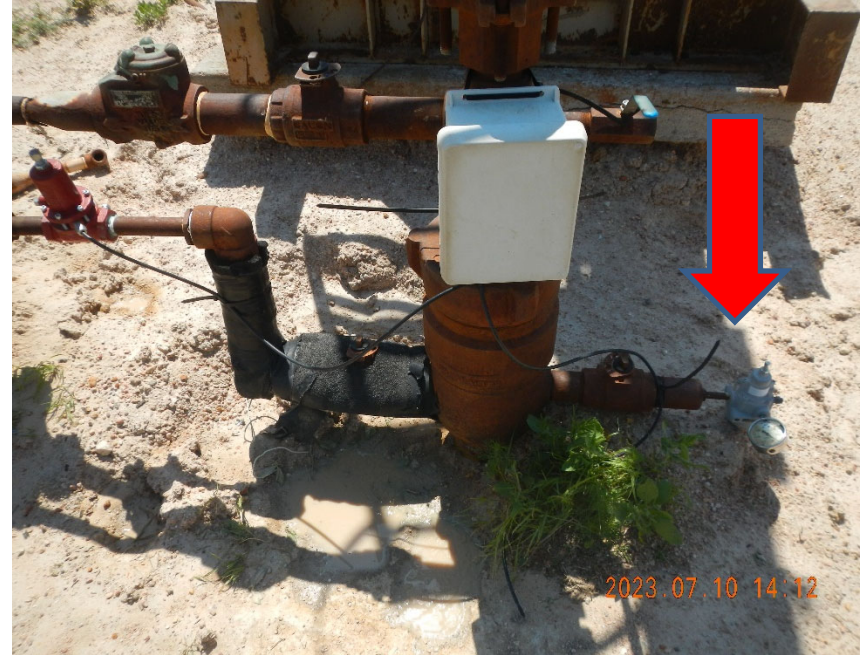
8. Wider view of Wellhead and venting Regulator on right side of frame under red arrow.

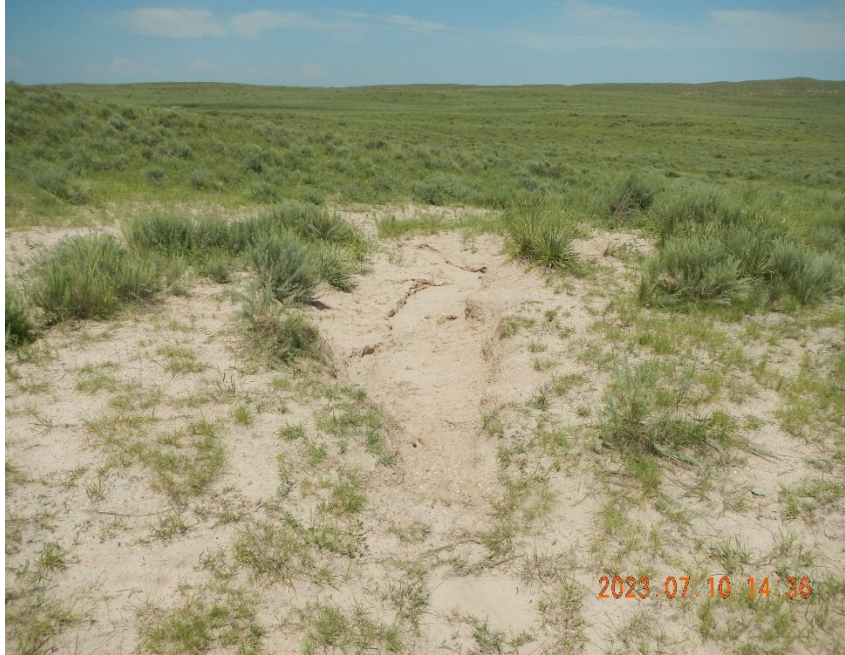
9. Erosion channel looking down slope to the NE from location.

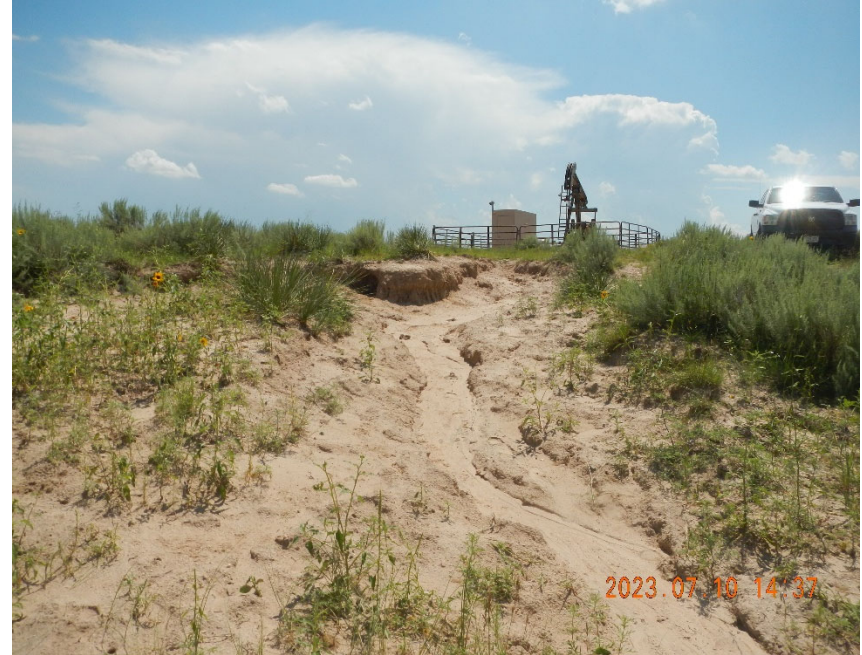
10.0 Erosion channel looking SW towards location.
