Inspection Photos

API: 043-06059

Operator: JAVERNICK OIL

Inspection Date: 7/13/2023

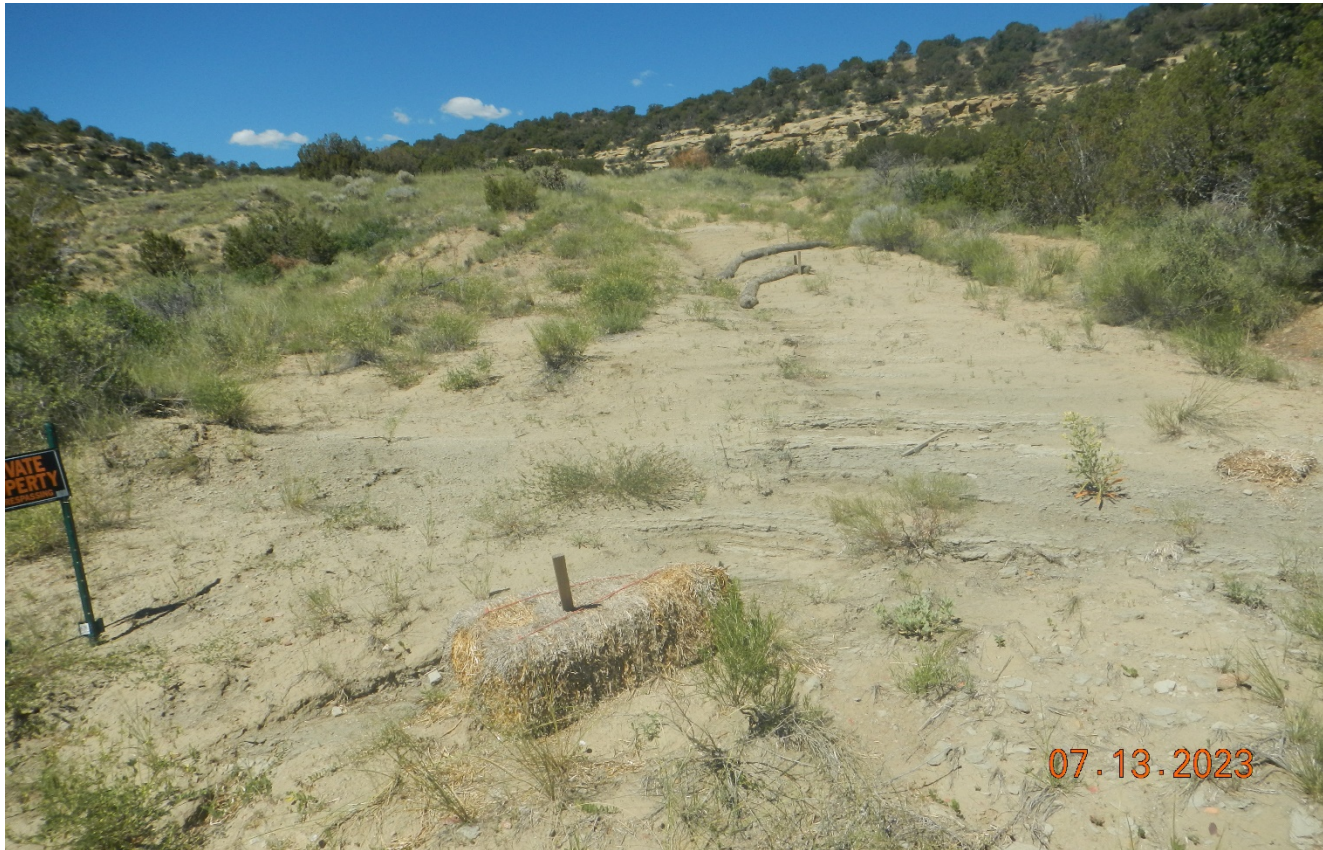
Photo 1. Facing southwest toward the former access road. This area is not stabilized with vegetation and there is erosion has occurred. It appears topsoil has been scoured off this area of the former road. Previous corrective action was not completed.

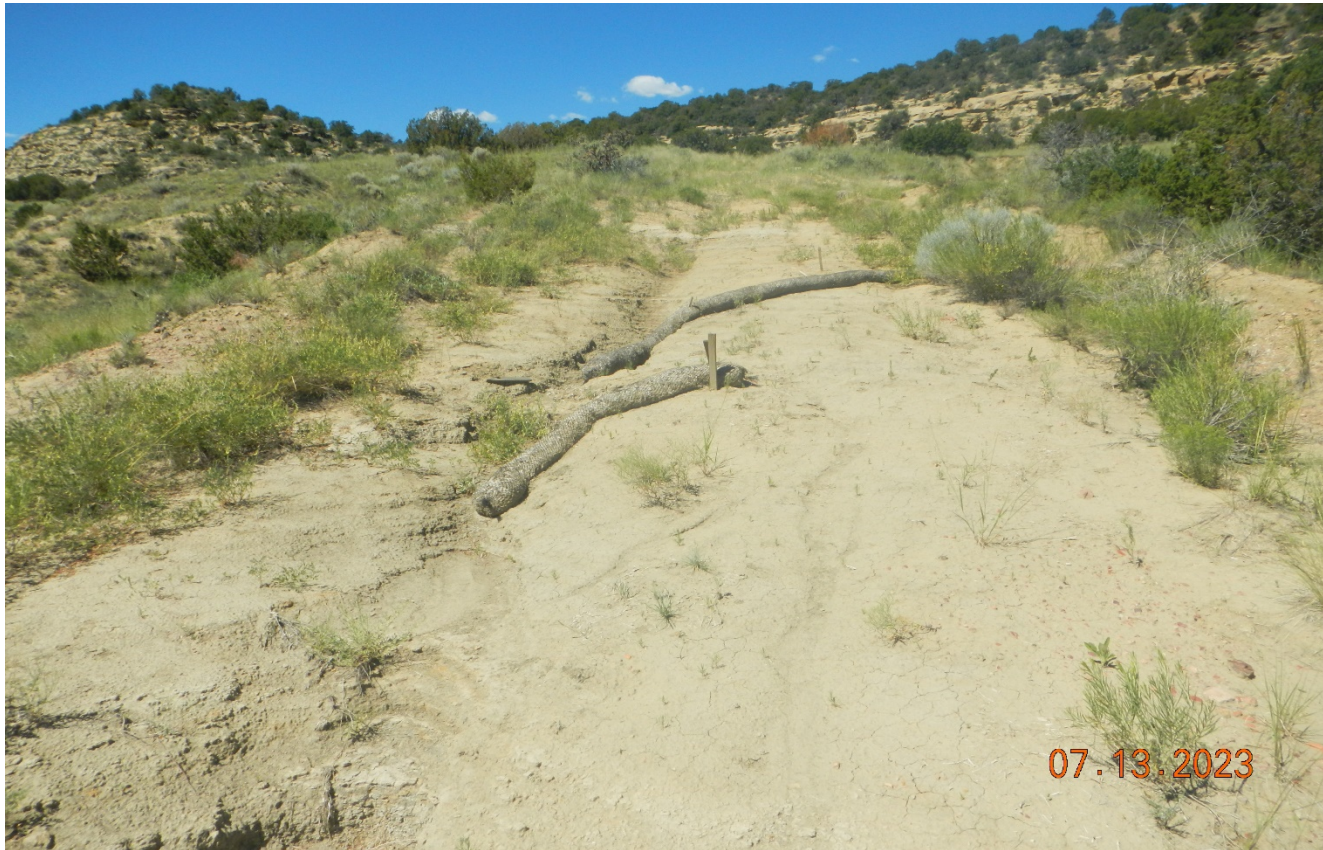
Photo 2. Facing southwest toward the former access road. There were temporary erosion controls installed which have washed out. This area of the access road needs to be reclaimed and stabilized for long term stabilization.

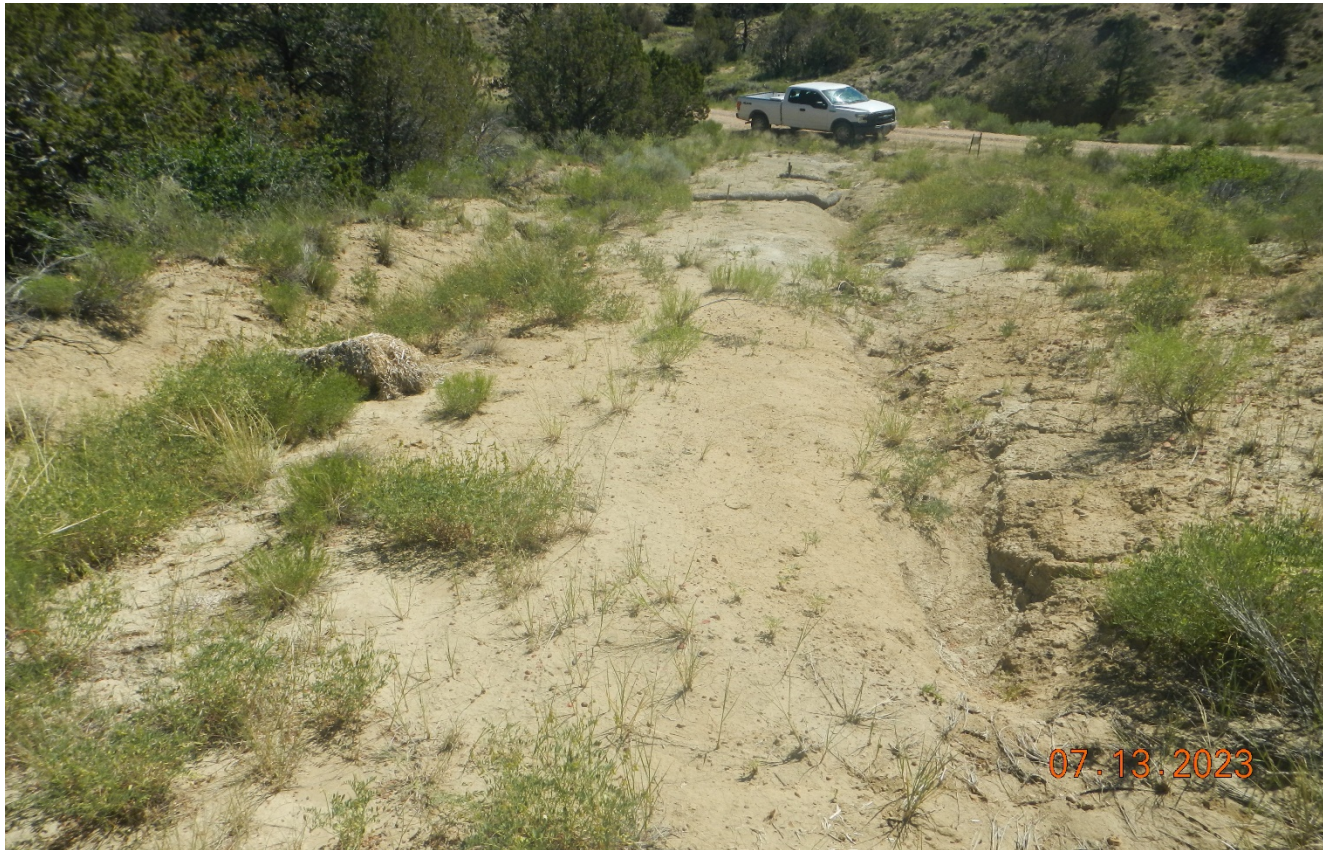
Photo 3. Facing back down the access road. There is stormwater erosion occurring on both side of the former road. Straw bales were placed on the left side and not staked in. The bales are degrading and are insufficient. This area needs to be reclaimed and stabilized for long term stabilization.

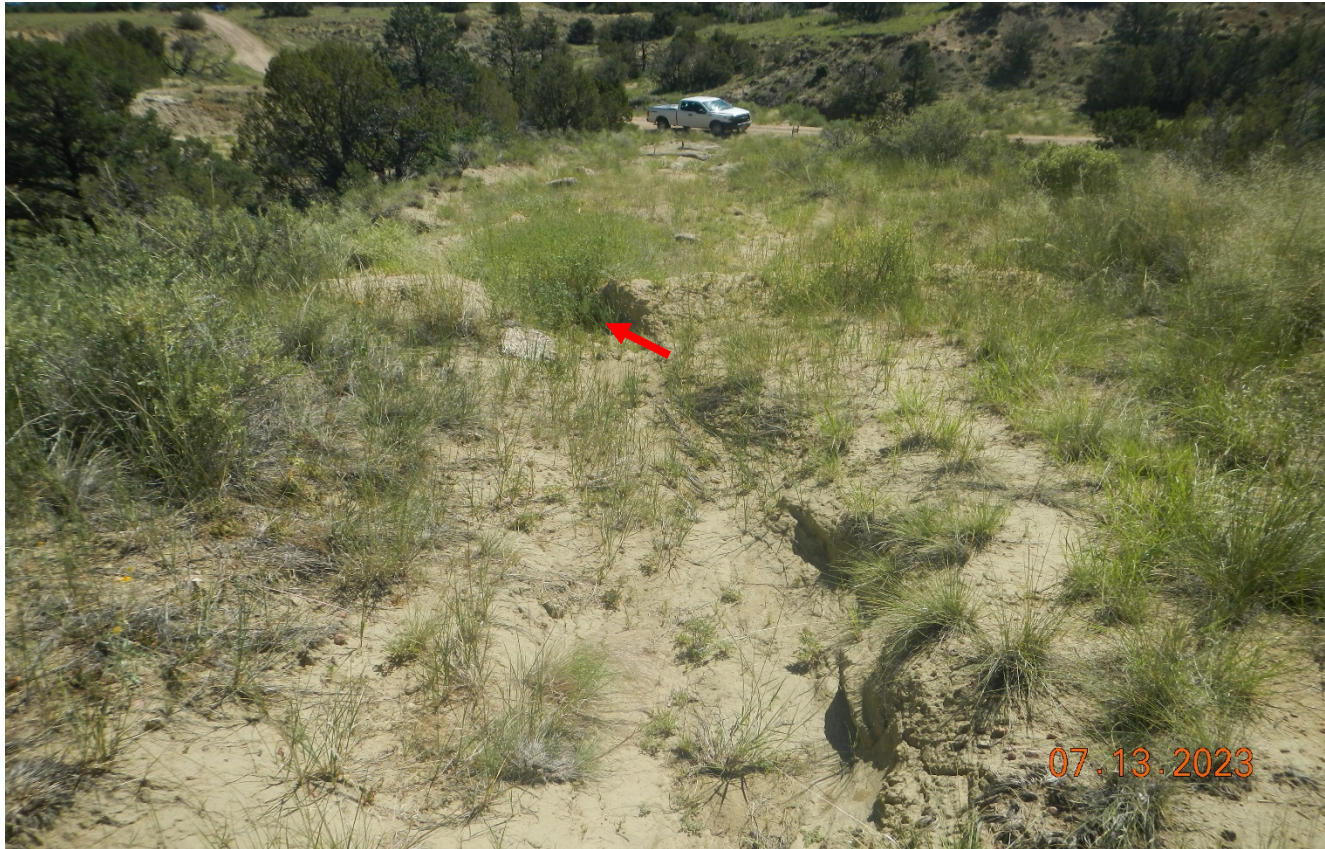
Photo 4. Further up along the access road facing northeast. There is an erosion channel directed down to the left side shown at red arrow.

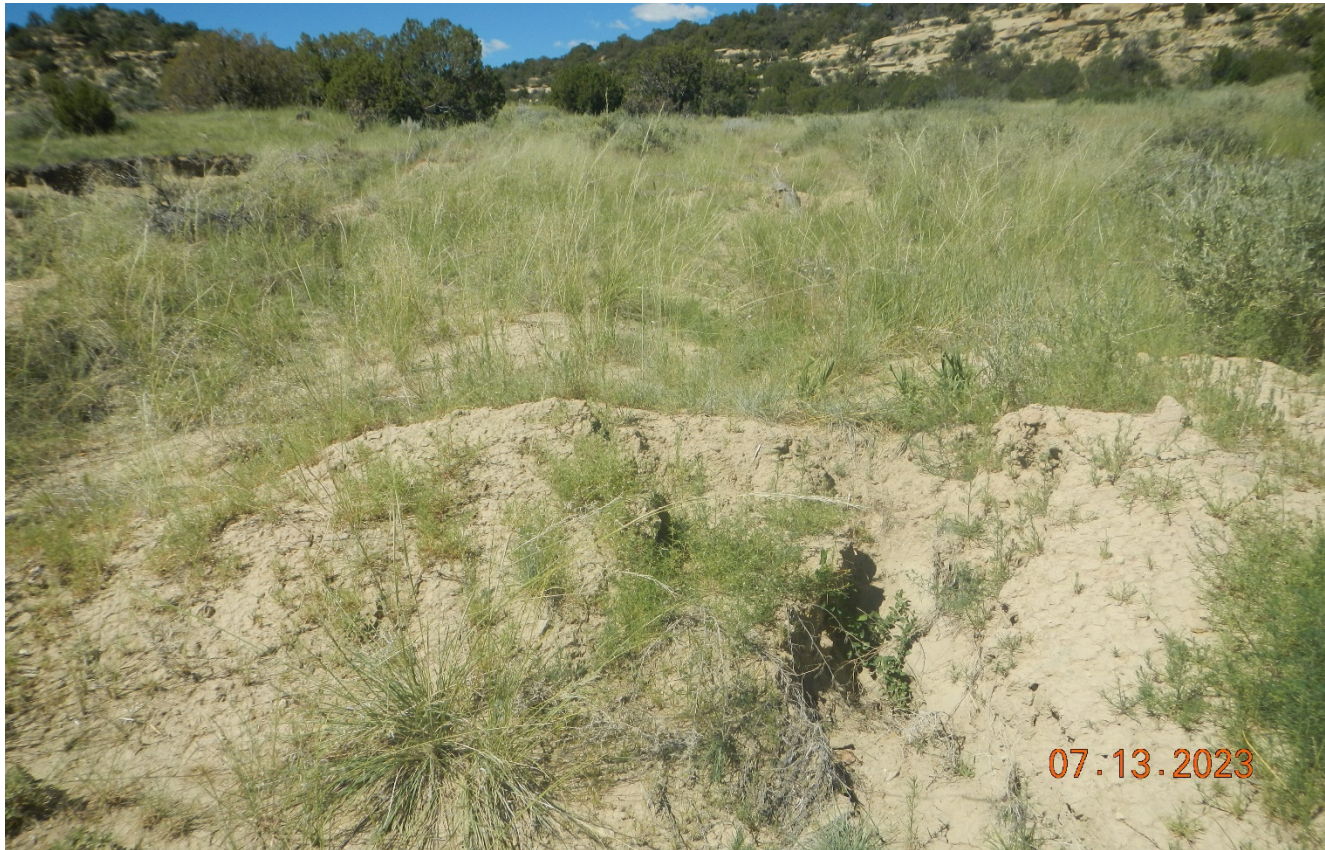
Photo 5. Facing southwest along the access road. It appears soil piles were placed along the road to slow stormwater however they have since eroded and washed out.

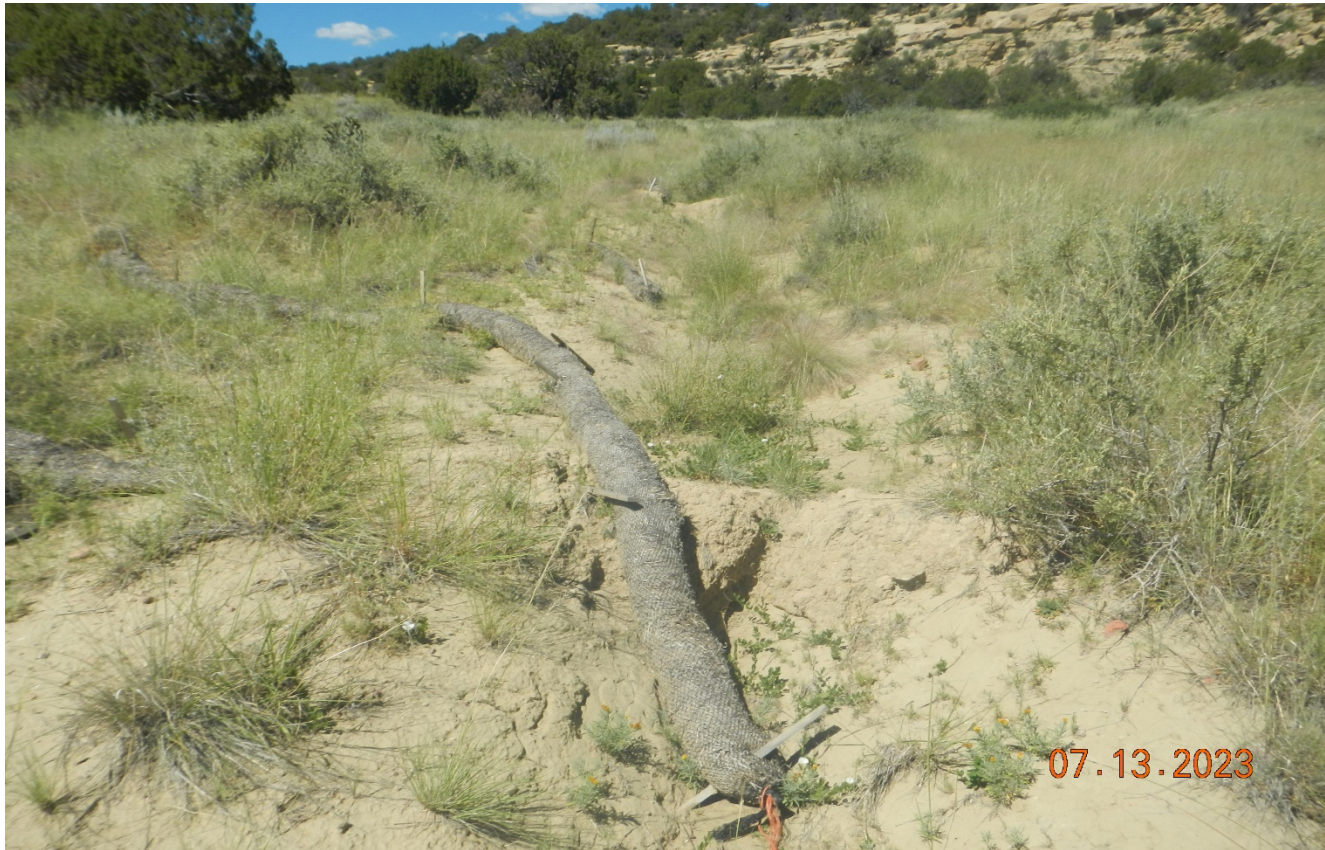
Photo 6. Facing southwest along the former access road. It appears that the stormwater from the location is directed down the road which is causing erosion issues shown in previous photos. Wattles that were installed have been washed out.

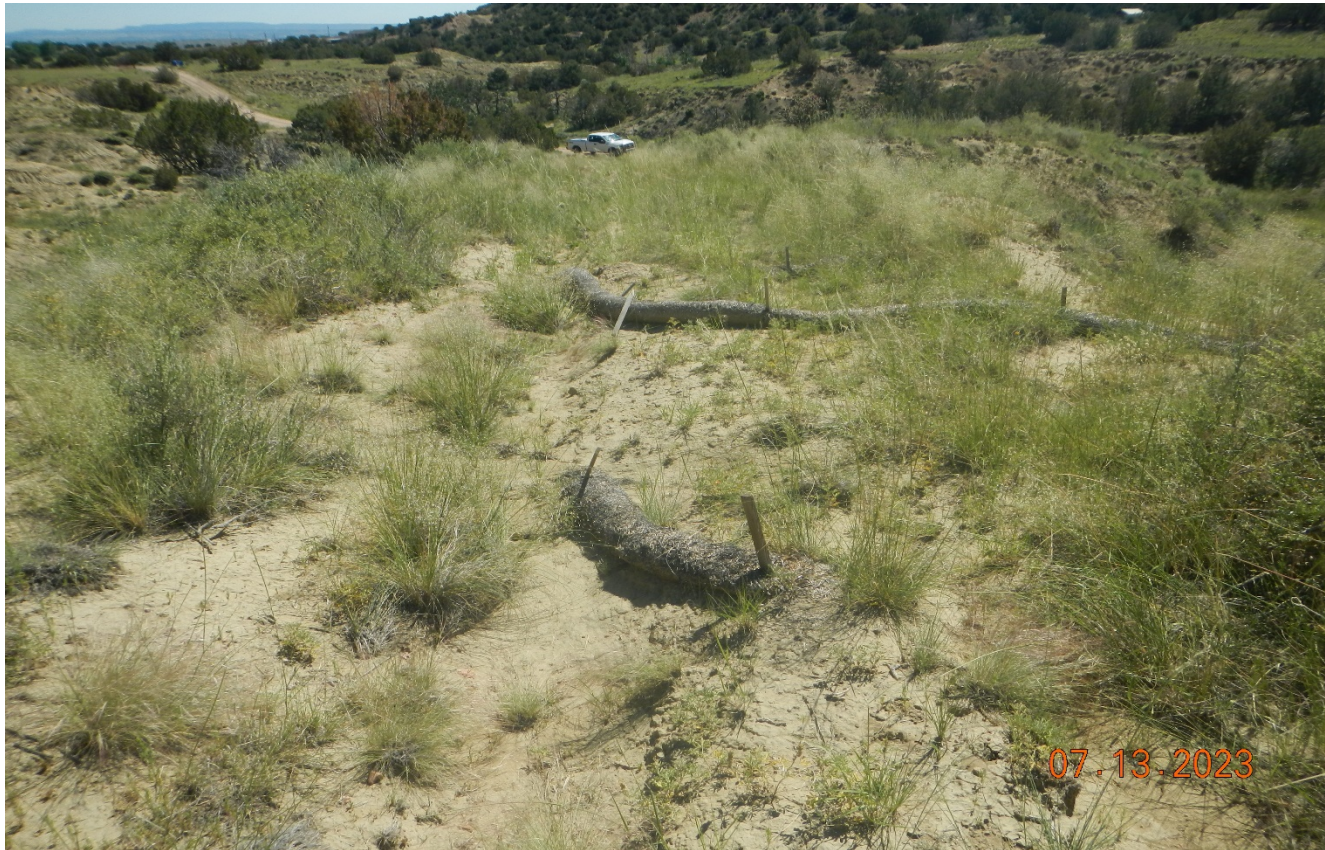
Photo 7. Facing back northeast along the former access road. It appears that the stormwater from the location is directed down the road which is causing erosion issues shown in previous photos. Wattles that were installed have been washed out.

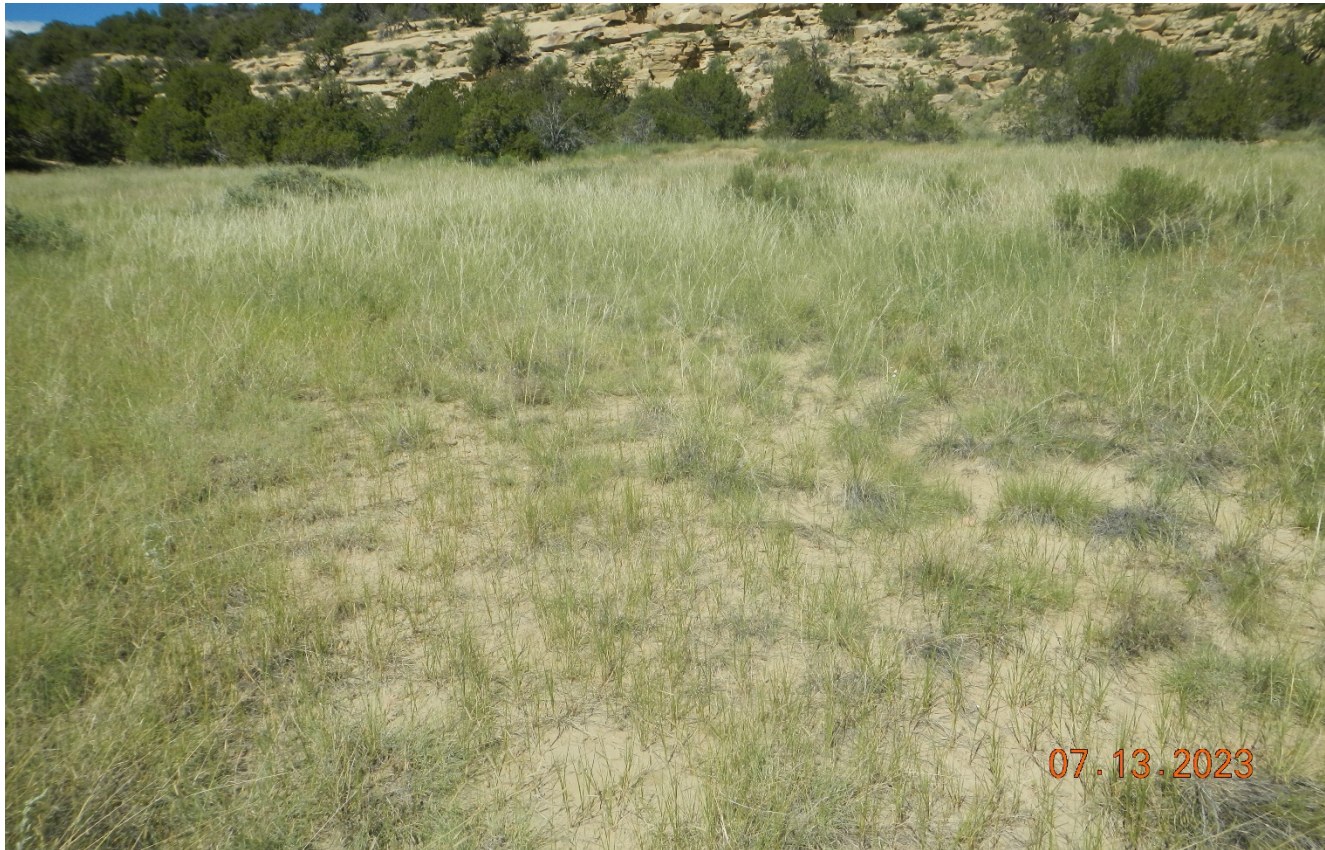
Photo 8. Facing west toward the location. Perennial native vegetation is progressing throughout the location.
