Inspection Photos

API: 043-05088

Operator: JAVERNICK OIL

Inspection Date: 7/13/2023

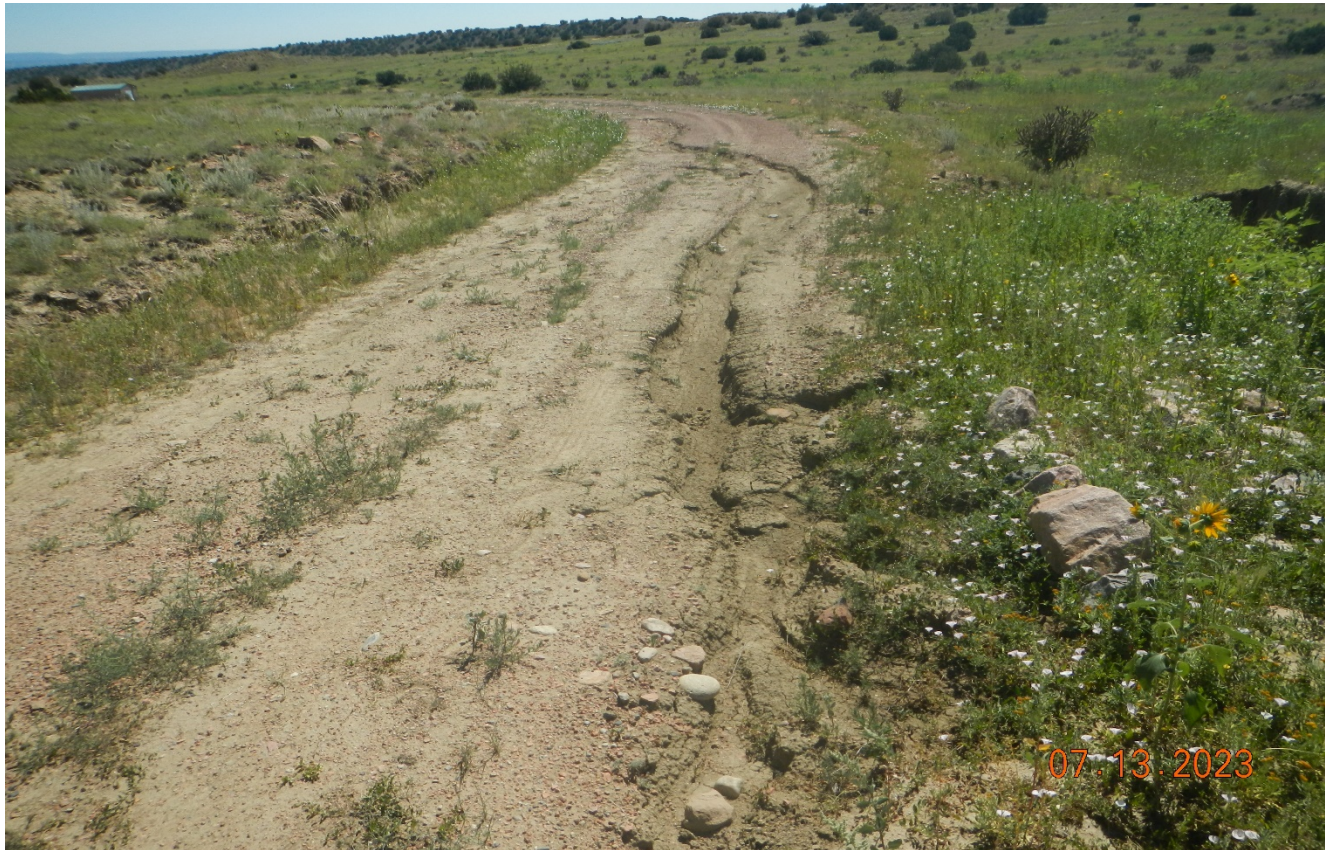
Photo 1. Facing northeast along the access road. There is erosion occurring along the road that needs to be repaired.

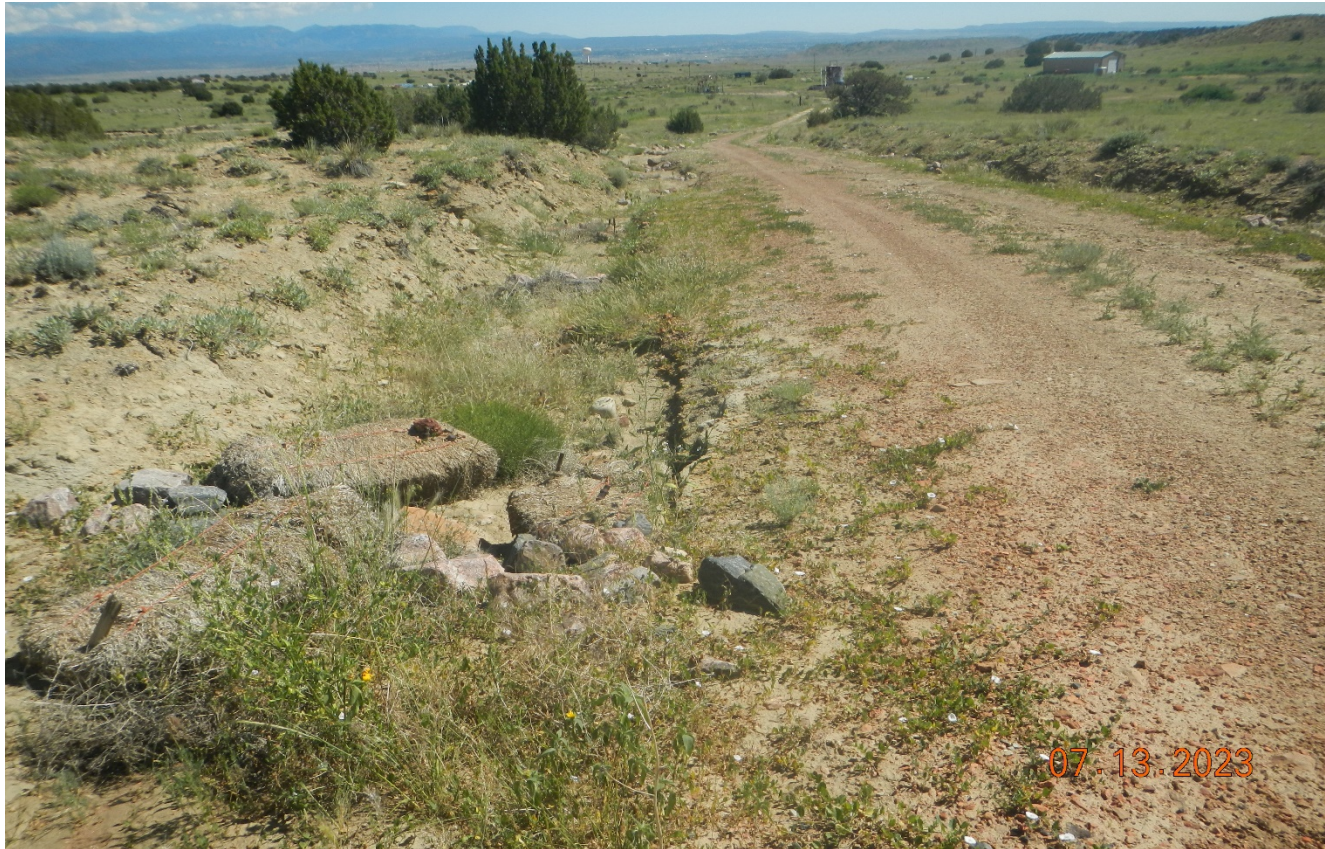
Photo 2. Facing northeast along the access road. BMP's along the road side are not maintained and have filled in with sediment.

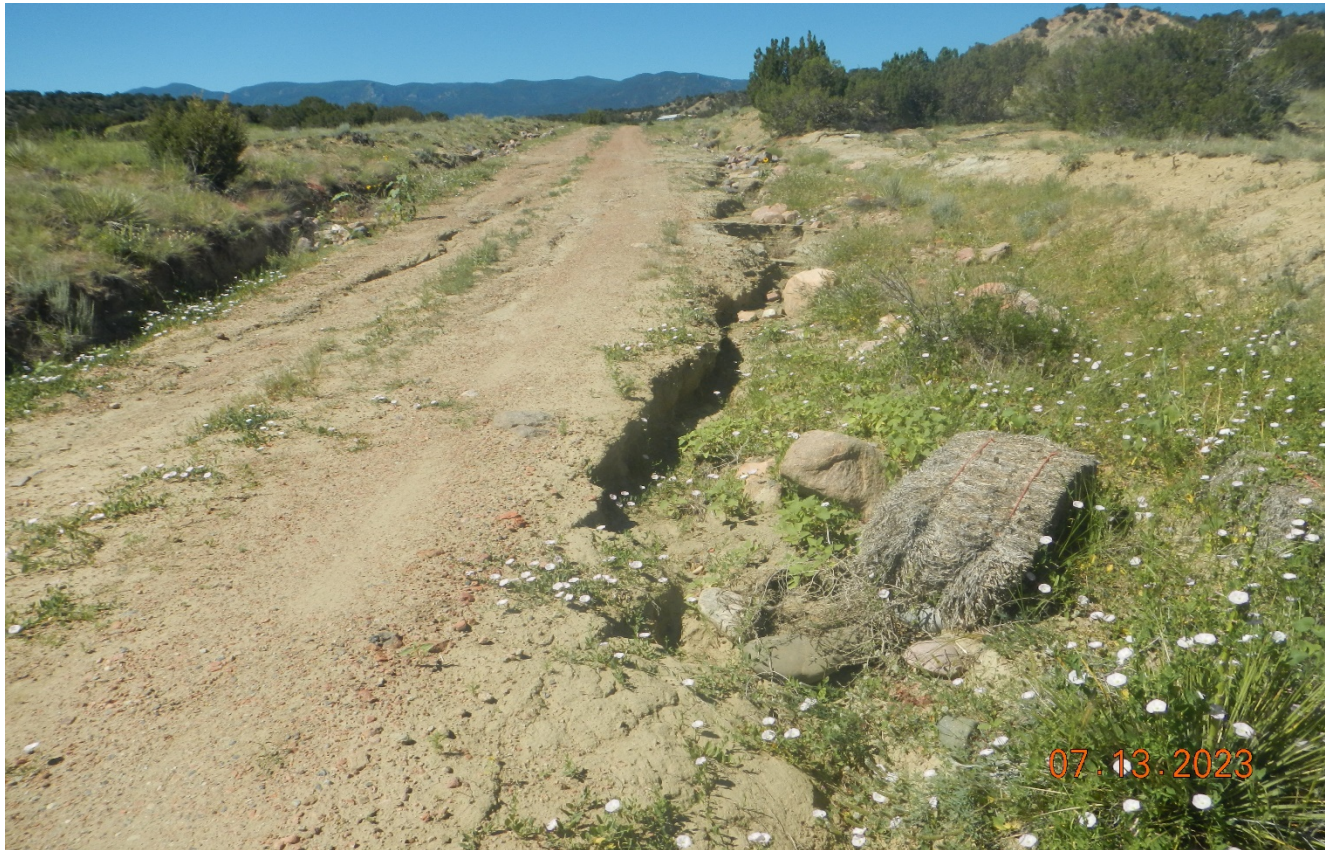
Photo 3. Facing back southwest along the access road. Stormwater has eroded around the rock check dams. The straw bale is displaced and degraded.

There are noxious weeds (Field bindweed) along the road that need to be controlled.

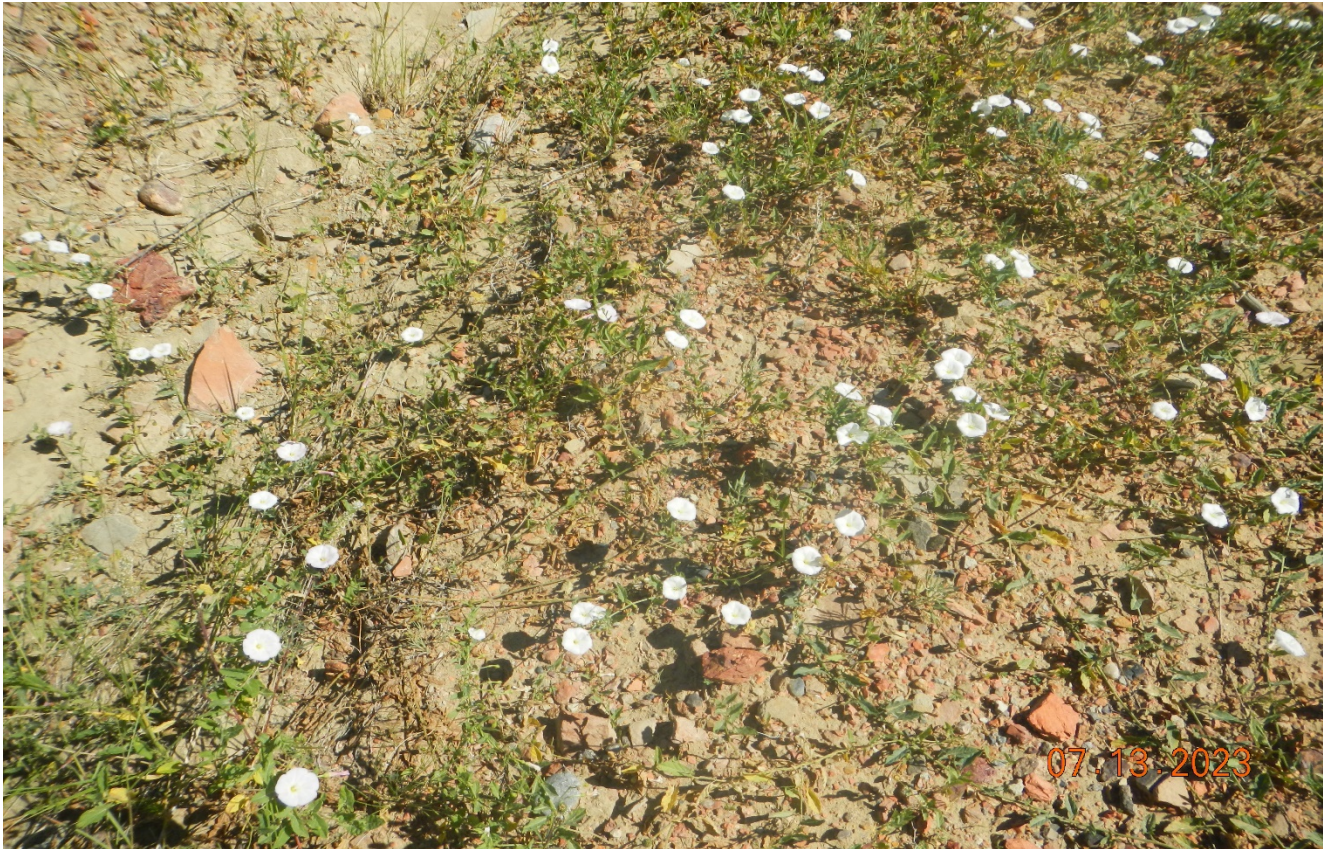
Photo 4. View of Field bindweed which is a noxious weed that needs to be controlled.

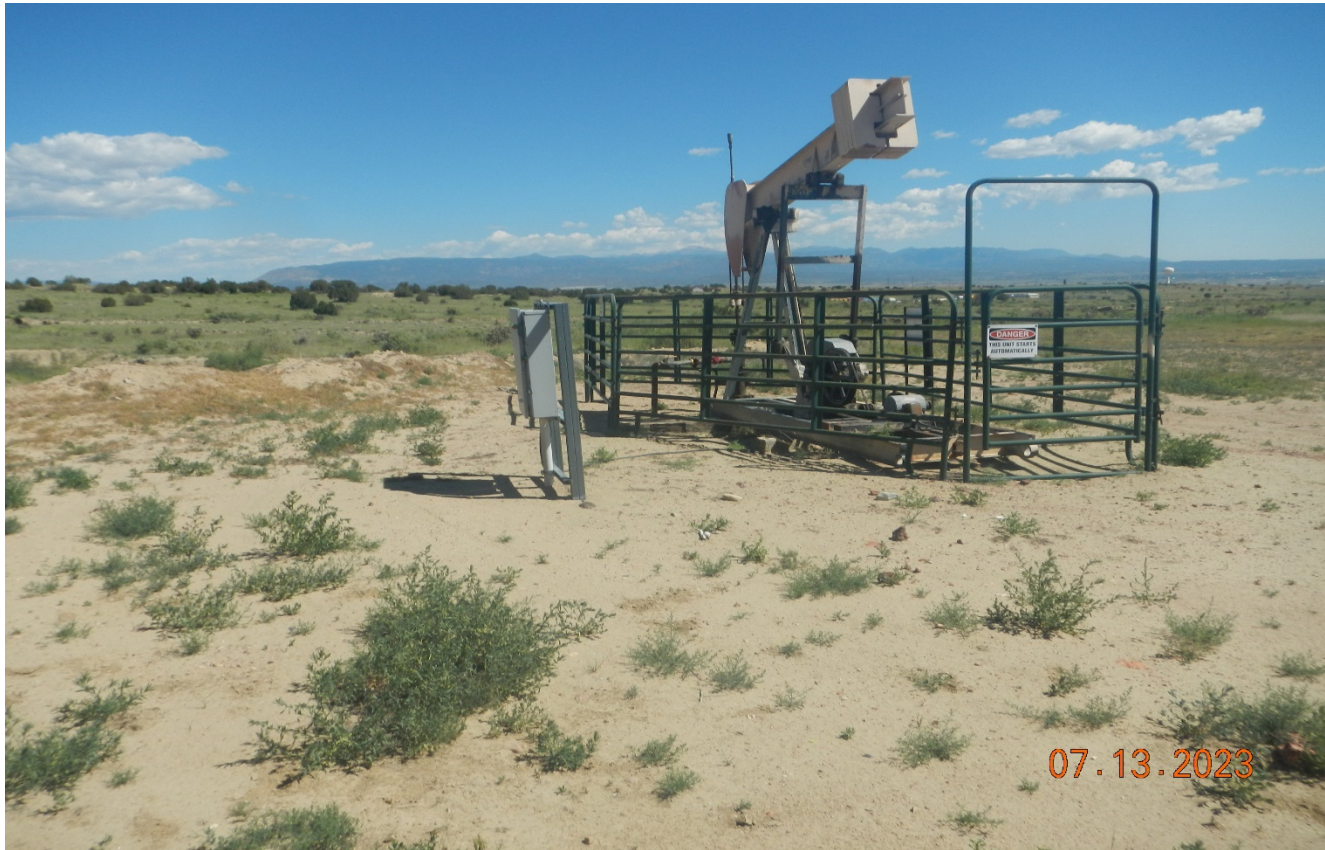
Photo 5. Facing toward the wellsite.

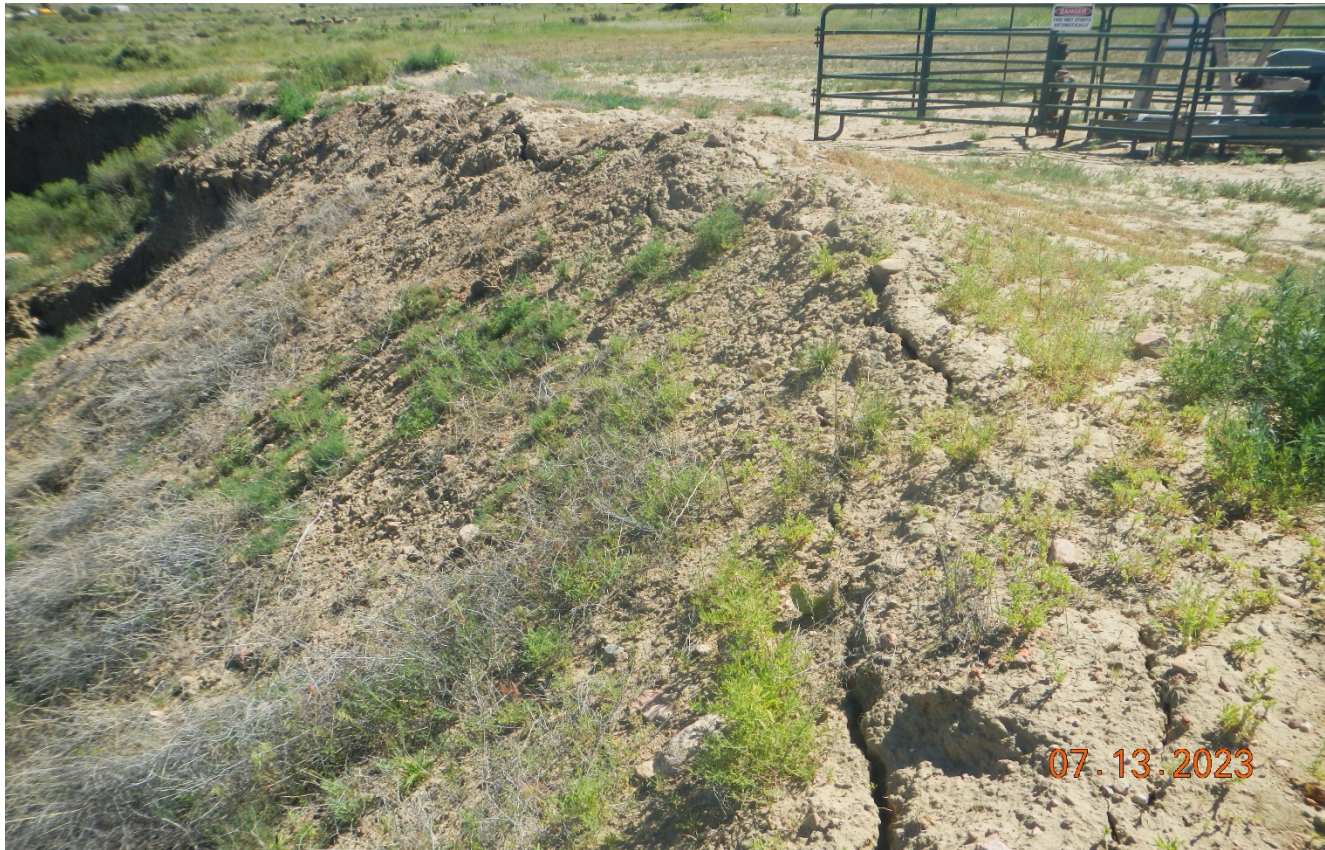
Photo 6. It appears additional soil was brought into the erosion gully near the well however, this area is not stabilized. There are cracks along this area which indicate soil movement which needs to be stabilized.
